FIELD ASSESSMENT NOTES

Subwatershed: Bavon

Site Name: BCB School (BO-1)

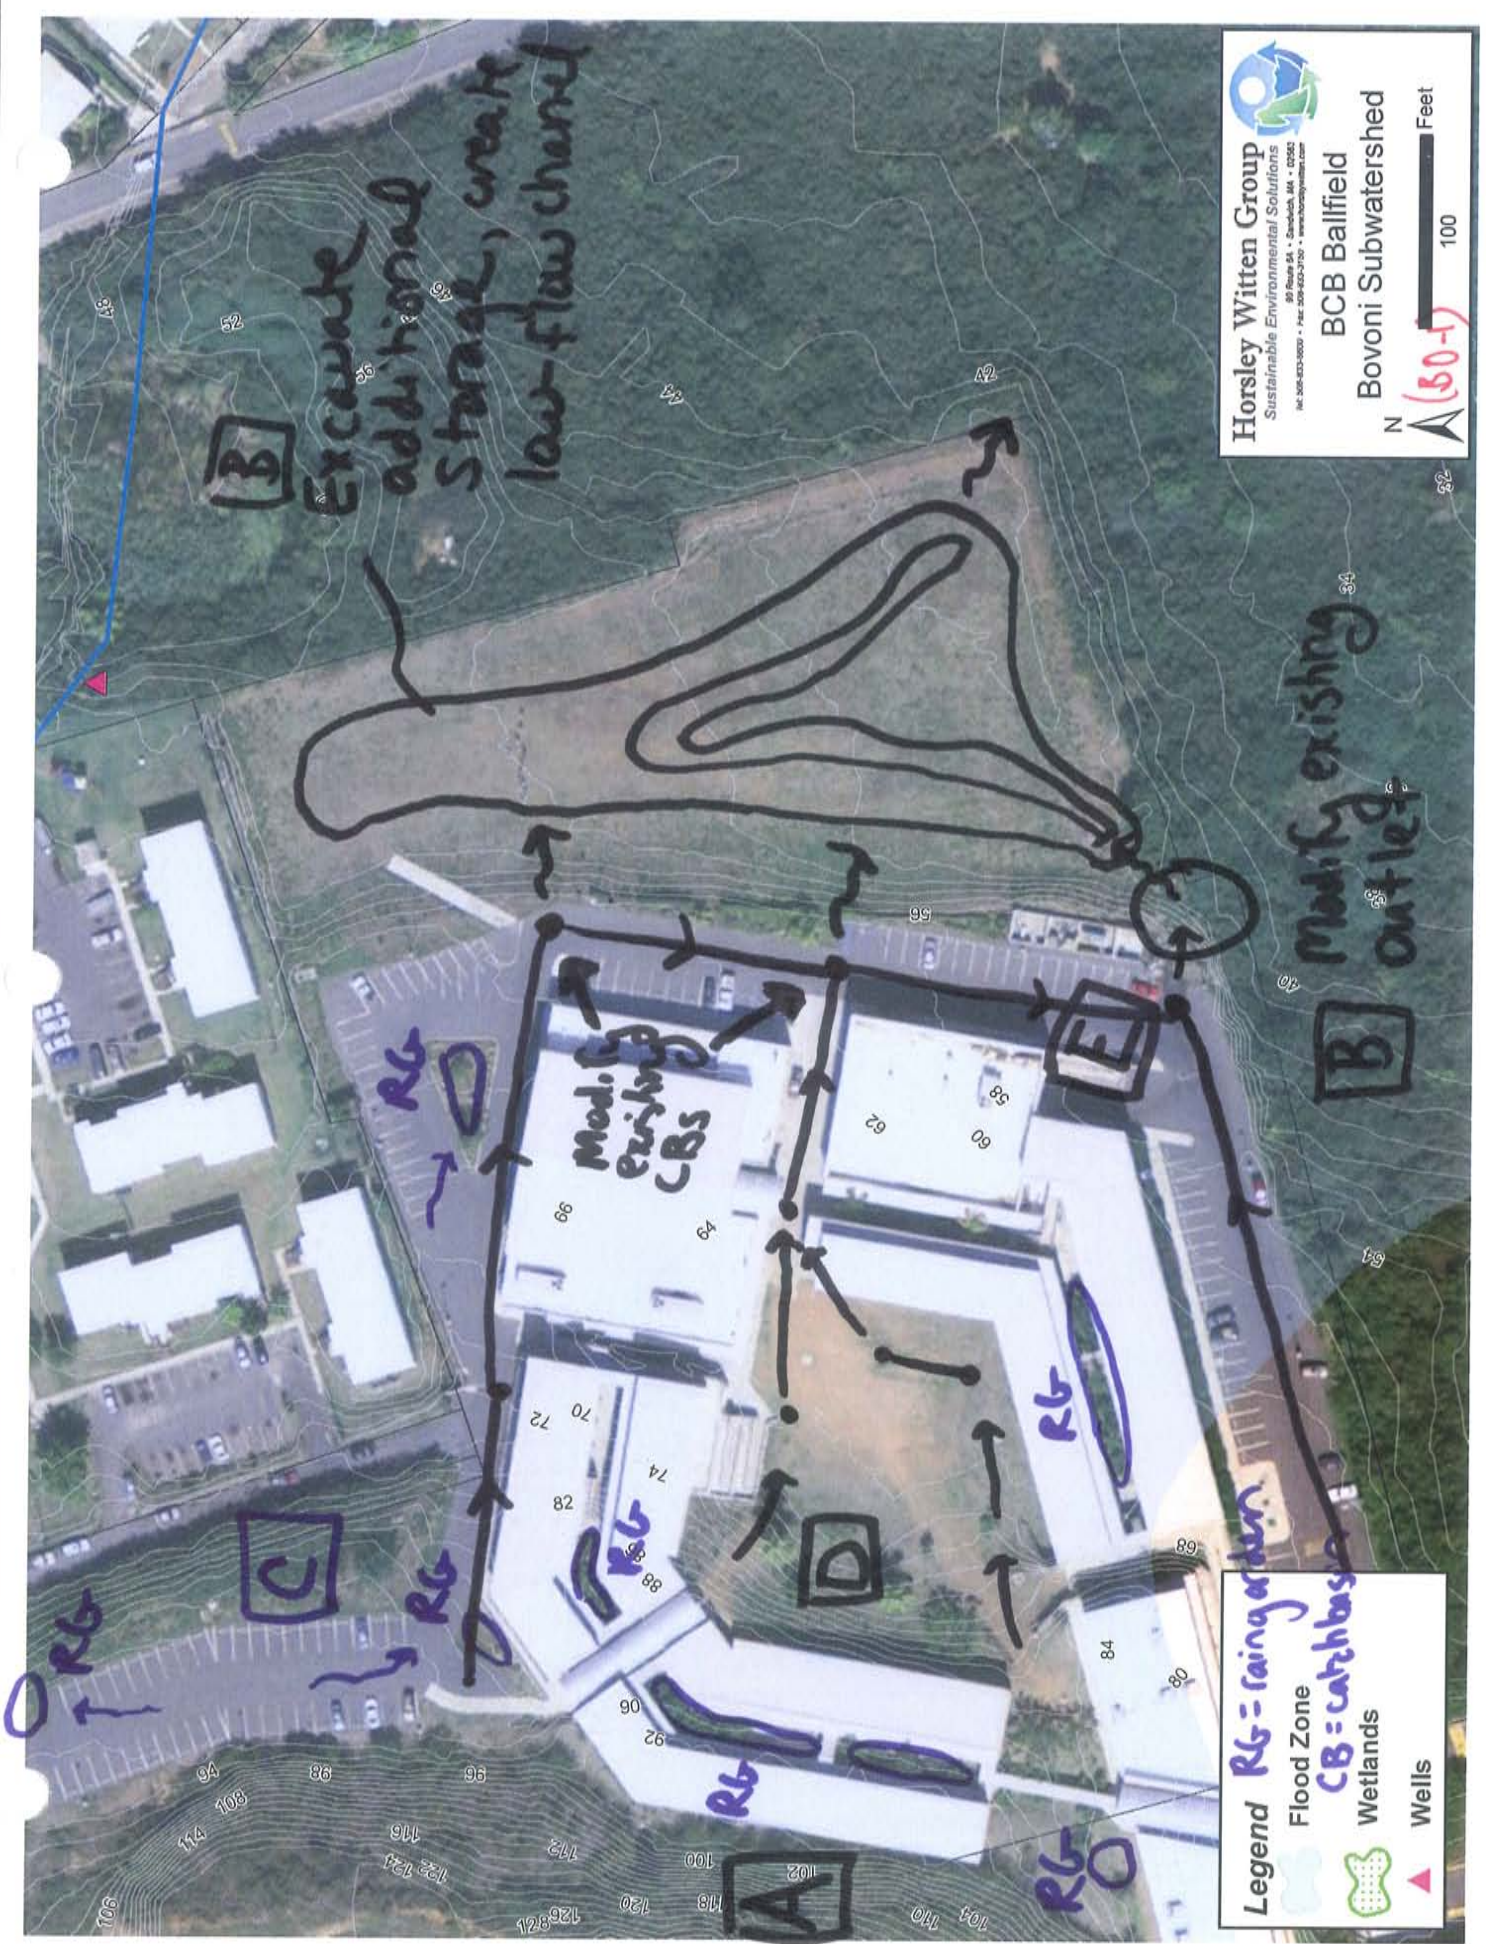
BCB Ballfield
Bovoni Subwatershed

used to have flooding problem, fixed it with a 6-foot pipe from behind the school down to the gut. Inlet to pipe is clogged with vegetation. Some roof drains connected to a cistern that overflows since it isn't used.
Septic/Sewer? Sewer
cisterns? Yes, one big cistern → irrigation. Next to cafeteria
How does H₂O enter 6' pipe? There is an inlet, but we couldn't find it.

Courtyards all have "rain gardens" that could be retrofitted to function better. Graded slope in main courtyard. All catchbasins flow down to same outfall area at corner of parking lot → into gut. Some H₂O may eventually flow into unused ball field. Dumpsters are right by gut, uncovered, and leaking into catchbasin.

- Retrofit concrete swales with baffles and detention to slow H₂O down and infiltrate as possible
- Convert courtyard gardens into rain gardens
- Stabilize eroded slope in courtyard and redirect H₂O (prevent driving there?)
- Move dumpsters to better location and cover
- Redirect stormwater into ball field to create stormwater wetland
- Convert a few other areas near catch basins/parking areas into rain gardens as demo projects
- Reduce unnecessary impervious cover throughout school property (excessive parking lots?)

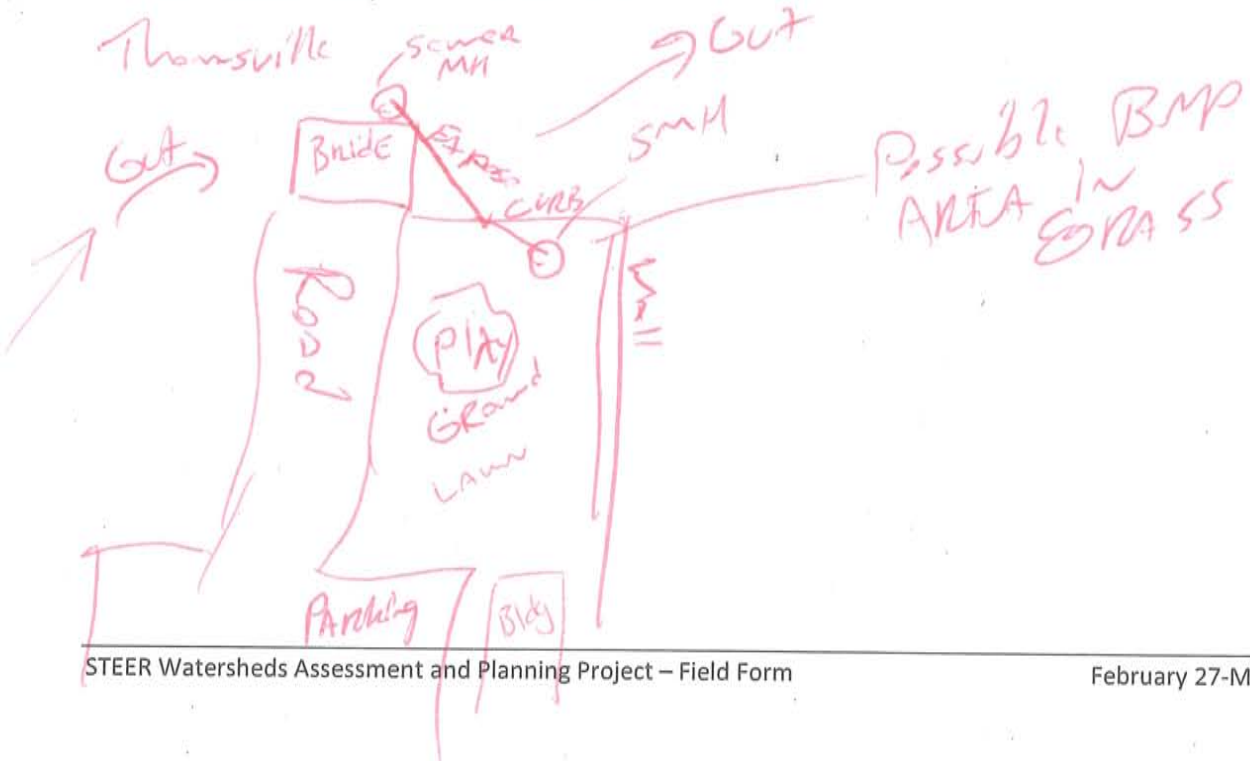
HAVE SEWER, HAVE WATER
HAVE CISTERNS w/ CISTERN OVERFLOW
Under parking LOT
Sydney → MAINTENANCE SUPERVISION

SOME EROSION IN LAWN GET
UPPER → FAIRLY GOOD SHAPE

SOME TRASH MOSTLY LAWN

AREA 7 → GUT DOWN CENTER OF ROAD OF
RESIDENTIAL DEVELOPMENT & COVERTED ROAD

* FURTHER INVESTIGATE SITE FOR R.G. OPTIONS

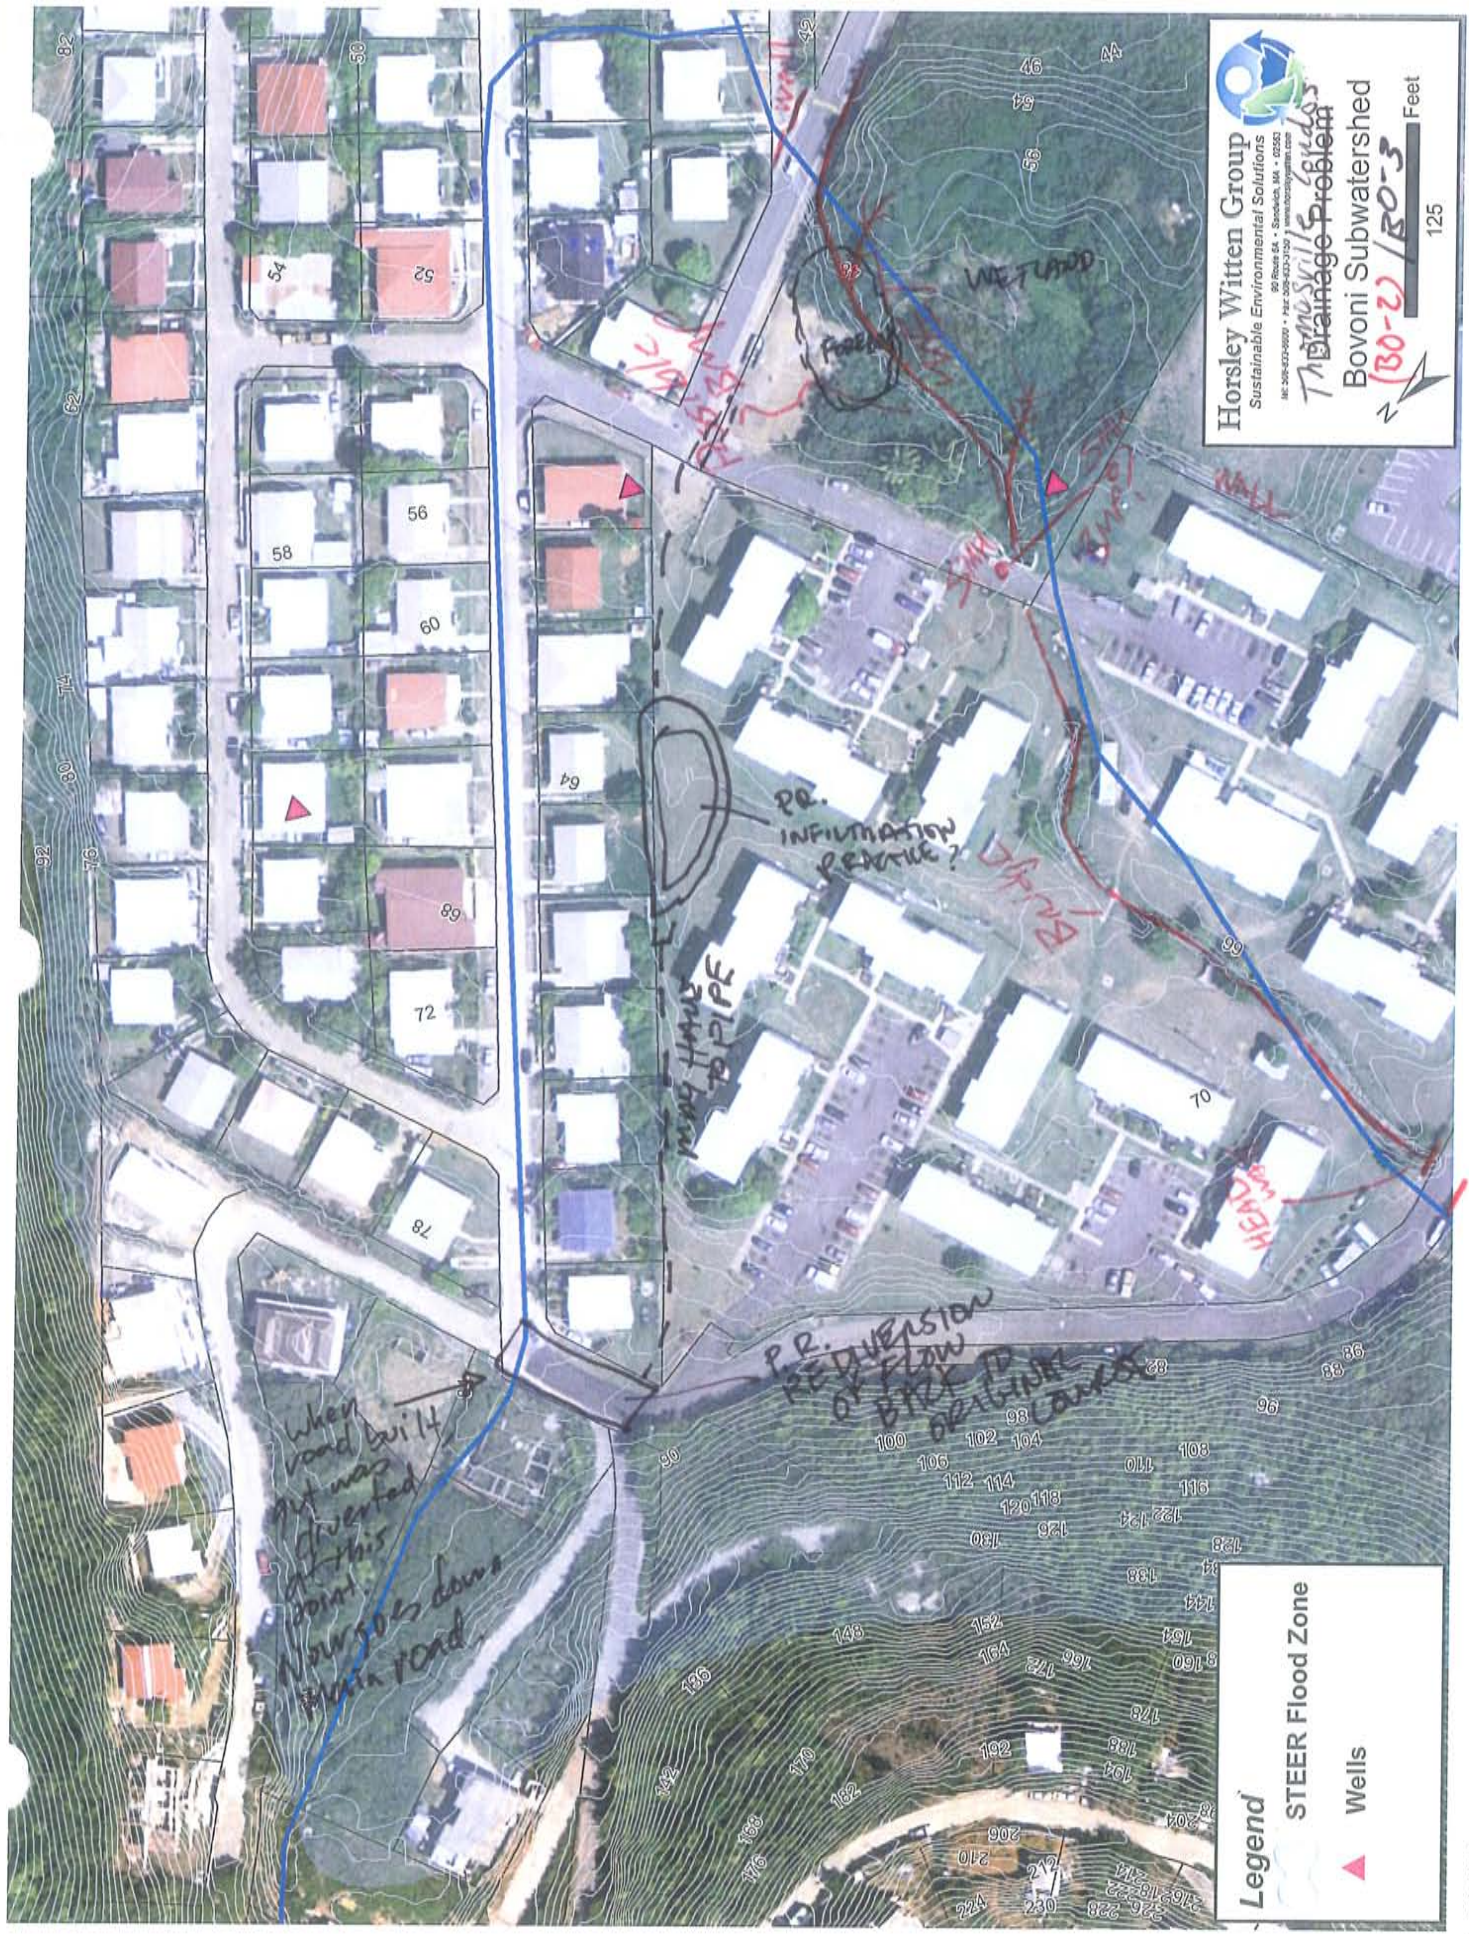
The Muskege Project
 Bovoni Subwatershed
 (B0-2) / (B0-3)

UPSTREAM OF SITE, GUT WAS DIVERTED WHEN CO-OP ROAD CONSTRUCTED (REPORTED BY CO-OP FACILITY MANAGER)

NOW GUT GOES DOWN ROAD TO TEXACO (30-7).

when road built
 it was diverted
 down this
 gully down
 with road

may have
 to PIPE

P.R.
 INFILTRATION
 PROTECTIVE?

P.R. DIVERSION
 OF FLOW
 BACK TO
 DRAINAGE
 CANAL

CONSIDER OPTION FOR RESTORING GUT TO ORIGINAL PATH; PIPE IT BEHIND HOMES, OPEN UP INTO AN INFILTRATION ~~AT~~ OR UNDERGROUND STORAGE TANK (TO USE FOR IRRIGATION AT CO-OP) AND THEN OVERFLOW TO WOODEN LOT.

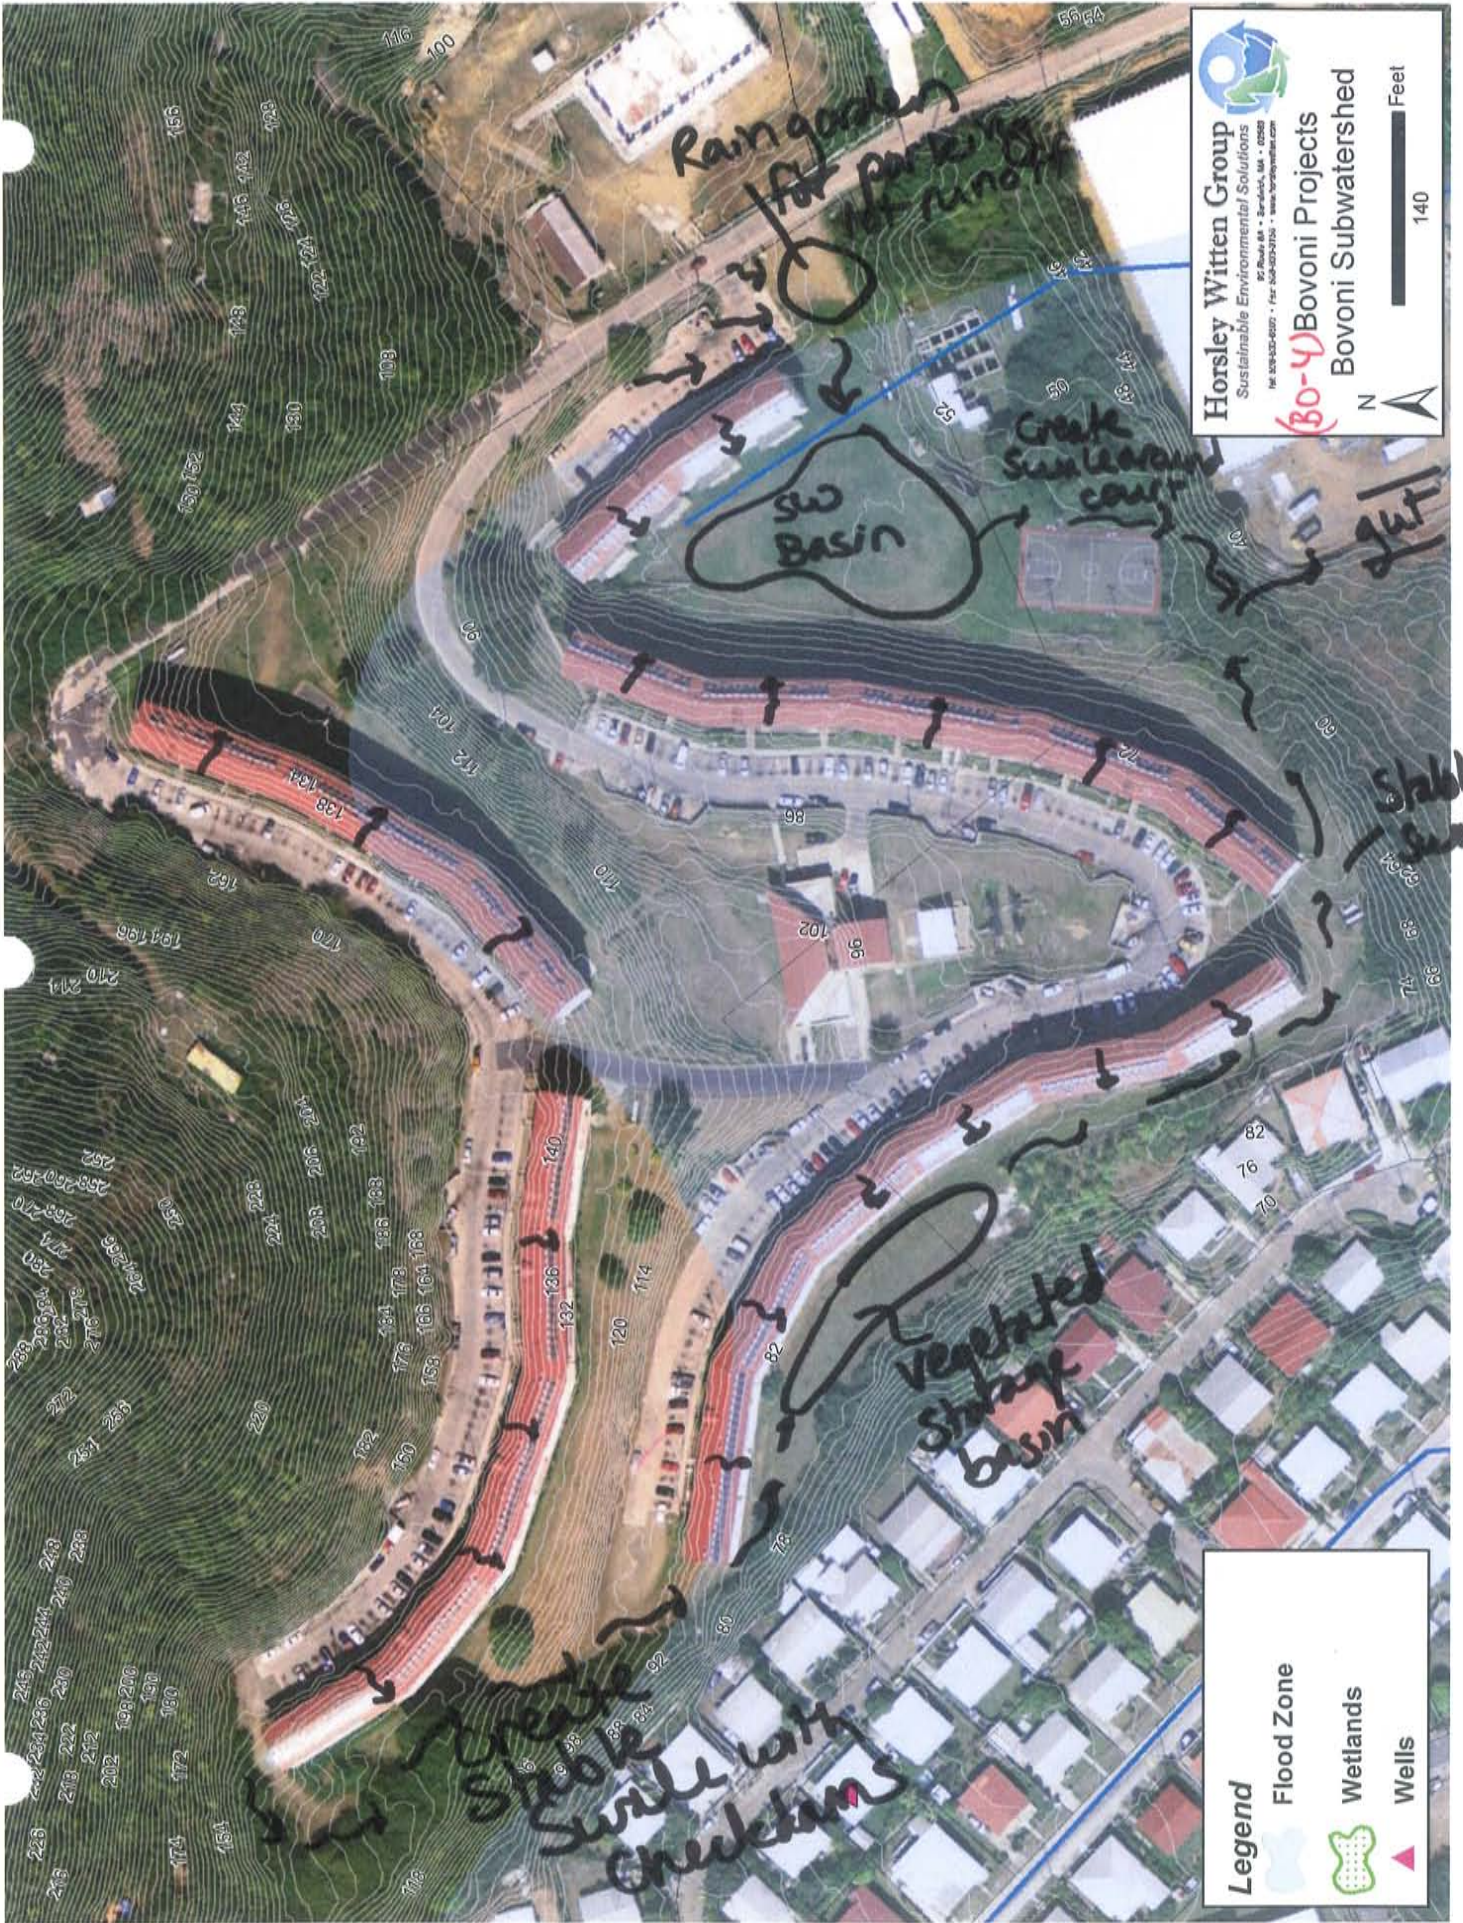
(30-4) Bovoni Projects
 Bovoni Subwatershed

HAVE cisterns → not used Pigeons. Also mentioned a NATURAL spring

Erosion outside from spring and on Runoff (most likely). Regarding ~~water~~ FIRE in Progress → MR Austin

Stormwater collects by Comb cuts that direct under buildings that ARE ^{occupied} TRASH RACKS. TRASH RACKS have maintenance doors for access & MR Austin said they clean regularly. Cisterns → slowly release to ground to help storage.

Dumpsters uncovered. MR Austin mentioned that he has a problem with Air borne Trash & Debris Around the site.

- Cover dumpsters
- Stabilize steep slopes with vegetation to reduce erosion
- Consider using cisterns again for gray water
- Formalize stable swales add stormwater vegetated stormwater basins for water quality and storage → prevent/reduce downstream issues.
- Construct rain garden near easternmost parking lot

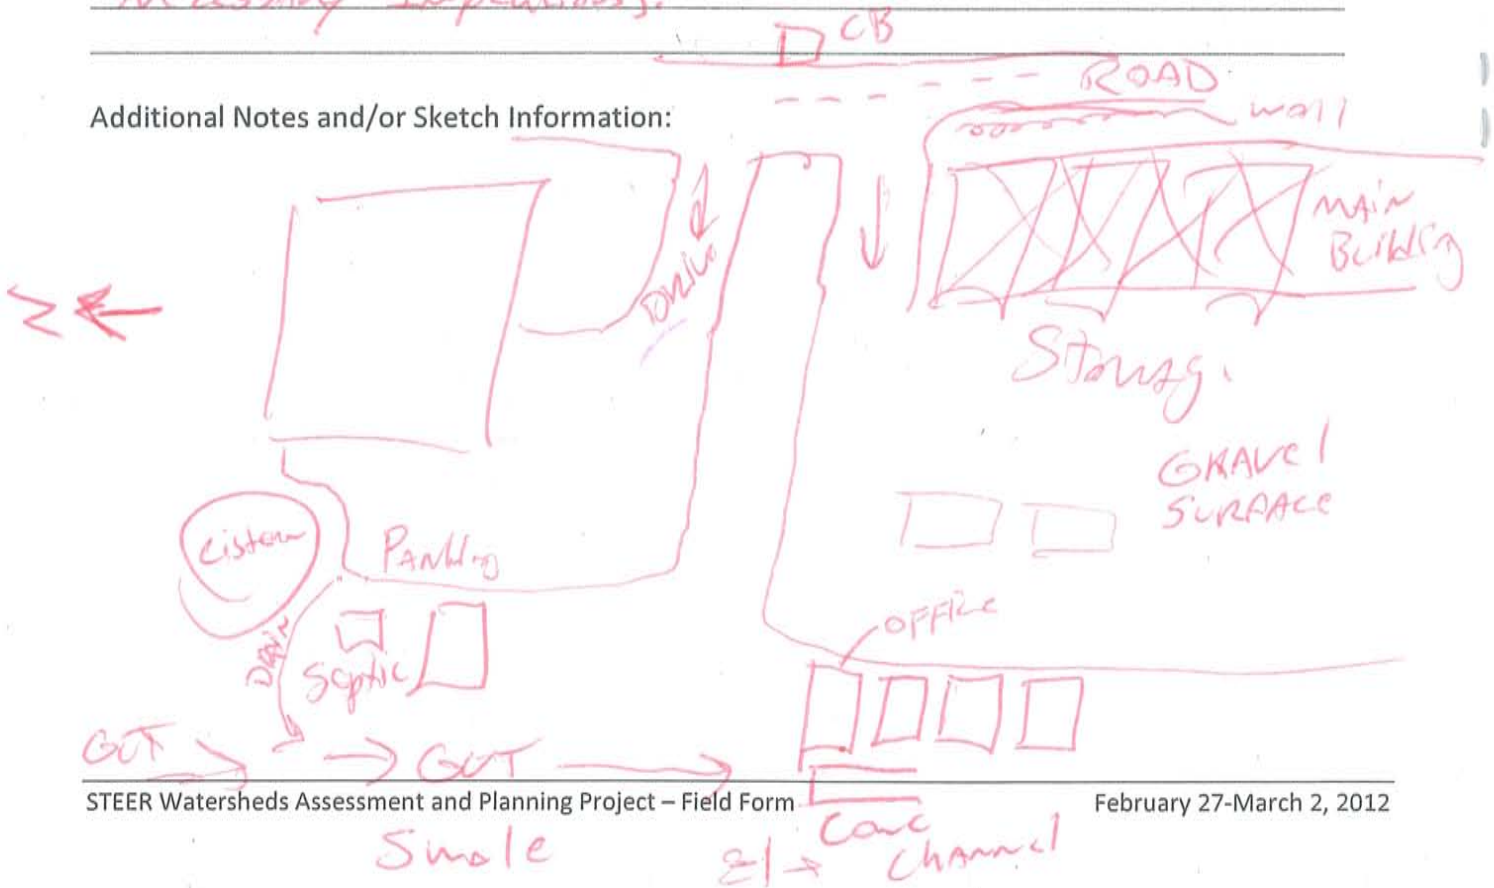
Field
Septic directly adjacent to gut w/ BANANA TREES
over & around. Has what appears to be
A septic tank.

Recommendations:
Monitor/maintenance of septic system

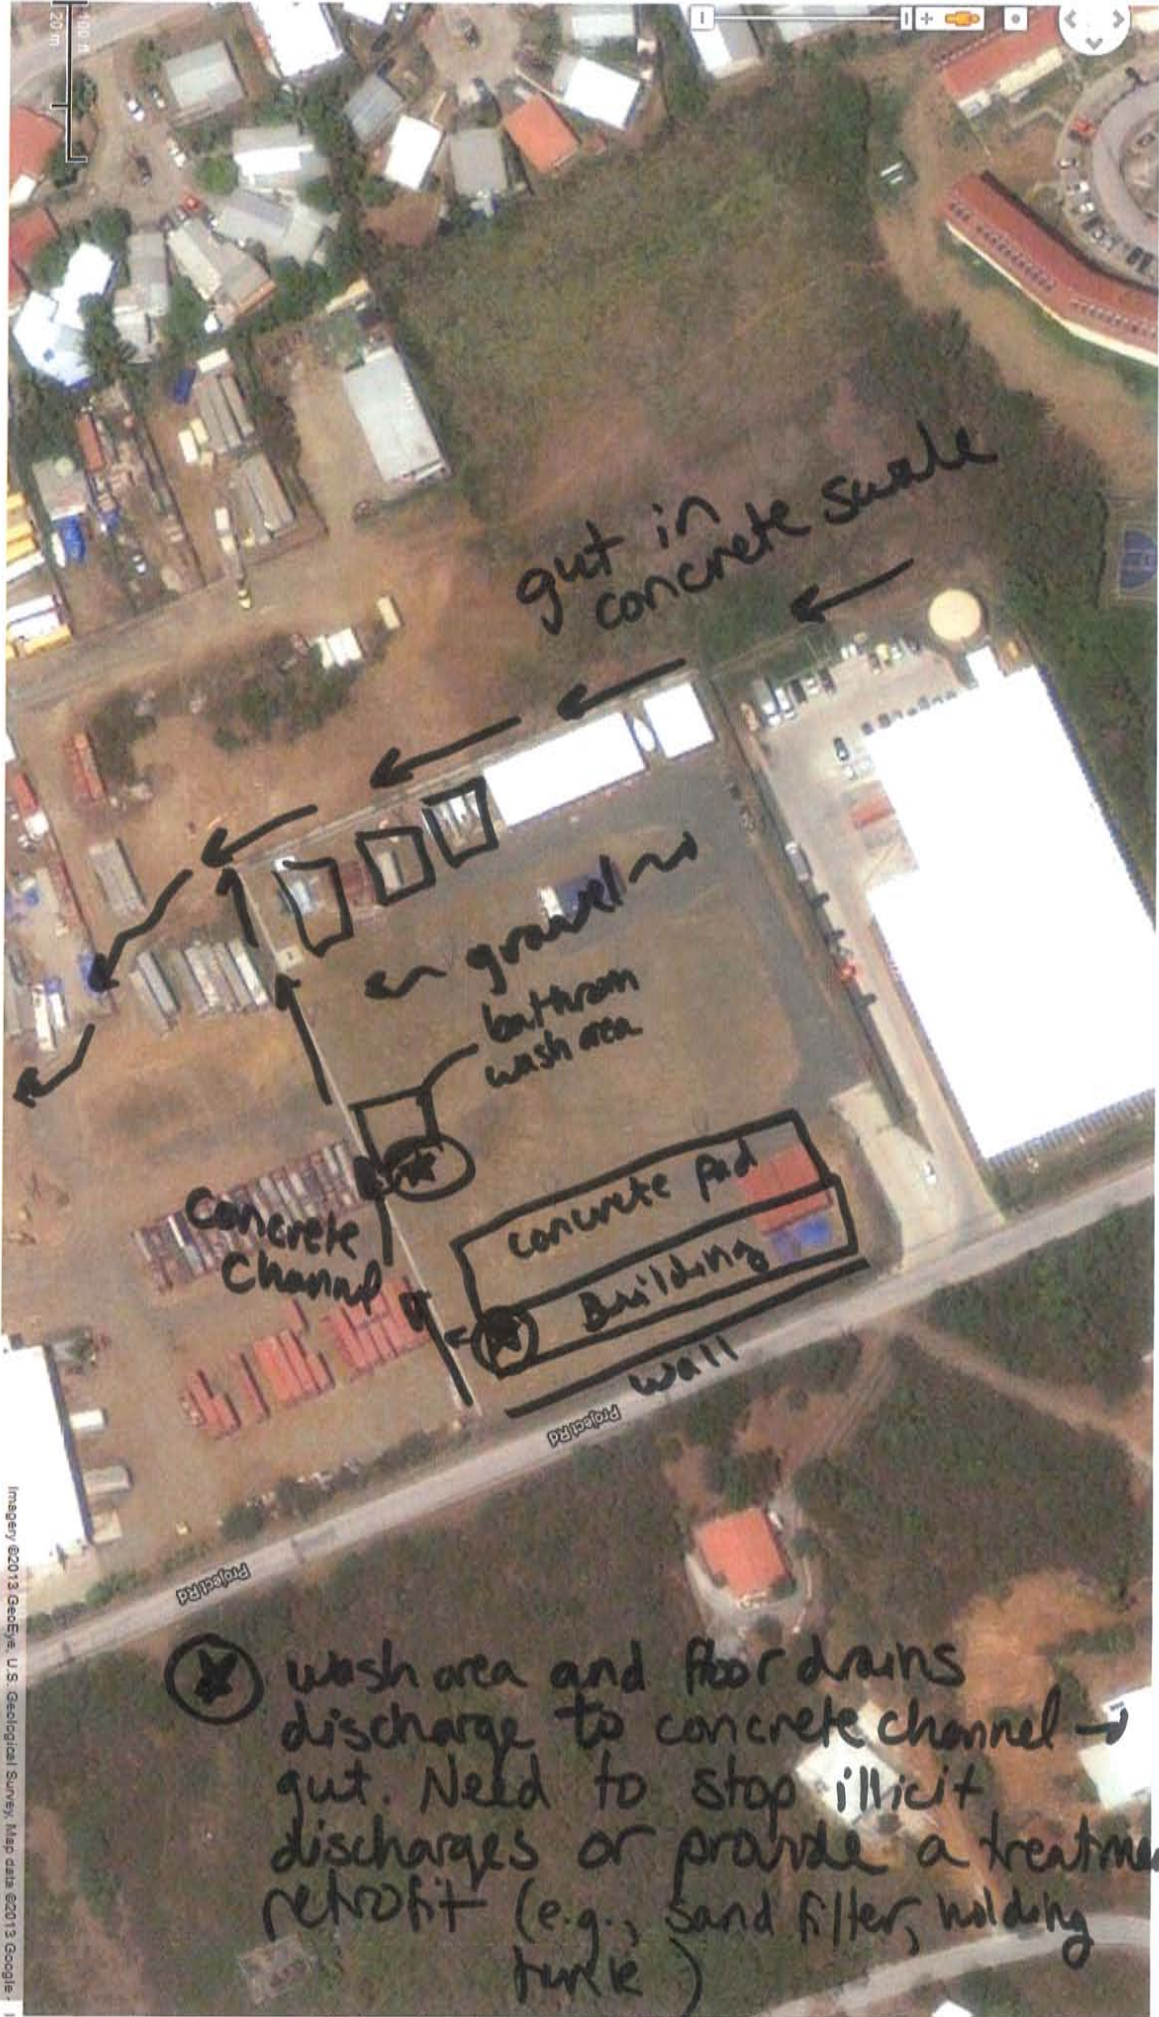
(B0-6) Booni Bulk Storage

Runoff from site collected in concrete channel along southern property line. Also discharging a sink and spray down cleaning from within main building. Appears roof runoff also goes to channel. Possible water closet adjacent to sink. Not sure where it discharges but did not appear to be the channel.

★ wash area and floor drains discharge to concrete channel → gutter. Need to stop illicit discharges or provide a treatment retrofit (e.g., sand filter, holding tank)

Retrofit would be education of cleaning operations and containment impacts.

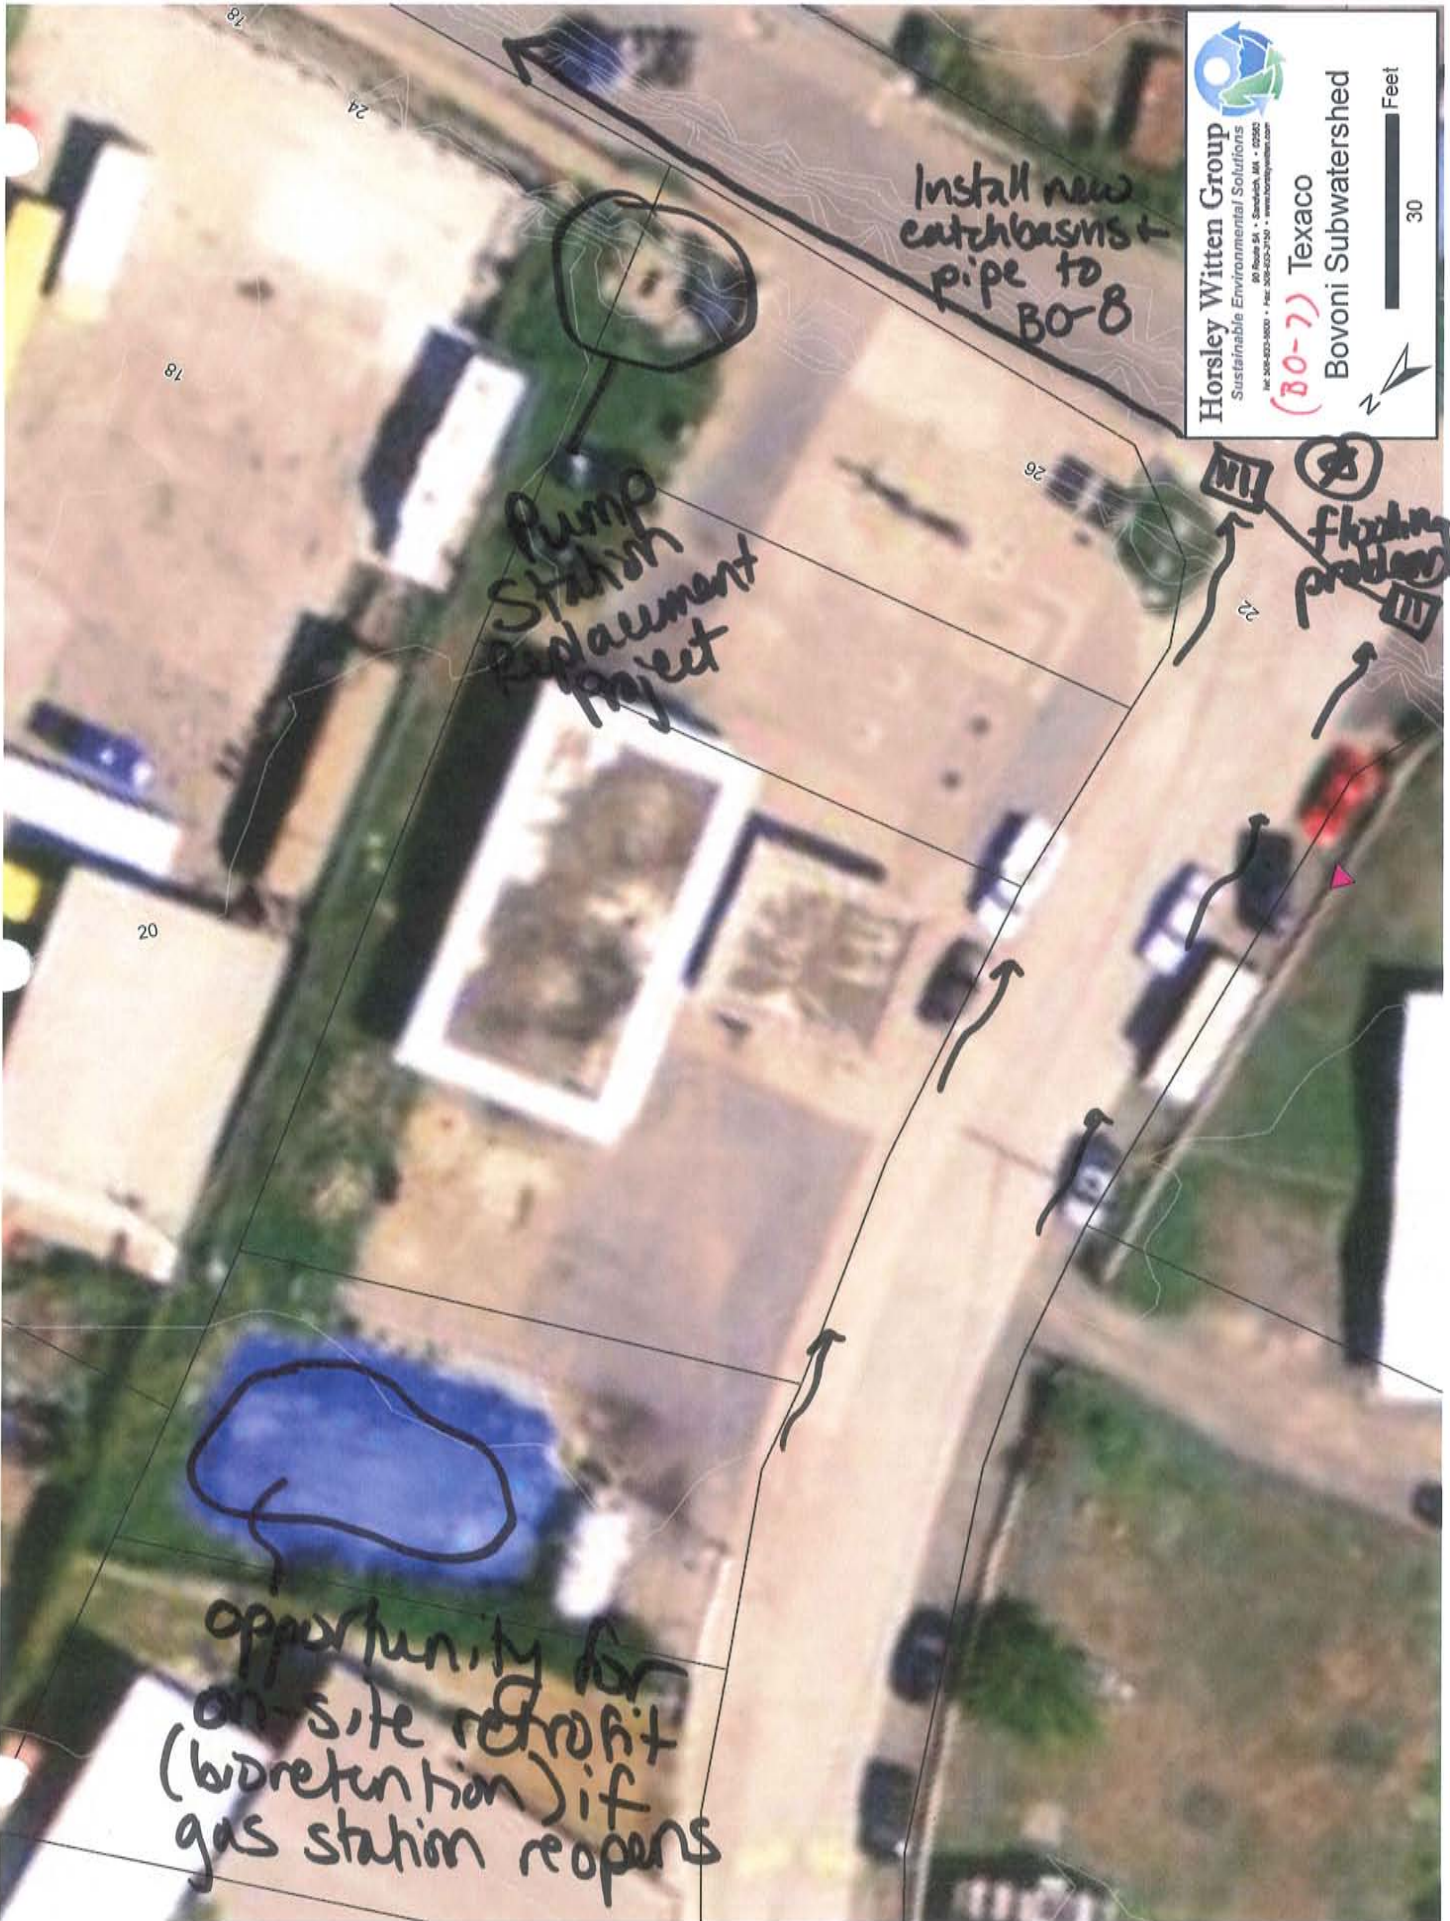
Appears Roof is Tilted To A grassed (wetland Area) ~~upstream~~ To the North of the GAS STATION, CB is clogged w/ sediment

WWPS is in bad shape and desperate for an upgrade.

Flooding on Bovoni Rd. Appears septic hauling company installed A basin T.V on effluent To keep runoff in Road.

- * Install new catchbasins/pipe at intersection to carry SW to BO-8
- * If site is redevelopment, manage on-site runoff in existing open space (e.g. rain garden/bioretentation).

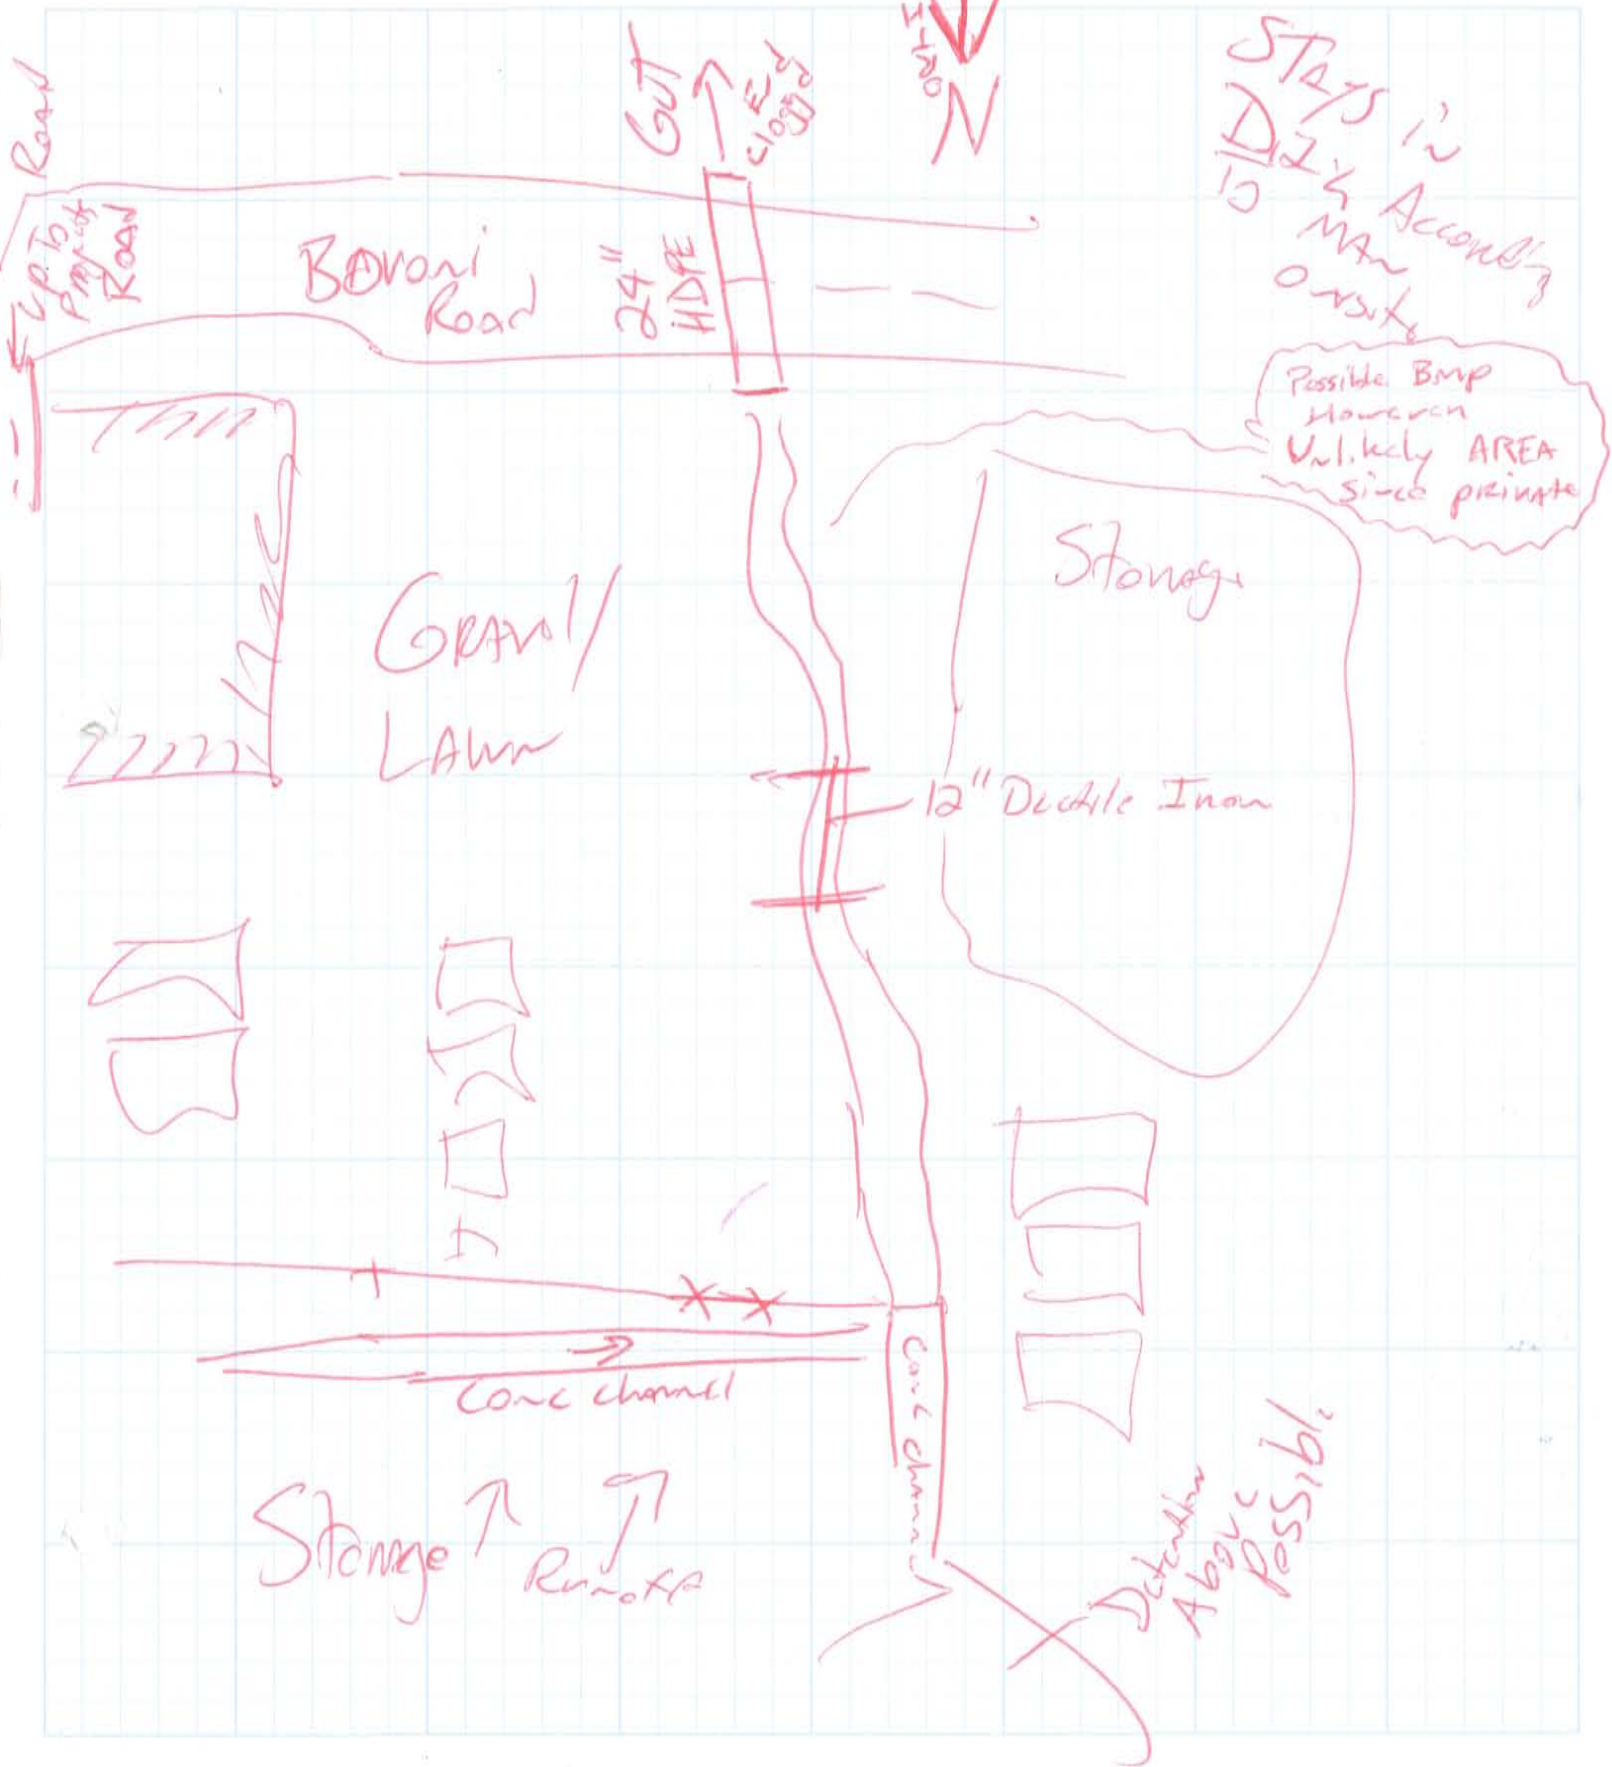
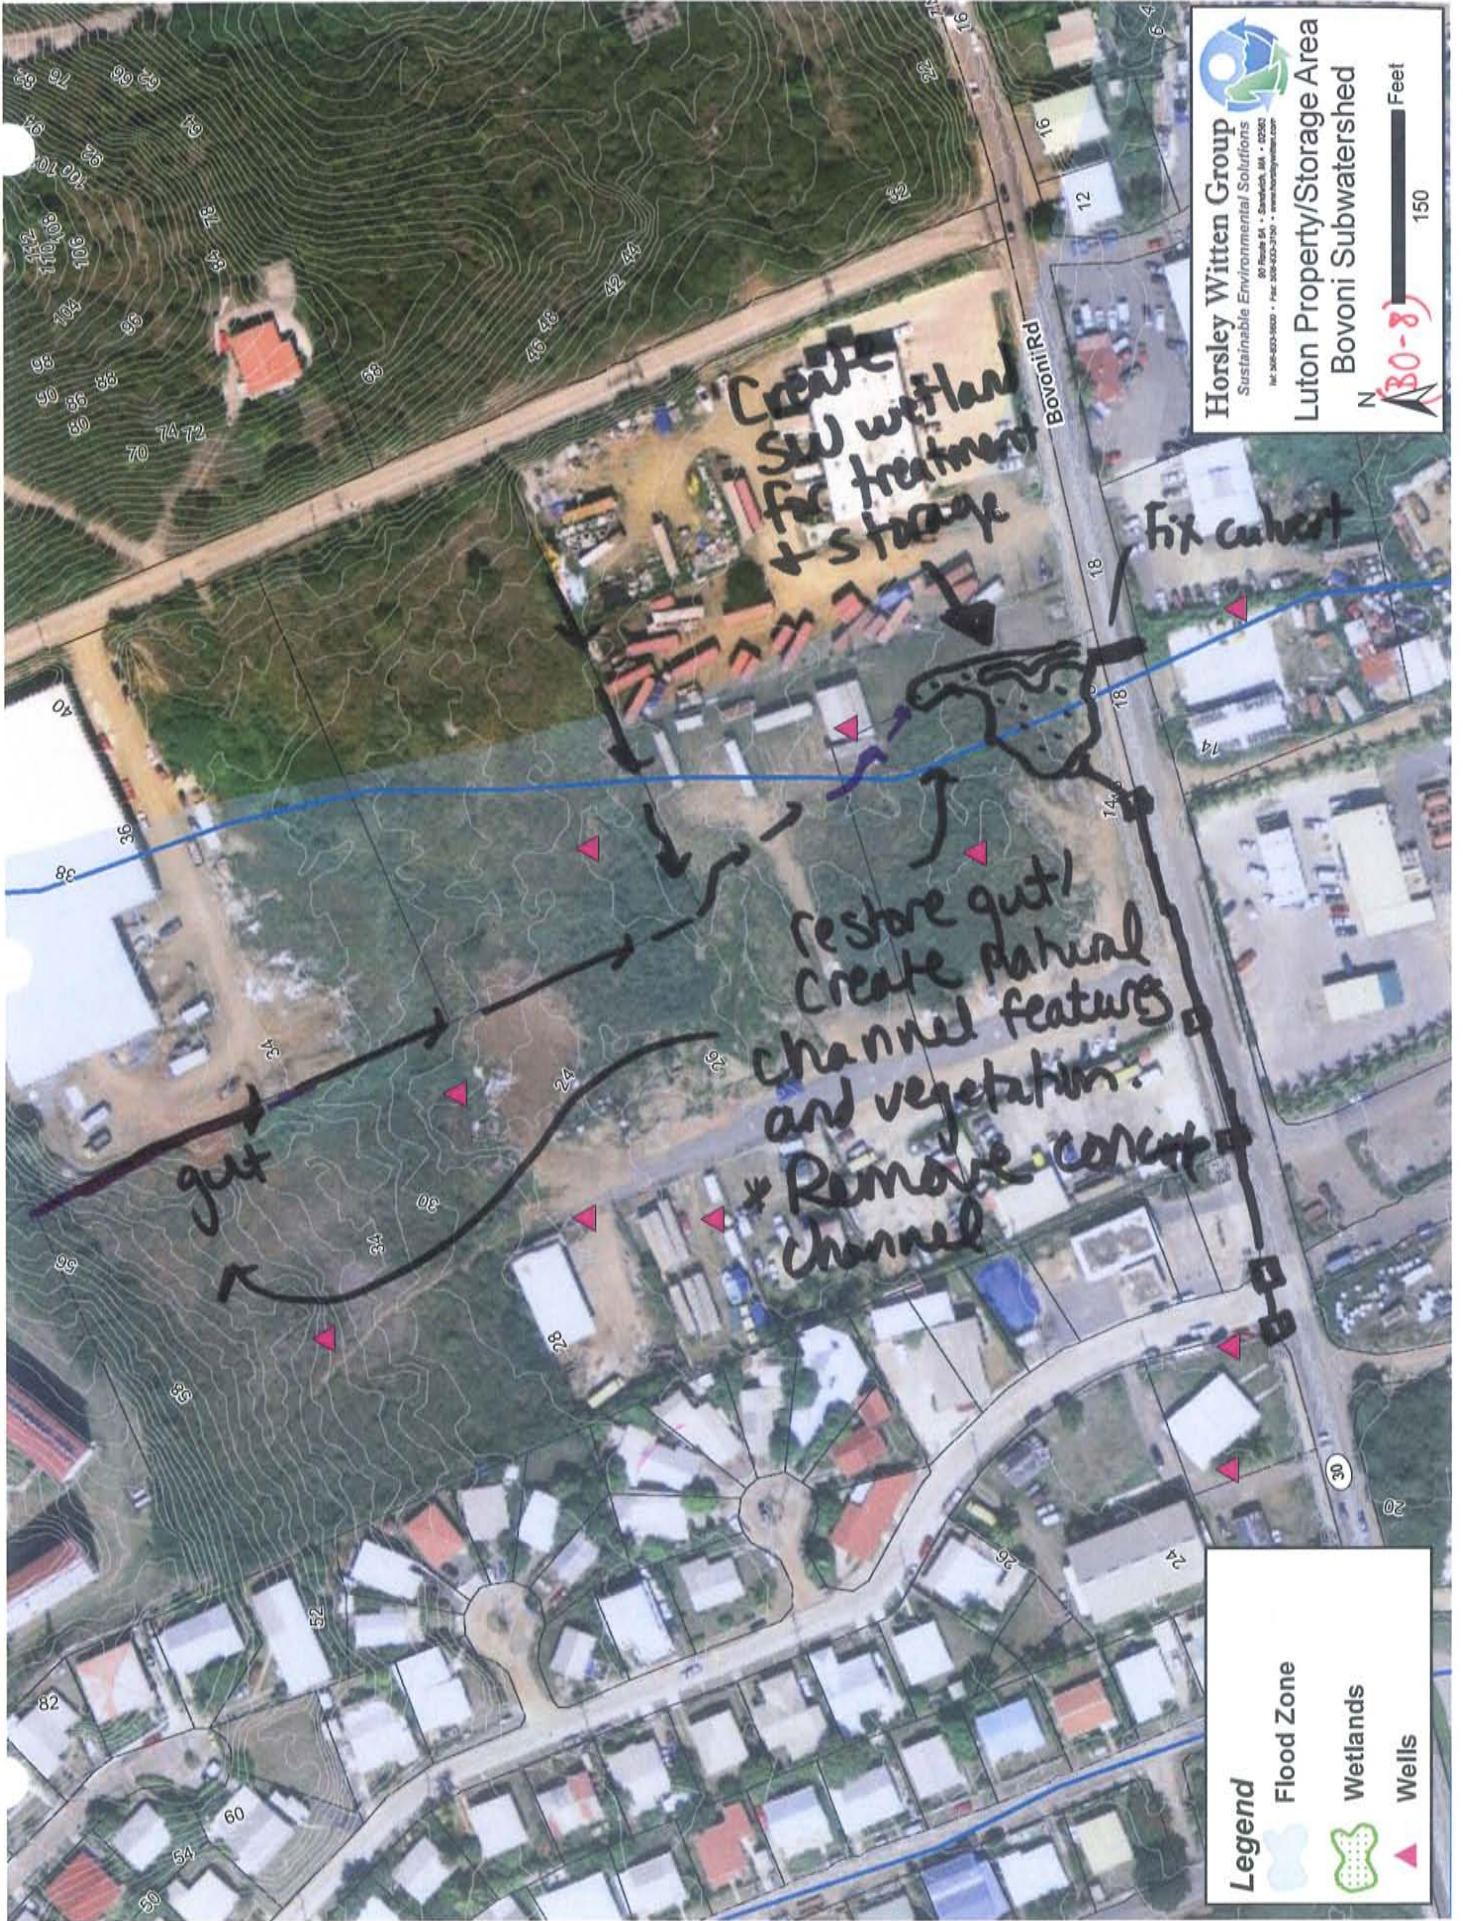
Luton Property/Storage Area
Bovoni Subwatershed

Property is mostly storage units. Gut is dirt for the most part with two piped sections - ONE drive aisle under Bovoni Rd (see sketch)

Gut flows from north property by concrete channels - that is the gut is over taking flow from storage facility (bulk storage) to the north.

Onsite person mentioned he has not seen it flood outside the gut but the lower AREAS of the property were ~~not~~ showed signs of ponding.

Gut Discharge pipe under Bovoni appeared clogged.

Possibly could do a wet BMP for the grass/gravel lot prior to Bovoni Rd. However, it is likely used for storage and may be difficult to acquire for such a use.
