FIELD ASSESSMENT NOTES

Subwatershed: Bavon

Site Name: BCB School (BO-1)

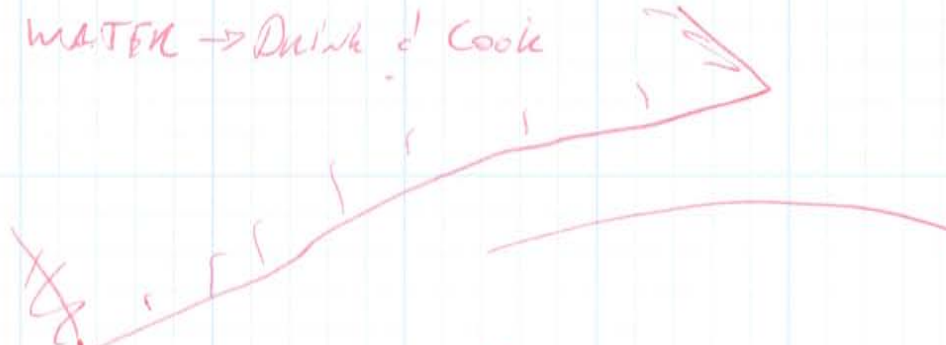
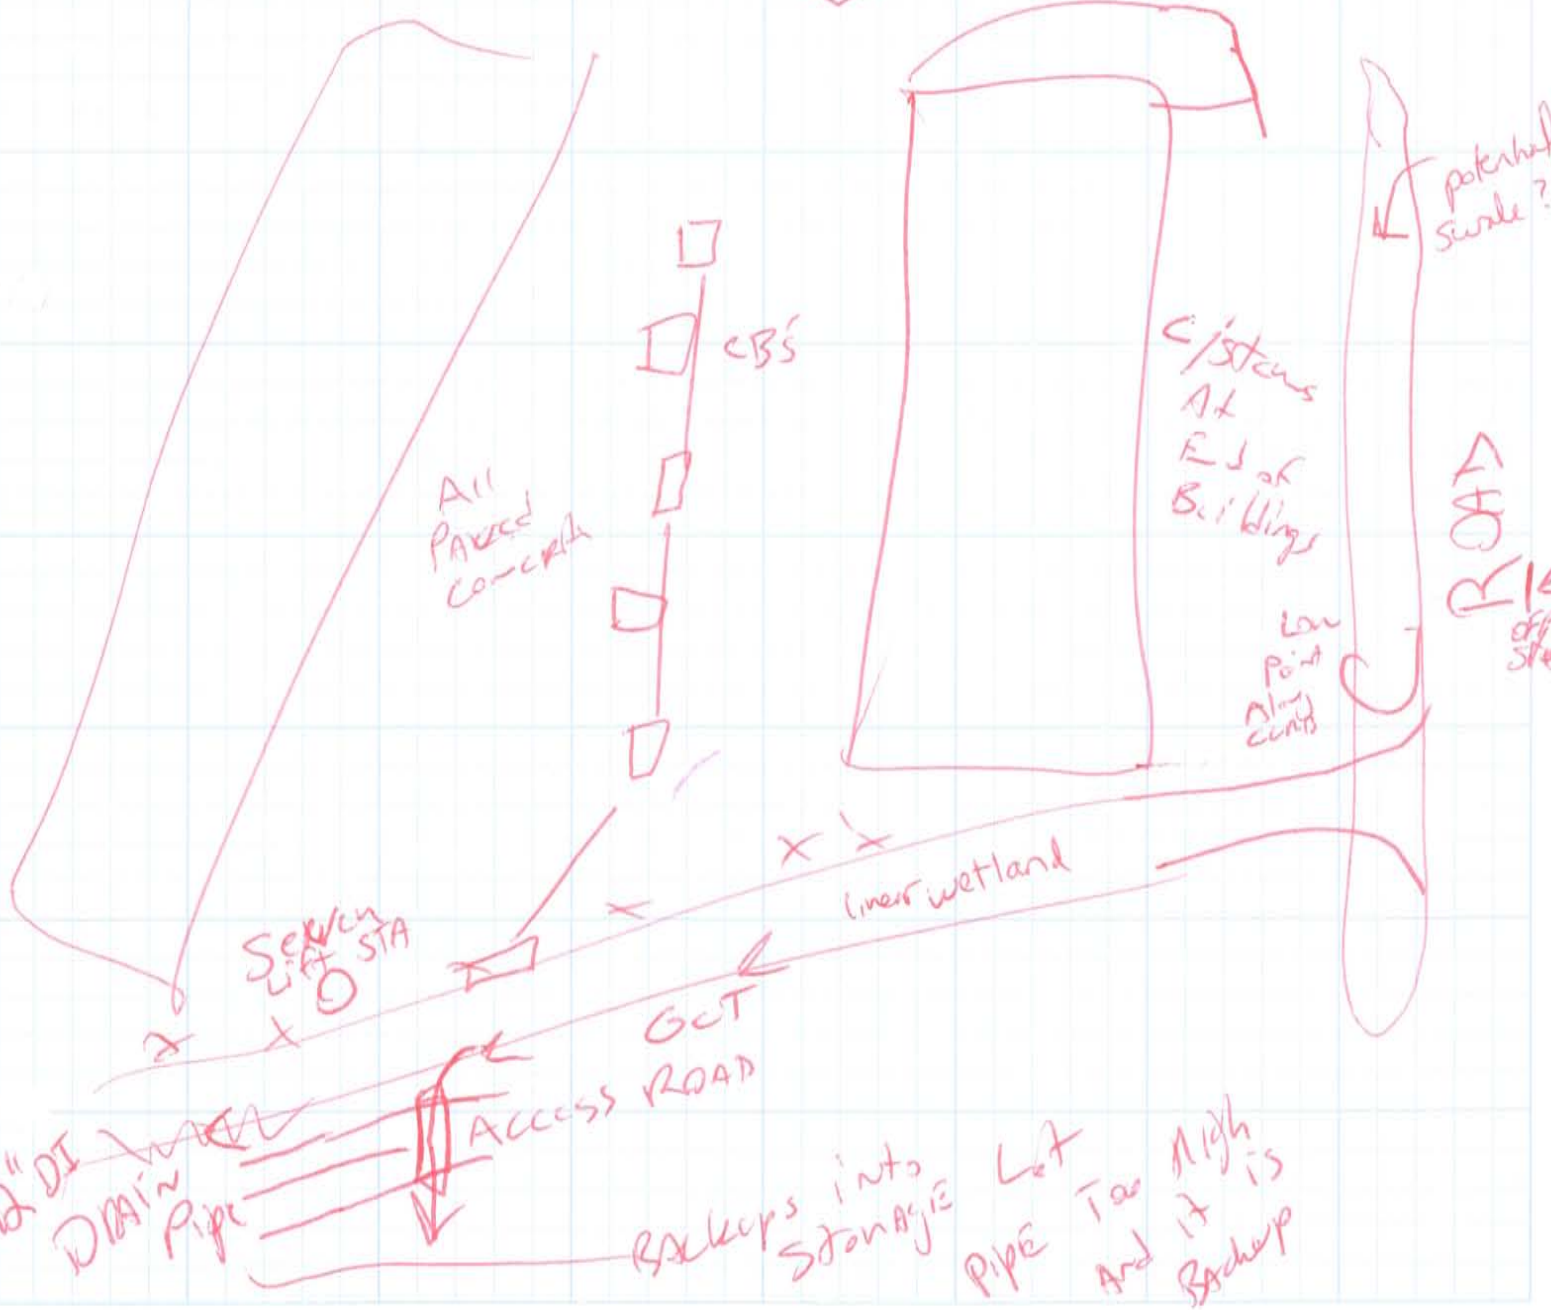
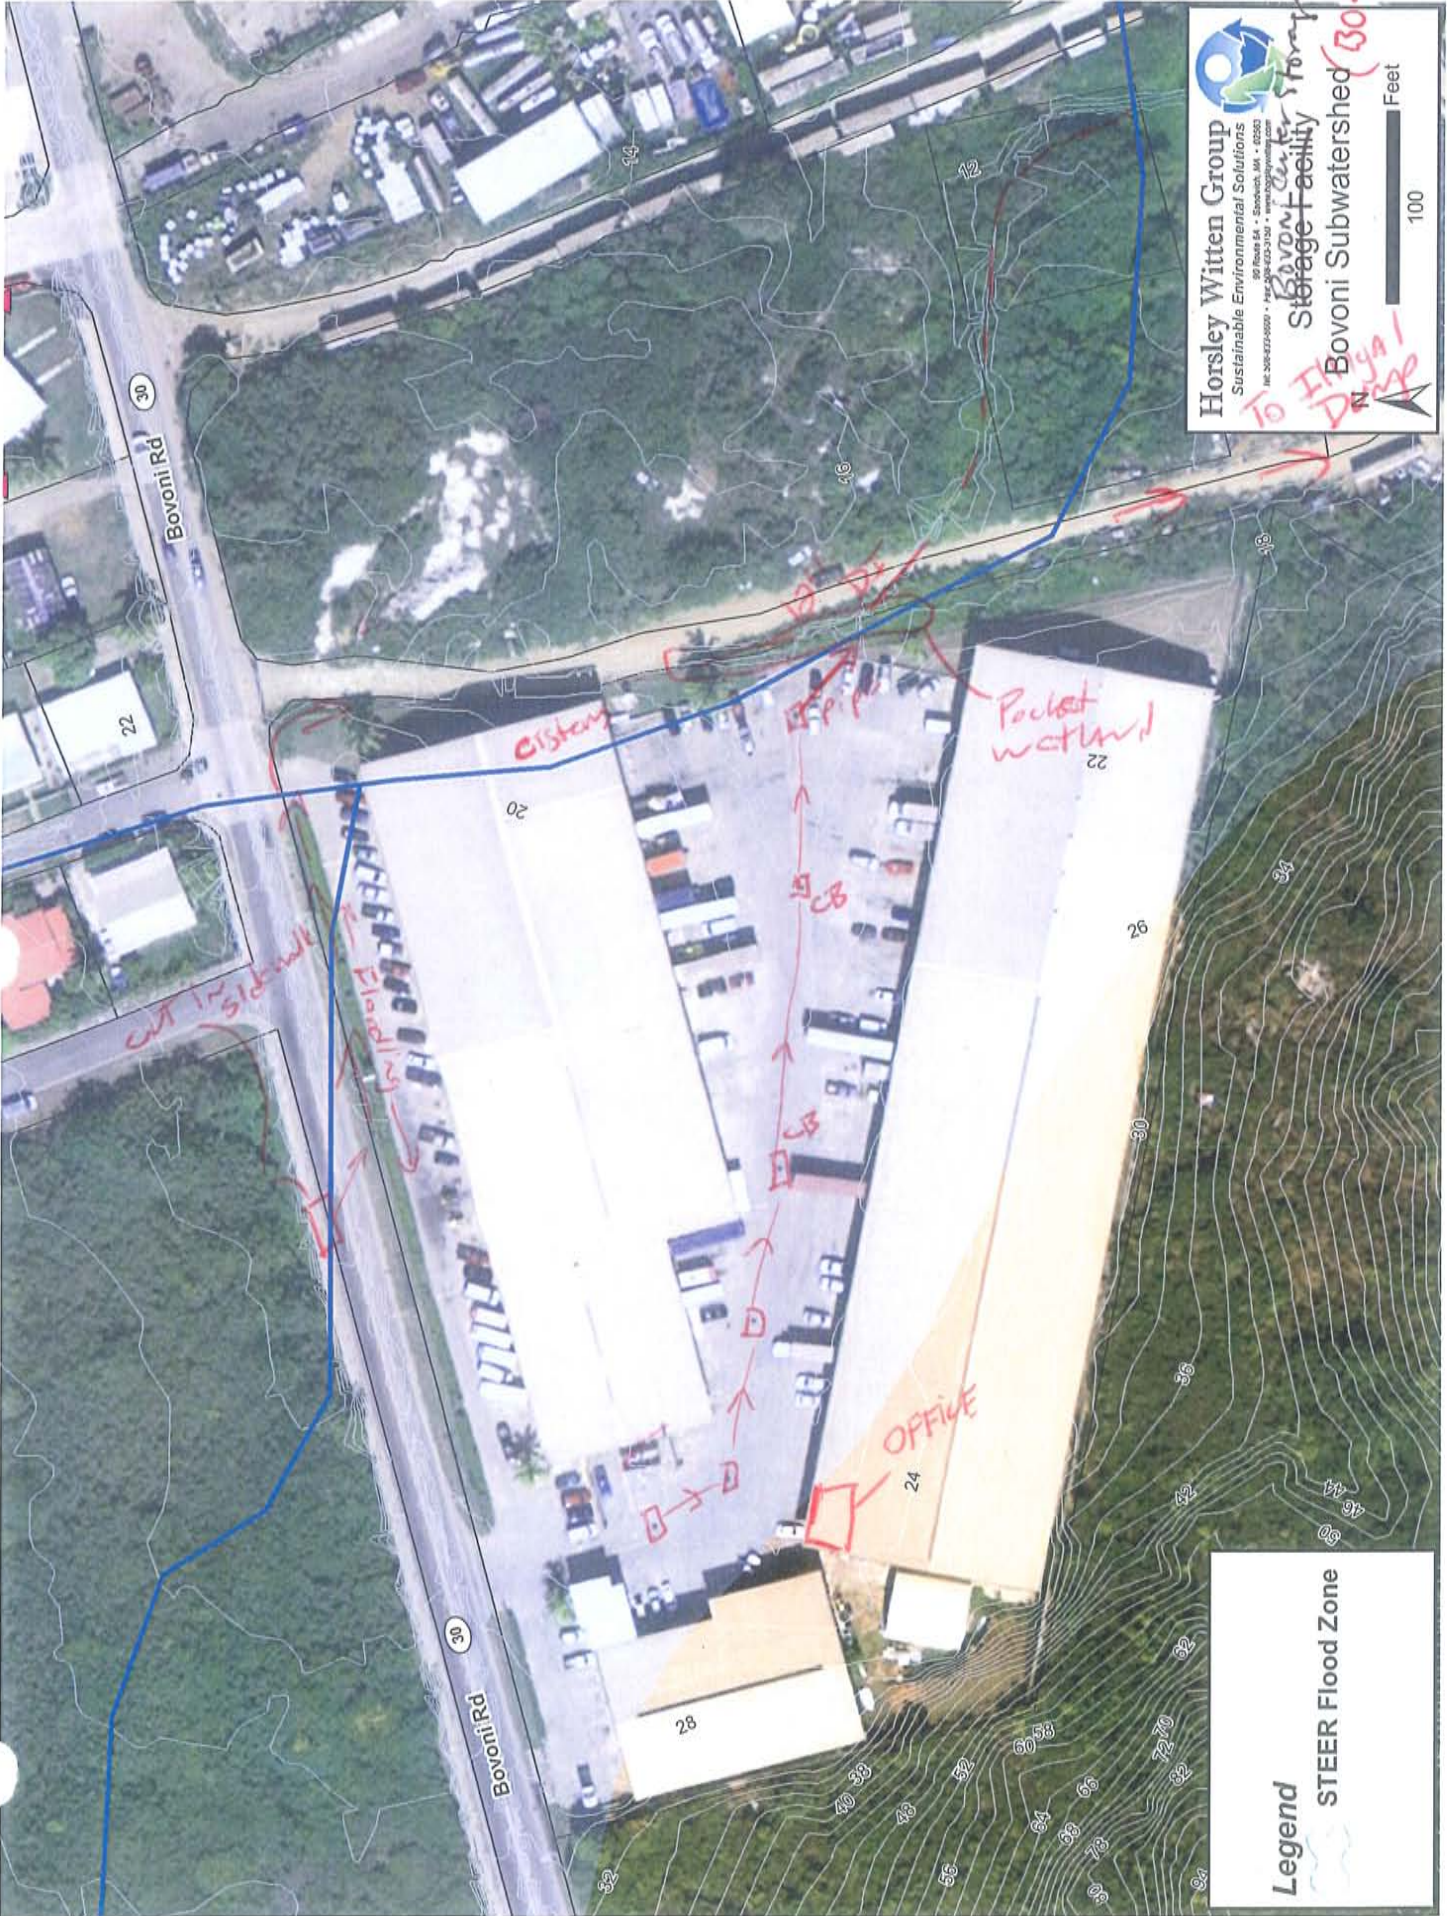
Bovoni Center
 Storage Facility
 Bovoni Subwatershed (30-9)
 To Ikiya Dump

Mostly concrete pavement, Buildings have cisterns at ends to collect roof runoff. Use cisterns to wash buildings but appear to mostly overflow to adjacent gut & drainage. C&S down center of parking area that are connected by pipe to the lowest C&S and discharged to the gut. Operator of facility (FRANCE) note: have his cand) said his parking lot floods back into his property in large storms due to the 12" pipe under the access road to the maintenance/housing being too high. Appears this area he was talking about is actually functioning as a veg/wetland. Could possibly use a second culvert at same elevation to convey the larger events while maintaining current

Backups into Storage Lot
Pipe Too High
And it is Backup

possibly add A pipe for conveyance of
by events

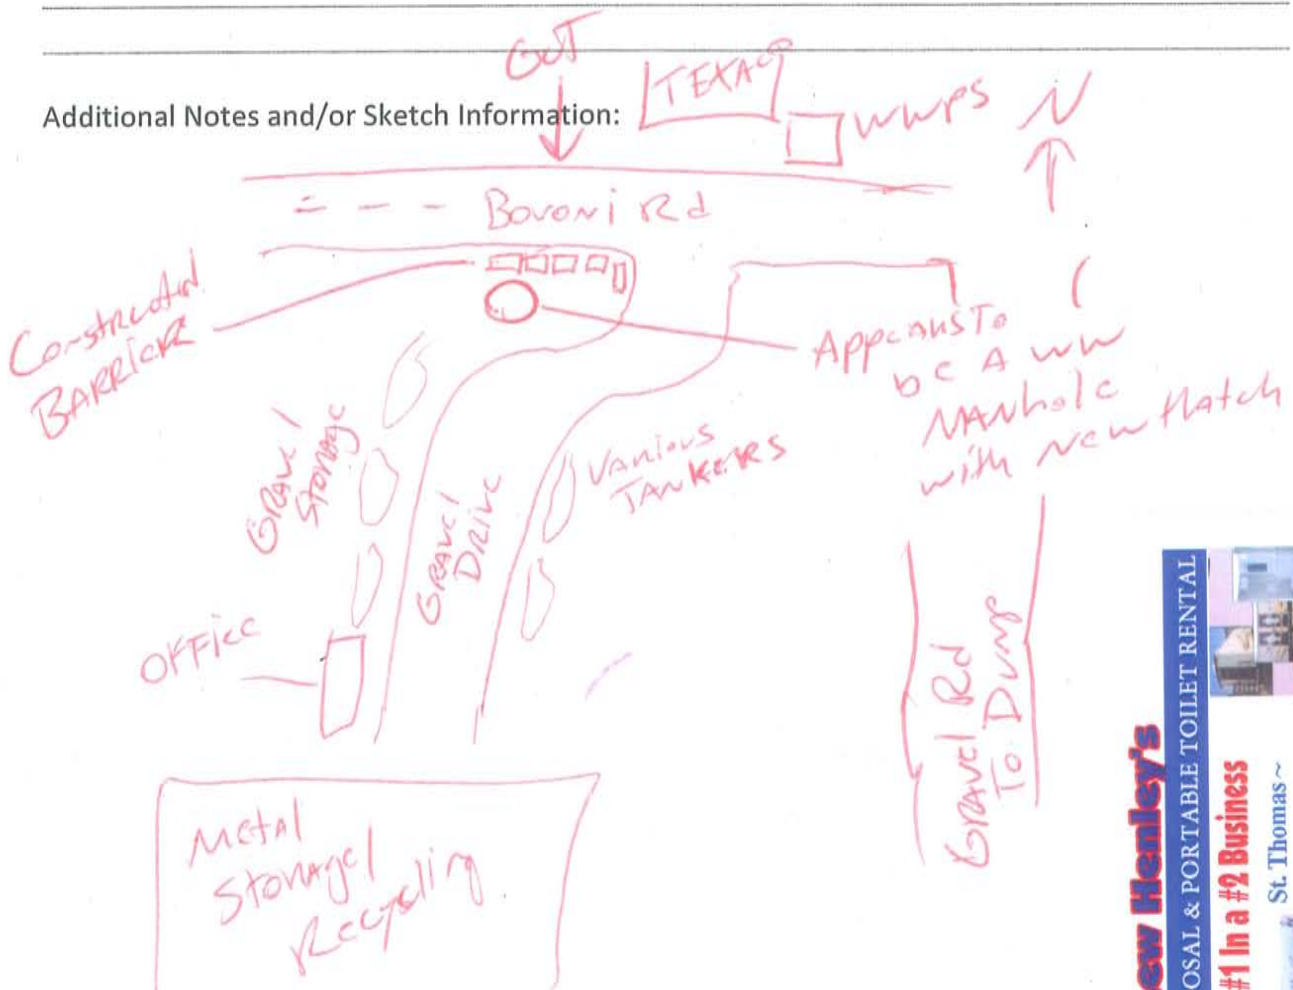
Site is south of Bovani Rd. Mostly all gravel and sloped from North to South. Majority of AREA is used for storage of Active and Inactive Tankers (Septic Haulers) & Borse Horses (PortaPots). Some of the older Tankers appear to be leaking septicage on to surrounding AREA. Various times during inspection smells of septic were prevalent. Lew not available at time of inspection. Secretary said she had only been there for a couple months.

Gut Flows from down Bovani Rd to the North and it appears someone made an effort to stop the runoff from entering the site & contain on the Road. Berm looks recent and is made of plastic barrels and loose dirt. Appears constructed recently.

There is a metal stripping (copper) Facility to the south of Lew's. Metal stripping was in progress at time of inspection. Metal Byproducts prevalent throughout gravel surface
 ↑
 A-d staining

Being At bottom of watershed These sites
 Receive highest volumes of offsite Runoff
 and ARE likely among the highest contributors
 To the Bays degradation. Cleanup
 would be a substantial undertaking i would
 likely require construction of a new Facility
 offsite w/ advanced containment & Treatment.

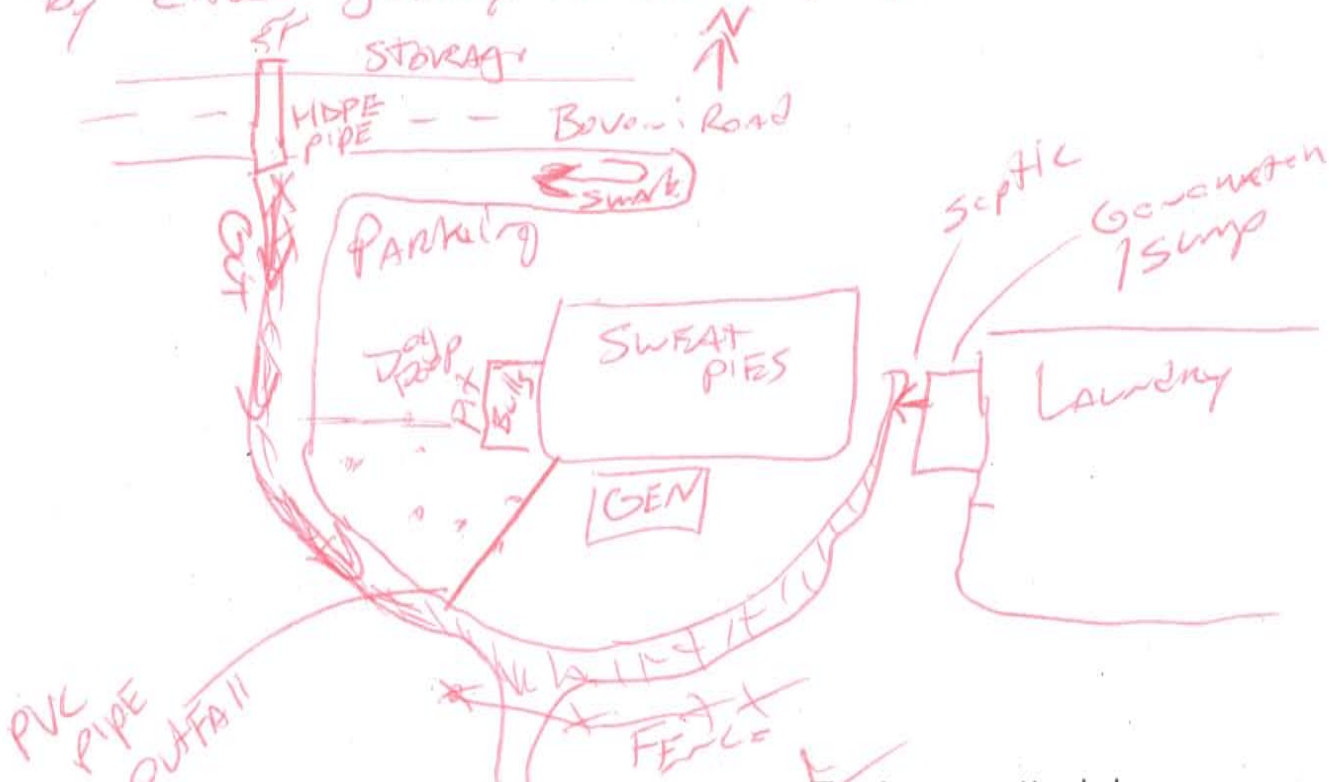
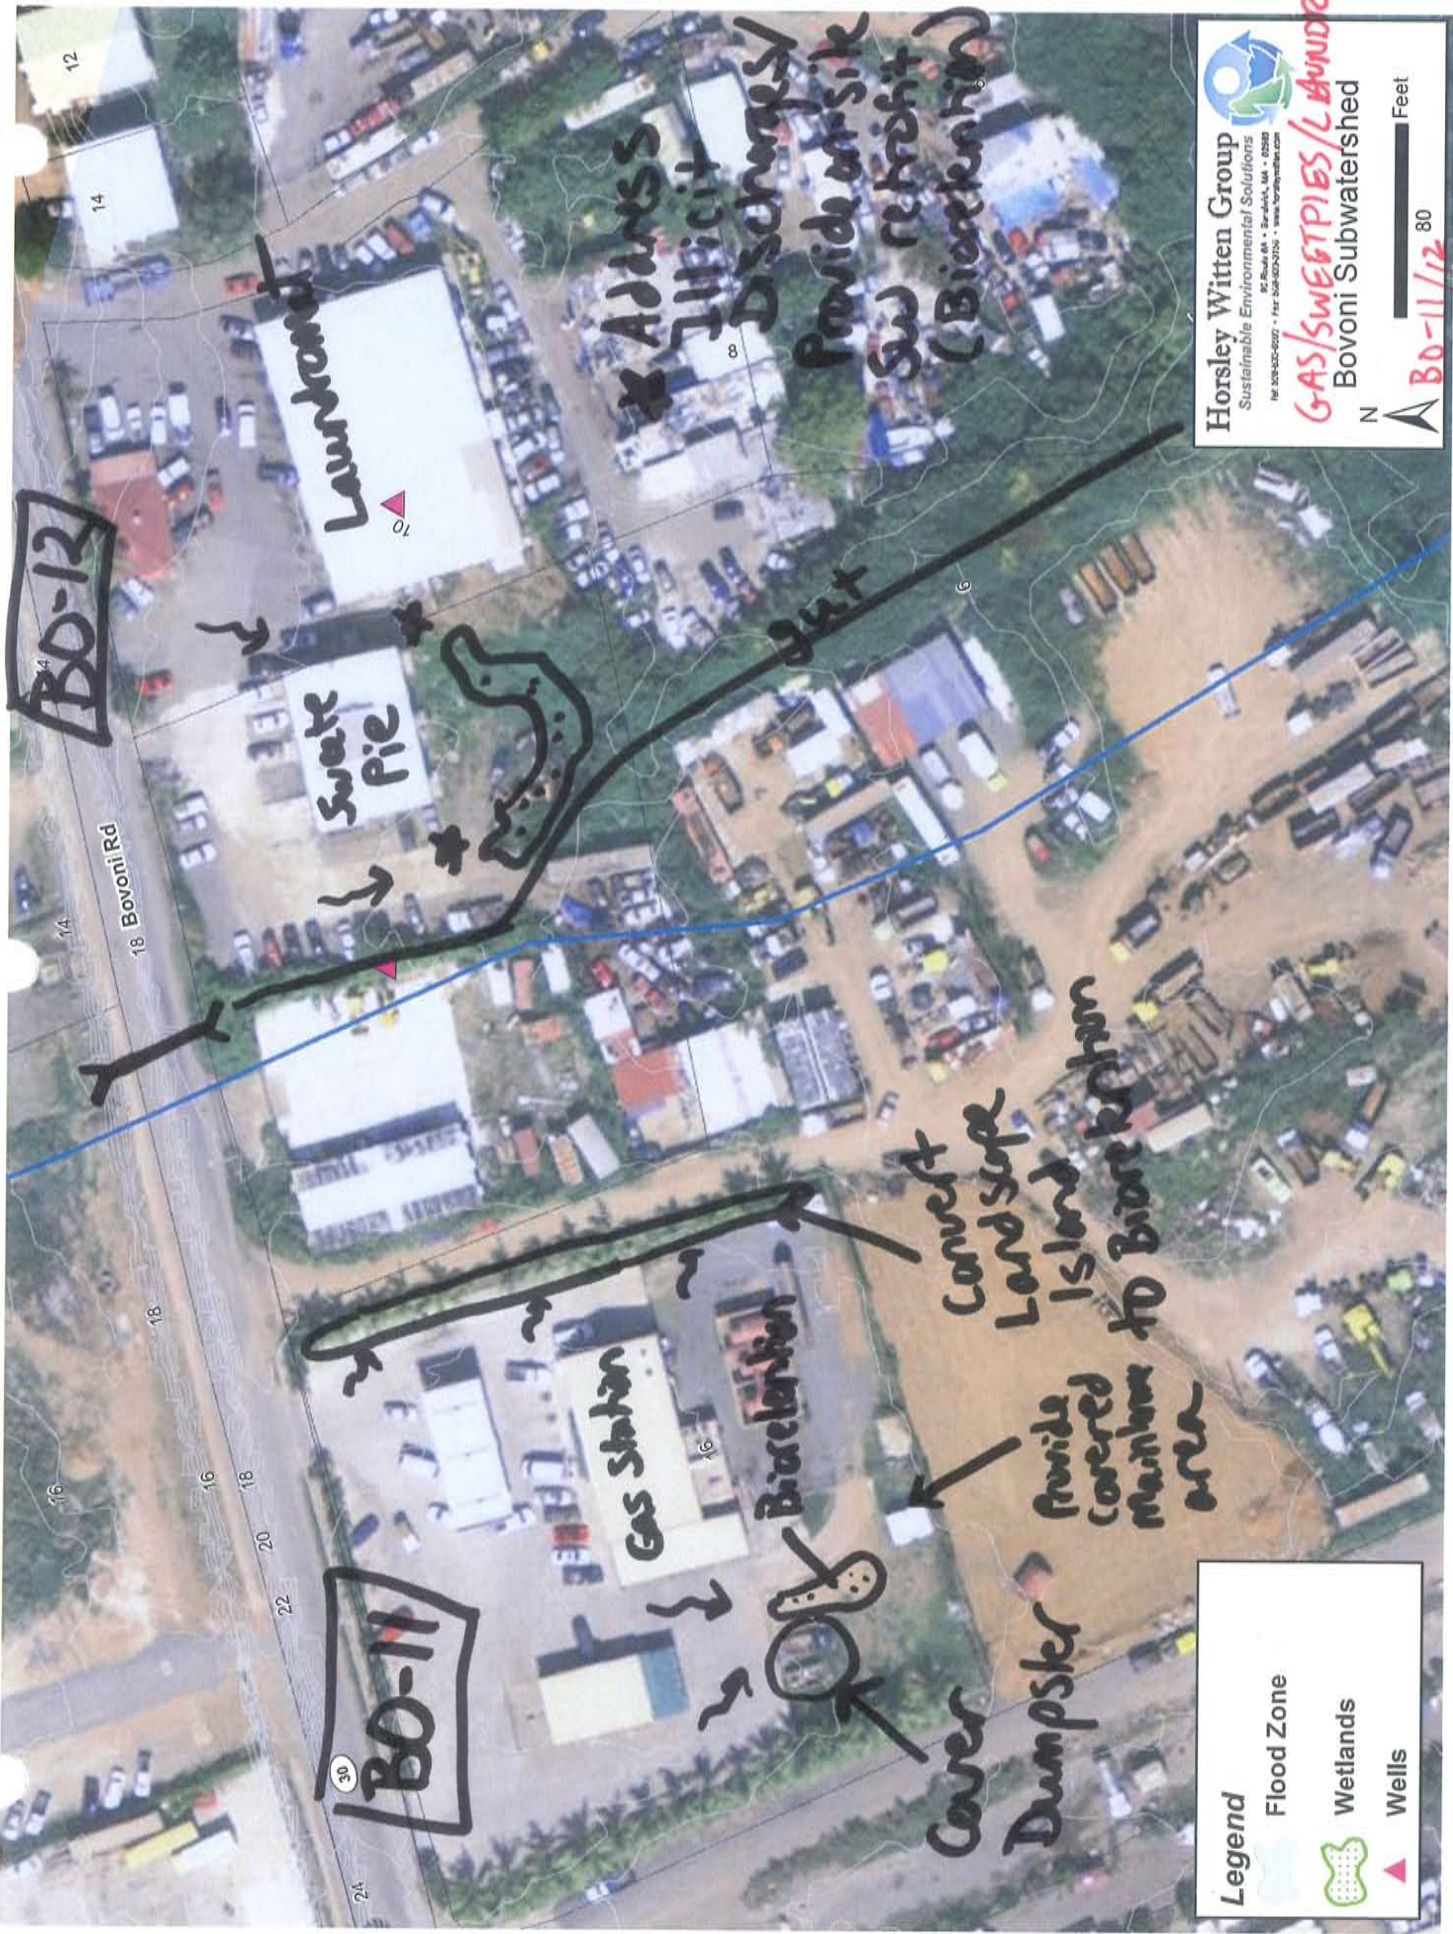
GAS/SWEETPIES/LAUNDRY
 Bovoni Subwatershed

Both Buildings ARE Adjacent to Sevan In Bovan Road & could easily discharge by either quality of small pump.

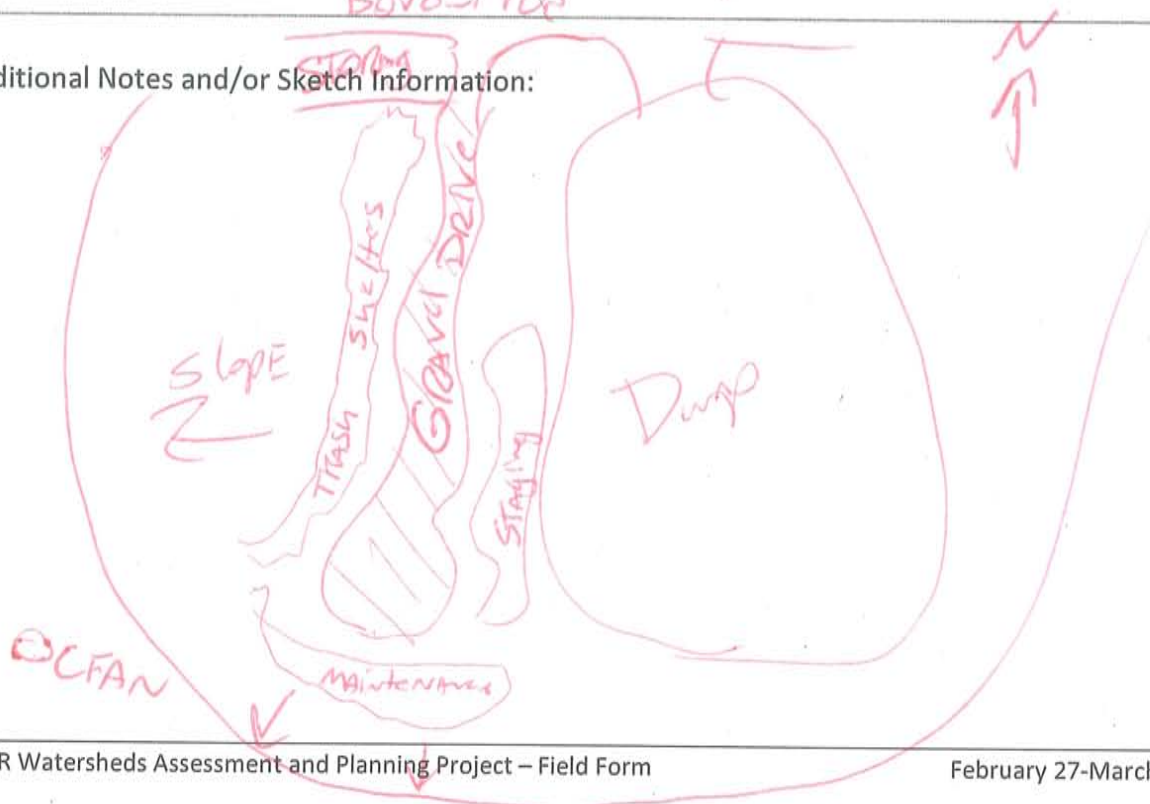
Area has various dump sites & vehicle/construction equipment maintenance areas. Vehicle byproducts (oil/etc) are everywhere and spills are visible. Area is also used for squatting as shelters have been constructed in various locations. makeshift cisterns were observed.

Extensive cleanup, most likely SuperFund.

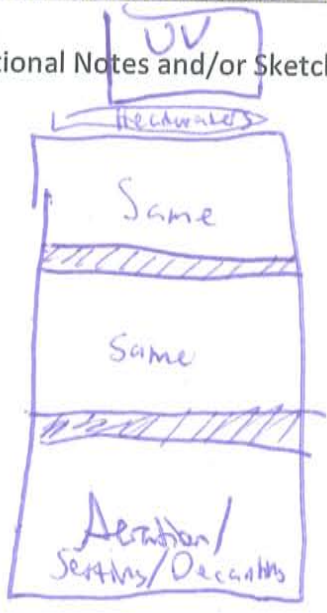
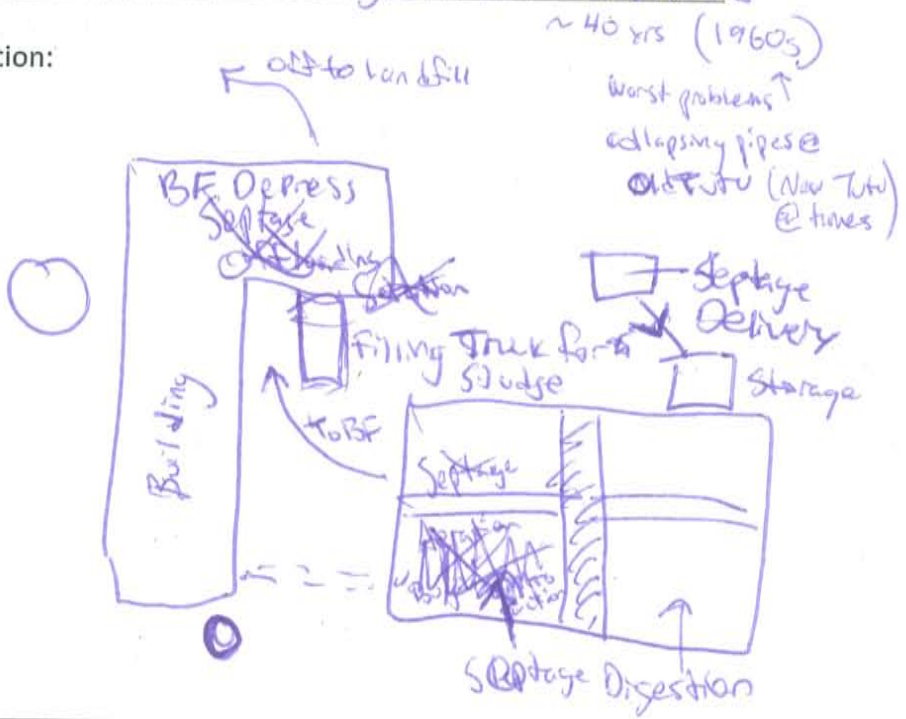
- 750,000 GPD Design / 400,000 GPD TYP. / 500,000 gal night flow
- Increased to 1.2MGD during rain events
- Septage handled at smaller plant where "bugs" are reintroduced and "diluted" prior to sending to main treatment facility
- Plant catches up on Waste treatment during 8hr workday
- ↳ plant does not operate at night unless there is a significant (2"-3") rainfall expected then it runs 24 hrs / day
- Treatment plant ^{on-line} built in 2002/2003
- Ft. Mylar WWTP should be going off-line and will hook up ^{at town TP} pump station ^{in Boggy Neighborhood} will be offline in a matter of weeks. New pump station to come on-line.
- Infrastructure in Arroyo Fluvial old - Orange pipe ~30 yrs old

- Repair Vista ^{new} Own WWTP
- Design for pipeline for new development near Ft Mylar + Home Depot, Repulse 3
- VESSUP WWTP
- When house w/in 60' of sewer - residents should connect
- Ask about % capacity
- Check Heavy Materials Connection to WWTP
- Raceback connected to sewer ~~at~~ ^{at} Dunsmuir Society, small station about 0.5 mil
- Downspout connections into manholes
- Manholes/pipes leak during rainfall - groundwater infiltration during extended rainfall periods
