FIELD ASSESSMENT NOTES

Subwatershed: Nadir

Site Name: Elm Rd/gut NG-1

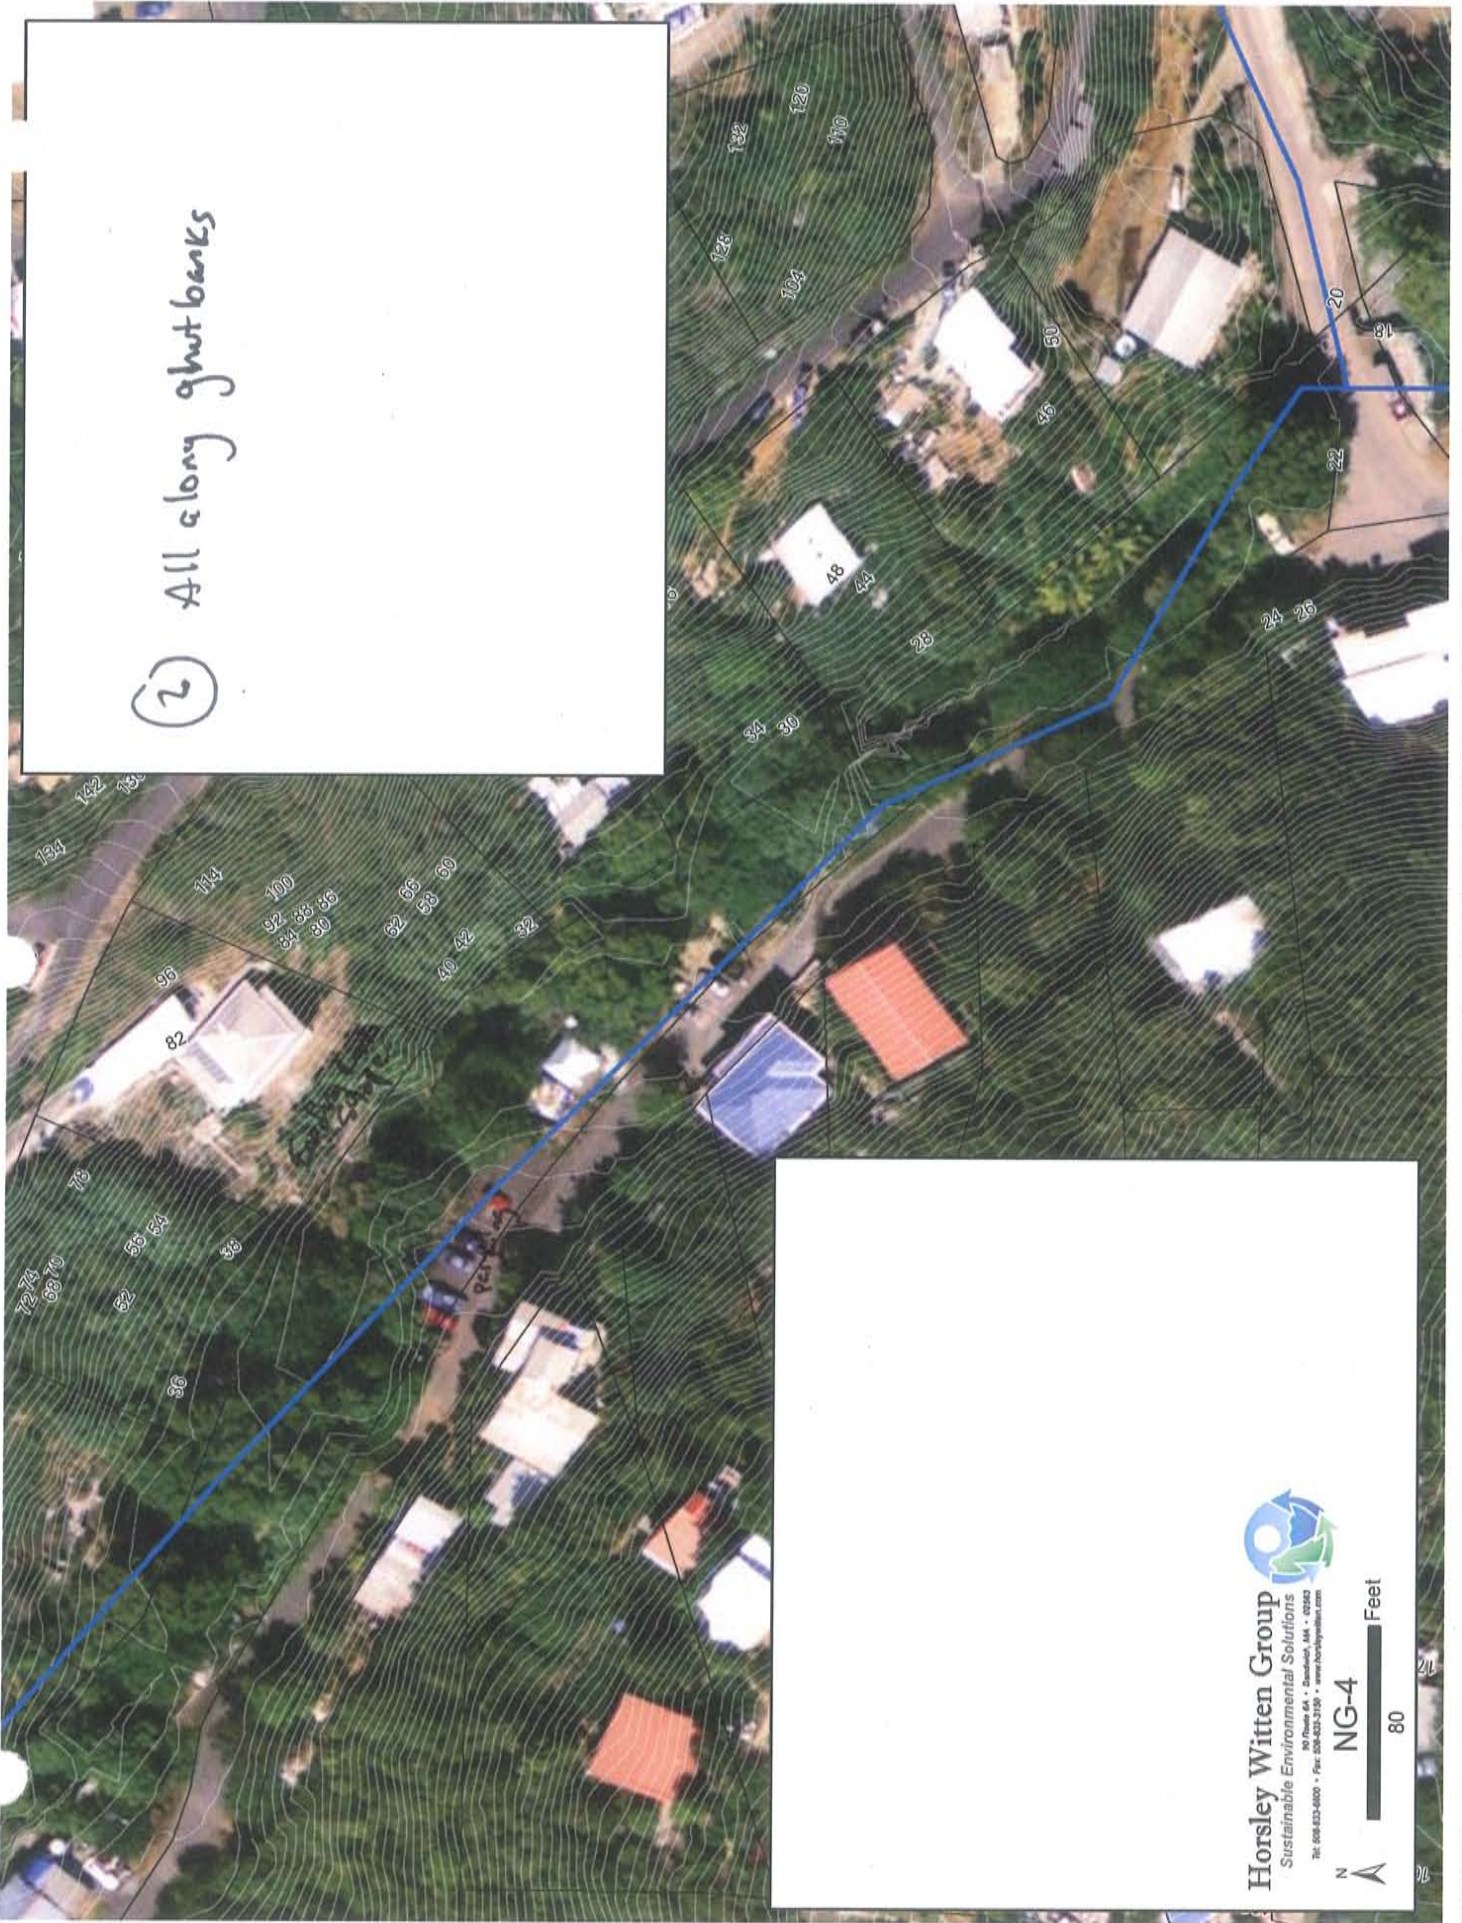
erosion observed along unvegetated slopes of gut, lots of trash, not maintaining vegetated buffers, goat farm in buffer/gut building walls in ~~alignment~~ to gut w/ no ESE
 - recommend that a residential Stewardship program to:

* Ex. where homes are built basically in the gut.

② All along gully banks

- ① sediment control
- ② Maintaining 35 ft veg. buffer
- ③ dumping prevention & clean up

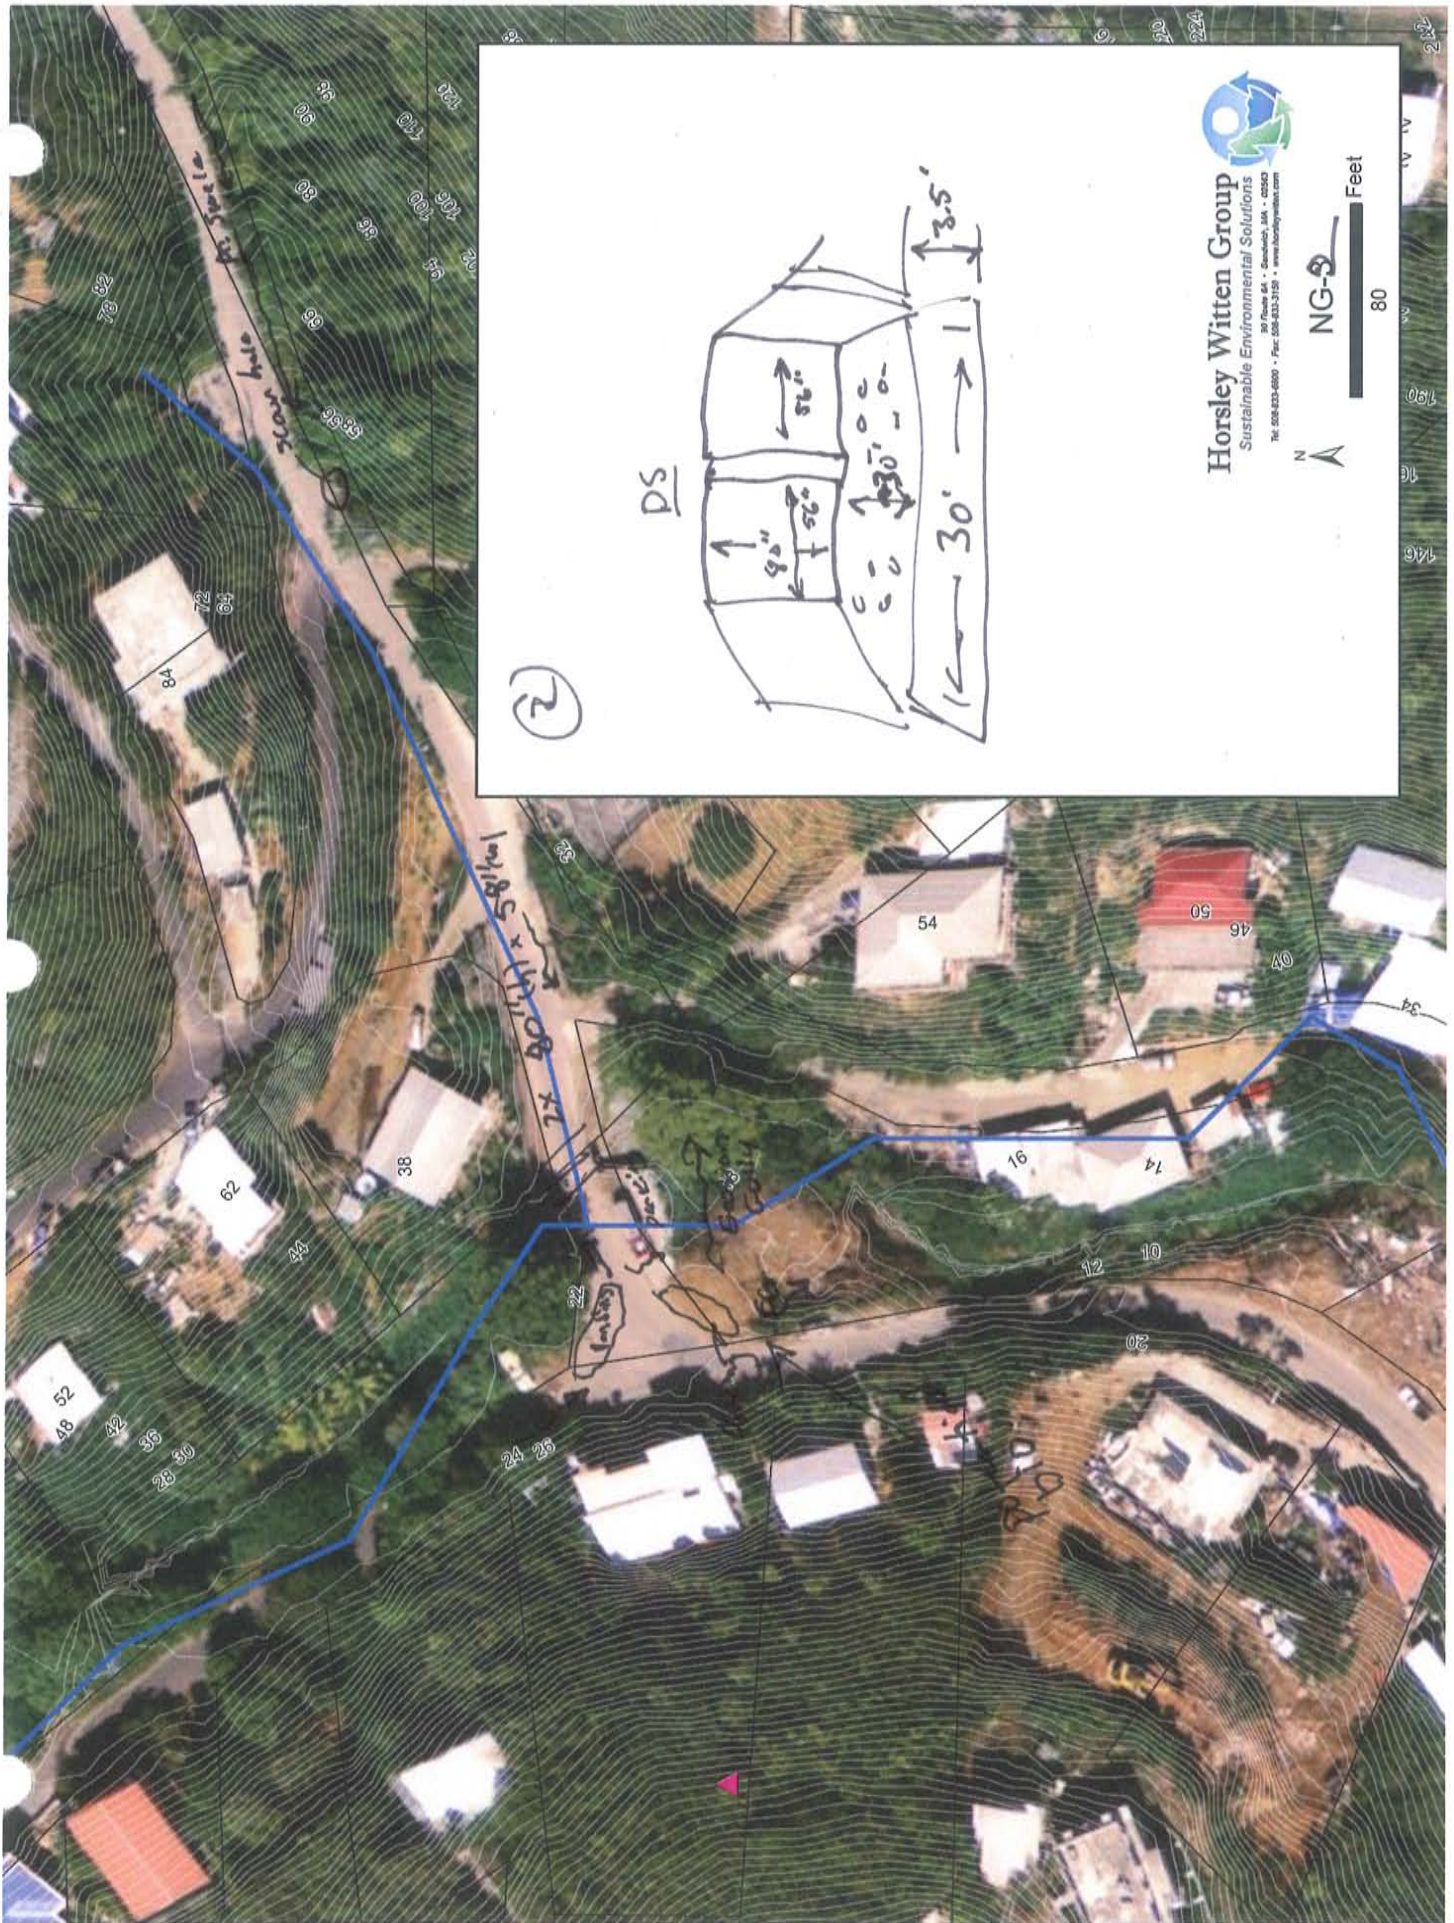
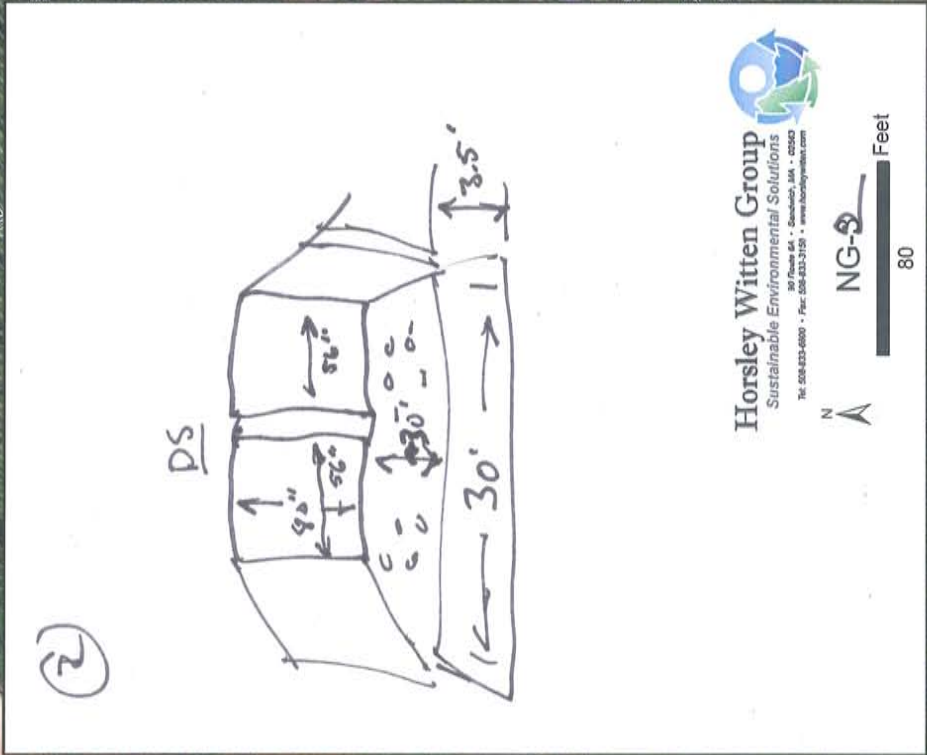
Site Name: GOLD HILL RD / EMERALD Xing (NG-2)

Trash and debris in gut to be removed.

~~The gut is the~~ scour hole
There is a head cut forming at the culvert splash pad - it appears that energy dissipaters at this location may be helpful

Runoff from uphill road network could be managed in a roadside bio-retention / or swale (but would be expensive for the benefit)

- small bios / rain gardens at intersection to reduce flooding of roadway.

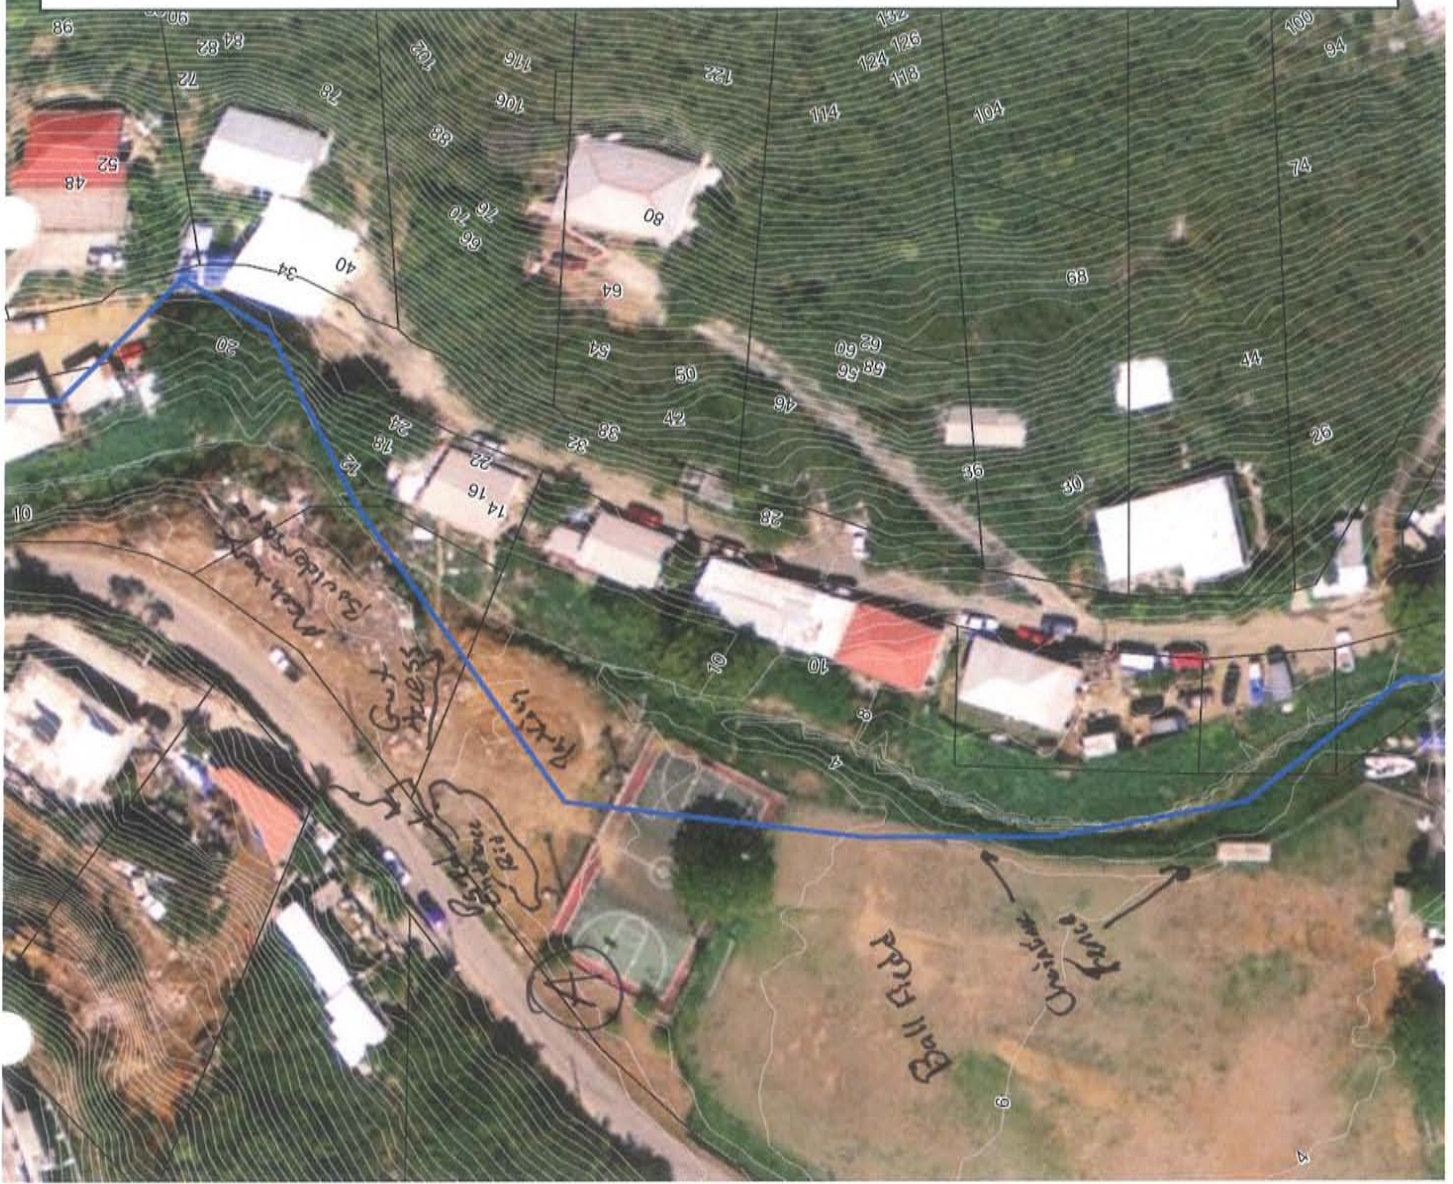
N
NG-3
 80 Feet

The bioretention area is proposed along the road shoulder, north of the basketball court. This practice could treat runoff from the 2.6 acre drainage area and reduce erosion in the dirt parking area.

A constructed wetland is proposed to capture and treat runoff from the southern portion of Elm Road. The practice is proposed in the ballpark property near the intersection of Elm Road and Red Hook Road. There is currently a 5,000 SF existing wetland in the proposed treatment location that has formed due to an elevated outlet pipe and likely high groundwater. Minor alteration to the existing

wetland would be necessary to enhance pretreatment and pollutant removal capabilities. This would involve installation of a stabilized drainage inlet or paved flume, construction of a sediment forebay, and modification of the existing outlet. There is currently a roadside drainage swale that discharges into the wetland which could be expanded and enhanced. The swale could be converted to wet swale to provide an additional 1,500 SF of treatment area. Improved management of the influent stormwater is paramount because severe erosion along the road shoulder has comprised the integrity of the roadway.

Two stormwater treatment facilities are proposed at Nadir Ballpark to treat runoff from Elm Road and the surrounding residences, one bioretention area and one constructed wetland facility. Runoff from the roadway will be directed to the treatment facilities via paved flumes and/or drainage swales. Sediment forebays will be included in the design to provide runoff pretreatment.

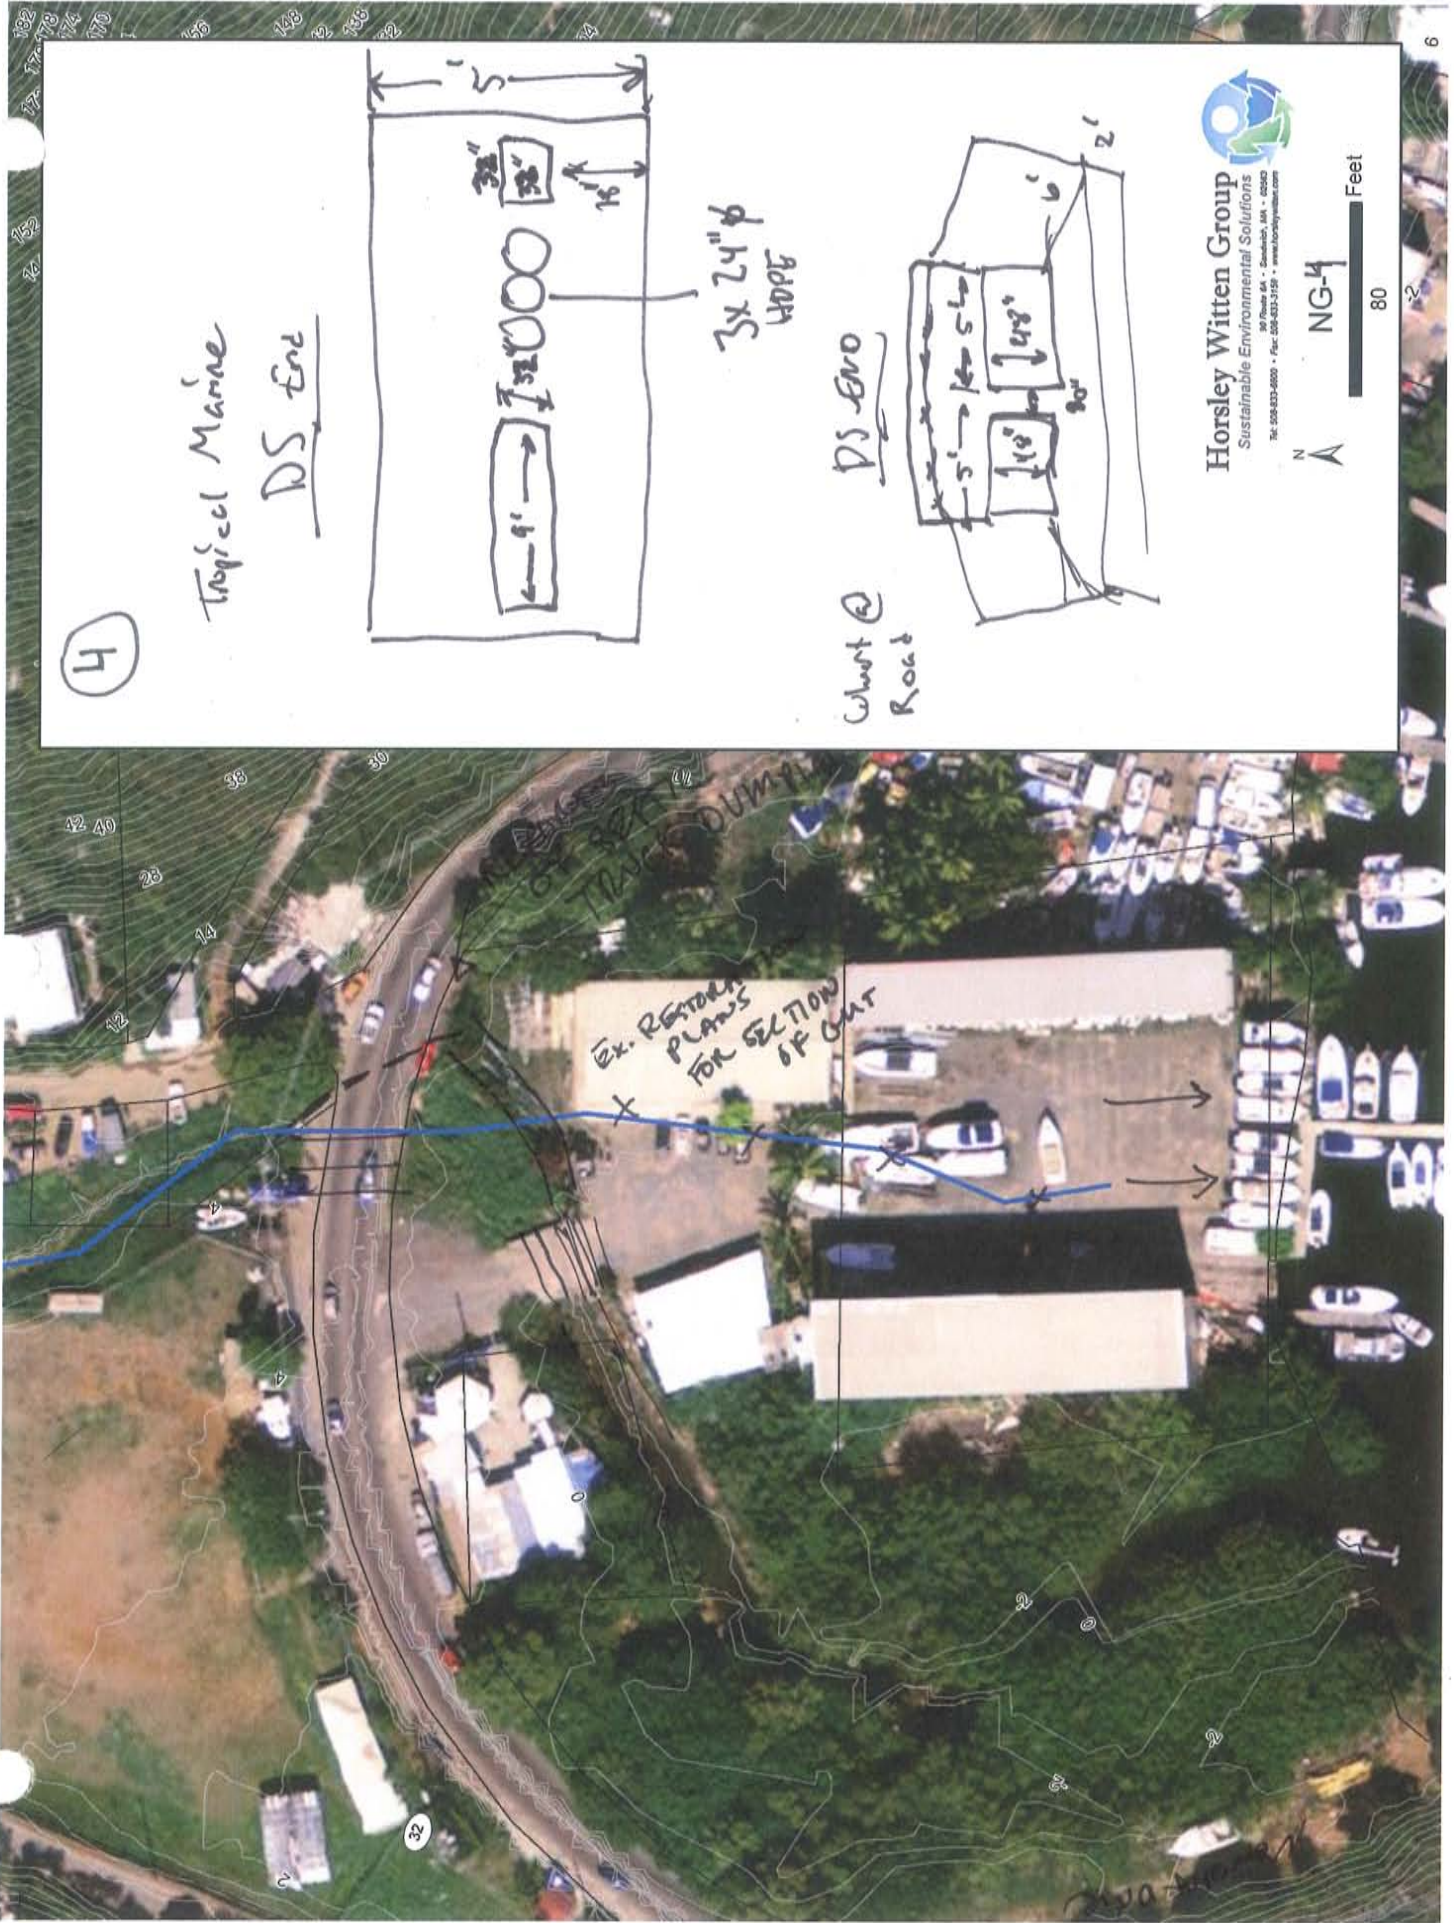
Site Name: TROPICAL MARINE NG-4

- gut takes a right angle turn to go under road ulvvert. There is an existing set of plans for a proposed stream restoration project here.

- Reports that septic pump out vehicle discharge at this ulvert/location

- Surface of boat yard drains directly to bay without treatment.

- Consider pollution prevention opportunities here such as
① paving for areas where fluids are drained.

- ② trench drain to O/W separator
- ② or sand filter

- consider rainwater harvesting @ roof that drains to "the patch"

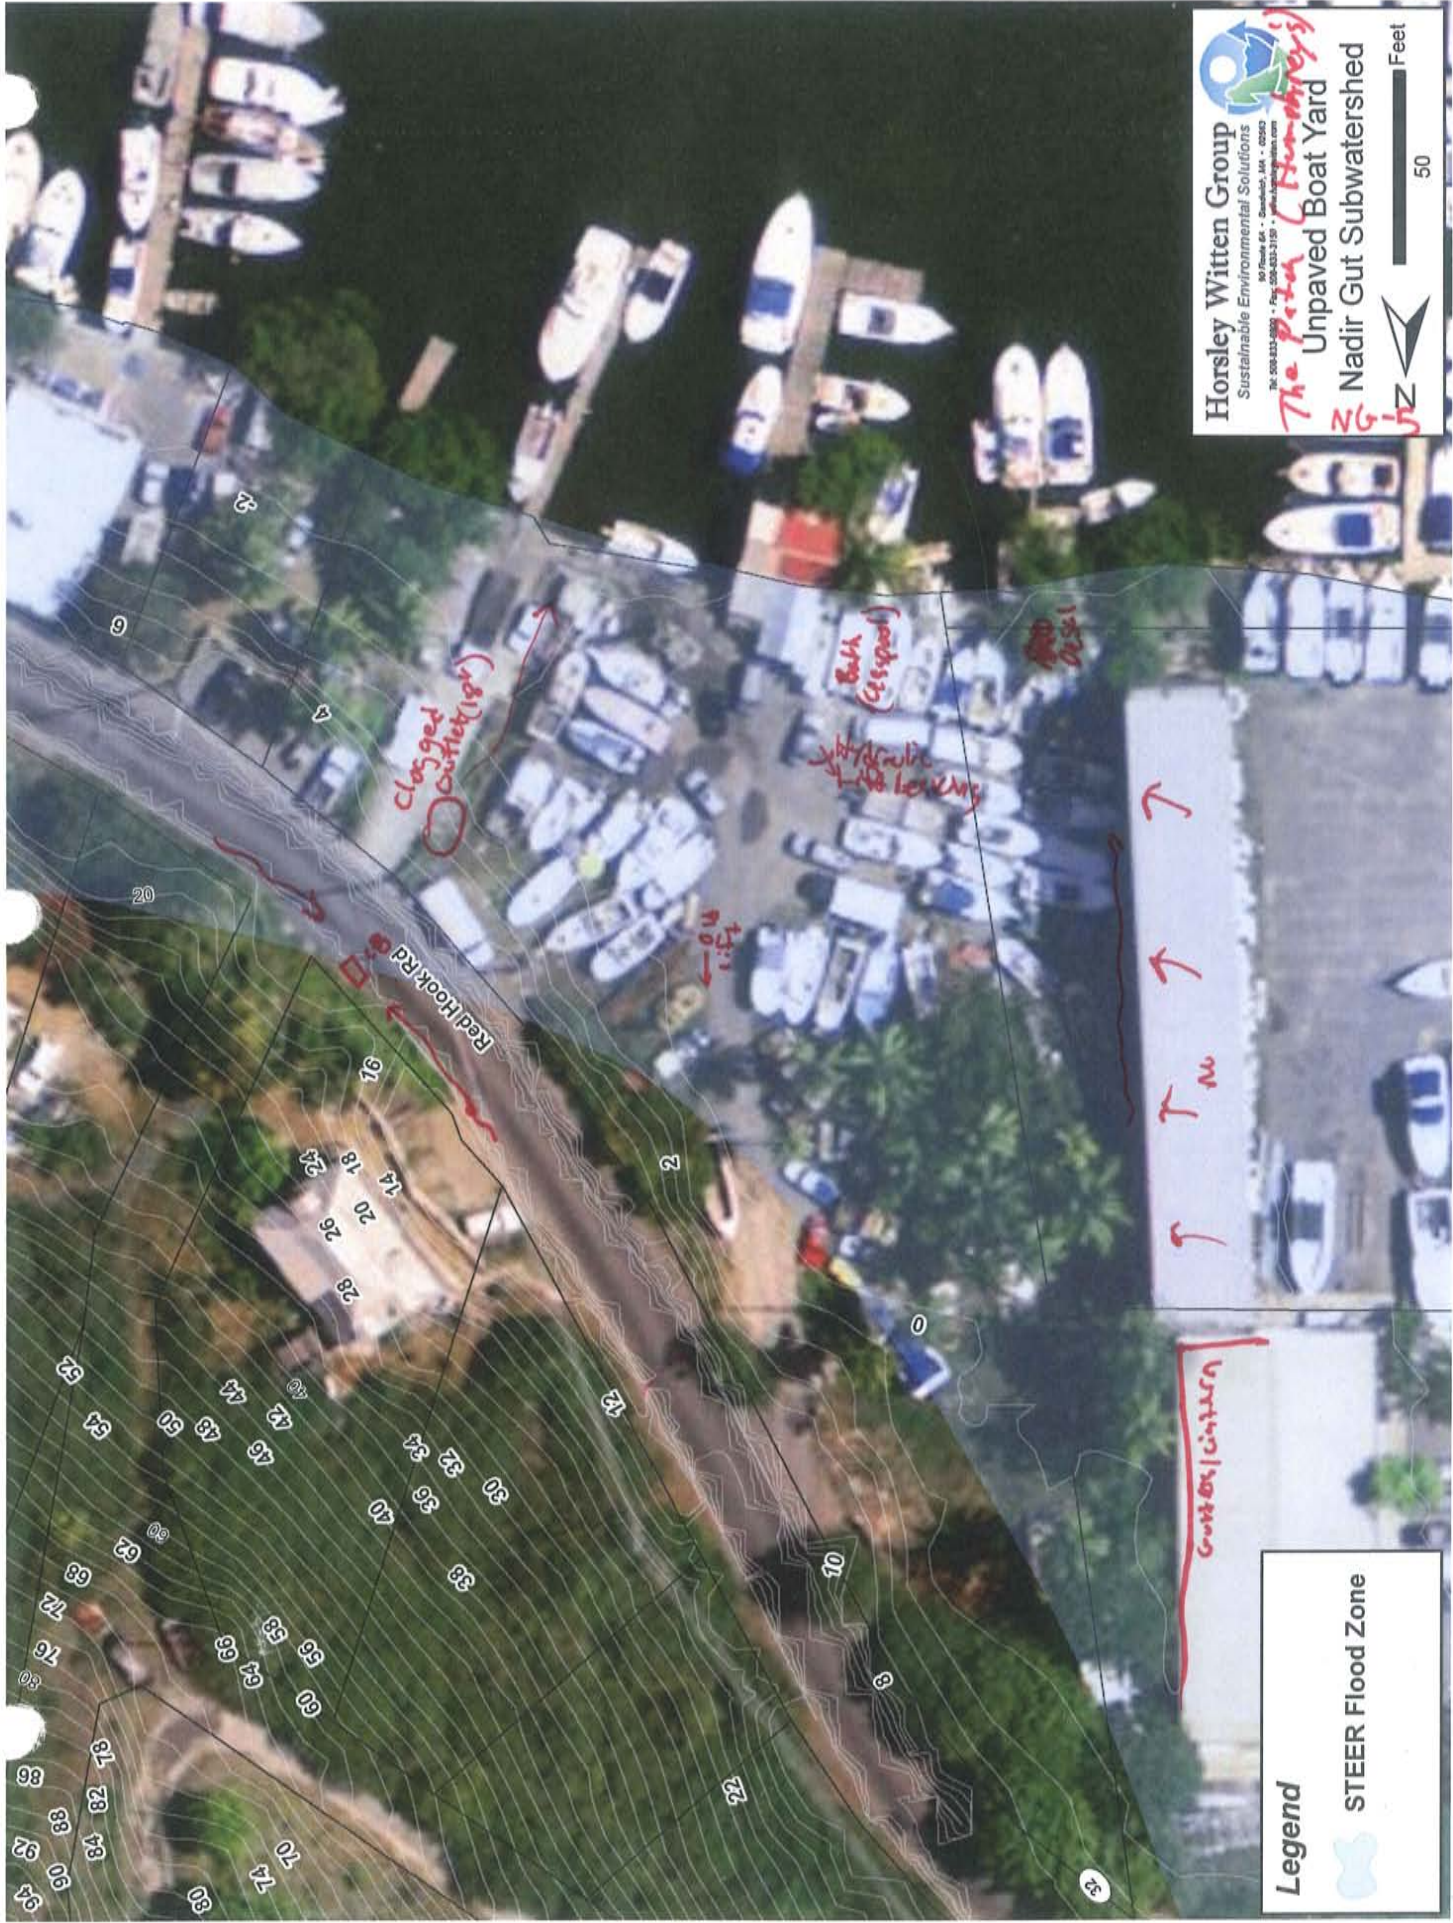
Site Name: The Patch **NG-5** (Humphrey's owner) *UNPAVED YARD*

- History of gut reworking around the ball field
- option for small swale down back of Tropic Marine. bid be ok with that, but not to much.
- brackish well & diesel plant
- wastewater goes into the ground
- cesspool
- wants to dredge when current drainage is right @ boat landing. average dredging every 3 years
- tropical marine rooftop not collected on cistern

- ① Remove and/or relocate cess pool.
- ② pave area designated to collect oils & other boat repair fluids/pollutants
- ③ direct sediment laden runoff from entrance to swale or other basin
- ④ consider bioswale along western edge w tropical marine
