FIELD ASSESSMENT NOTES

Subwatershed: Turpentine Run

Site Name: Whispering Hills ~~Woods~~ (TR-4) & Flag Hill (TR-1)

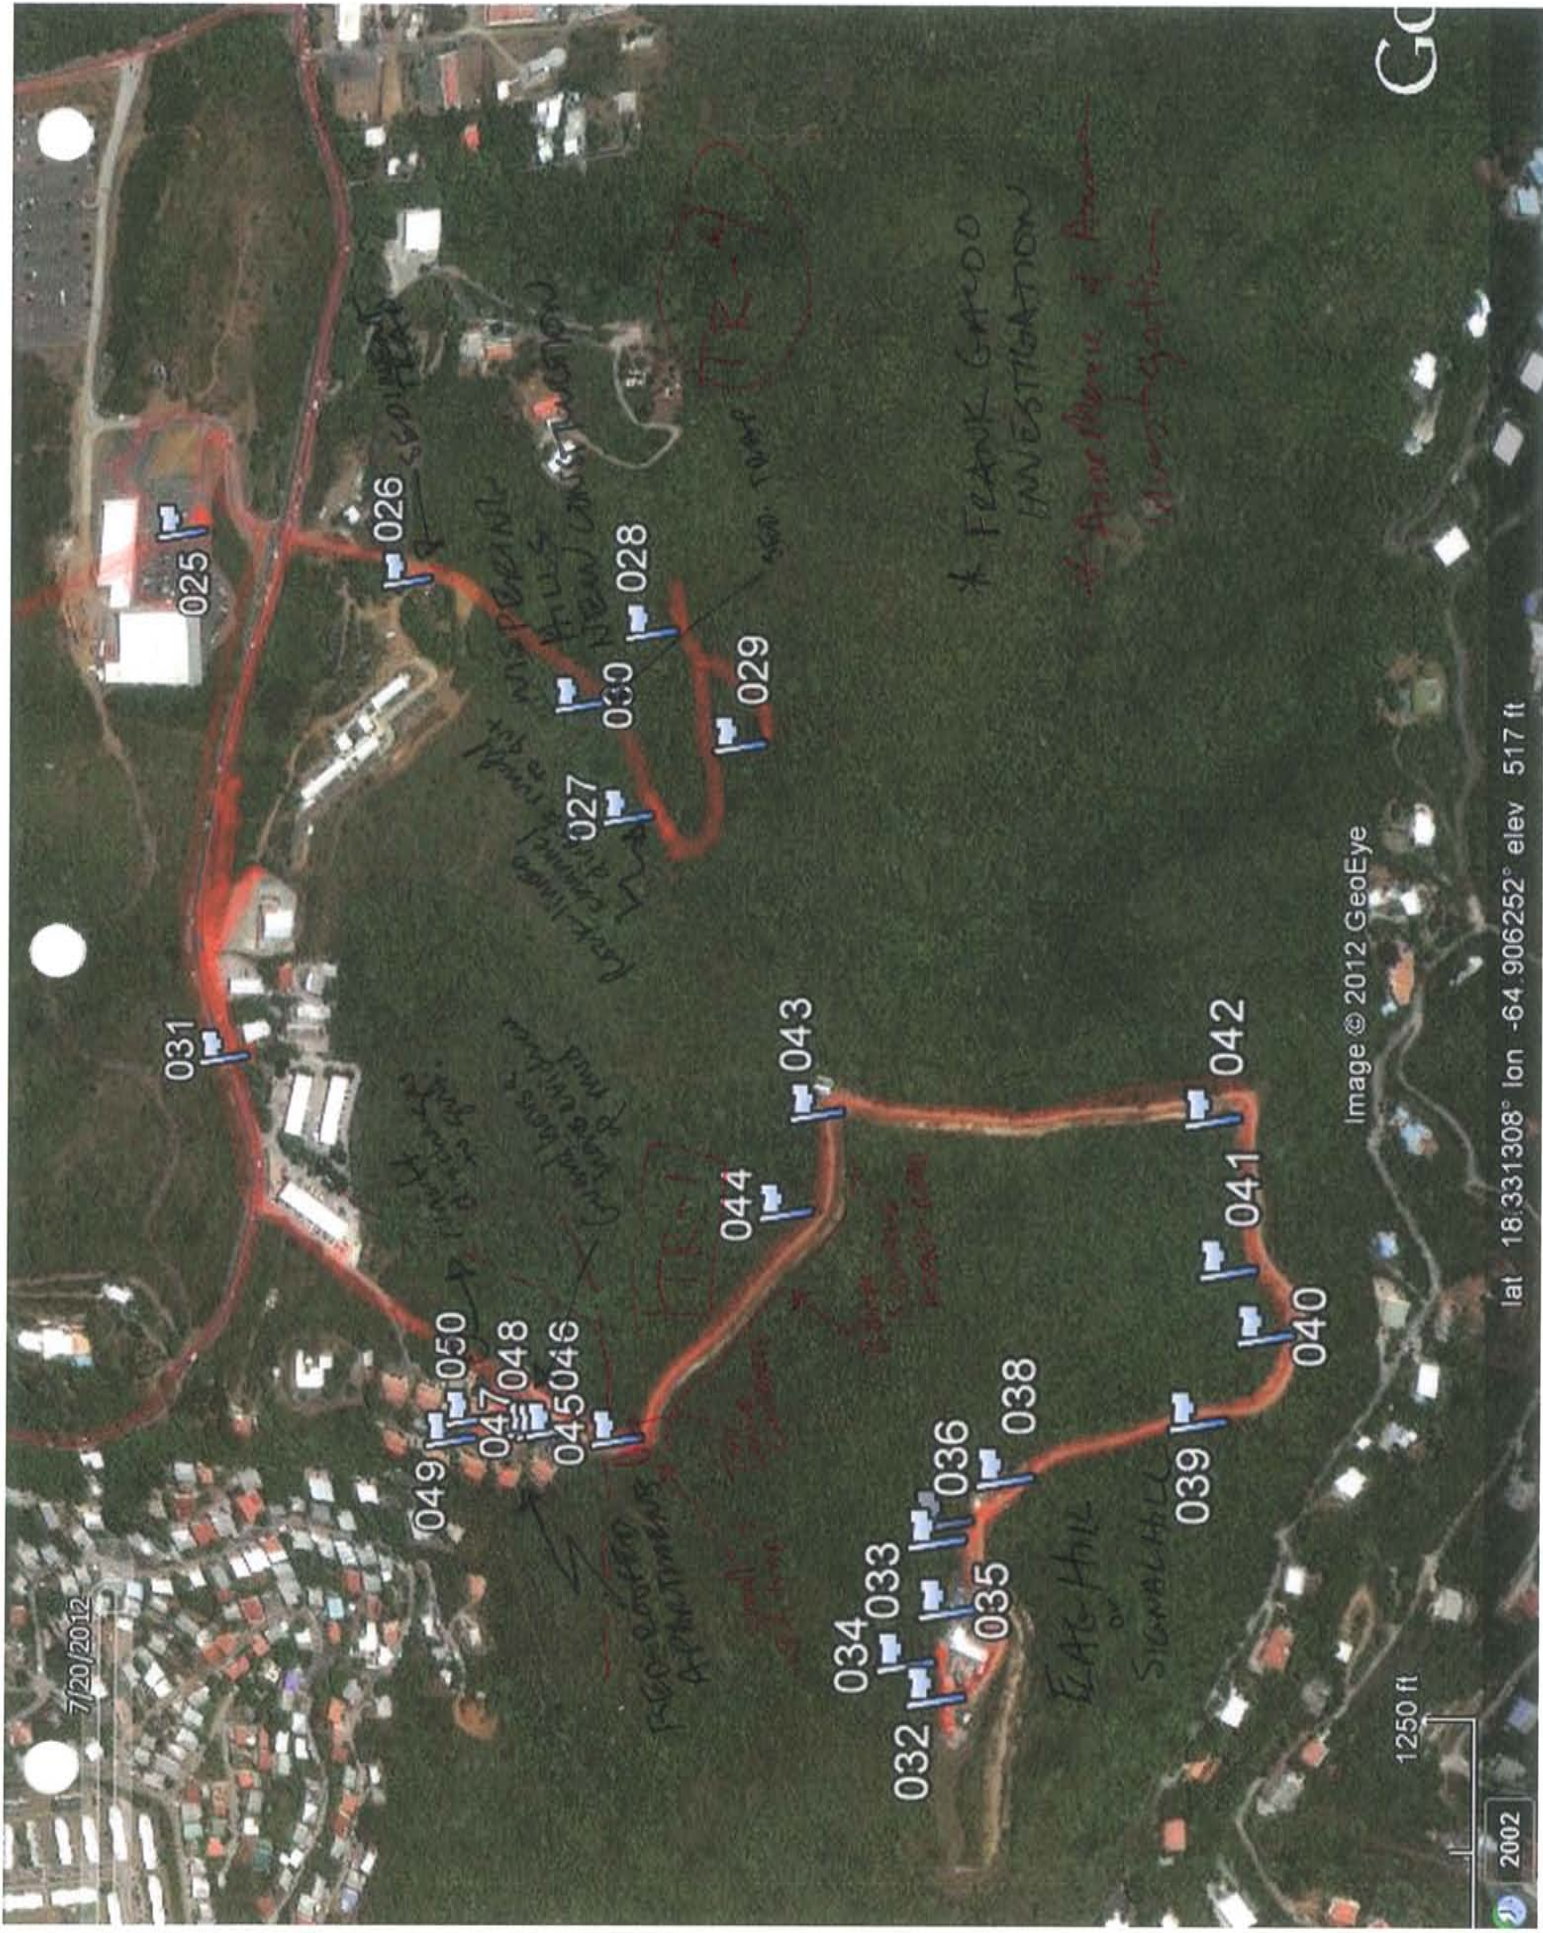
Flag Hill - Evidence of sedimentation at guard house. Investigate permit associated w/ road/development project. Unpaved road may need additional stabilization if to be permanent. Runoff discharge across entrance from Red-roofed apartments.

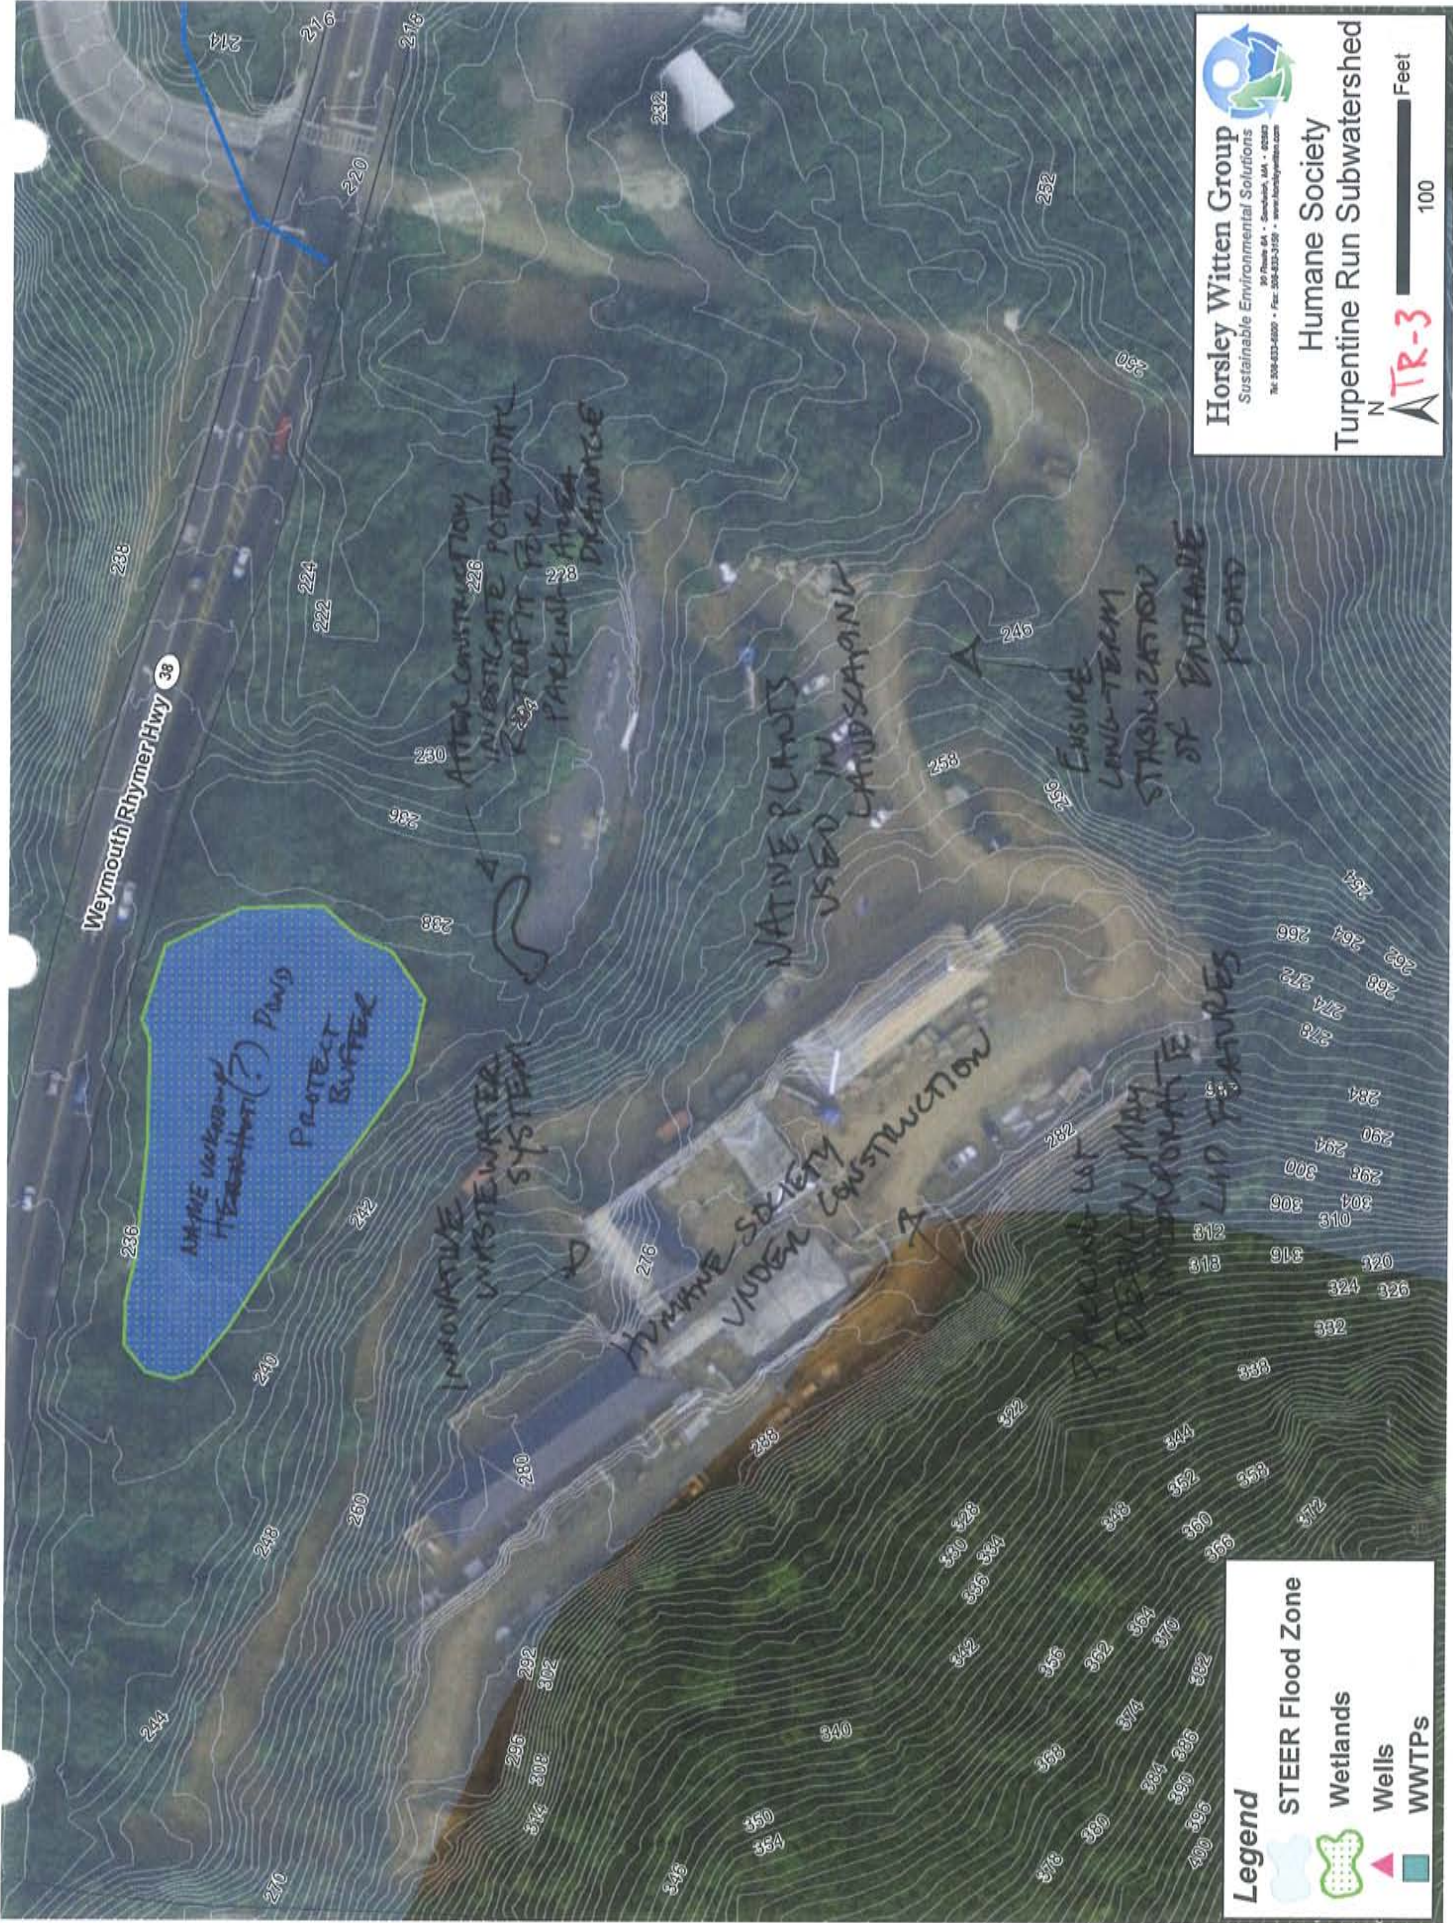
Humane Society
 Turpentine Run Subwatershed

INNOVATIVE WWTP ; ~~at~~ LID application possibly in the parking lot. Native plants.

→ ownership Hornhutt pond. possible buffer protection / enhancement discussion w/ owner.

→ Keep an eye on entrance road erosion. possible installation of water bars, etc.

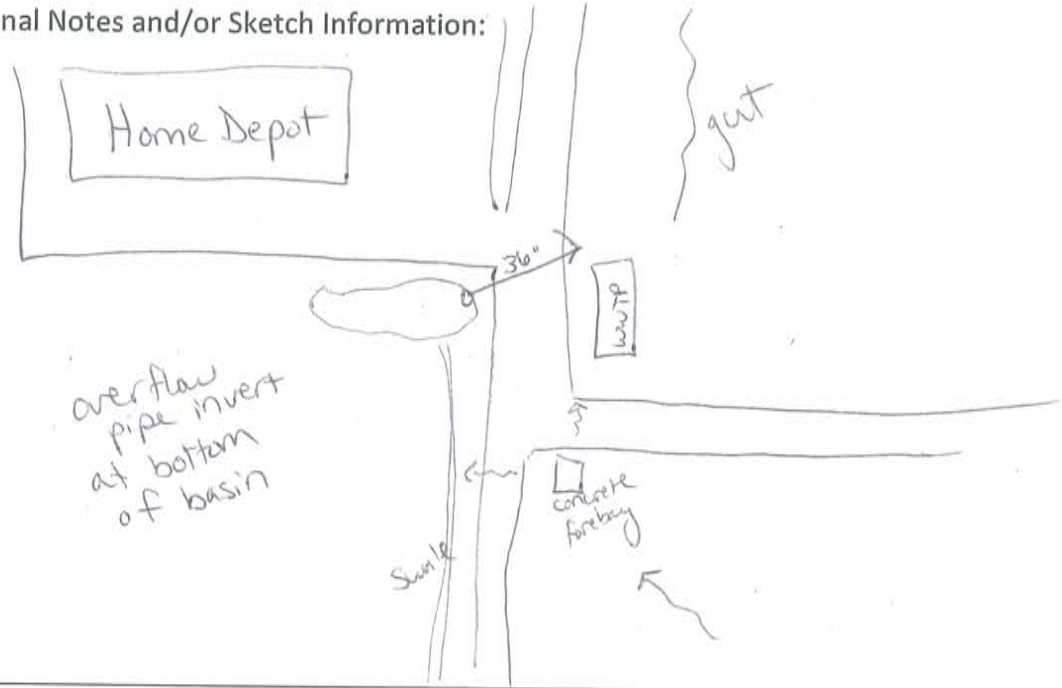
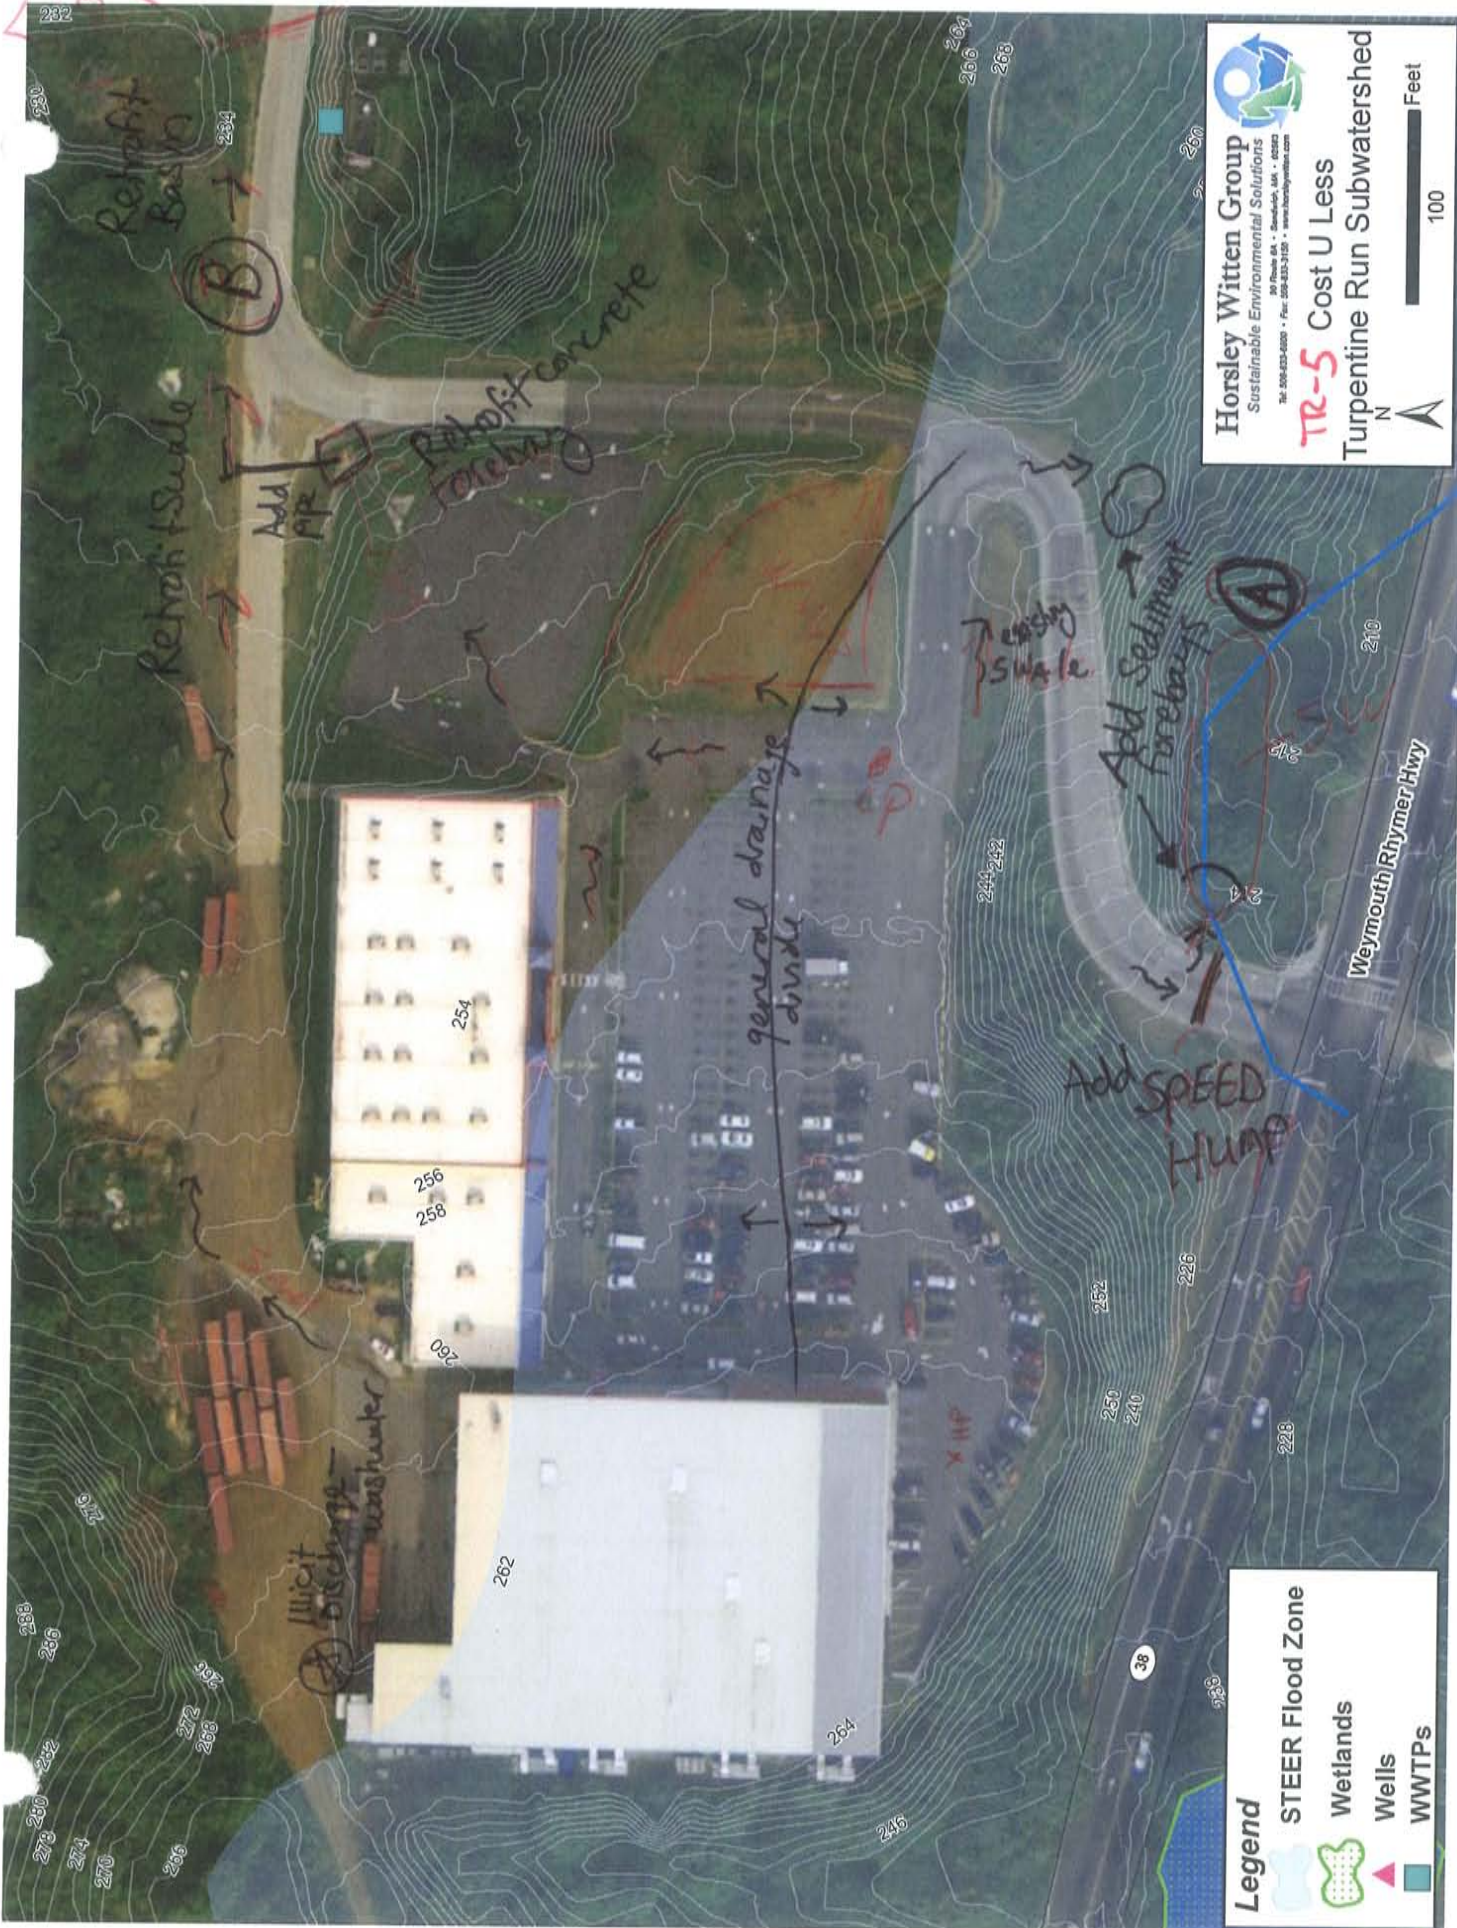
TR-5 Cost U Less
Turpentine Run Subwatershed

Half of lot flows into a concrete swale that leads to a new detention basin. Basin is in very good condition; may not see much stormwater. There is a curb cut under sidewalk that may not be effective.

Back half of lot flows into very steep swales that lead to a detention basin near Home Depot. Some dry weather flow observed - dumping of washwater from back of Cost U Less. There is one concrete sediment basin near intersection of entrance road and loading dock driveway - dirt has been bermed there to prevent overflows down into the package plant area. The package plant seemed to be working, but the generator needs maintenance. Any overflows here go straight into the gut.

A. New detention basin — direct more runoff into basin with a speed hump near the major intersection. Add sediment forebays for easier maintenance.

B. Basin near Home Depot — retrofit with sediment forebays and a 90° bend on outlet pipe to detain more water here, perhaps get some infiltration. Basin could be planted with more vegetation. Swales should be converted to more gentle side slopes, and add some check dams to reduce velocities. Retrofit concrete forebay with pipe to swales. Educate Cost U Less about washwater dumping. Make sure WWTP is regularly maintained. ○

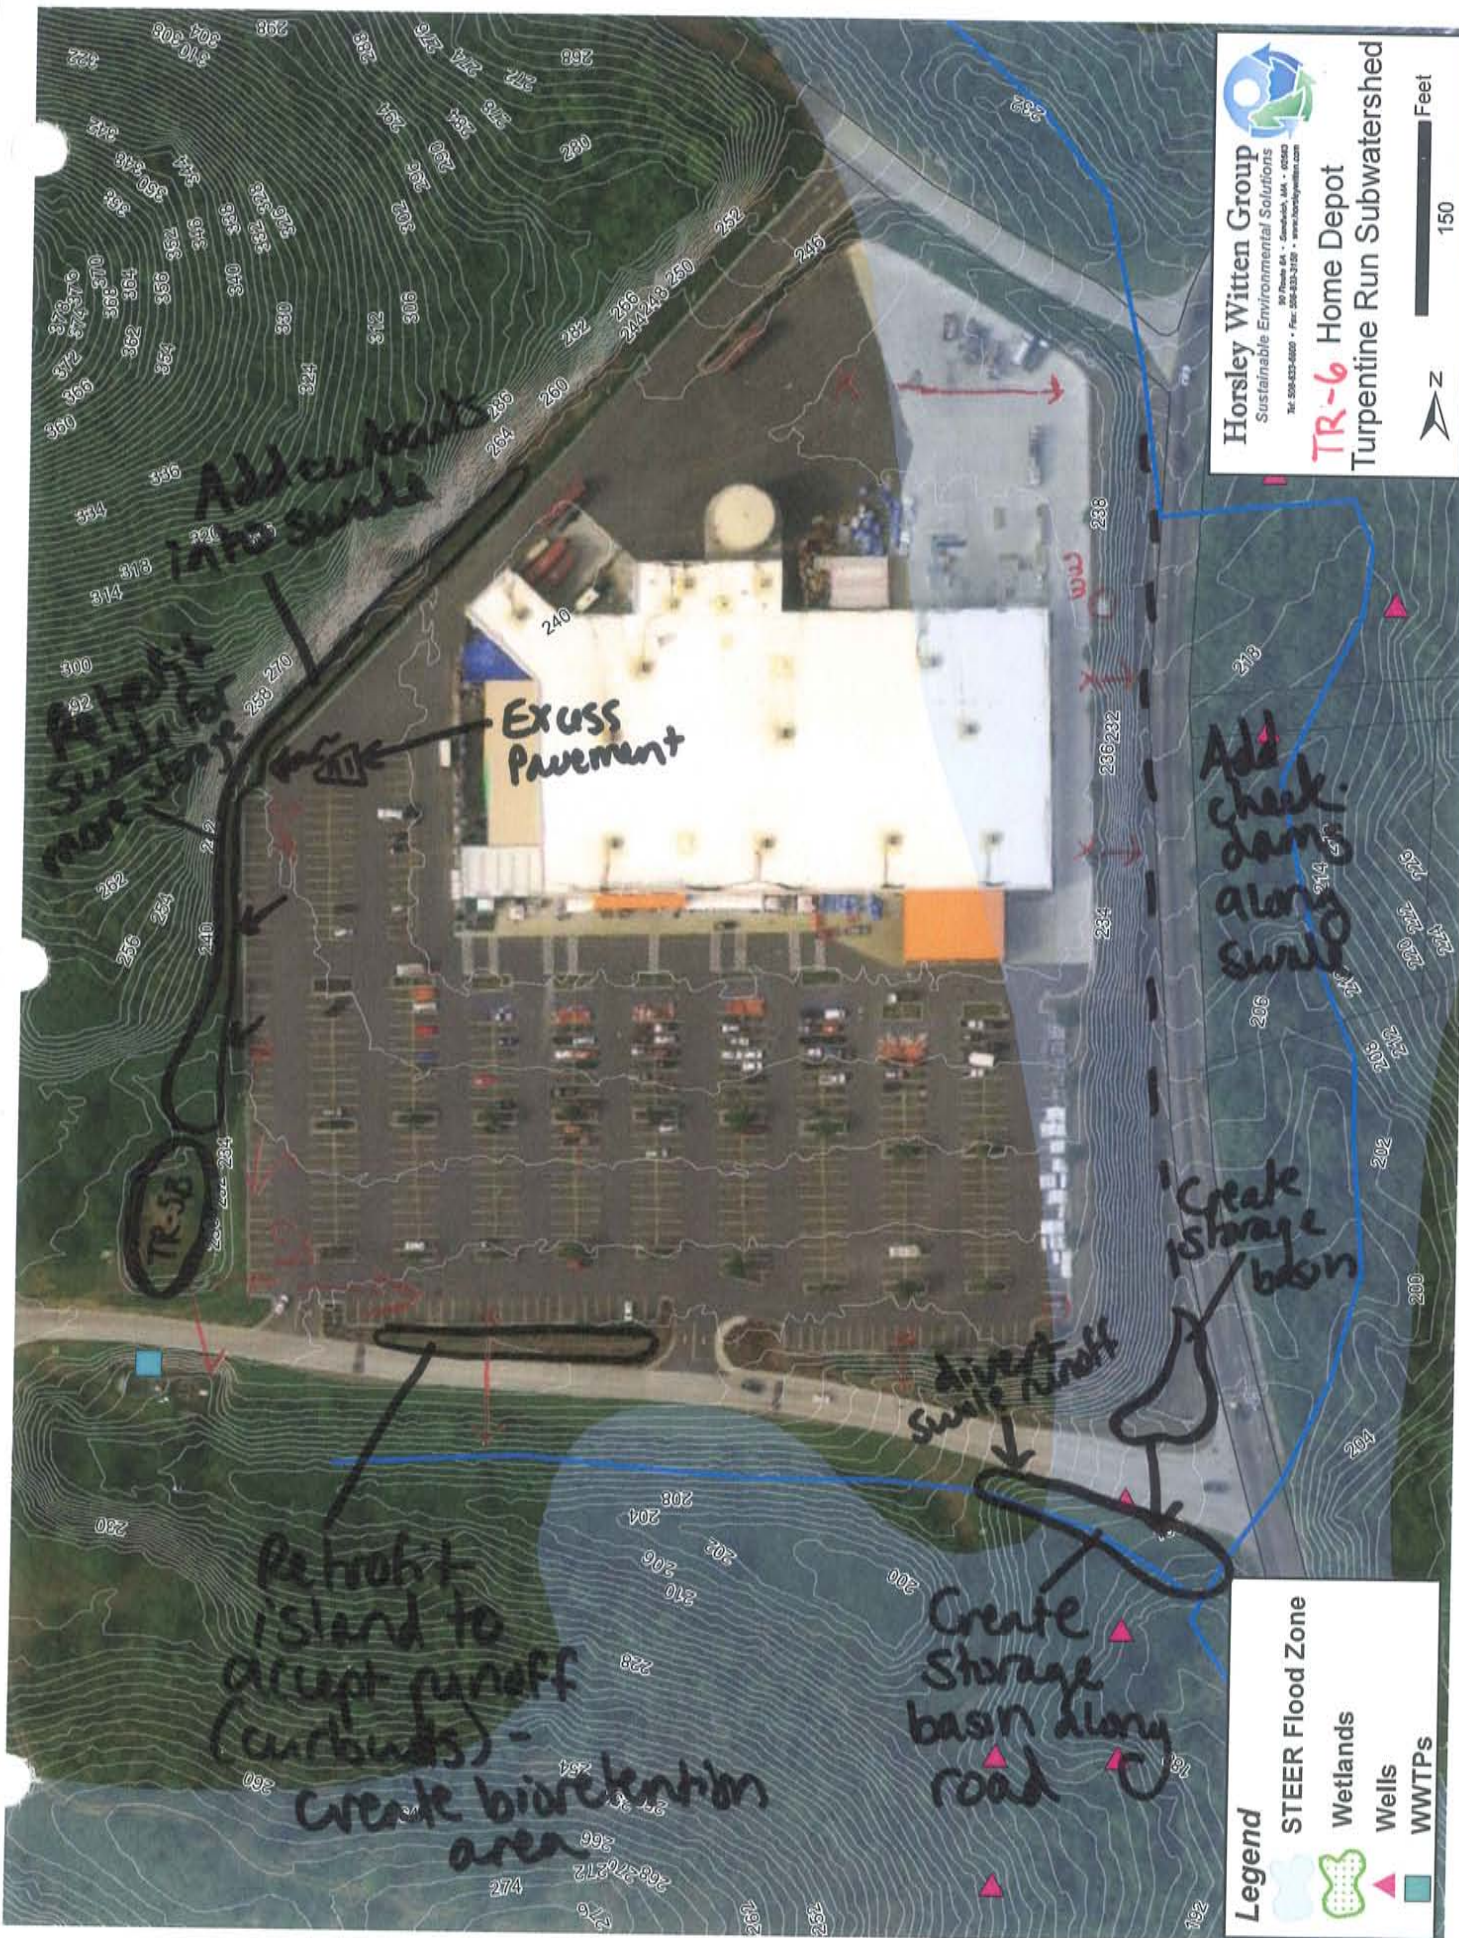
TR-6 Home Depot
 Turpentine Run Subwatershed

CBS → Discharge to ^{stone} swale/ditch
 Parking is larger than needed
 28' DRIVE AISLES
 CURBED Islands → Potential Bios
 Have wastewater TREATMENT → small system
 out back that looks like it discharges
 to A LSA under parking AREA
 WATER HARVEST system for FIRE protection
 with LARGE storage tank Fed from
 Look like ROOF

Possible potential cost v Less Detention
pond w/ riser to capture ~~water~~ ~~water~~
more SW.

CBS could be equipped w/ hoods and/or
WP units downstream

Curb cuts in islands to accept
runoff.

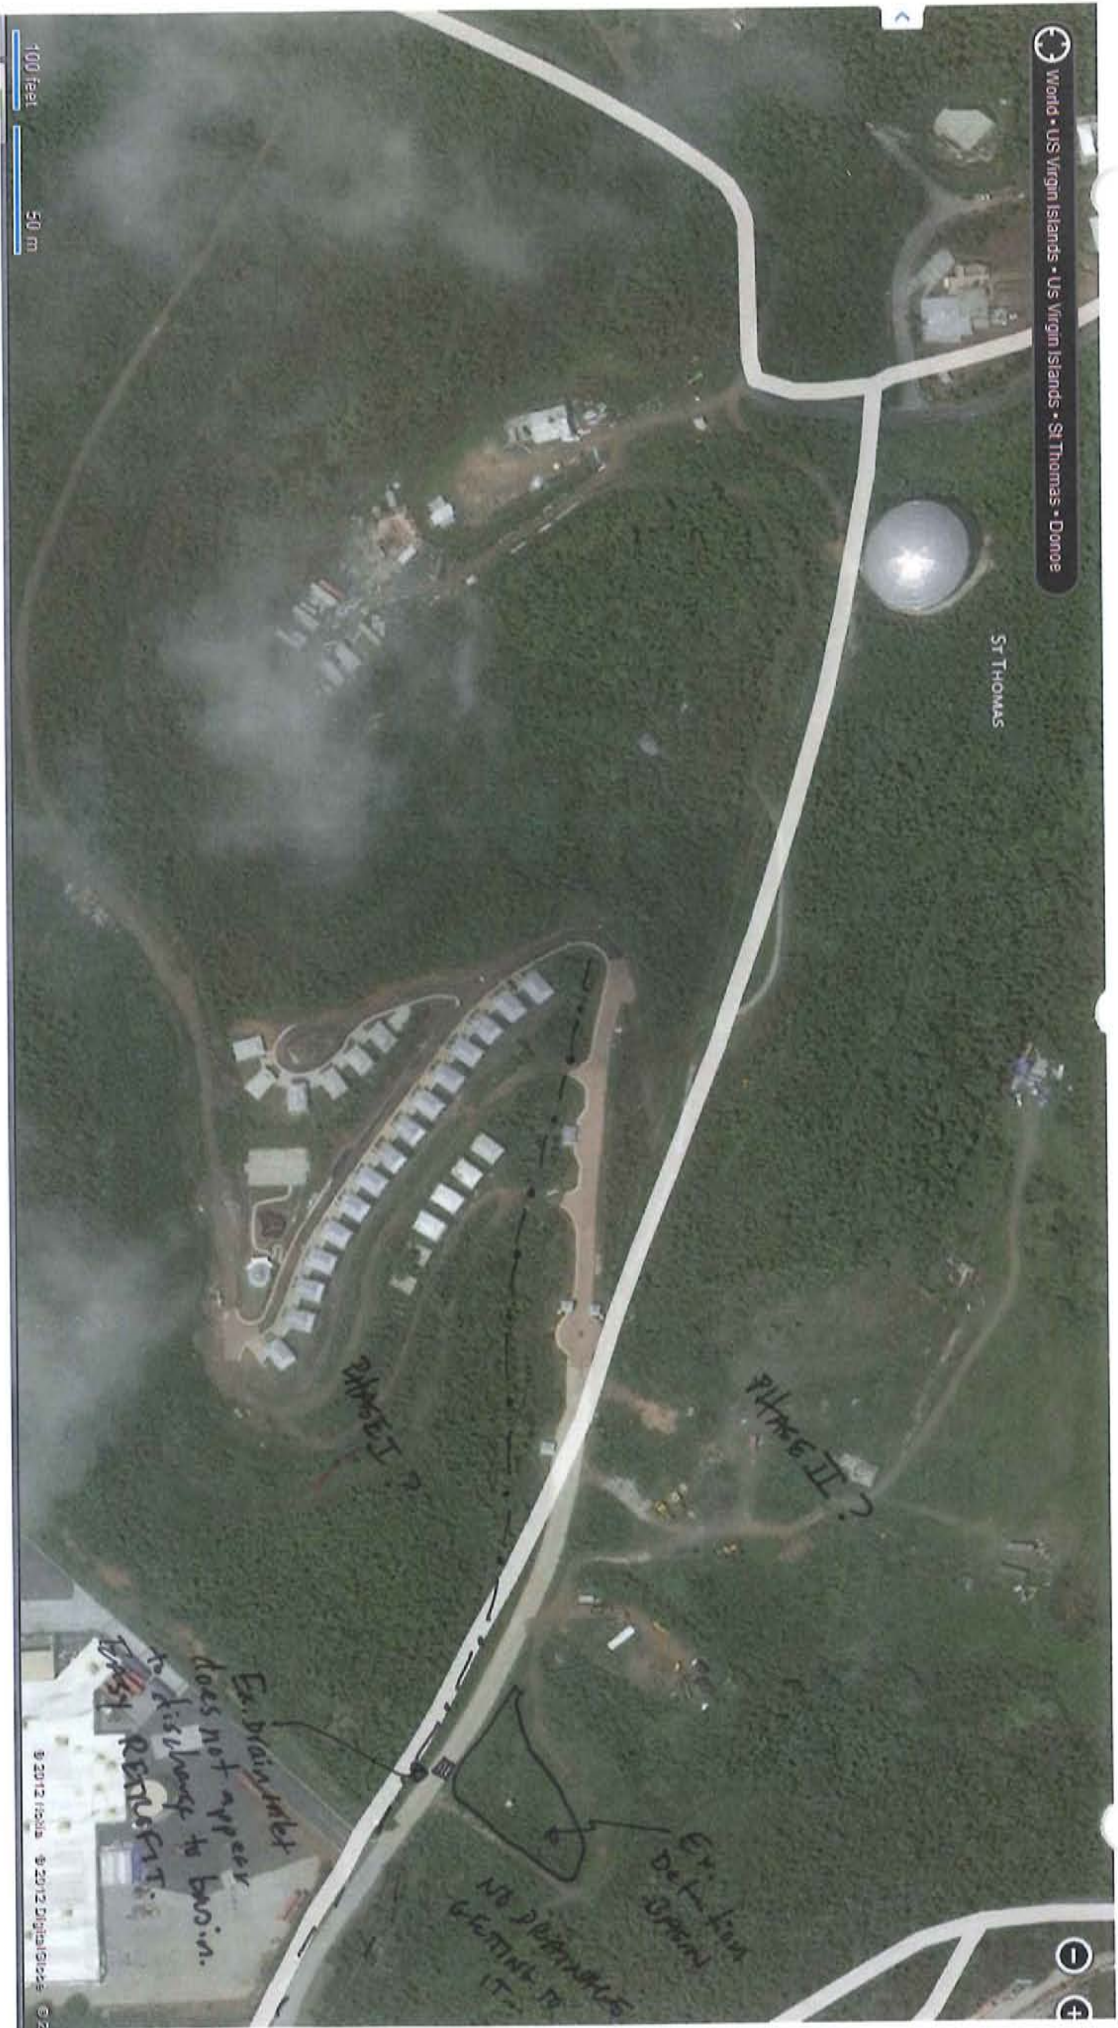
TR-7 Raphune Vista.

Onsite WW → Looks like Biodecan systems
 Drains → collect CBS (ADS) i
 Through Drains To Discharge To Gut.
 Houses equipped w/ cisterns From Roof
 Runoff.
 Road 16-17' wide
 Solar lighting
 Community pavilion
 Municipal water
 Fairly nice

Detention Pond near start of subdivision
 → Does not look like it is getting
 much runoff

SPEED Hump to Get more Runoff To Ex.
Detention Basin

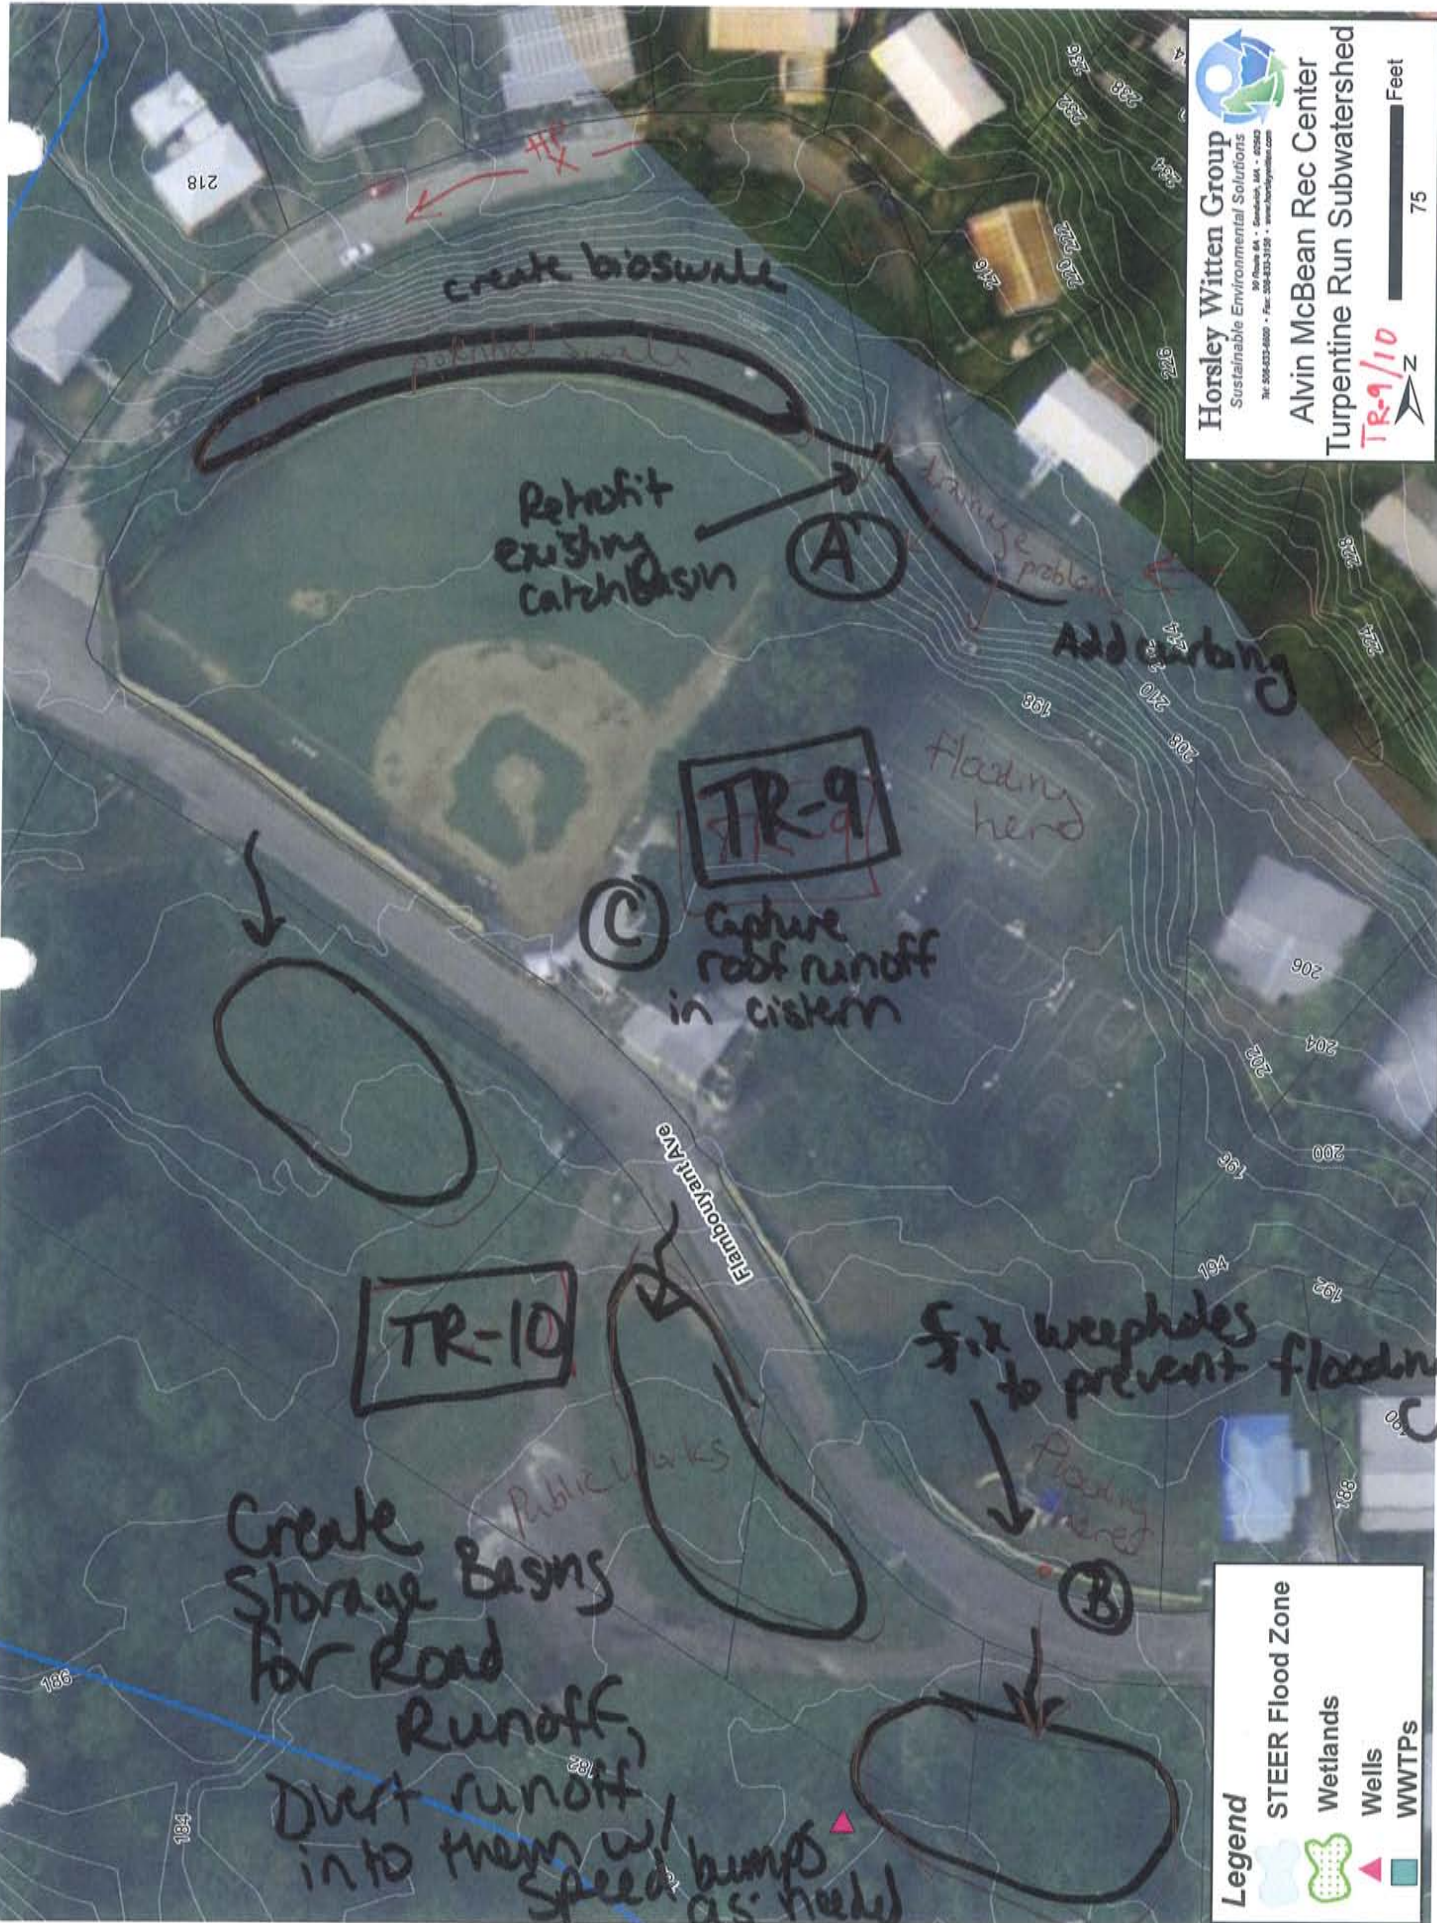
Alvin McBean Rec Center
Turpentine Run Subwatershed
TR-9/10

The Rec Center has catch basins for drainage in various places. However, it is experiencing flooding issues due to clogged inlet + ~~holes~~ lack of curbing along the road that is upgradient of the rec center. The runoff flows down the steep slope onto tennis courts + eventually ponds in playground area where there is a yard drain and openings in the wall; but the yard drain is too high to take the runoff and the wall openings get clogged with lawn debris. Some roof drains in this area discharge to impervious surfaces. Also the DAW land across the street has some great open grassy areas that could help provide SW treatment/storage. There's evidence of dumping and uncovered maint.

and storage of DAW vehicles in that area, which is directly adjacent to the gut/Tutu Reservoir. Also, when we were there, a sewer line appeared to be under construction and several manholes were left uncovered directly adjacent to gut. Trash and old cars were left in this area, too.

The existing catchbasin along the road above soccer center should be cleaned out + redirected to discharge to a SW swale along ball field. Curbing should be installed to ensure flow is captured + prevent it from flowing down the slope to the tennis courts. Signage should be installed about SW + watershed issues. Perhaps runoff should be disconnected, and the playground area should be retrofitted to prevent flooding. The open areas on the DPW land should be converted to accept runoff from roadway - great location for signage - and trash should be removed. Sewer system should be covered + maintained regularly to ensure no overflows into the gut.

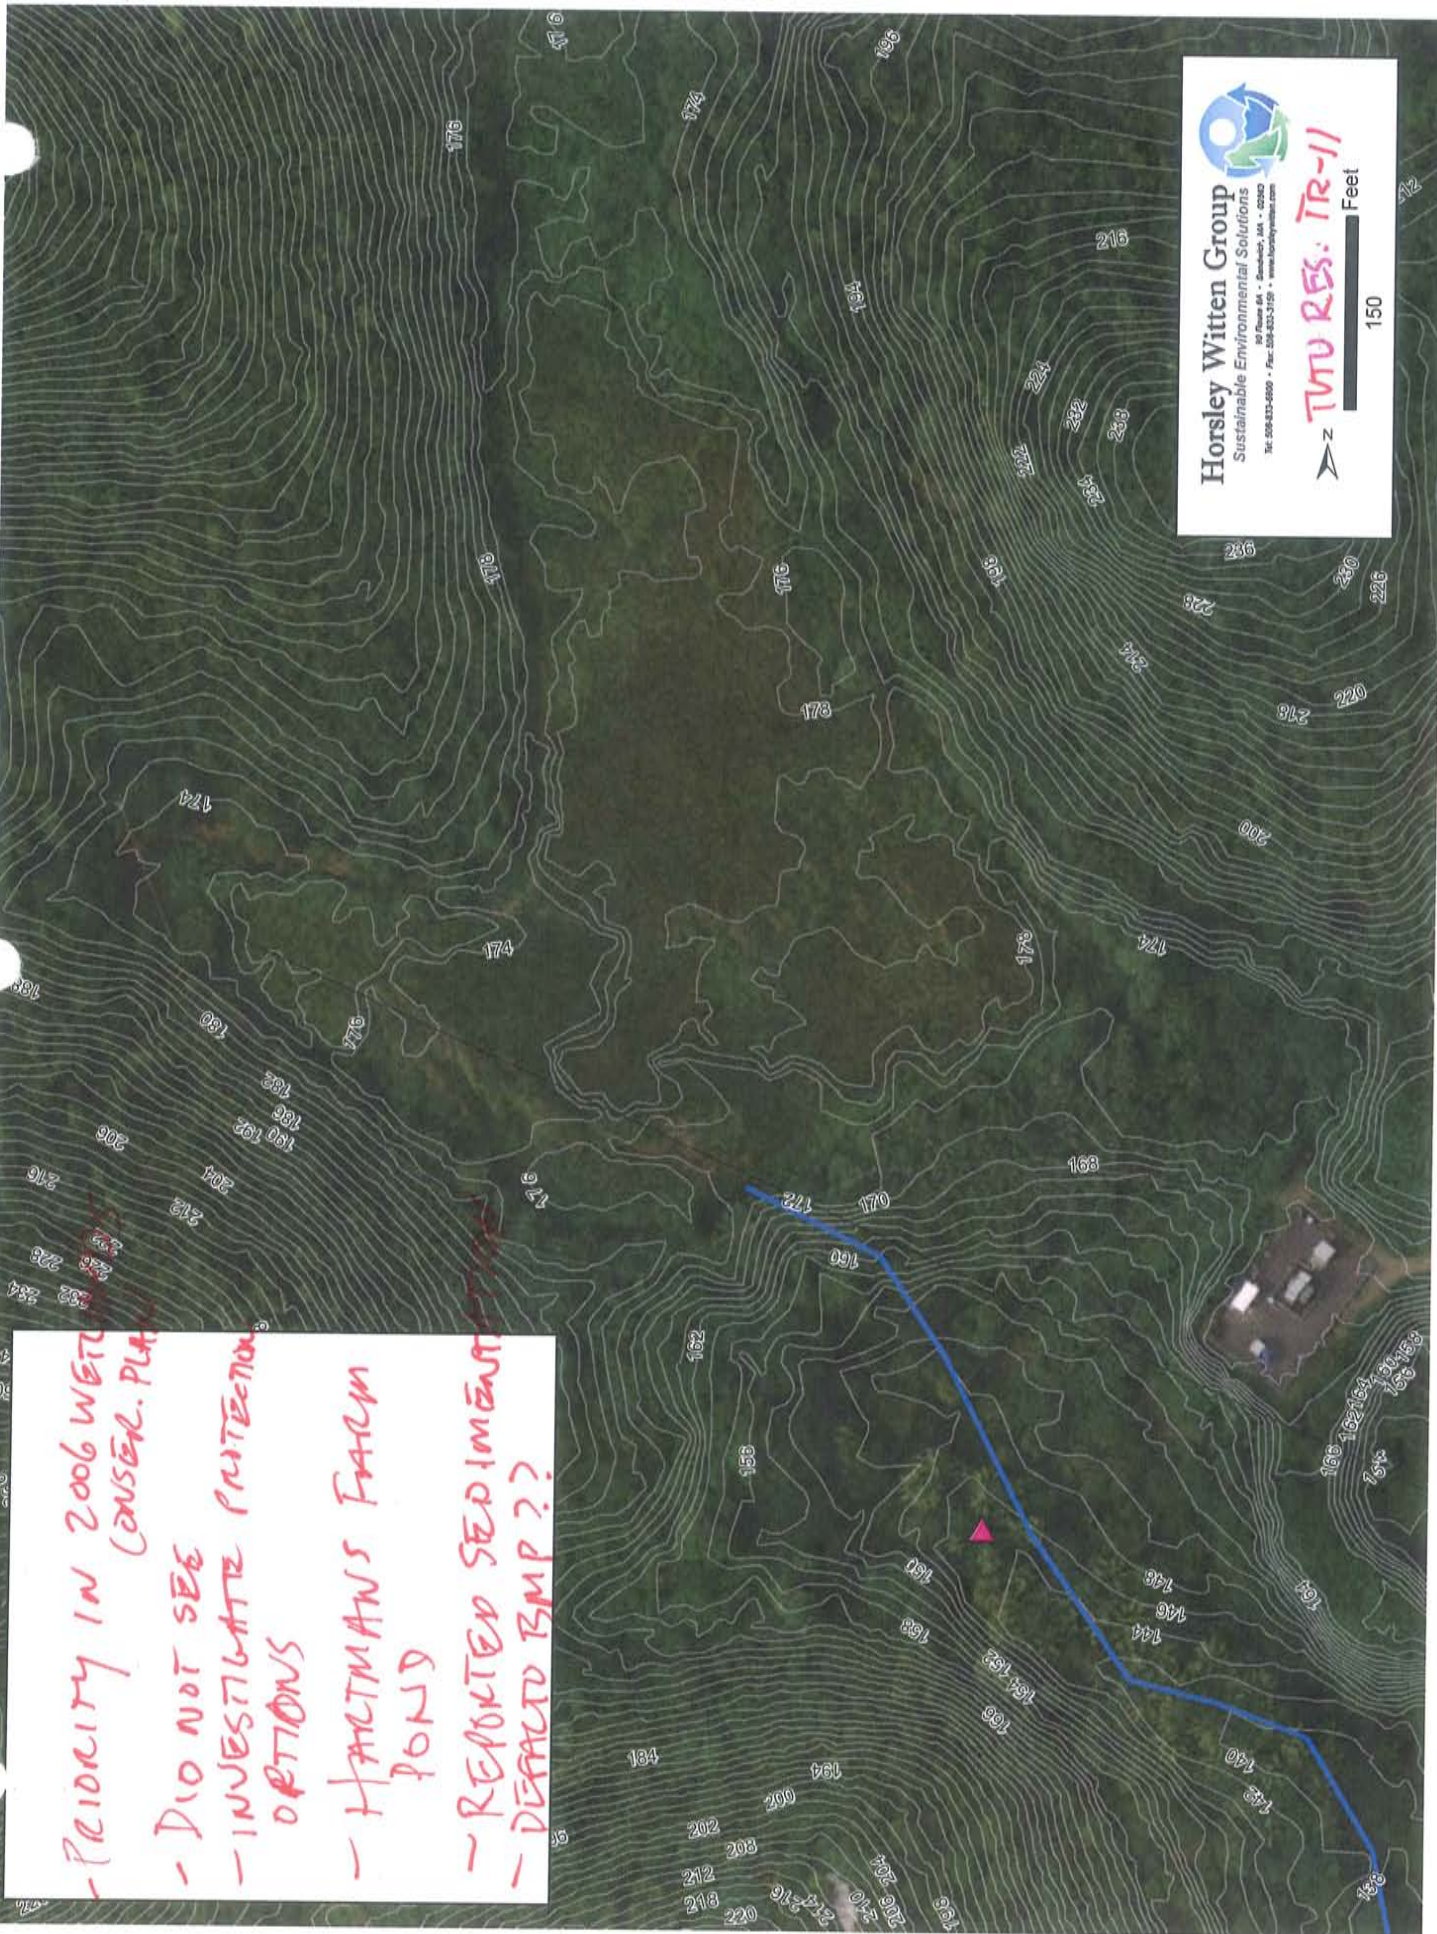
TUV RES: TR-11
 Feet
 150

- Called out in DFW as important wetland
 - serving as defacto regional stormwater facility (Grandview & Tutu)

- PRIORITY IN 2006 WERE
 CAUSED. PLAT
 - DID NOT SEE
 - INVESTIGATE PROTECTION
 OPTIONS
 - HARTMANS FARM
 POND
 - REPORTED SEDIMENTATION
 - DEFUNCT BMP??

- ① CONTACT OWNER
- ② INVESTIGATE RESTORATION & CONSERVATION OPS.
- ③ MONITOR SED. DEPOSITION HABITAT/BIO PARAMETERS WQ
- ④ CHECK DAM INTEGRITY & ~~DIFFERENT~~ OUTLET STRUCTURE
