FIELD ASSESSMENT NOTES

Subwatershed: Turpentine Run

Site Name: Whispering Hills ~~Woods~~ (TR-4) & Flag Hill (TR-1)

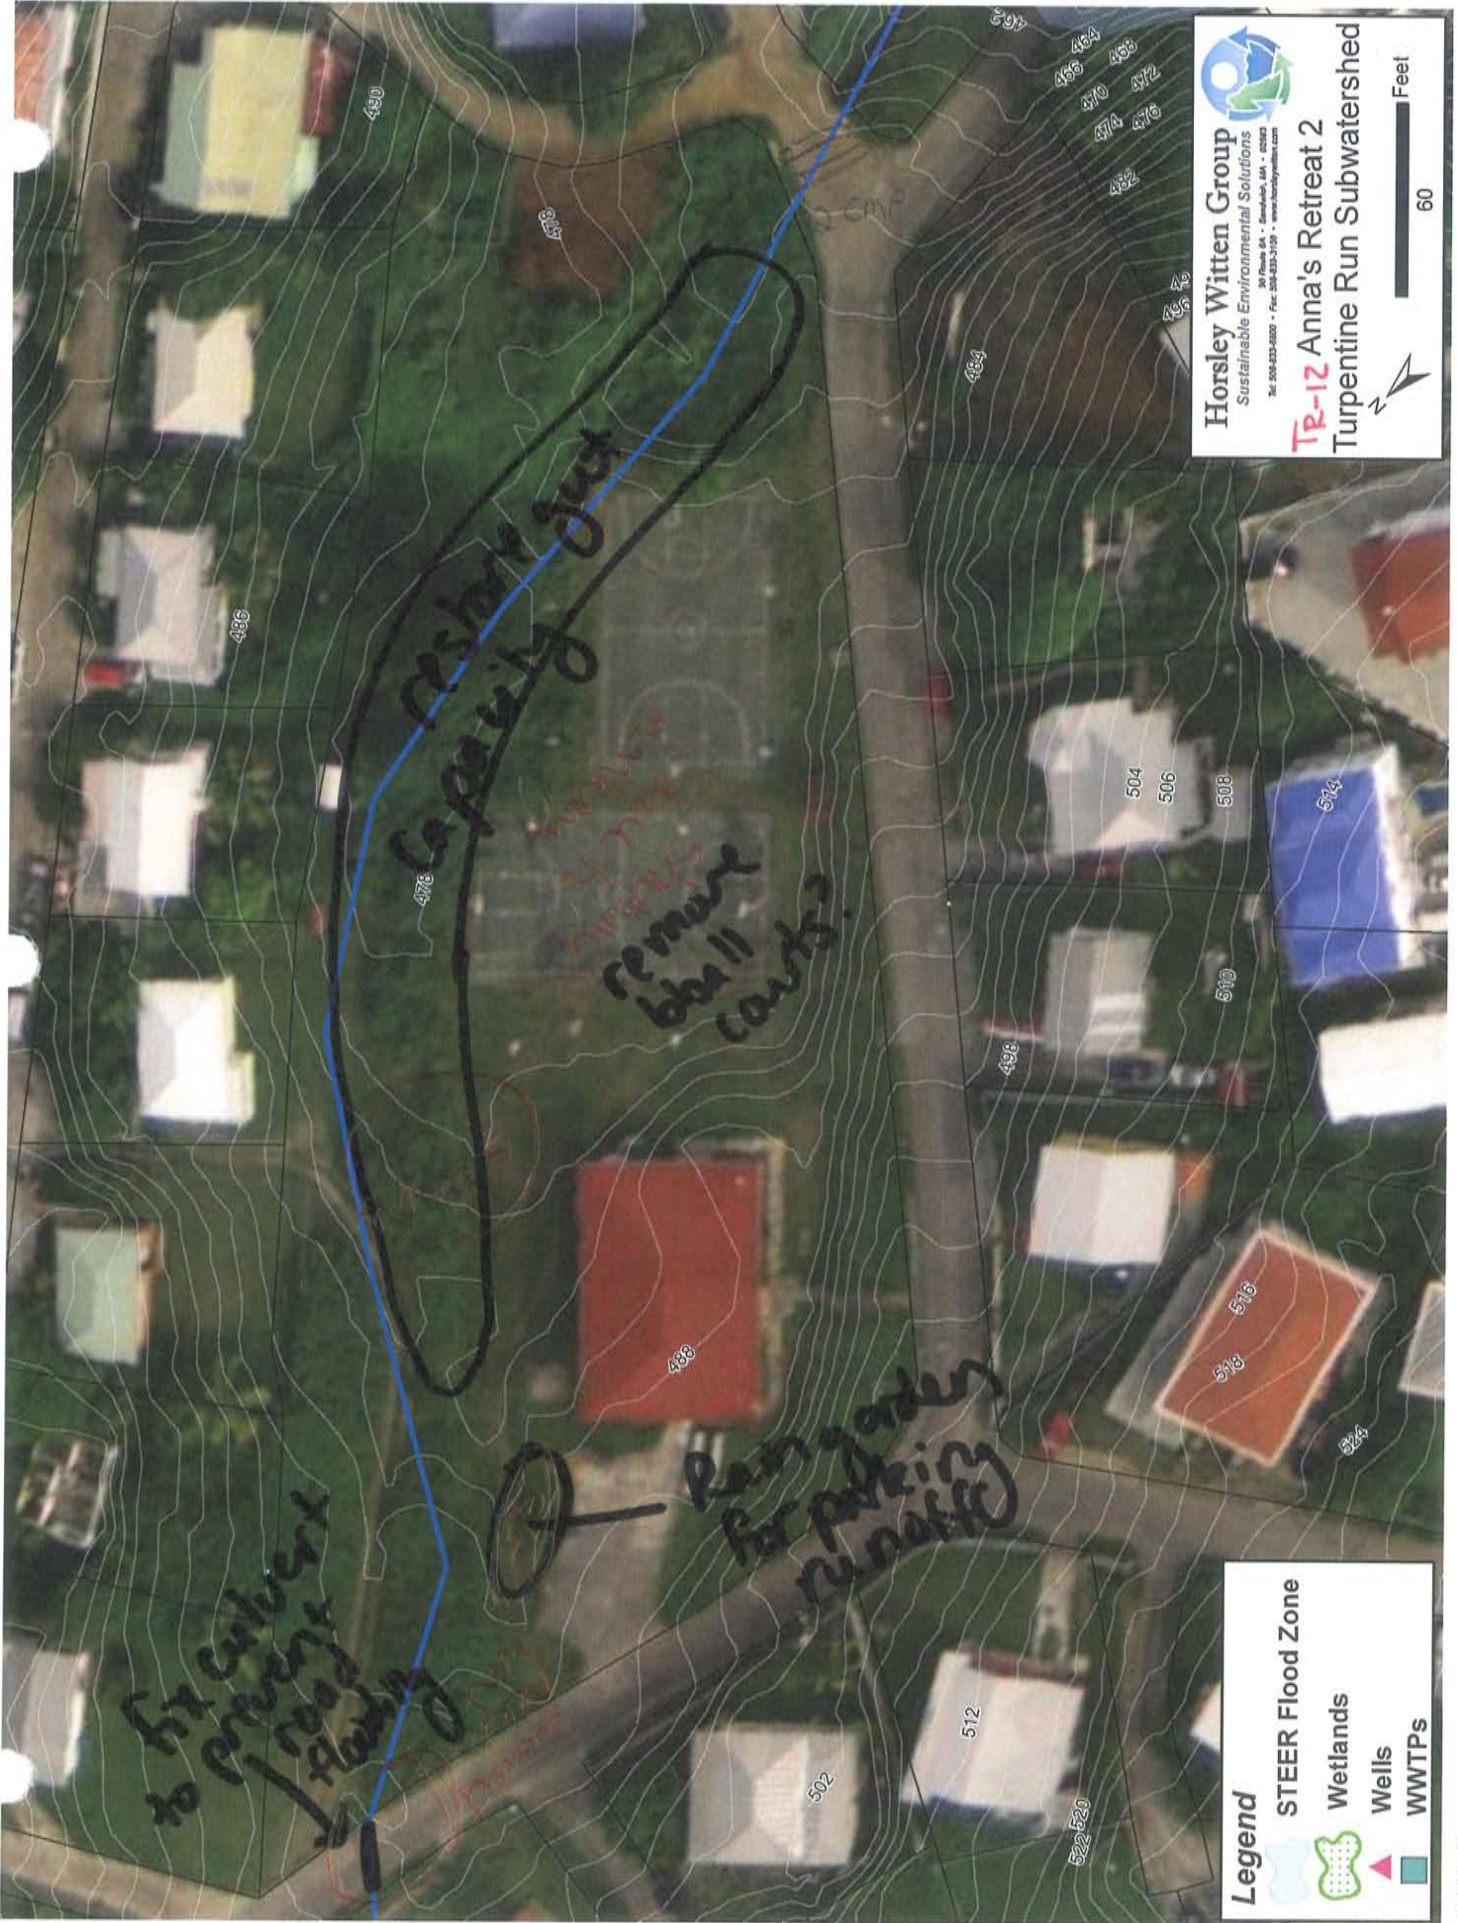
TR-12 Anna's Retreat 2
 Turpentine Run Subwatershed

Anna's retreat is an extremely large, dense neighborhood constructed on steep slopes with narrow, windy roads. Stormwater is conveyed through a series of paved swales, culverts, inlet structures, etc. - some of which run under/through buildings. Retrofitting this road system would be extremely costly & difficult as there is very little open space available. Some residential education could be useful on pollution prevention activities such as dumping things into drainage network & car maintenance. Demo projects at the two Community Centers would be a good way to reach people.

The Anna's Retreat Community Center is built in the gut particularly the new ~~tennis~~ Ball Courts. During the field visit, road work

was underway; the stockpile of materials was placed directly in the gut. Upstream culvert is damaged, causing flooding over the road.

~~This~~ The Community Center should be retrofitted to: provide a rain garden for parking lot runoff and restore capacity in the gut. This may include removing Ball Courts? This would be a great location to try to get additional offline storage if possible. Education should be provided on what a gut is and why it should be preserved. Upstream culvert capacity should be restored.

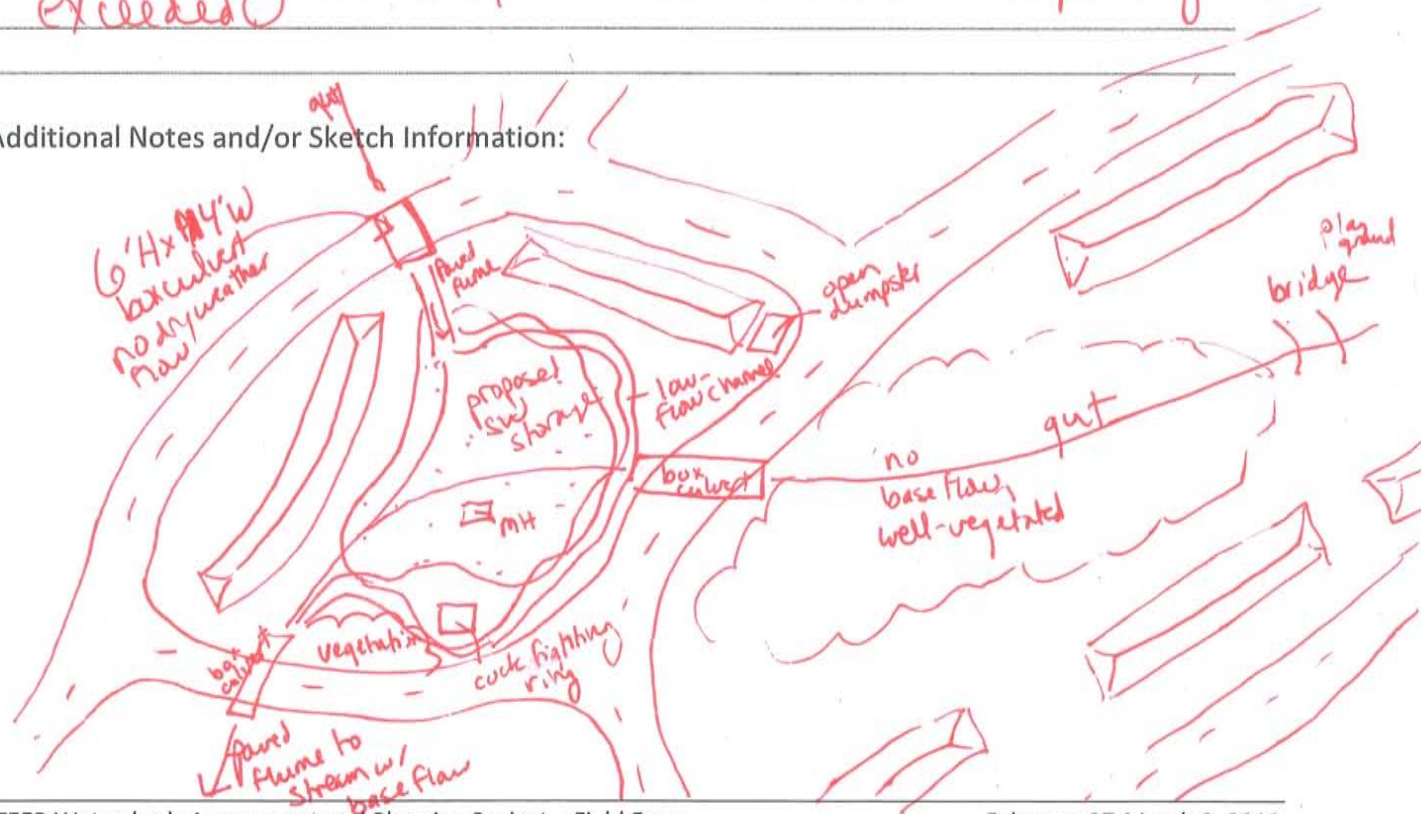
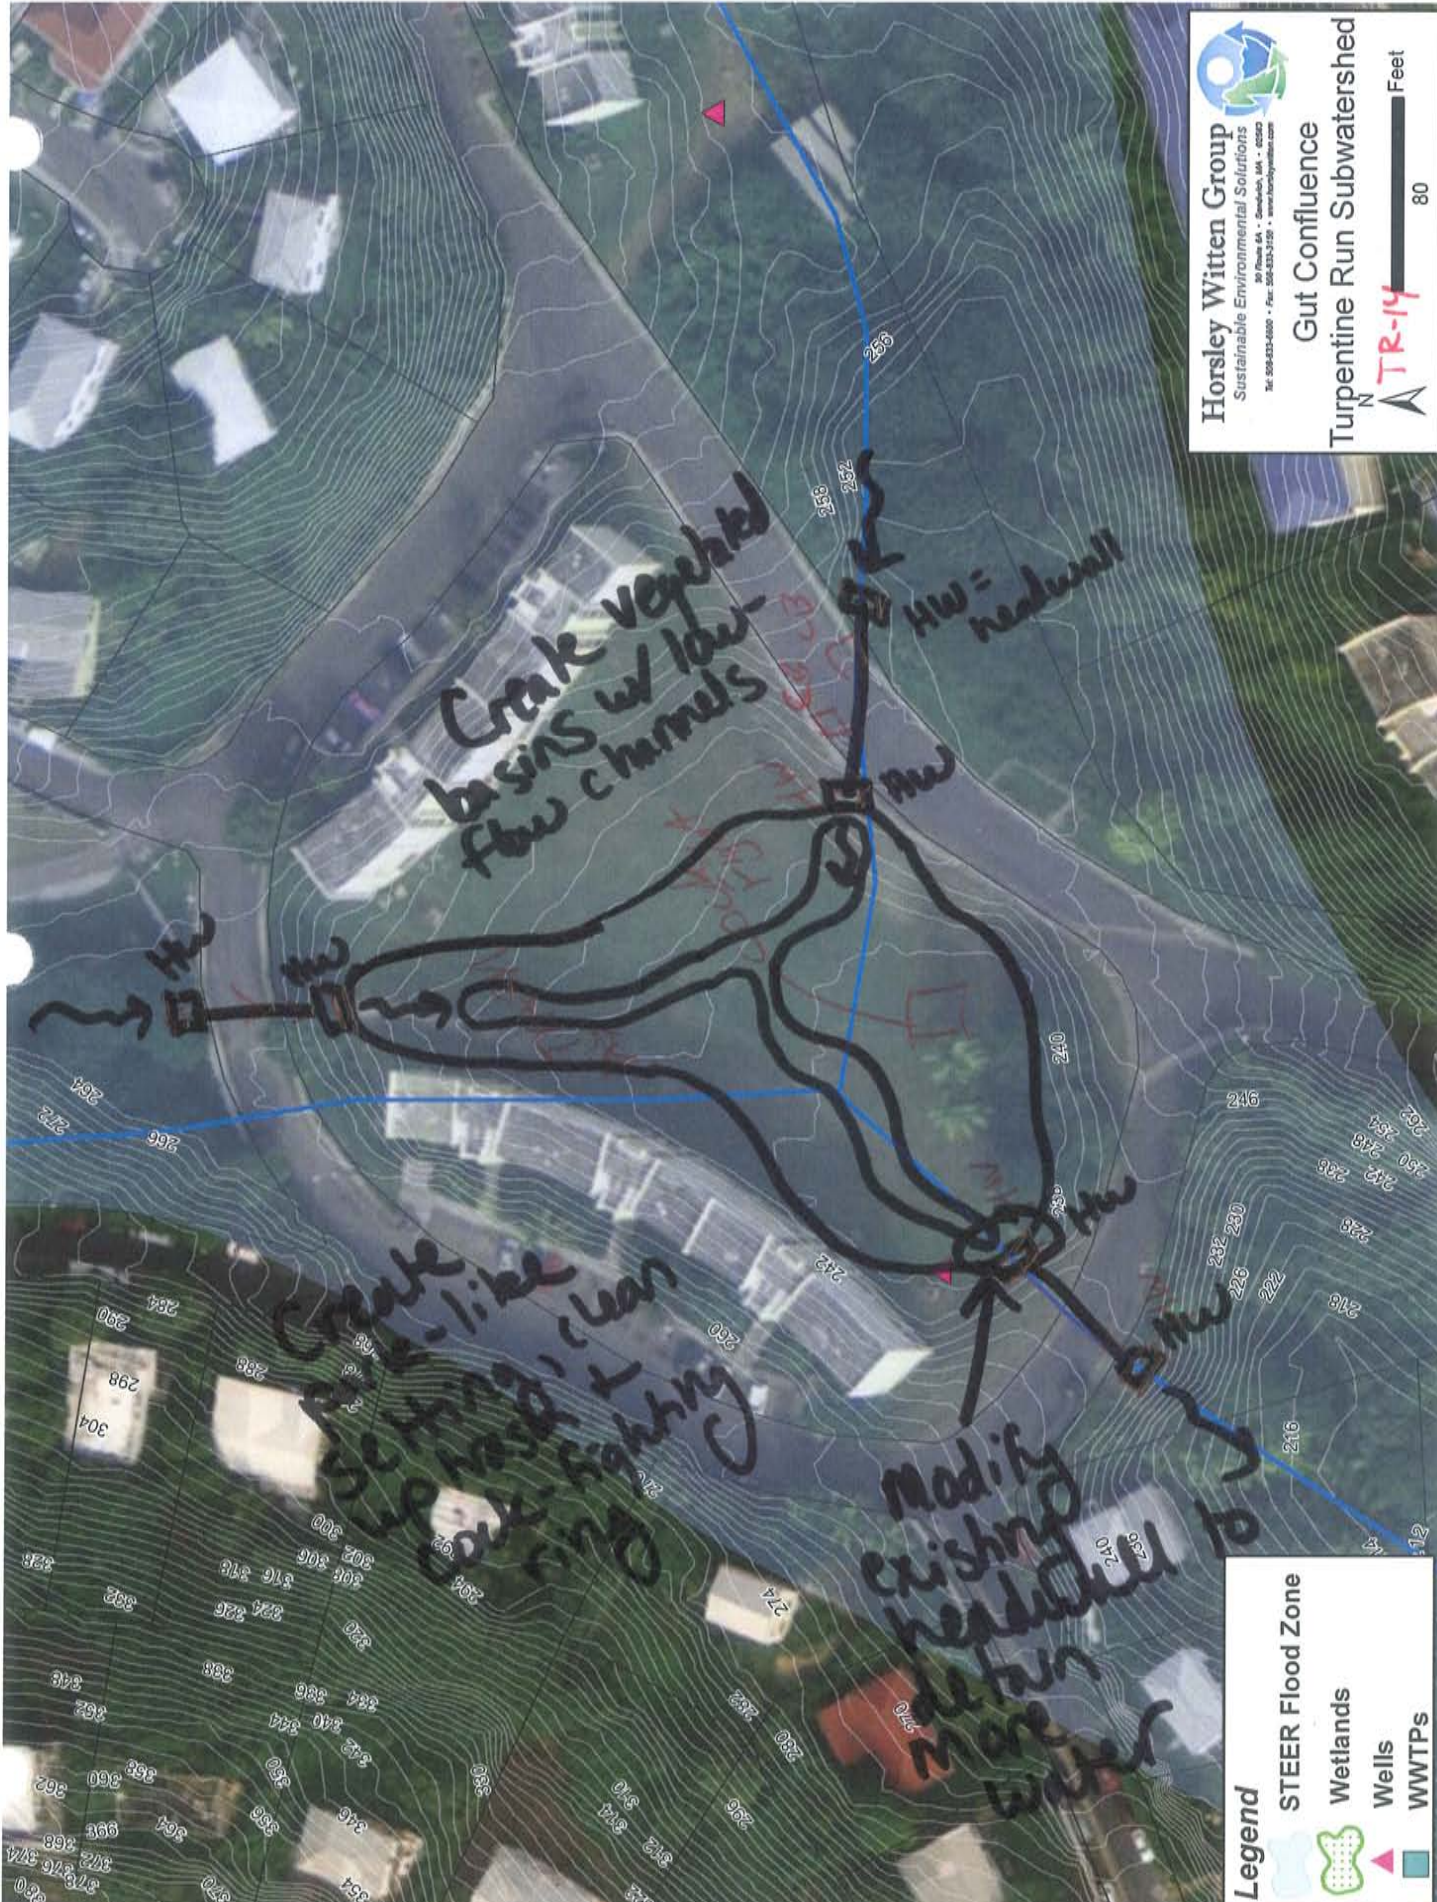
Open, flat area at gut confluence that is currently mown. Doesn't seem to be used for recreation other than the cycle fighting ring (e.g., no courts, playgrounds, etc.) Trash was observed, and the dumpsters on site were not covered. The gut to the east was well-vegetated. To the north, see other retrofit form. To the south, the gut has a base flow as it flows towards the Curriculum Center and fire station. Paved flumes and box culverts are used to direct runoff, as well as some catchbasins on the road. Currently, the outlet box culvert is set at grade, only debrising at high flows when capacity is exceeded.

Re-grade the open area for formalized vegetated channels and increased storage. Adjust the area near the outlet to provide more detention/infiltration/evaporation before any outflow occurs. Cover dumpsters, clean up trash + provide signage other education for homeowners. Need to get housing authority on board.
