FIELD ASSESSMENT NOTES

Subwatershed: TR-26

Site Name: MR. RODRIGUEZ / TOTAL GAS

Near Tutu Park Mall 3
Turpentine Run Subwatershed

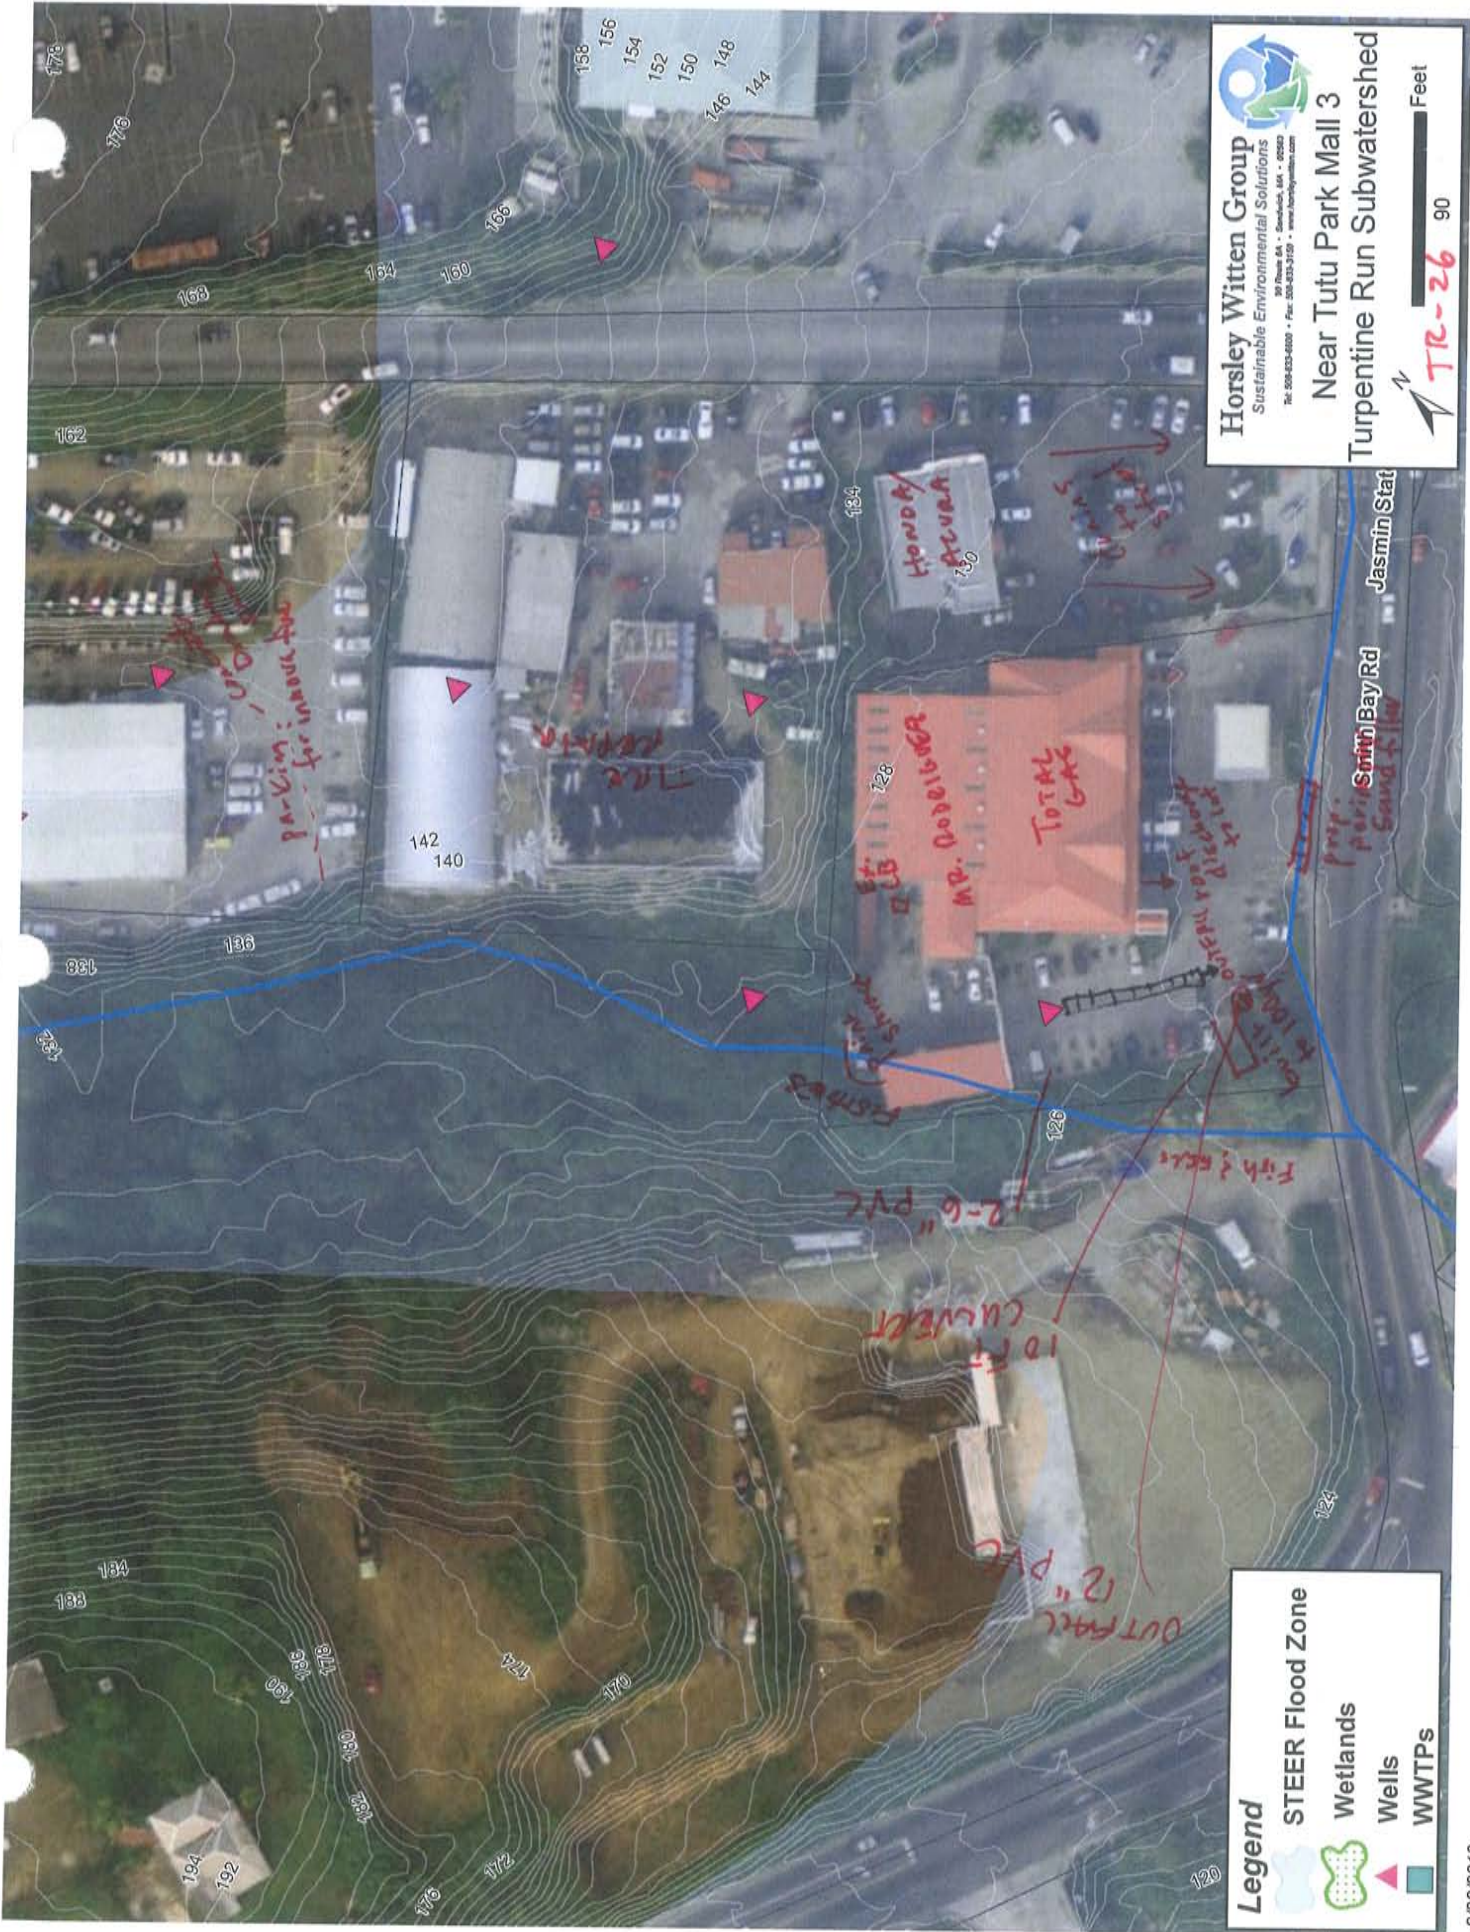
TR-26

Large culvert goes under buildings of Auto shop

Rooftop and parking lot drainage goes directly to ~~street~~ gutter with no treatment.

Perimeter sand filter at entrance to gas station prior to discharge to road drain line and down central isle of Auto shop.

Tough site.

Conduct pollution prevention eval. of auto shop to assist w secondary containment, storage, & waste management to reduce pollutants.

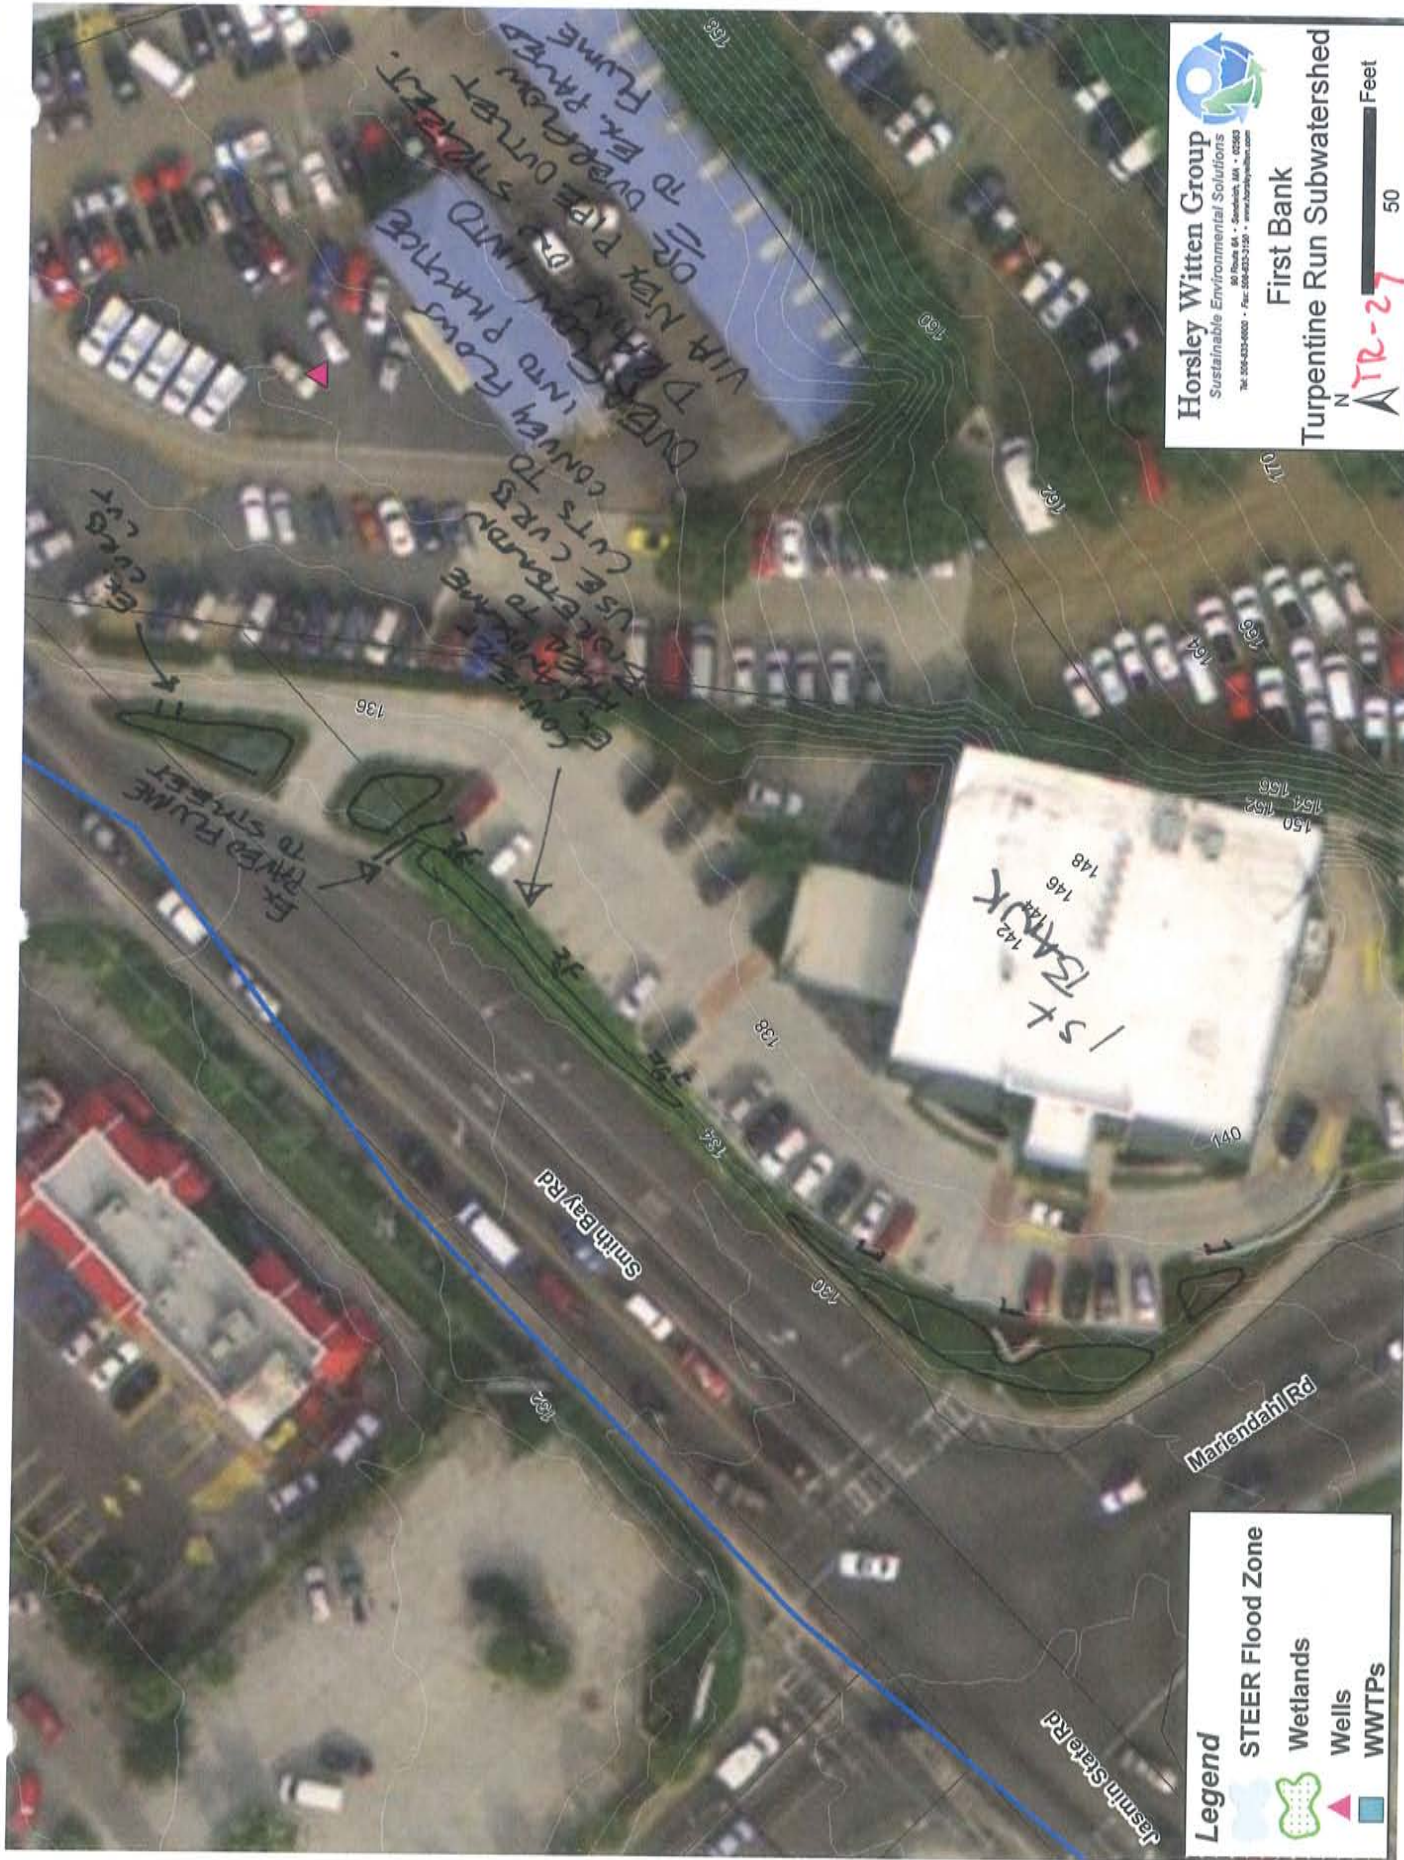
First Bank
 Turpentine Run Subwatershed
 N **TR-27**

Across from McD's at Tutu Plaza

good example of using landscaped area to collect runoff (there is one ex. curb cut into landscape)

highly visible site.

- investigate potential retrofit to enhance landscape area to provide WA treatment for entire parking lot via more curb cuts.

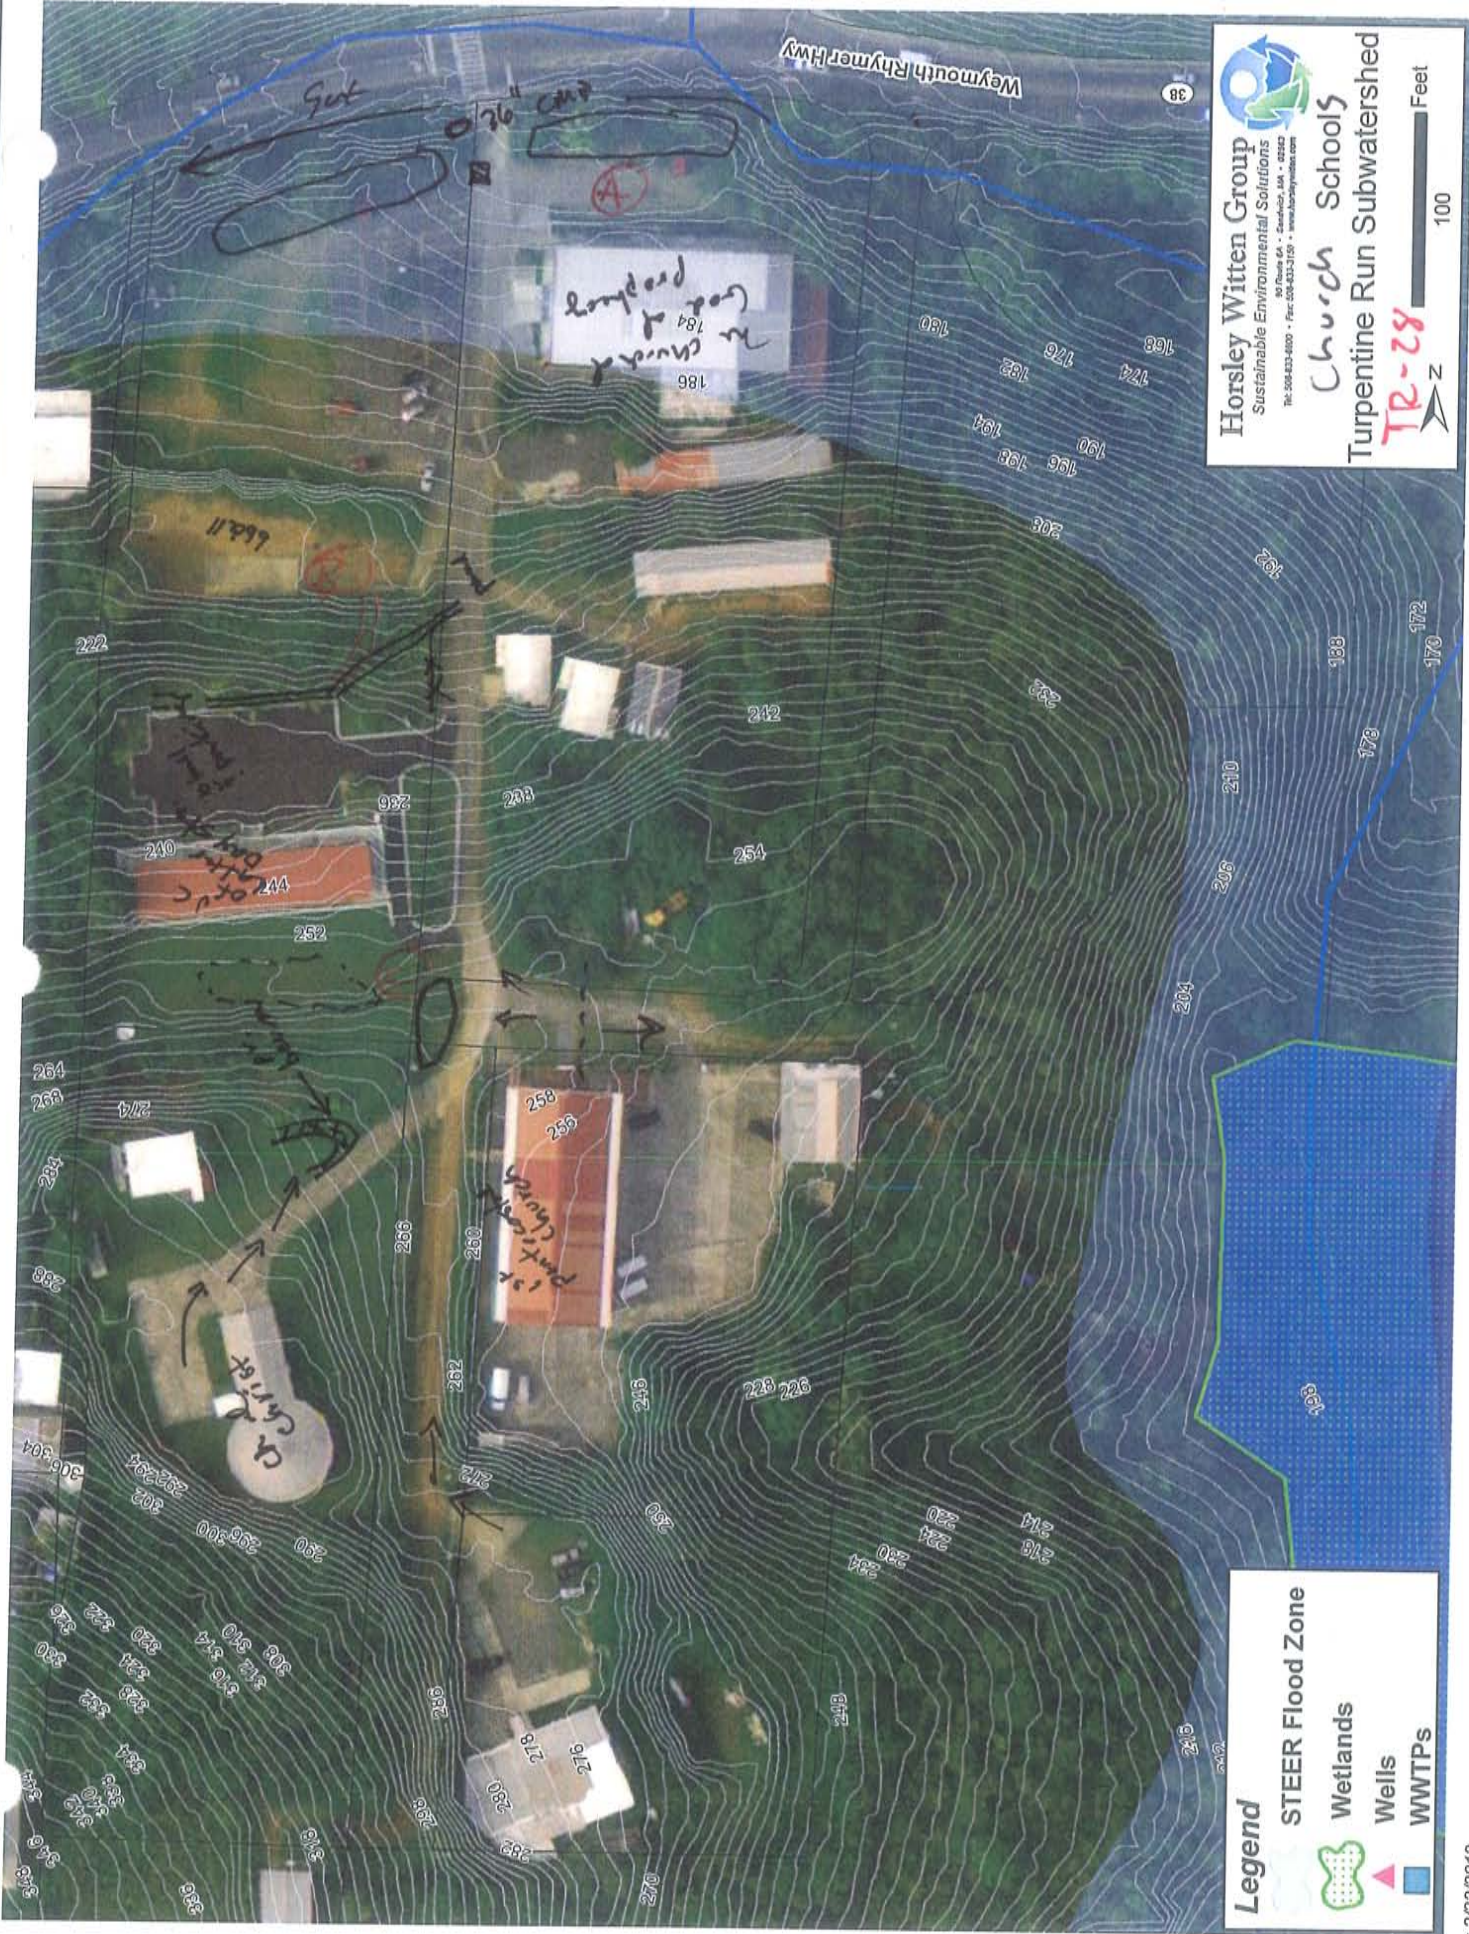
Church Schools
Turpentine Run Subwatershed
TR-28

Direct portion of flow into grassed areas
in a few locations - but not easy.

- bottom of hill (A)
- (B) into basketball court area (redirect
to concrete flume)
- (C) open grassed area adjacent to
driveway

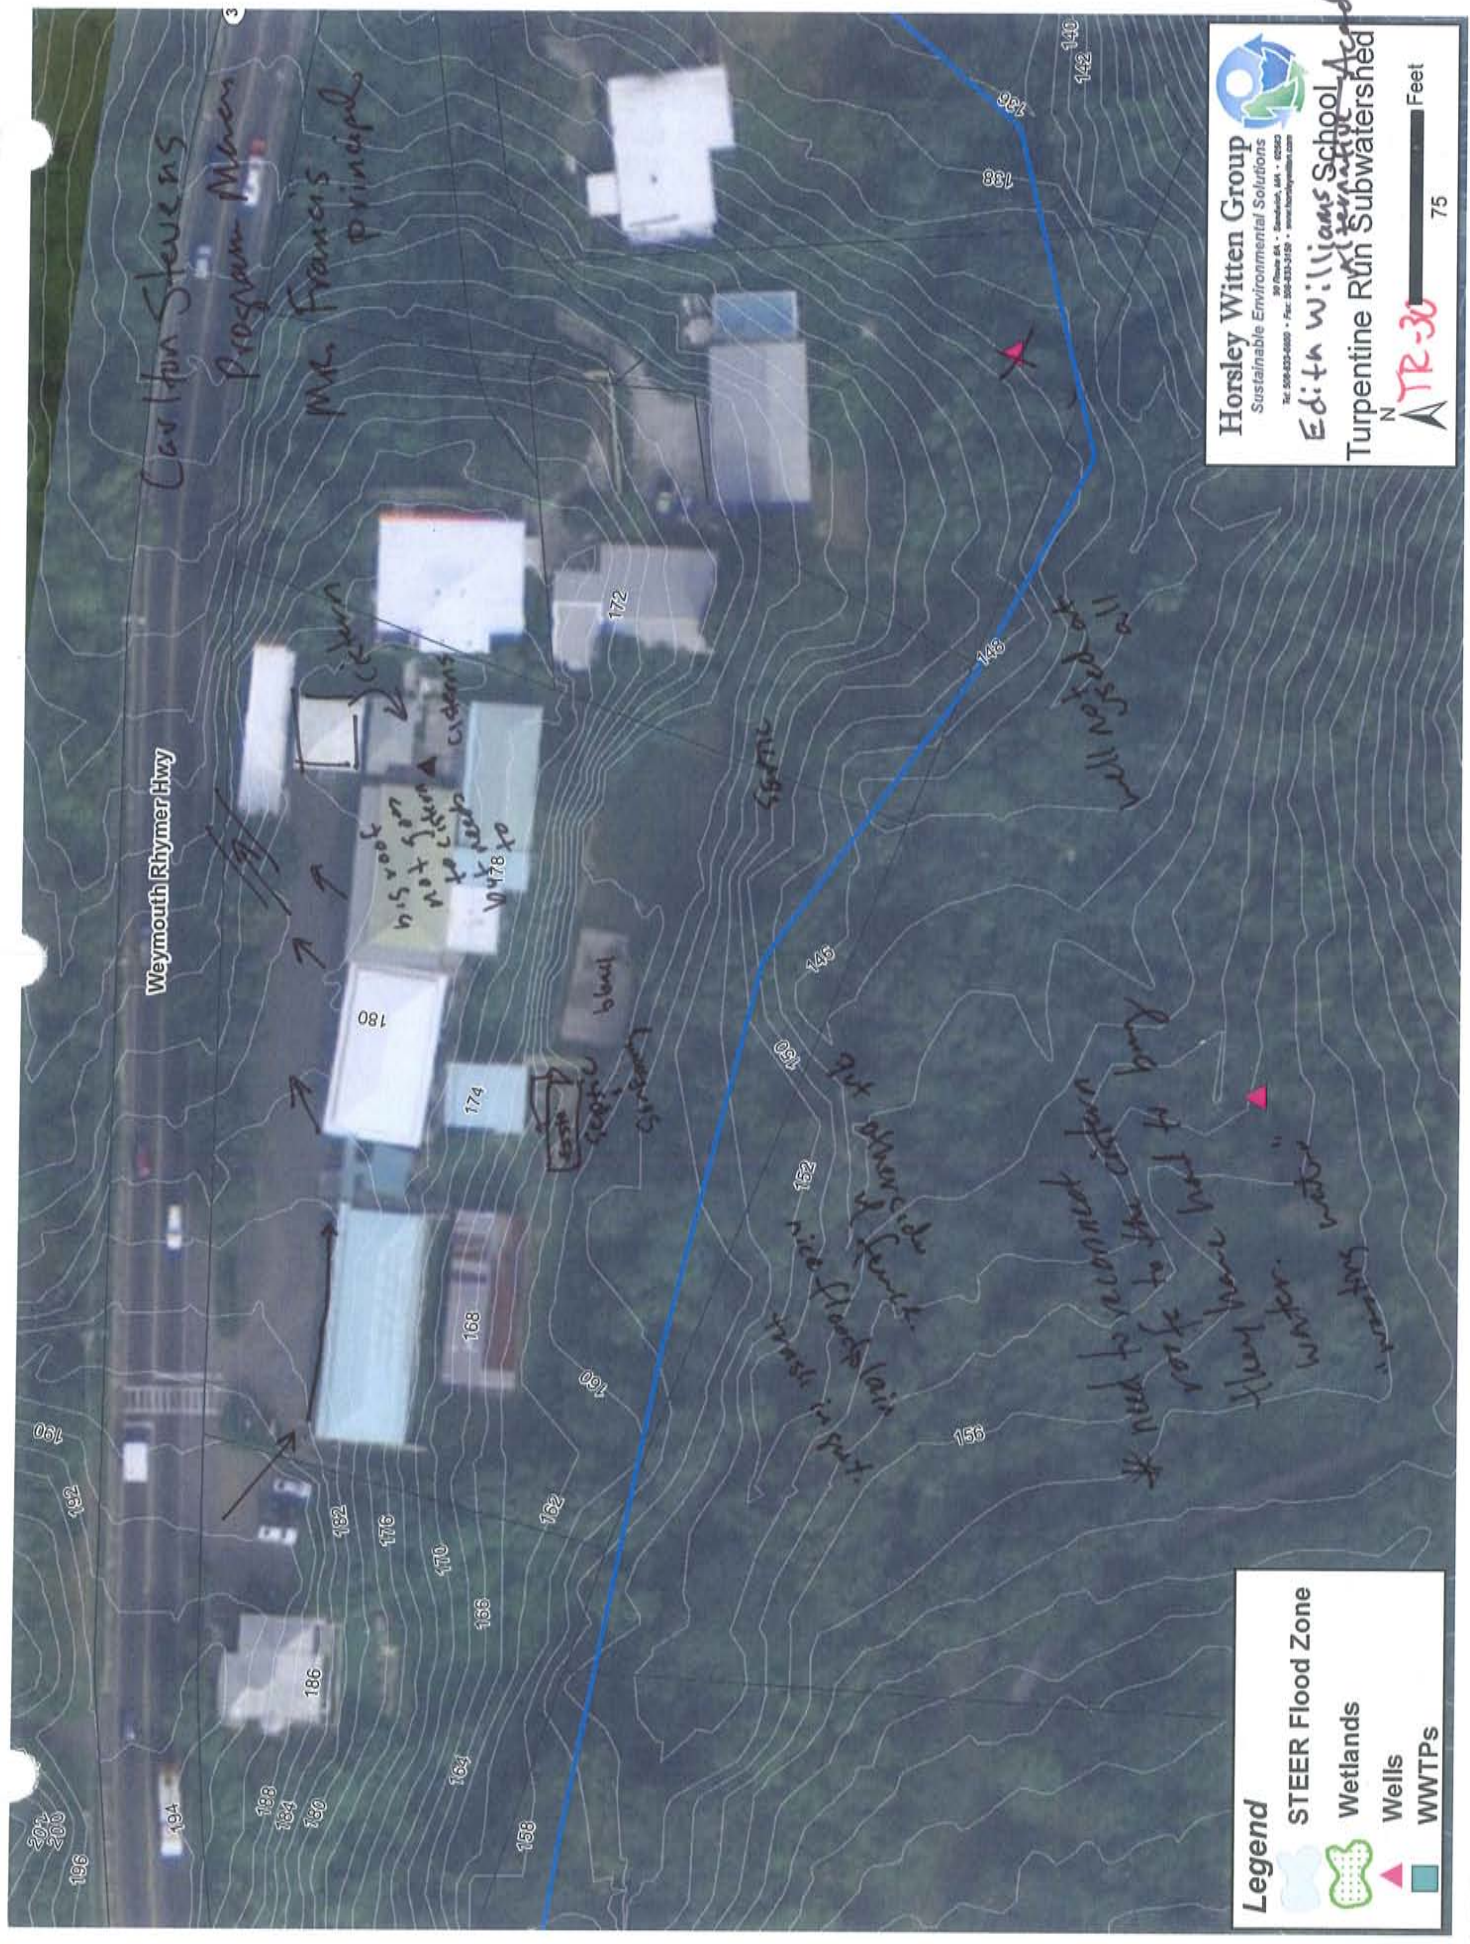
TR-30

School has no real drainage issues, parking lot in front drains to road. Some roofs are directed to cisterns. Gut runs behind school fence - has a wooden buffer. Some trash. School is on septic.

- have had to pay money to fill up cistern w/ purchased water

- tight space, not much opportunity
for stormwater reverts of parking
lot.

- hook up rest of roofs to the system.
- saves \$

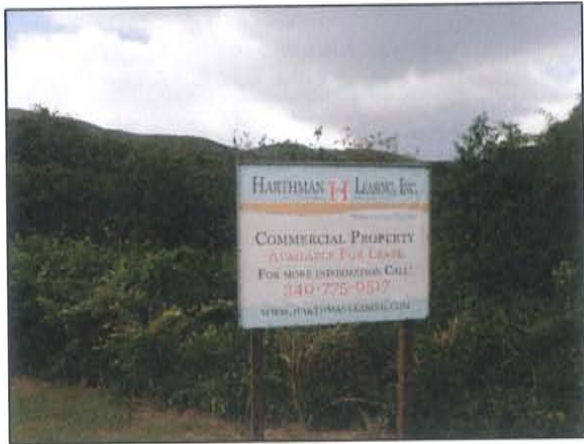
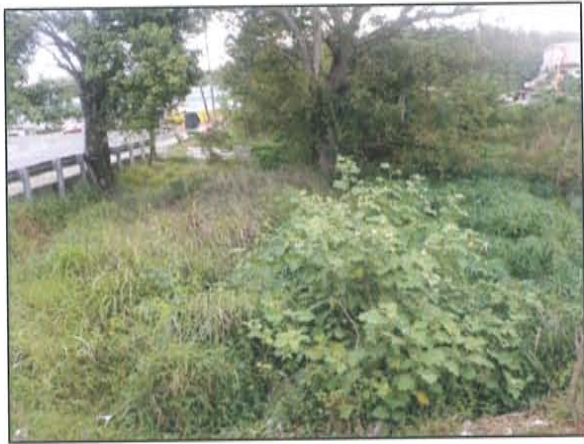
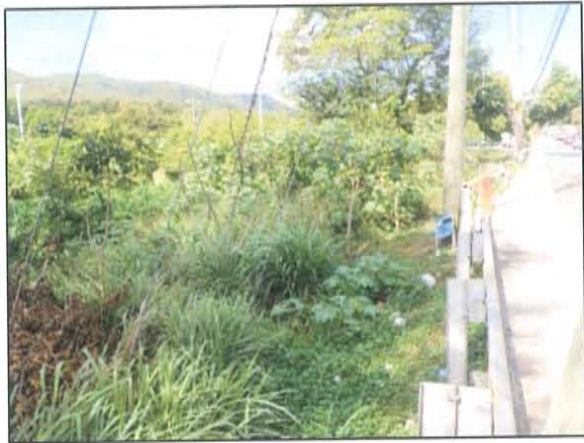
TR-100-31

OPEN AREA ADJACENT TO FT. MYLNER PLAZA AND PRICESMART DRIVE THAT COULD BE EXPANDED TO MANAGE HIGH FLOWS FROM GUT AND TREAT RUNOFF FROM SMITHBAY RD.

OVER FLOWS TO DISCHARGE TO GUT. MAY BE POSSIBLE depending on space available, to divert high flows from gut into wetland also.

Existing road flume takes
road drainage. Plenty of space
for forebay and wetland retrofit

- CONCEPT IS TO DIVERT SMITHBAY RD DRAINAGE VIA NEW CATCH BASINS AND CONCRETE SWALES ON ROAD INTO A STORMWATER WETLAND.

★ NEED TO CONFIRM EX. WETLAND BOUNDARY AND PROPERTY OWNERSHIP.

INSTALL
NEW DRAINAGE AND
CONCRETE DRAINAGE SWALES
ON SMITH BAY RD
TO DIVERT FLOWS
TO WETLAND

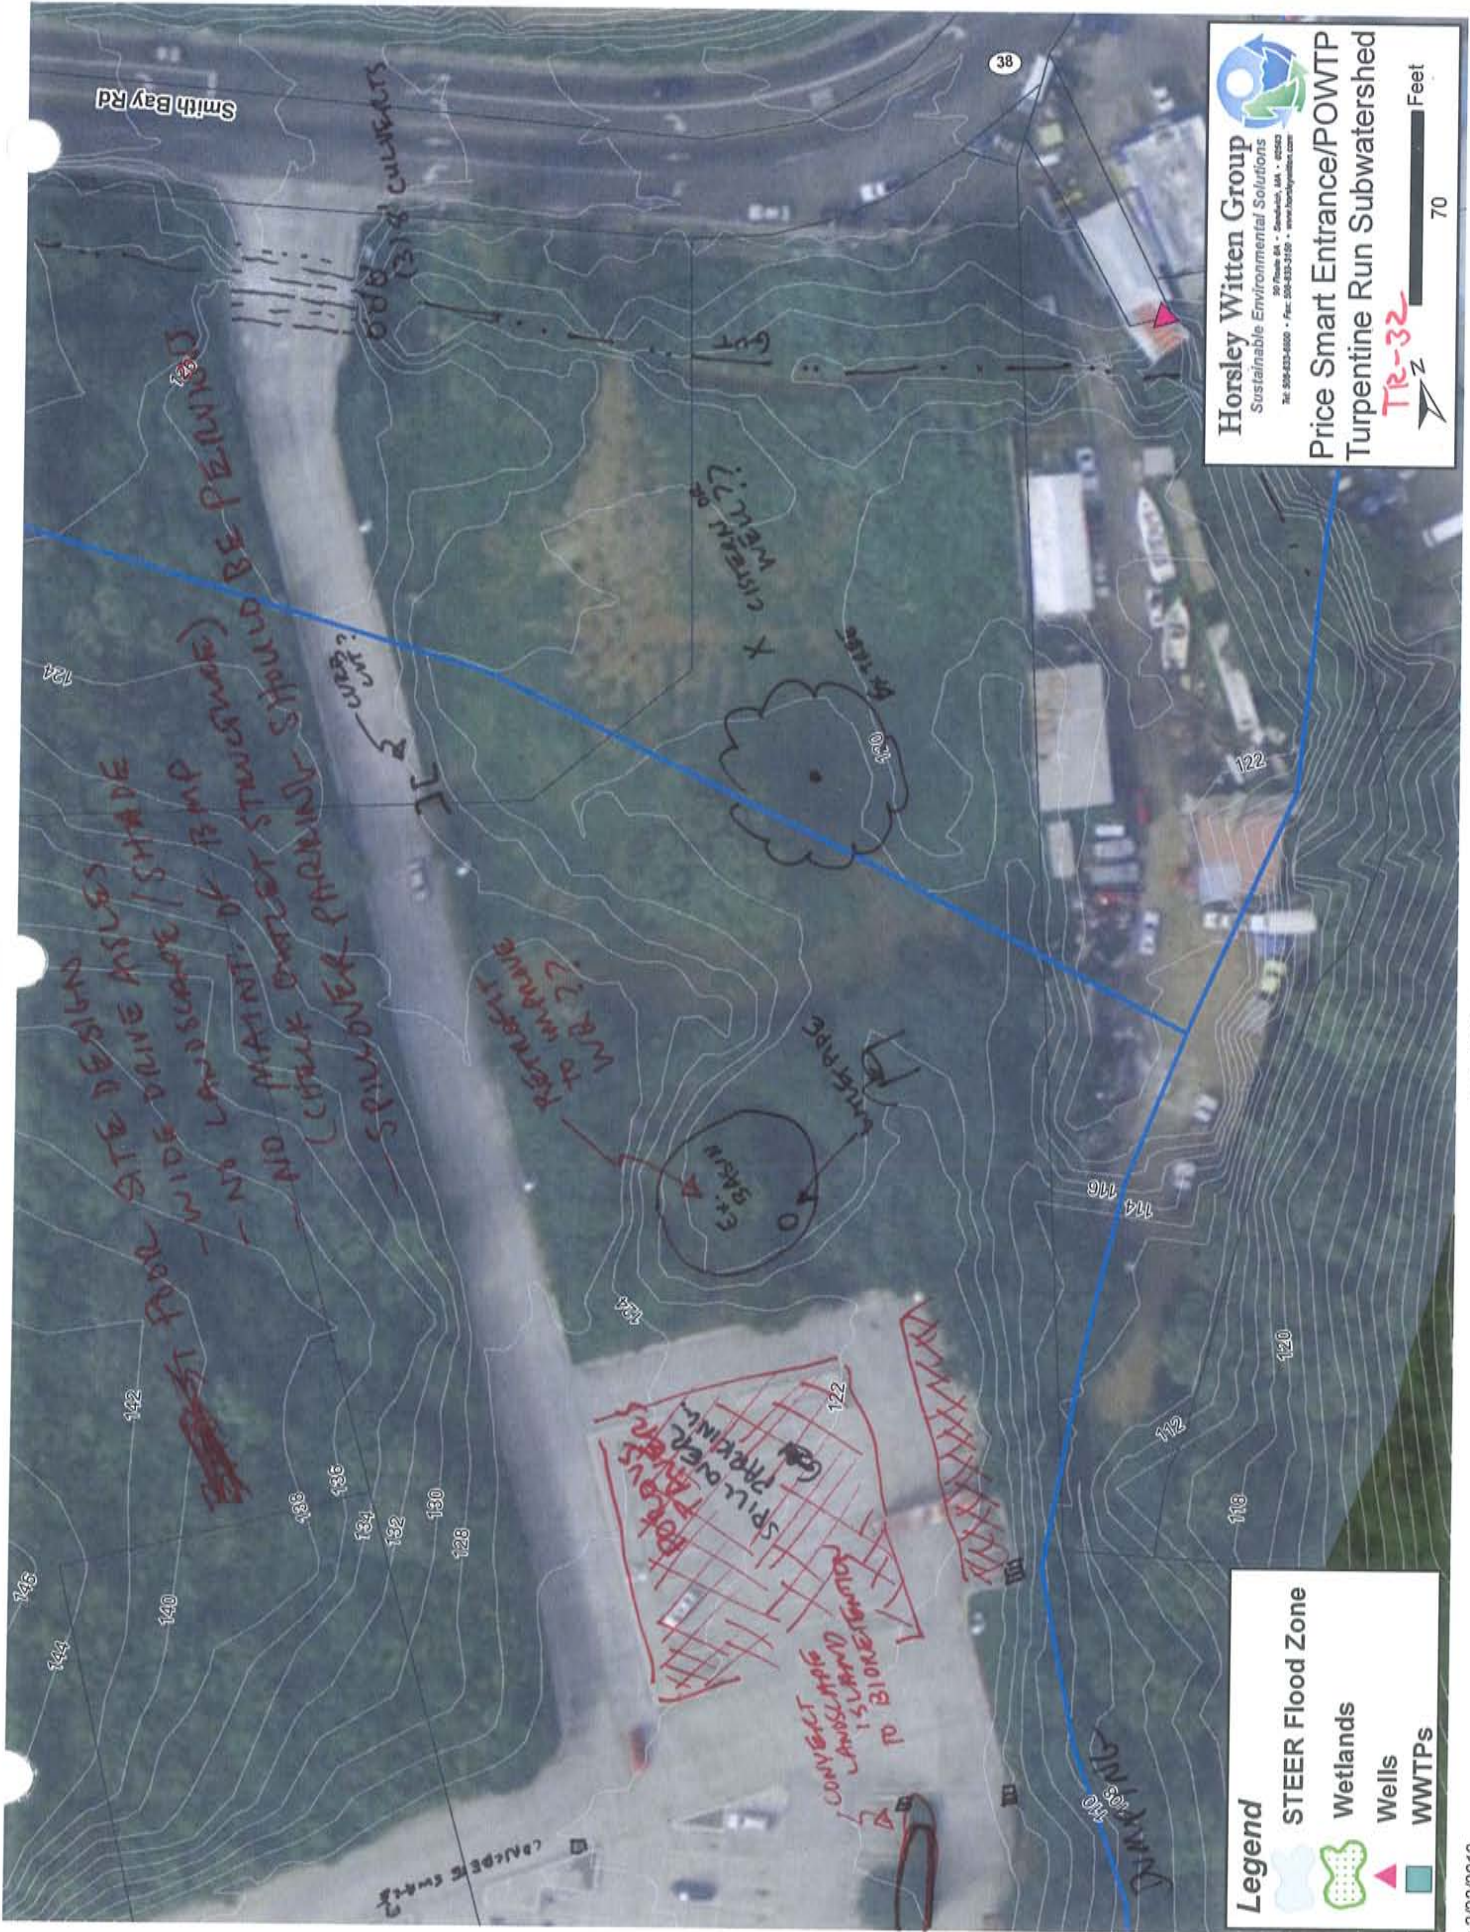
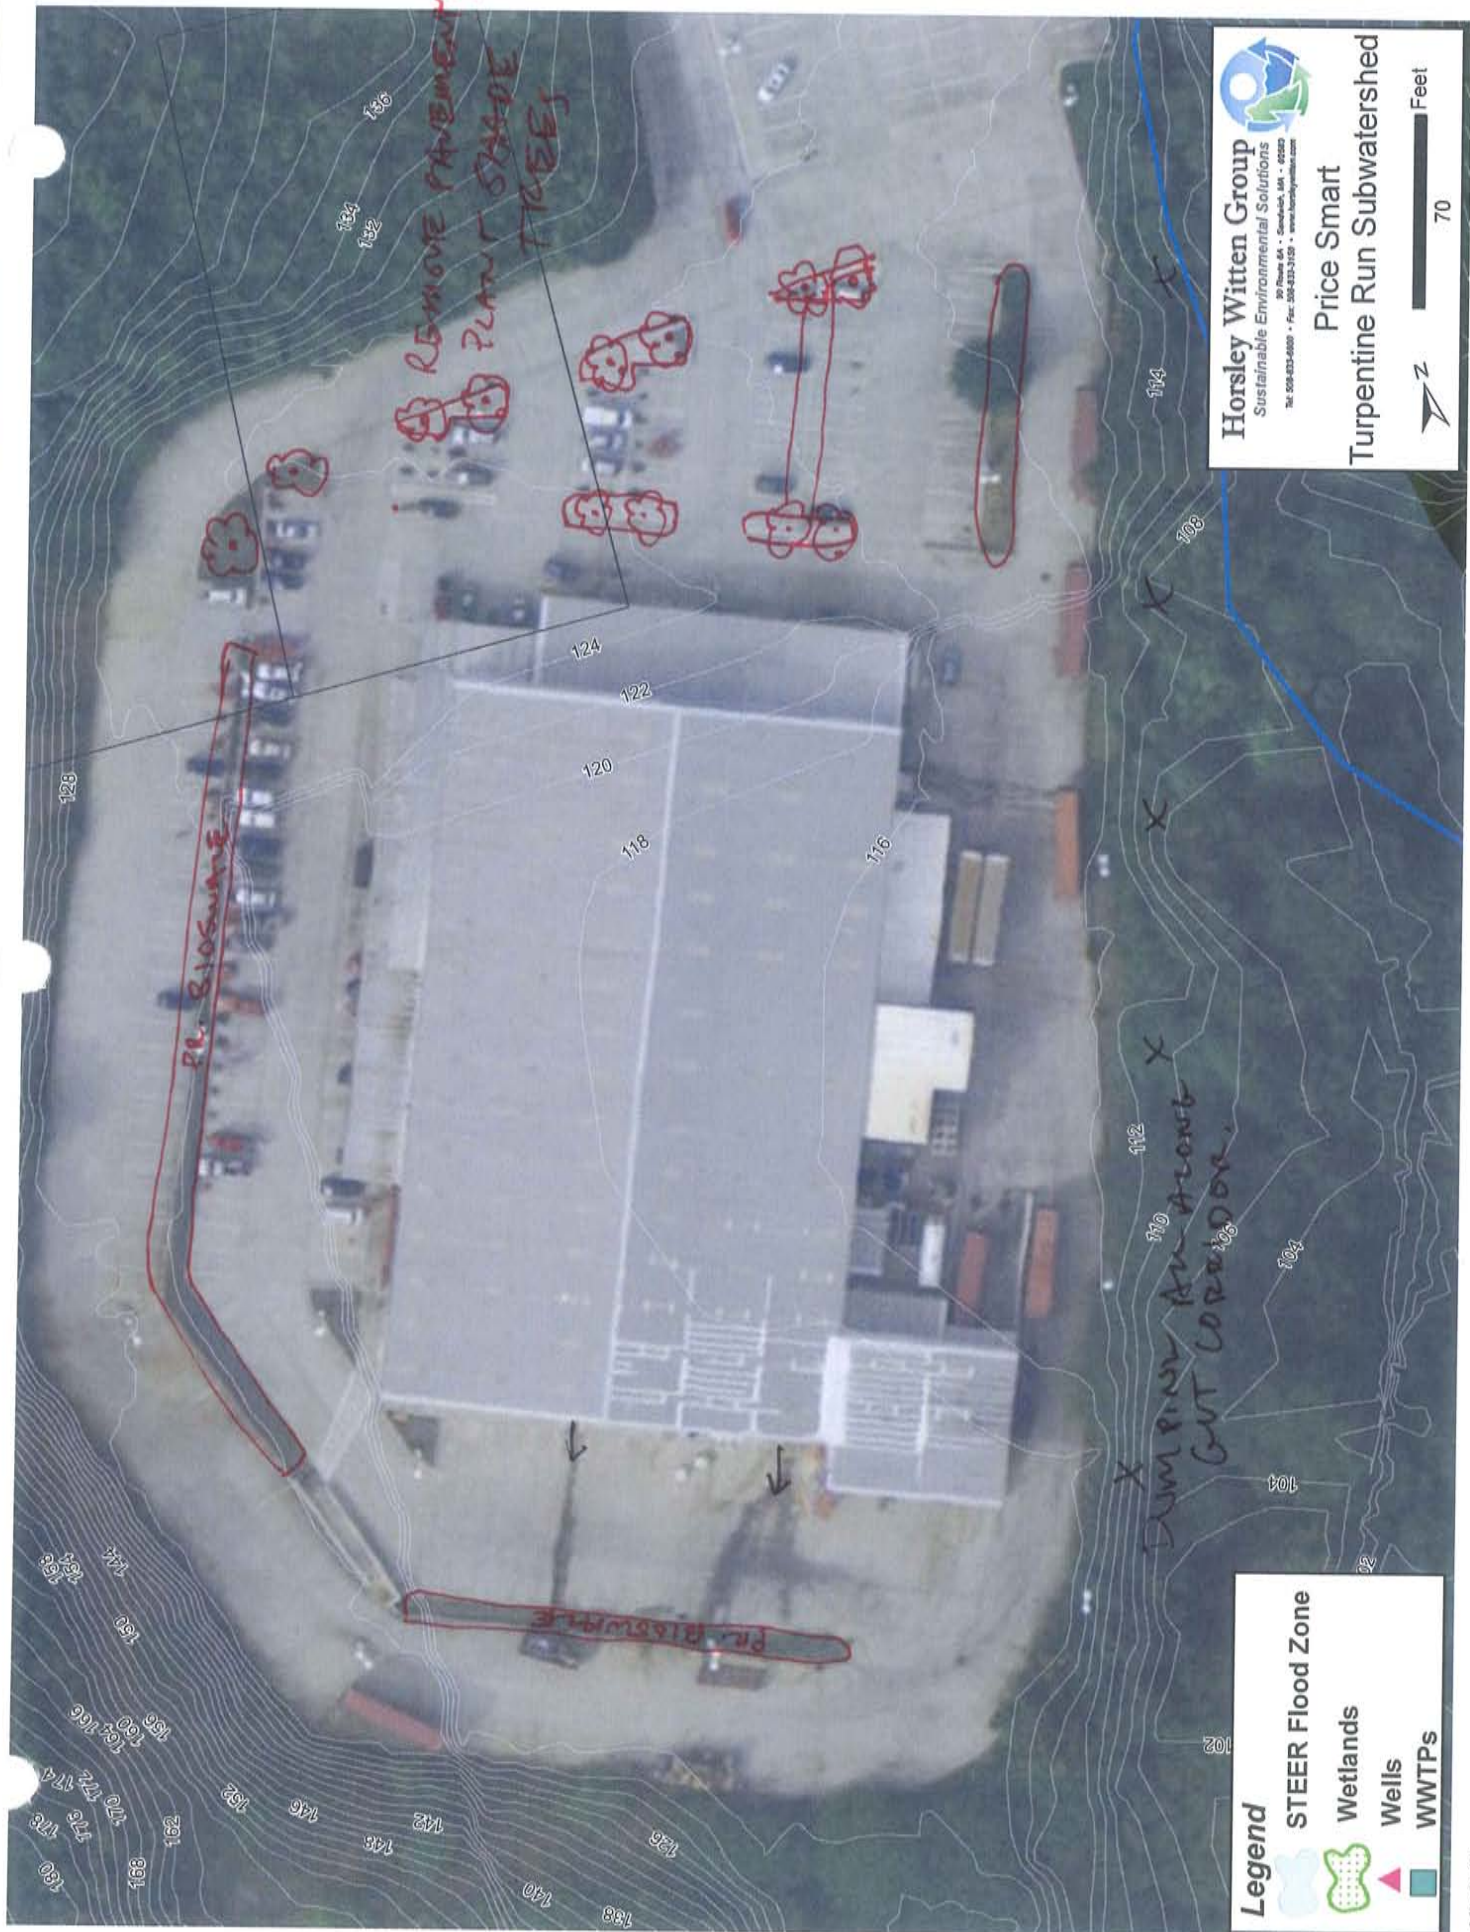
TR-32

- CLEAN UP DEBRIS / TRASH / CARS, ETC
- REMOVE PAVEMENT - POSSIBLE PERVIOUS PAVEMENTS
 - * PLANT SHADE / CANOPY COVER
 - * INSTALL LINEAR BIOS
 - * INVESTIGATE EX. FACILITY. RETROFIT POTENTIAL.
- OPEN ~~UP~~ THERE ANY WAY TO TAKE ADDITIONAL RUNOFF FROM ROAD?

PRIVATE PROPERTY.

MAY BE EASY RETROFIT OF EX. FACILITY TO IMPROVE WQ. TREATMENT. NEED TO GET PLANS.

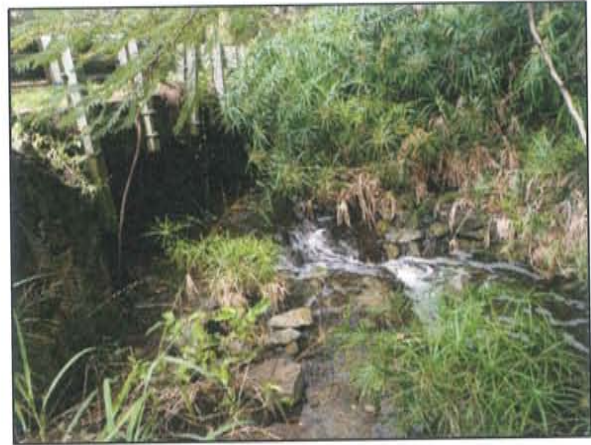
Approximately one-half mile north of the main entrance to Heavy Materials, Turpentine Run flows beneath Turpentine Run Road. There is a box culvert at this location (TR-35) that is reportedly overwhelmed during significant rain events. At the public meetings that were held in February 2012, many residents commented on the observed roadway flooding at the site. The culvert is approximately 4'x8' which is not sufficient for handling large storm flows given the hydrology of the gut. Increasing the culvert size or constructing a bridge in its place would offer the most improvement for flow capacity and for better managing the flooding. One significant design constraint is the elevation of Turpentine Run Road at the culvert location. There is only ~18" above the culvert to the top of the roadway, therefore limiting the improvements to options that create a wider channel cross-section. Installing a bridge would be the least flow restrictive option but it will likely be the most expensive to construct and cause the longest traffic delays. An alternative to a bridge would be to target better floodplain drainage by installing multiple small culverts adjacent to the existing culvert. This option may provide a reasonable balance between effectiveness and cost.

TR-35 culvert. USGS gauging station is upstream from here.

TR-35
Box Culvert
(undersized)
• Not much room
for size increase
• Need bridge?

*** MAJOR PROBLEM
AREA IDENTIFIED
BY LOCAL RESIDENTS
FOR FLOODING PROBLEMS**

There is not a lot of space available for larger culverts, probably need to replace with a bridge.

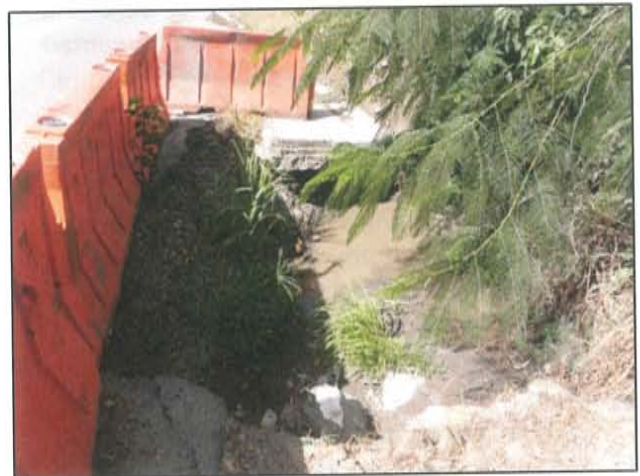
Across from the main entrance to Heavy Materials is a third location where inadequate drainage infrastructure has caused severe impacts to Turpentine Road (TR-40). Here runoff from the steep roads of the Mariendahl neighborhood collects and flows underneath Turpentine Road through a 24-inch diameter CMP. Due in part to the likely undersized culvert, poor channel alignment, and high velocity storm flows, undermining of the roadway has occurred. This has created a safety hazard not only to vehicles but also pedestrians. Pedestrians now have to walk into the roadway to maneuver around the resulting scour hole. Design improvements may include a combination of increasing the culvert size, relocating it to provide better channel alignment, and providing runoff energy dissipation up-gradient of the culvert.

TR-40 showing hazardous conditions below Mariendahl neighborhood.

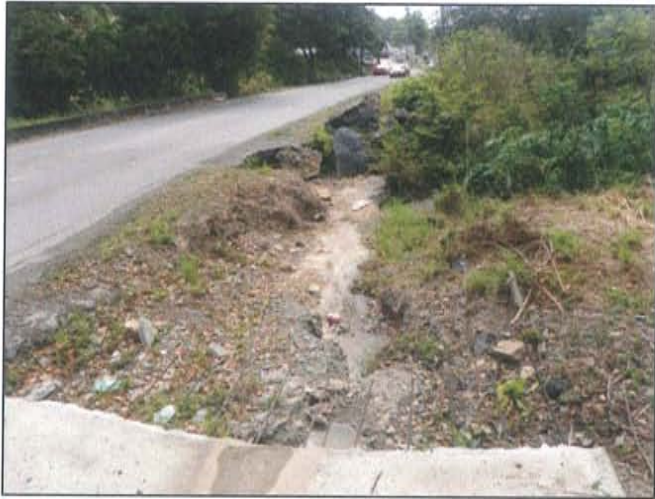
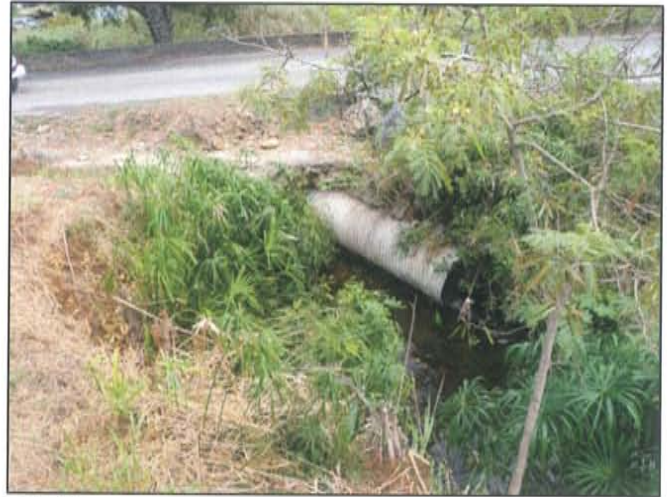
About one-quarter mile south, near the northern entrance to Heavy Materials, Turpentine Run crosses Turpentine Run Road again through a 48-inch diameter corrugated metal pipe (CMP) at TR-37. Velocities at the downstream end of the culvert are so great that a large scour pool has formed and the culvert is protruding 10-15 feet from the roadway embankment. Lack of and deteriorating roadway drainage infrastructure has exacerbated the problem. An incomplete concrete channel has caused an erosion gully to form leading into the gut. Sedimentation in the gut is a problem, both from erosion and from the dirt driveway leading to Heavy Materials. Design improvements should include: (1) upgrading and properly sizing the culvert beneath Turpentine Run Road, (2) stabilizing the stream bank and bed downstream of the culvert, (3) and repairing the concrete drainage channel that empties into the gut and providing adequate energy dissipation.

Concrete channel and scour downstream of culvert at TR-37.

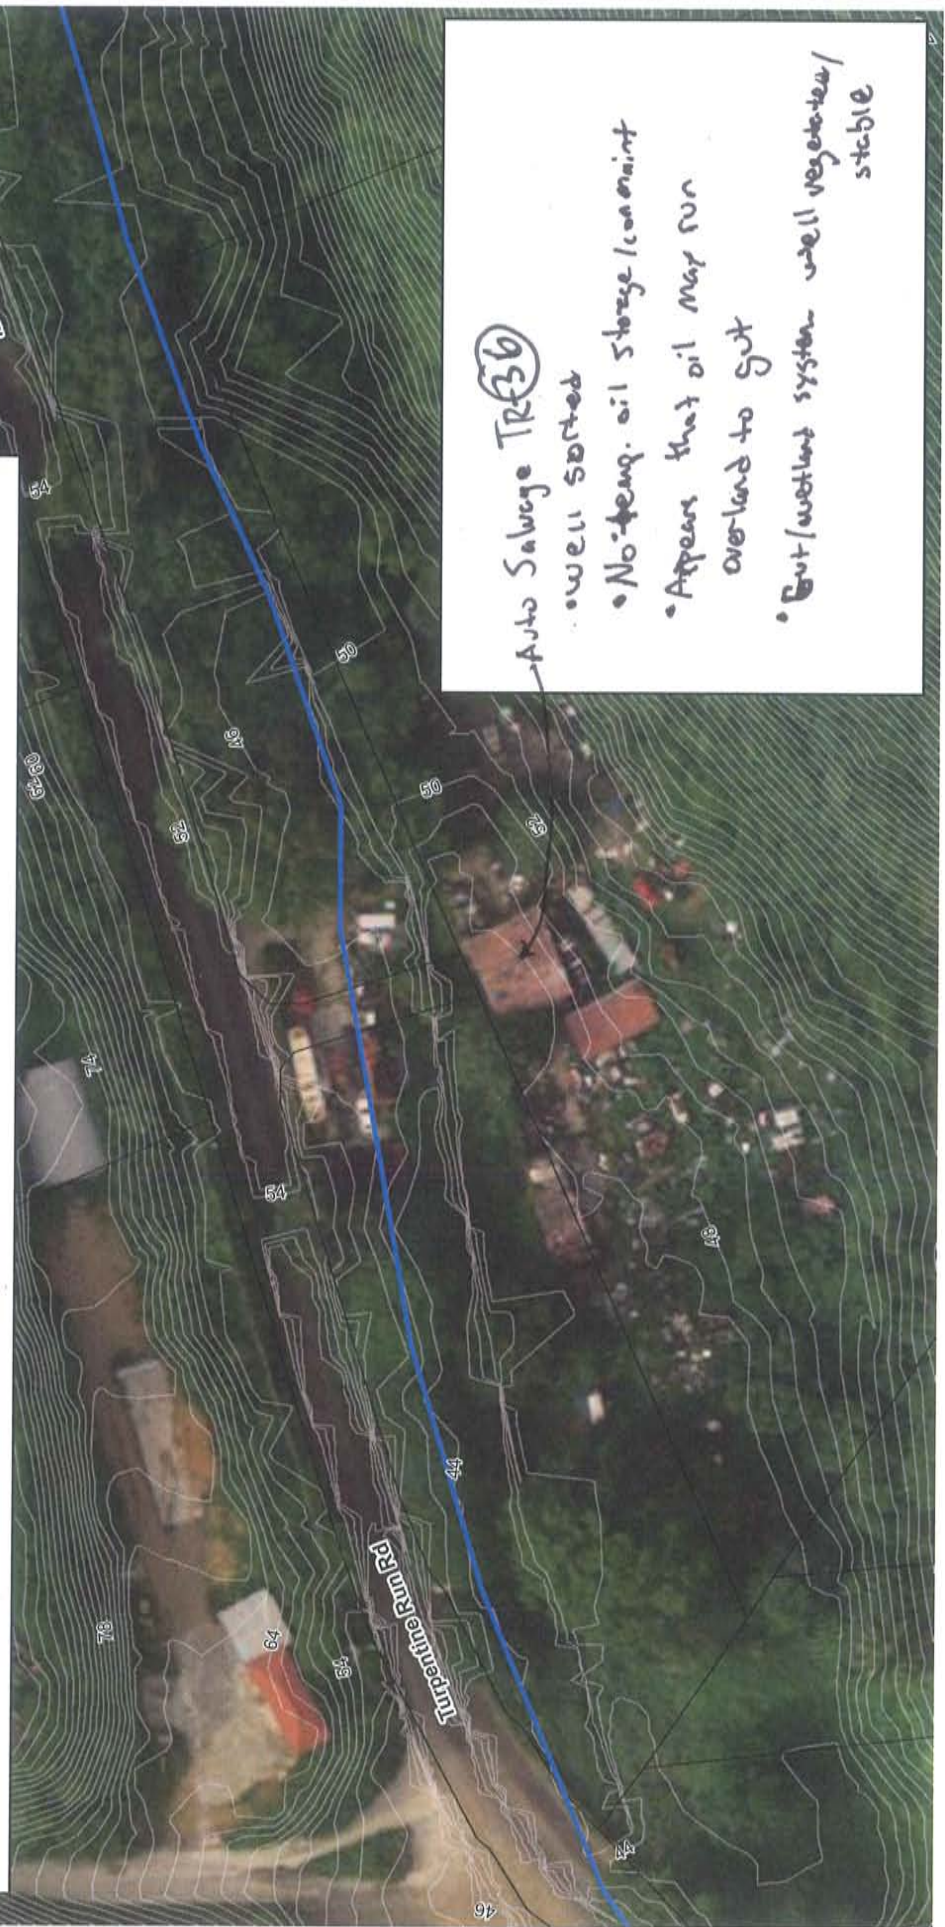
Auto Salvage TR36

- well sorted
- No temp. oil storage / comment
- Appears that oil may run overland to gut
- Gut/wetland system well vegetated / stable
