FIELD ASSESSMENT NOTES

Subwatershed: TR-26

Site Name: MR. RODRIGUEZ / TOTAL GAS

Near Tutu Park Mall 3
Turpentine Run Subwatershed

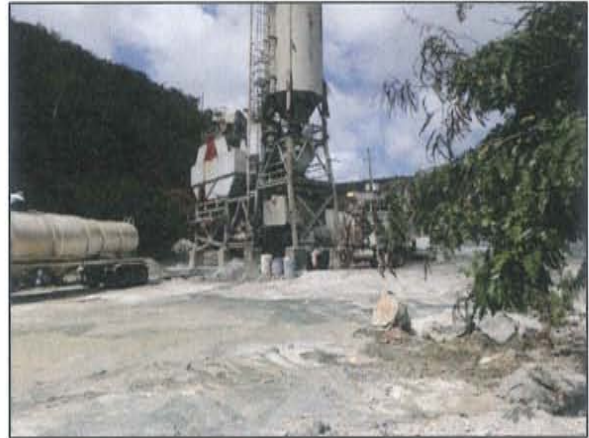
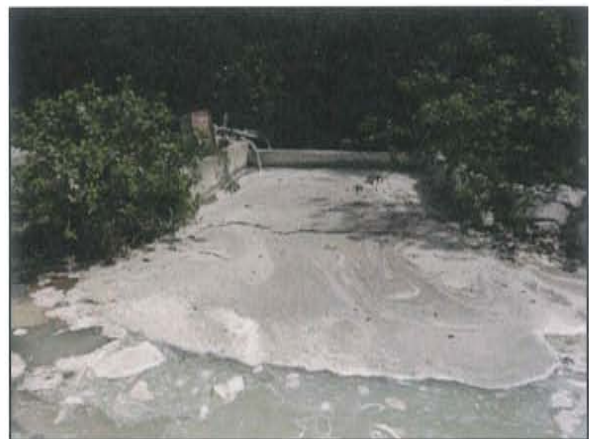
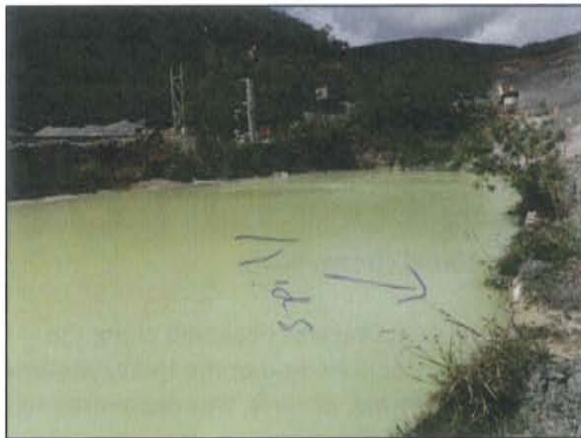
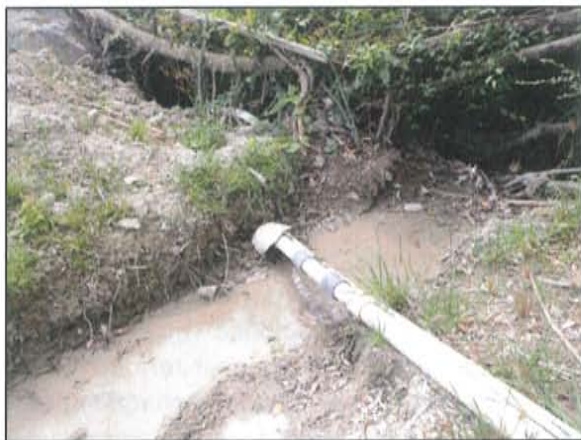
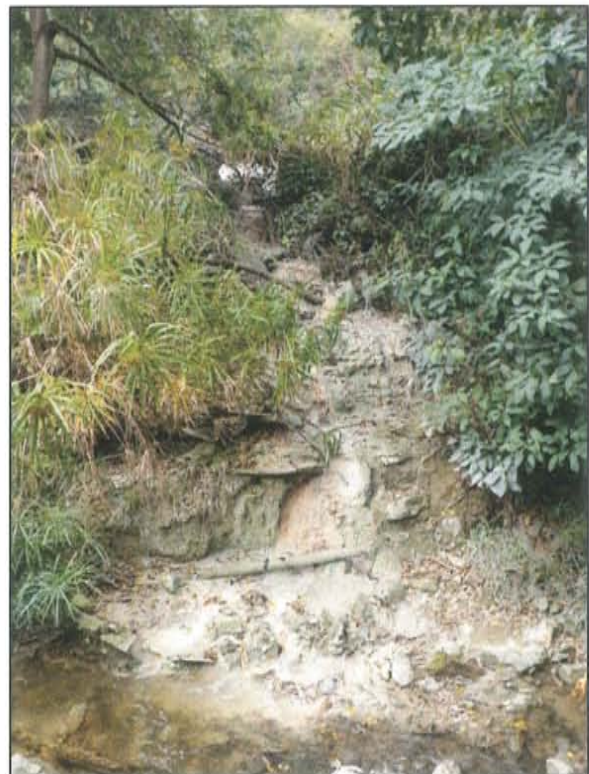
- No stormwater management
- Direct discharges from concrete truck filling station
- Leaking septic pipes / septic discharges
- Human waste area along gully bank
- Heavy sedimentation in gully from stockpiles/runoff
- Settling basin overtops (very turbid) and flows overland to gully, only silt fence protecting gully (currently filled in).
- No containment for asphalt/oil facilities
- Major earth change activities

Heavy Materials, LLC operates a quarry facility on Turpentine Run Road that supplies construction aggregates, masonry blocks, and ready-mix concrete. It is one of the largest facilities of its kind in the U.S.V.I. The quarry consists of approximately 23 acres of disturbed land. The magnitude of the operation alone gives it the potential for significant impact to surrounding resource areas. All precipitation that runs off the site ultimately travels northeast to Turpentine Run. Erosion control and runoff management practices on the property were found to be either poorly maintained or non-existent. Numerous opportunities for site improvements were observed that would help to reduce sediment and pollutant discharges.

Water is commonly used in the production of aggregate and concrete products. For this reason, at least four settling ponds can be found on the Heavy Materials property for removing sediment particles from the facility process water. In order for the settling ponds to be effective, they must be sized appropriately according to influent flow rates and desired settling times. The ponds must also be periodically maintained to remove accumulated sediments. At the time of the site walk, the most down-gradient settling pond was observed to be overtopping its banks and was flowing across the access drive to its ultimate discharge point in Turpentine Run. Proposed strategies for preventing pond overtopping include increasing the available storage within the setting pond and modifying the pond outlet control system to handle the appropriate flow rate. Furthermore, settling ponds do little for removing the fine, suspended particles from water. Consequently, filtration and/or

Proper sediment containment was also lacking at the concrete truck filling stations on the Heavy Materials property. The process for producing concrete involves mixing water with cement and aggregate. During the filling process, water was allowed to spill from the truck, creating a stream of cement slurry that was flowing directly into Turpentine Run with little or no treatment. A small containment bay was observed in one location near ghat but the flow of slurry at the time of observation was much greater than the capacity of the bay. Impacts from this process were observed in Turpentine Run at and downstream of the truck filling station, including cement deposits and highly turbid stream flows.

Bacterial pollution was observed along the banks of Turpentine Run at the Heavy Materials facility. A latrine, of sorts, was discovered near concrete truck filling station. Human waste was present along the banks of Turpentine Run in close proximity to the cement slurry flows.

flocculation processes are recommended in conjunction with the existing settling strategies.

- Meet with the facility operations manager to discuss the current and future plant processes;
- Develop goals and strategies to adequately manage and treat the facility process water;
- Develop a plan and schedule for construction and installation of agreed-upon management strategies;
- Educate the Heavy Materials staff on the importance of protecting the sensitive resource areas that abut the property.

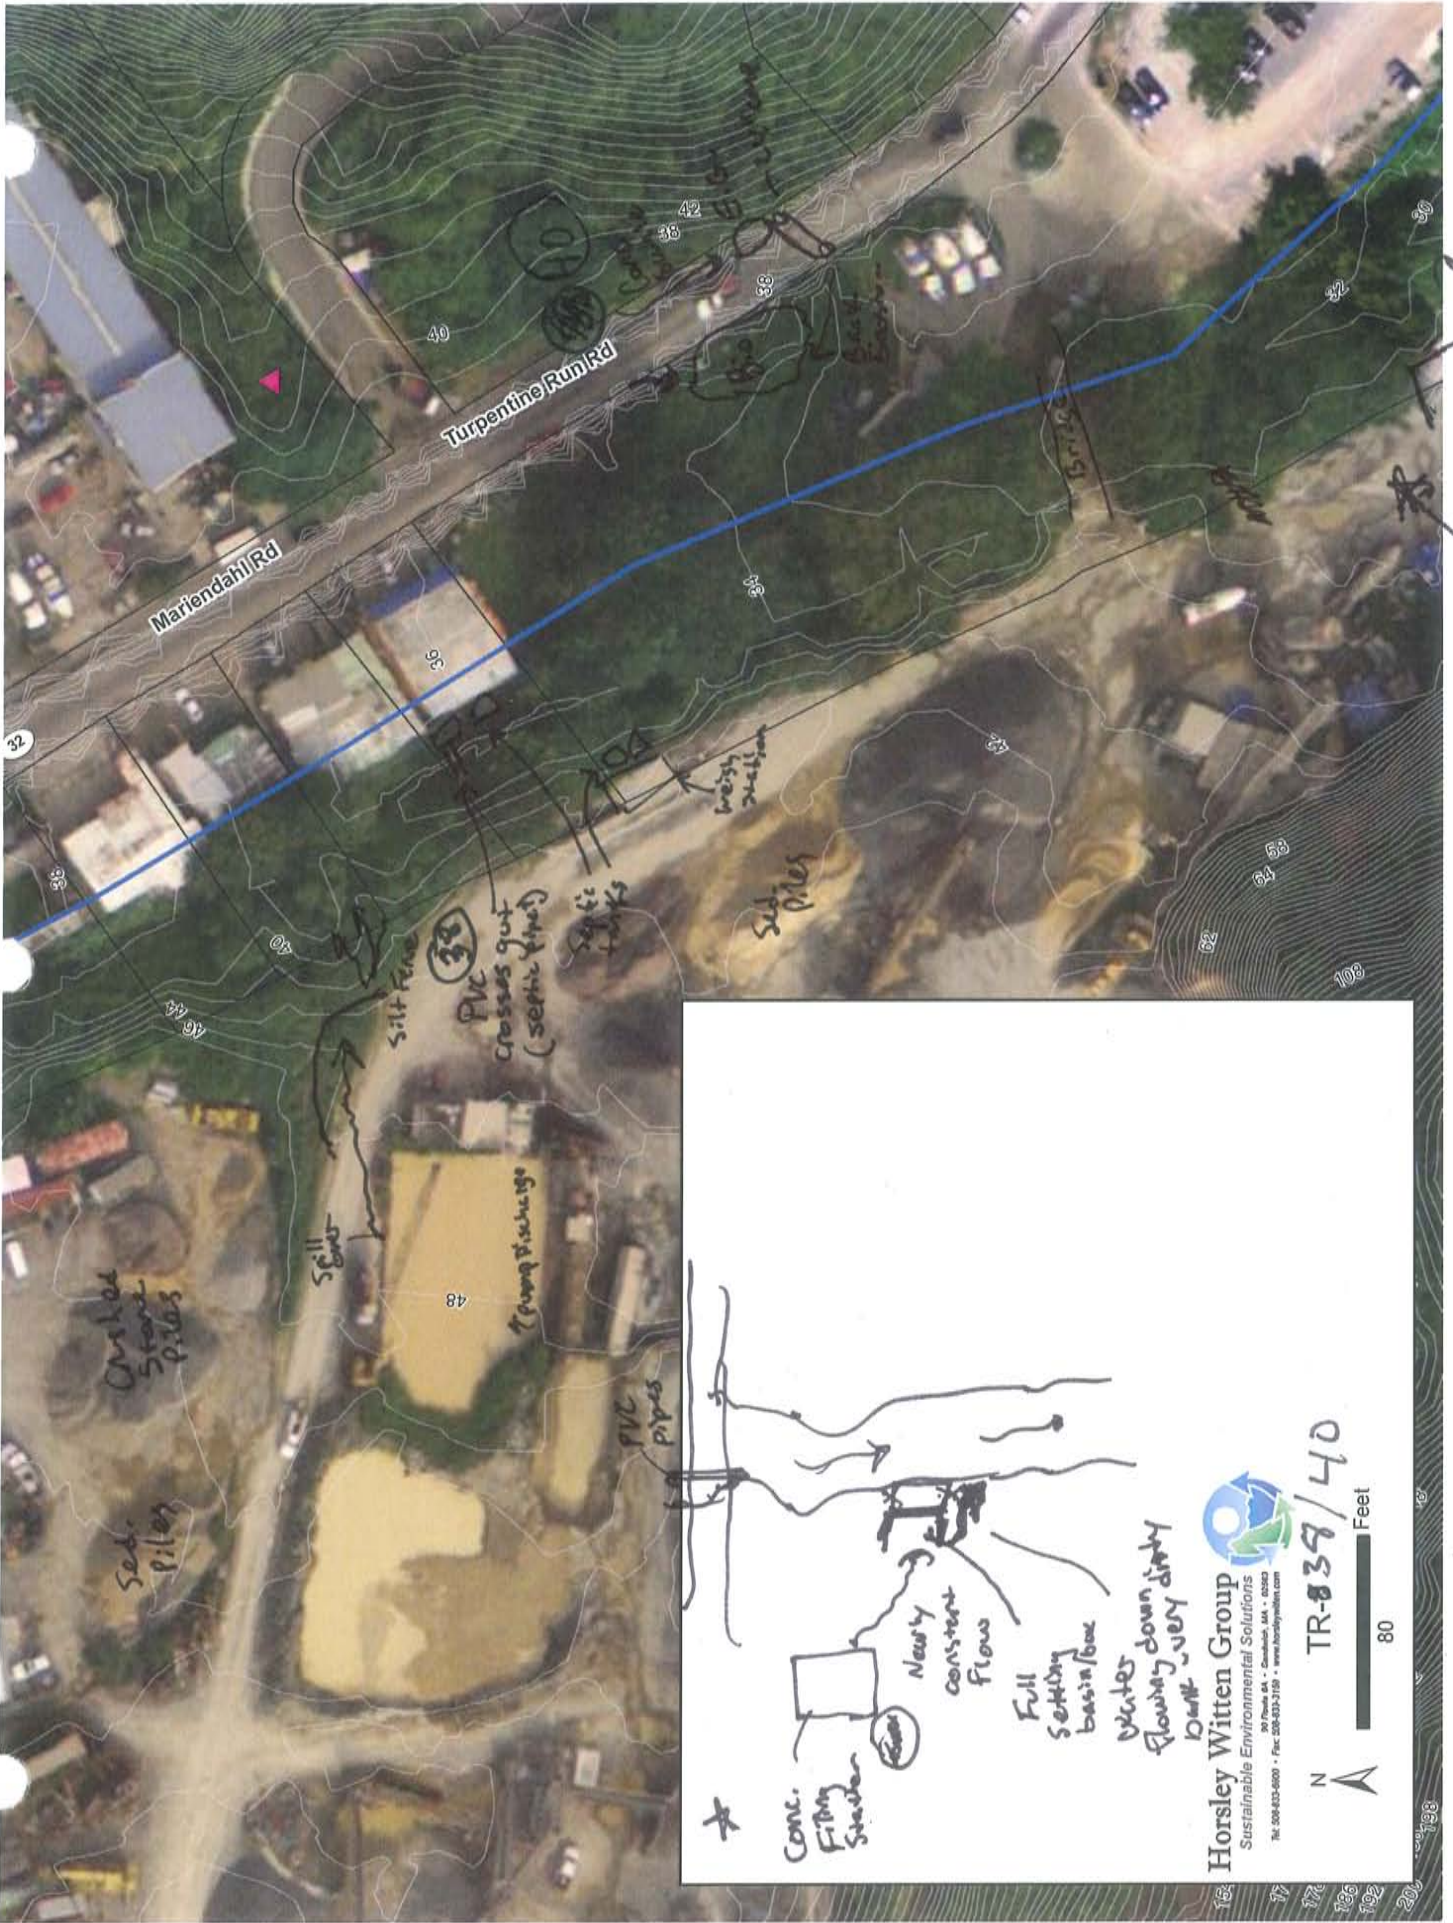
TR-039/40
 Feet
 0 20 40 80

this is a dumping area and area of outdoor storage. lots of trash & debris dumped near gut. Material stockpiles w/ no ESC. Barrels of oil sitting open were observed.

Conc. Filter Strainer
 Nearly constant flow
 Full settling basin/lake
 Water flowing down dirty bank
 Dent

Silt Piles
 Silt Fence
 PVC crosses gut (septic filter)
 Septic Tanks
 weedy swales
 Pump Discharge
 PVC pipes

- Need to clean up & prevent further dumping*
- take used oil to Bovoni for recycling / cover stockpiles.*

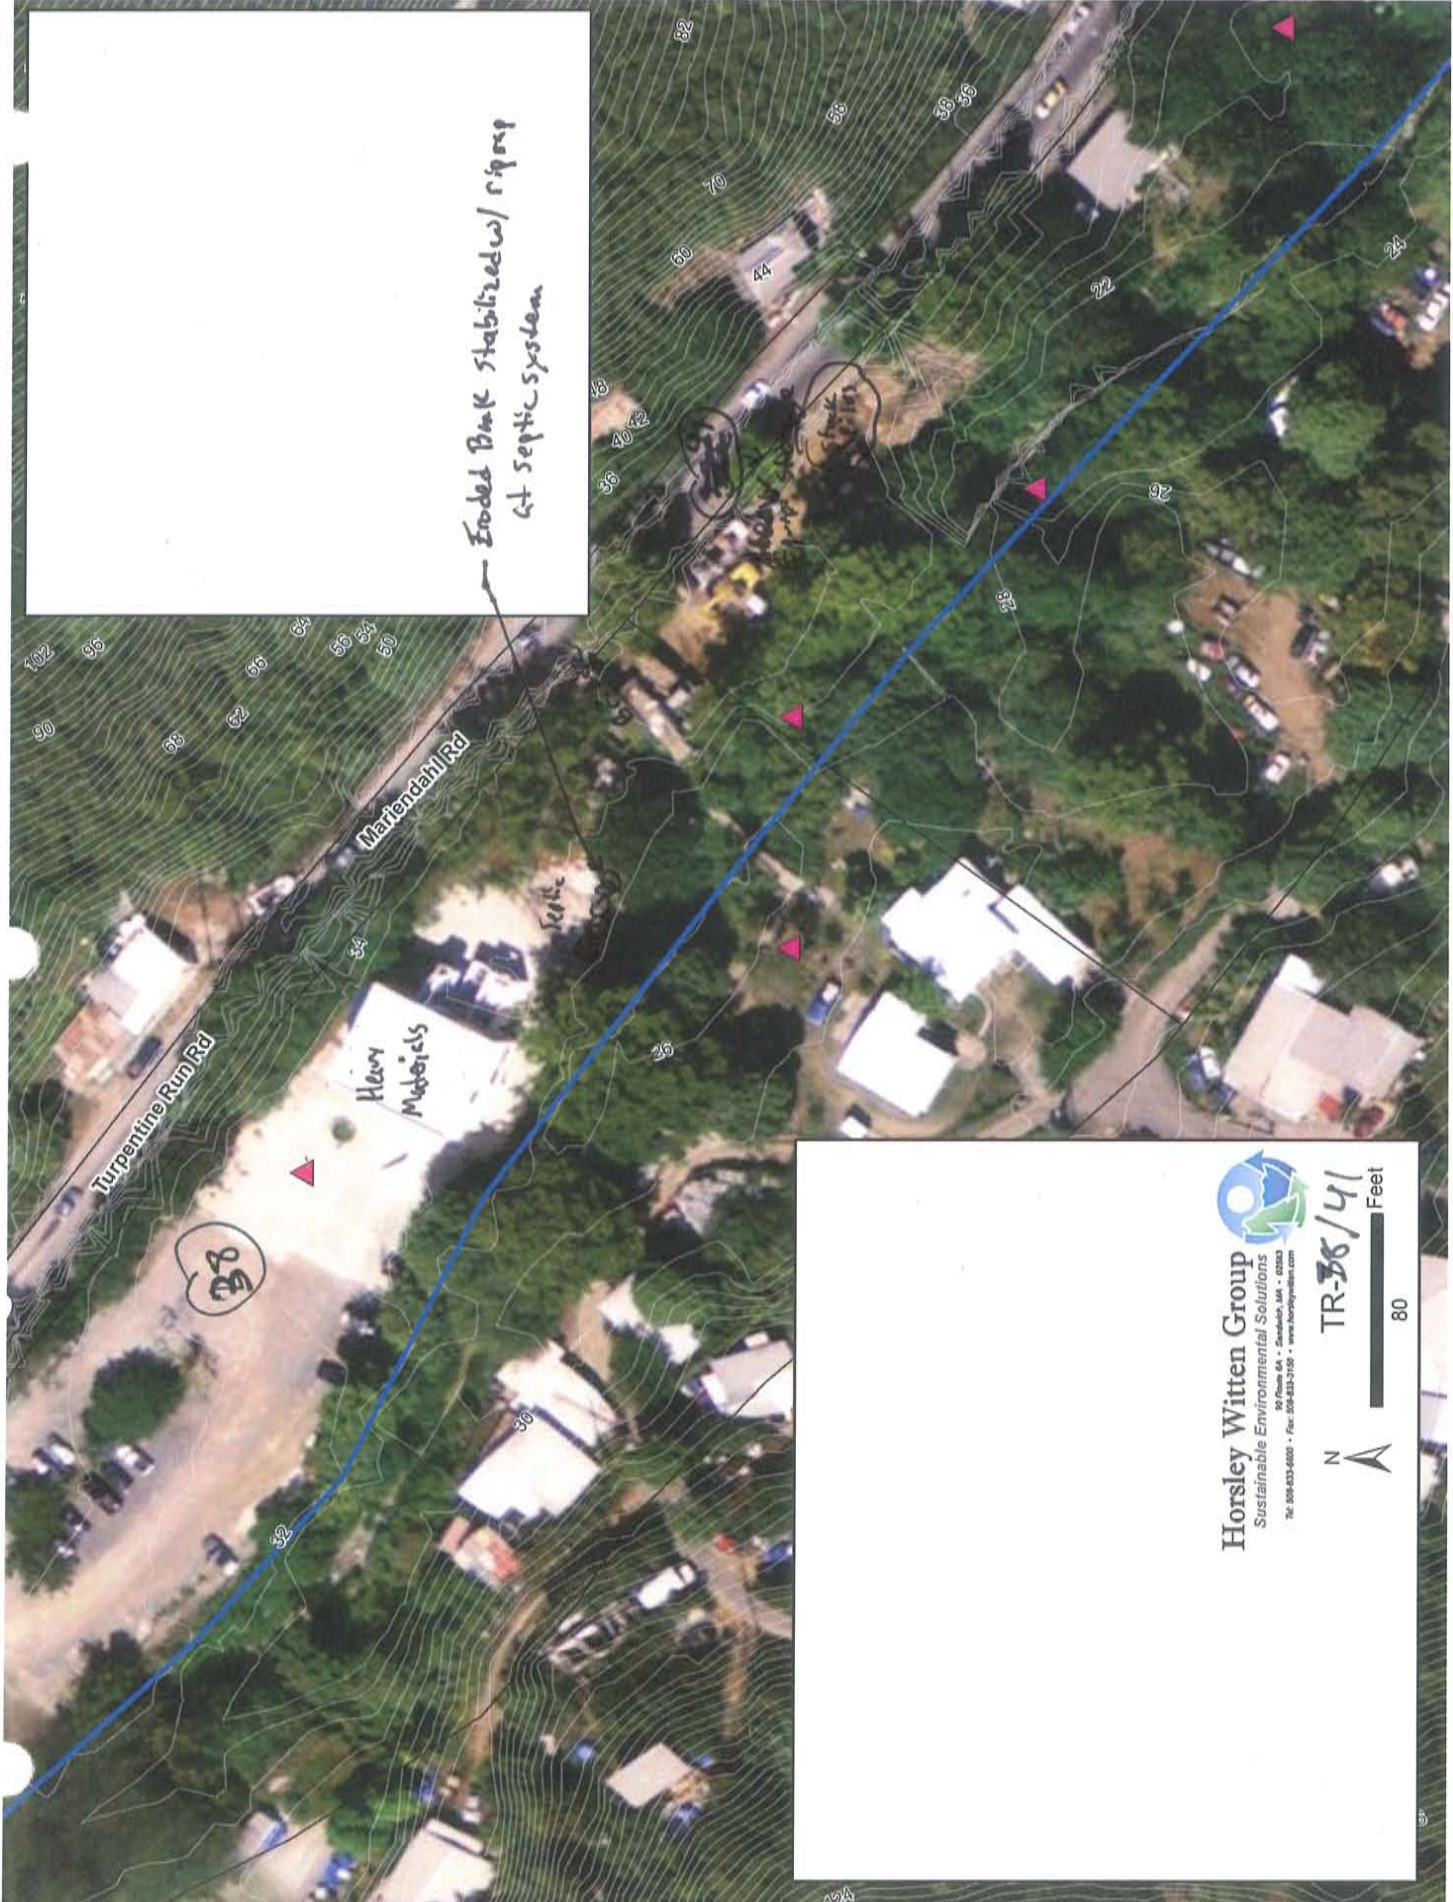
Eroded Bank Stabilized w/ riprap
at septic system

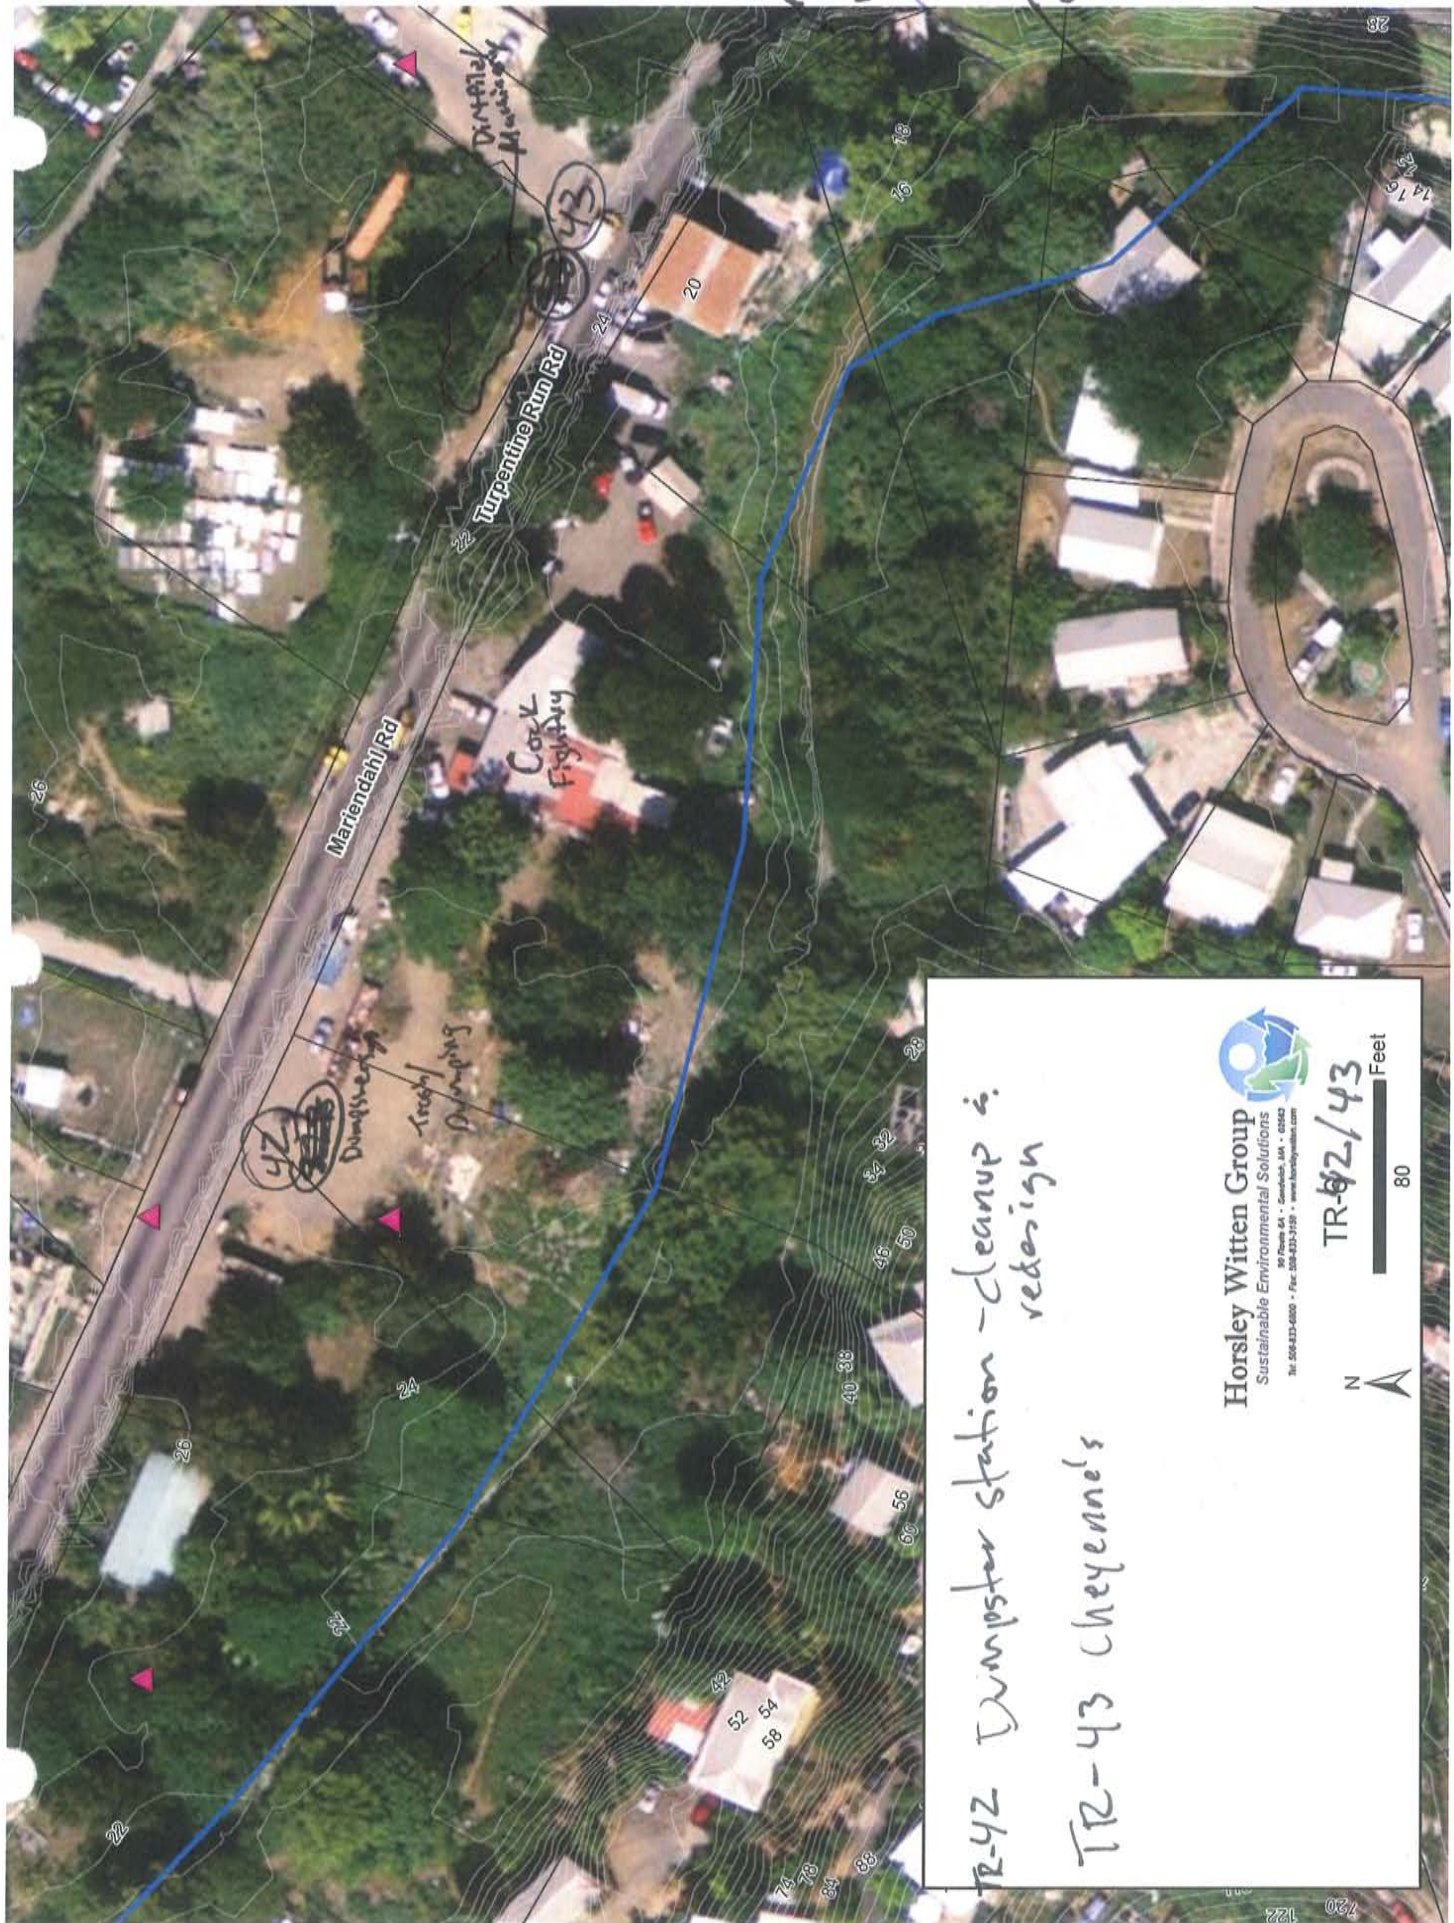
TR-42 Dumpster station - cleanup & redesign
 TR-43 Cheyenne's

soil stockpiles in parking area should be stabilized (e.g. covered or with silt fence perimeter)

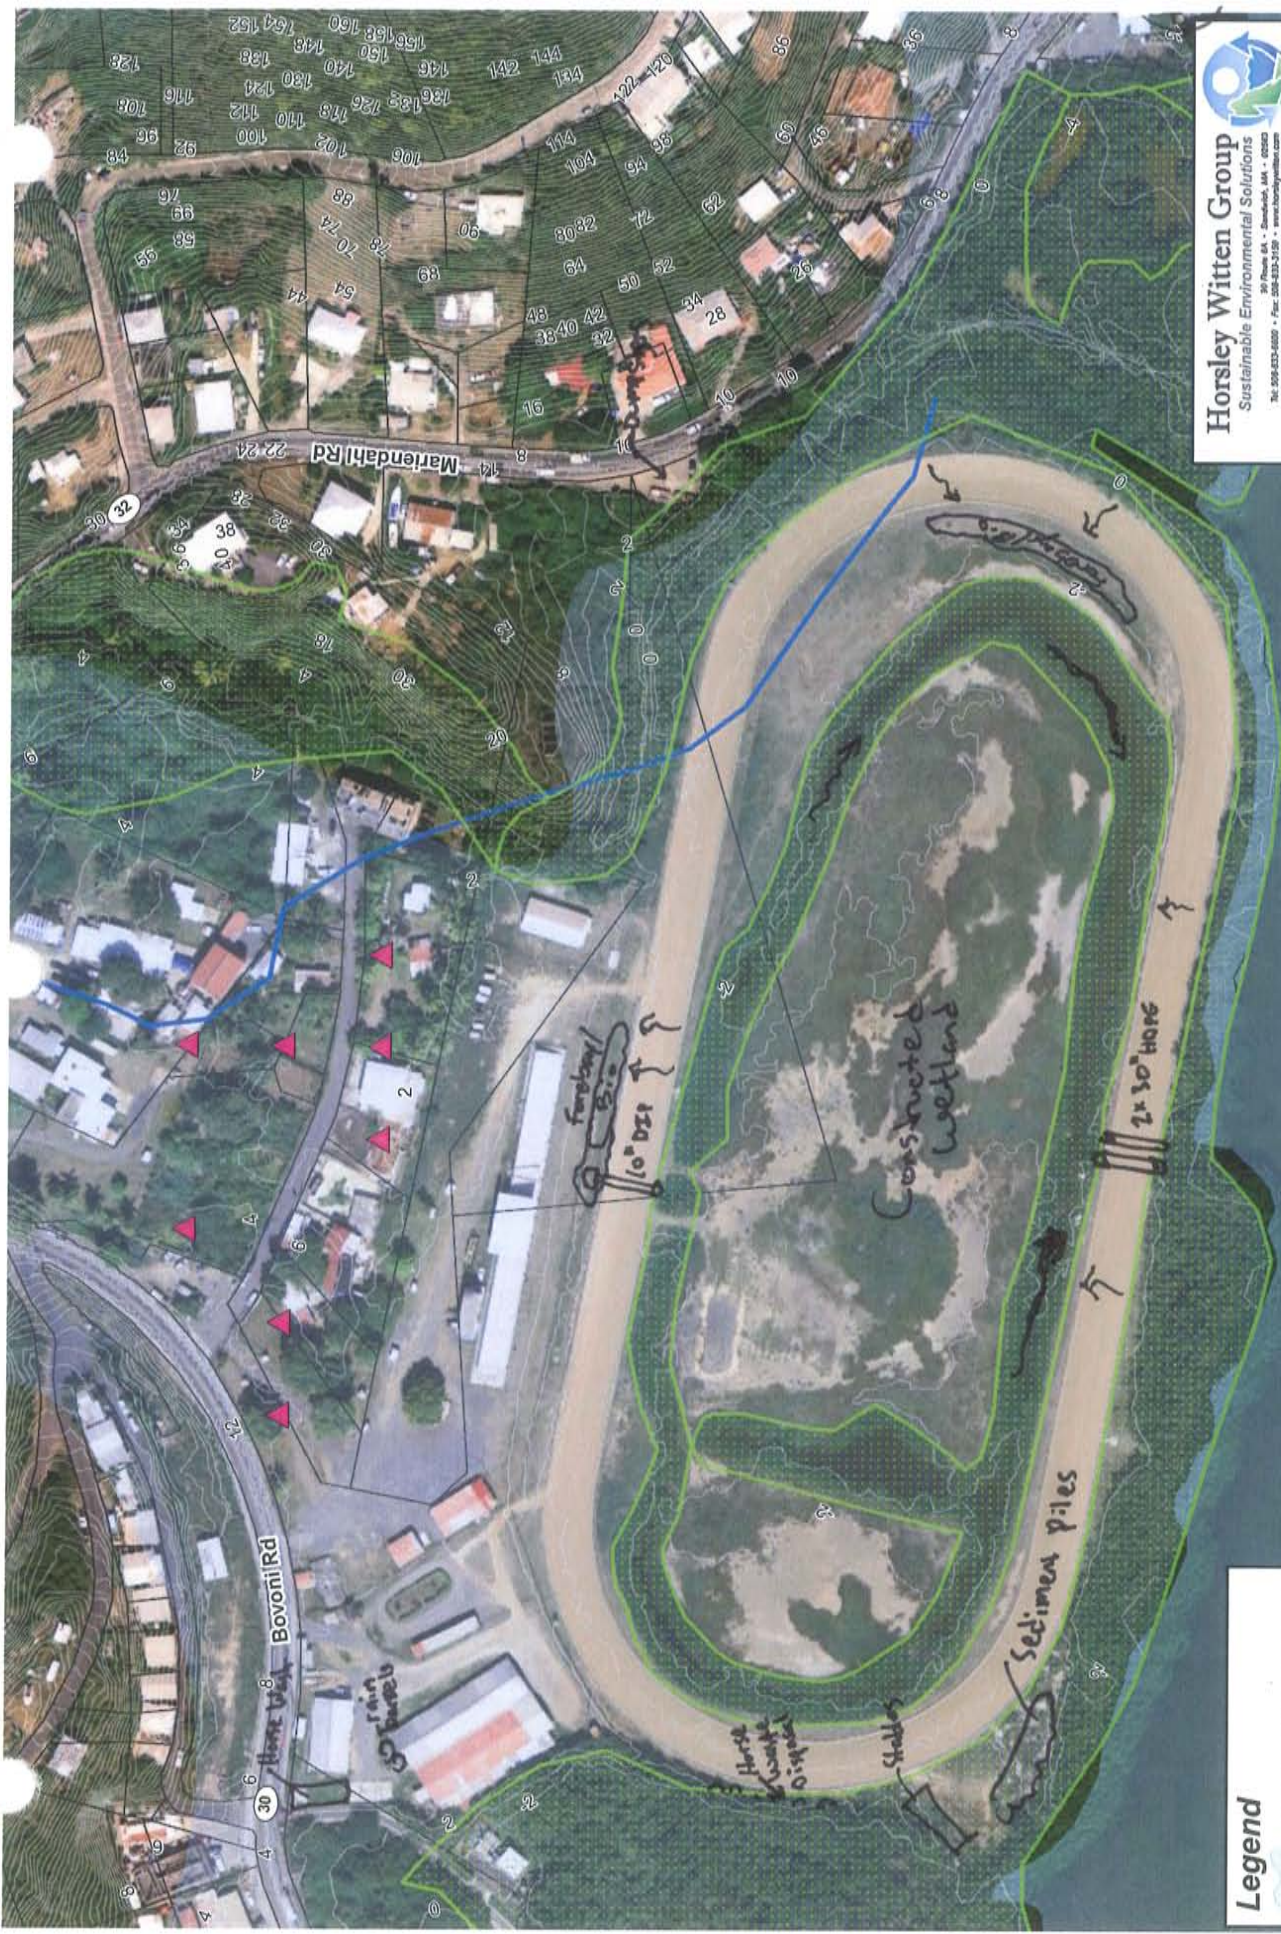
Clinton Phipps Racetrack
Turpentine Run Subwatershed

Active horse track - ~~refer~~ center of track is wetland area, sediment and loading from track into central wetland. Piles of horse waste observed at disposal site to east of track.
~~2~~ x 30"

- ③ options for smaller practices in the upland portion of site.
