FIELD ASSESSMENT NOTES

Subwatershed: NAZARETH

Site Name: DOLPHIN COVE / SECRET HARBOR ESTATES

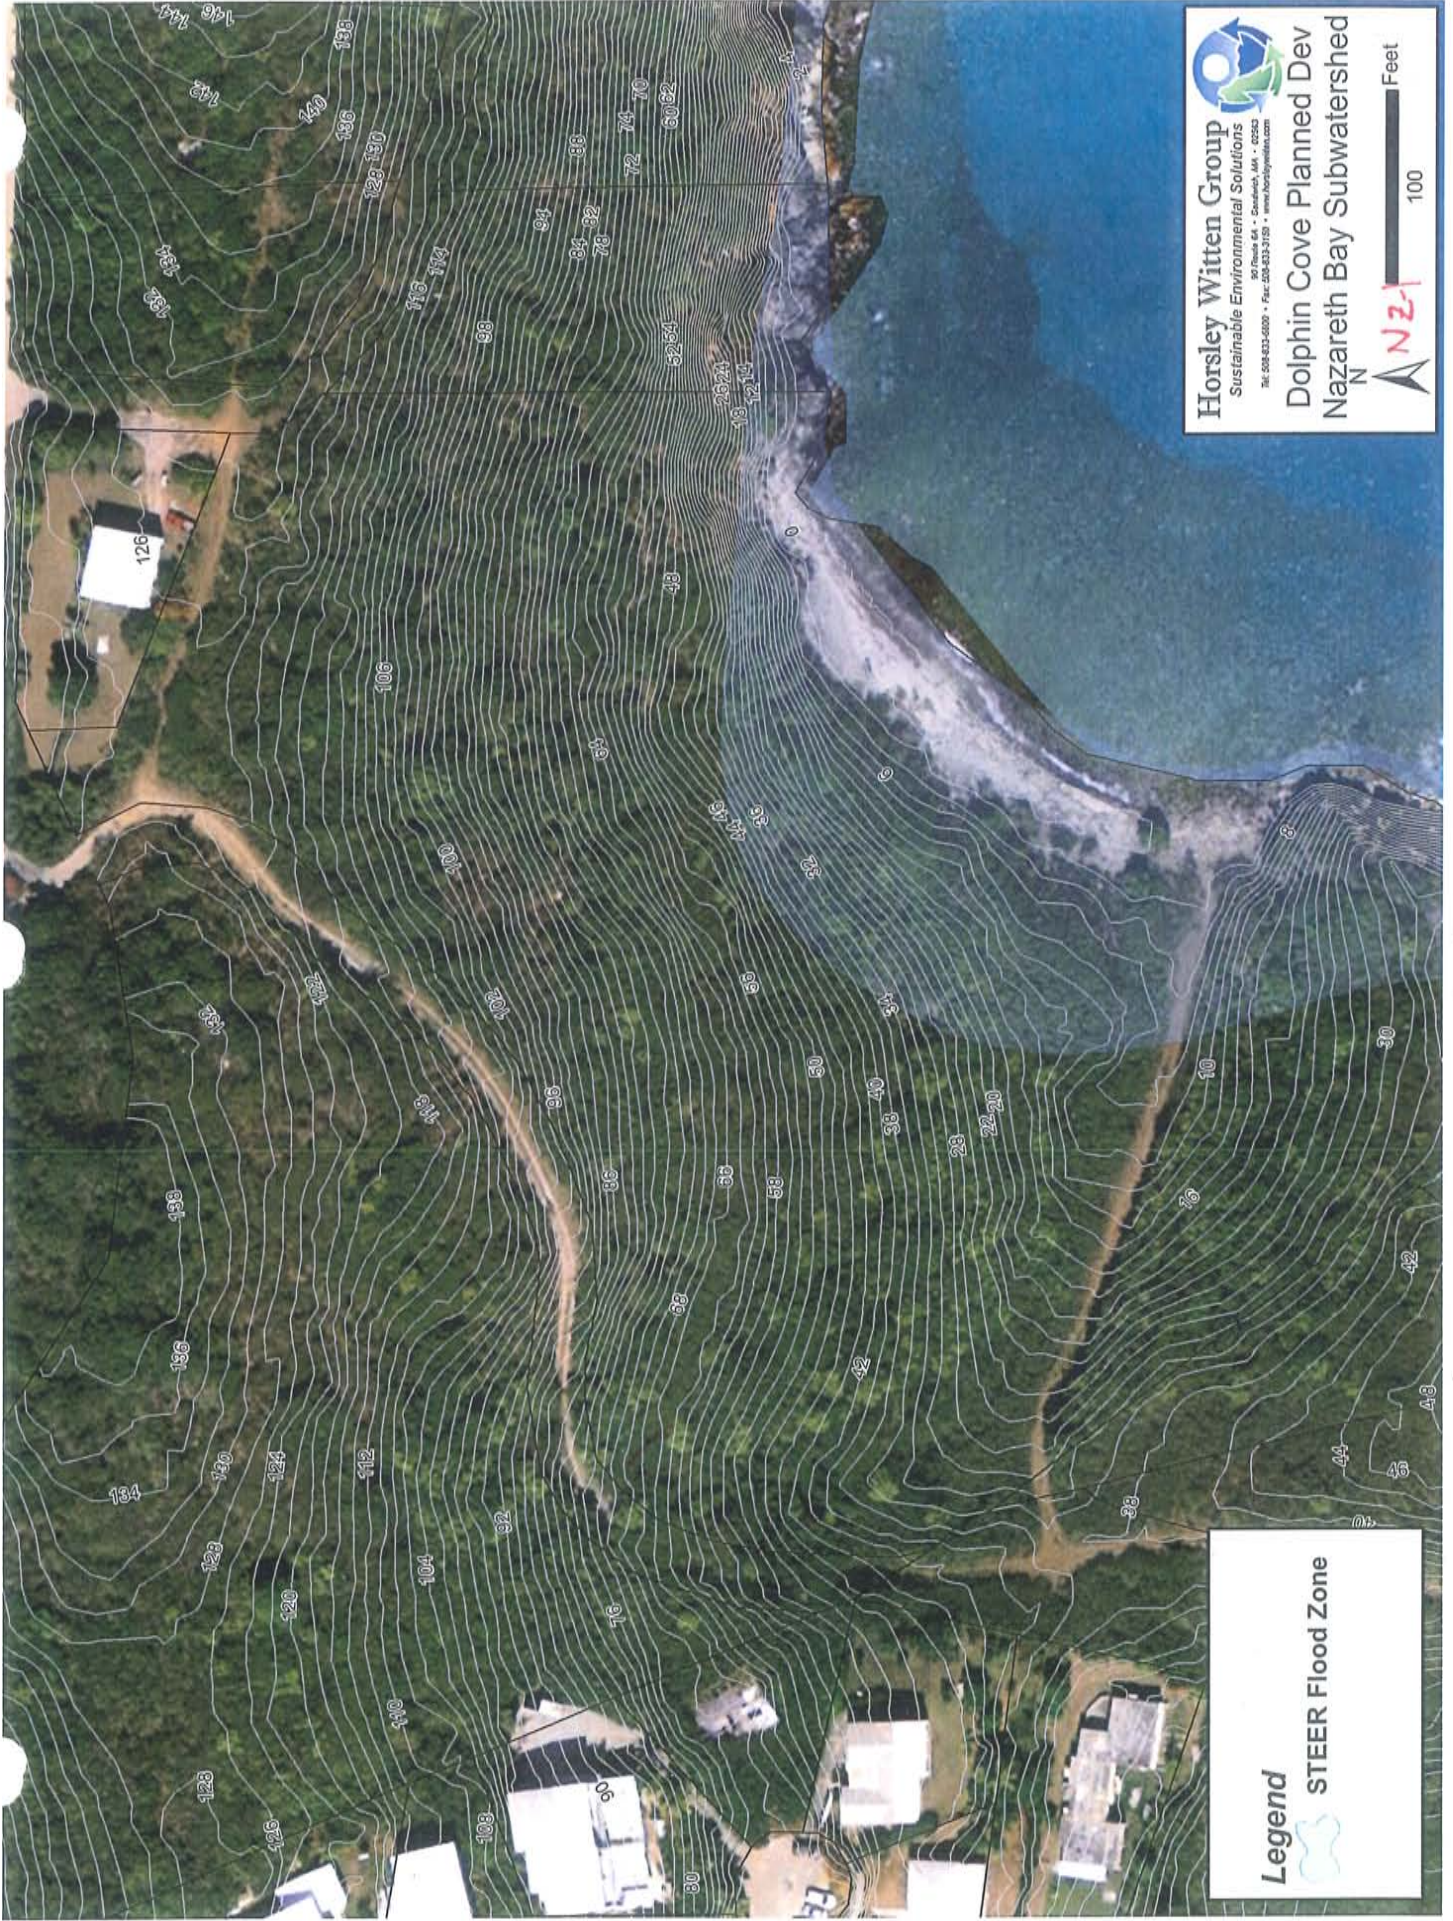
Description of Existing Conditions: NZ-1 NZ-2

New development projects here need to ensure full compliance to ESC and other dev. regulations.

Given location at SECRET, consider requiring stormwater facilities to provide WA treatment for 1.25" of runoff.

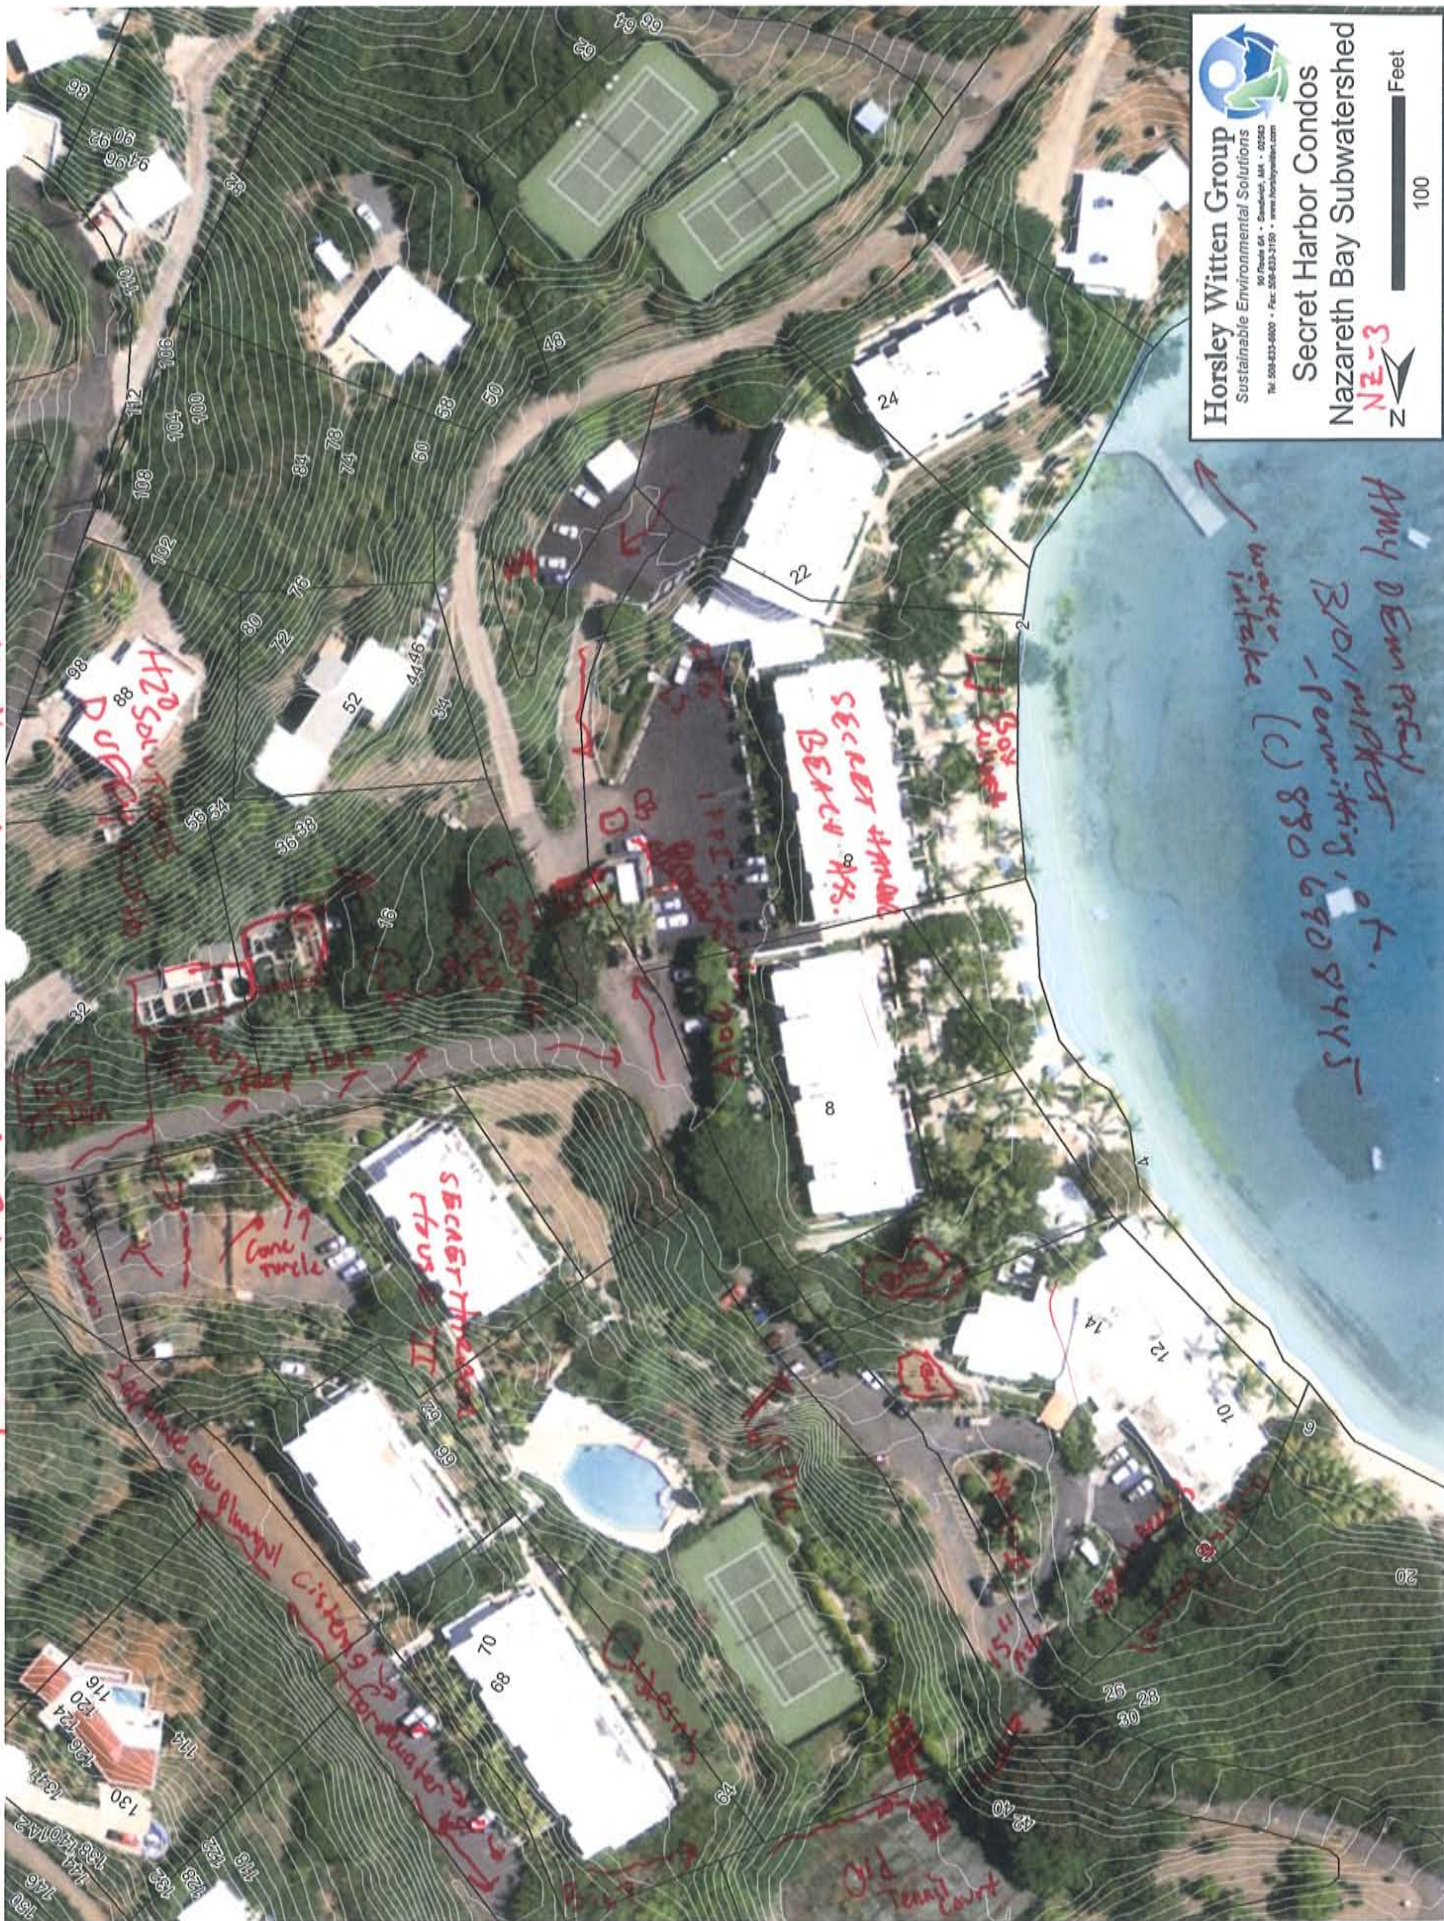
Description of Existing Conditions: NZ-3

Potential for a number of bio-retention to be installed to treat parking lot runoff (north end of upper lot and near main building).

low priority

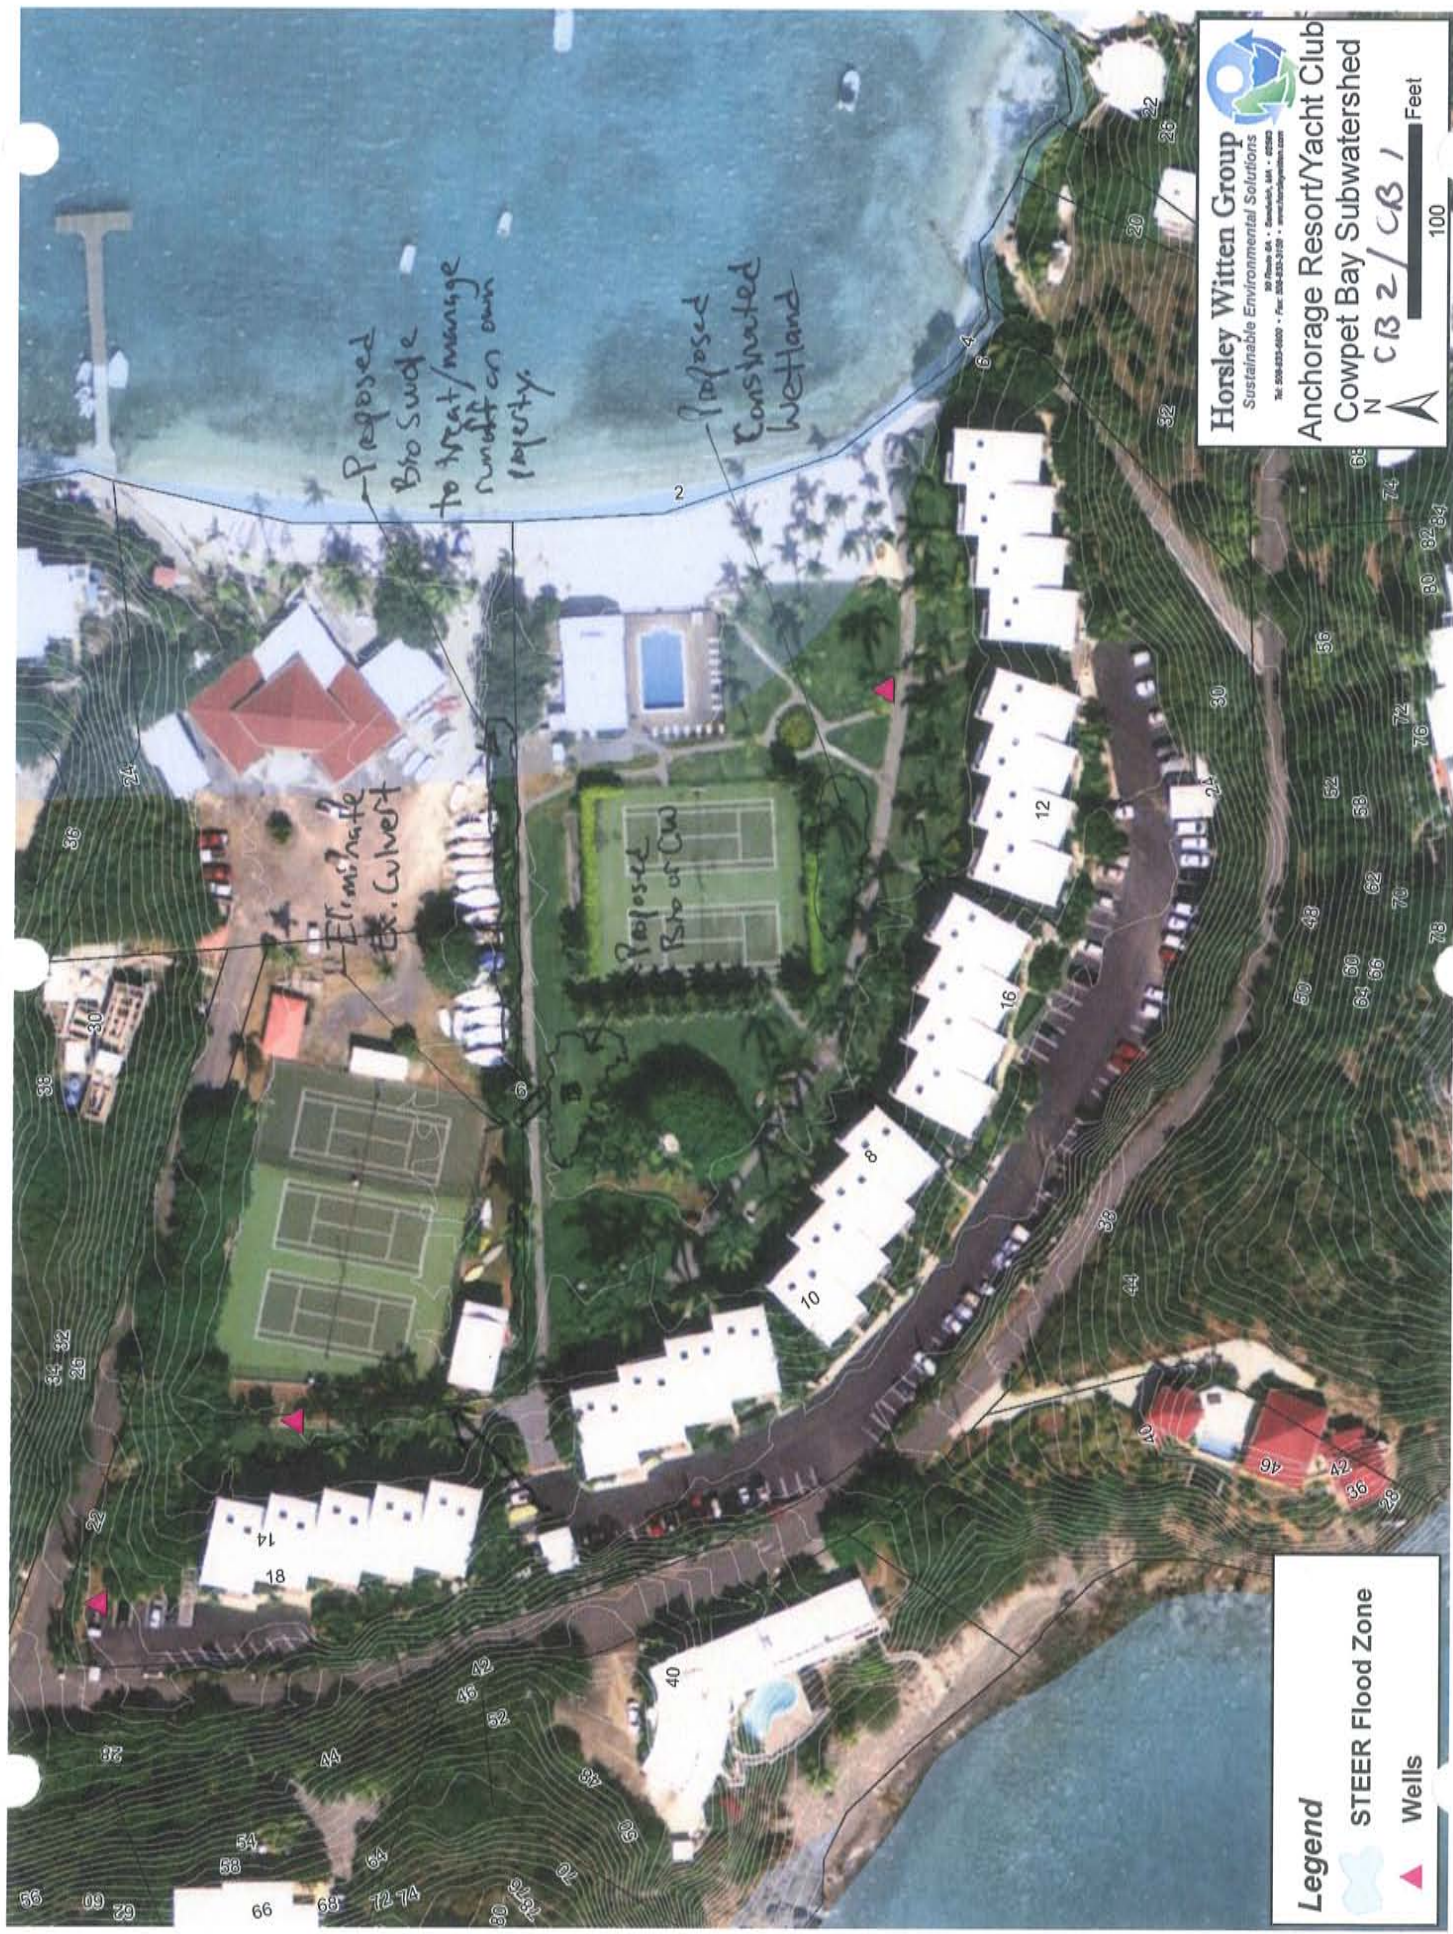
CB1-CB2

Drainage above yacht club/Anchorage comes down on causes flooding by the boathouse at Yacht Club. Drain (infirmed) was created to divert onto Anchorage property northwest of tennis courts.

Water comes down from condo parking lot and from road. Saturates tennis court and area to shed. Once wall was constructed, the water could no longer drain.

There used to be a salt pond in grassed area adjacent to tennis courts at anchorage.

Yacht Club installed drain pipe, but it gets blocked by Anchorage. French drain system in discharge on beach.

- Consider creating small constructed wetland or shallow bio ~~at~~ in grassy area at anchorage and formalize drainage from yacht club to be diverted into the retrofit.

- Eliminate culvert from Yacht Club leading to Anchorage.
↳ Runoff should be managed on each individual property
- Consider a bio swale type system on Yacht Club lot on north side of existing concrete wall. Vegetation removal and replacement will be required. Boat storage will have have to be relocated slightly north.
- Install a bio retention area or constructed wetland type system on Anchorage property to manage and treat their site runoff prior to discharge at beach.
- Install a second constructed wetland system south of tennis courts on Anchorage site to treat runoff from the southern half of the property.

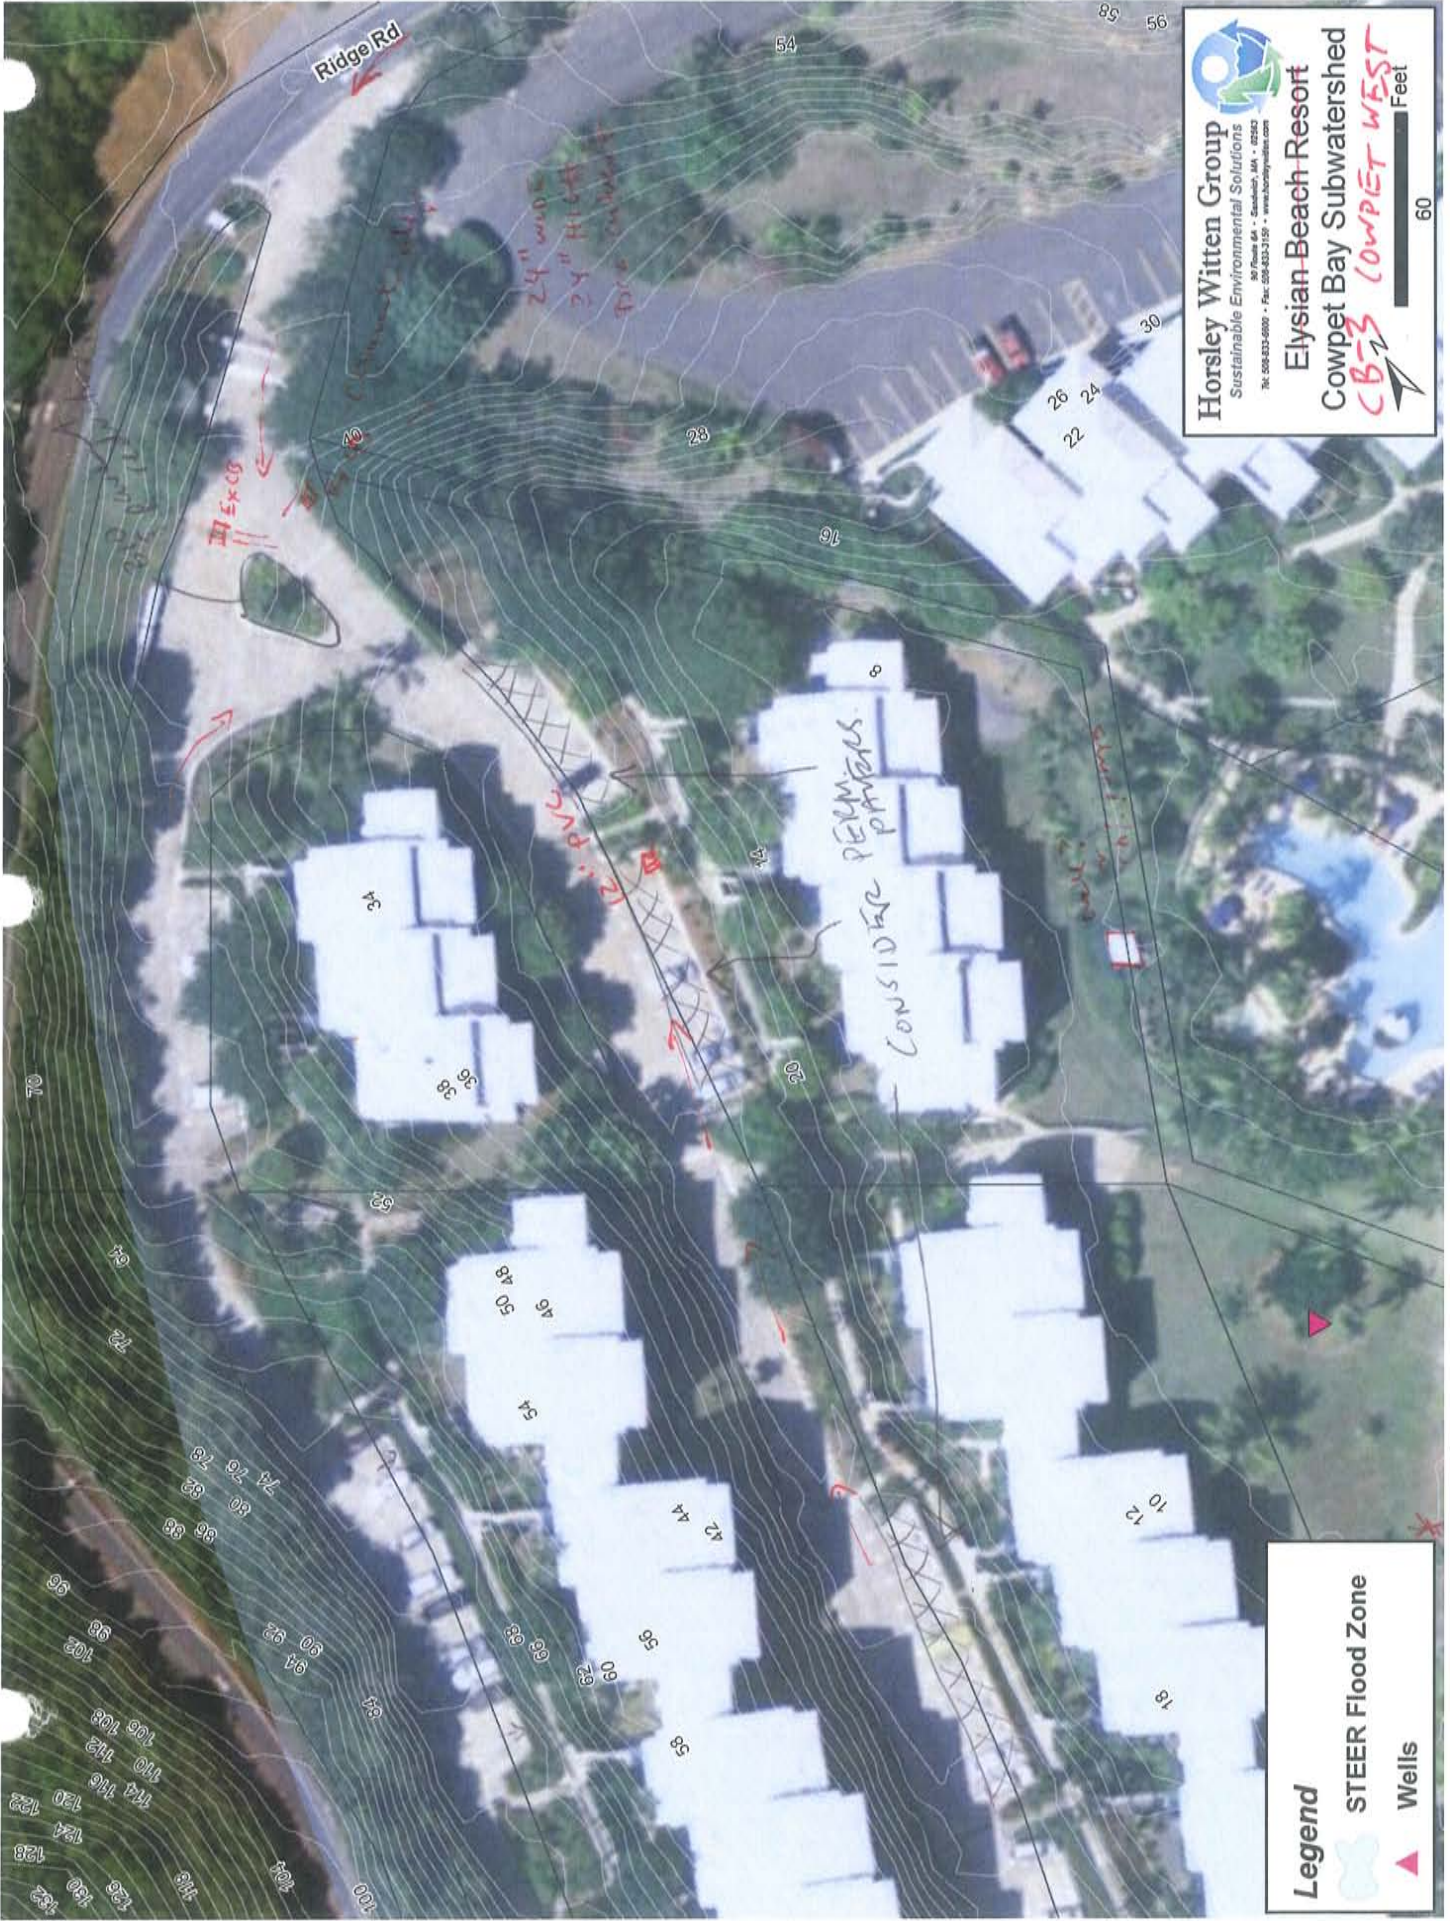
Elysian Beach Resort
Cowpet Bay Subwatershed
CB-23 COMPLET WEST

Manager mentioned no issues w/ drainage
high density condo area, no BMPs
parking lots are used for some residential
vehicle maintenance.

drain inlets and pipes appear to discharge
primarily to "rock channels" on sides of
properties

Some room in parking lot islands to
demo a rain garden — or porous pavers
in parking stalls; however this is a
low priority.

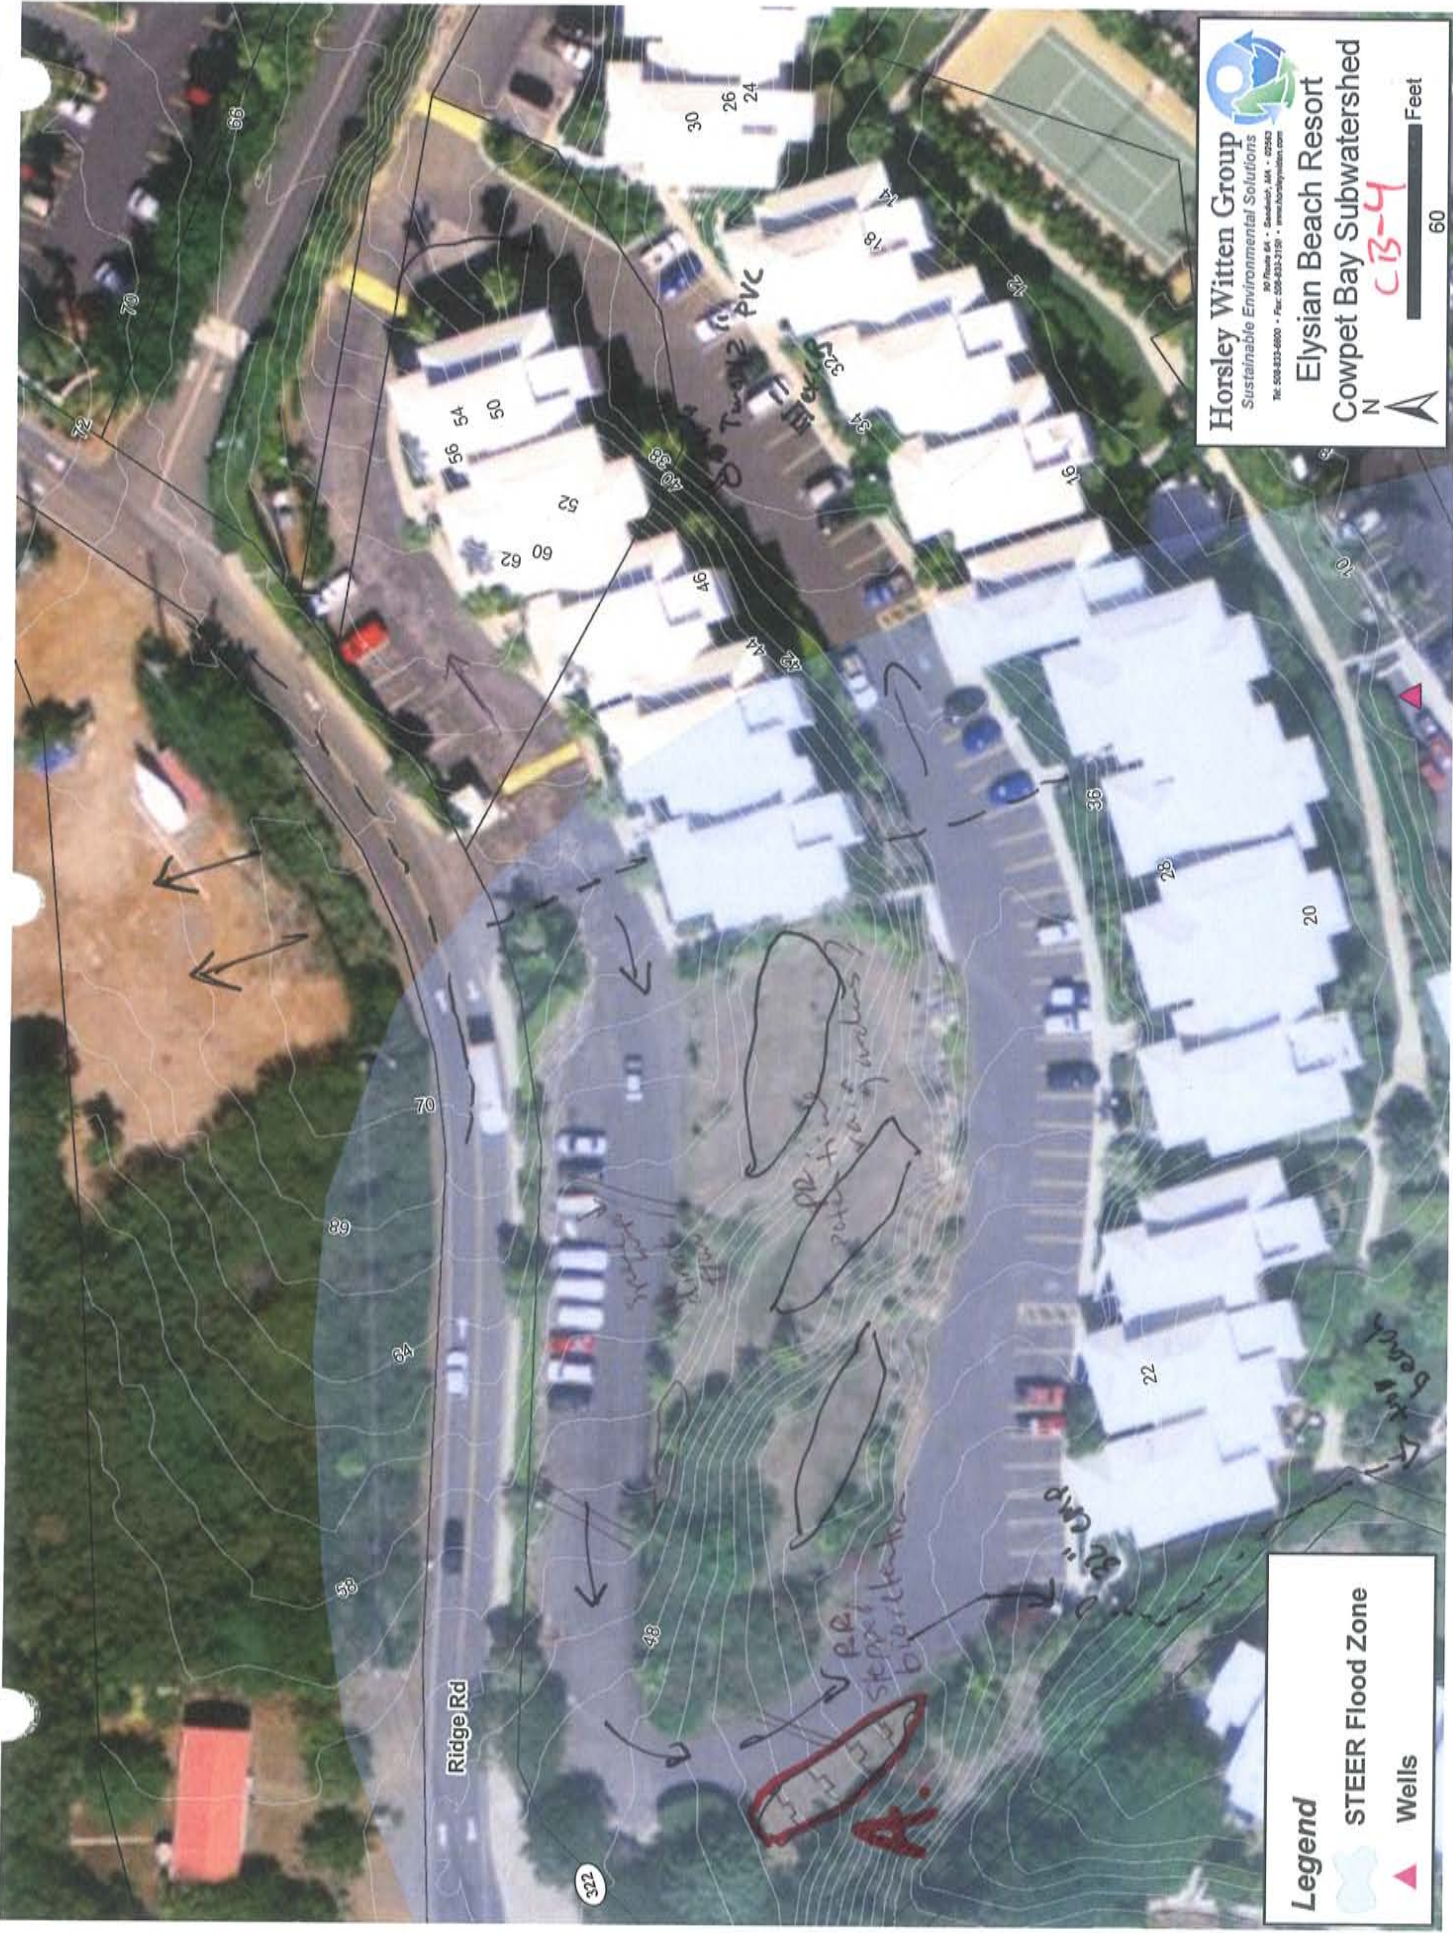
CB-4

The east edge of Elysian accepts runoff from Cowpet East down steep concrete channel

(logged CB at tennis courts. Lower lot drains to curb cut and outlet pipe near restaurant entrance.

1/2 Upper lot drains to 32" CMP on western property line and discharges at beach (some photos show open pipe) (drainage crosses into Cowpet West.

*Retrofit options exist at (A) western loop of parking area where boat trailers are stored; (B) parking lot island near restaurant/tennis court; (C)

at curb cut area near restaurant (could expand and include sediment forbay.

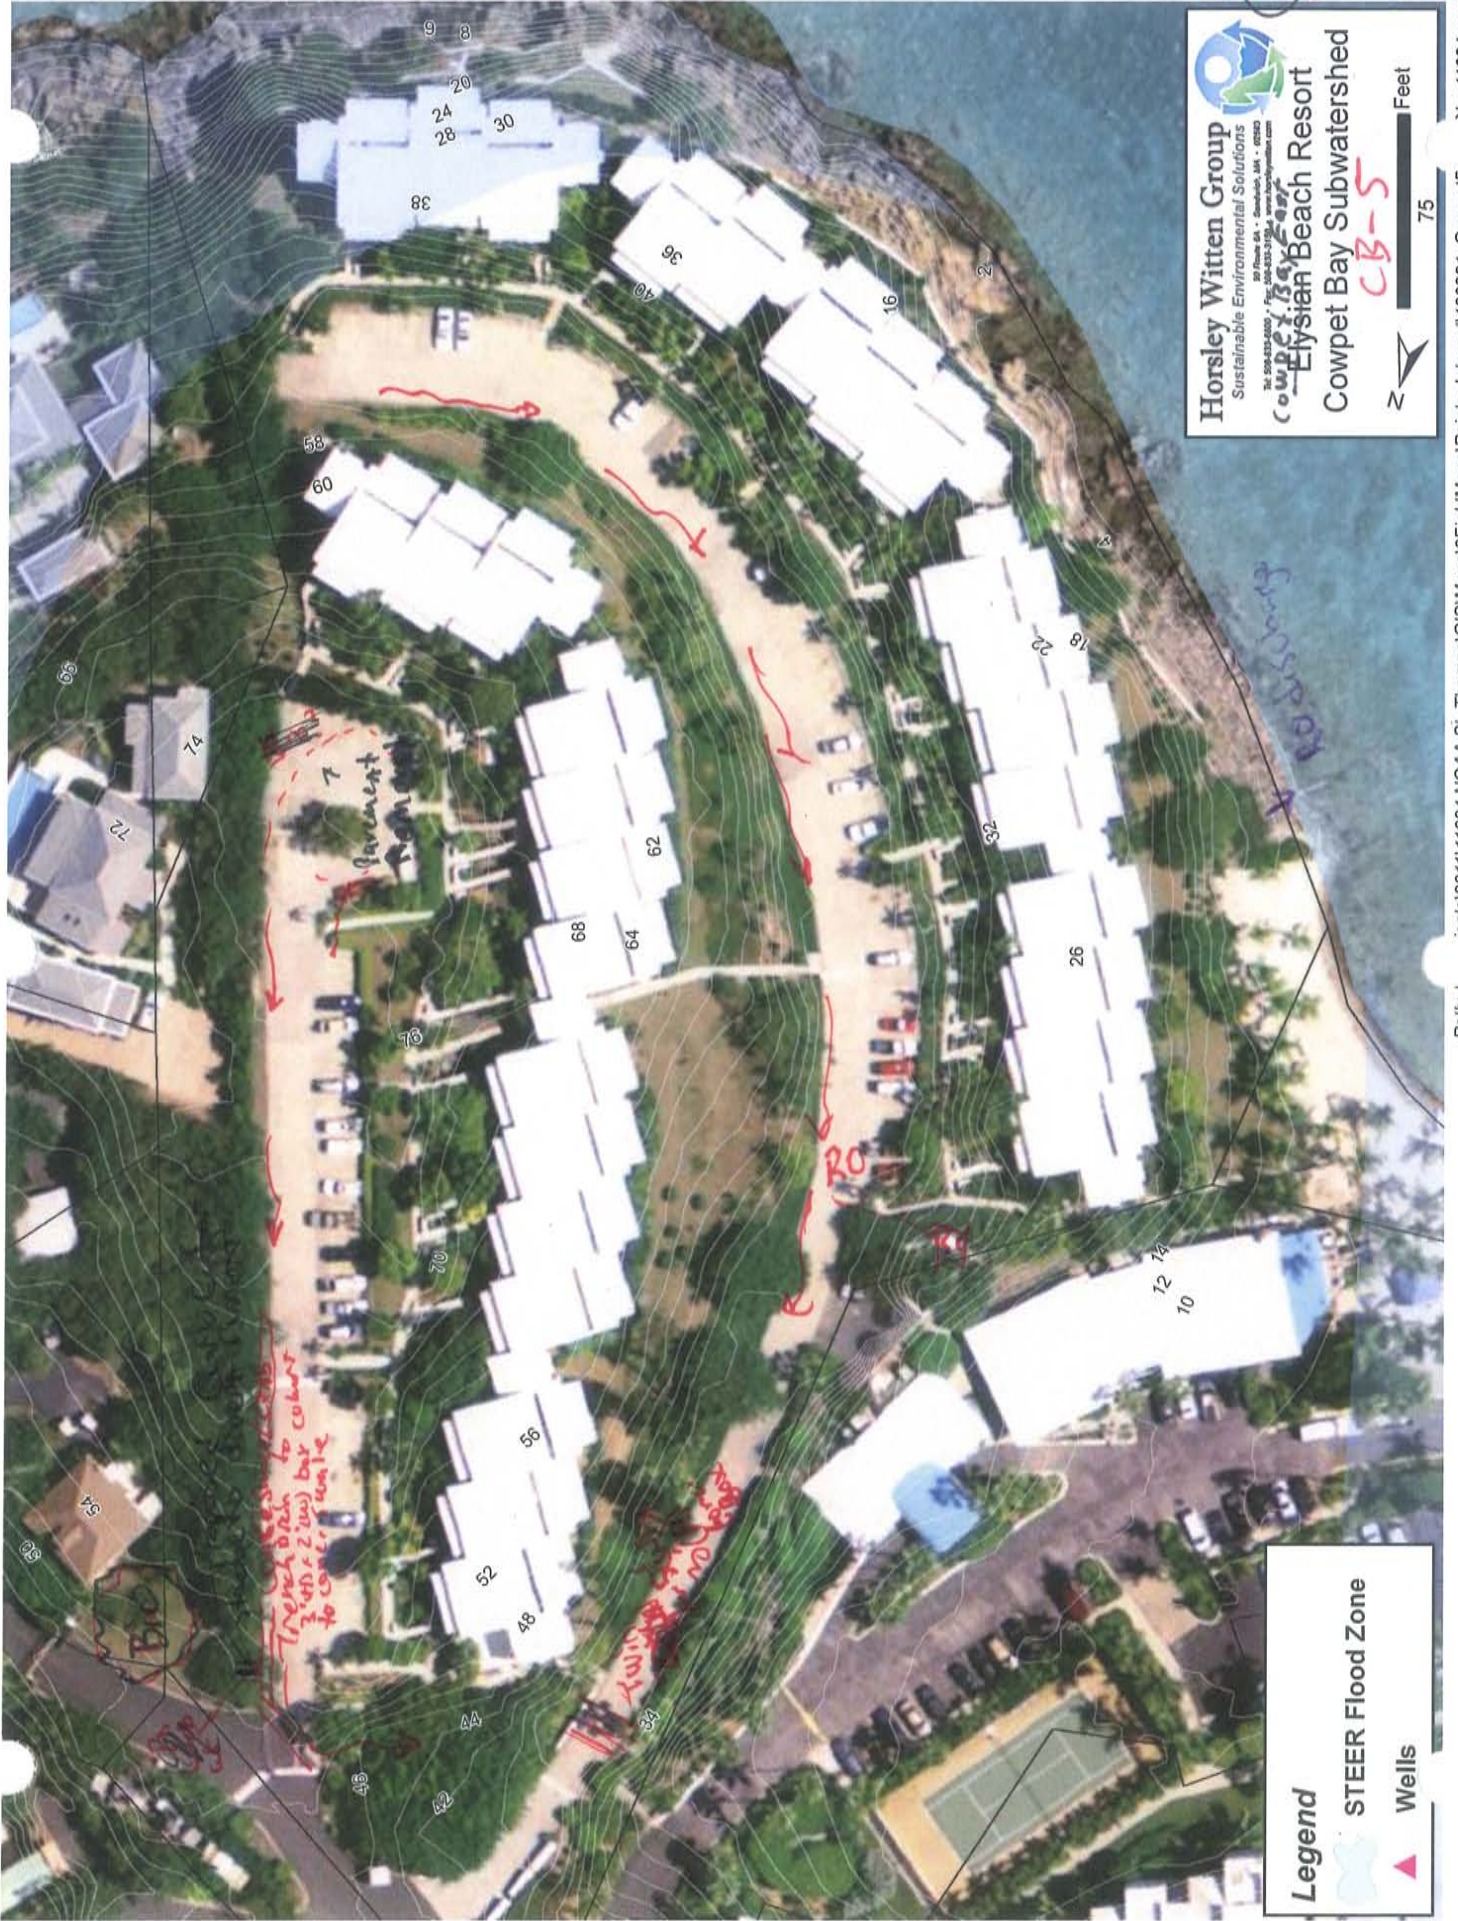
CB-5

- Contact - Alan LaPlante
- WWTP (Package Plant) Services All condos
 - discharges approx. 10 gpm (or 14400 gal/day)
- RO facility produces ~20 gpm of produced water
 - ↳ drinking water stored in cisterns
 - ↳ roof runoff kept in cisterns w/ RO product and all treated w/ chlorine - 9 cisterns total
- WW used for irrigation + toilet flushing
- Beach nourishment (sand) req'd once per year
 - ↳ about 200 tons requested annually
 - ↳ comes from TNT? (company from Bermuda)
- All runoff flows downhill to Elysian Beach Resort and is discharged at main outfall near Elysian Restaurant
- RO discharge near restaurant (see photos)
- WWTP ~~is~~ across road from Ritz Plant. Same location as Elysian WWTP.
