FIELD ASSESSMENT NOTES

Subwatershed: NAZARETH

Site Name: DOLPHIN COVE / SECRET HARBOR ESTATES

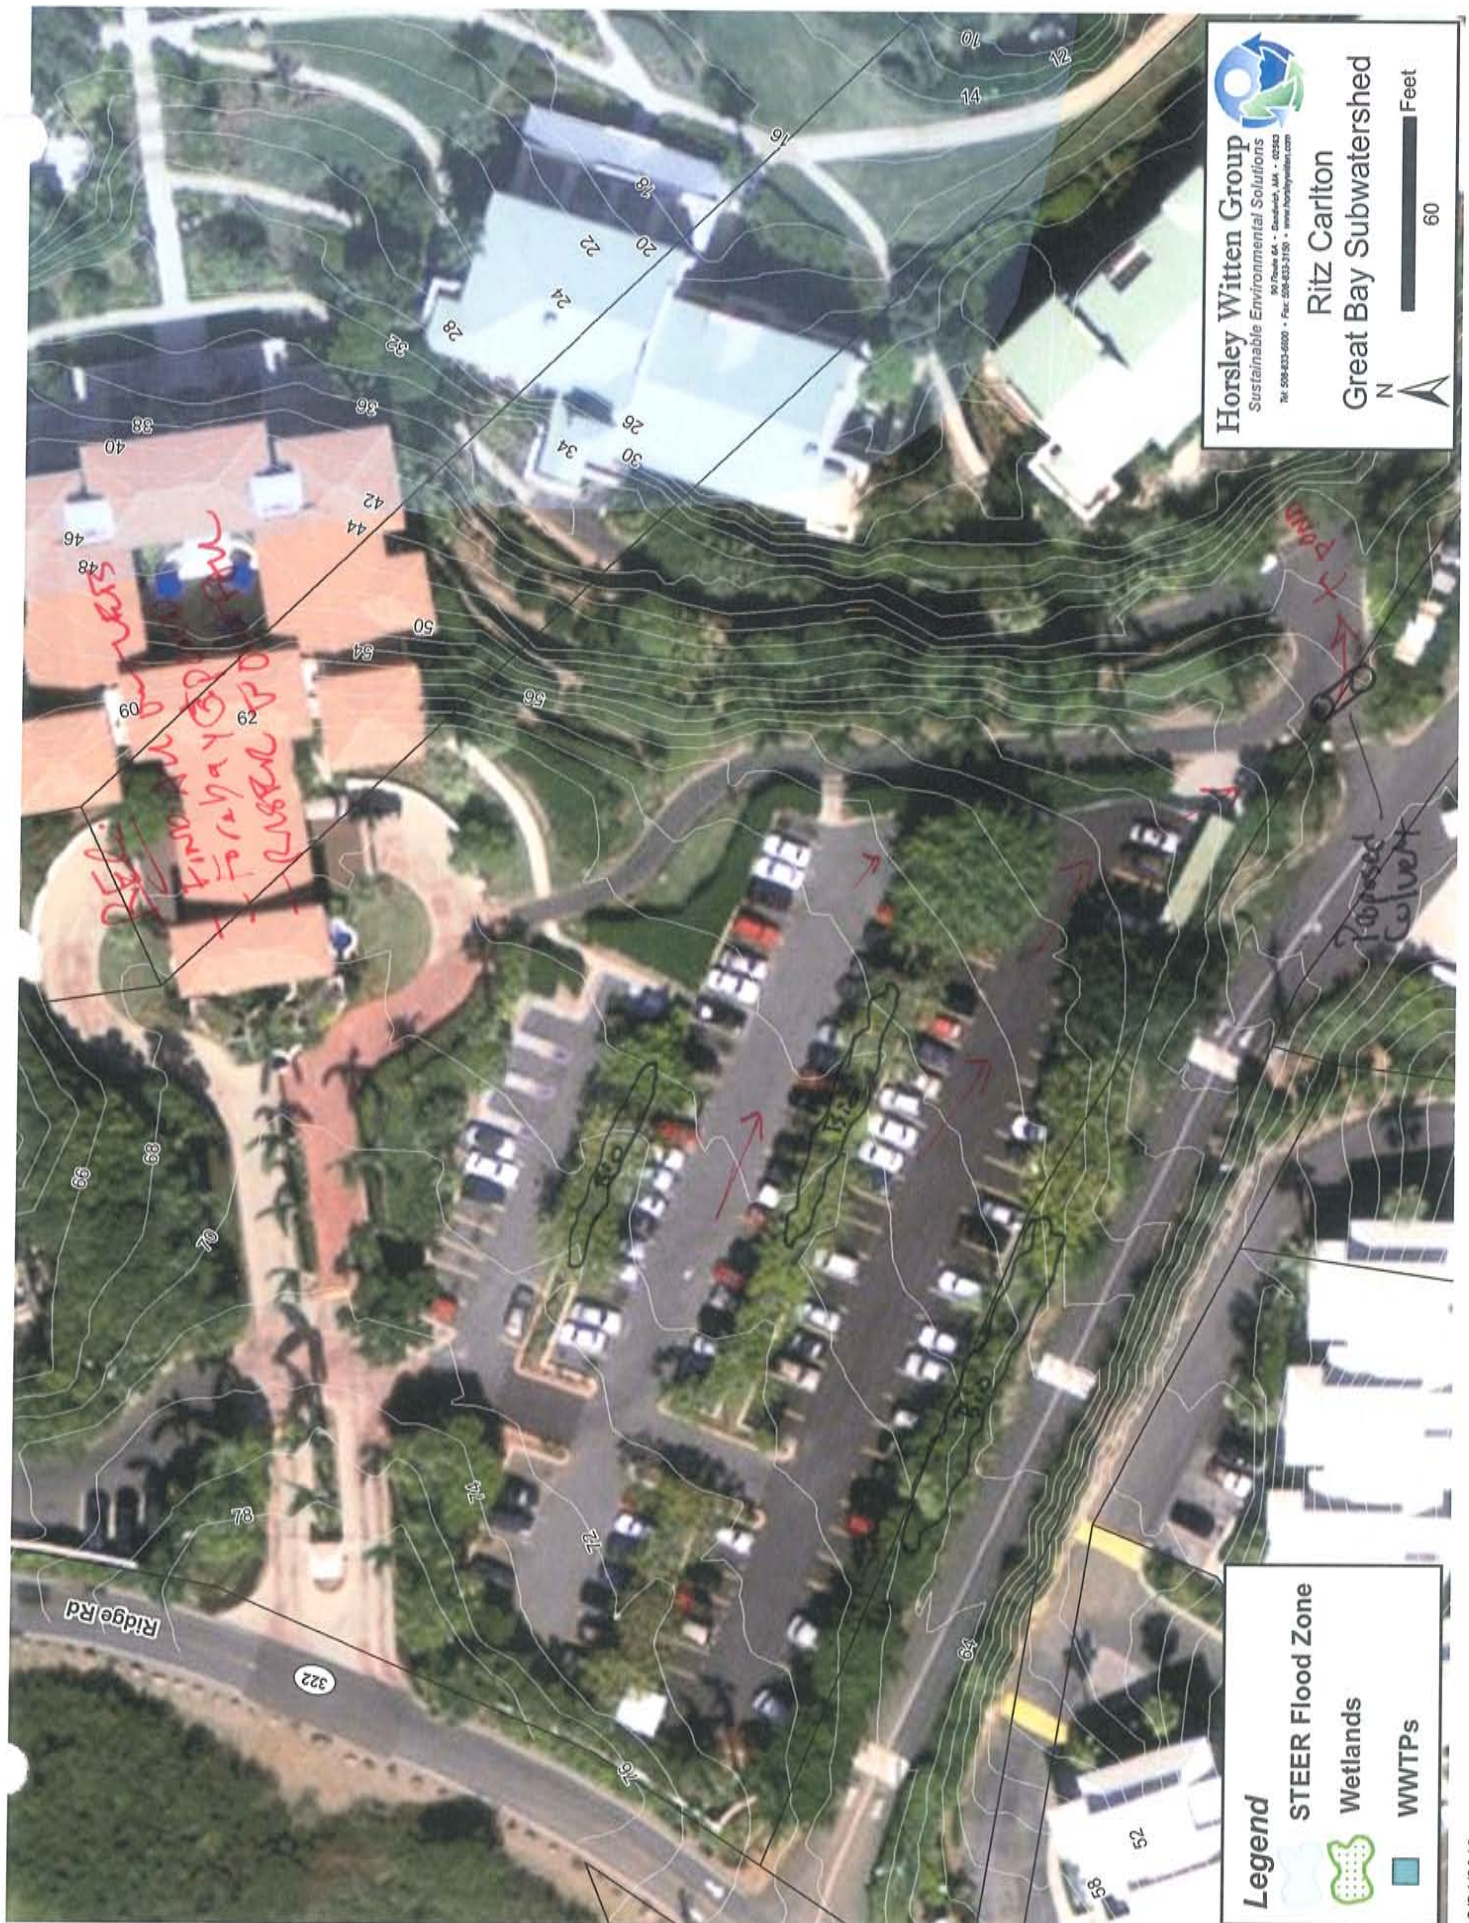
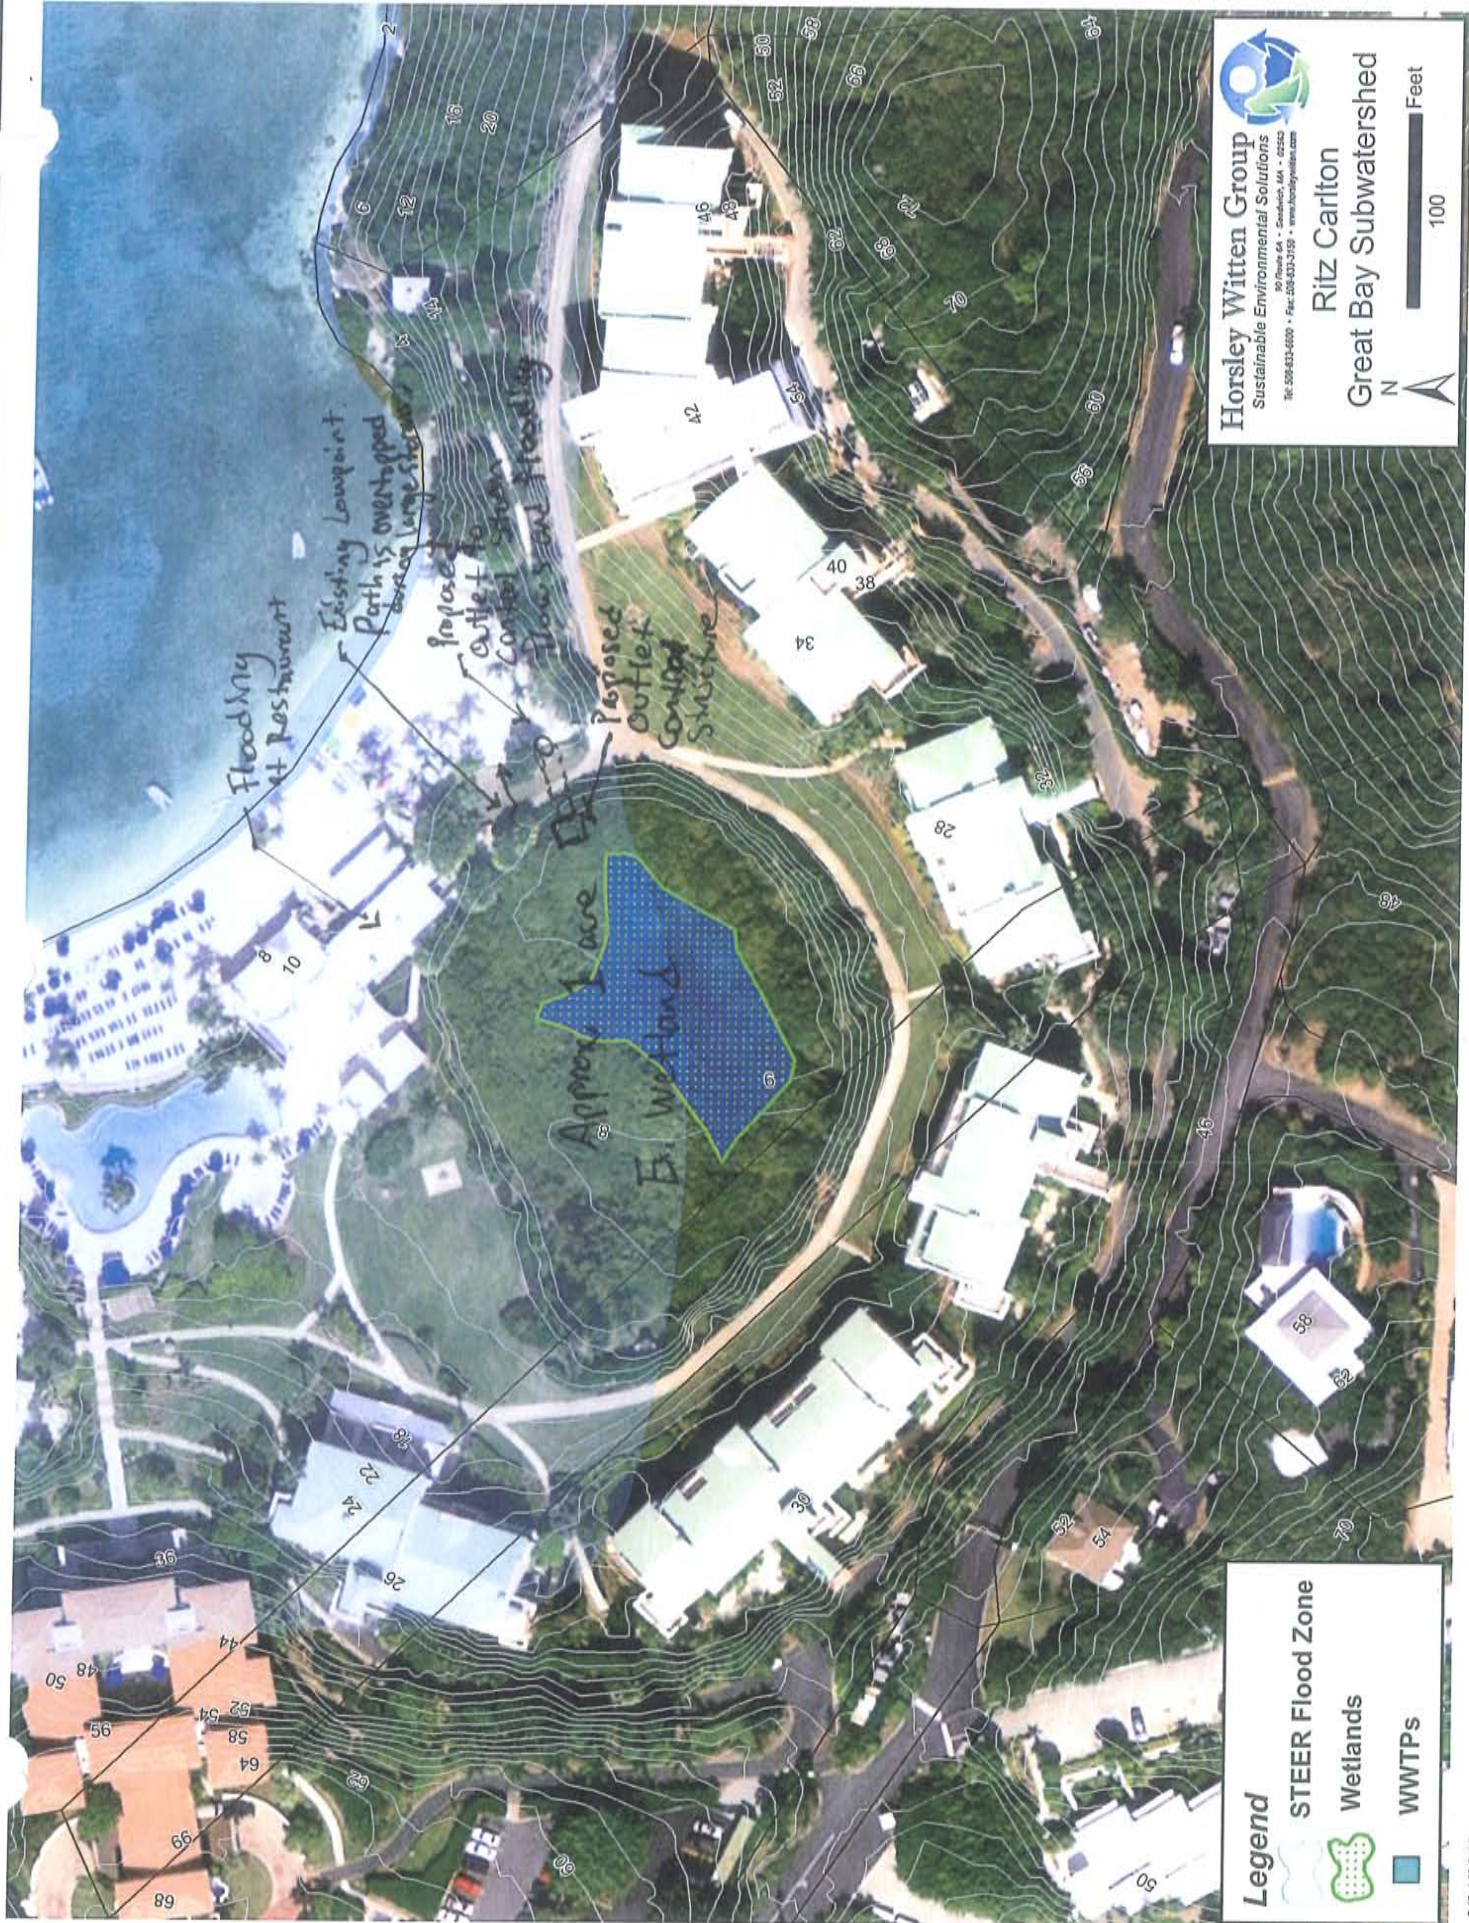
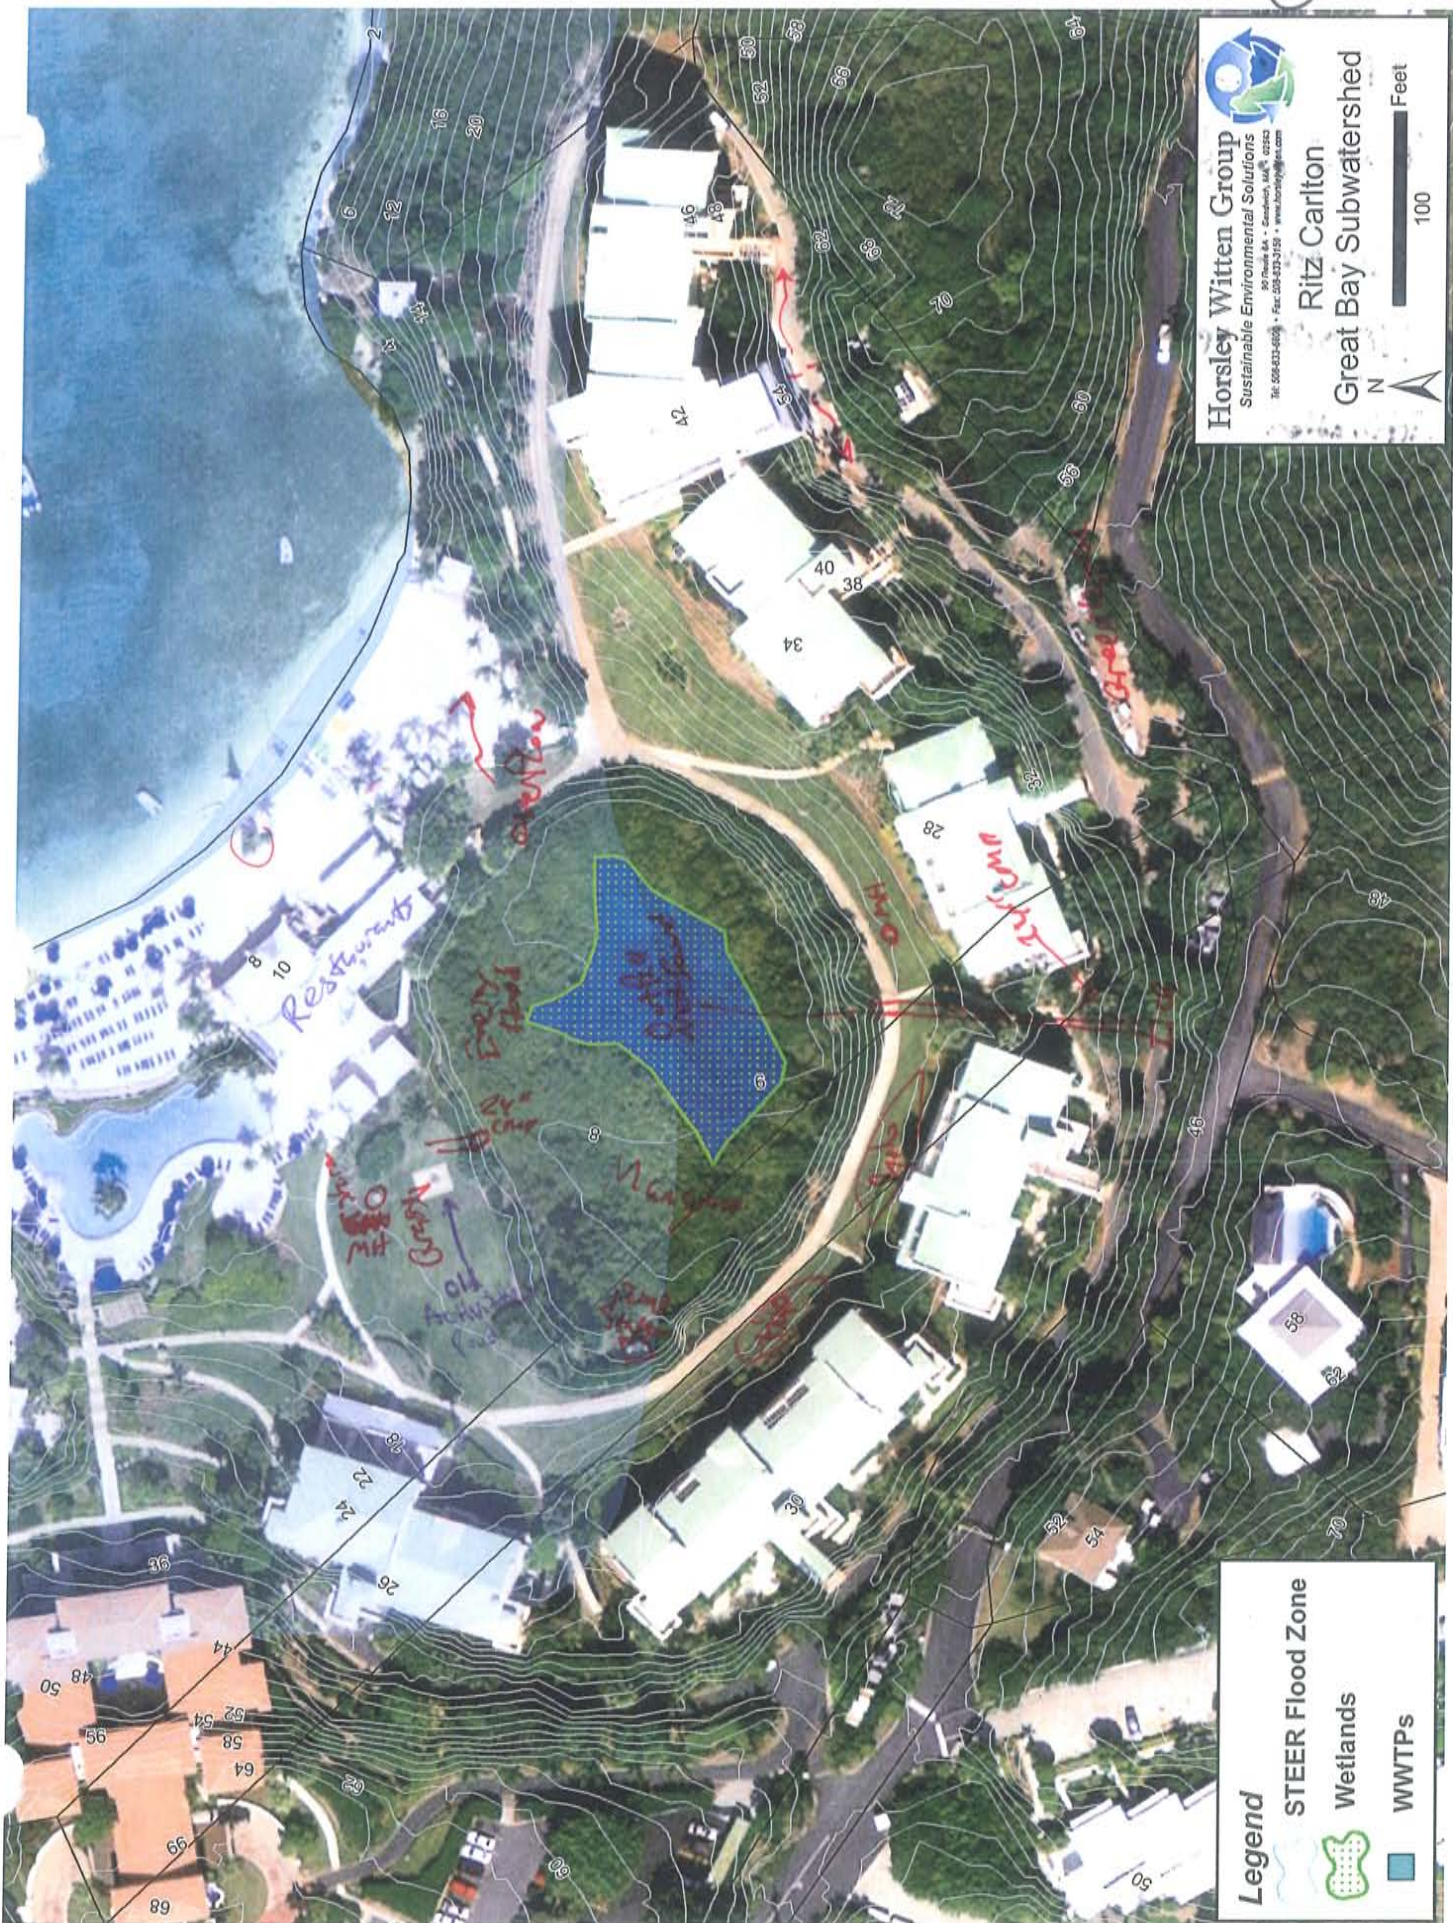
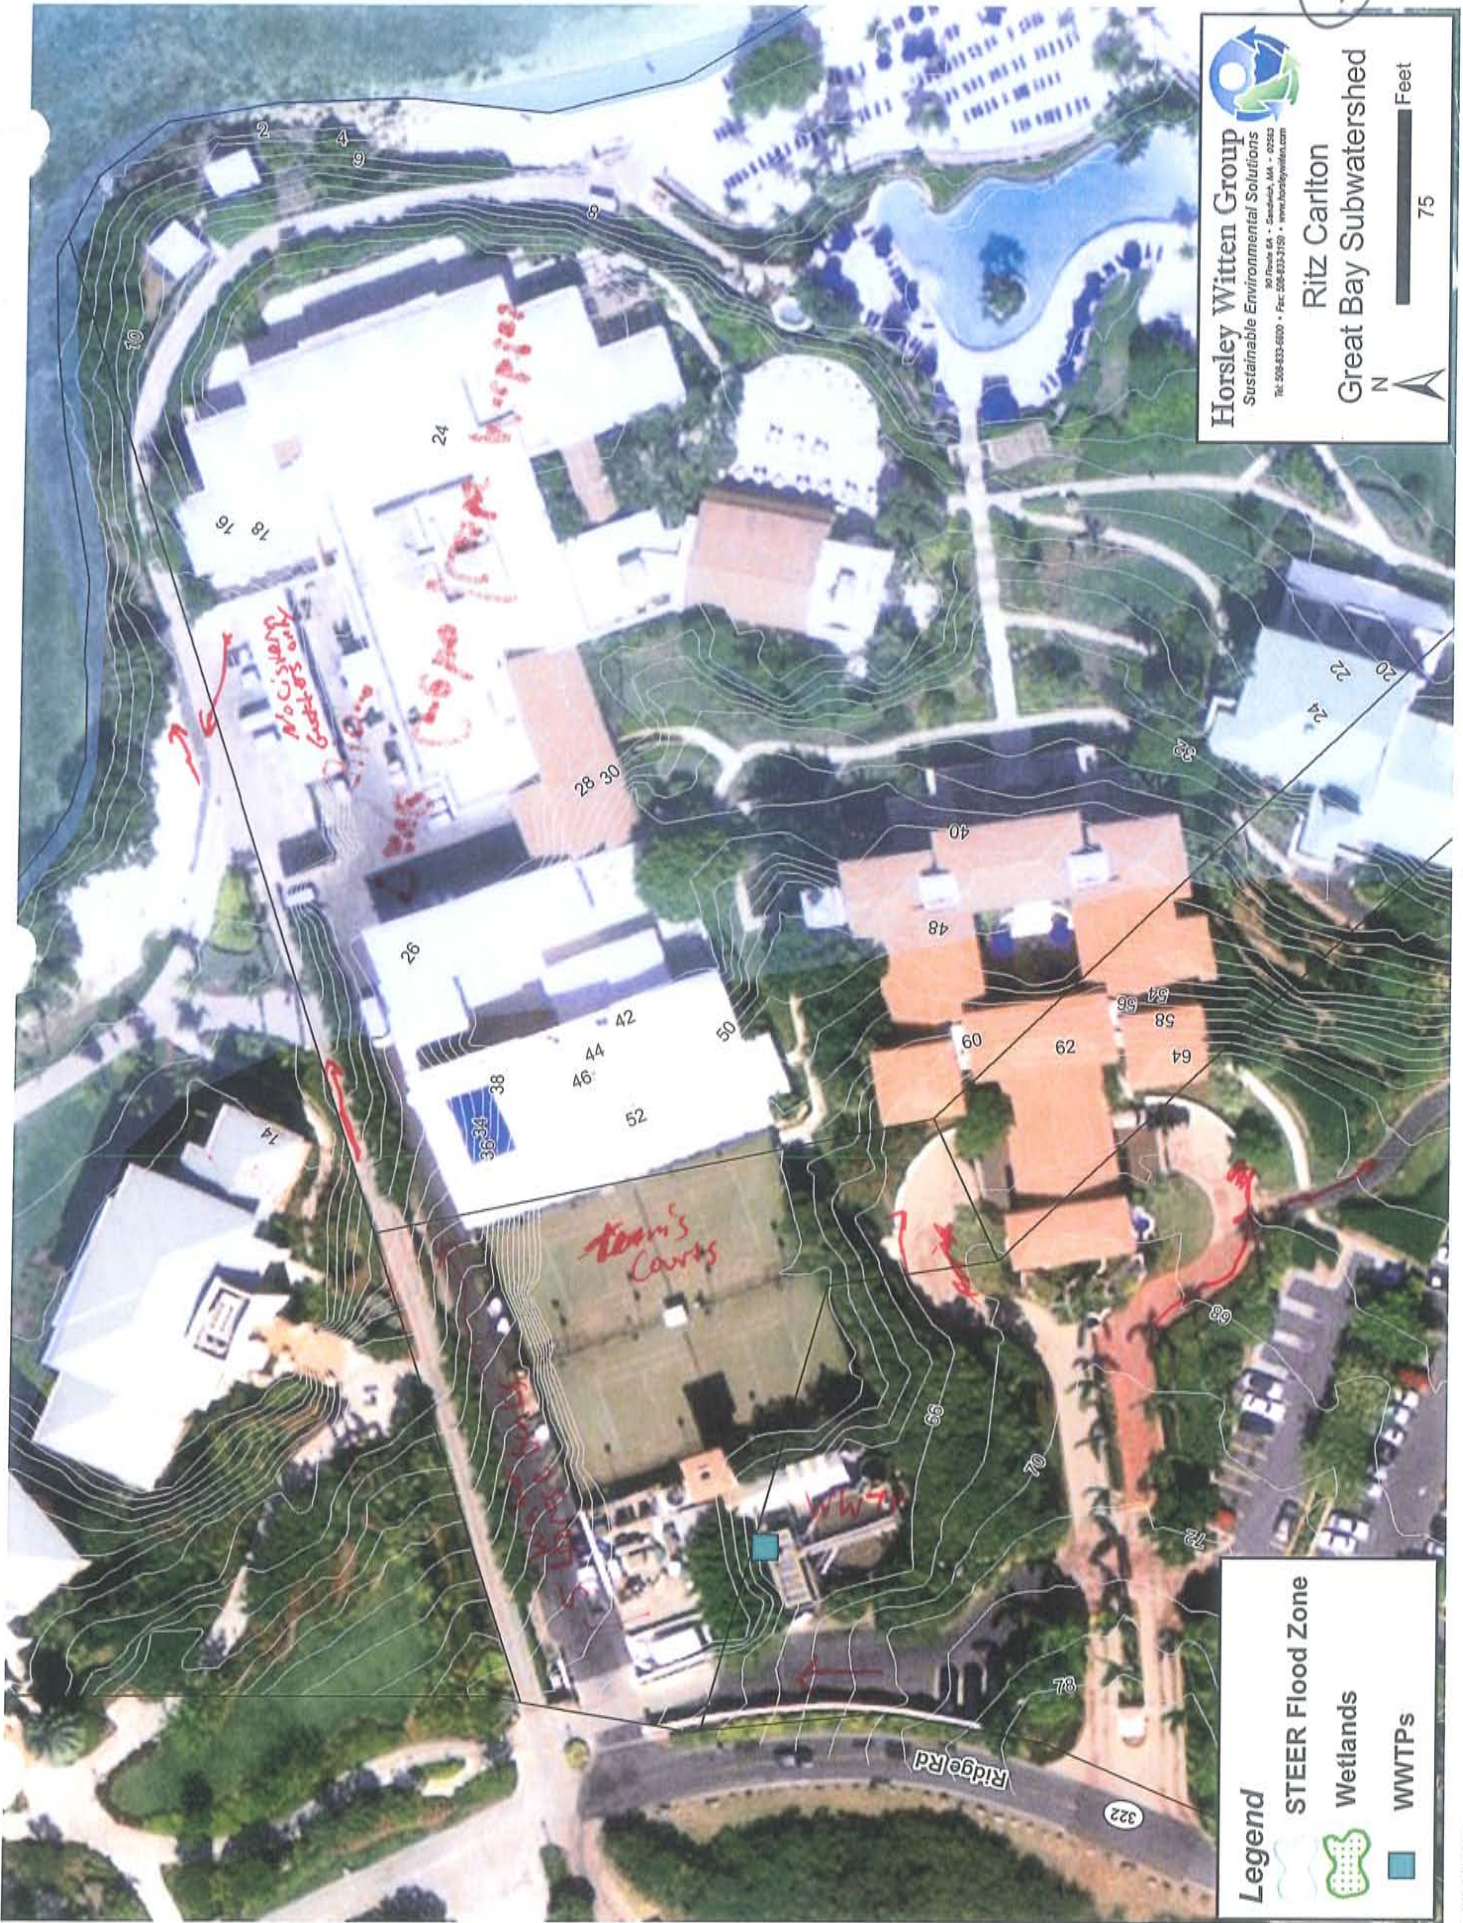
GB-2. The Ritz-Carlton Resort — Drainage Improvements

- Contacts: Mr Kuhler (GM); Dave Gebb (Dir of Eng); Lester Nichols (Asst. Eng); Dudley — (Manager of WWTP Plants)
- Ritz is a ~~Blue~~ Play resort
- Treated RO water is used for toilet flushing
- ~~Roof runoff~~ is not used - flows overland to wetlands
- Restaurant often floods out when wetland overtops
 - ↳ nearly every year -
 - ↳ beach erosion is also an issue when pond overtops - no ex. pond outlet

Engineers were previously discussing adding an outlet to the wetland to stop overtopping
 ↳ they are concerned that beach erosion may result if an outlet (pipe) is installed on the beach

The Ritz-Carlton Resort is located in the Great Bay subwatershed. It lies on an approximate 15 acre beach-front lot. The primary resort facilities such as the lobby, guest rooms, and beach-front restaurant are centrally located around an interior wetland. The majority of the runoff from the immediate surrounding area discharges into this wetland. Ritz-Carlton employees have reported that during large storm events, or about 1-2 times per year, the capacity of the wetland to manage stormwater is exceeded. When this occurs, the wetland overtops and floods the downgradient restaurant. Field investigations suggest that the wetland lacks a primary outlet structure or pipe. Therefore, when the approximate 3-4 feet of storage is exceeded, water spills over the wetland embankment and flows onto and underneath a nearby footpath. Since the restaurant is below the footpath, runoff can easily flow into it.

- Consider bio-retention area installations in the upper parking lot island.
 - ↳ Islands will need to be converted from raised beds to depressions.
 - ↳ Significant tree and vegetation removal would be necessary for bio installations.
- Install culvert at southeast parking lot corner / driveway location to prevent pavement deterioration.
- Existing wetland retrofit - see Site Description memo.

Ritz-Carlton managers were receptive to possible retrofits that would help to reduce the number of instances the restaurant was flooded and consequently closed. To solve this problem, an outlet structure could be installed within the wetland to manage most storm events. Discharges would then flow through an outlet pipe adjacent to the restaurant and ultimately discharge on the beach. Utilizing an outlet structure over a culvert helps to reduce susceptibility to clogging. In addition to this retrofit, opportunities for flow reduction to the

The wetland outlet structure should be sized to accommodate flows for up to the 25-year recurrence interval storm event. The total drainage area to the site is approximately 10.5 acres with 35% impervious surface. The wetland currently offers about 5,000 cubic feet of volume for attenuation. A primary design consideration for this project is where to locate the proposed outfall. It will have to be placed in a location that is effective for drainage and will not contribute to beach erosion. Resort managers are also likely to want it placed in a hidden location, away from beach goers.

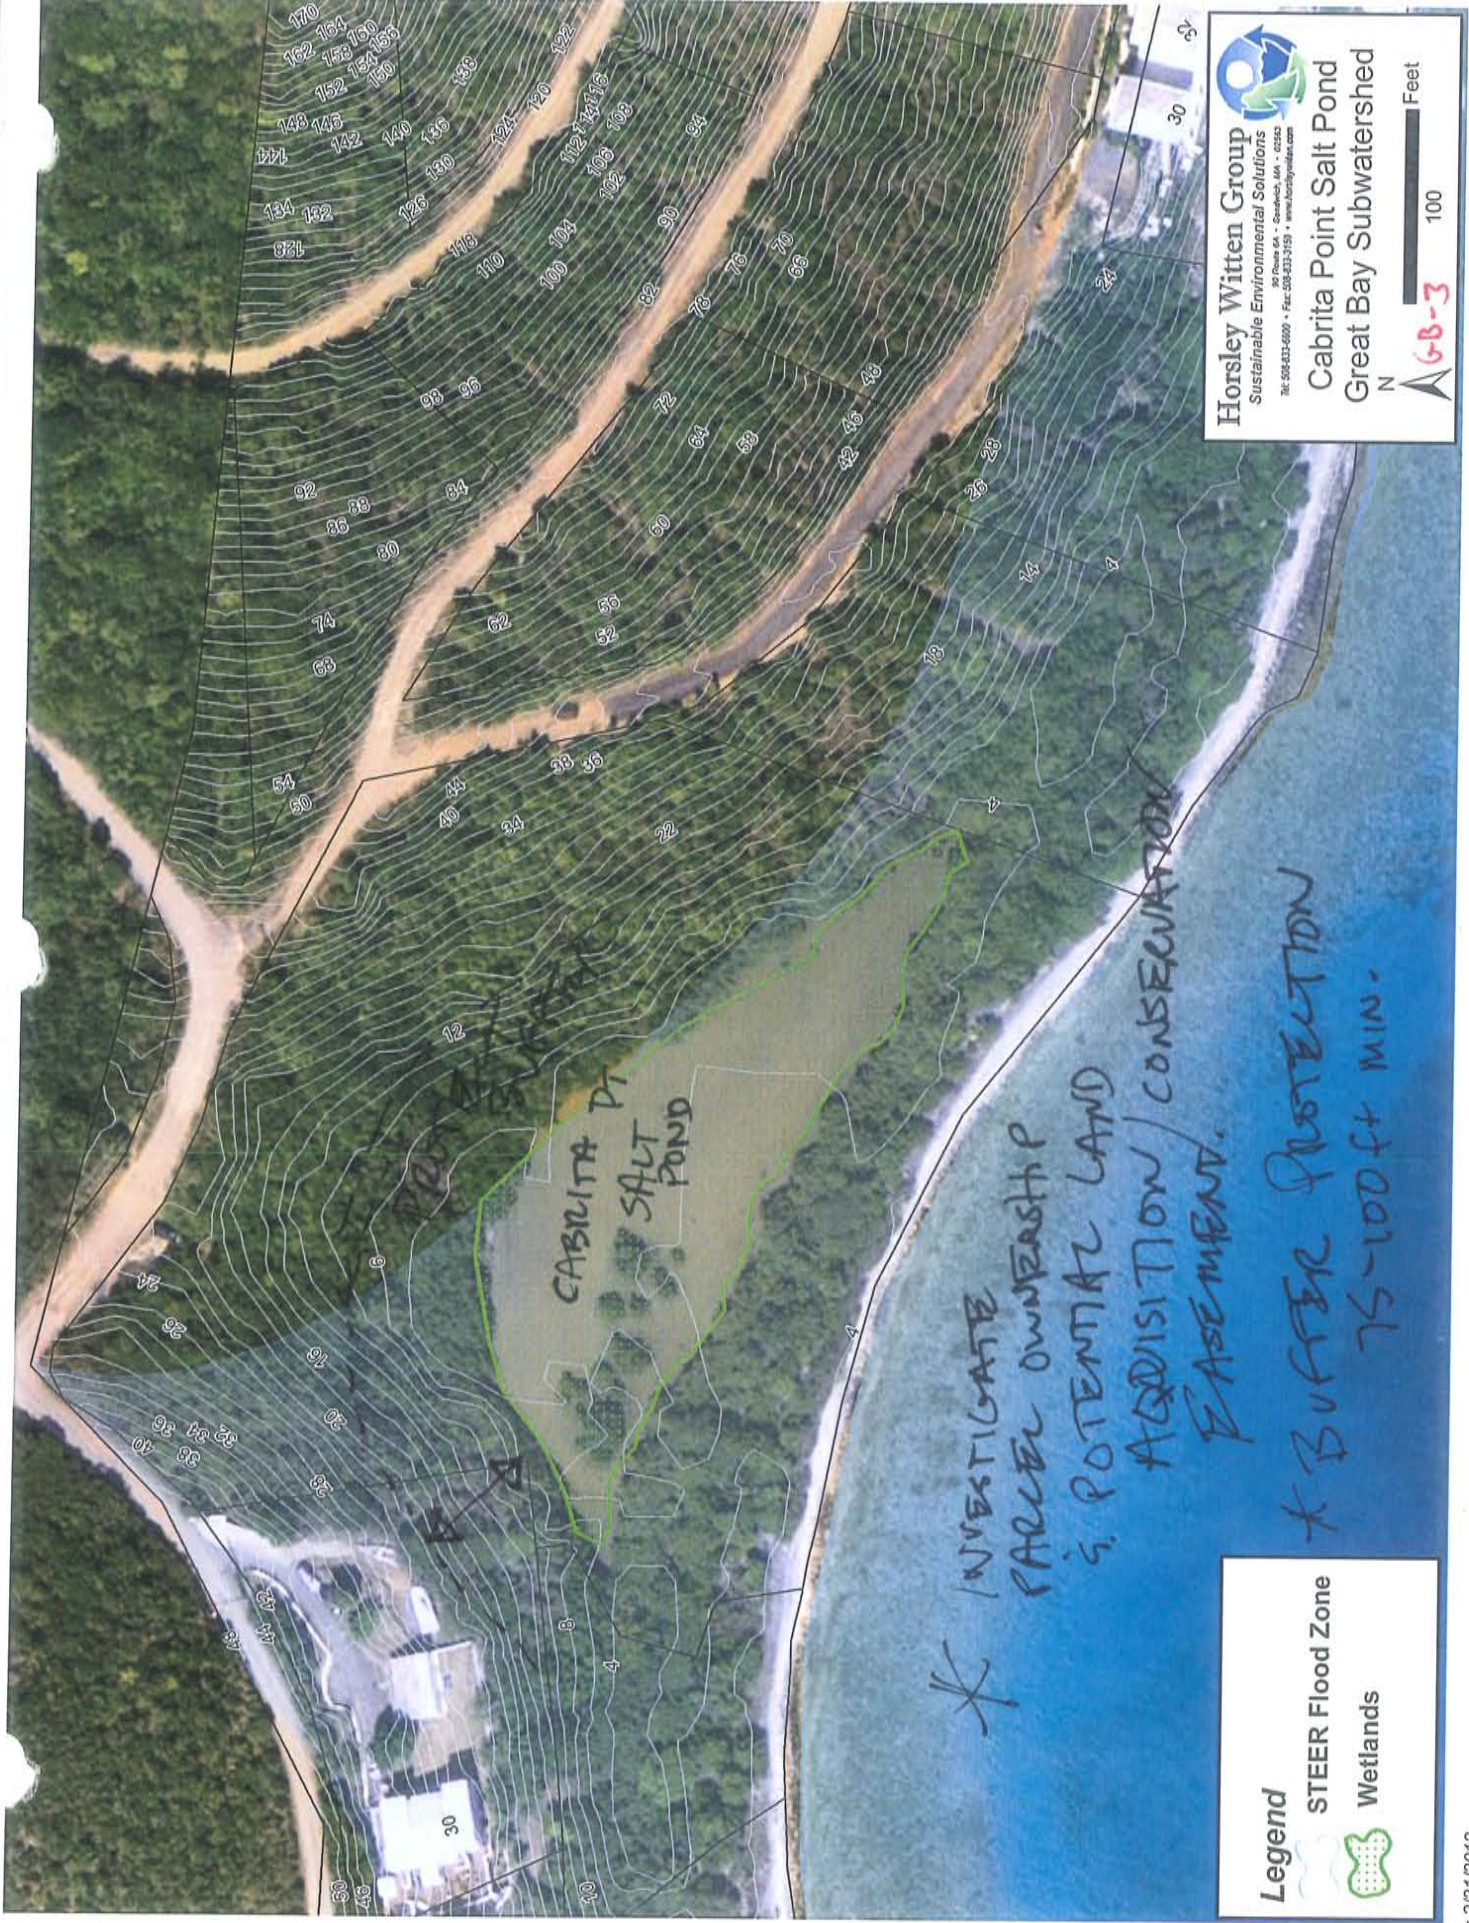
**6B-3**
 Feet

Called out in DFW Wetlands Conservation Plan — one of last remaining salt ponds that hasn't been impacted.

- ① investigate land acquisition options
- ② apply WQ criteria for new dev.
- ③ enforce additional buffer req.

* INVESTIGATE
 PARCEL OWNERSHIP
 & POTENTIAL LAND
 ACQUISITION / CONSERVATION
 EASEMENT.

* BUFFER PROTECTION
 75-100ft MIN.
