## STX EE WATERSHEDS

## RETROFITS

Site Name/ID: TB-R-1 (Eastend Beach Parking) Watershed: League  
 Date: 1/24/2011 Assessed by: RAC ALG

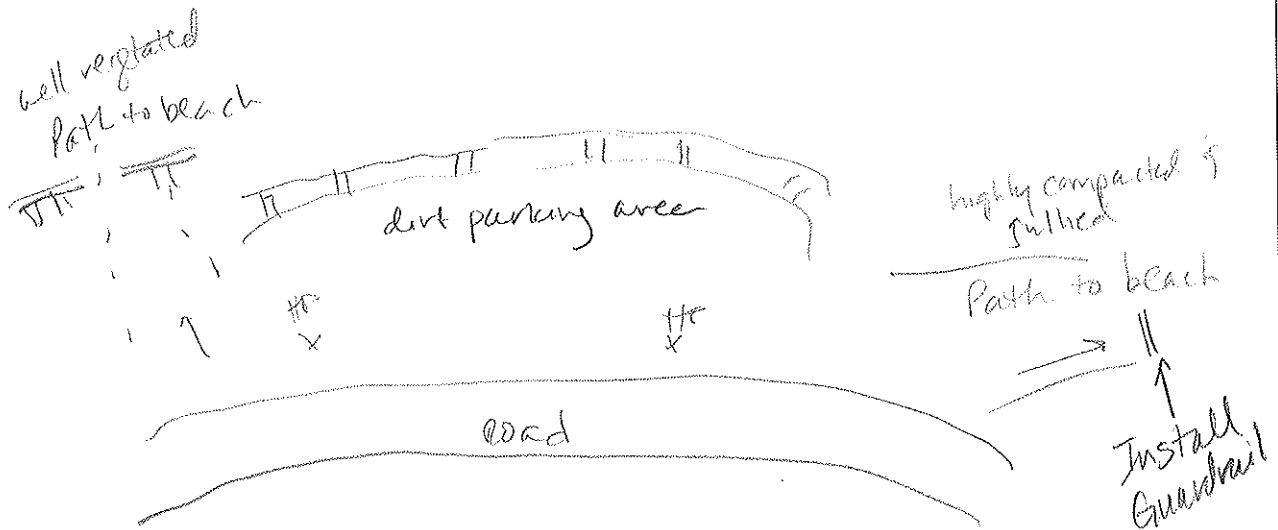
Informal parking w/rusted guardrails - gravel/dirt parking w/erosion gullies leading to beach

insert guardrail at entrance to eastern<sup>beach</sup> access road to  
restrict vehicle access so soils can stabilize and vegetation restored

fill in gullies

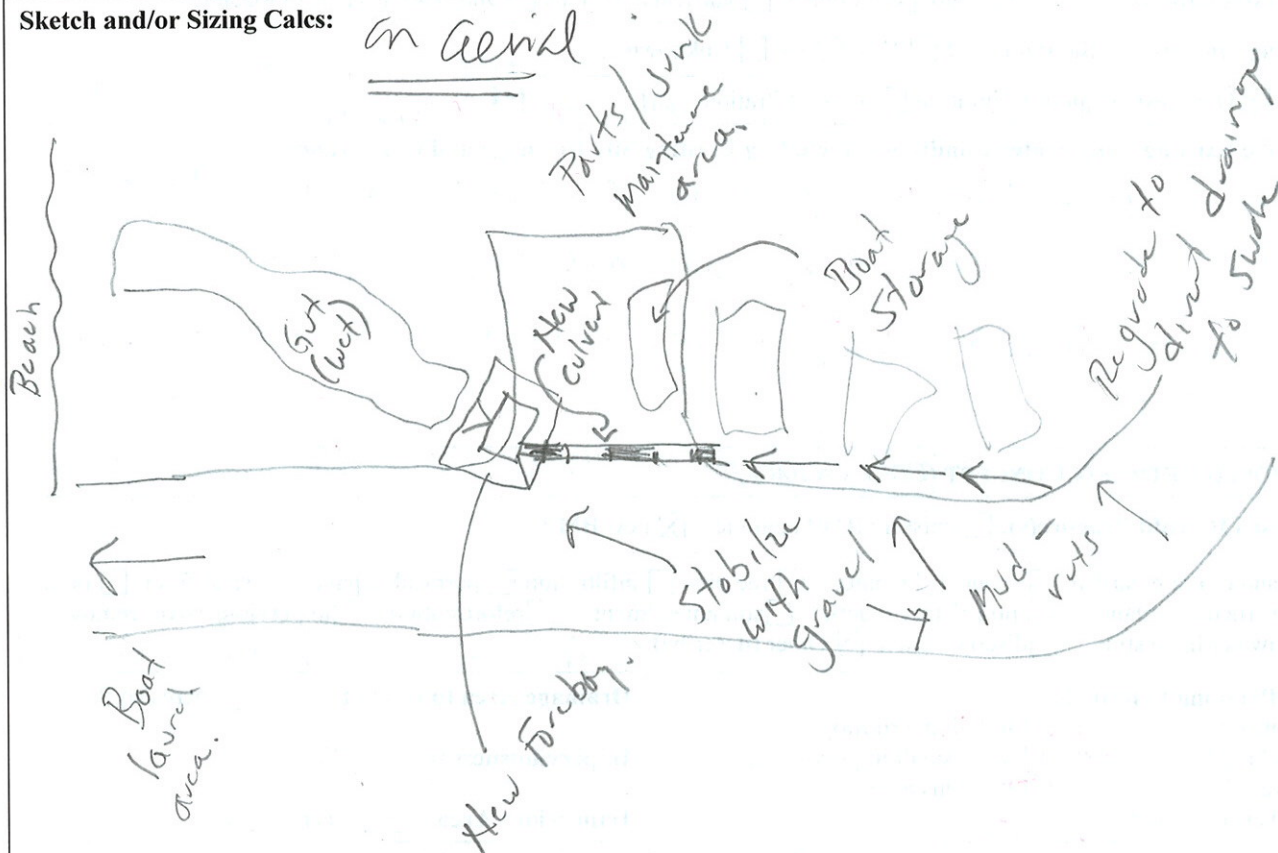
drains from boat storage area overland to gut-like area  
 gully, erosion tree roots are highly gullied  
 -some trash & debris in wooded areas surrounding/drainage to  
 gut

restore eroded area/ruts downgradient of boat storage with gravel. Construct ditch to facilitate runoff flow into a constructed wetland/forebay area adjacent to existing gut.

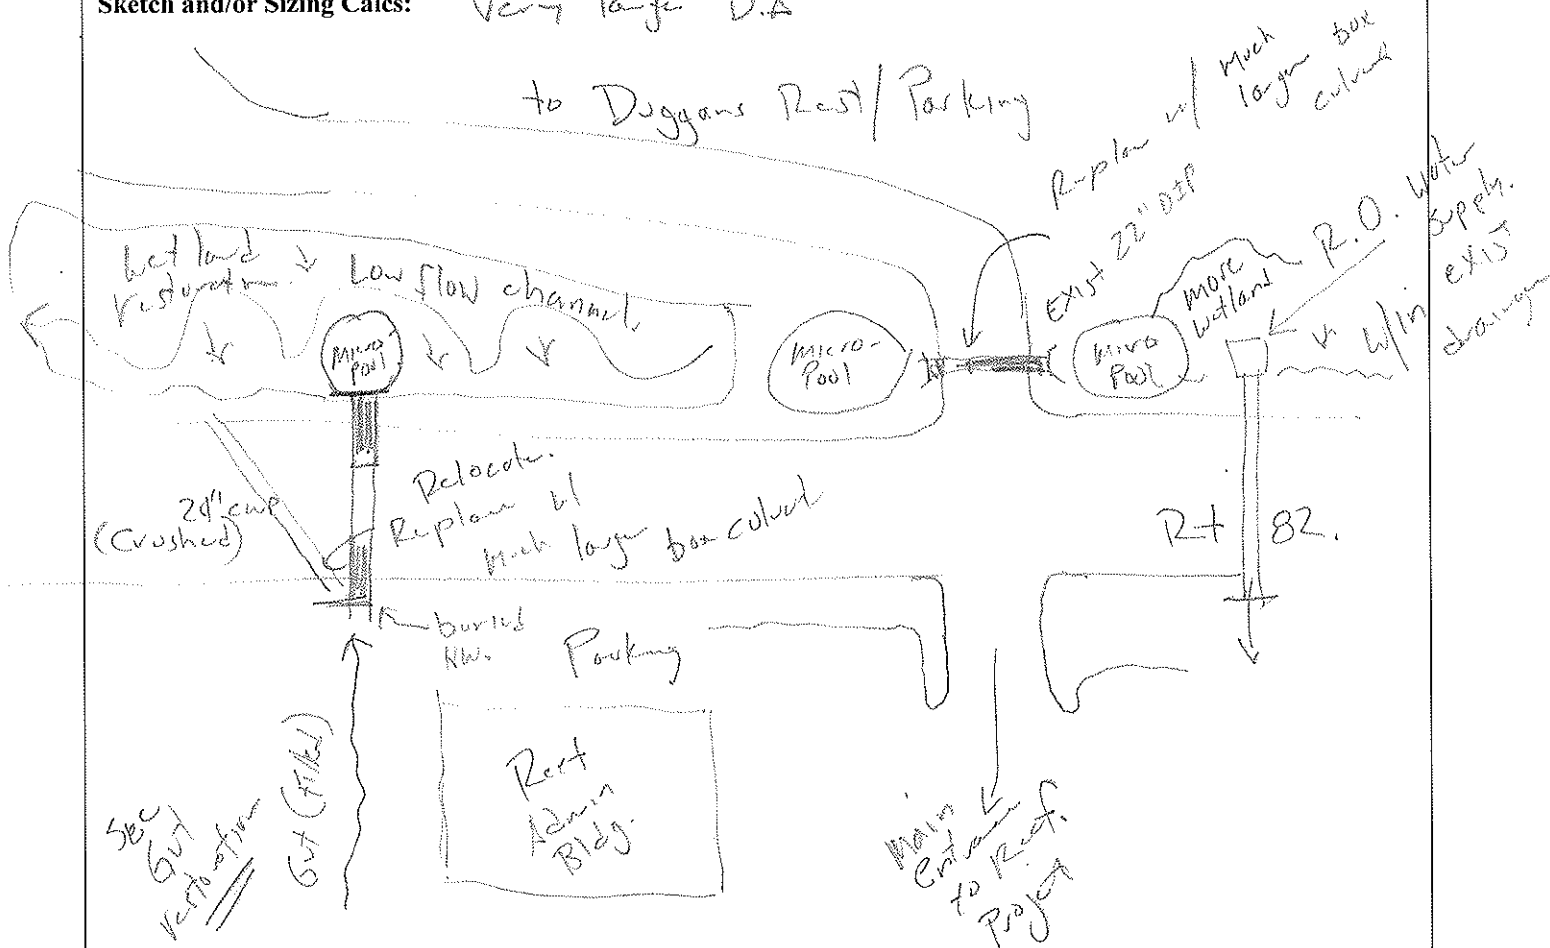
Conveyance Issues.

- Re-plan culverts
- Micro pools
- low flow channels
- wetland marsh

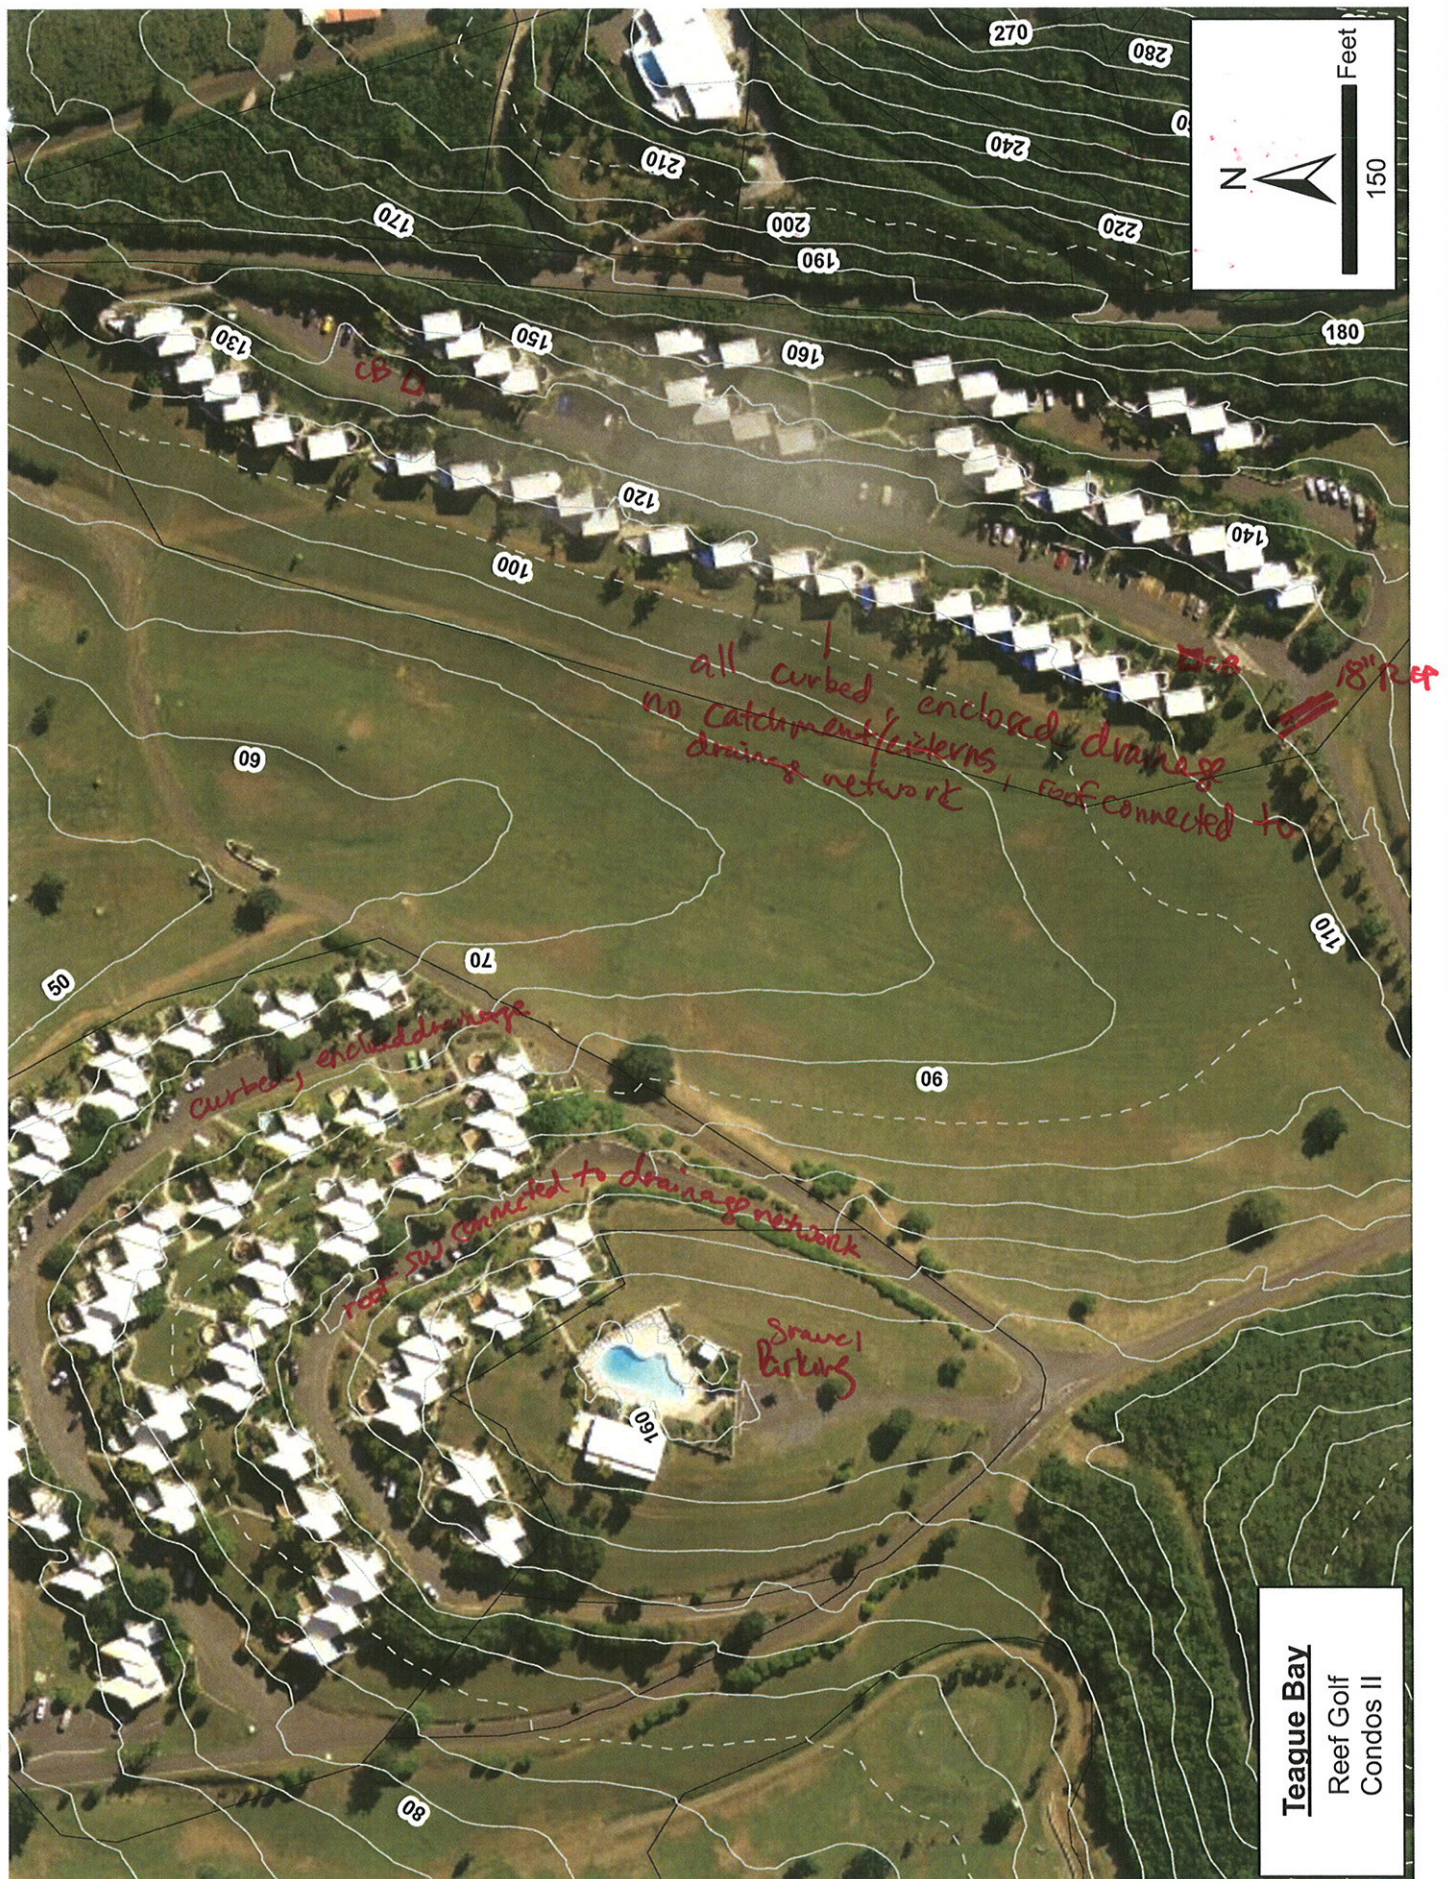
TB-GR-1 / TB-RC-1

Ponds finally had conc/plastic liners ~~to~~ installed in 70s  
↳ feed into each other

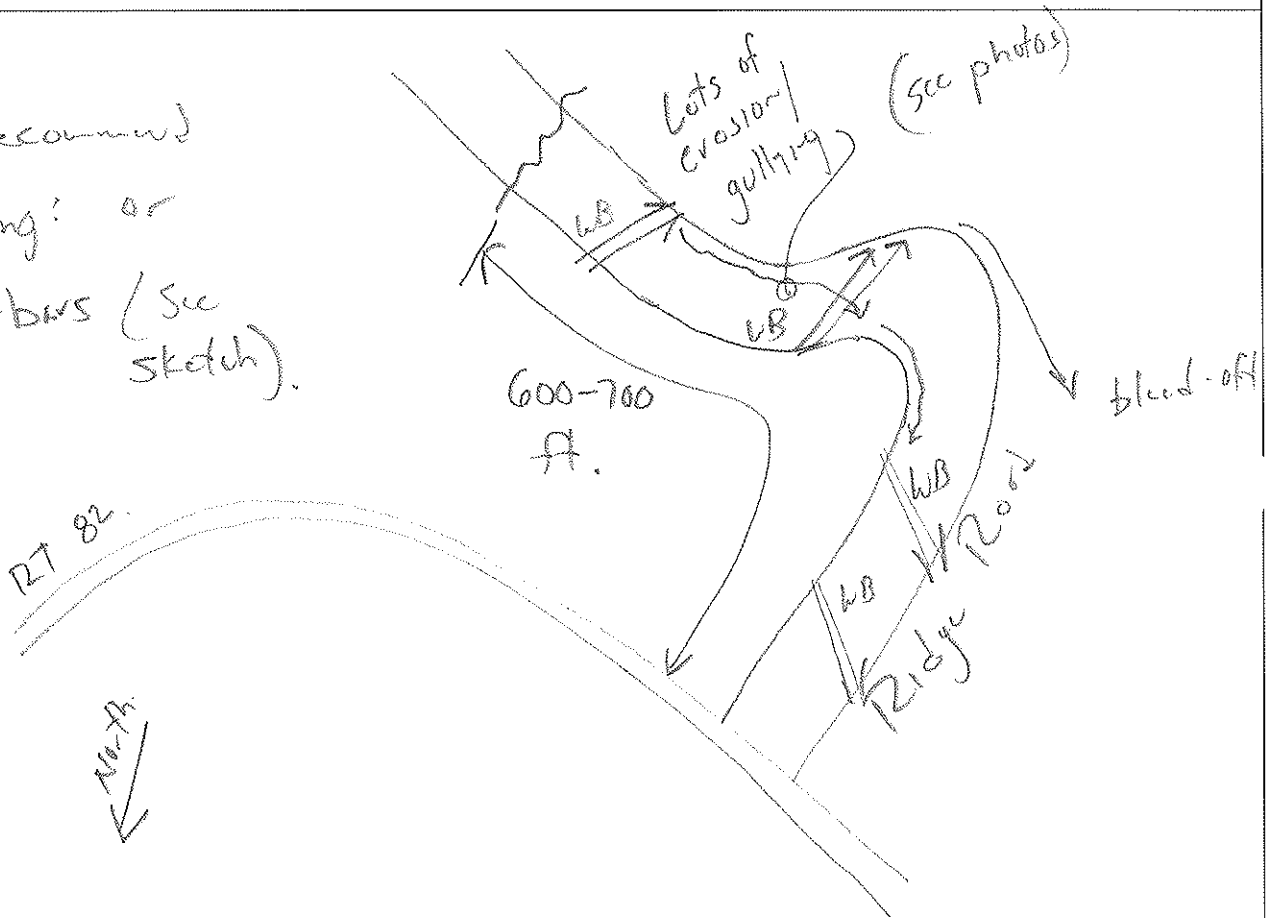
<b>SEVERITY OF PROBLEM:</b> <input type="checkbox"/> High <input checked="" type="checkbox"/> Med <input type="checkbox"/> Low (Explain): <u>Note. Significant sediment load.</u>				
	<b>POTENTIAL FOR SEDIMENT LOADING TO RESOURCE AREA:</b> <input checked="" type="checkbox"/> HIGH <input type="checkbox"/> MED <input type="checkbox"/> LOW				
	<b>DESCRIPTION OF EXISTING CONDITIONS:</b> <u>large gullies and erosion on first segment of Ridge Road off Rte 82 - sediment washing down toward main road.</u>				
<b>NEXT STEPS</b>					
<b>Potential Repair Candidate?</b> <input checked="" type="checkbox"/> YES <input type="checkbox"/> NO <input type="checkbox"/> OTHER:					
<b>CONTACT</b> <input type="checkbox"/> DPW; <input type="checkbox"/> LANDOWNER <input type="checkbox"/> HOA; <input type="checkbox"/> OTHER:

Candidate for paving - water bars as an option

Recommend  
Paving? or  
water-bars (see  
sketch).
