Response to Physical Impacts on Coral Reefs in Puerto Rico and the USVI

2020 Report

Pre-Assessment for Earthquake Damage to Coral Reefs in La Parguera, Guanica and Guayanilla Puerto Rico

February 26-28, 2020

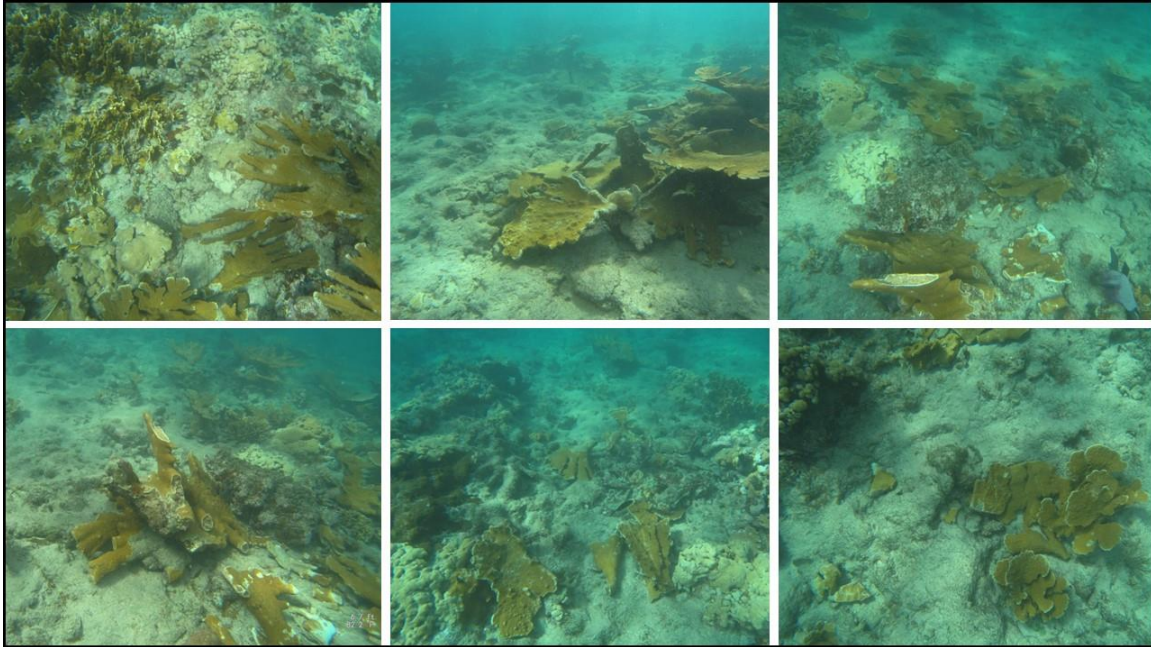
Figure 1: Coral reef damaged caused by 2019/2020 earthquakes in Puerto Rico. Photos by Sea Ventures Marine Response Unit

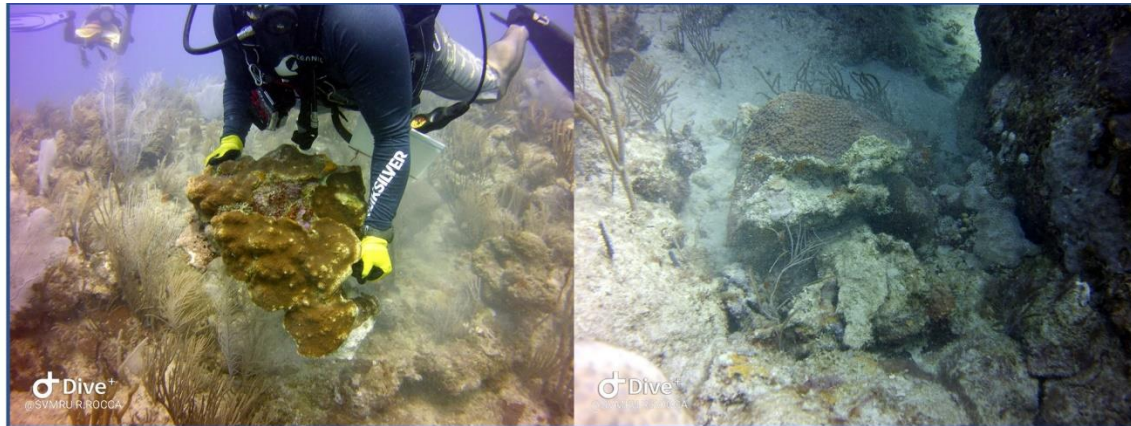
Guilligans PM, Guanica

At Guilligans PM, there are hundreds of corals that appear to have been shaken loose by seismic activity (Figure 3). Hundreds of loose corals were observed in the survey, mostly *Montastraea cavernosa*,

Dendrogyra cylindrus and *Orbicella* spp and it is likely that there is similar damage in the area outside of the survey track. Most loose corals are face up and temporarily stable, and 10 were turned face up and temporarily stabilized.

Figure 3: Loose and broken corals observed at Guilligans PM during earthquake damage pre-assessment surveys.

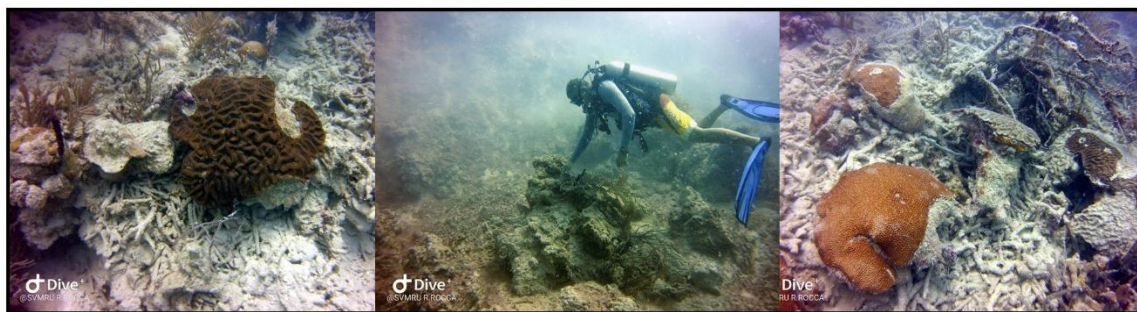
Enrique, La Parguera

At Enrique, a collapsed ledge (Figure 4) and hundreds of loose corals were observed. While approximately 100 loose corals were surveyed, mainly *Orbicella* spp, *Colpophyllia natans*, *Dendrogyra cylindrus*, *Diploria labyrinthiformis* and *Pseudodiploria* spp., approximately 140 additional corals were turned upright and temporarily stabilized. Most loose corals were less than 50 cm, but about 20 of the surveyed *C. natans* were between 50 and 100 cm. Damage was observed throughout the 1,750 m² (350 m x 5 m) of reef surveyed. There are likely hundreds more loose corals spread out over a large area at this site. While corals buried in the ledge collapse are not likely to be salvageable, many corals at this site appear to have collapsed a short distance into an upright position and are loose but in good condition.

Figure 4: Photographs of damage observed at Enrique.

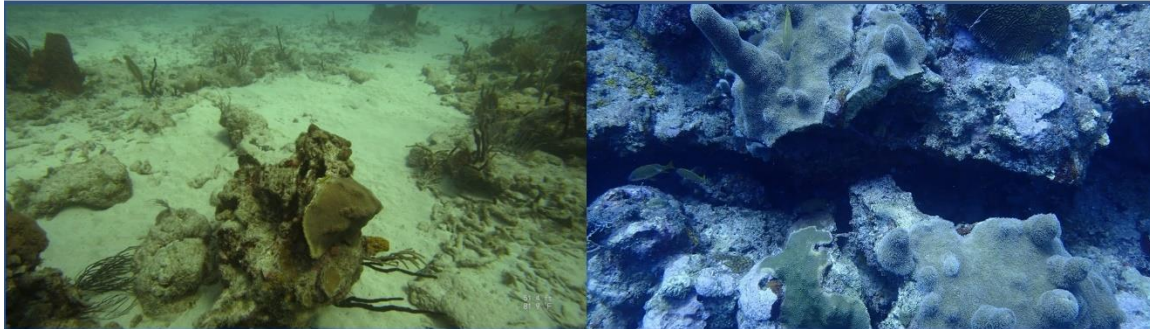
Andrea, Guanica

At Andrea, cracks were observed on the spurs near the sand channel. Some slabs have collapsed and are resting in the sand (Figure 5). Approximately 65 corals between 20 and 50 cm, mainly *Orbicella* spp, *Montastraea cavernosa* and *Dendrogyra cylindrus*, were surveyed on these collapsed slabs. The slabs are relatively stable but could be moved by a major storm surge, threatening the corals.

Figure 5: Damage observed at Andrea during earthquake damage pre-assessment surveys.

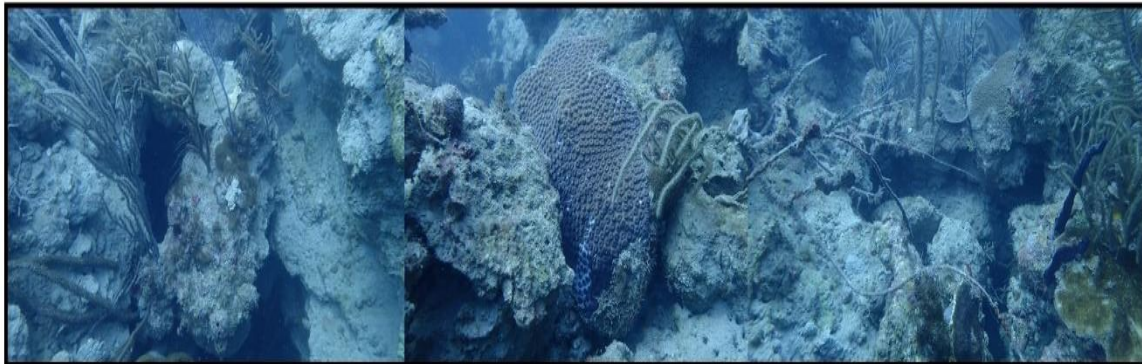
Tito, Guayanilla

A large crack approximately 100 meters long and an average of 1 meter wide was observed. Approximately 40 loose corals were observed. Most were attached to larger slabs and face up. 5 loose colonies were turned face up and stabilized. Triage potential is low at this site because it is too deep to work safely, and most corals are stable.

Figure 6: Damage observed at Tito's during earthquake damage pre-assessment survey.
