# Response to Physical Impacts on Coral Reefs in Puerto Rico and the USVI

## 2016 Report

### Damage to *Acropora palmata* Thickets in Guanica, PR after Hurricane Matthew

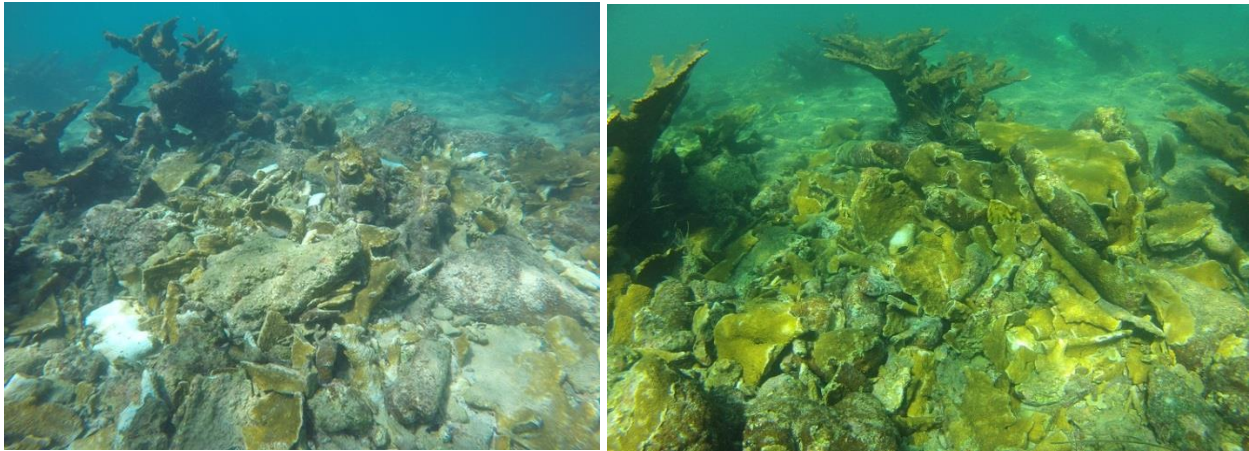
Hurricane Matthew passed south of Puerto Rico in October 2016 generating large swells that impacted the south coast including 1.2 km of reef in Guanica with large numbers of the ESA listed elkhorn coral, *Acropora palmata*. This sub-population is one of the few remaining large stands of *A. palmata* on the island. The large waves caused extensive damage to many of the colonies and generated tens of thousands of coral fragments (Figure 1). Many of these fragments that land on hard substrate and are stable have a good chance at survival; but the fragments that end up in sand and sea grass or are loose and unstable will likely perish through abrasion and smothering. NOAA's Restoration Center with support from its support contractor, Sea Ventures, began an effort on October 26 to actively stabilize at-risk storm generated fragments to increase the number of corals that will recover from this event. Over the course of several weeks, approximately 8,500 at-risk fragments were rescued. Fragments were stabilized *in situ* as well as transplanted to 10 other reefs to assist population recovery in those areas. Fragments were also brought into 5 different coral nurseries to assist coral propagation efforts in the area.

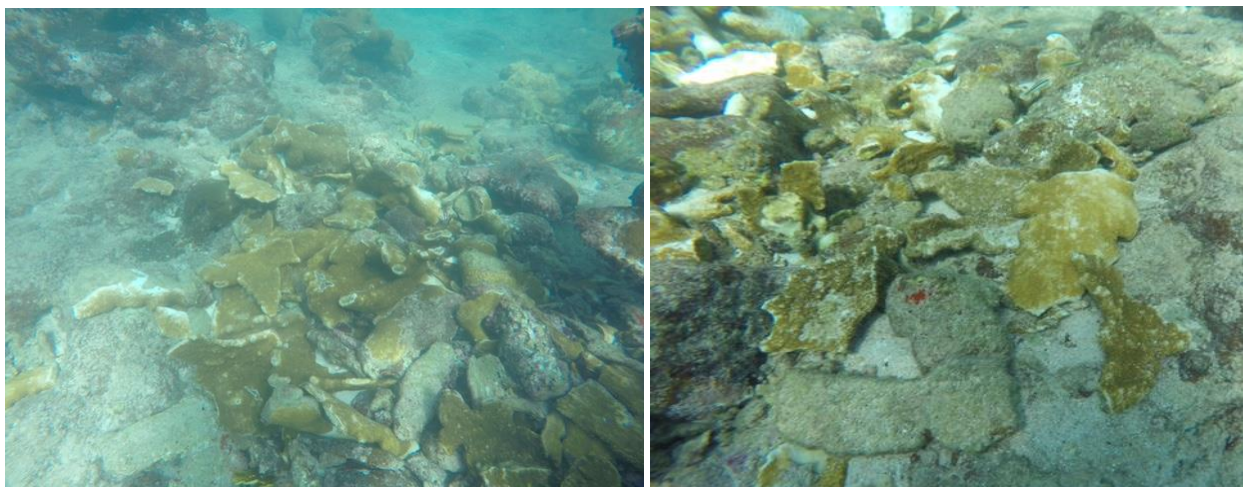
**Figure 1: Fragments of *Acropora palmata* in Guanica, PR after Hurricane Matthew.**
