# Río Loco Structure #1 Removal (El Tren)

## Task #5 Progress Report

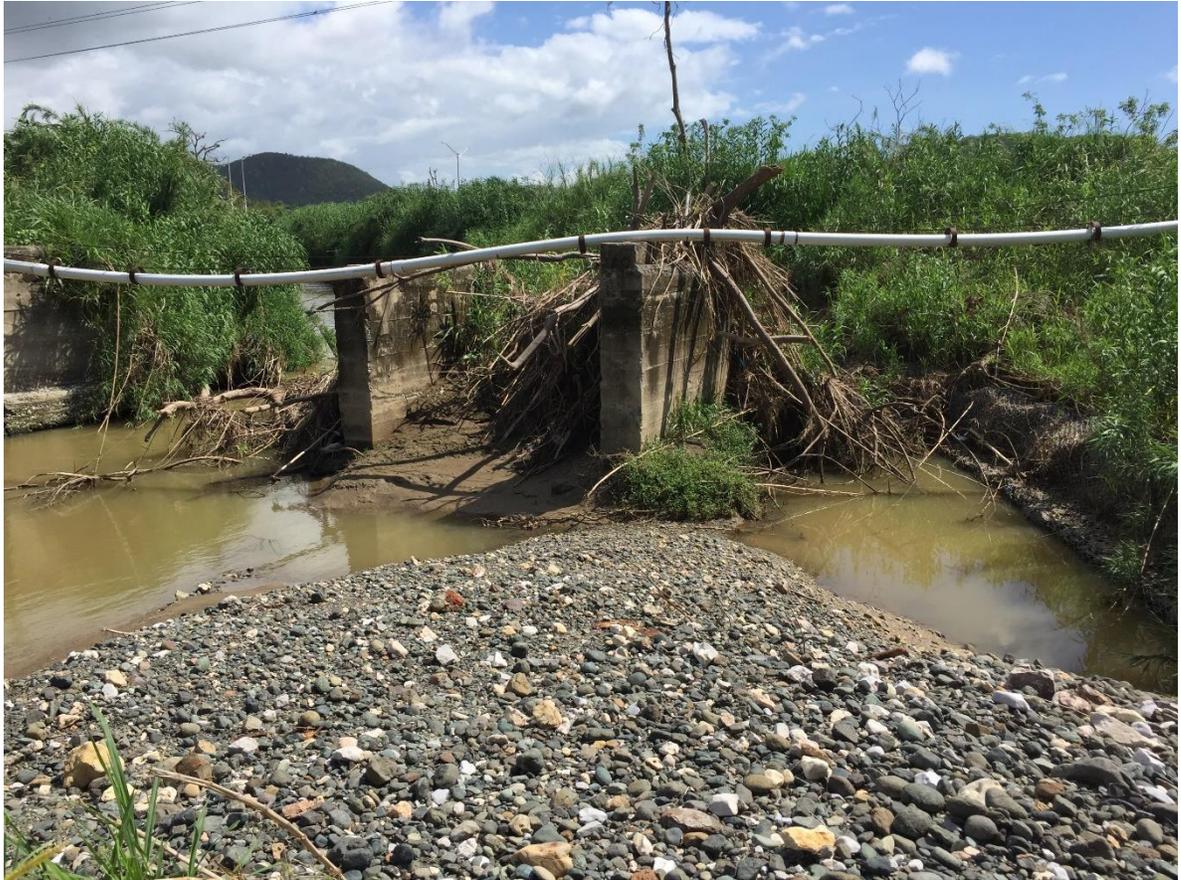
required significant effort to break and tear down. Two of the 5 structures had suffered severe damage and had fallen to the banks, while the remaining 3 represented a threat to a river bank restoration project completed by NRCS at this site.

Figure 4. Project site with abandoned railroad crossing piers prior to removal.

A total of 4 concrete pillars were removed from the river bed with heavy equipment that included a backhoe, a skid steer with hammer, and crawler dozer. All of the concrete debris was collected into 3 dump trucks and transported for proper disposal. Below we include photographs for reference (Figures 4-9). The measures taken will help restore the conditions of the Río Loco river bed, reduce the amount of erosion taking place, and therefore, reduce the amount of sediments being transported downstream and reaching coastal and marine environments associated with the Guanica watershed. The implementation of this project will help reduce the erosive forces previously observed by the presence of these manmade structures. Their removal will ultimately improve the water quality and health of the coral reefs systems, not only by reducing sediment loads but also by reducing the impact caused by the presence of debris that had accumulated by the structures.

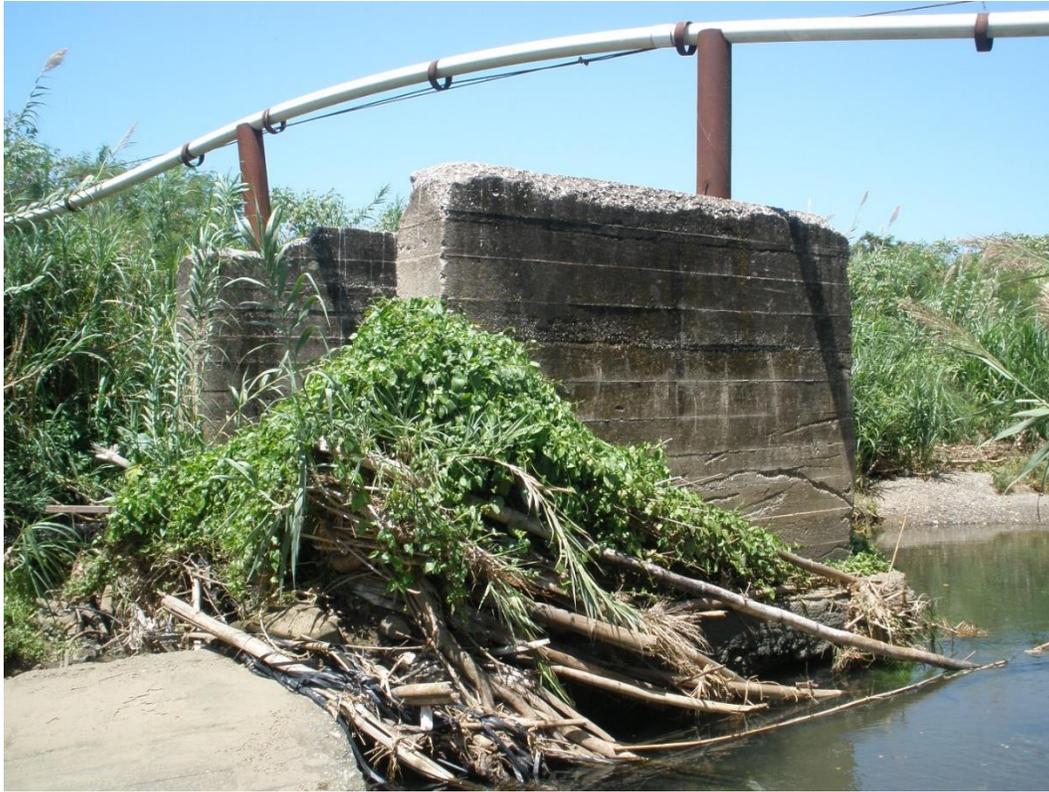
Figure 5. Project site with abandoned railroad crossing piers prior to removal.

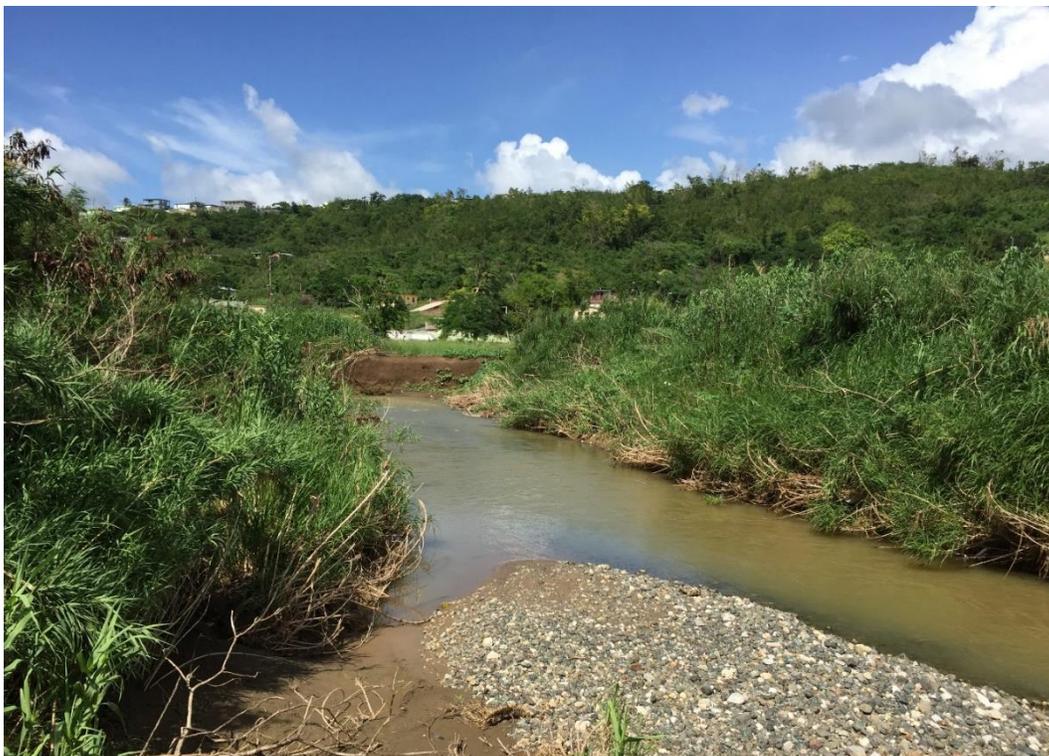
Figure 6. Project site prior to project implementation.

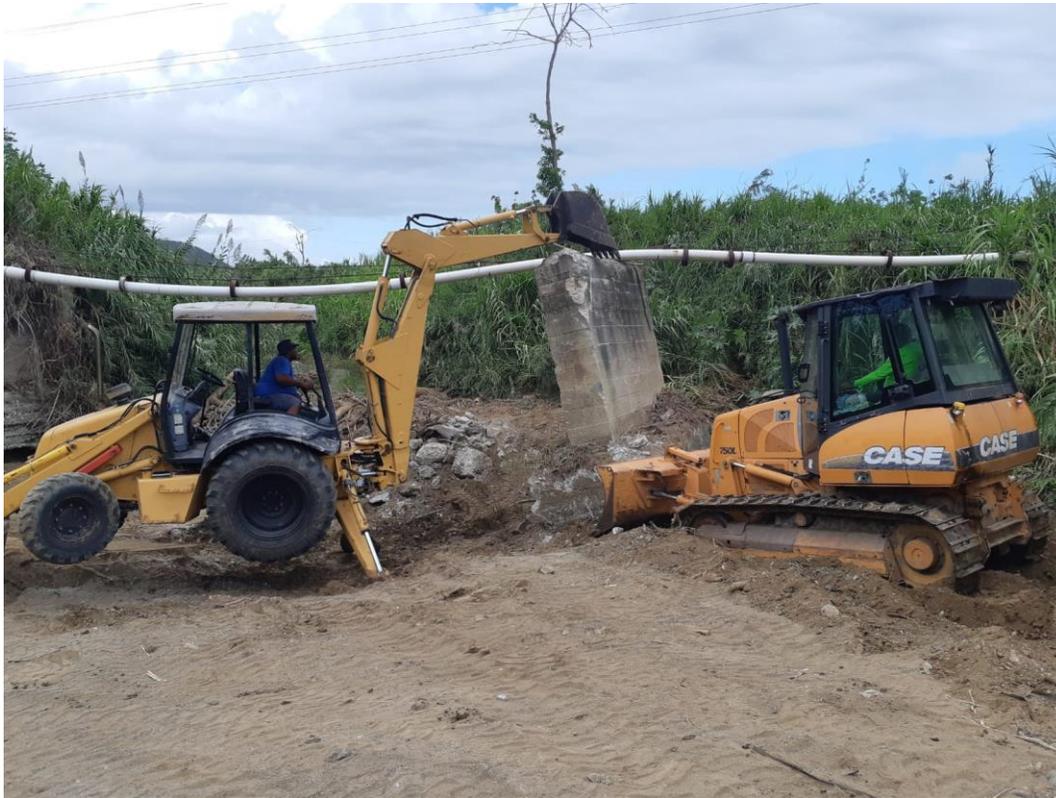
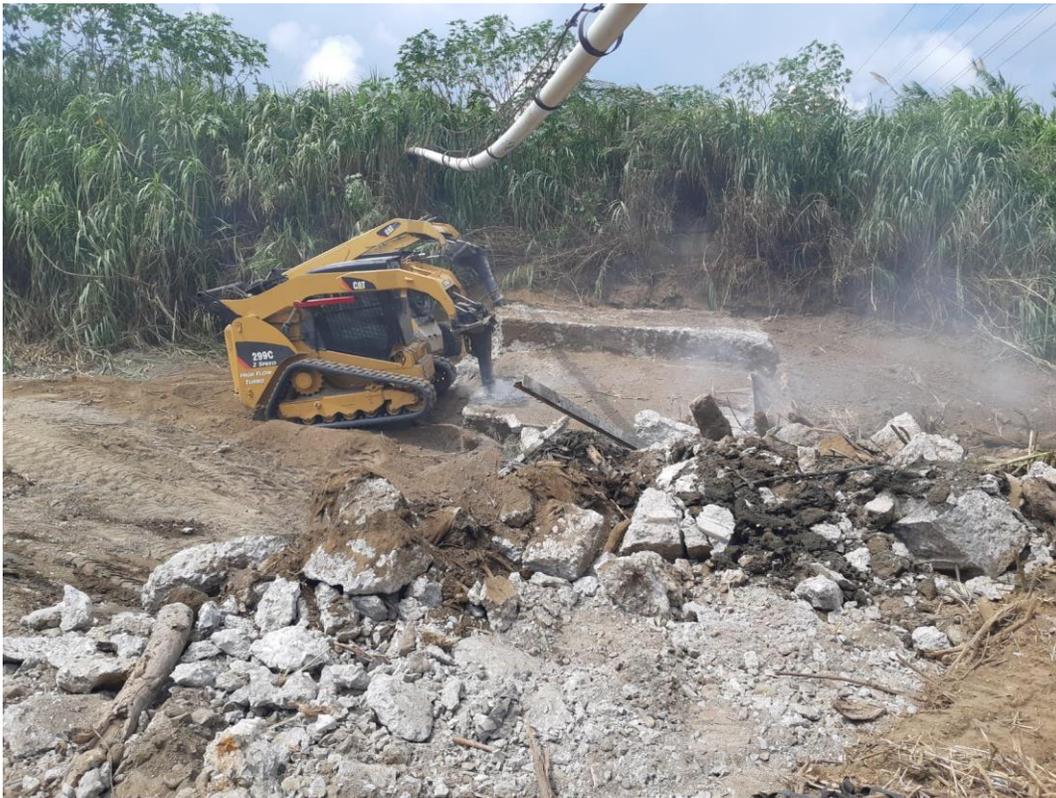
Figure 7. Project site during structure removal.

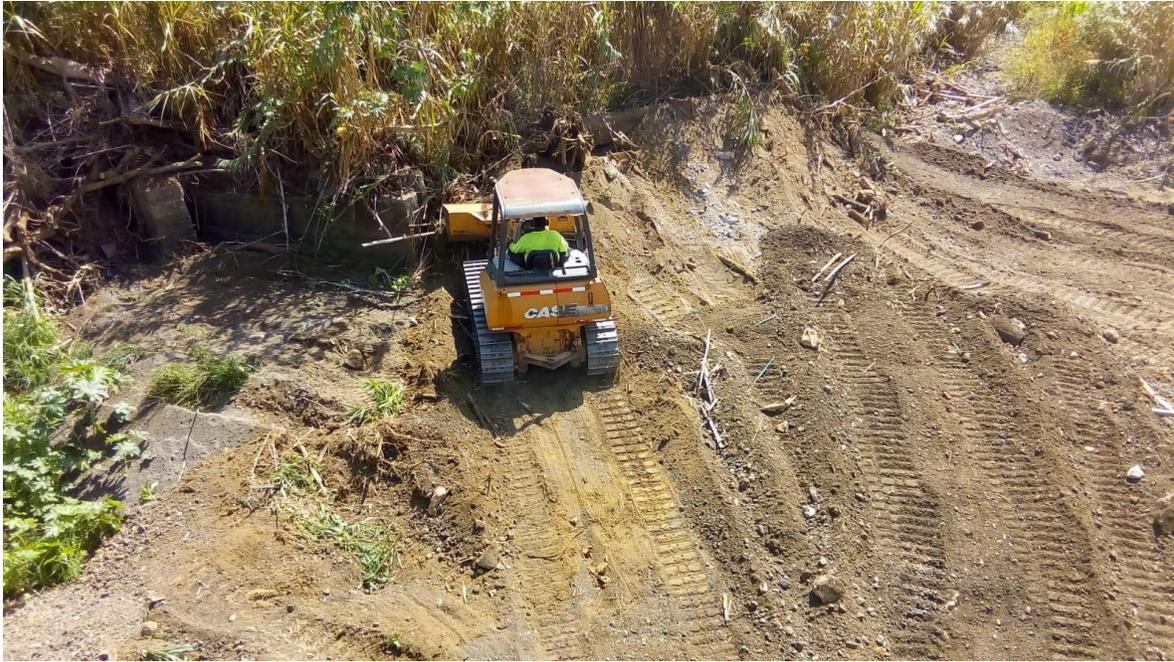
Figure 8. Project site during completion of structure removal.
