MEMORANDUM

To: Lisa Vandiver (NOAA)
From: Geoffrey Glover and Brian Daley (HW)
Date: December 13, 2018
Re: Assessment of green cay headcut stabilization project and recommended repairs
cc: May Cornwall Adams, Rudy O'Reilly (NRCS), Julie Wright (NRCS), JP Oriol (CZM), Marlon Hibberts (NOAA), Rob Ferguson (NOAA)

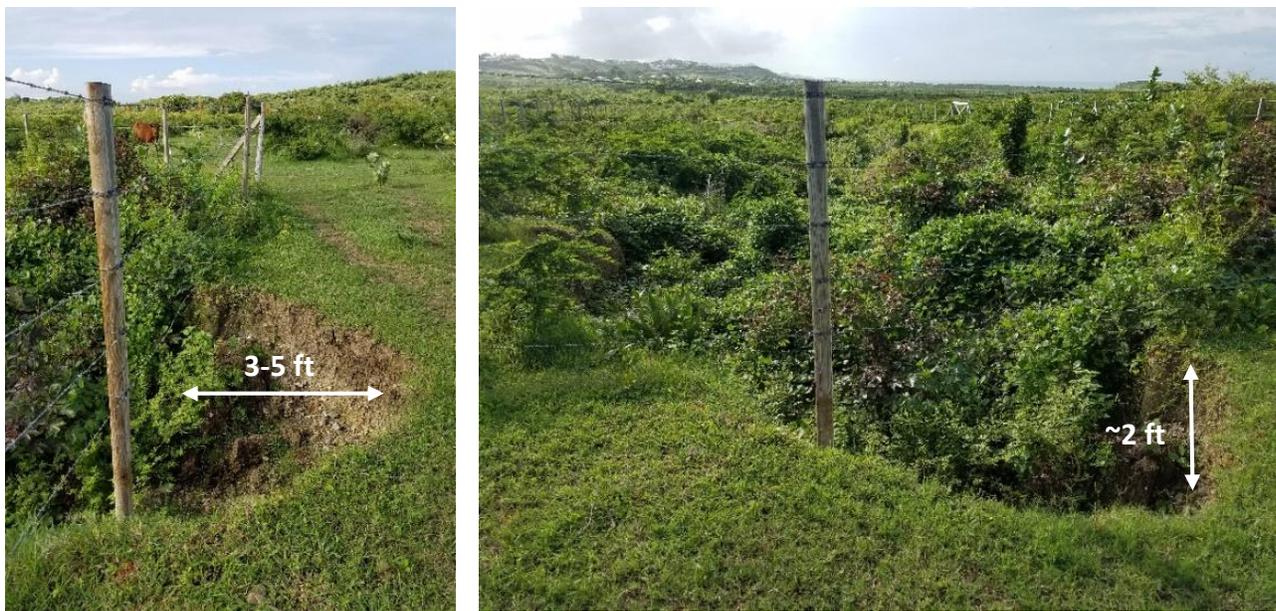
1. The headcut advanced to the east (uphill) post-hurricane. The new erosion has extended beyond the fence line by approximately 3-4 ft and is approximately 2 feet deep. This erosion has compromised the integrity of fence posts, and created a nick point where continued erosion may occur (Figure 1). The small stone apron that had been installed at the top of the channel washed out completely, due in part to installation issues as well as a minimalist design and use of non-specified materials.

Despite the problems in the project site, it is reasonable to conclude that the damage from the severe rains following Hurricane Maria would have been worse without the installation of the structural erosion control/stabilization measures. However, the headcut has reformed and should be effectively resolved before additional up-gradient erosion occurs.

Figure 1. Erosion observed at top of channel.

1. **Fix cattle exclusion fencing** to prevent horses/cattle from entering the project site. It is unclear when the fencing was compromised, but no work should be performed until the site can be fully secured. The fencing at the top of the project site will need to be expanded outward to accommodate repair work at the top of the channel. Make sure the gate is properly secured to restrict access.
2. **Reset and reinforce the top of headcut.** The headcut now has an elevation change of approximately 2 feet. We recommend filling in this area with a stabilized stone apron and installing an impermeable barrier to stop any progression of the headcut and prevent sediment movement underneath. In addition, we recommend including a reinforced turf mat and a plastic geogrid wrapped in an impermeable liner to be installed 6" below the current existing grade.

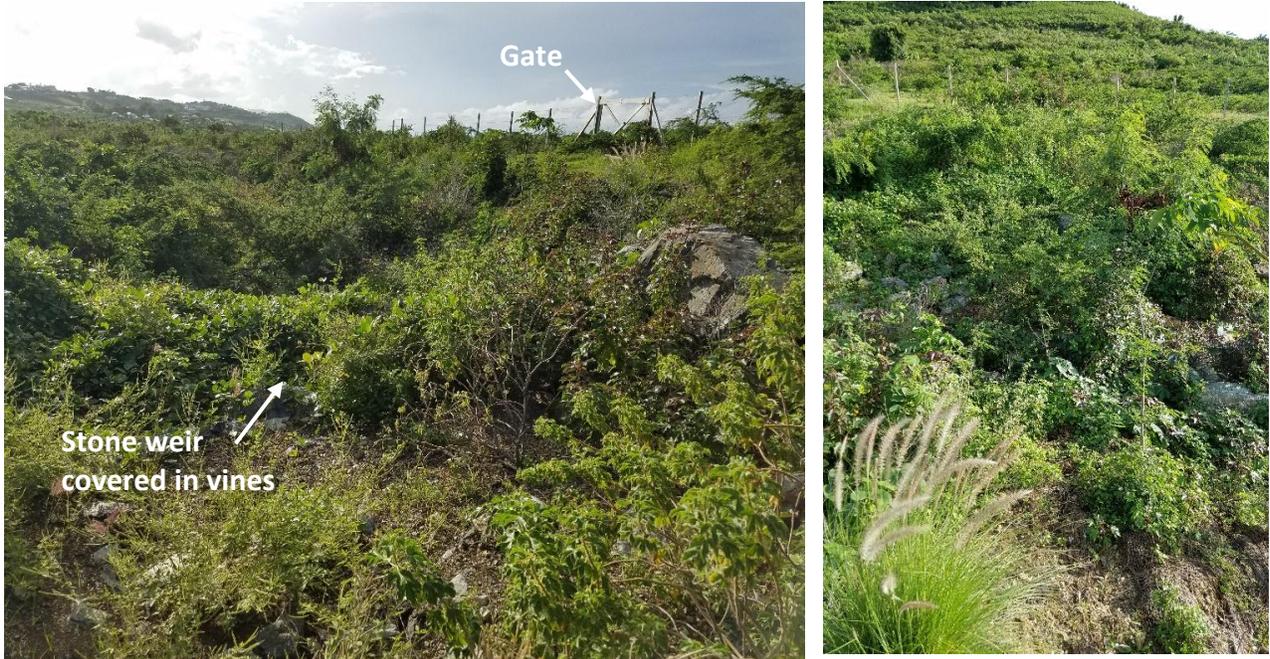
2. No evidence of erosion or channel formation was observed upstream of the project site.
3. The vegetation within the fence has filled in to form a dense scrub layer. Planted species are combined with volunteer plants from the surrounding pasture. Planted vines sprawl along the surface and climb the taller trees and shrubs. No new soil erosion was observed under the vegetation layer. Native birds and butterflies were abundant. The dense vegetation restricted ability to inspect and photograph some of the damaged stone work. Vegetation did not establish in the lowermost section of the side slope on the south west side of the channel. This is presumed to be an issue with low quality clay soil. New erosion occurred in that location (Figure 2).

Figure 2. Vegetative cover is dense for most of the project site (except southern slope in downstream corner).

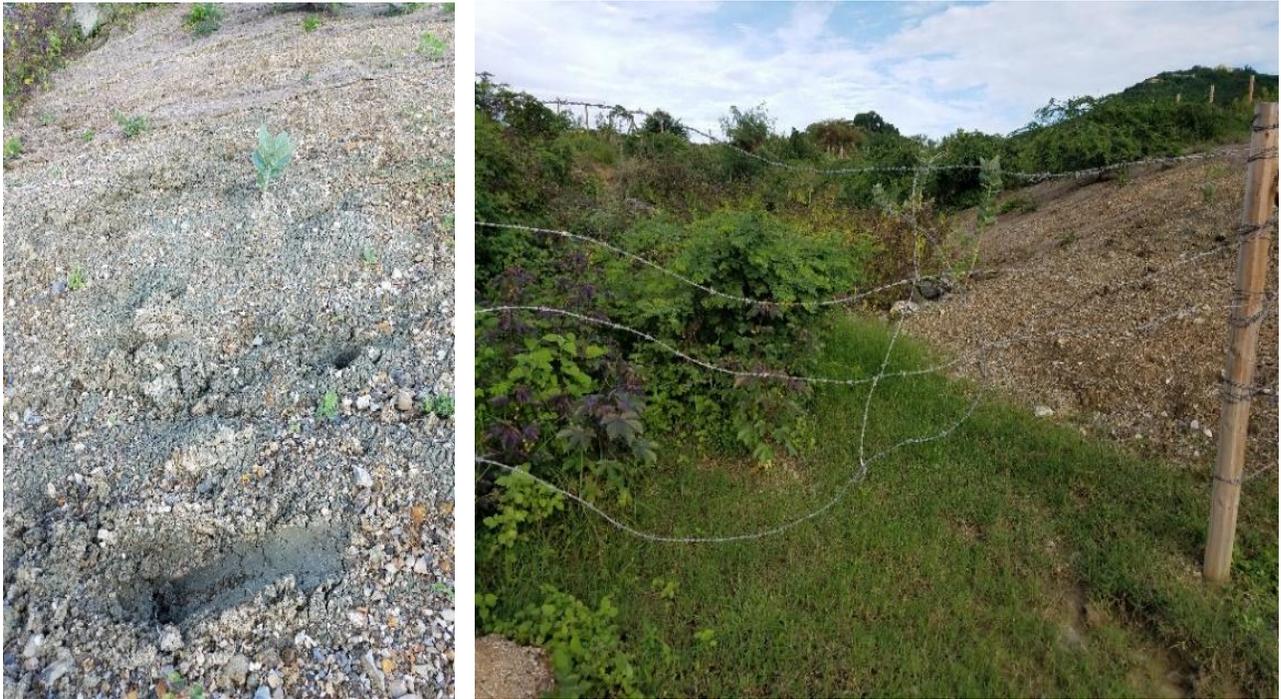
4. Holes in the barbed-wire fence and fresh cattle tracks within the fenced off area leads us to believe that there has been a fair amount of animal activity within the site. Deep hoof prints in saturated soil have torn the erosion control fabric, resulting in continued erosion along the side slopes. Installed plants have also been browsed and crushed. The barbwire fencing at the bottom of the project site is open and was found tied back to allow open access. (Figure 3)

Figure 3. Hoof prints and fencing at bottom of site (looking upstream). Note lack of established vegetation on side slope.

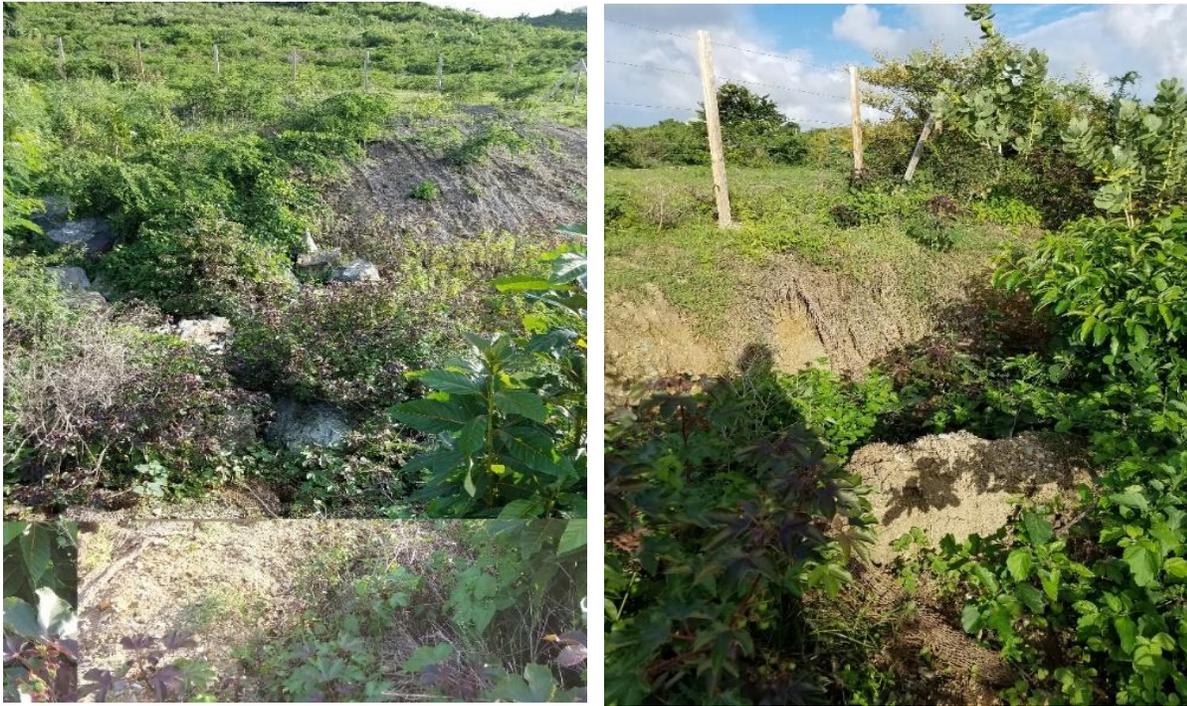
6. Bank erosion resulting from flow “run around” the weirs was observed at a number of locations (Figure 4). This may have been exacerbated by abnormally high rain fall and flow

velocities in addition to step-pool construction issues. Evidence of soil deposition and accumulation of smaller stones was observed in the last pool in the system.

Figure 4. Slope erosion from runaround behind stone weirs.

3. **Repair the two uppermost stone step-pools and extend weirs.** We recommend reconstructing and enhancing the first two steps pools. The weir wings should be extended an additional 3-7 feet up the side slopes. Proper construction is critical to prevent shortcutting or run-around at high flows and to maintain proper elevation differences between weir crest and pool inverts. While laborers and equipment are on site, consider reshaping any downstream weirs where boulders were dislodged.
4. **Fill and revegetat eroded or bare slopes.** Add suitable soil and reseed southern corner of project site where vegetation never established. Where slopes were distrurbed for step-pool repairs, this area will need to be revegetated as well. Use alternative soil stabilization techinque such as wood chips rather than erosion control blanket, if needed.

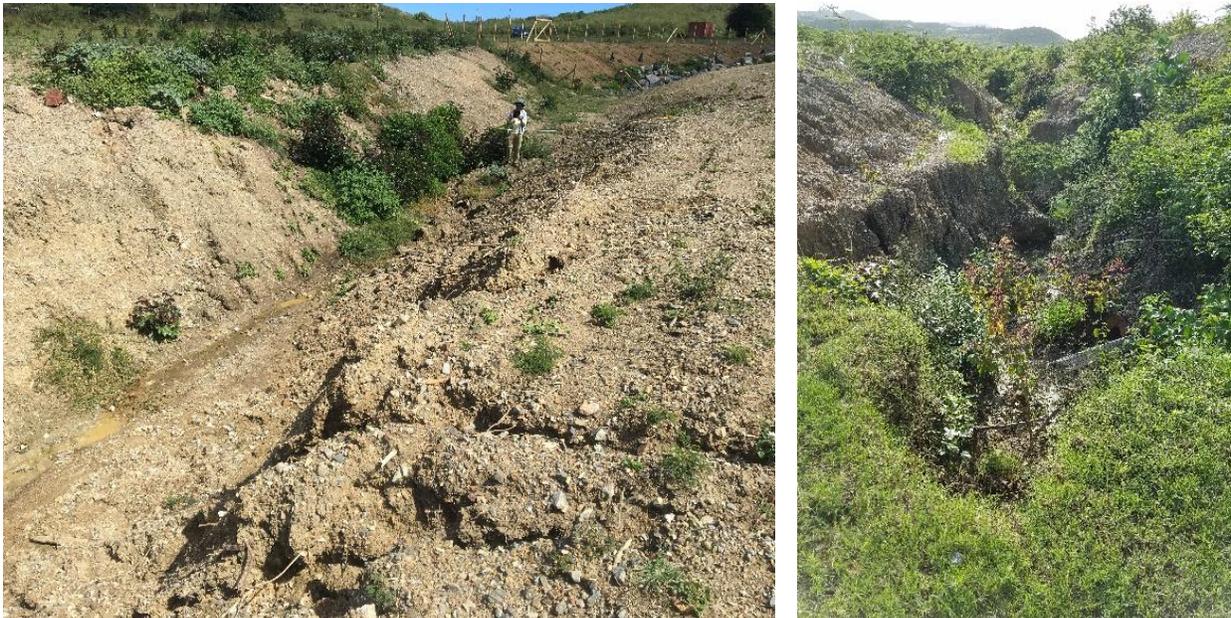
8. Conditions were notably worse immediately downstream of the project site, in the reach that had been cleared by the owner in conjunction with the stabilization project (Figure 5). Here the channel appears to have downcut by several feet and there were vertical banks in several locations. Multiple sloughs were visible where large clumps of soil and small stones fell from the banks into the channel. There were deep animal prints all over the side slopes and little to no vegetation. Surface rills were present across the side slopes.

Figure 5. (Left) Photo from construction inspection in Jan 2017, identifying channel instability issues. (Right) Photo taken during October 2018 site assessment on, showing signs of increasing bank erosion downstream.

- 5. Evaluate conditions along the remaining downstream gut channel** and develop a comprehensive restoration plan in conjunction with DPW culvert replacement planning (mid-term, medium cost). Much of the green cay gut channel is eroded between the project site and East End Rd. It was recongized that the original stabilization project was not intended to address full channel restoration, rather it was limited to arresting the active migration of the headcut. During construction of the stabilization project, however, vegetation was cleared and the banks disturbed along 300 feet of channel directly downstream of the project site. This activity likely contributed to additional erosion along this segment of the gut as evidence by sloughing slopes, exposed soils, and erosional features created by new side discharges. Due to these concerns, HW offered a restoration plan to the owner in January 2017 (Figure 8). It is unclear if elements of this plan were implemented.

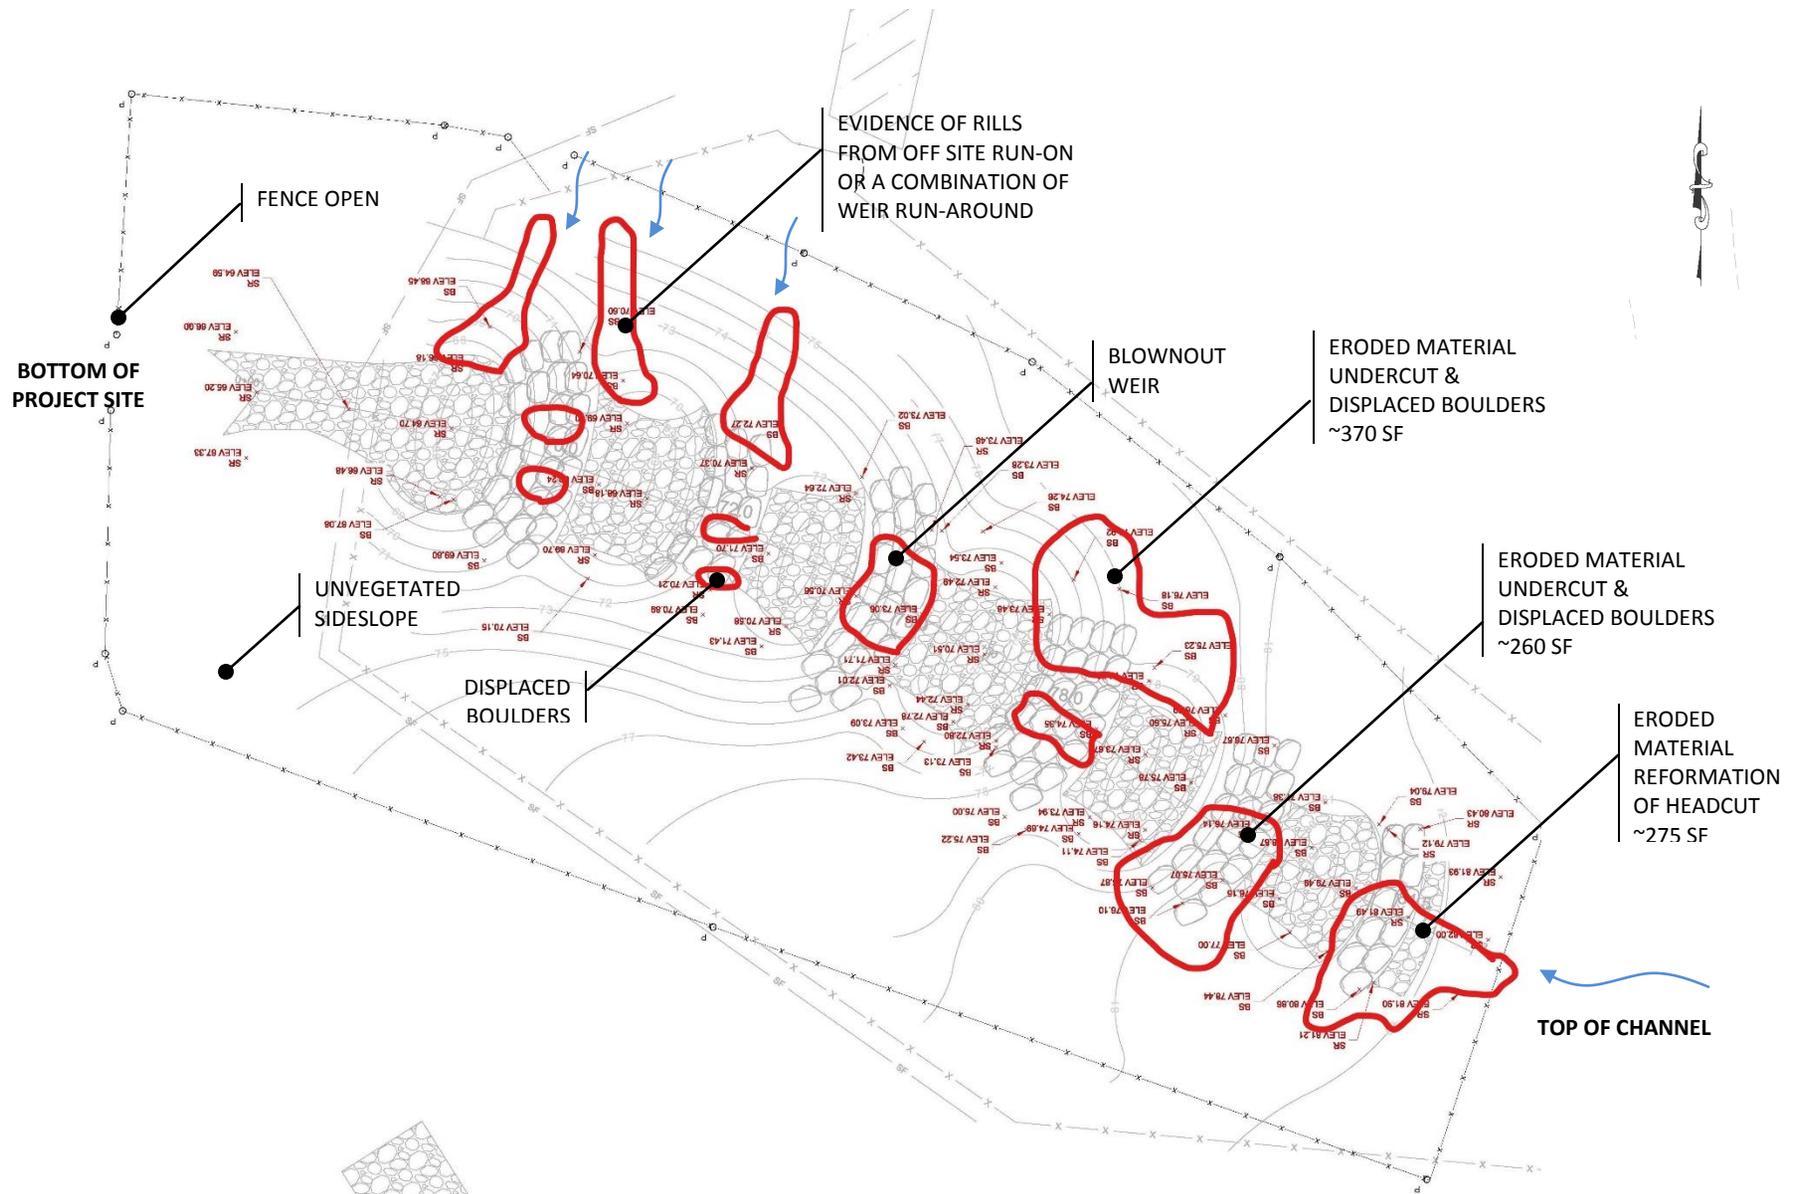
Figure 6 is a site map mark up showing the locations of erosion and boulder displacement these features.

Figure 6. Locations of erosion and boulder movement (in red circles) over preliminary as-built survey
