MEMORANDUM

To: Lisa Vandiver (NOAA)
From: Geoffrey Glover and Brian Daley (HW)
Date: March 8, 2019
Re: Green Cay Headcut Stabilization Project Repair
cc: May Cornwall Adams, Rudy O'Reilly (NRCS), Julie Wright (NRCS), JP Oriol (CZM), Marlon Hibbert (NOAA), Rob Ferguson (NOAA)

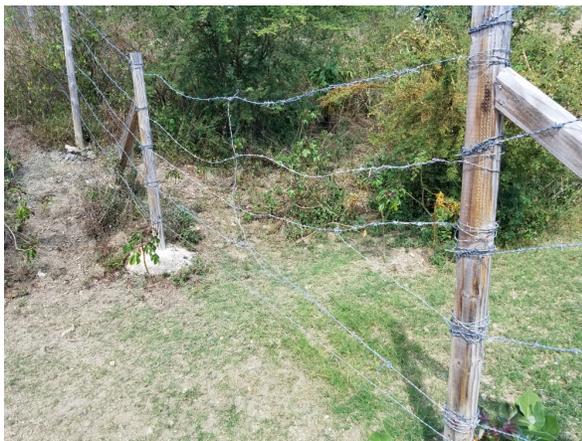
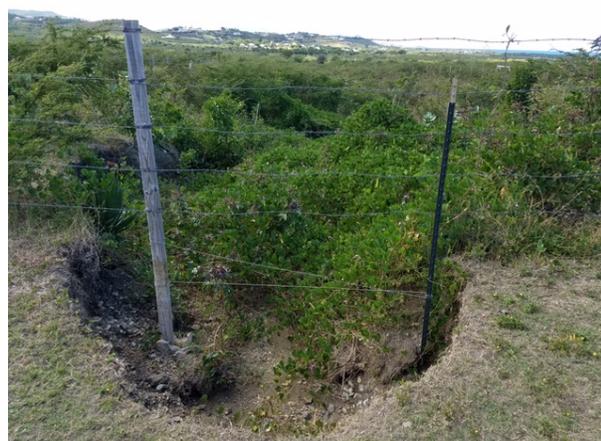
Figure 1. Fence at lower end of project site (left); fencing at top of project site (right).

On January 24, 2019, HW repaired the cattle exclusion fencing by adding barbed-wire strands to close gaps in existing fencing at the bottom of the project site, as well as adding an additional post and strands to keep cows out at the top of the site (Figure 1). The design plans call for removal and relocation of the fencing at the top of the headcut.
