***Hurricane Impact Assessment on Implemented BMP  
Projects in Guánica and Culebra Watersheds, Puerto Rico***  
**FINAL REPORT**

**Roberto A. Viqueira Ríos**  
Executive Director  
**Protectores de Cuencas, Inc.**  
Box 1563 Yauco Puerto Rico 00698

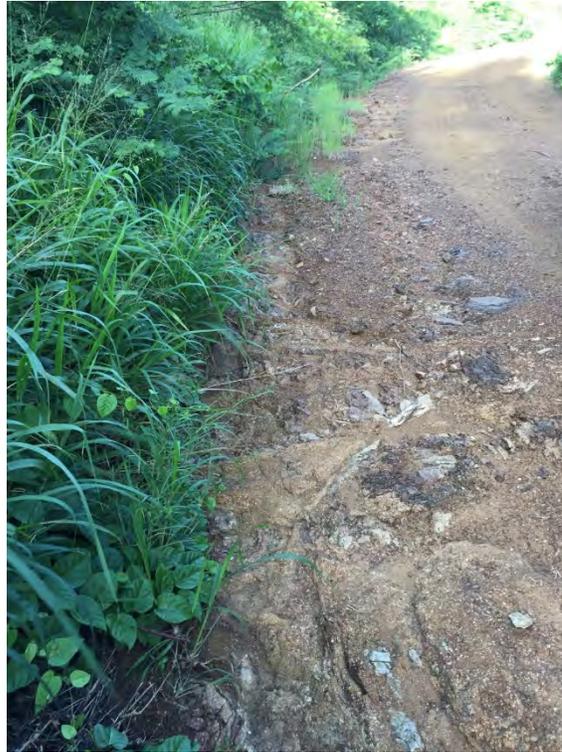
During the evaluation process, PDC identified that the previously stabilized dirt road had suffered erosion due to the rains associated with the storms. The photographs show the culverts formed by the water flowing over the dirt road (Figures 3-5). The sediment traps were in good conditions and found to have suffered minimal damage. The location of the sediment trap proved to be asserted as sediment eroded was transported and accumulated within the sediment trap.

Figure 3. Formation of ruts and false ditch on previously stabilized dirt road at Punta del Viento following impact of hurricanes Irma and Maria.

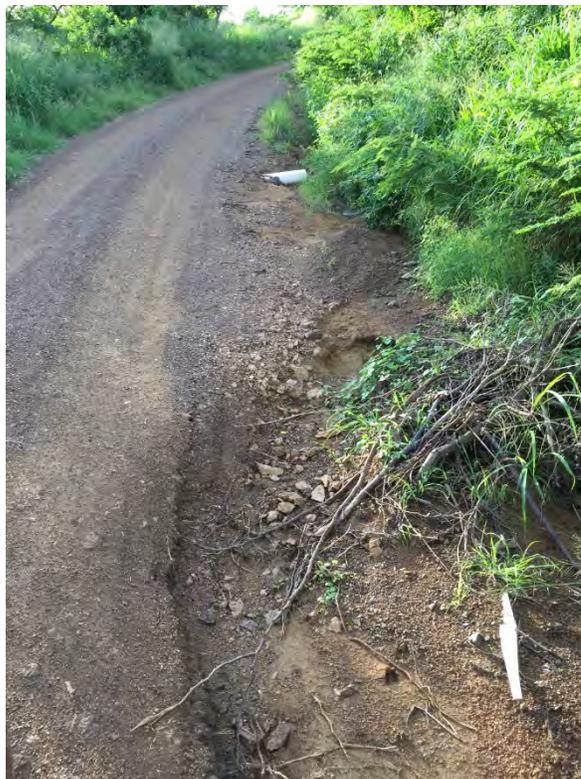
Figure 4. Erosion on previously stabilized dirt road at Punta del Viento following impact of hurricanes Irma and Maria.

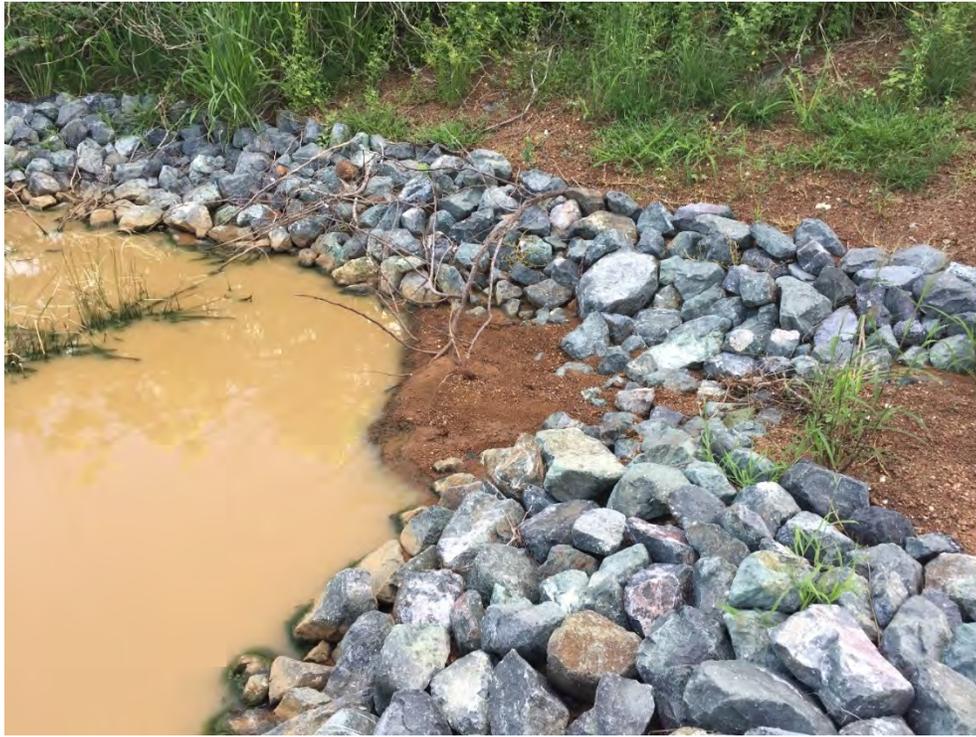
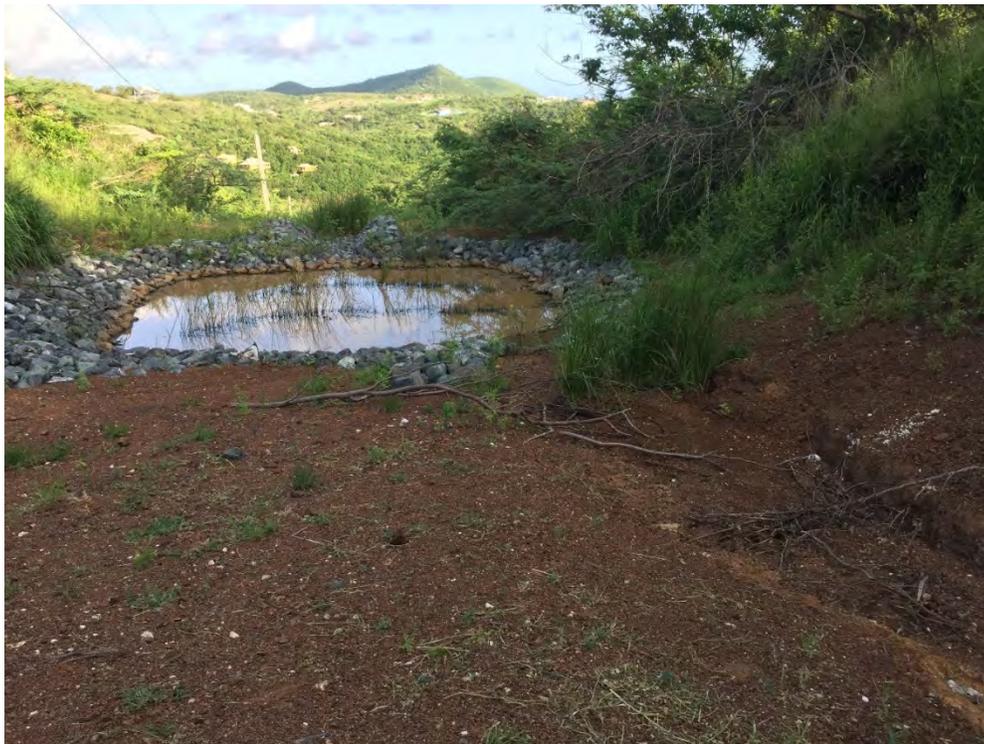
Figure 5. Sediment trap conditions at Punta del Viento following impact of hurricanes Irma and Maria.

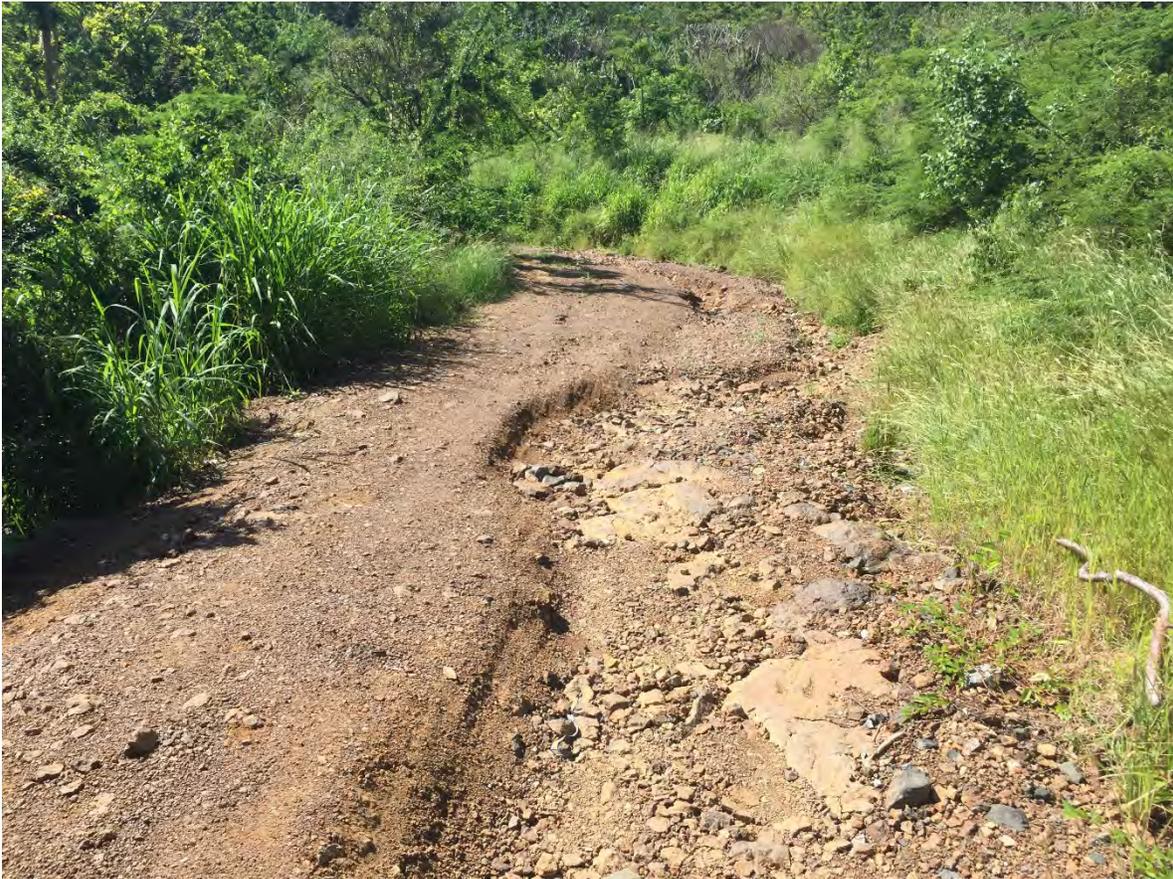
During the evaluation process at Punta Soldado, PDC identified that the stabilized dirt road had suffered greatly. The rains and water flowing caused serious erosion on the road. The photographs shown below are of the ditches formed by the water flowing over the dirt road. Wooden posts used for delimitation of public access and critical habitat areas were also damaged and require replacements. The restored coastal beach berm area with native vegetation barriers has been overgrown by weeds, limiting the healthy growth of the planted native trees. The elevated boardwalk constructed showed minimal damages, with some posts needing to be replaced (Figures 10-14).

Figure 10. Previously stabilized road located at Punta Soldado showing damages following hurricanes Irma and Maria.

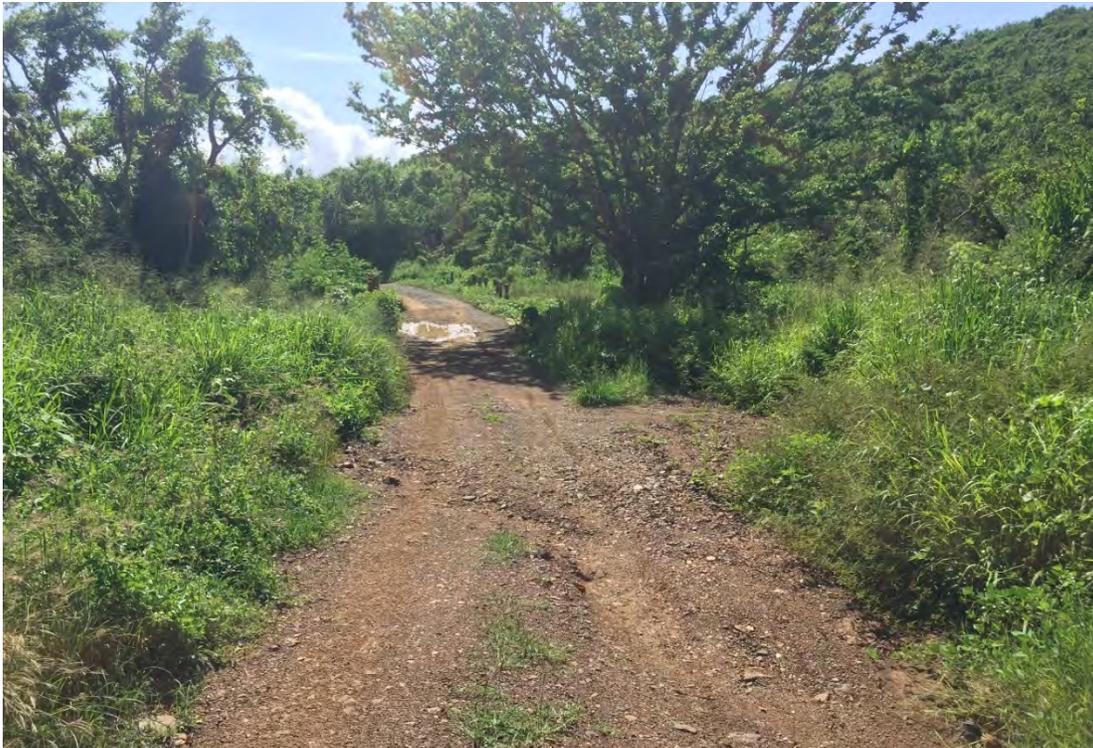
Figure 11. Previously stabilized road located at Punta Soldado showing overgrowth of vegetation following hurricanes Irma and Maria.

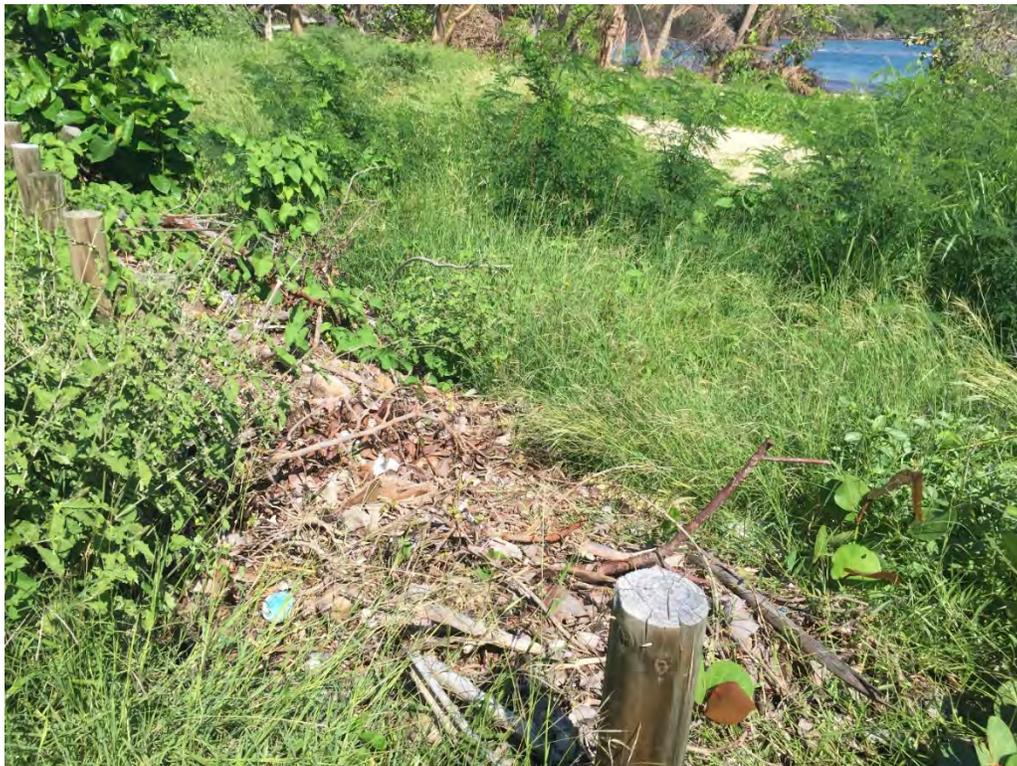
Figure 12. Delimited public area located at Punta Soldado showing overgrowth of vegetation and debris following hurricanes Irma and Maria.

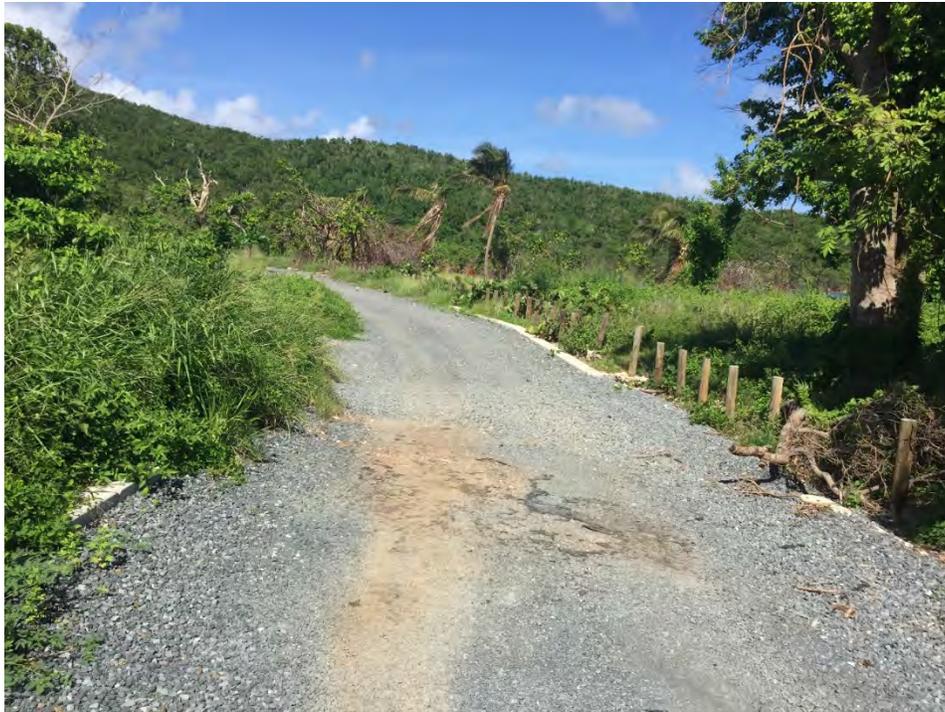
Figure 13. Previously stabilized road located at Punta Soldado showing damages following hurricanes Irma and Maria.

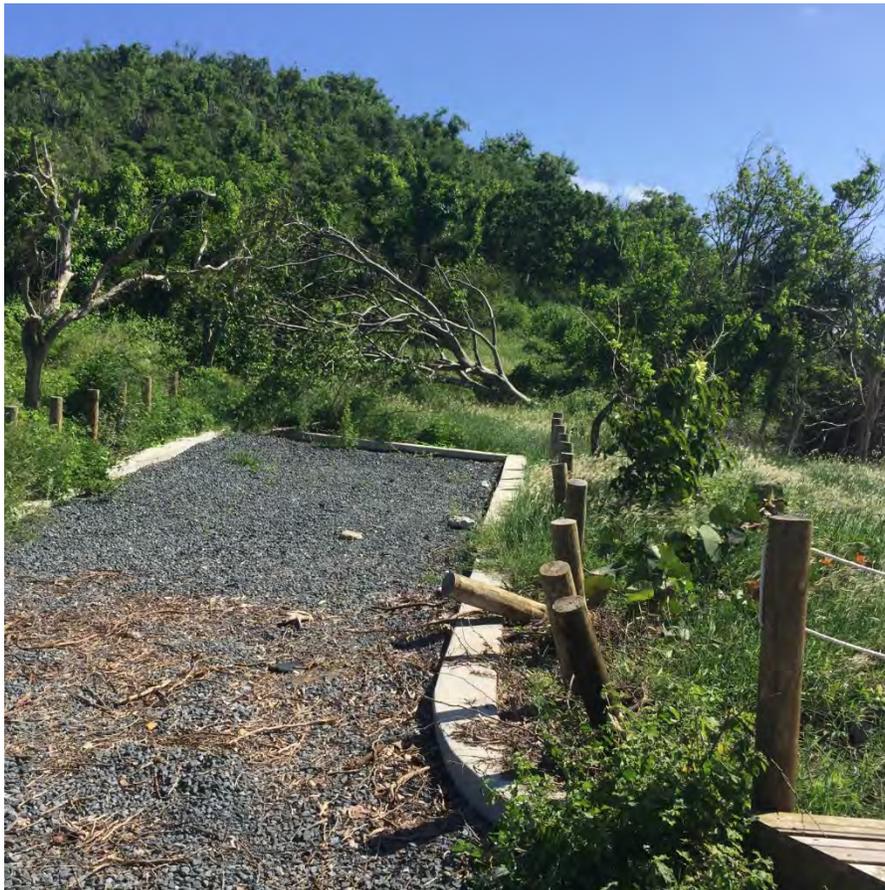
Figure 14. Permeable parking area located at Punta Soldado showing damages following hurricanes Irma and Maria.

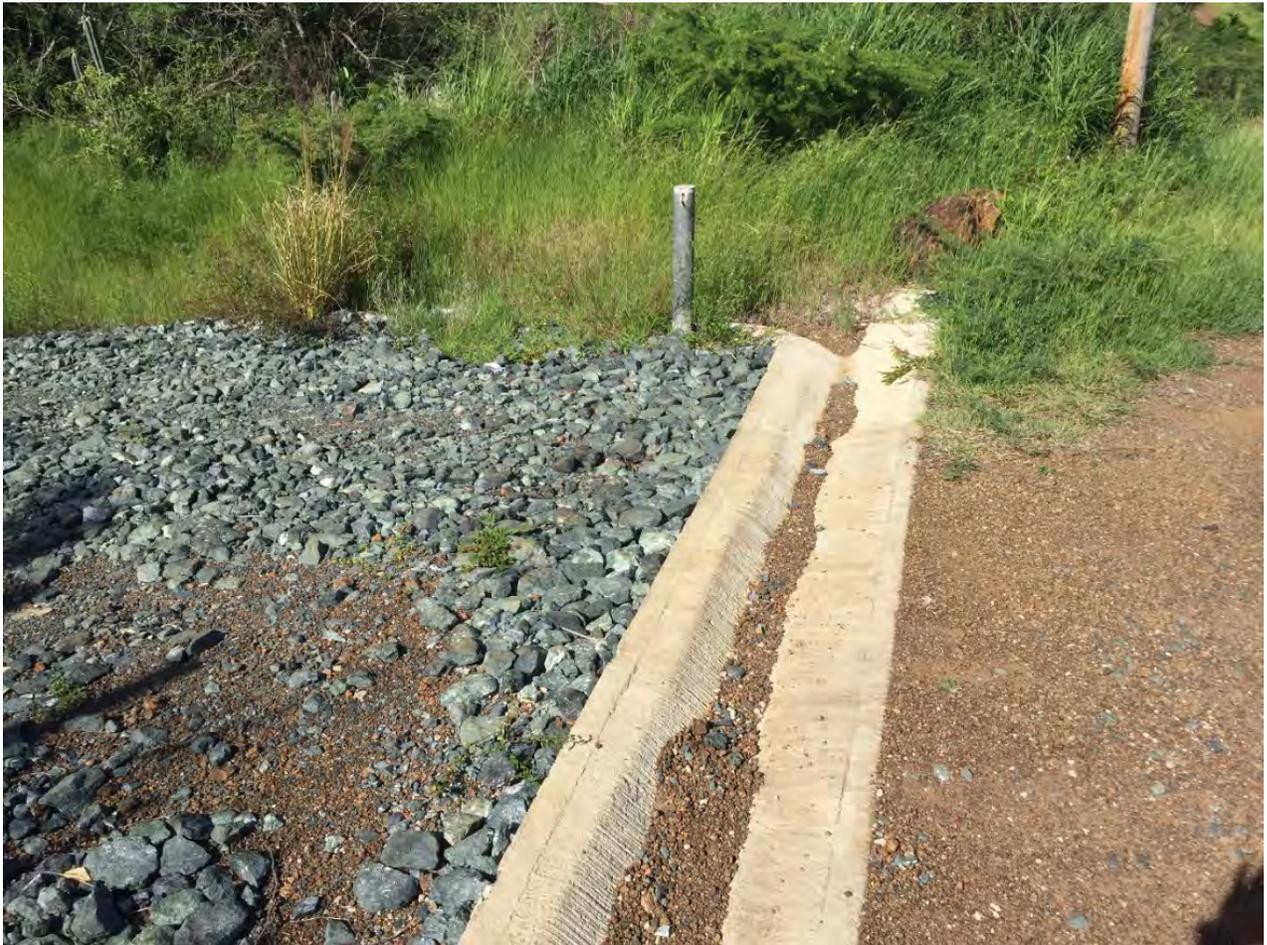
Damages observed at Puerto del Manglar was of structural and vegetative damages. The previously stabilized road is in need of resurfacing and clearing the accumulated debris. Areas with vegetative cover will require replanting of several trees and clearing those that were uprooted by the force of the storms. The affected areas are showing signs of water flowing through and accumulating at the dirt road as before instead of being redirected with the help of the green infrastructure constructed by PDC (Figures 17 and 18).

Figure 17. Damages suffered at stabilized site at Puerto del Manglar following hurricanes Irma and Maria.

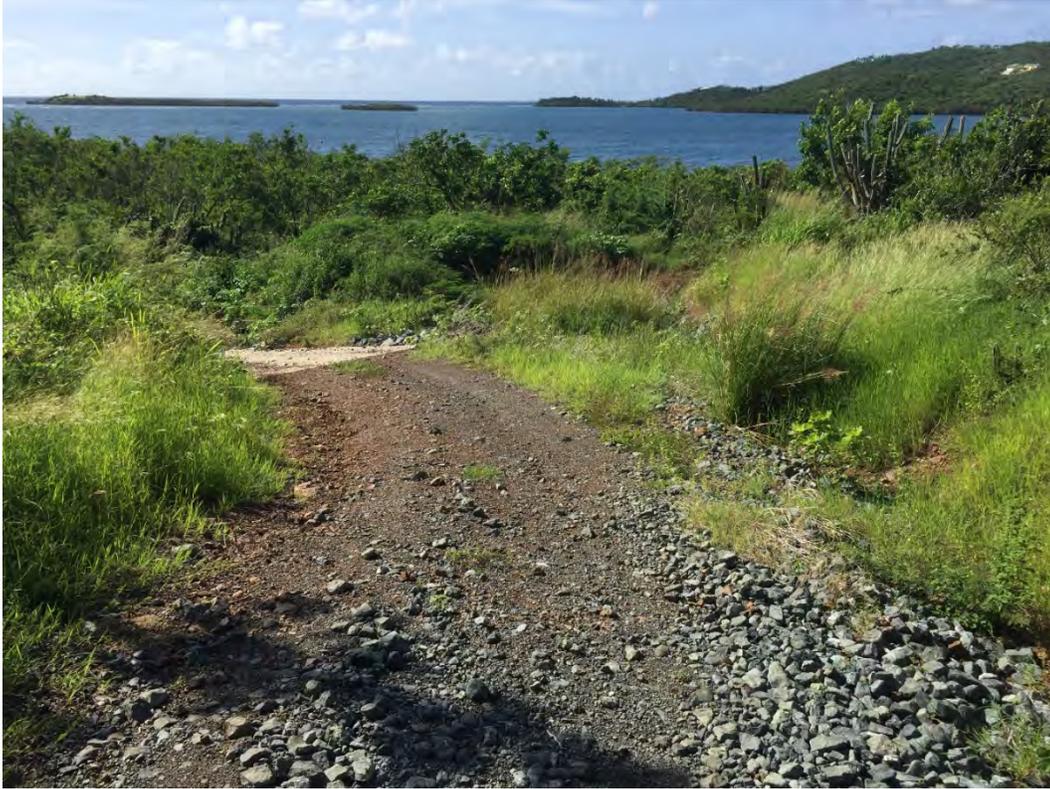
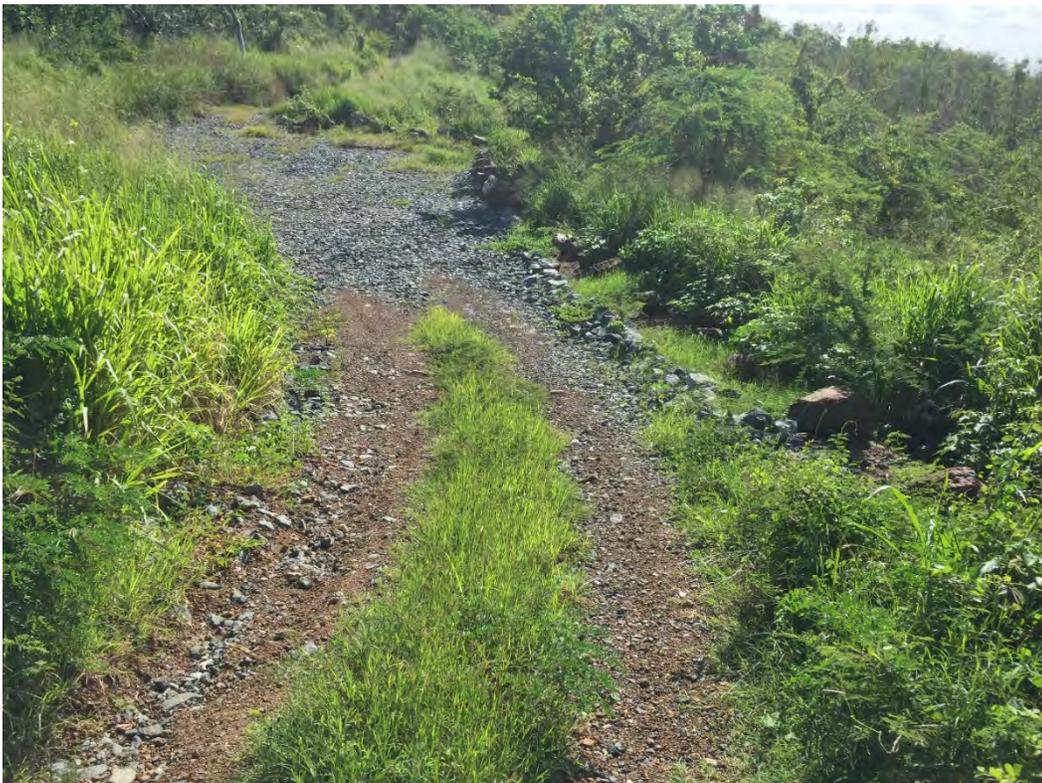
Figure 18. Damages suffered at stabilized site at Puerto del Manglar following hurricanes Irma and Maria.

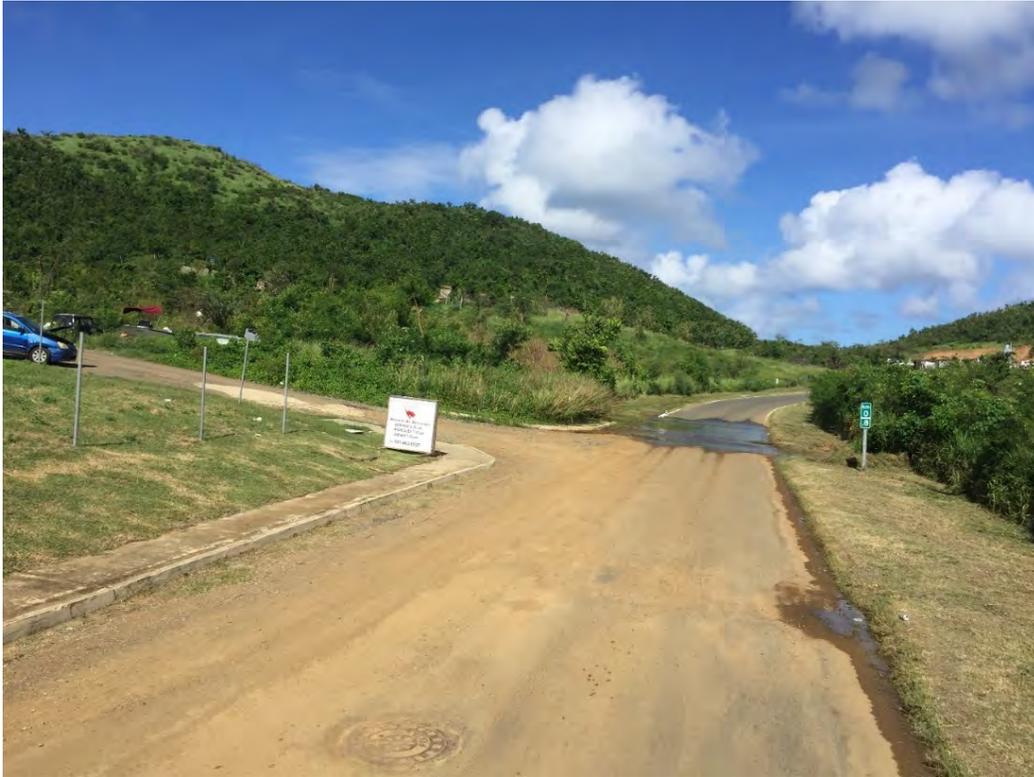
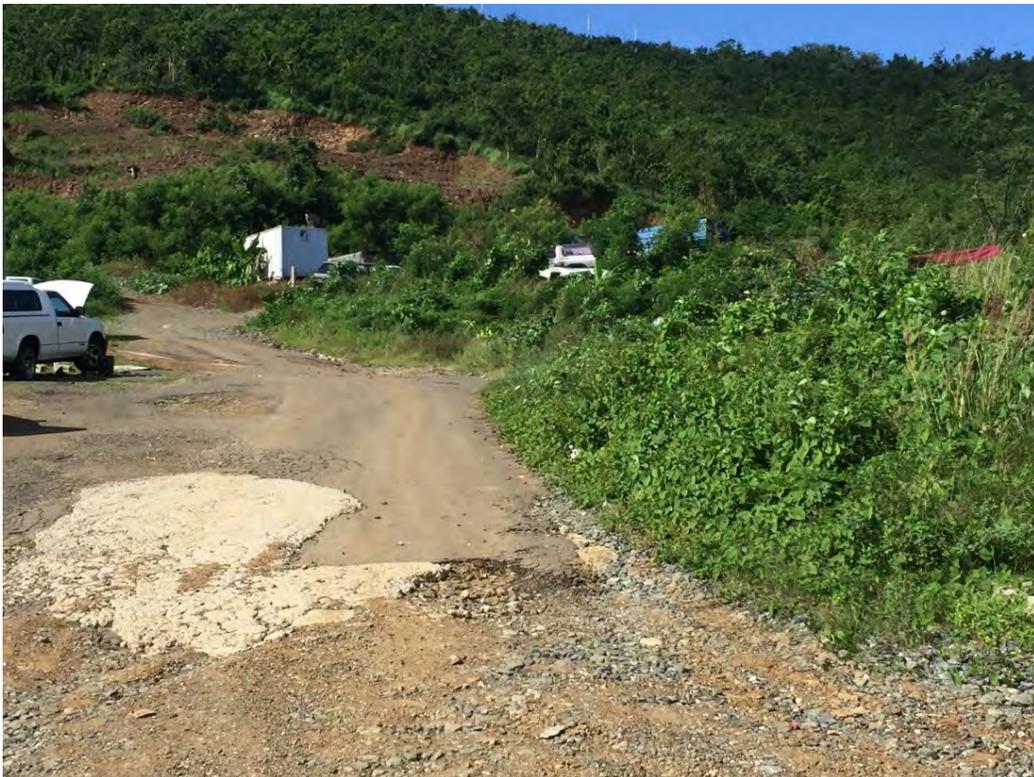
The Aeropuerto site BMP work implemented by PDC suffered mostly vegetation damage. It was estimated that 65% of the hydroseeding work previously performed during the implementation phase was damaged and required remediation. Structural damage encountered includes the washing away of areas that had been previously stabilized with gravel stones allowing once again for the runoff to erode away the sediments in the path of water flow (Figure 22).

Figure 22. Damages suffered at stabilized site at Aeropuerto following hurricanes Irma and Maria.

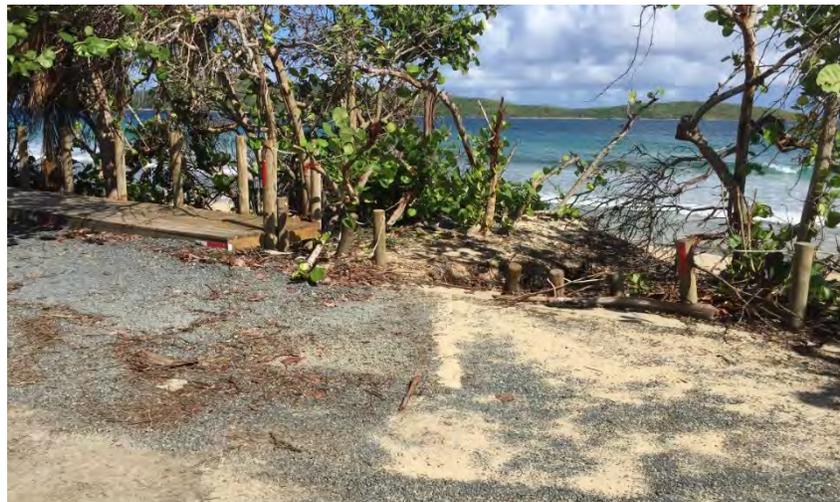
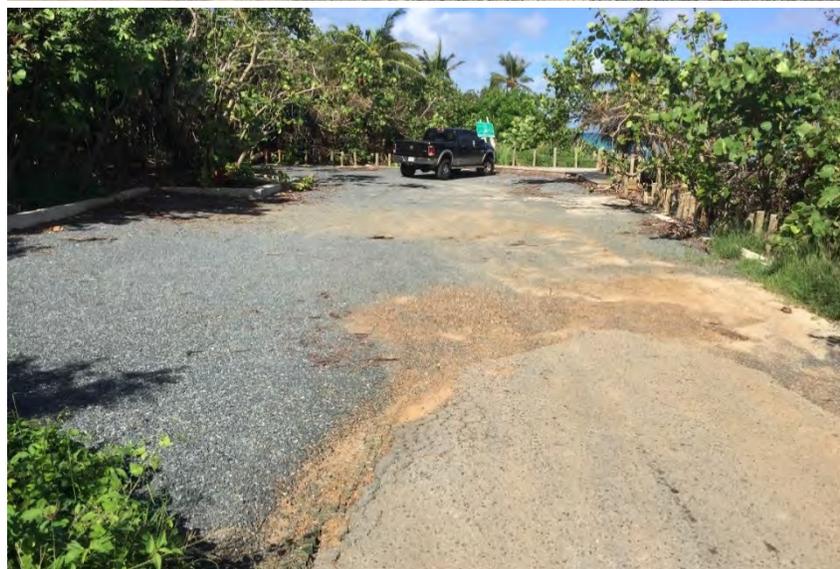
Damages encountered following the hurricanes Irma and Maria at Zoni were described as mostly vegetative damages with approximately 85% of areas needing recovery, while over one third of the structural components need repairs. Of the structural repairs needed, the parking area and delimitation need attention, while the boardwalk requires minimal repairs (Figures 26-27).

Figure 26. Structural and vegetation damages suffered at Zoni parking area following hurricanes Irma and Maria.

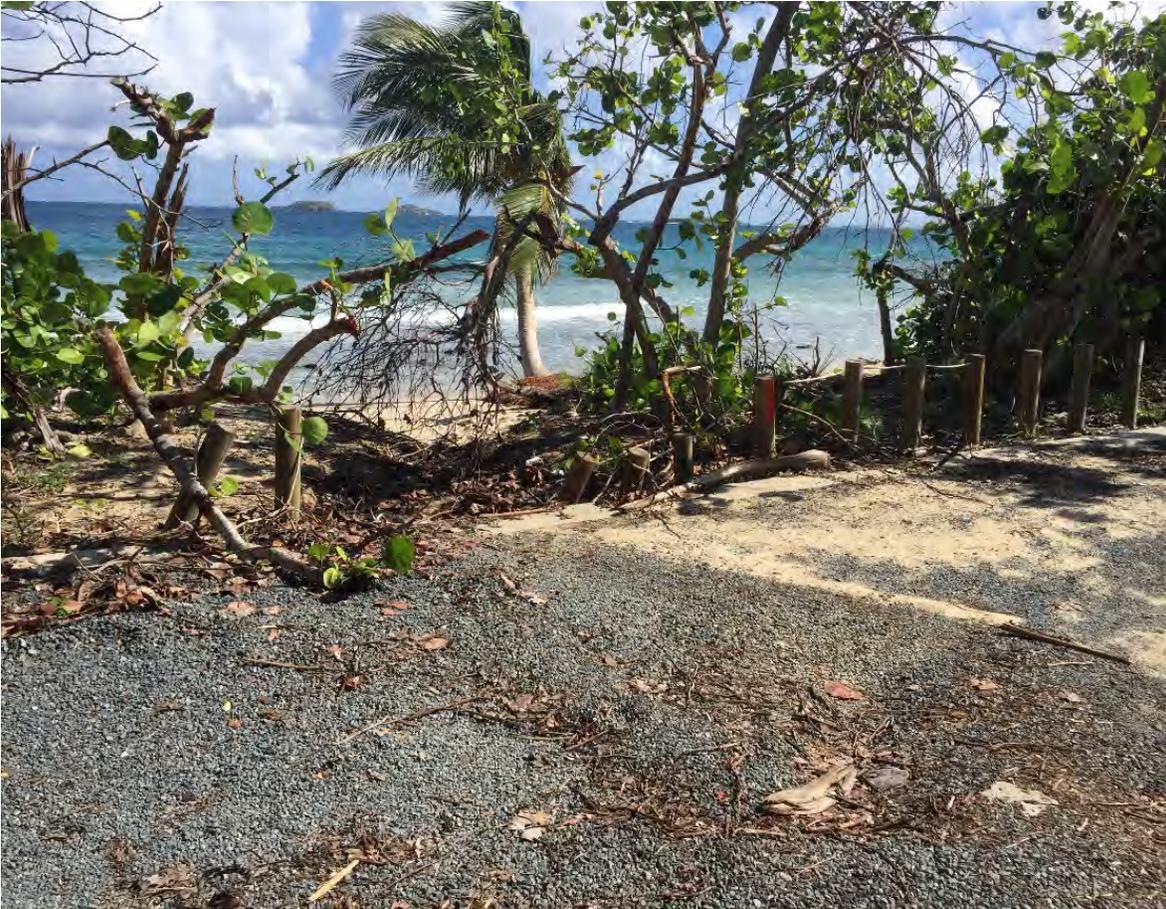
*Figure 27. Structural and vegetation damages suffered at Zoni following hurricanes Irma and Maria.*

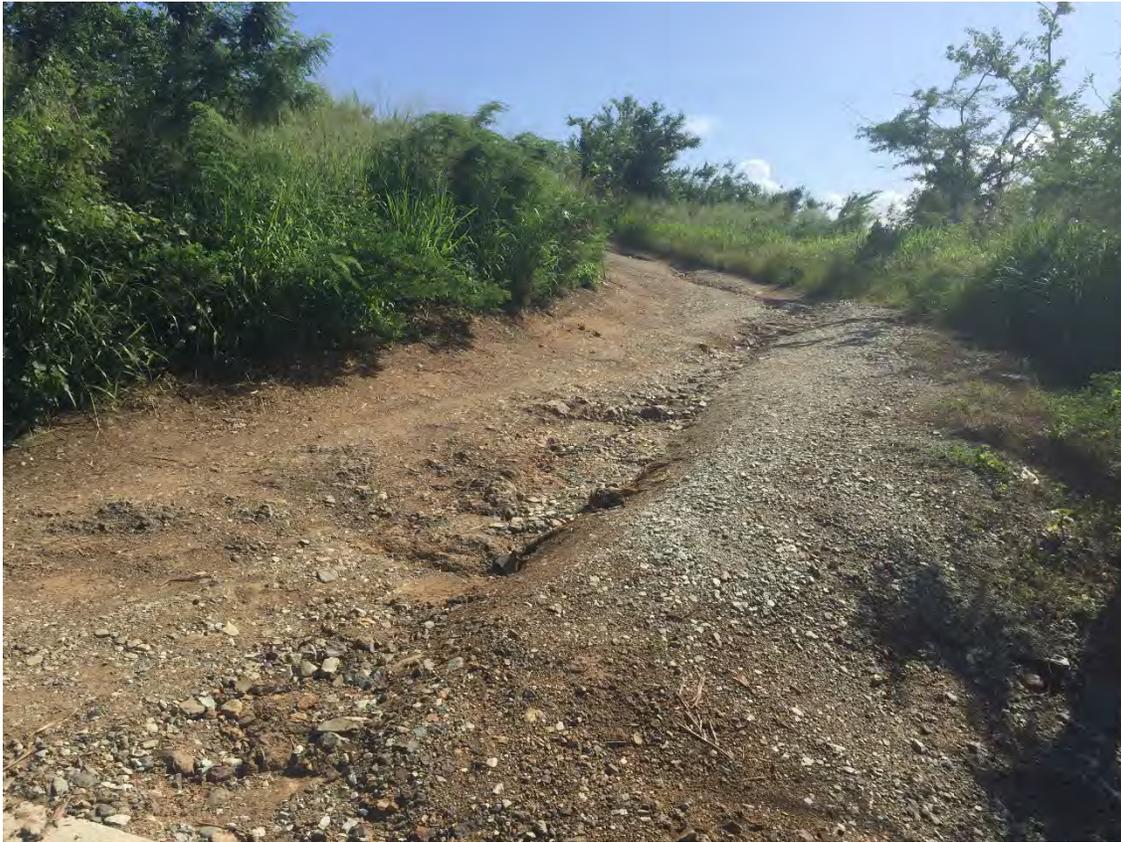
Damages in the Town site include road stabilization and vegetative loss. It is evident that sediment has been transported by runoff following the storm events of 2017. Deep grooves can be observed from the photographs taken at the implementation Town sites. Repairs are needed to prevent further impact of the Lobina Channel with sediment laden runoff (Figures 30 and 31).

*Figure 30. Damages suffered at the Town site following hurricanes Irma and Maria.*

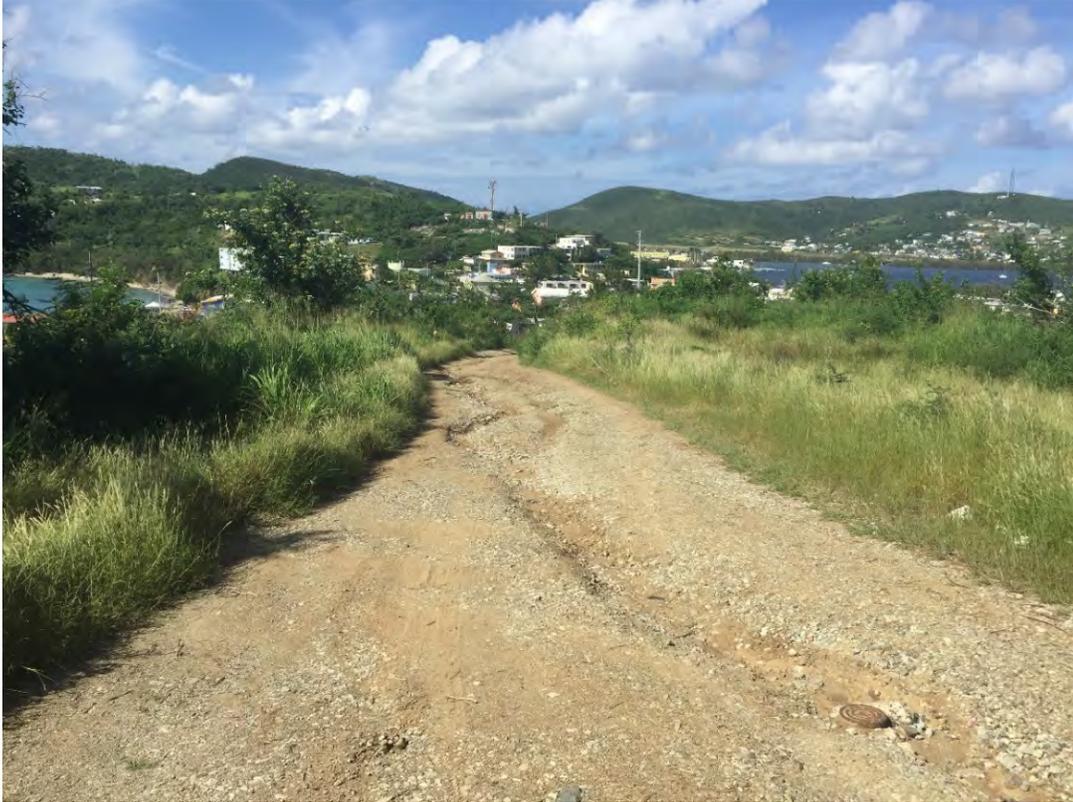
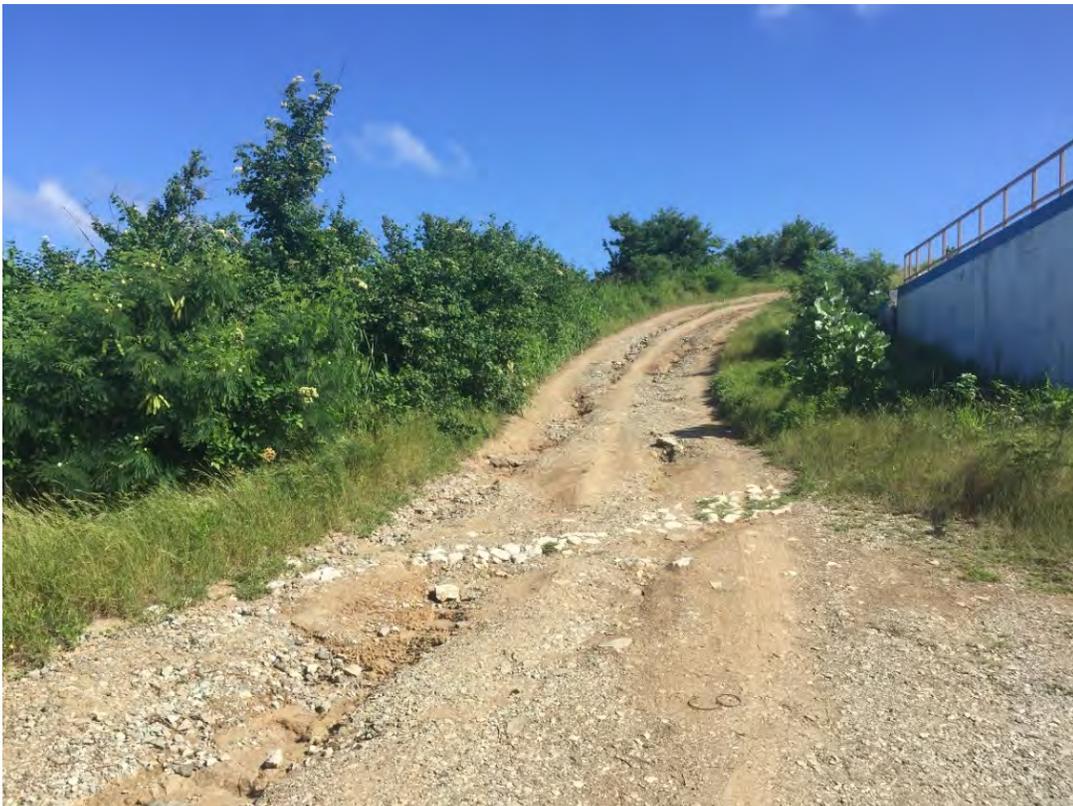
Figure 31. Damages suffered at the Town site following hurricanes Irma and Maria.

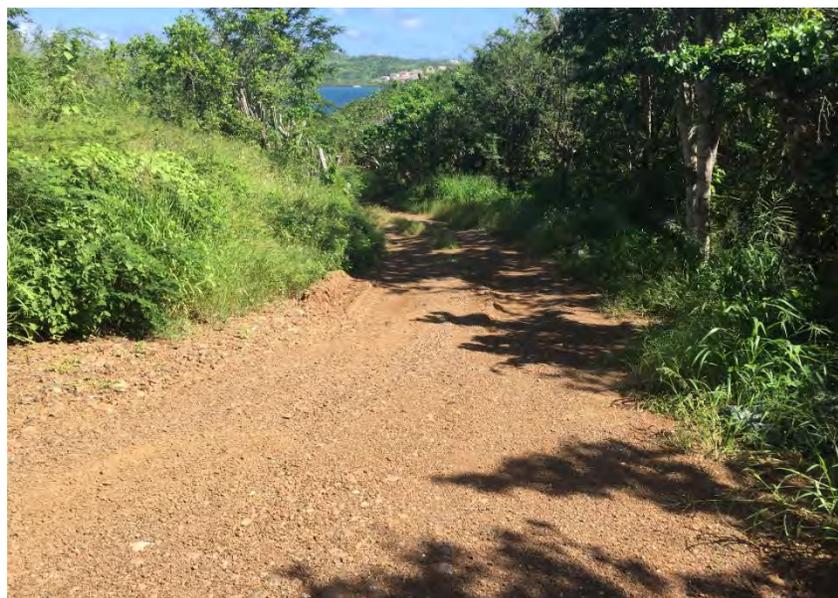
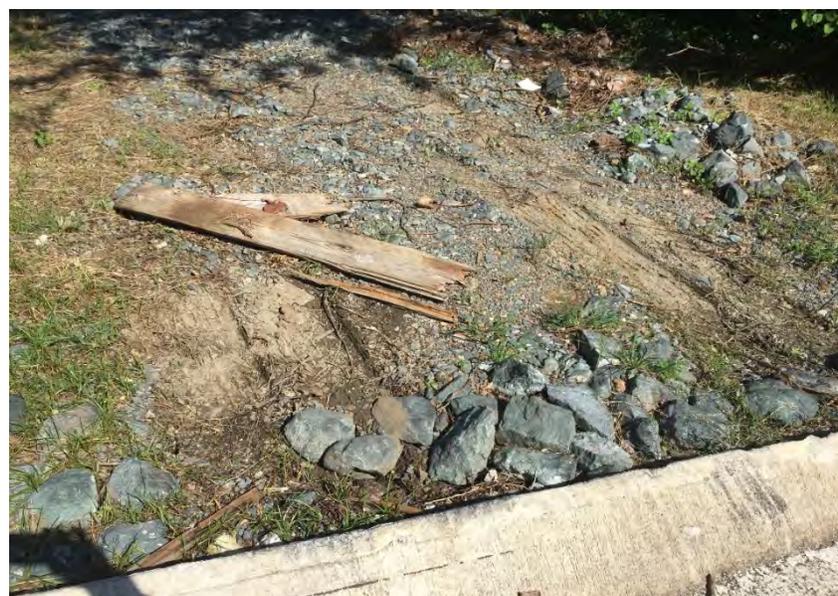
Damages identified during the evaluation process include erosion of the previously stabilized road due to the rains associated with the storms. The photographs show the culverts formed by the water flowing over the dirt road (Figures 35-37). The sediment traps were in good conditions and found to have suffered minimal damage. Vegetation and debris require attention as the site is overgrown with invasive grasses and weeds.

Figure 35. Damages suffered at the Fulladosa site following hurricanes Irma and Maria.

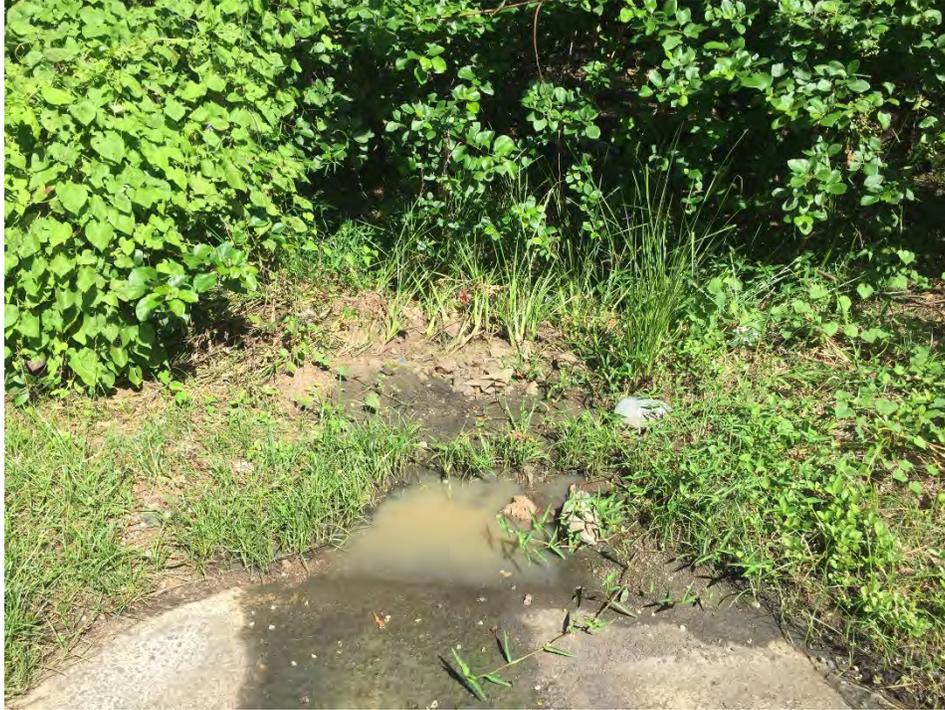
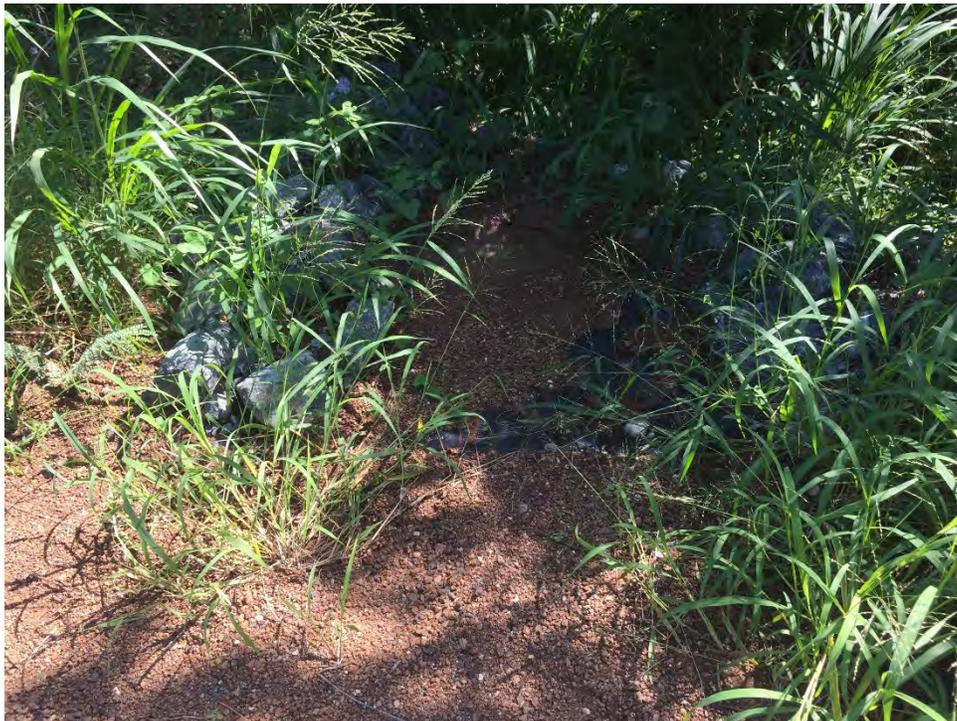
Figure 36. Damages suffered at the Fulladosa site following hurricanes Irma and Maria.

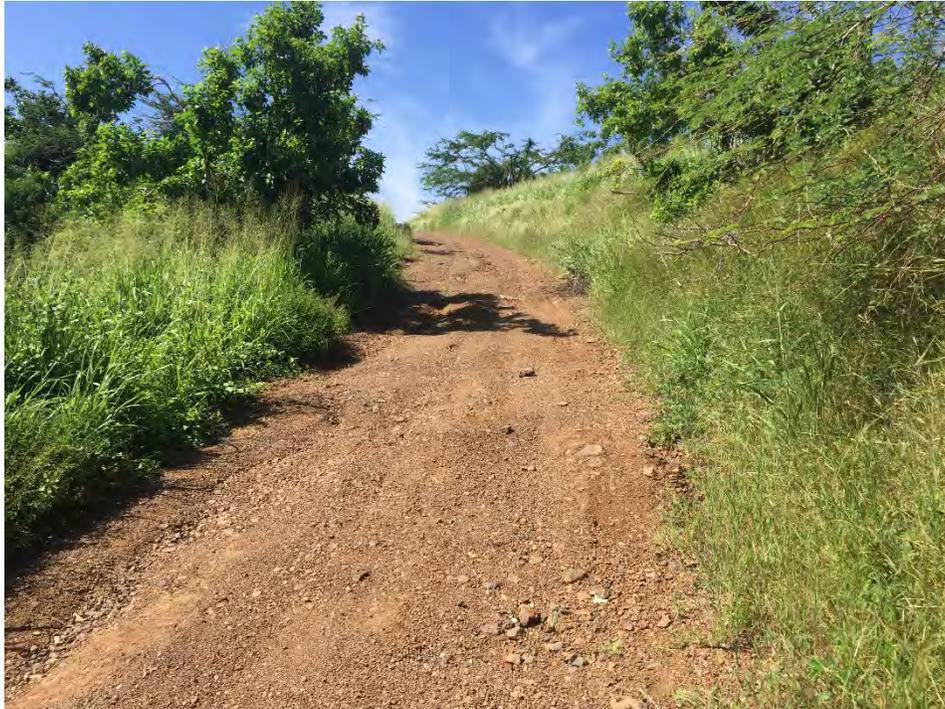
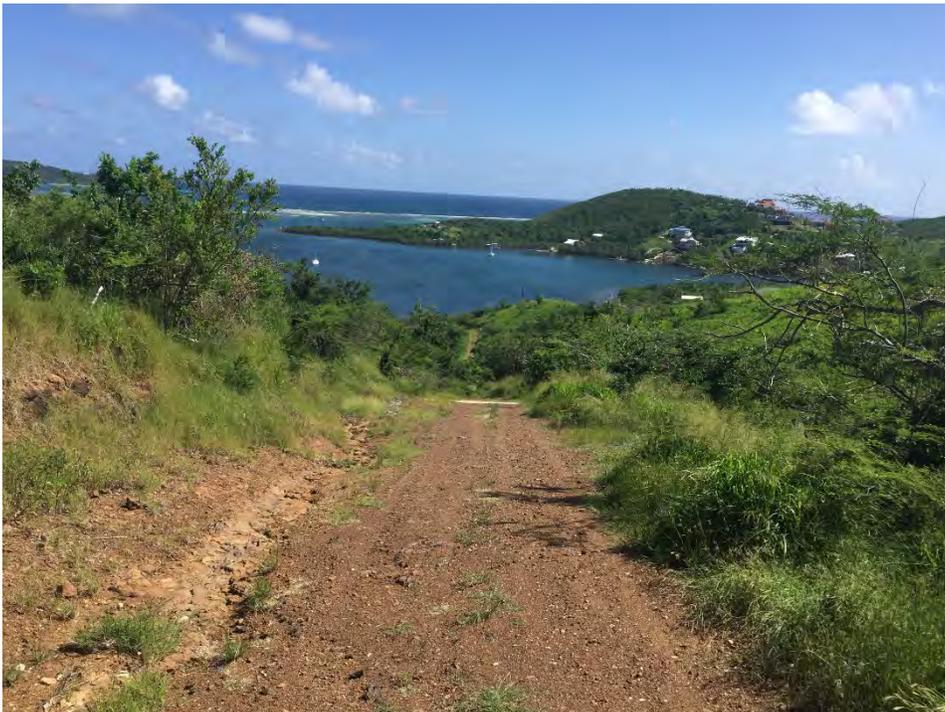
Figure 37. Damages suffered at the Fulladosa site following hurricanes Irma and Maria.

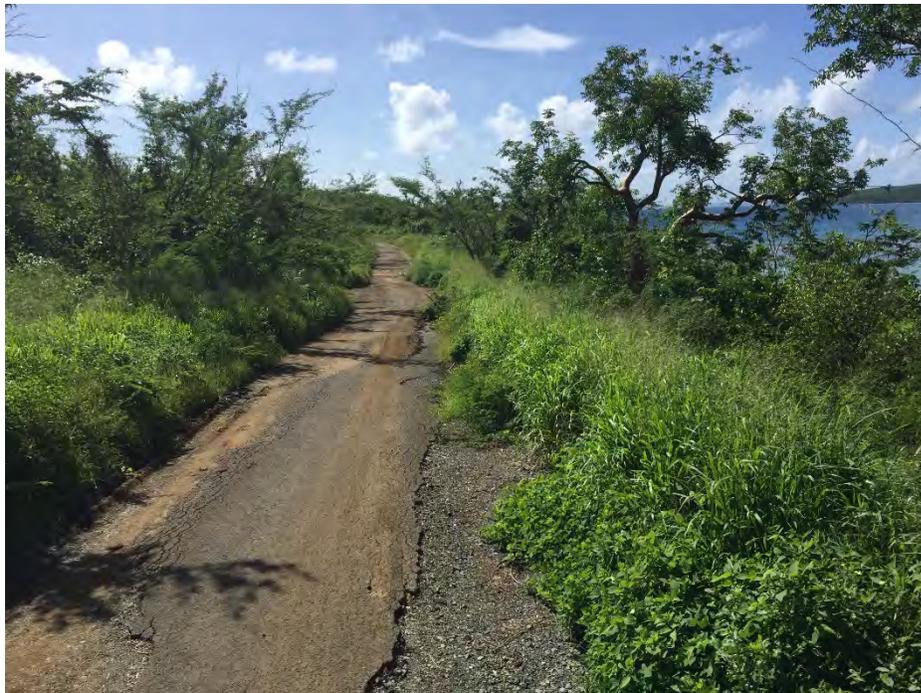
Damages as a result of the impact of hurricanes Irma and Maria at Tamarindo were found to be 100% structural and 100% vegetative. This level of damage should receive priority attention in comparison to the other Culebra implementation sites. During the post-hurricane evaluation, PDC found severe erosion of the previously stabilized road due to the rains associated with the storms. The photographs below show the formation of deep ditches formed by the water flowing over the road. Vegetation was also overgrown and covering the BMP structures put in place during project implementation. Implementation for the coastal stabilization work was also severely impacted and in need of repairs (Figures 41-44).

Figure 41. Damages suffered at the Tamarindo site following hurricanes Irma and Maria.
