***Hurricane Impact Assessment on Implemented BMP  
Projects in Guánica and Culebra Watersheds, Puerto Rico***  
**FINAL REPORT**

**Roberto A. Viqueira Ríos**  
Executive Director  
**Protectores de Cuencas, Inc.**  
Box 1563 Yauco Puerto Rico 00698

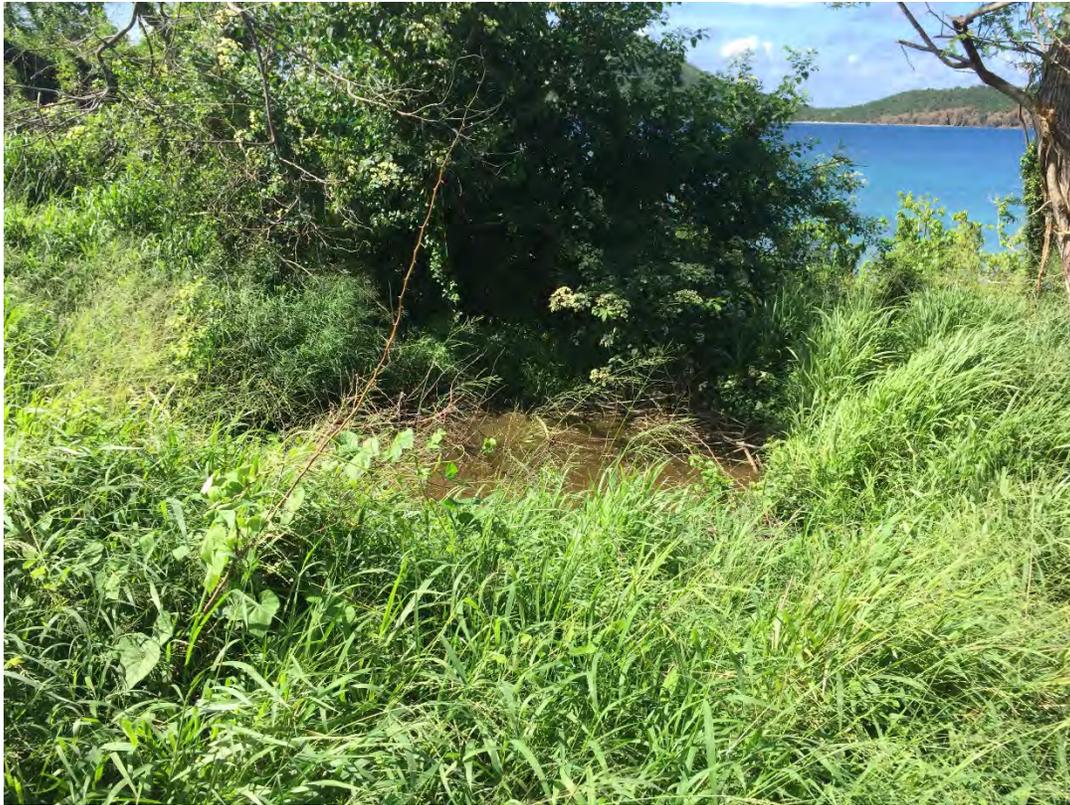
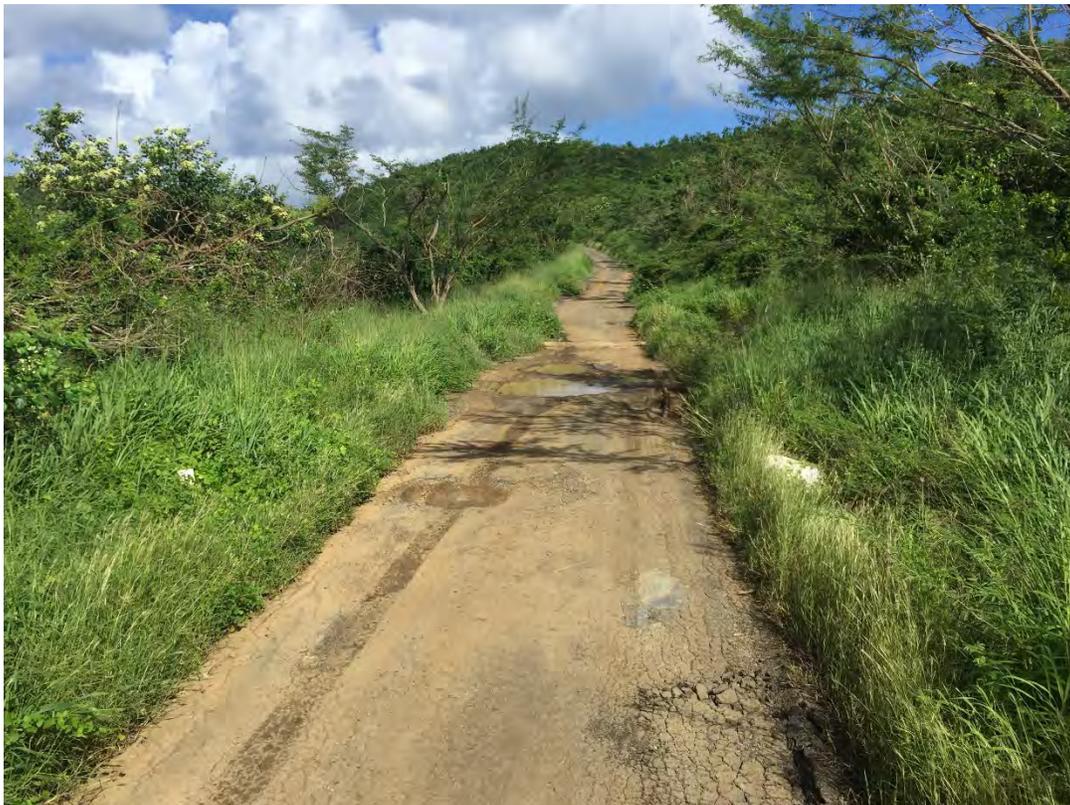
Damages as a result of the impact of hurricanes Irma and Maria at Tamarindo were found to be 100% structural and 100% vegetative. This level of damage should receive priority attention in comparison to the other Culebra implementation sites. During the post-hurricane evaluation, PDC found severe erosion of the previously stabilized road due to the rains associated with the storms. The photographs below show the formation of deep ditches formed by the water flowing over the road. Vegetation was also overgrown and covering the BMP structures put in place during project implementation. Implementation for the coastal stabilization work was also severely impacted and in need of repairs (Figures 41-44).

Figure 42. Damages suffered at the Tamarindo site following hurricanes Irma and Maria.

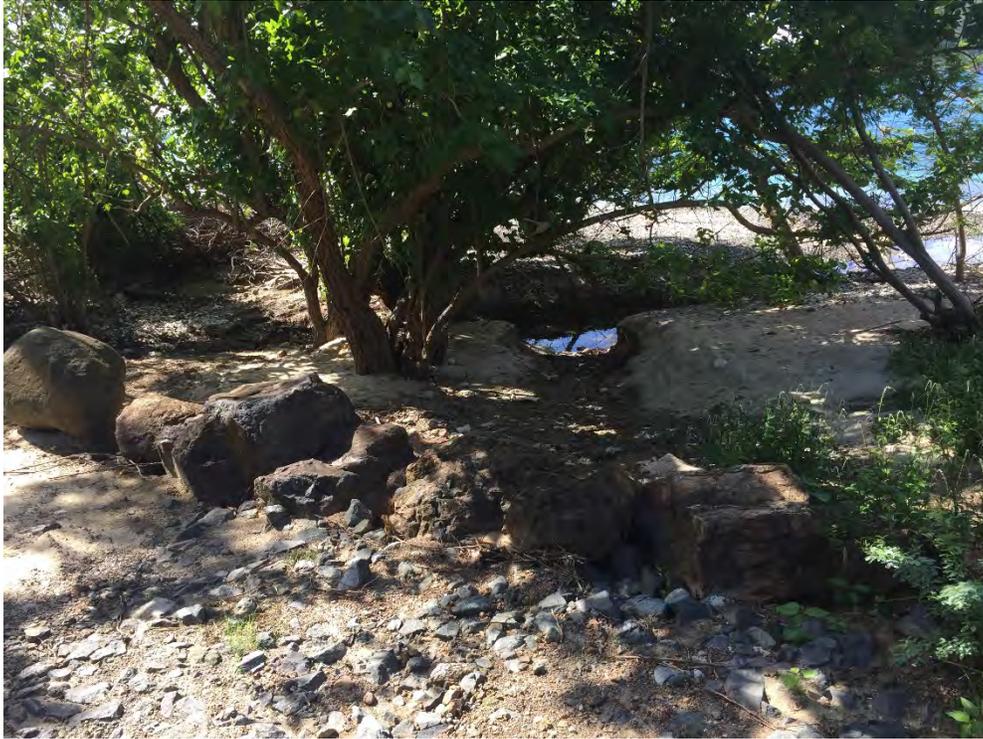
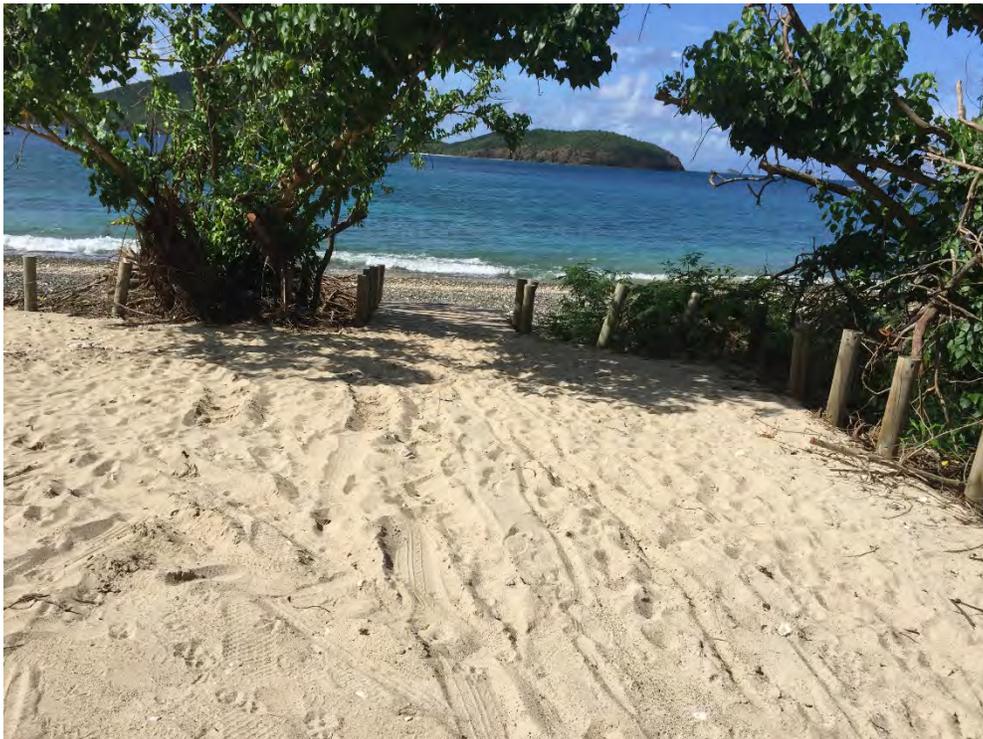
Figure 43. Damages suffered at the coastal Tamarindo site following hurricanes Irma and Maria.

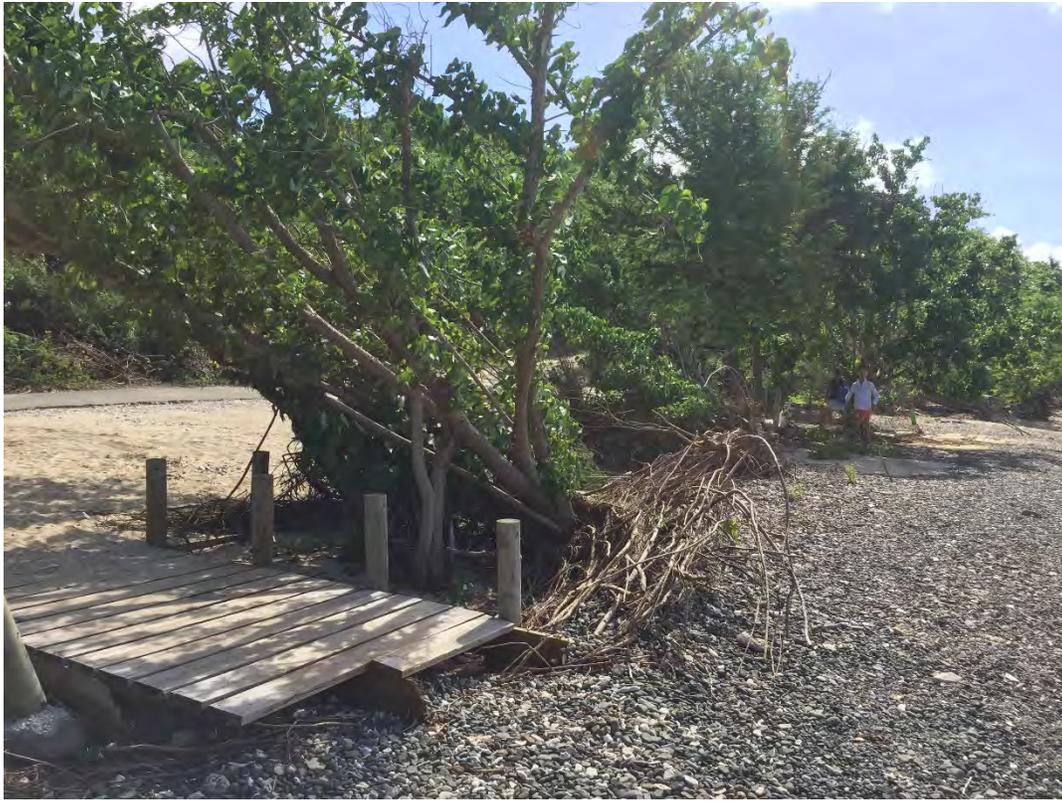
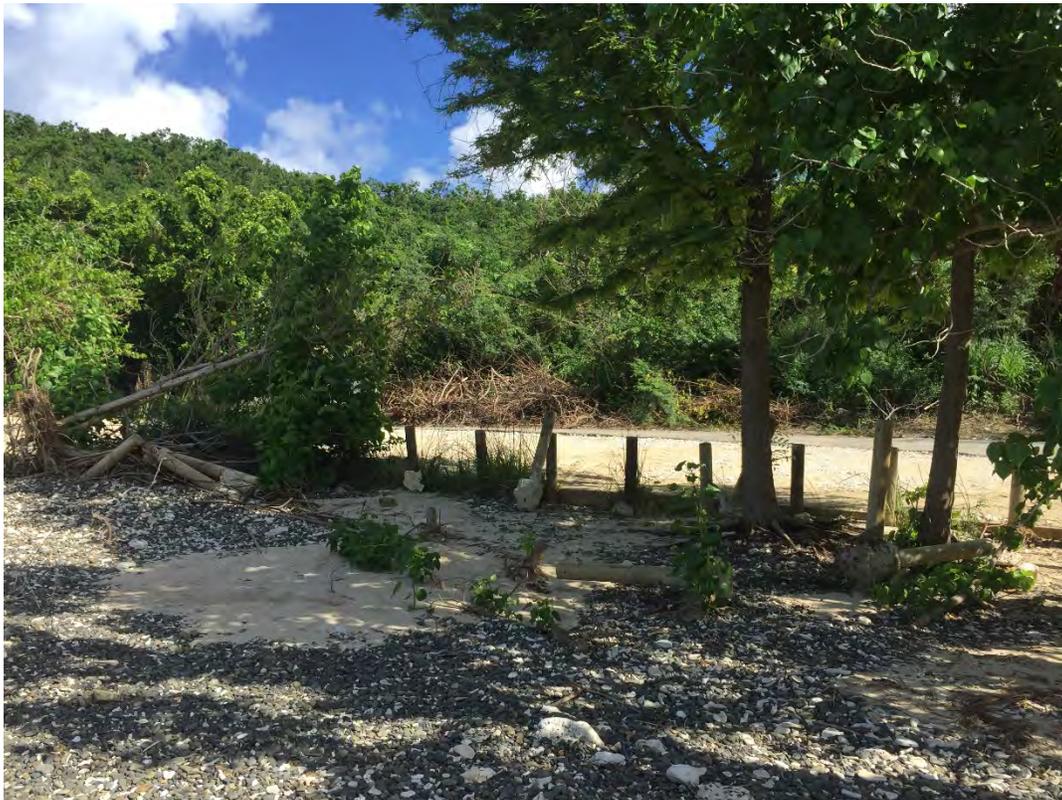
Figure 44. Damages suffered at the coastal Tamarindo site following hurricanes Irma and Maria.

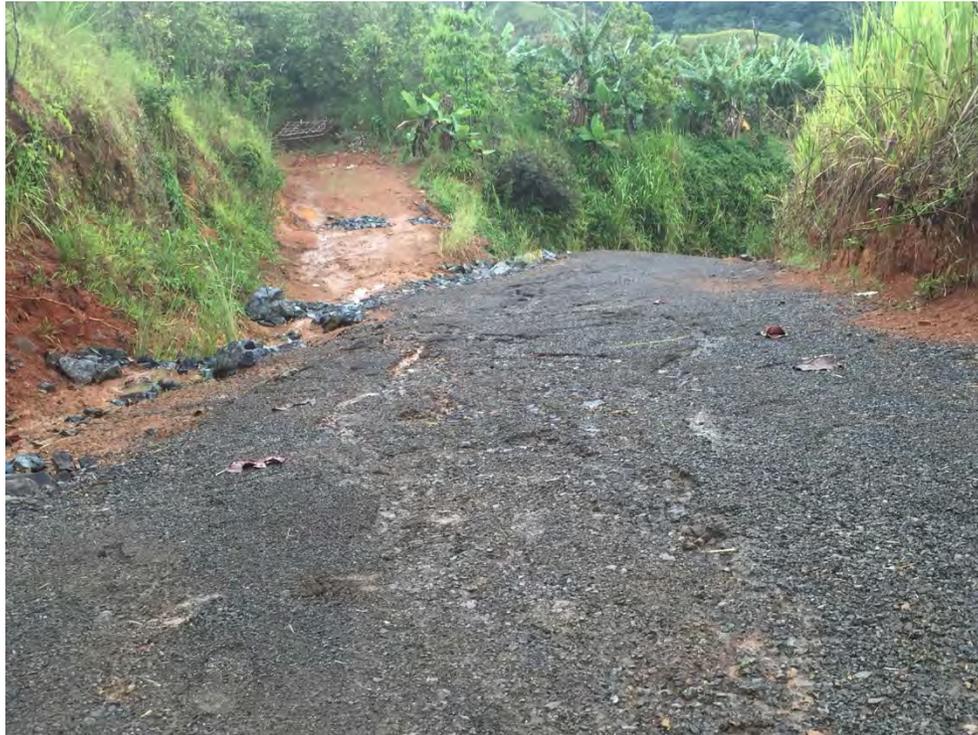
The previously implemented BMPs in the upper Guánica Bay watershed were seriously impacted by hurricane Maria in September 2017. As a result of the amount and duration of rain, major landslides occurred at the farms targeted during project implementation. Large quantities of runoff were reported and responsible for damaging the check dams, swales, sediment traps and stabilized roads. In the photographs below, it is evident that these BMPs require immediate restoration in order to return them to optimum conditions and allow the continued runoff and sedimentation control impacting the lower Guánica Bay watershed (Figures 48-50).

*Figure 48. Damages suffered at Guánica Bay watershed site following hurricane Maria.*

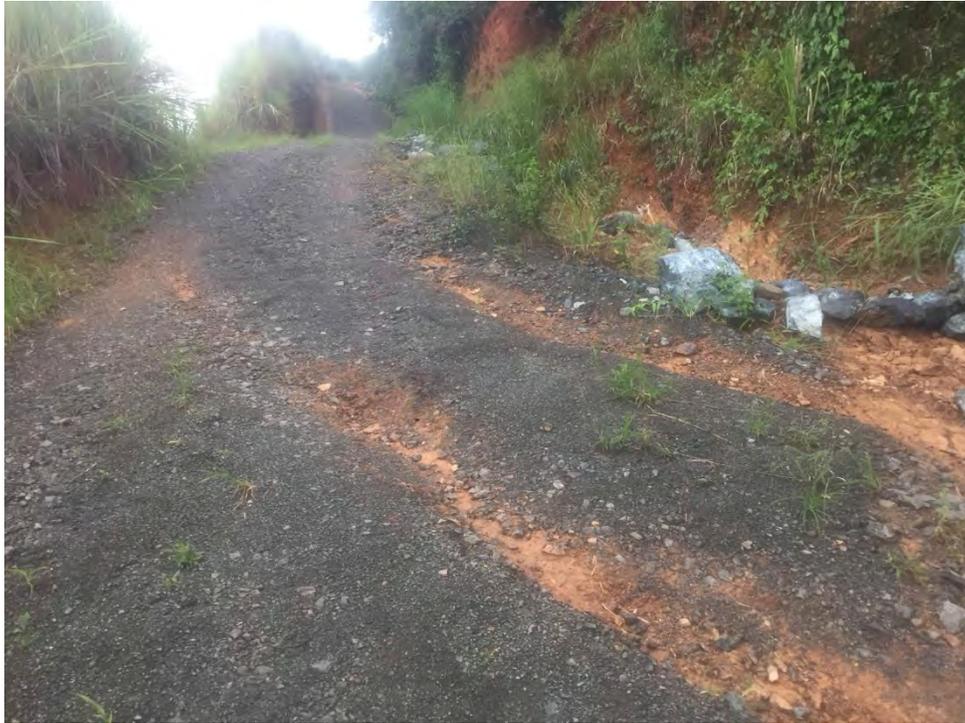
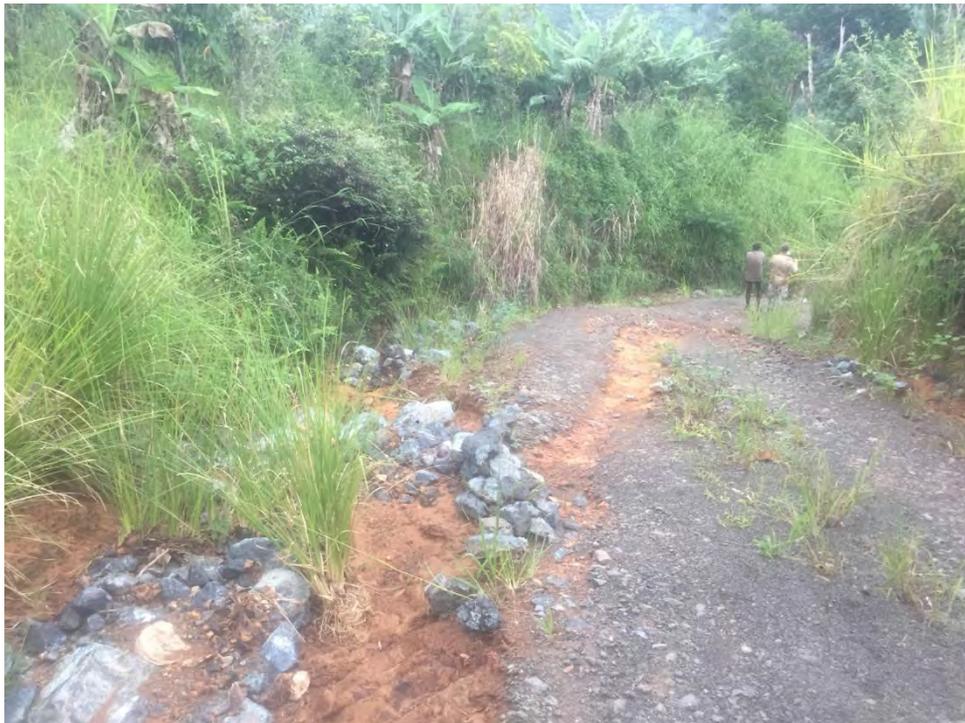
Figure 49. Damages suffered at Guanica Bay watershed site following hurricane Maria.

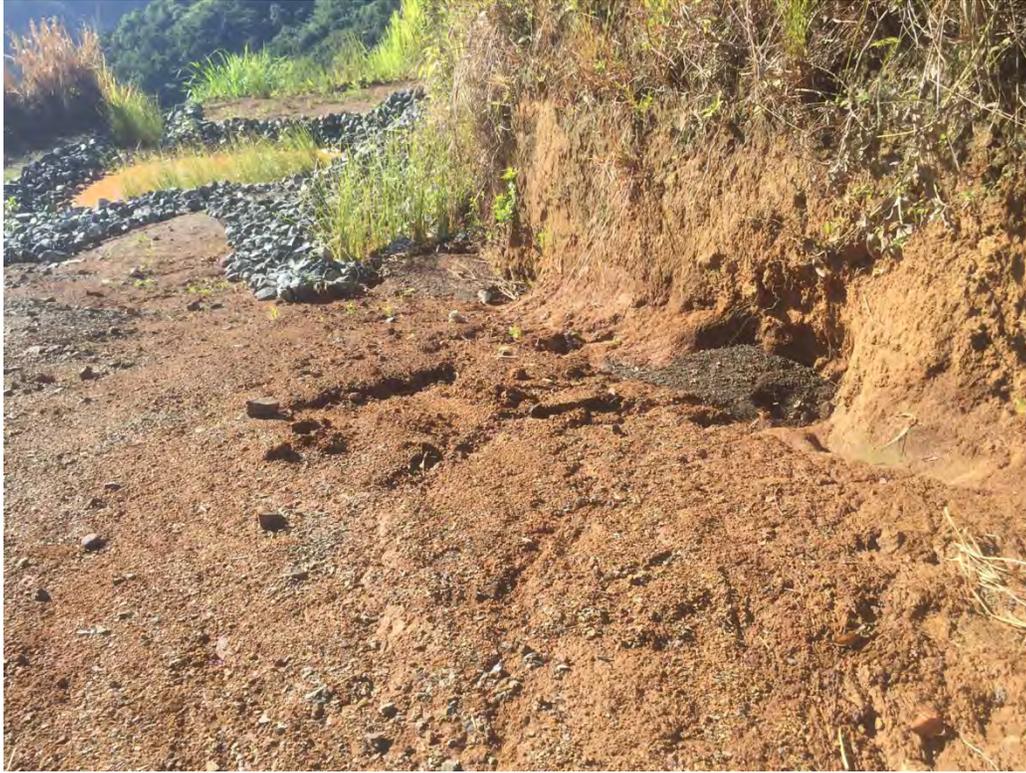
Figure 50. Damages suffered at Guánica Bay watershed site following hurricane Maria.
