PUERTO RICO ARTIFICIAL REEFS EVALUATION ON THE EAST COAST

**RE: PROGRESS REPORT #1 - PUERTO RICO ARTIFICIAL REEFS EVALUATION ON
THE EAST COAST. CONTRACT # 2013-000096**

PUERTO RICO ARTIFICIAL REEFS EVALUATION ON THE EAST COAST PR CONTRACT # 2013-000096

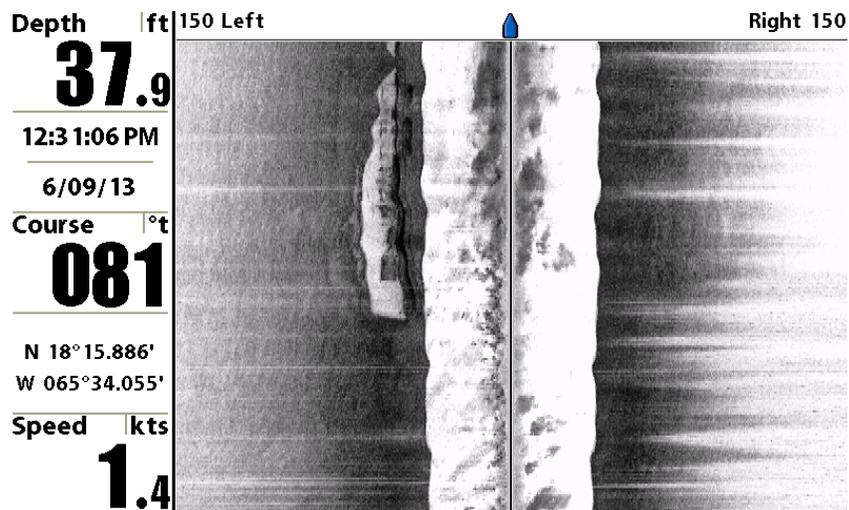
SD CARD IMAGE #1

Larger Wreck-Look alike structure

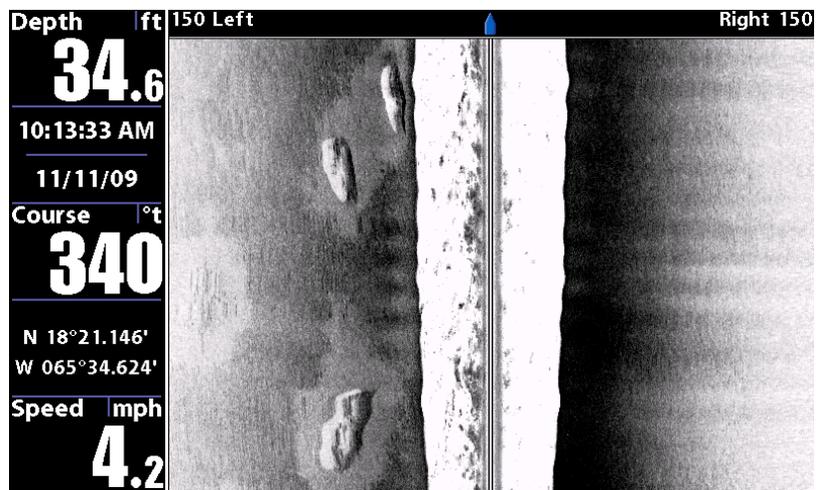
SD Card Image #2
Sunken Sailboats

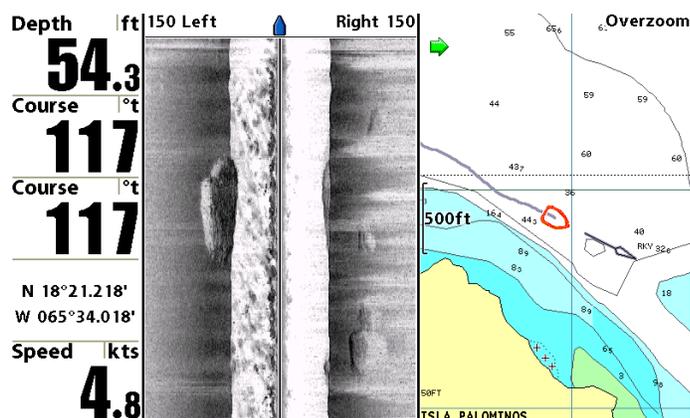
Item #4

Item # 4, located close to the north east coast of the Palomino Island will require further study. Due to the proximity to the cliff on shore and windward conditions, this target will need proper sea state during next ROV/ visual inspection phase. The target resembles a near fifty feet length vessel.

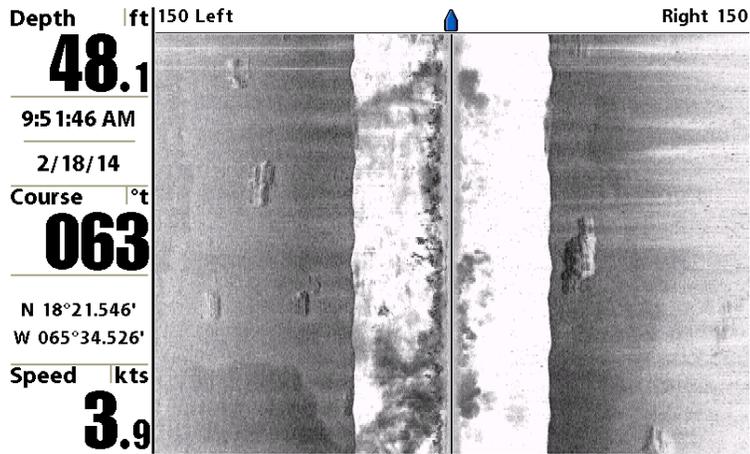
Item #5

Item #5, Was found off the north point of Palomino Island, outside the protected waters of "Punta Aguila" at a depth of approximate 50 feet. The possible wreck site appears to be formed by various structures or debris of man-made materials.

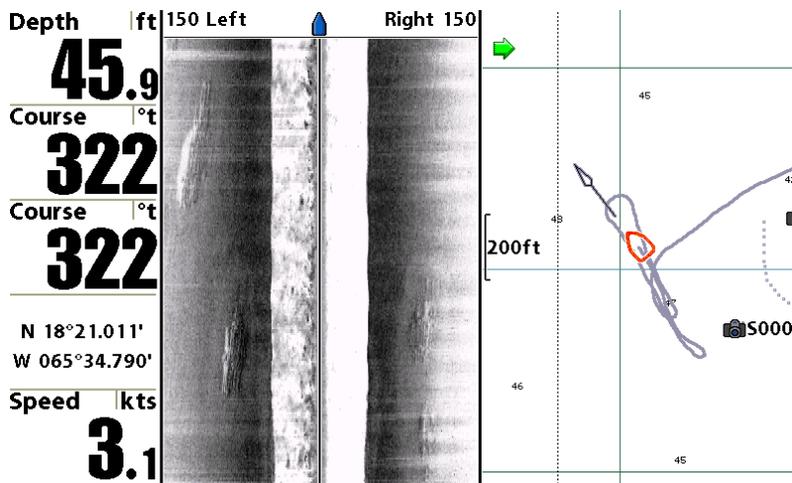
Item #6

Item #6, A long and narrow structure resting in 46 feet deep with the shape of a medium size sailing vessel. The site will be explored with ROV or scuba in order to further study the type of structure.

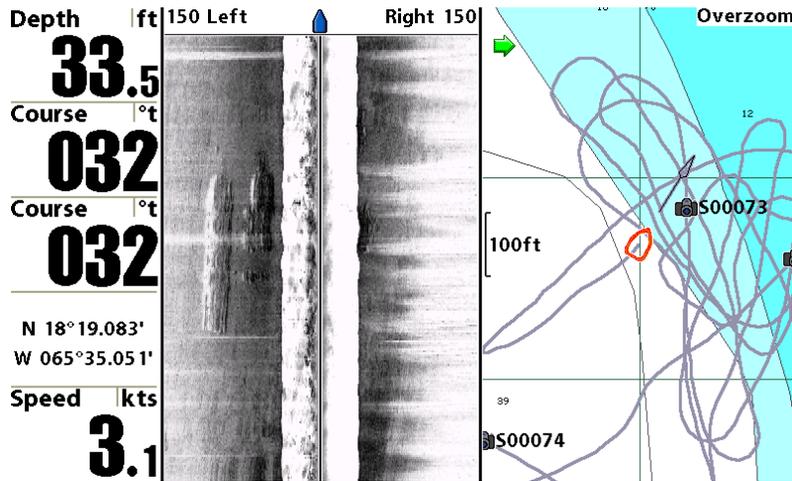
Item #10

Item #10, Located on the South West corner of an "open water" reef called Cayo Largo. Resembles a steel hull structure because of the strong return signal. Also because its proximity to the famous "Cayo Largo" reef, it is very probable to be some type of wreck. Please see SD Card image for details.

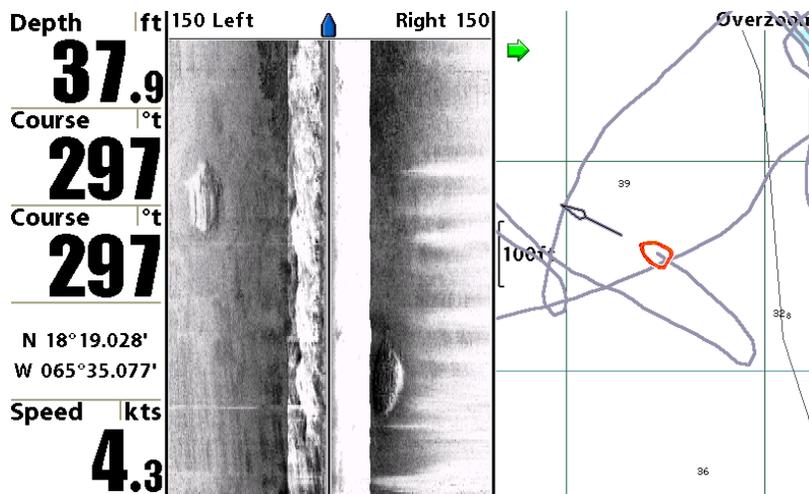
Item #11

Item #11, Also located near Cayo Largo Reef, the target in 38 feet of water, resembles a medium size vessel.

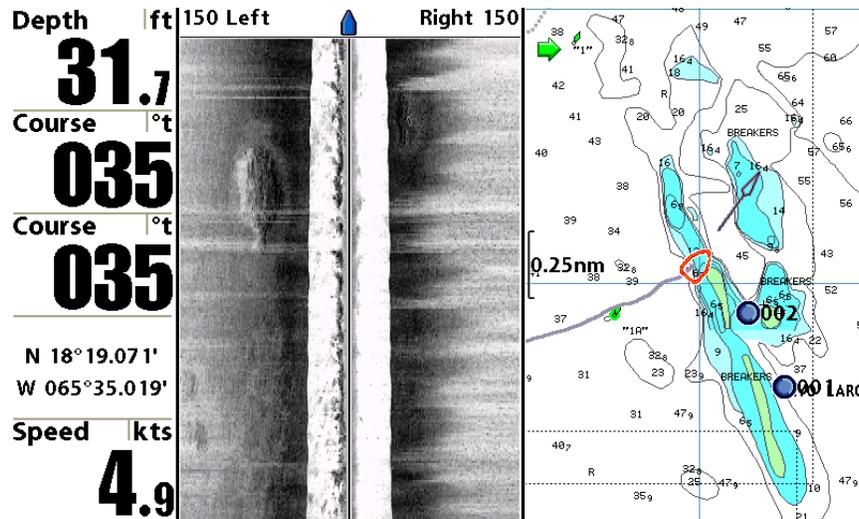
Item #12

Item #12, Very close to Item #10. The apparent structure can very well be the same as Item#10. Appears to be a smaller target but due to proximity, is possible to be one and simply look different due to the angle of the boat passing over. The narrow point on the object seen on the SD Card image could be the bow of a small power or sailboat.

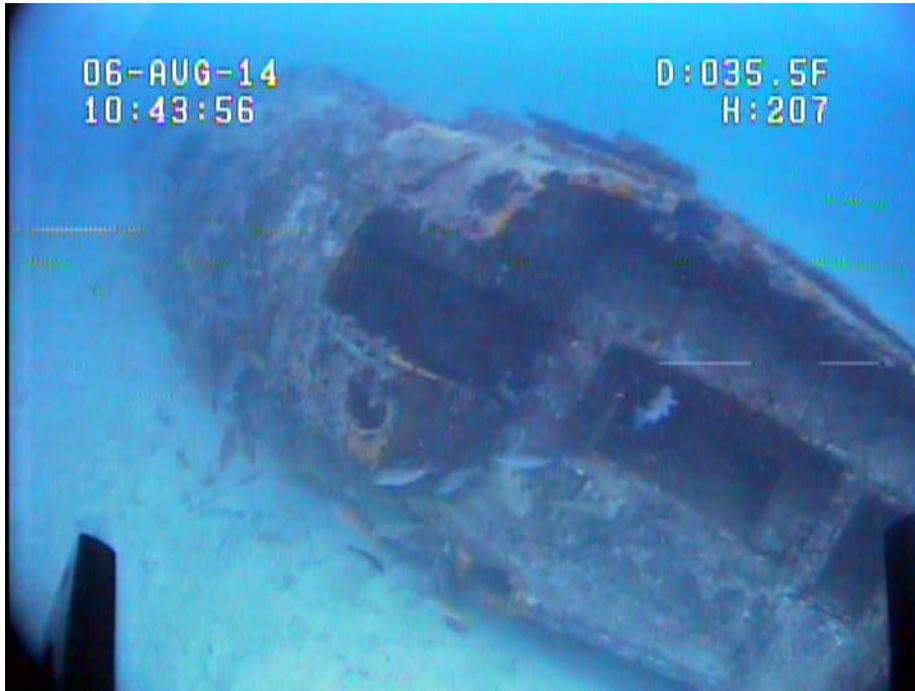
Target #1

Located on the leeward side of Palomino Island, this verified wreck is a production sailboat of approximately 30 feet in length. The wreck sits on a sandy bottom of 38' depth with a noticeable list to her port side. Amidships on the starboard hull, exists a large rectangular opening of about 8 feet long by three feet wide. The companionway hatch is fully opened providing easy access to interior. Cockpit is mostly free of debris with some missing hatch doors. Standing rigging cables should be removed from mast step area and sides. Auxiliary outboard engine still hanging from transom. Interior shows typical wreckage rubble and debris consisting of fragments of furniture, bunk cushions, and some electrical / plumbing hardware.

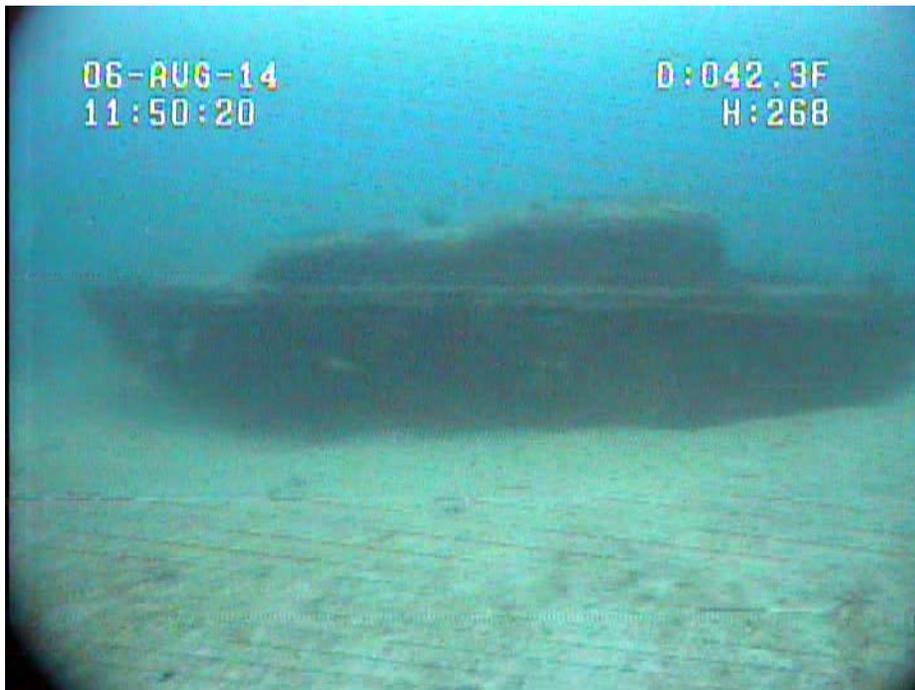
Target #2

Located less than 100 feet from Target#1, this is a classic Pearson 26' sailboat sloop. In general, the hull appears to have structural integrity. The wreck rests on an even keel on a sandy bottom as well. Most hatches are missing. Porthole side windows remain intact. Companion way hatch closed (but can be pushed back to open position). Many parts of rigging wires around cockpit and transom area. Interior shows typical rubble, cushions, wood fragments, electrical hardware.

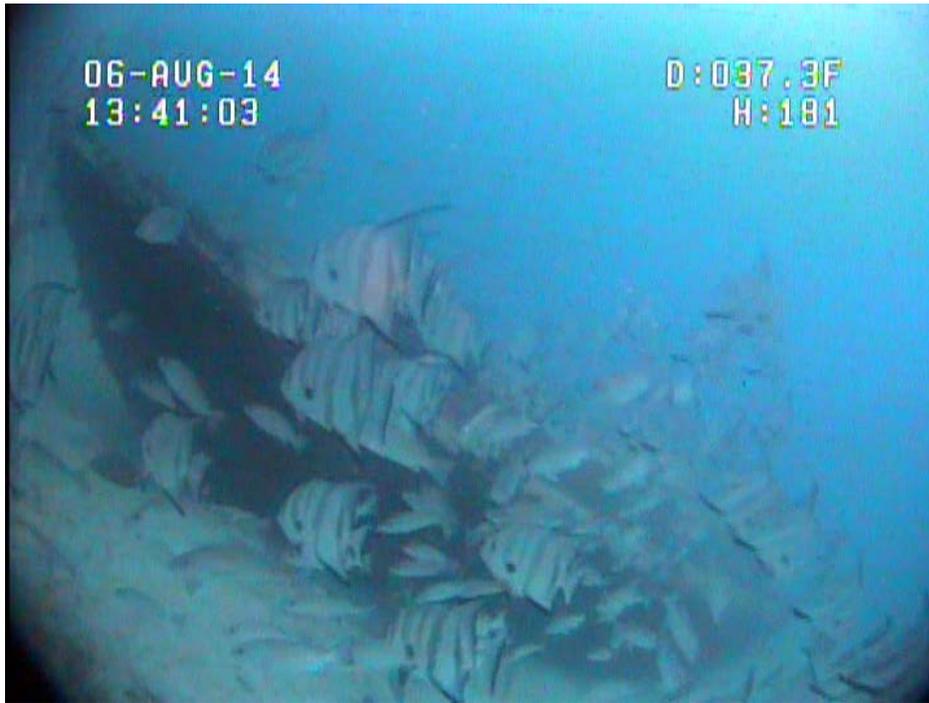
Target #3

Also located in the vicinity of the previous wrecks, wreck #3 is a slightly larger sailboat of approximately 35 feet in length. The wreck lies on a sandy bottom. The boat's helm pedestal still standing with wheel. Rigging cables, fiberglass fragments and debris observed in cockpit area. The sailboat's inboard diesel engine very probably to remain inside. Most hatches missing, main hatch fully opened or missing. Typical interior with substantial amount of wreckage fragments.

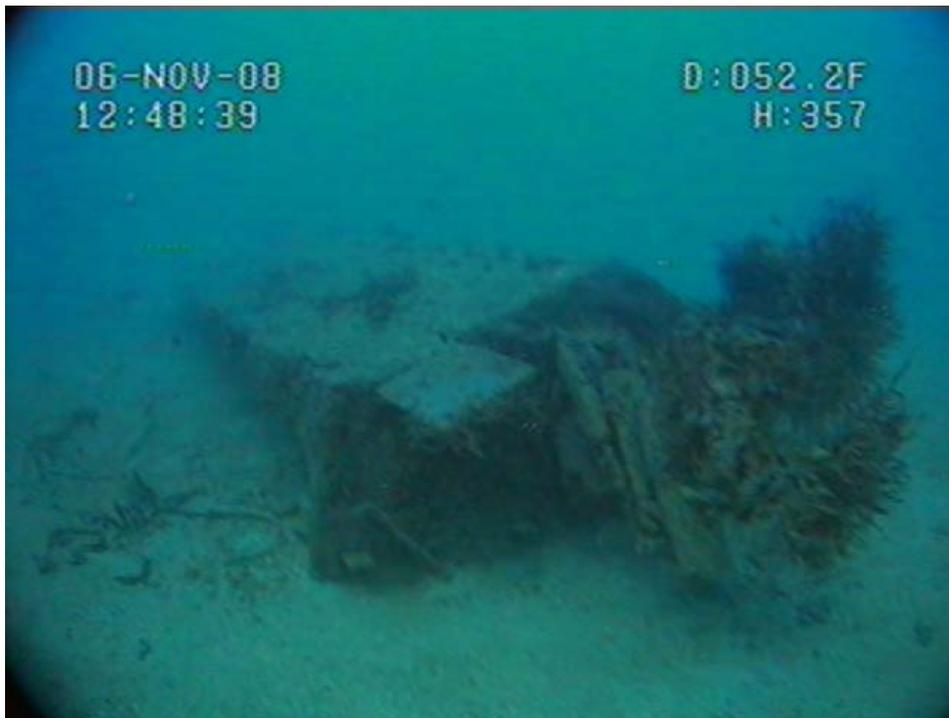
Target #7

Wreck of a small powerboat located south of Icacos Island beach area. The vessel appears to be an approximately 28' feet twin inboard cruiser resting inverted on a sandy seabed. The depth is 52 feet deep. Except for the two engine lower drives, no other substantial hardware is present. Some smaller hull fragments and electric cables were observed in the vicinity. The hull positioned upside down provides decent shelter to reef fish species. Among these ; *Anisotremus* sp., *Holocentrus* sp., *Acanthurus* sp., etc.

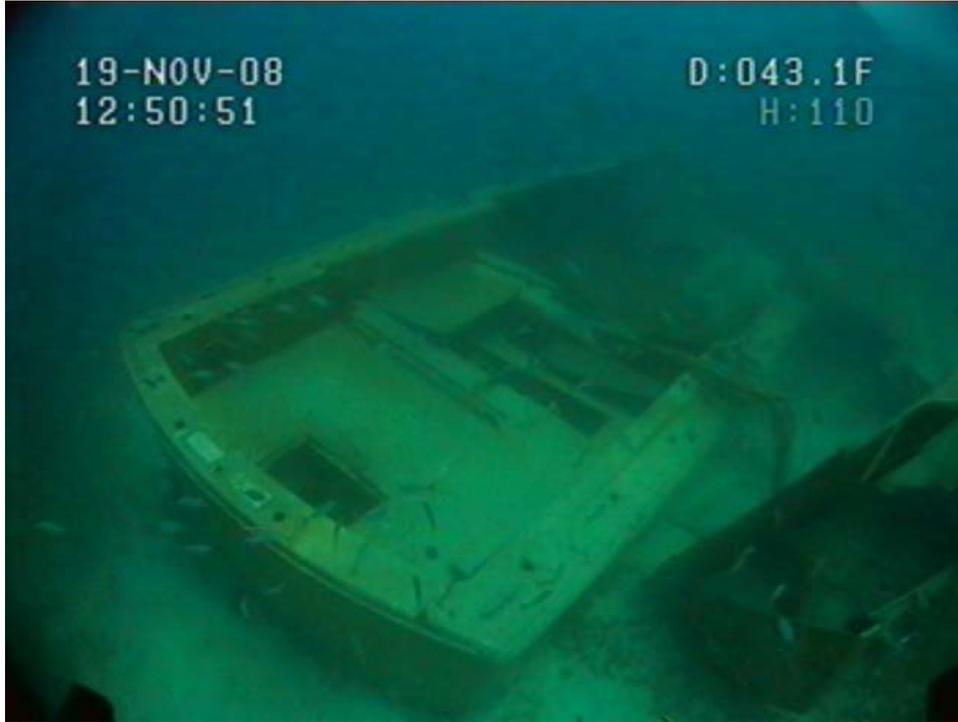
Target #8

A medium size wreck of a powerboat of about 34 feet in length. The structure was found off the south shore of Lobos Island in 46 feet deep. The remaining of the vessel are scattered in a radius of approximately 100 feet. The hull appears to be complete, resting evenly on a sea grass bottom. The rest of the wreck consists of dismantled tops, marine hardware, and fiberglass pieces. The interior or cabin is not accessible due to abundant debris on deck. Substantial amount of reef fish can be seen at this location.

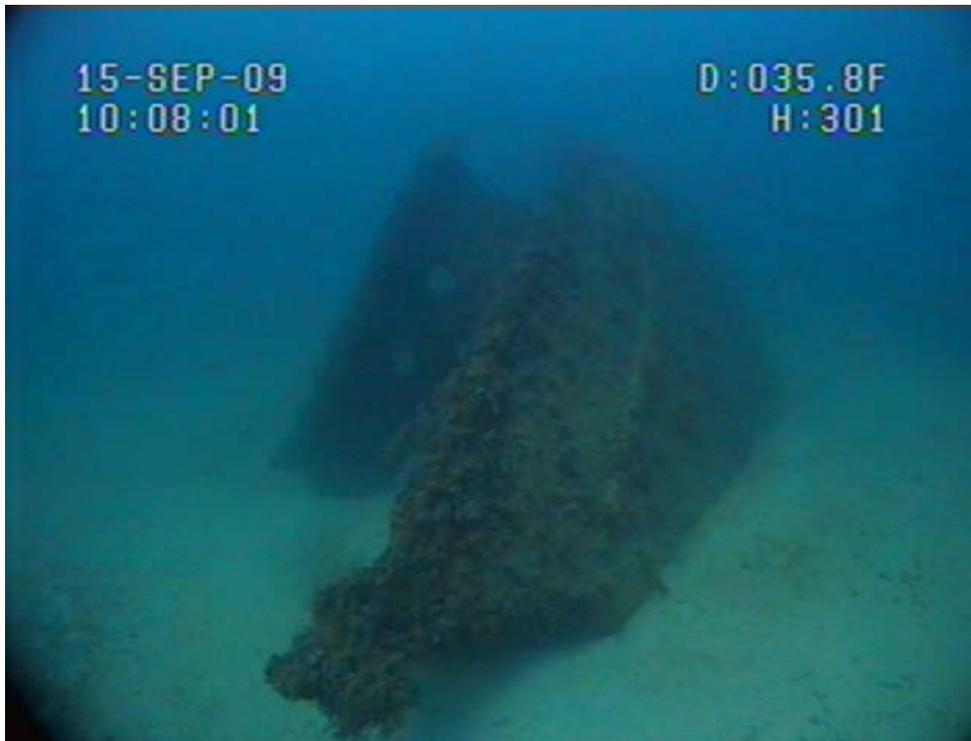
Target #9

A larger size structure consisting of a steel hull wreck. The vessel resembles a commercial fishing boat sunk in 47 feet of water north east of Cabeza de Perro Island. The hulk sits on a sea grass bottom with large sand patches. The wreckage rests on its starboard side. Port side hull not visible under seabed. The classic fishing vessel has a flat aft deck and forward wheel house with hardtop and round portholes. Aft towards stern, a few large openings are visible on the structure. The larger is possible a cargo hold with missing hatch cover. Others seem as fractures on the steel plating. The cargo hold can be easily accessed. Great amounts of various fish species live in this void. Forward towards the wheel house, no doors are found and very few obstructions, although typical amount of debris present. On the seabed vicinity, some large and medium size metal fragments can be seen. The overall marine growth coverage on this wreck indicates at least 30 years sunk. The amount of fish (mostly *Lutjanos griseus*) swimming on this wreck is stunning.

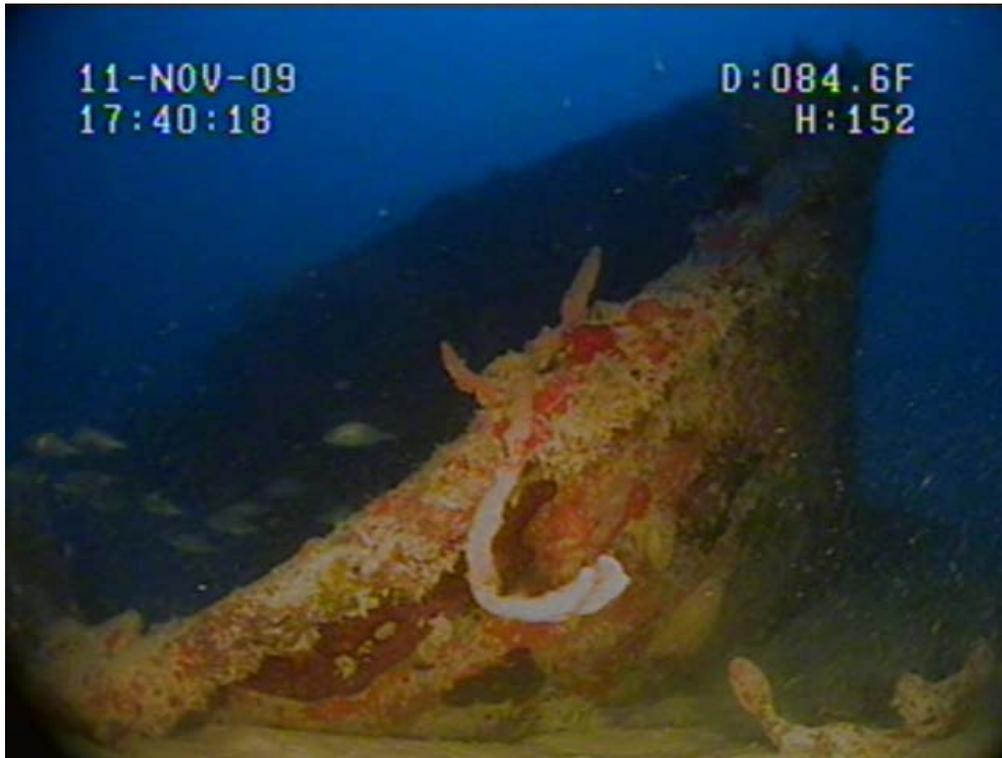
Target #13

and visibility is less than 12 feet. The structure provides shelter, however is not as integral as the other wrecks found. Seems that the deck was separated from the hull.

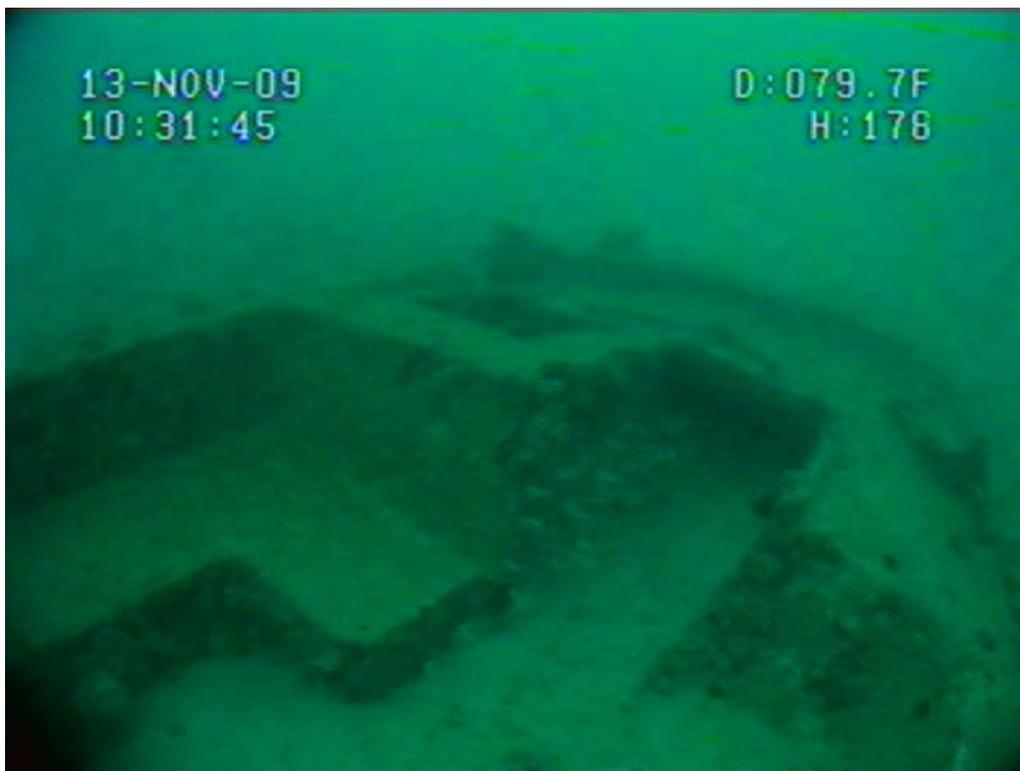
Target #14

Located off the south shore of Palominito Island at 83' feet depth. The only part visible of this sailboat is the top deck. The rest may be in the sub bottom or simply not in the same location. The deck resembles a 35+ feet length overall sailboat. All hatches are missing, exterior hardware, rigging and windows. The deck platform lies flat on seabed. The color and texture of the marine growth on the structure resembles the actual seabed, giving the wreckage a camouflaged feature.
