# South Kohala Stream Corridor Assessment Erosion Monitoring, and Recommendations

## Final Report September 2014

Prepared for:  
Hawaii Department of Land and Natural Resources  
Division of Aquatic Resources  
1151 Punchbowl St, Room 330  
Honolulu, HI 96813

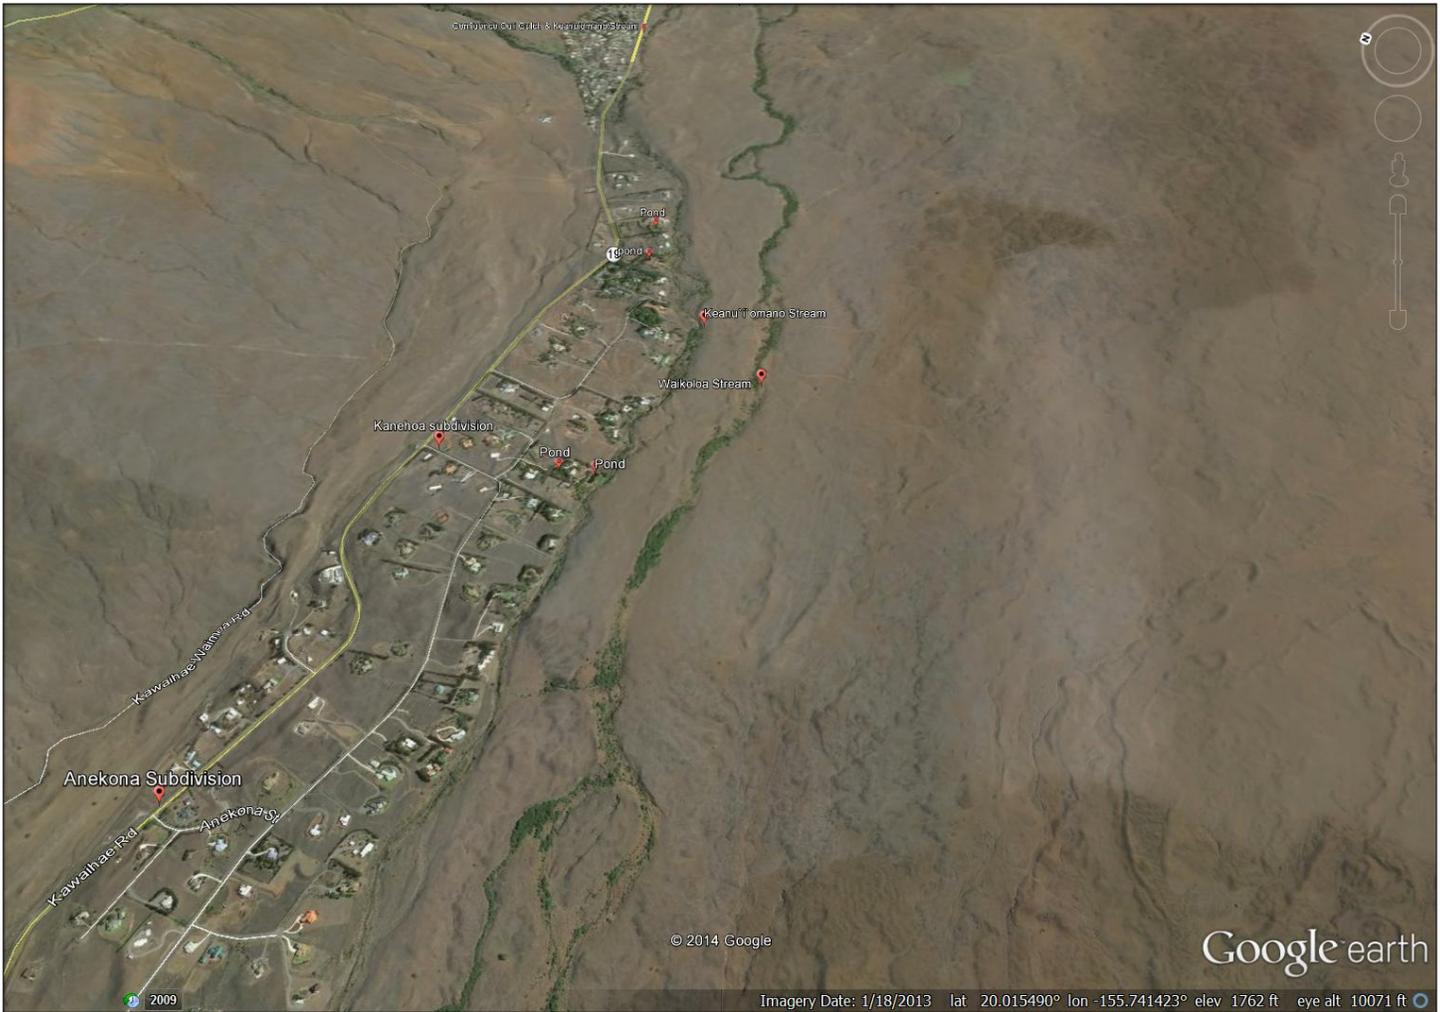
### Photo 11. Ponds

Four ponds adjacent to Keanu'i'iomanō Stream. The source of water for these ponds, which are located on private parcels, is assumed to be withdrawals from the stream.

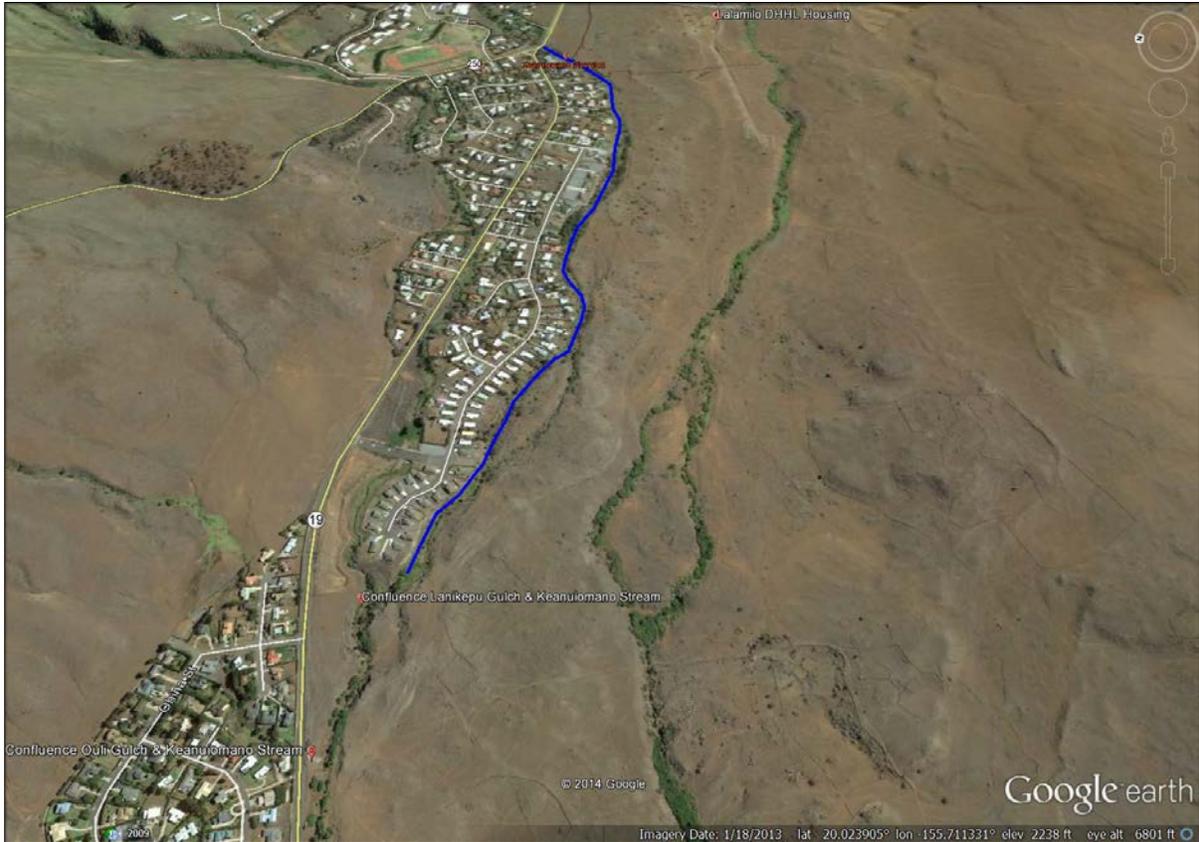
**Photo 12. Keanu'í'omanō Stream, nearby development**

Blue line depicts Keanu'í'omanō Stream; houses to the left and their OSDS close to stream.

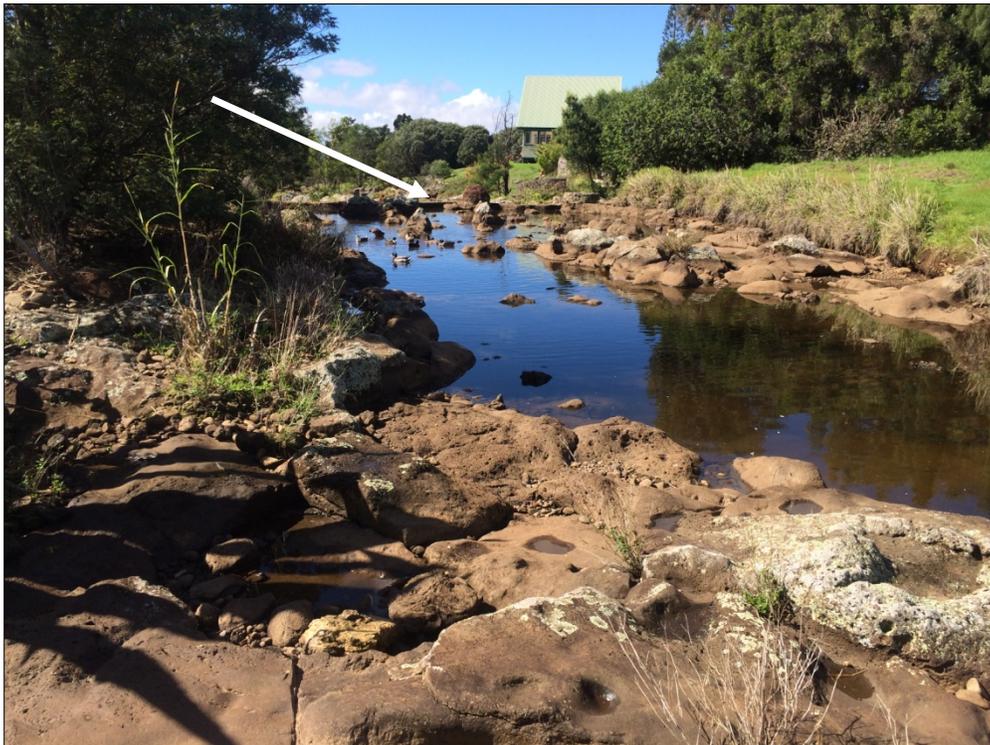
**Photo 13. Rock Dam on Keanu'í'omanō Stream**

Rock and mortar dam on stream near Waiaka Street.

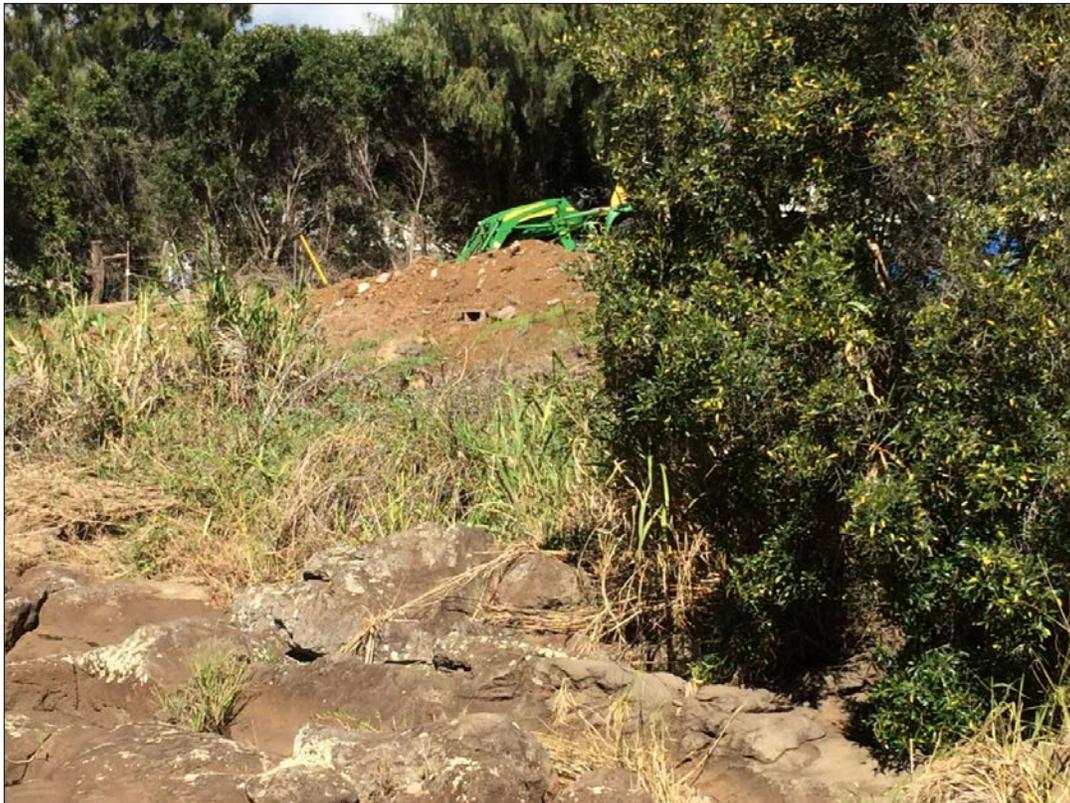
**Photo 15. Stream Encroachment**

Uncontained fill above Keanu'i'omanō Stream.

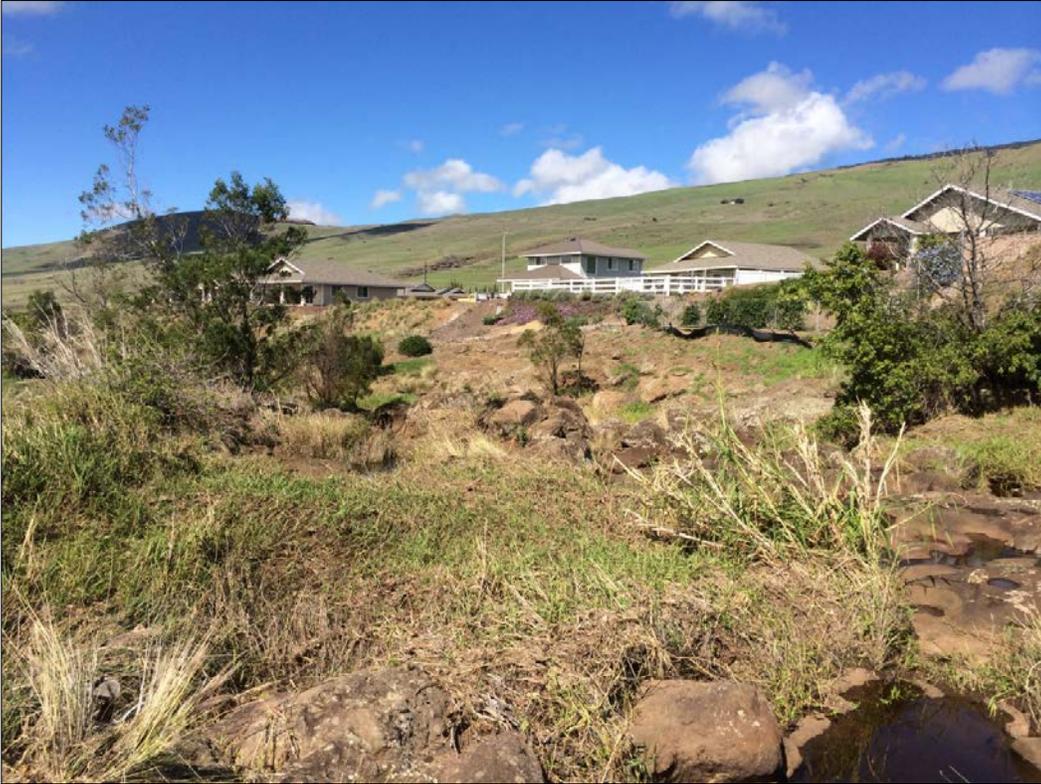
**Photo 16. Failing BMP along Stream**

Silt fence failing; fill material was observed in active channel.

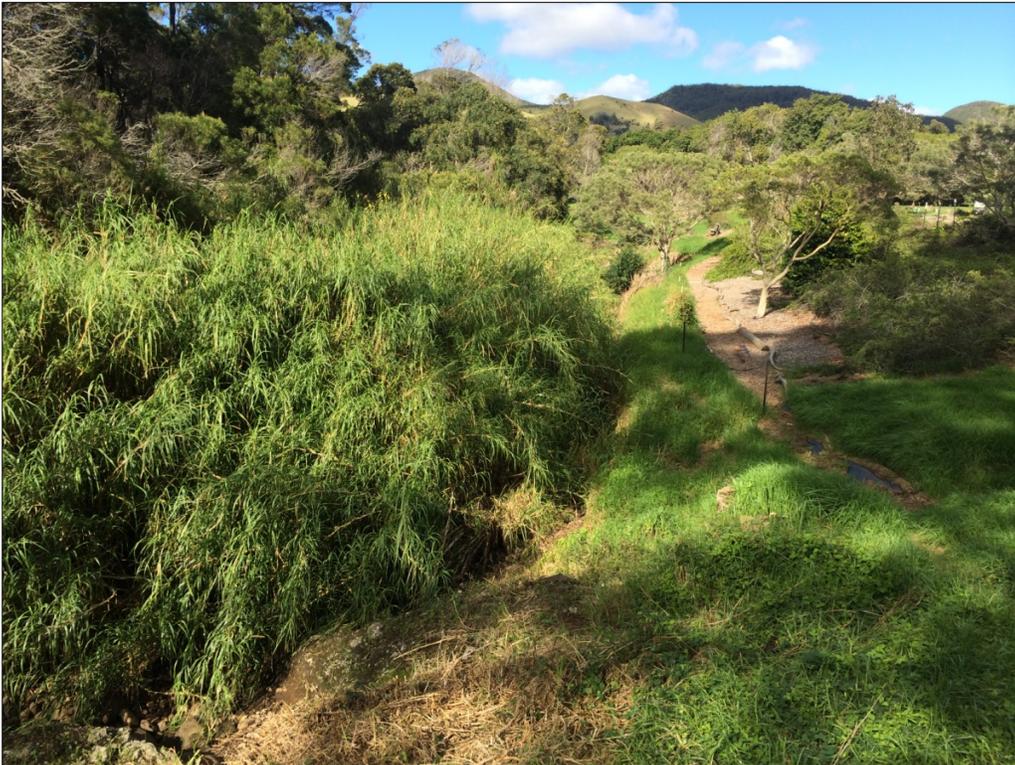
**Photo 17. Waikoloa Stream, channel blockage**

Section of Waikoloa Stream along trail below Waimea Nature Park.

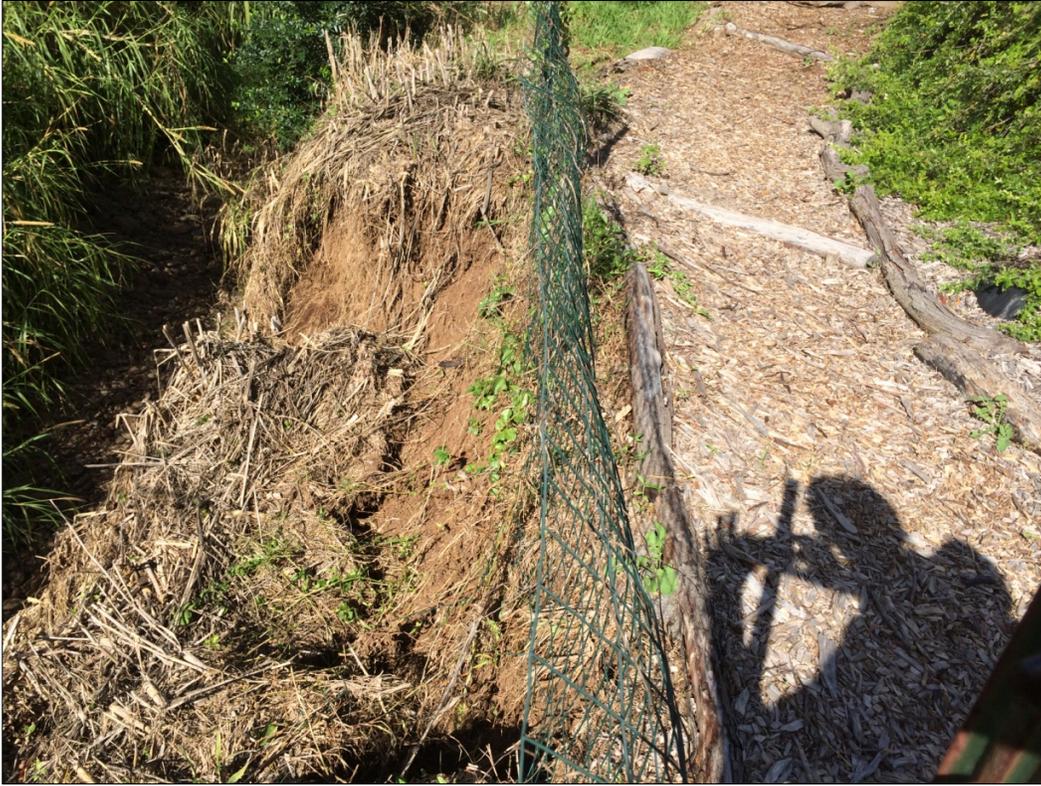
**Photo 18. Waikoloa Stream, failing stream bank**

Section of Waikoloa Stream bank within Waimea Nature Park.

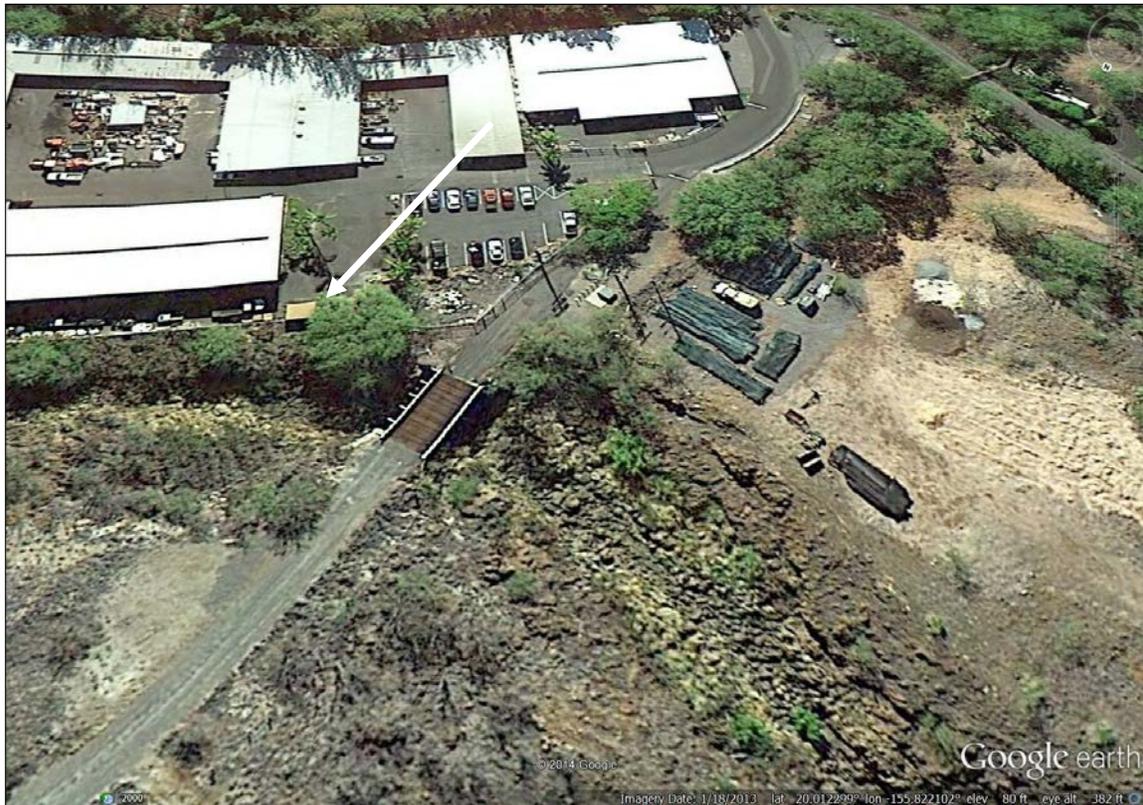
**Photo 4. 4PT, Maintenance yard runoff**

Edge of parking lot located on top of Wai'ula'ula Stream south bank.

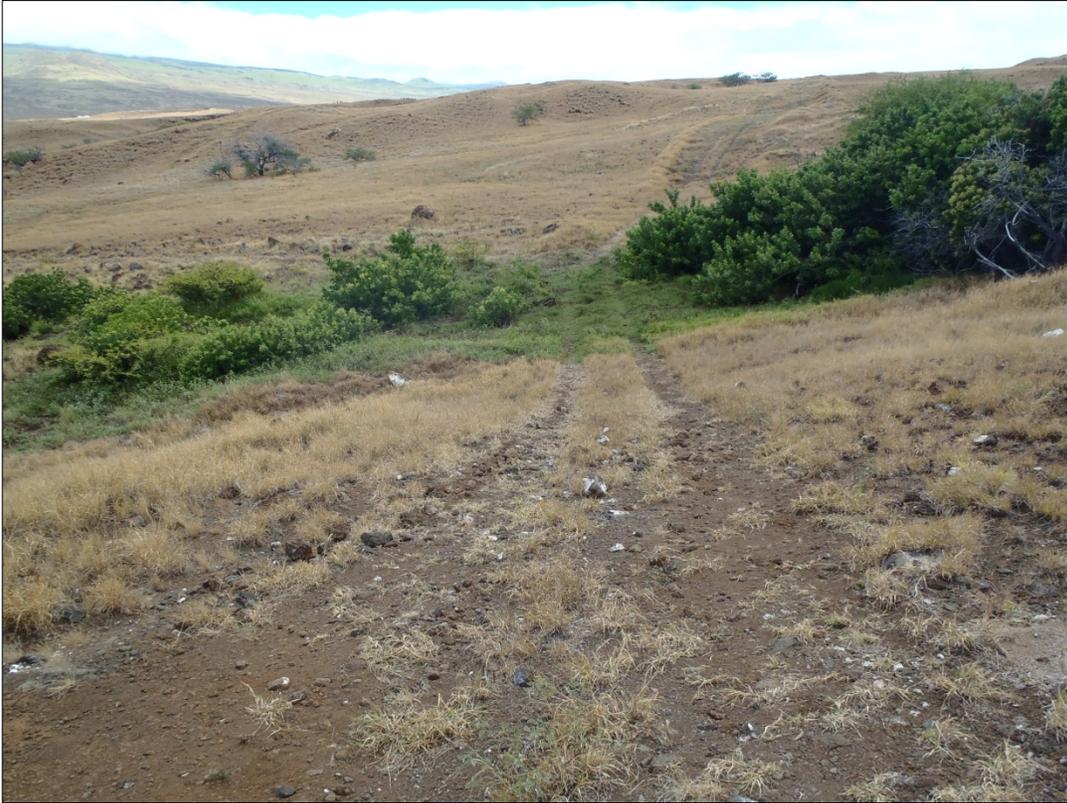
**Photo 7. 9PT, Dirt Road Crossing Channel**

Dirt road approach over southern branch of Waikoloa Stream, State Land

8PT	Sediment input at dirt road crossing stream	Stream ford over southern branch Waikoloa Stream downstream of Old Rock Wall	Mauna Kea Plantation Estates	Low	Diversion swale
9PT	Sediment input at dirt road crossing stream	Stream ford over southern branch Waikoloa Stream upstream of Old Rock Wall	State of Hawaii	Low	Diversion swale and road BMPs
10PL	Degraded channel, sedimentation/erosion from cattle	Southern branch Waikoloa Stream above confluence with Keanu'i'omanō Stream	State of Hawaii	Low	Fencing
11PL	Degraded channel, sedimentation/erosion from cattle	Middle branch Waikoloa Stream above confluence with Keanu'i'omanō Stream	State of Hawaii	Low	Fencing
12PT	Sediment input at dirt road crossing stream	Confluence of Waikoloa and Keanu'i'omanō Streams	State of Hawaii	Low	Diversion swale and road BMPs
13PG	Cut fill pile with coarse and fine materials migrating into Waikoloa Stream	Waikoloa Stream DHHL Land Lalamilo Phase 2	State of Hawaii - DHHL	High	Stabilize pile; drainage

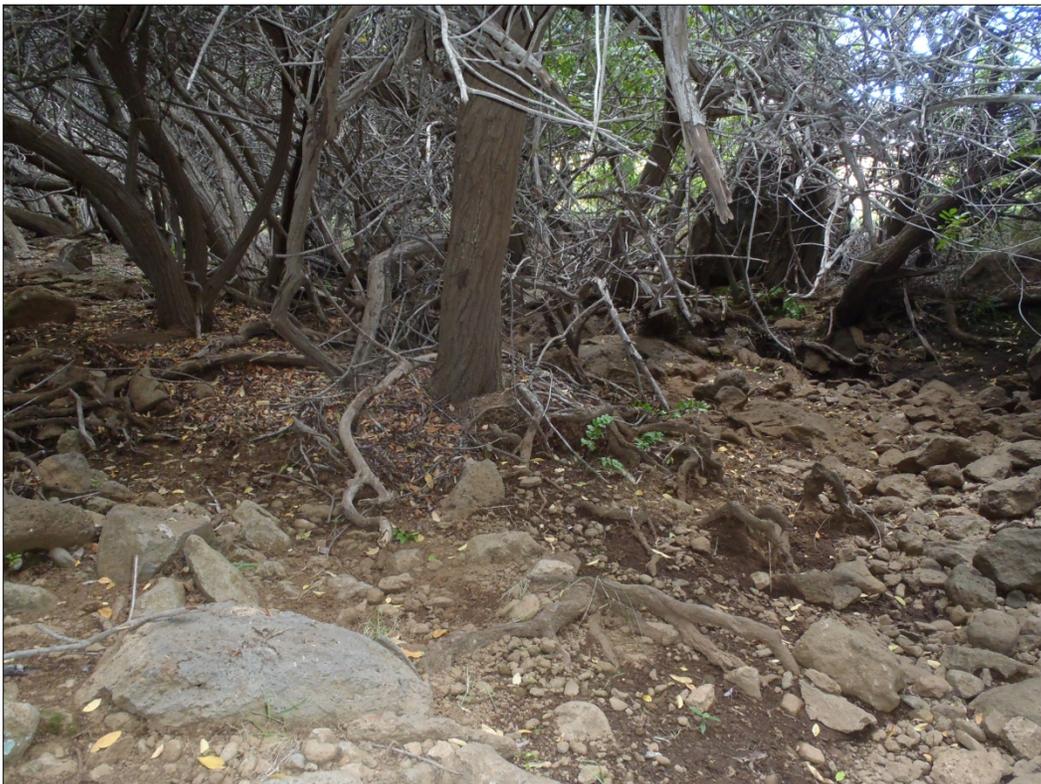
**Photo 8. 10PL & 11PL, General Landscape Image**

Channel on Waikoloa Stream branch, typical of accessible steam areas where cattle bed.

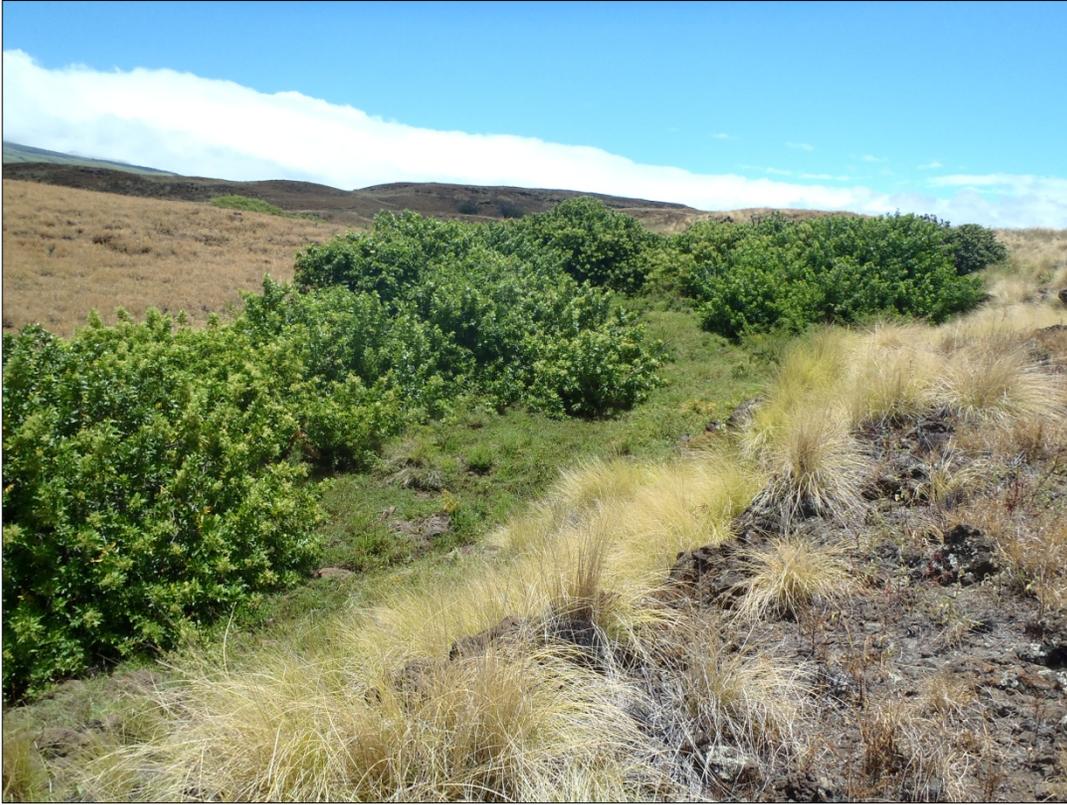
**Photo 9. 16PG, Typical Stream**

Representative image of stream zone within trees, varying degree of stream channel damage

Site ID	Issue	Location	Land Owner	Priority	Management Measures
15PT	Stream bank trampled by cattle	Keanu'i'omanō Stream at Ouli Gulch	State of Hawaii	Medium	Fencing, bioengineering, install water trough for cattle
16PG	Stream damage by cattle	Waikoloa Stream downstream of DHHL-State parcel	State of Hawaii	Low	Fencing, bioengineering
17PG	Erosion of steep exposed slope above Lanikepu Gulch	Lanikepu Gulch west of HPA	Parker Ranch	Medium	Bioengineering
18PT	Erosion of channel at culvert outfall	Lanikepu Gulch at Kohala Mountain Road	UK	Low	Outfall protection/energy dissipater
19PG	Sediment runoff into stream	Waikoloa Stream at UH Lalamilo Farm	State of Hawaii	Medium	Sediment buffer, bioengineering, grade adjustment
20PL	Sediment discharge off access road along margin of crop field	Waikoloa Stream, Lalamilo Farm Lots	UK	Low	Bioengineering, sediment buffer
21PL	Eroding and unstable stream bank in paddock	Keanu'i'omanō Stream at junction of Kawaihae Road and Kohala Mountain Road	UK	Medium	Fencing, revegetate exposed banks

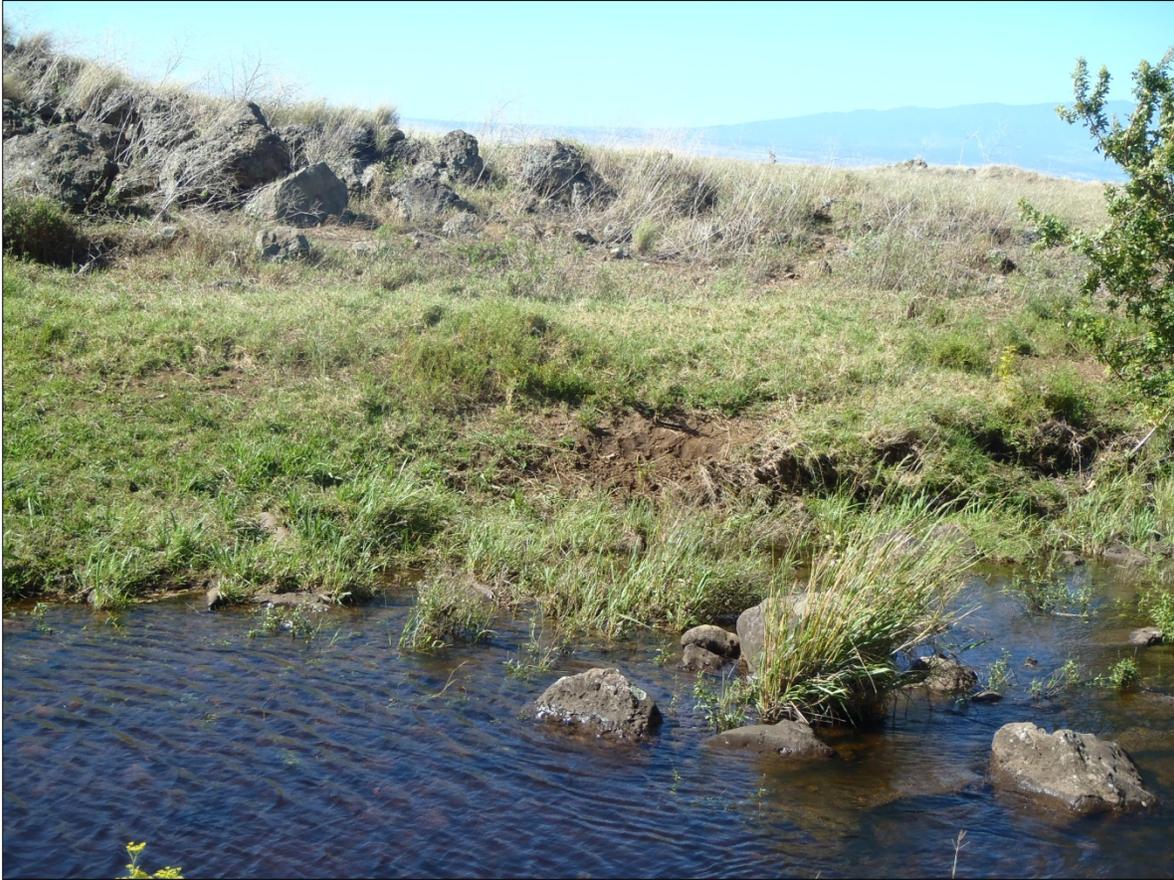
**Photo 11. 15PT, Bank Damage**

Keanu'i'omanō Stream access point by cattle at perennial pool

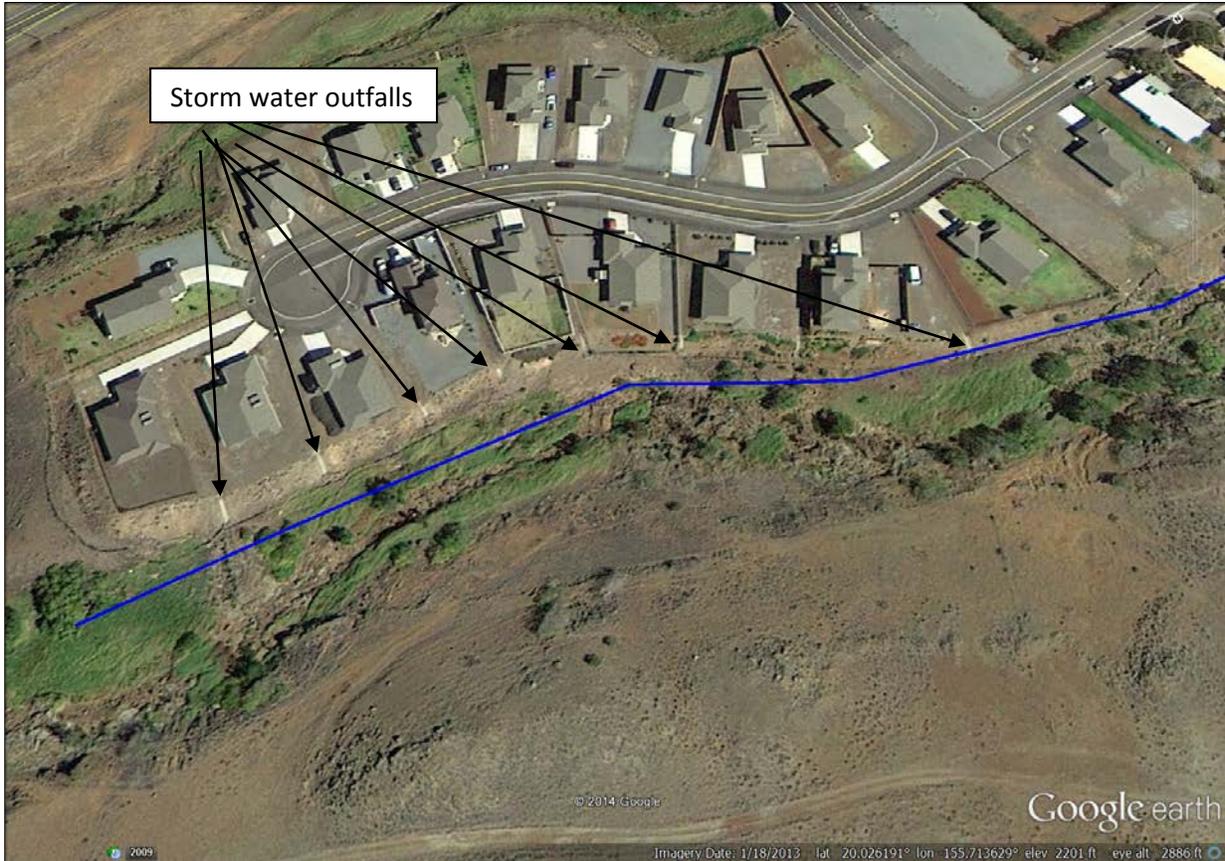
**Photo 13. 29PT, Storm Water Outfalls**

Waiaika subdivision home lots with rock mortar swales discharging onto bank of Keanu'i'omanō Stream

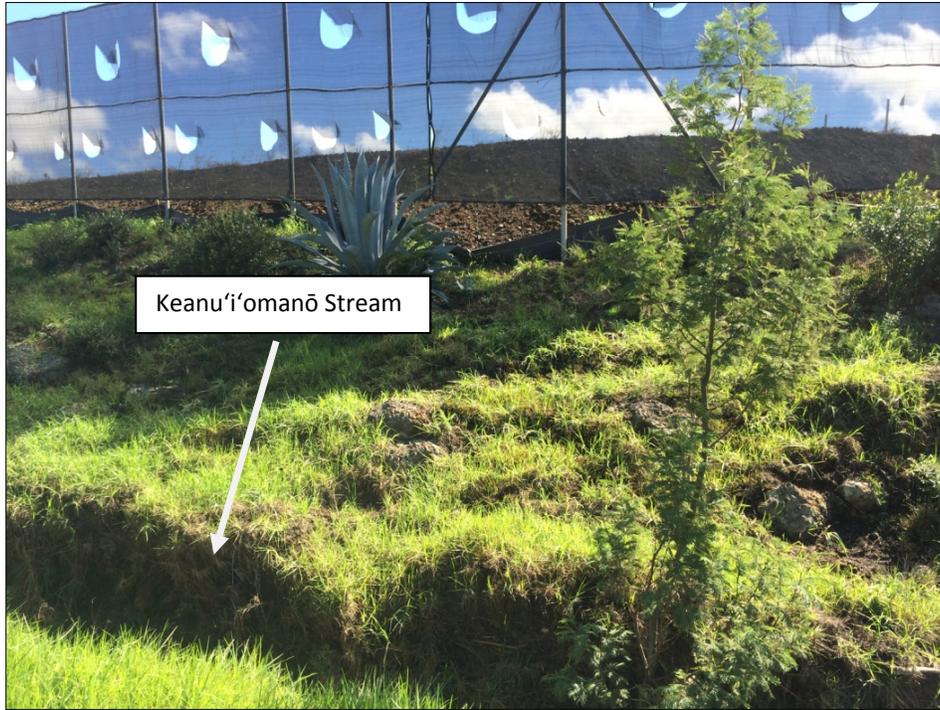
**Photo 15. 24PG, Cut and Fill Piles**

Cut and fill piles spilling onto floodway and stream from State DHH Lalamilo development

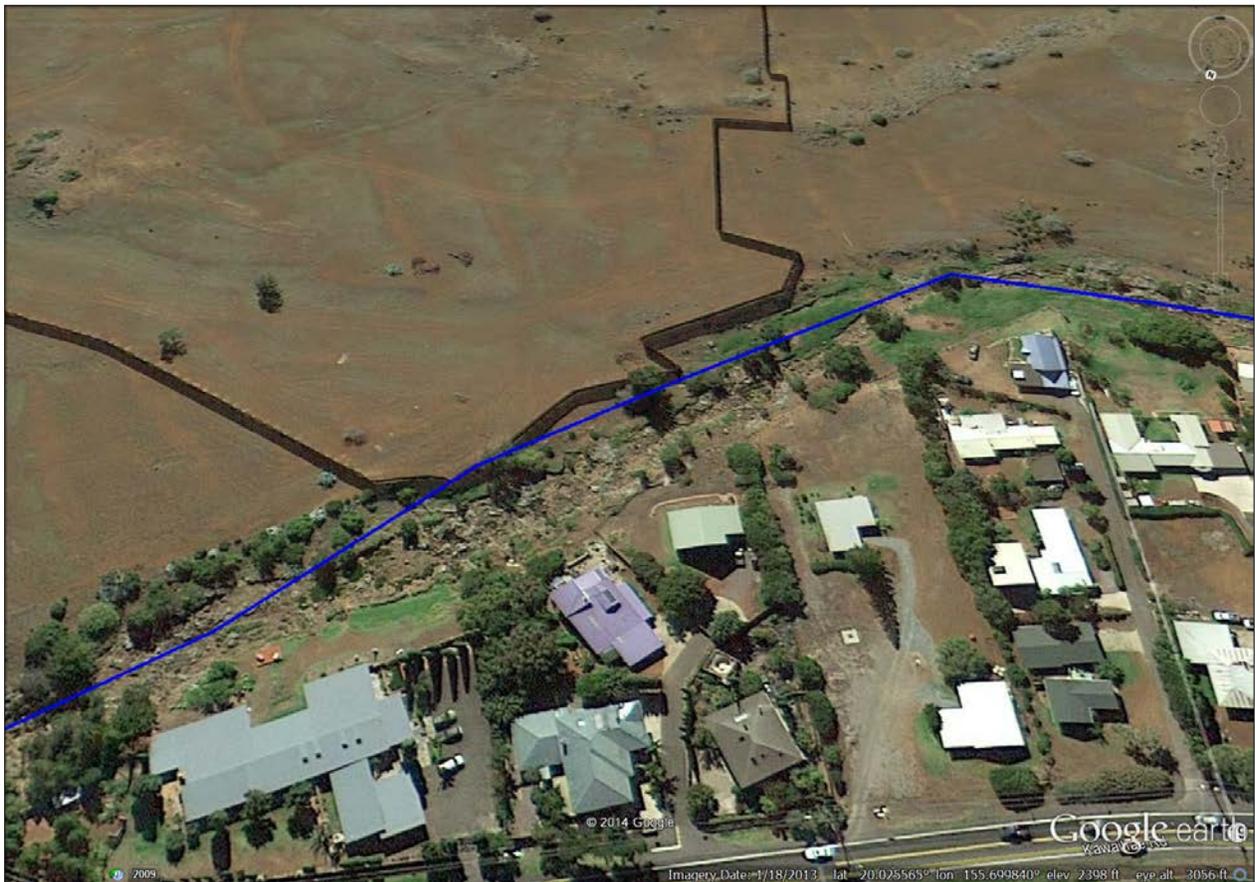
**Photo 16. 24PG, Aerial View of State DHH Lalamilo Development**

Build out foot print within black fence area appears to encroach onto floodway along Keanu'i'omanō Stream

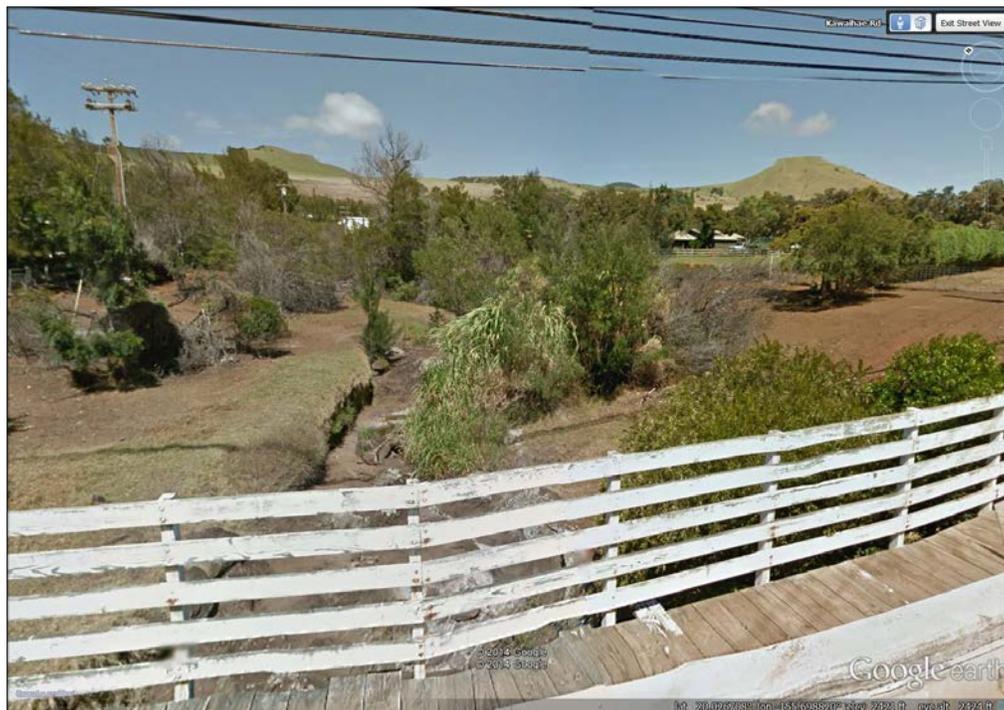
Photo 18. 21PL, Keanu'i'omanō Stream

Erosion and unstable bank of stream, zone used for pasture

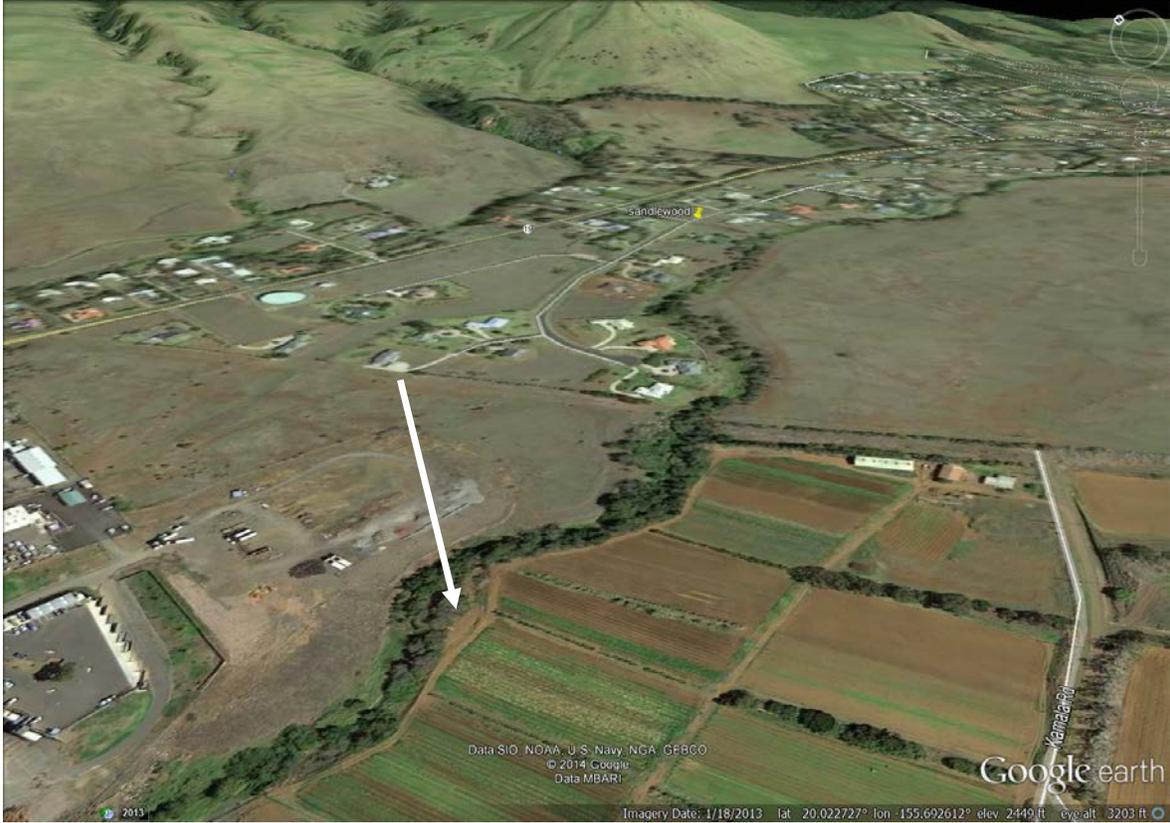
**Photo 19. 20PL, Lalamilo Farm**

Narrow buffer between edge of field and Waikoloa Stream

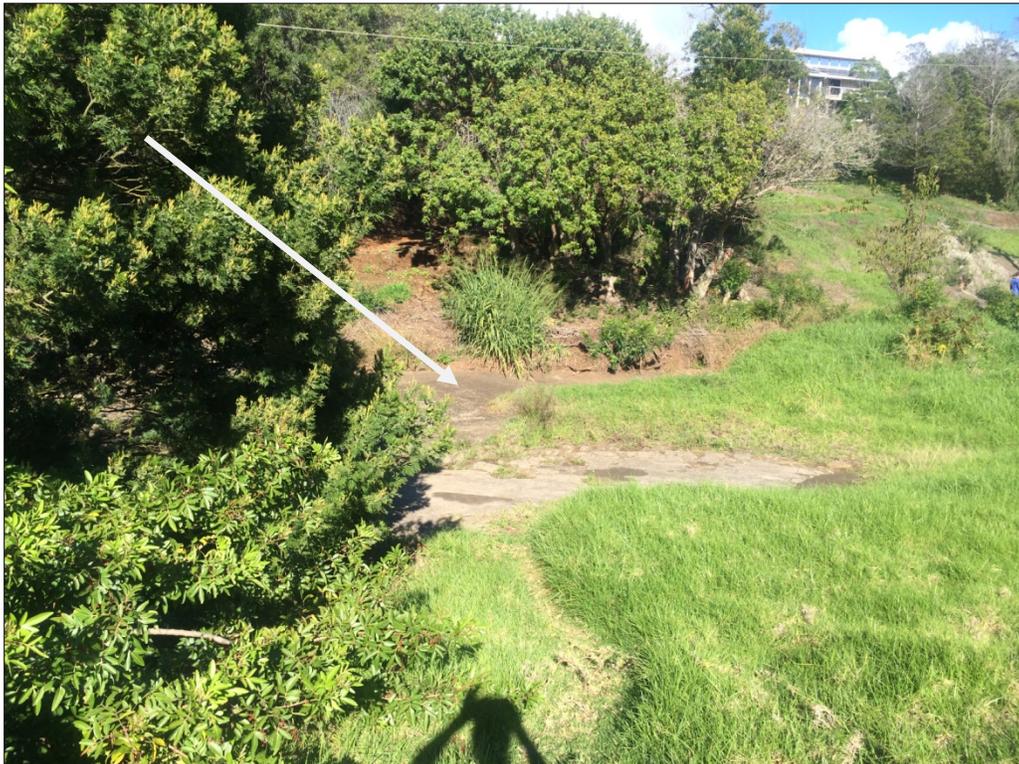
**Photo 20. 30PT, Waikoloa Stream - old stream ford**

Concrete ford instream creates possible fish barrier. Erosion and sediment input for approach roads into stream.

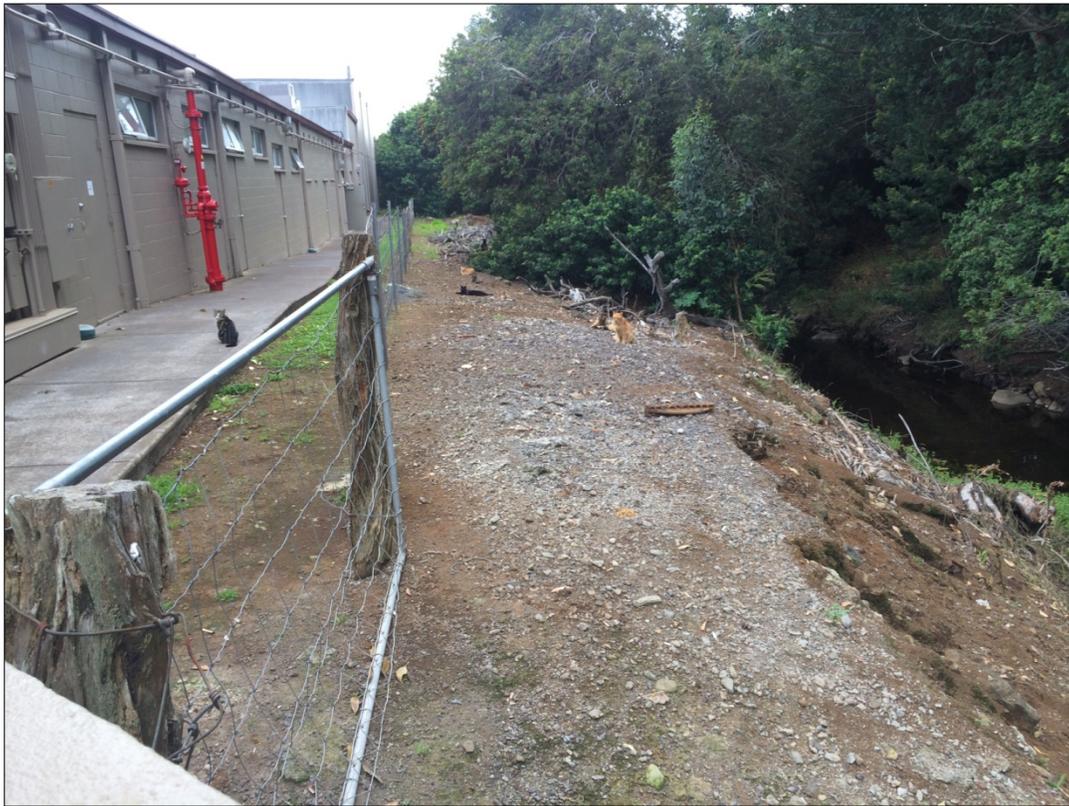
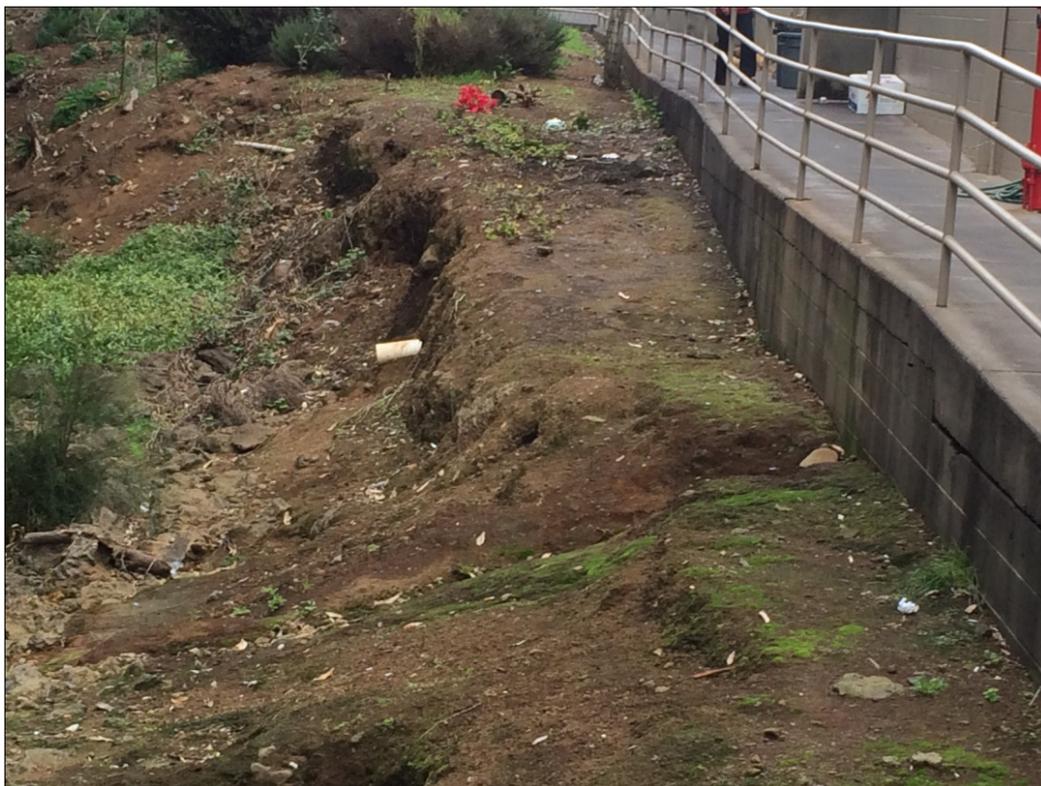
**Photo 23. 23PG, Waikoloa Stream - Waimea Shopping Center**

Multiple issues: degraded banks eroding, illicit discharge onto stream banks, feral cat colonies, bacteria loading into water, bare banks, parking lot runoff into stream.
