Surveys of Abandoned Vessels: U.S. Caribbean Region

**SURVEYS OF ABANDONED VESSELS:
U.S. CARIBBEAN REGION**

Jacqueline Michel, Scott Zengel, Christine Lord, and Zach Nixon
Research Planning, Inc.
Columbia, South Carolina 29202

September 2002

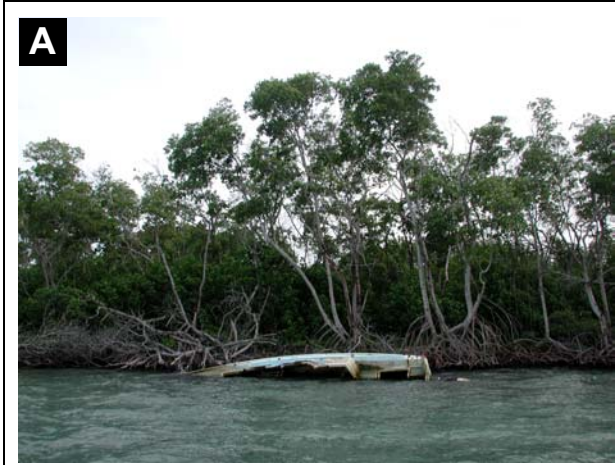
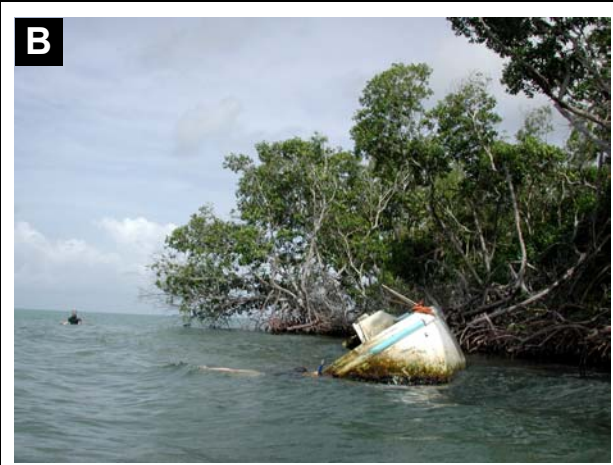
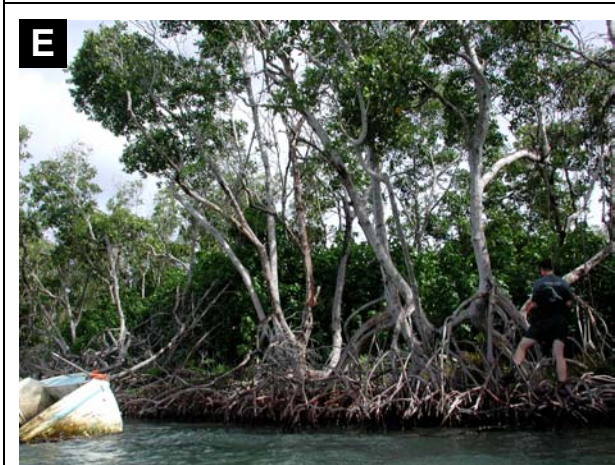
PLATE 2. *Be??trix*, Boqueron Bay, Puerto Rico.

Comparison to Other Vessels: This vessel is typical of sites consisting of sailboats that were stripped and not removed after they sank during a hurricane. It is one of three sailboats lodged against the mangrove fringe that were surveyed in Boqueron Bay. In other areas, such as Culebra Harbor and Ensenada Honda at Roosevelt Roads, the sailboats sank a further distance offshore and sit on seagrass or mud bottoms.

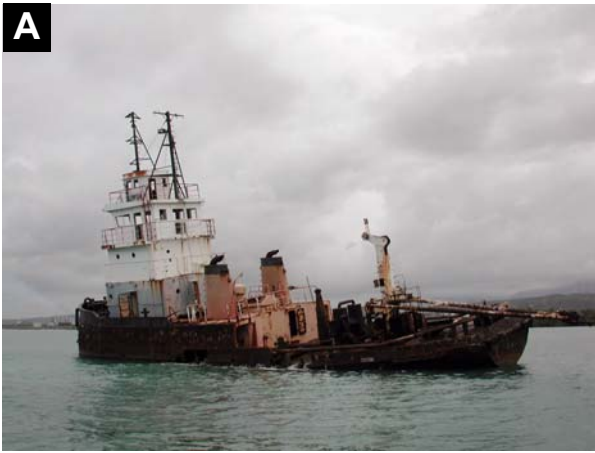
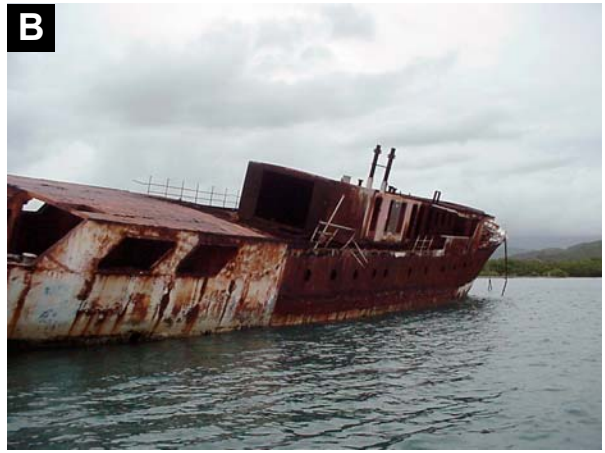
PLATE 3. Tug *Pawnee* and cruise ship *Princess I*, Bahia de Tallaboa, near Ponce, Puerto Rico.

Comparison to Other Vessels: There are many sites with multiple grounded vessels that were not removed. The *Princess I* and *Pawnee* sites are characteristic of the type of seagrass damages expected for larger vessels grounded in open bays.

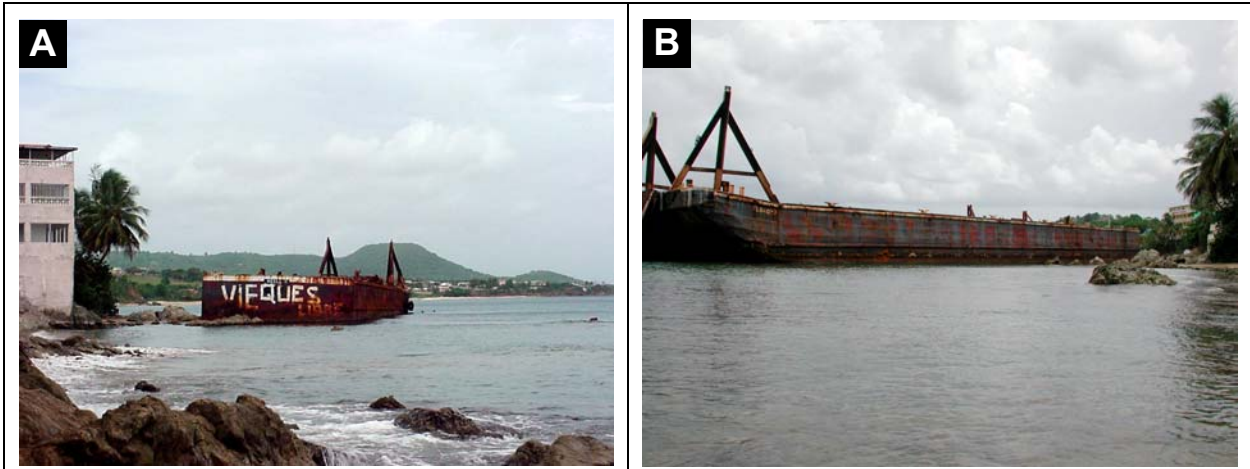
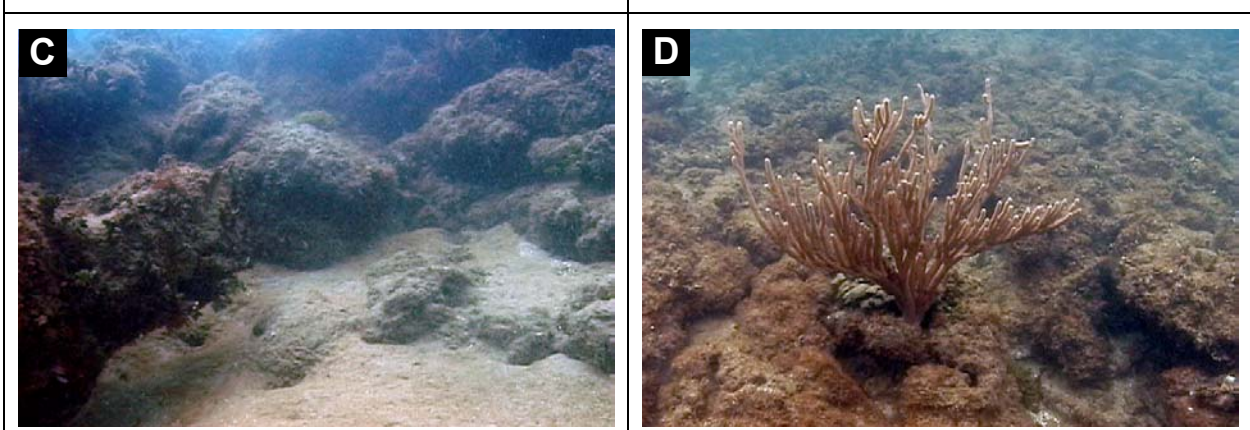
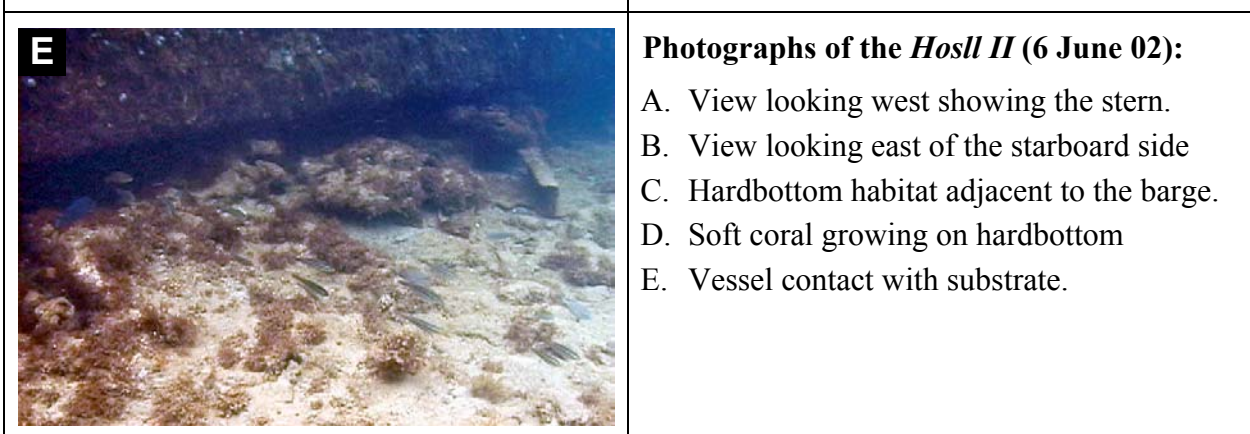
PLATE 6. *Hosll II* barge, Isabel Segunda, Vieques, Puerto Rico.

Comparison to Other Vessels: Five abandoned barges were surveyed in Puerto Rico. Three (*El Canuelo*, one inside San Juan Harbor, and the *Hosll II*) were large, intact barges, whereas the other two were rusted out hulks.

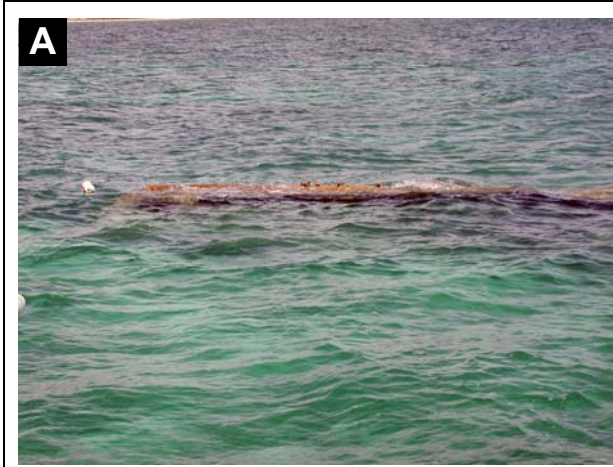
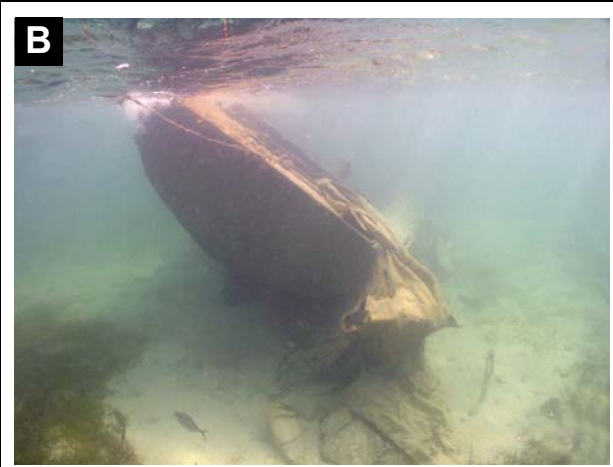
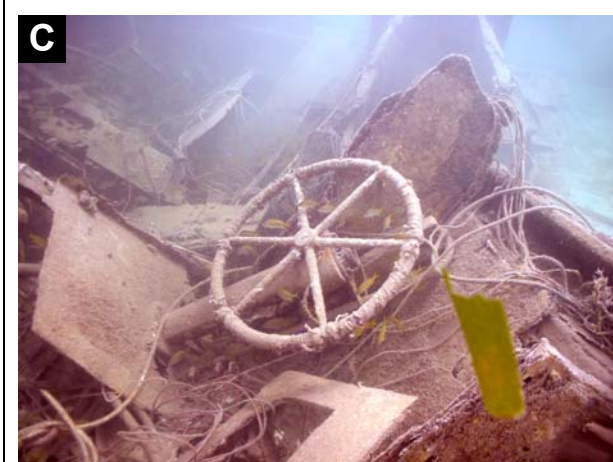
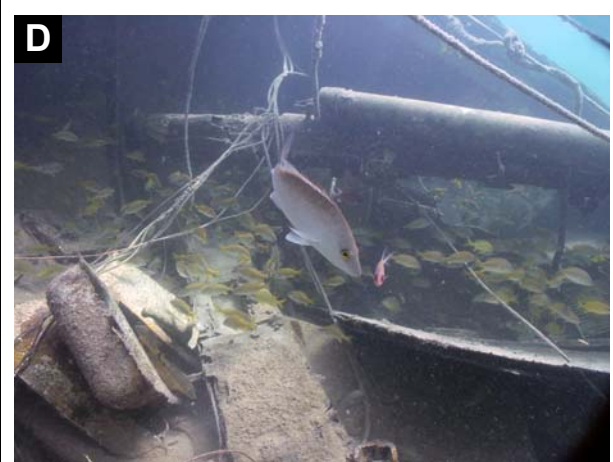
Photographs of Unk1949 sailboat (26 June 02):

Comparison to Other Vessels: This vessel is typical of several sailboats that sunk at their moorings during storms or unknown causes. Portions of the hull are exposed and visible, and a few buoys poorly mark the vessel, thus these vessels are potential hazards to local vessel traffic. This vessel is also typical of sailboats that sank in seagrass habitat.

- A. View of vessel as navigation hazard.
- B. Scour in seagrass habitat.
- C. Wheelhouse and debris.
- D. Vessel as artificial reef habitat.
- E. Seagrass habitat.

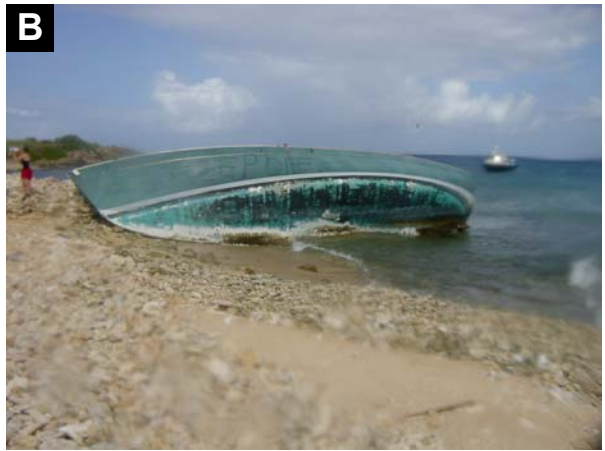
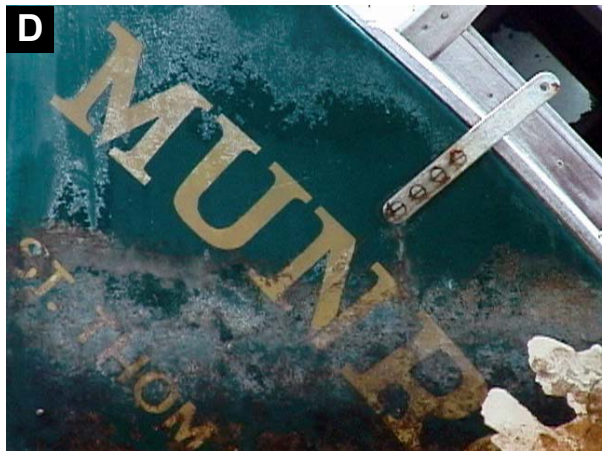
Photographs of *Munro* (27 June 02):

Comparison to Other Vessels: This vessel is representative of a few vessels that were grounded on gravel beach habitat on a small islands with surrounding hardbottom habitat in the surf zone.

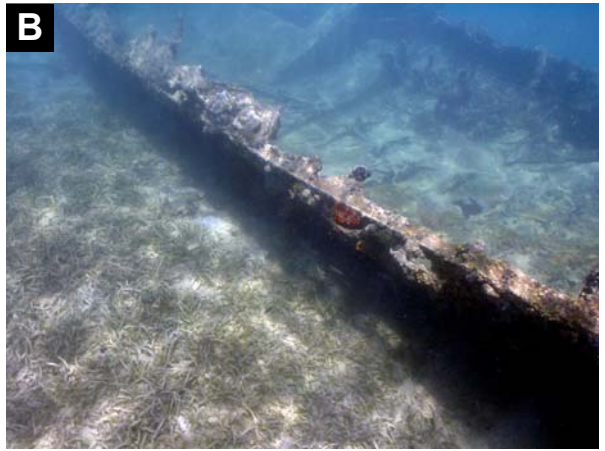
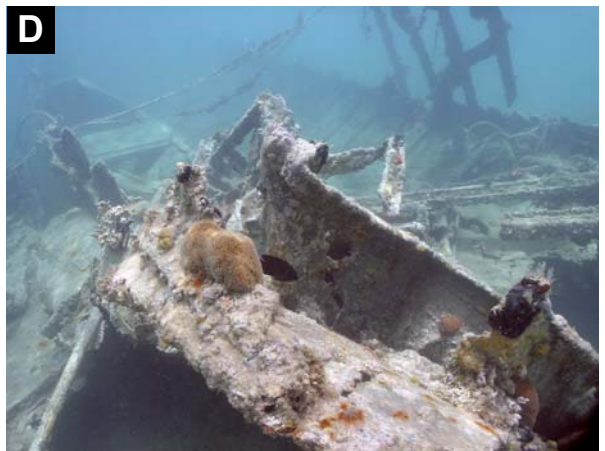
Photographs of Unk2443, sailboat (27 June 02):

Comparison to Other Vessels: This vessel is representative of sailboats that are grounded in seagrass habitat that leave an unvegetated scour area around a portion of the vessel.

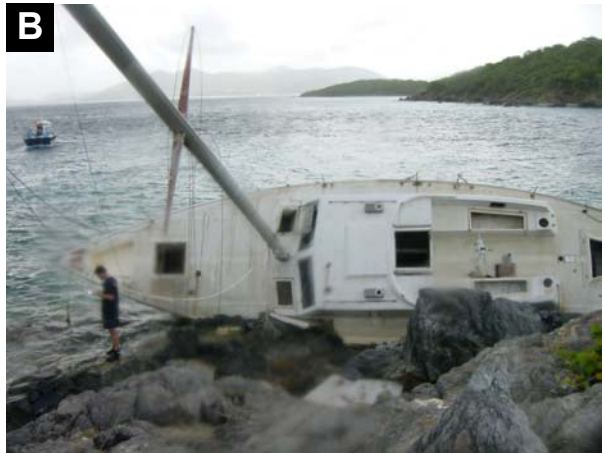
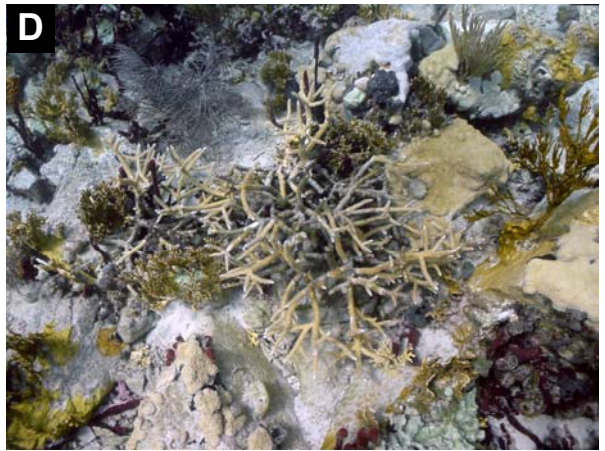
Comparison to Other Vessels: This vessel is unique among the vessels surveyed in the USVI because it is grounded near coral reef and hardbottom habitat.

Photographs of *Serendipity* (28 June 02):
 A. View of vessel from starboard side.
 B. View of deck.
 C. Reef habitat.
 D. Staghorn coral.
 E. Pillar coral.

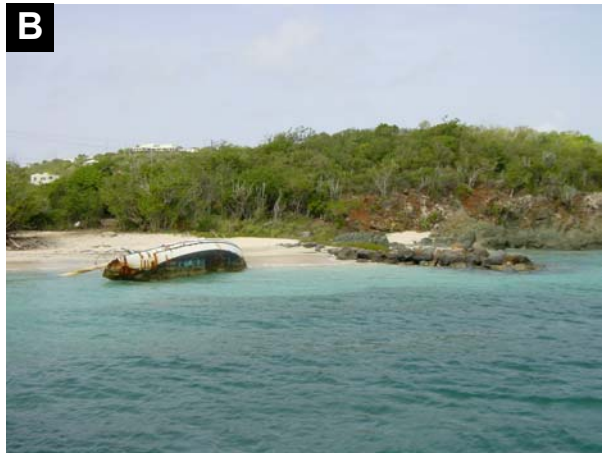
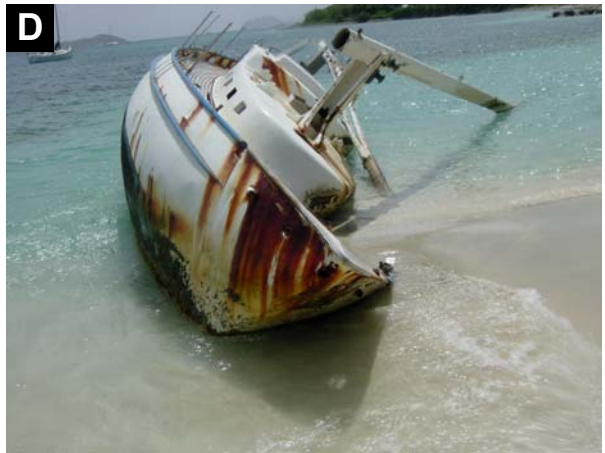
Photographs of ORCA (28 June 02):

Comparison to Other Vessels: This vessel is unique among the sailboats surveyed in the USVI because it is aground at a public beach.
