NOAA ARRA USVI Watershed Stabilization Project

Coral Bay Watershed Management Project – Lower Bordeaux Drainage Improvements

Patricia Reed
Environmental Projects Manager
Coral Bay Community Council

March 31, 2012

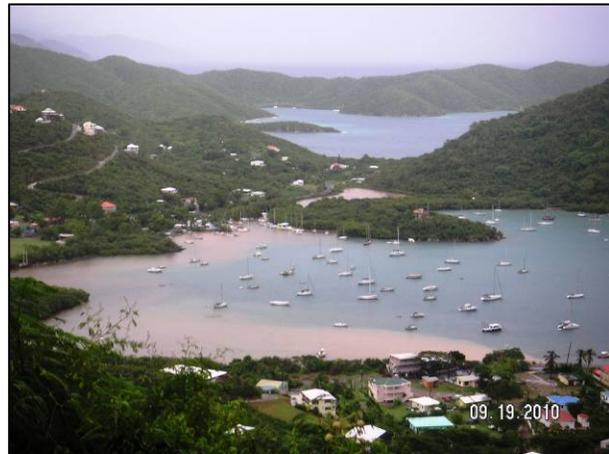
Photo 1: Plumes into Coral Harbor.

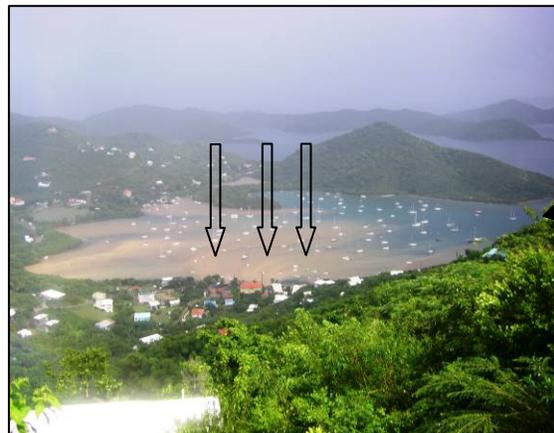
Photo 3: Sediment Plumes below the Lower Bordeaux Watershed.

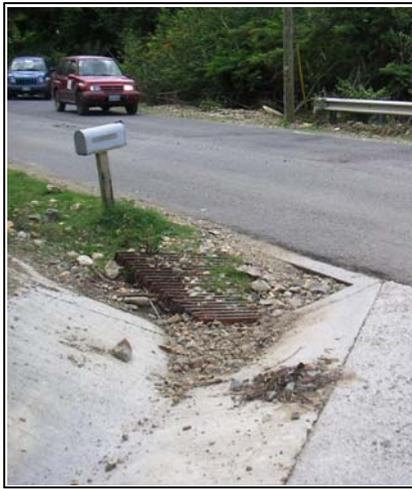
being sent down the paved road clogging the new devices (Photos 4-5), and entering into the mangroves fringing Coral Bay (Photo 6). In this circumstance, because mangroves filter much of this sediment before it enters the bay, the quantity of sediment filtered out will eventually take a toll on the health of this habitat. Additionally, the volume of runoff laden with rock debris and sediment often caused the roadside and culvert grates to become blocked; thereby, leaving rocks and debris on the road surface, causing road damage and unsafe driving conditions (Photo 7). The area downstream discharges directly into the mangroves and was designed as an energy dissipater and sediment area; however, it has fallen into a state of disrepair. The originally installed culvert outlet baffle box was not designed properly for cleanout because it had a concrete bar blocking machine “bucket” access.

Photo 4: Culvert blockage.

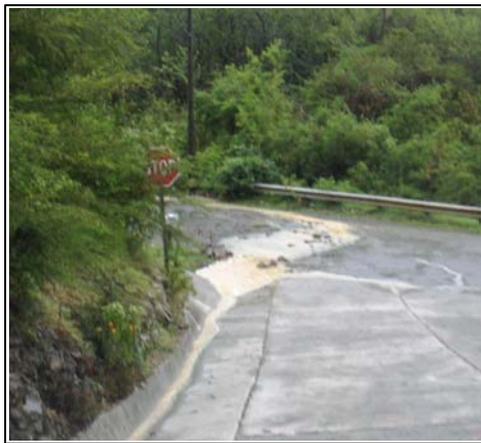
Photo 5: Stormwater runoff.

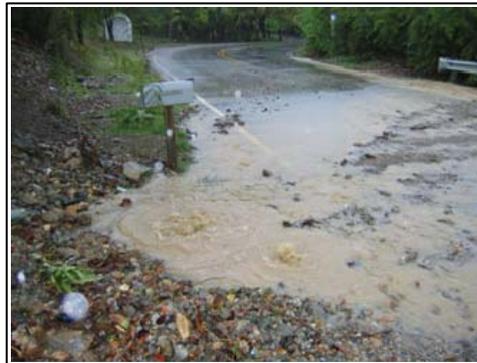
Photo 7: Culvert blockage and stormwater runoff.

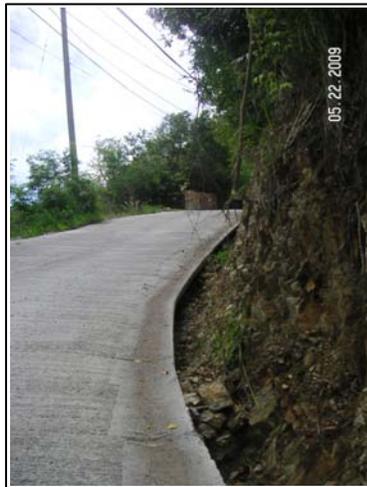
backfilling “to grade” was not done when concrete forms were removed after PW paving, thereby allowing water to flow under the concrete, erode the soil, and possibly undermine the roadway (Photo 8). After rains, landslides block roadside swales and sometimes even travel lanes causing altered flows, poor stormwater management, and dangerous driving conditions (Photo 9). These problems are exacerbated when PW does not have the resources to clear roadside swales quickly after storms. Road switchbacks have altered flow paths to convey runoff down roadways (Photos 10 & 11), increasing water volumes on roadsides in some ghuts and reducing the volume in others. Three ghuts serve this basin: the one draining to Little Plantation which serves the upper switchback area, and two other ghuts that merge downstream to become the “Voyages Ghut” and are bisected by Route 108. The 2006-2007 PW road paving project redirected water from the larger of these ghuts to flow down the roadway and into a single culvert at the head of the smaller ghut. This redirection of water by PW caused serious ghut bank erosion and damage to adjacent property and private roads. This was the most significant problem in the Lower Bordeaux Watershed.

Photo 8: Improper backfill.

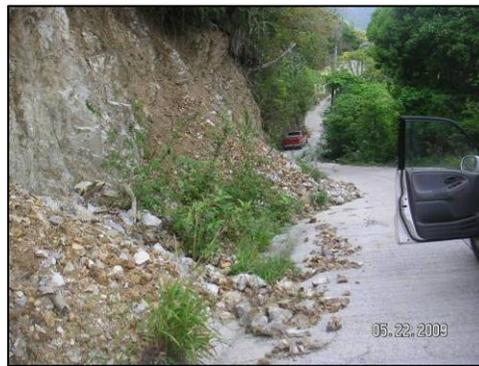
Photo 9: Route 108 landslide.

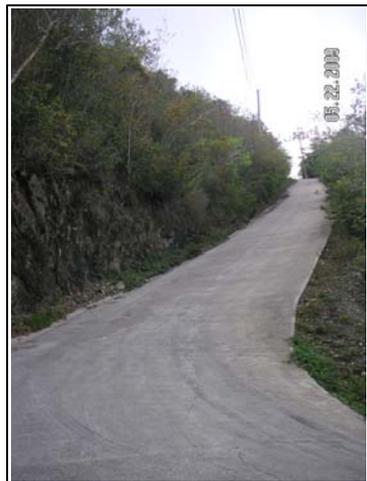
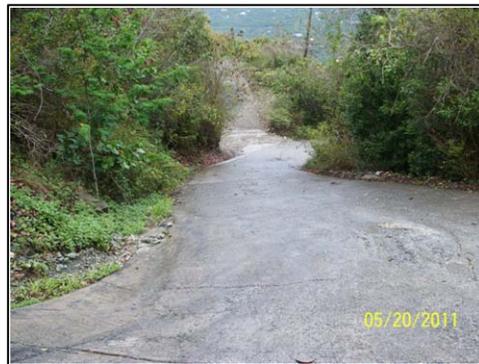
Photos 10-11: Route 108 corner with unmanaged water flowing down the road into the wrong ghut.

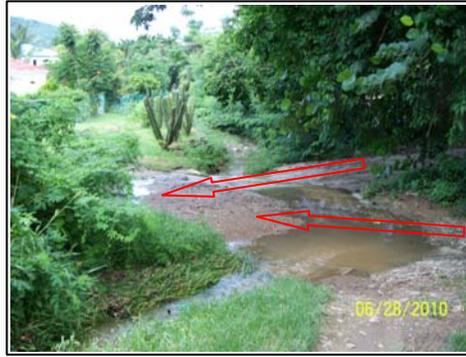
Residential dirt roads in the Spring Garden area cross one major ghut and several subghuts (Photo 12). Additionally, there are numerous springs that emerge after rainfall events throughout the area, including in the middle of roadways. Stormwater runoff and road layout ensure that water flowing through the area erodes the roads and is heavily sediment laden. The Voyages Ghut drains over half the Lower Bordeaux Watershed. All stormwater flowing out of this area discharges through a single culvert under Route 107 into Coral Bay (Photos 13 & 14). Pre-construction turbidity monitoring identified this ghut as the ghut in Lower Bordeaux that flows with the highest turbidity (223 nephelometric turbidity units [NTUs] sampled September 5, 2009 vs. 80.3 NTUs at the Route 107/108 intersection culvert outlet) (CBCC 2012).

Photo 12: Voyages Ghut and road crossings (red arrows) in Spring Garden.

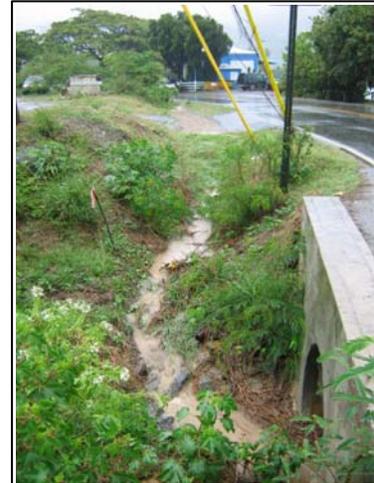
Photo 13: Runoff from unpaved parking area into Voyages Ghut.

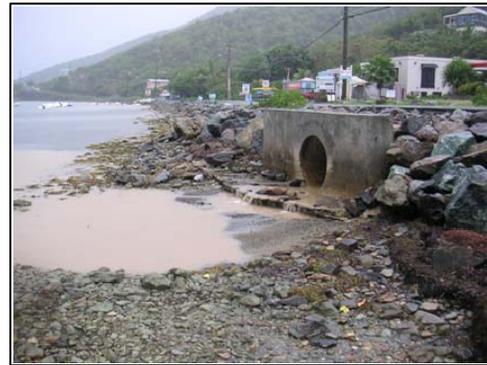
Photo 14: Voyages Ghut runoff into Coral Harbor.

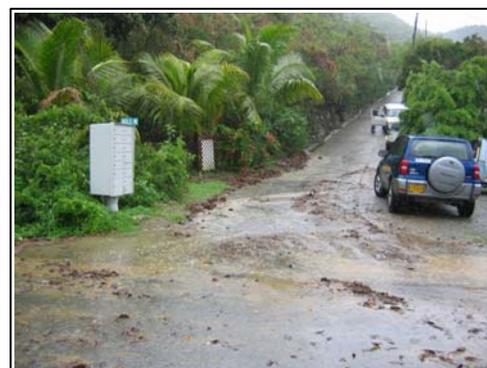
Photo 15: Harold's Way stormwater runoff.

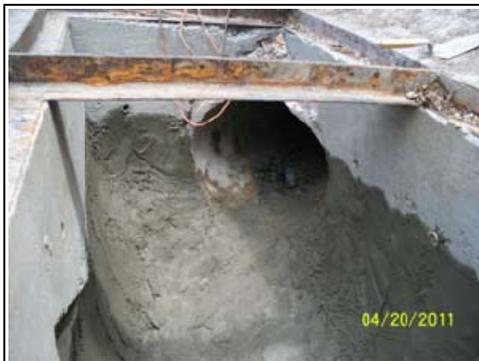
Photo 16: Route 107/108 Intersection culvert inlet repair.

Culverts, or other below-ground devices, are necessary to funnel runoff below roads to maintain traffic flow even during heavy rains. Proper culvert design will provide for sufficient runoff conveyance and “flushing” flows to allow any accumulated vegetation and fist-sized rocks to pass through a culvert without clogging the pipe. In addition, energy dissipaters are required at the outlet to reduce the velocity of the runoff before discharge, which prevents downstream damage. For this project, the contractor, by pressure washer and manual labor, removed all debris that had accumulated in the existing pipe alongside the lower part of Route 108, inlets along this stretch, and the culvert at the Route 107/108 intersection. He then modified the primary inlet box to remove a previous construction defect that snagged debris in the pipe (Photo 16). Additionally, silt sacks were installed on three inlets along Route 108 to remove silt and sediment and keep it from clogging the drainage system. For the baffle outlet structure, the contractor saw-cut and removed the original cross beam energy dissipater that was located so close to the culvert mouth that machine cleanout was not possible, and thus the water flow backed up and the pipe became clogged (Photos 17 & 18). The contractor then installed a riprap energy dissipater in its place (Photo 19).

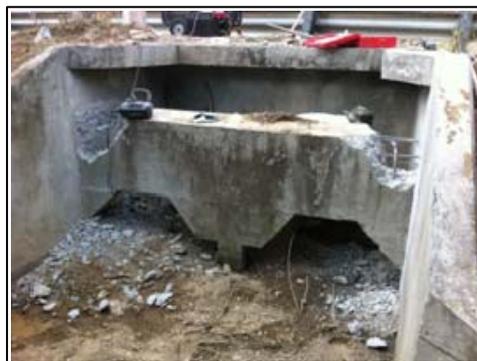
Photo 17: Route 107/108 Intersection culvert energy dissipater repair.

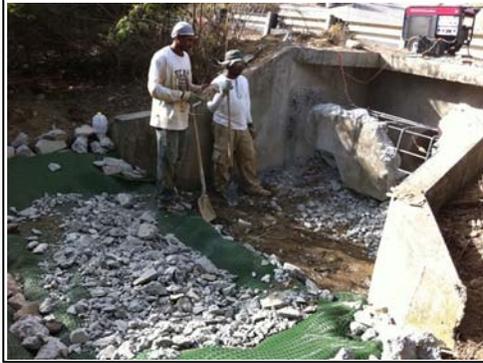
Photo 18: Route 107/108 Intersection culvert energy dissipater repair.

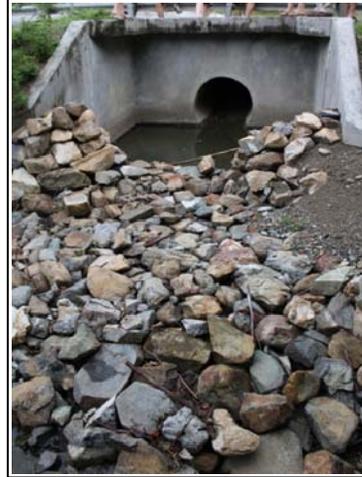
Photo 19: Route 107/108 Intersection repaired culvert outlet.

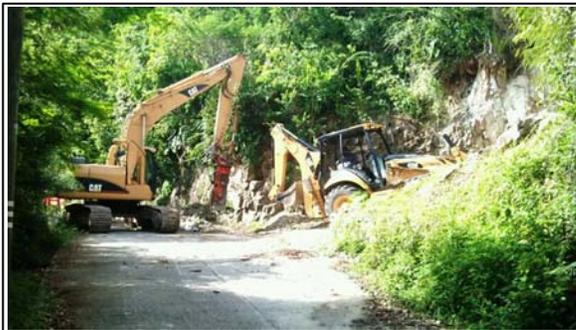
Photo 20: Trench drain excavation.

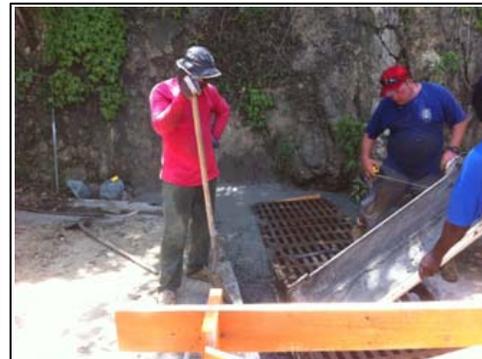
Photo 21: Trench drain installation.

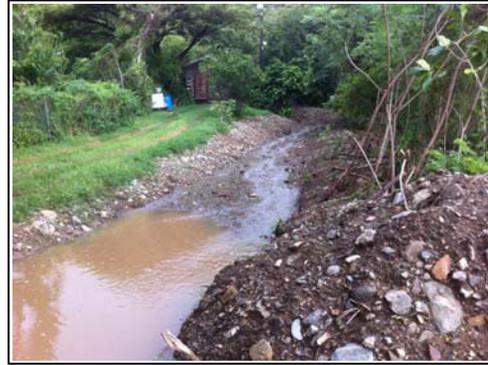
Photo 22: Excavated Voyages Ghut.

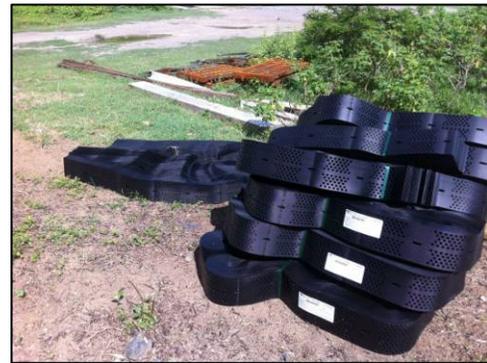
Photo 23: Geoweb® material prior to installation in Spring Garden.

The contractor also installed about 200 linear feet of Geoweb® (Photo 23) by first providing sufficient rebar (approximately 300 pieces, each 2-foot long) to anchor and stabilize the Geoweb® in place. He then used an excavator and manual labor to backfill the Geoweb® with excavated ghut material.

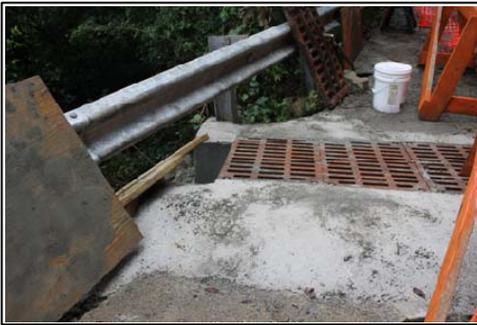
Photo 24: Trench drain.

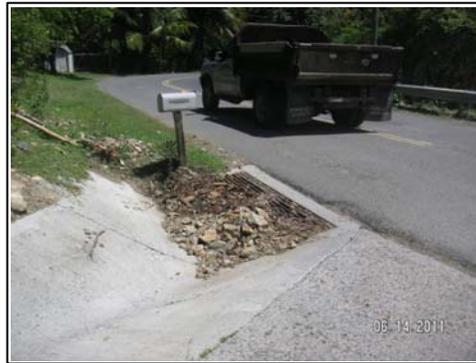
Photo 25: Route 107/108 Intersection culvert inlet grate.

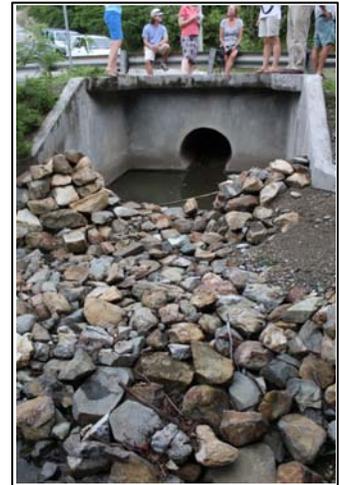
Photo 26: Route 107/108 Intersection culvert riprap energy dissipater.

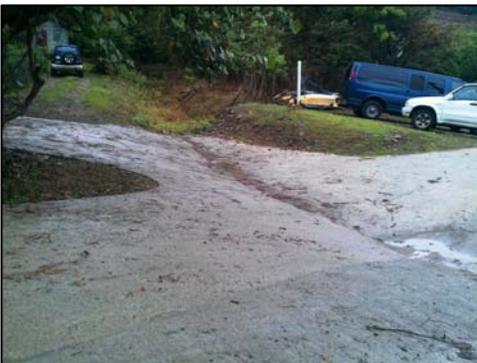
Photo 27: Spring Garden swale.

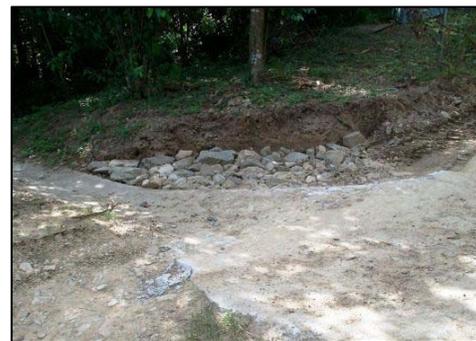
Photo 28: Spring Garden riprap drainage channel.

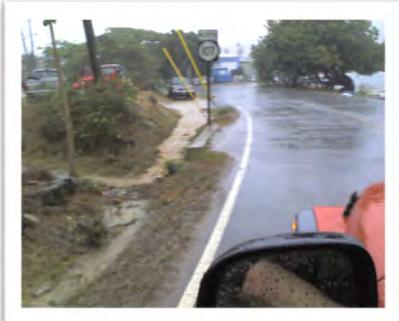
Flow entering gully at Voyages upstream of pipe

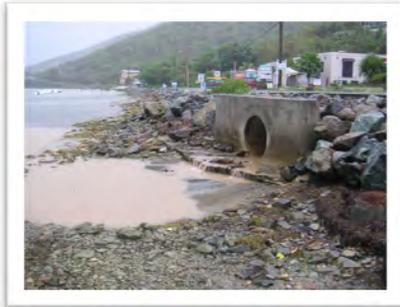
Pipe at Voyages Outlet to Bay
(from previous storm)

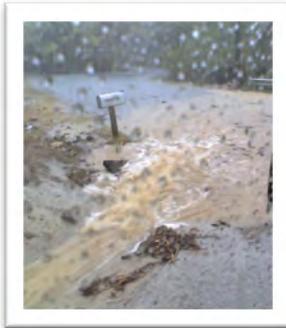
Blocked pipe
at Intersection causes
Flow over Rt. 107

- Immediately clean out blocked pipe and remove debris from inlets along road. Flush entire system to ensure removal of existing sediment and debris. Once this action is taken, the system should operate since much of the initial causes of this blockage are remedied with the recent paving of Rt. 108.

- Ultimately, replace the pipe under Rt. 107 with a larger more accessible box culvert. Exact sizing should be done based on an analysis of the drainage area reaching the pipe, however, the culvert should be a minimum of 3 ft. high by 10 ft. wide and be fitted with a hatch opening to the road to allow for access and cleaning.

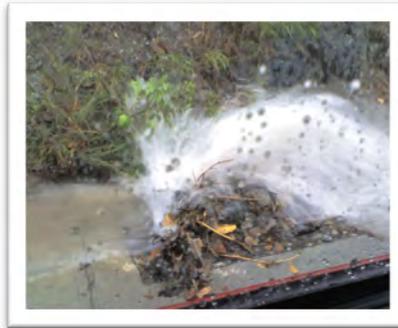
Blocked inlets uphill cause large flows to bypass inlets and
run over the road.

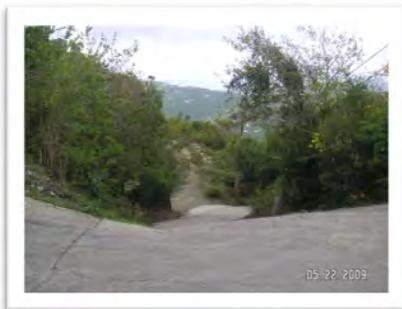
Upper Bend – Water does not make
It around the curve

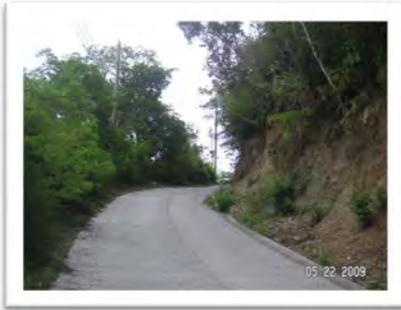
Roadside with undermining due to no backfilling after forms were removed

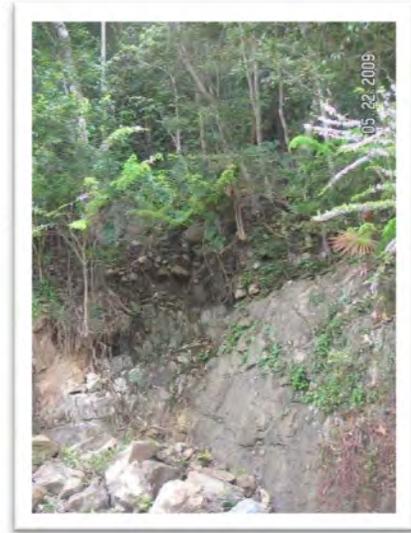
Upper Ghut above existing pipe culvert
