## Response to Physical Impacts on Coral Reefs in Puerto Rico and the USVI

July 2014

## Minimizing Damage to Corals during the Salvage of the S/V “Arena”

December 2010

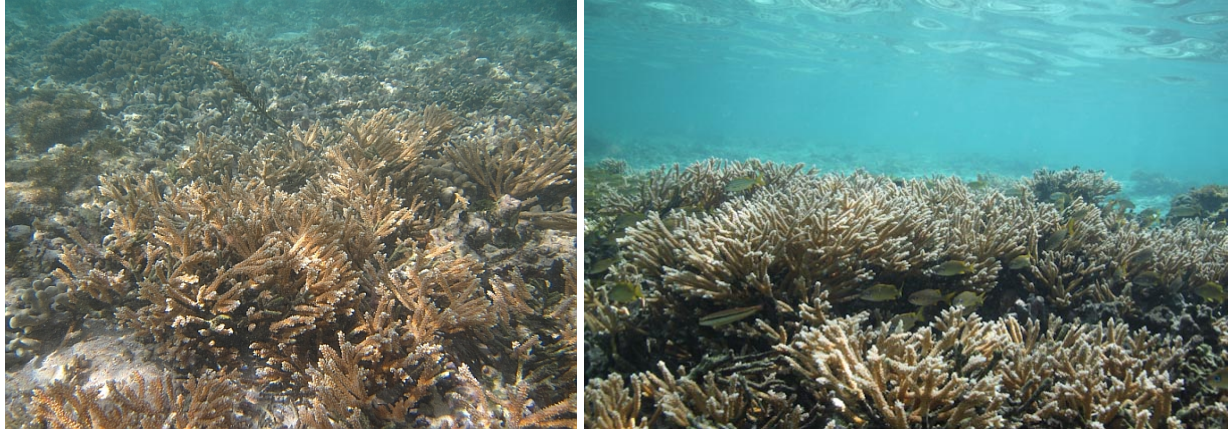
Special emphasis was placed on determining the location of staghorn coral (*Acropora cervicornis*) colonies since this species is listed as threatened and it was known to occur in the area of the grounding. Two areas with small staghorn coral thickets in approximately 1-1.5 m depth were located 50m to the south-southwest of where the vessel had come to rest on the reef crest (Figure 2). An additional 10 isolated small to medium sized colonies of staghorn coral were located in the vicinity of the salvage operations. Upon consultation with the salvage supervisor, it was determined that a removal path could be planned to minimize impacts to the staghorn corals. To assist this effort buoys were placed to the north of the staghorn coral area (Figure 3).

**Figure 2: Staghorn coral (*Acropora cervicornis*) thickets located near the grounded vessel and the focus of efforts to minimize damage to corals.**

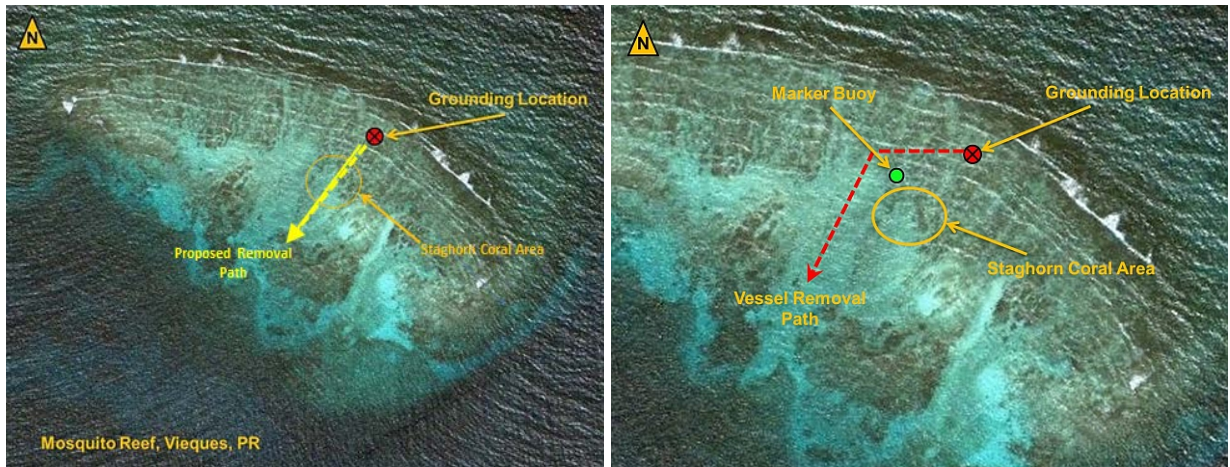
**Figure 3: Diagram showing the removal path proposed originally by the salvers (left) and the final path established for removing the vessel to minimize coral damage (right). It also depicts the area where staghorn corals are located and the marker buoy used for guidance.**

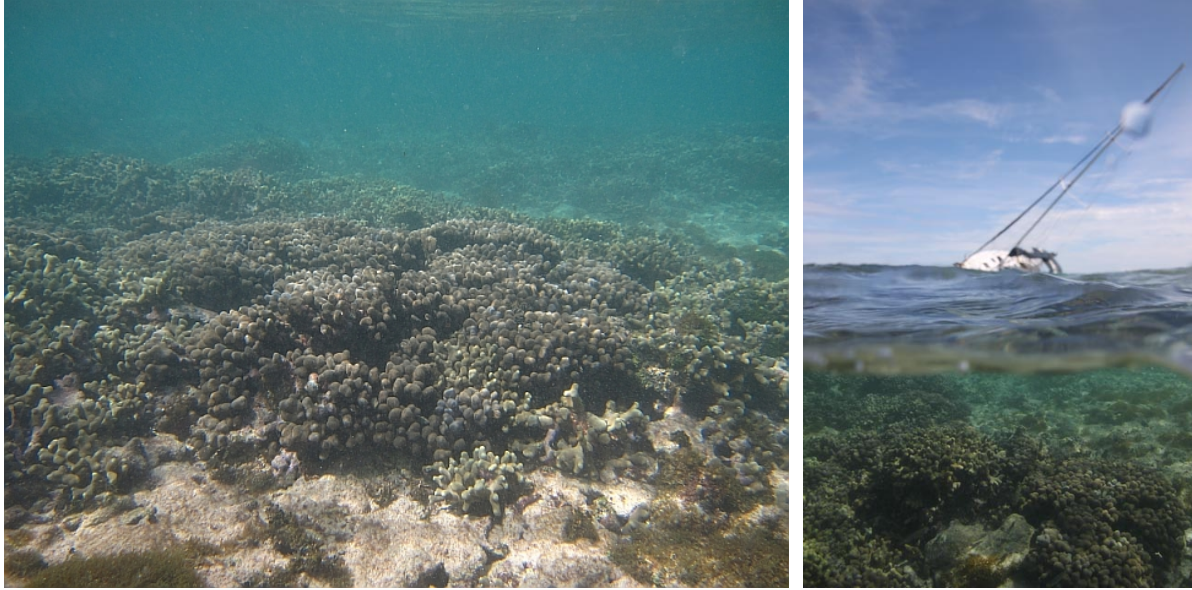
In addition to *A. cervicornis*, an area of *Porites spp.* (*P. porites* and *P. furcata*) was found located adjacent to the vessel and in the removal path selected by salvage operations (Figure 4). Coral colonies within close proximity of the vessel and at risk of immediate damage were temporarily relocated to a cache location for later reattachment to the reef. Approximately 200 colonies of *P. porites* and *P. furcata* with sizes ranging from 10-40 cm diameter were cached by divers utilizing plastic bins (Figure 5). Additionally, 300 individual braches or small groups of branches of *Porites* colonies were cached as well. Cached corals were moved approximately 50m to the south to an area of bare reef substratum (Figure 5).

**Figure 4:** *Porites* colonies adjacent to the vessel. A portion of these corals were moved to avoid damage during vessel removal.

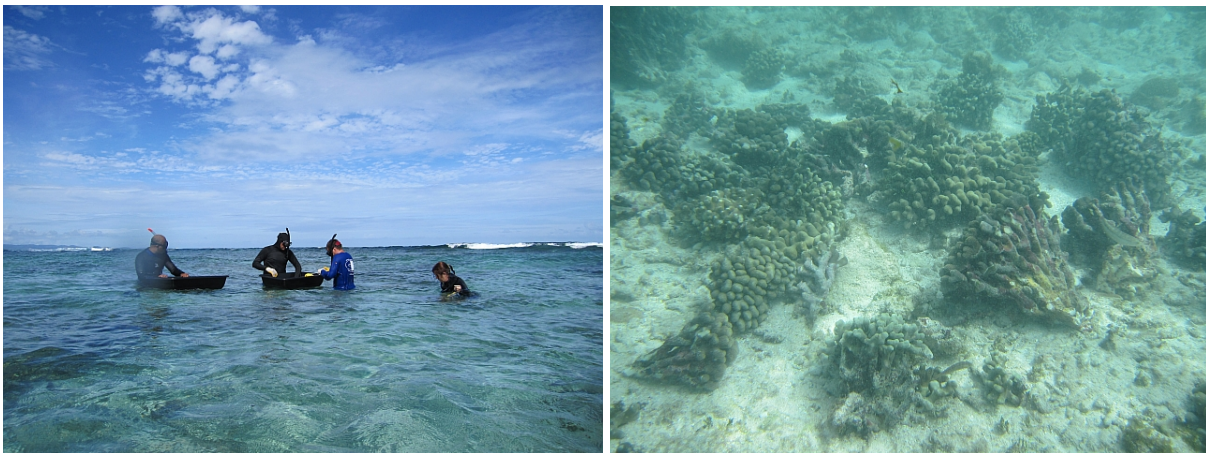
**Figure 5:** Divers from NOAA, Sea Ventures and DNER caching finger corals for later reattachment (left). *Porites* colonies in cache prior to reattachment (right).

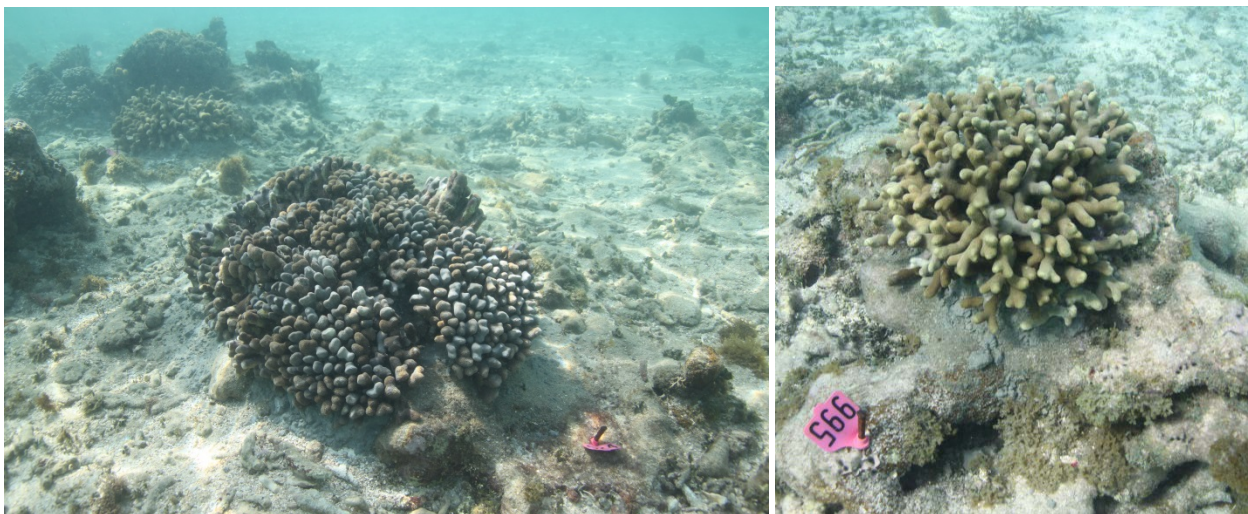
**Figure 6: Transplanted *Porites* colonies that were reattached to the bottom with cement.**

The cached *Porites* colonies were reattached to bare areas of the reef substratum utilizing a mixture of hydraulic cement and sand. The selection of reattachment sites was done by locating areas of the reef that were bare of live corals and other biota. Approximately 200 *Porites* colonies were reattached by embedding the lower portions of the colonies without live tissue into the uncured cement mixture. Larger colonies with multiple branches were secured individually. An additional 400 individual branches or ‘nubbins’ were grouped in bunches to simulate larger natural colonies. Numbered tags were nailed to the bottom near a subset of reattached colonies for future monitoring of these corals (Figure 6).
