NOAA Technical Note NCDC No. USCRN-04-06

USCRN Temperature Aspirated Shield Modifications

Brent French
Oak Ridge Associated Universities
NOAA Atmospheric Turbulence and Diffusion Division
Oak Ridge, TN

October 2004

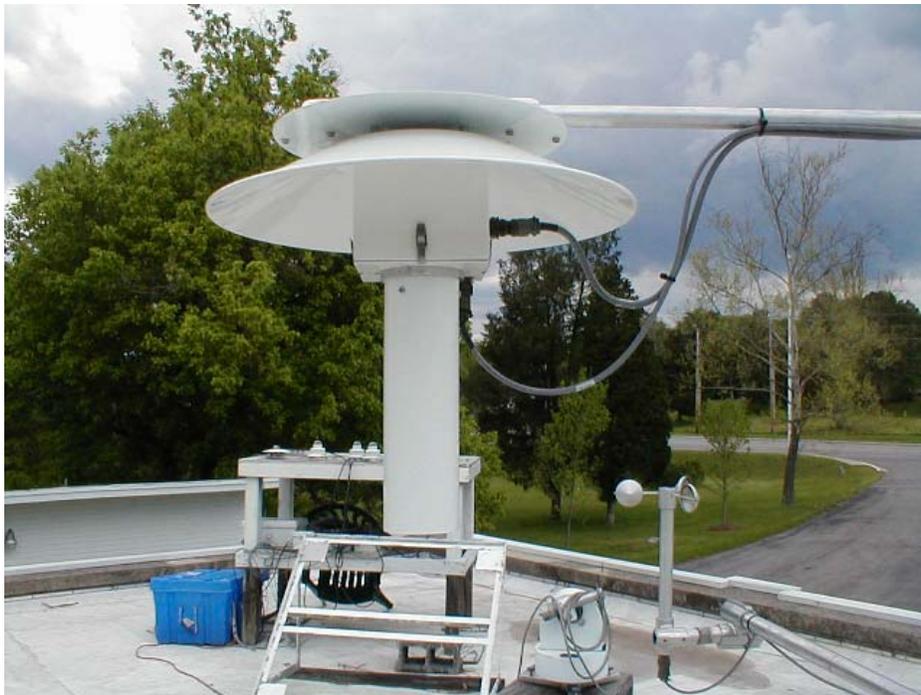
Figure 1: An USCRN unmodified Met One aspirated solar shield mounted on a test site at the ATDD facility. The shield assembly is suspended from the mounting bar (horizontal bar extending to the right at the top of the assembly). The fan is mounted in the square box under the umbrella-shaped shield. The electrical connector for the fan can be seen on the right side of the square fan chamber.

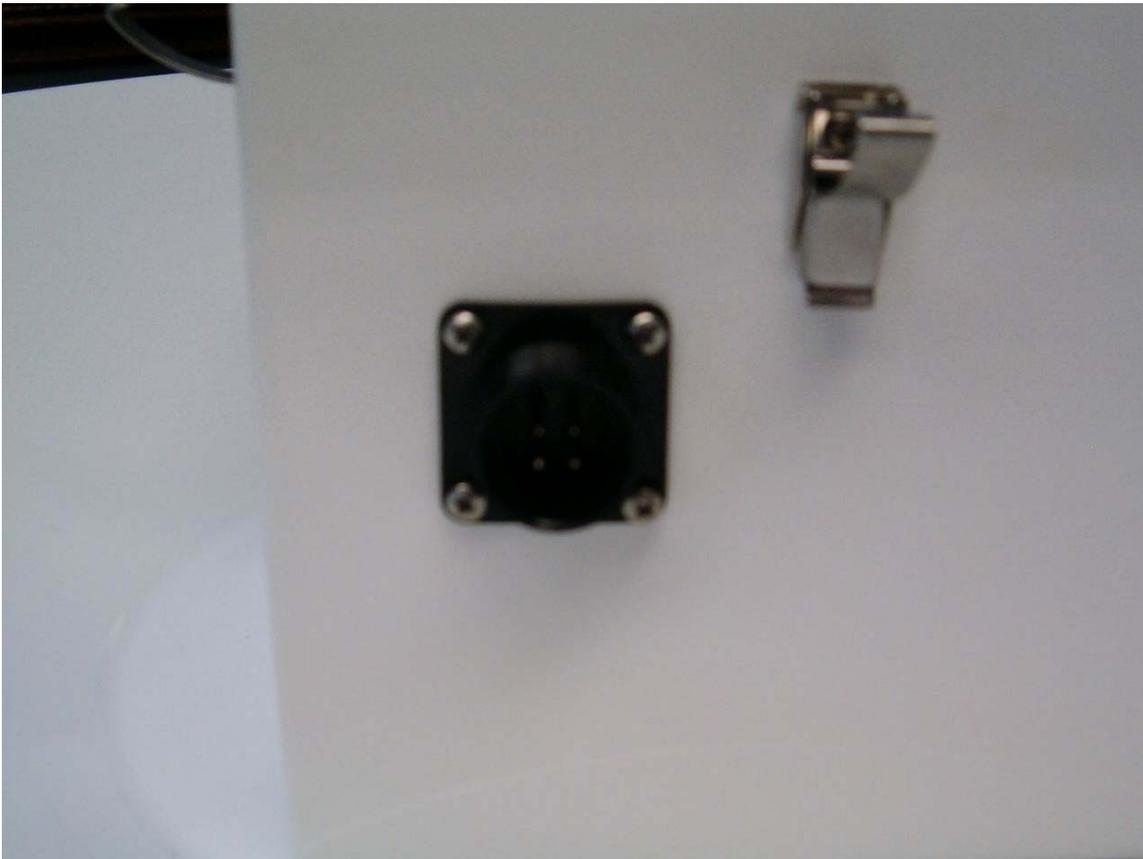
The electrical connector for the fan in the aspirated shield, as delivered from the manufacturer, required the electrical cable to be cut in order to replace the fan. ATDD did a simple modification on how the connector is mounted that allows the connector to be removed along with the fan, and no longer requires cutting the cable.

Figure 2: Exterior view of the electrical connector, as delivered by the manufacturer, for the fan in the aspirated shield. The external mounting of the connector required the cable to be cut in order to remove the fan; the wires for the new fan had to be soldered into the connector after assembly.

The factory-installed electrical connector is mounted on the exterior of the fan chamber (see Figure 1). The ATDD modification consists of removing the electrical connector, enlarging the mounting hole from the original $\frac{3}{4}$ " diameter to a diameter of $\frac{7}{8}$ ". The connector is then remounted from the inside of the fan chamber (see Figure 2) such that the connector can be removed along with the fan.

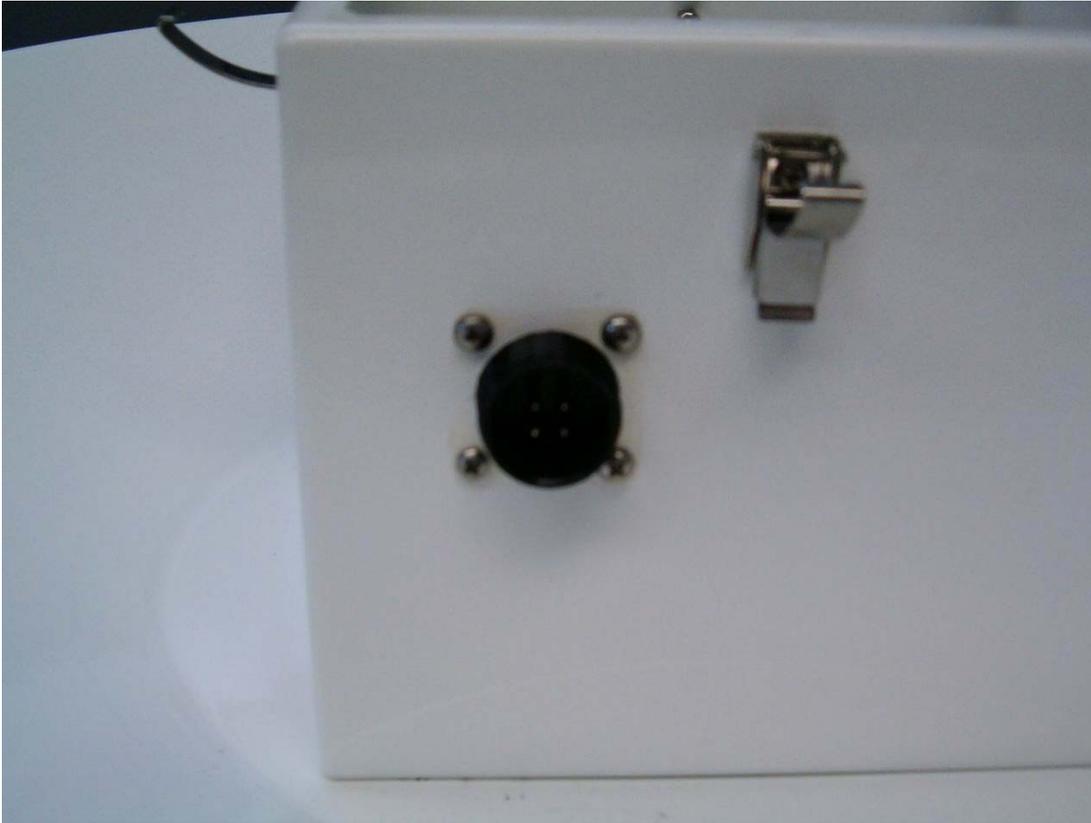
Figure 3: The ATDD modified electrical connector for the aspirated shield fan. The connector is mounted from the inside of the fan chamber and can be removed, without cutting the wiring, along with the fan when the fan requires replacement. The fan is replaced as part of routine maintenance every 3 years.

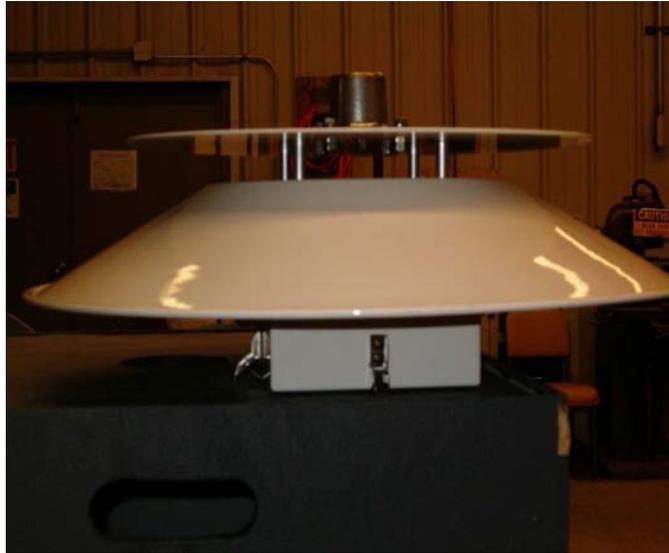
The factory-delivered aspirated shield assembly is held together with 4 bolts that extend from the top of the assembly down through the shields, with the fan mounted inside the fan chamber at the bottom of these four bolts (see Figure 4). Removing the four nuts on the bolts to remove the fan allowed the entire assembly to come apart, and made it more difficult to install a new fan.

Figure 4: The assembled upper shield portion of the aspirated shield. As delivered from the factory, four bolts are used, inserted from the top of the upper flat shield shown above, down through the aluminum spacers separating the flat shield from the lower umbrella-shaped shield, and down into the square fan chamber. The fan assembly was mounted on the lower end of the bolts. Then the nuts were tightened to hold the whole assembly together.

The ATDD modification consists of removing the fan and securing the remaining assembly with the original nuts. The mounting holes on the fan are then bored out from their original 0.17" inch diameter to a diameter of 0.40". This allows the fan to be placed into the fan chamber such that the nuts on the mounting bolts fit within the enlarged holes. A second set of nuts is then applied on all four bolts on the outside holes on the fan, which have been left at their original size. This allows the fan to be removed without disassembling the entire shield apparatus.

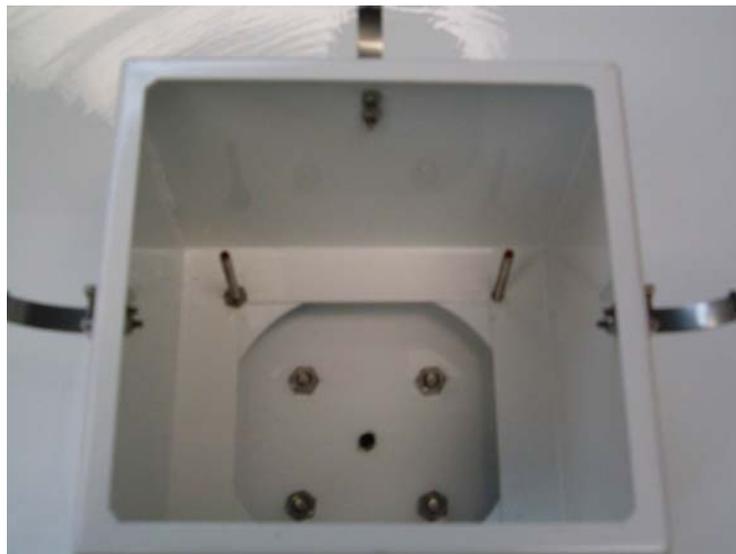
Figure 5 shows the interior of the fan chamber with the modified fasteners installed, prior to the mounting of the fan.

Figure 5: The interior of the fan chamber. The ends of two mounting bolts can be seen. The fan is mounted onto these bolts. The bolt on the left has the new fastener installed, while the bolt on the right is as originally delivered. The modified fastening procedure allows the fan to be removed without the entire shield assembly coming apart.

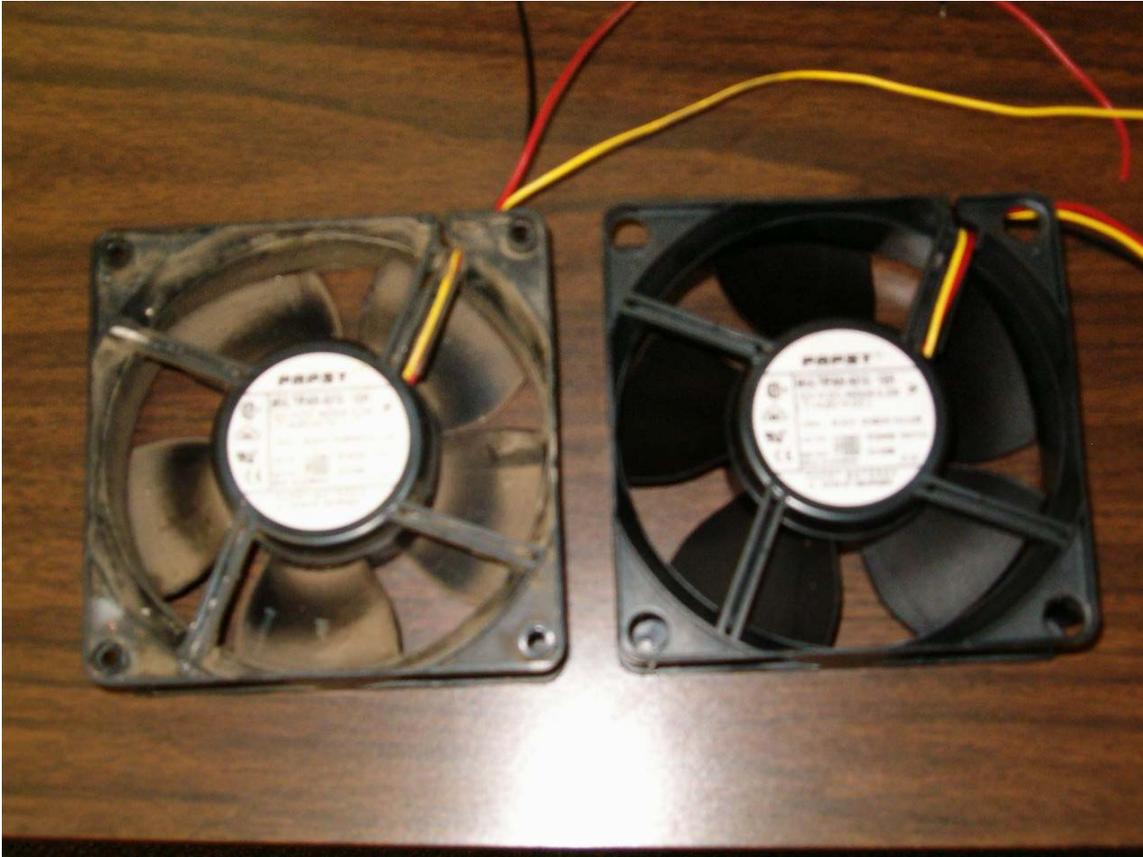
Figure 6 shows, on the left, the fan assembly prior to enlarging the top mounting holes. On the right the holes have been enlarged. The enlarged holes fit over the added fastener, as seen in Figure 5, and allow the fan to fit snugly at the top of the fan chamber.

Figure 6: Aspirated shield fans before (left) modifying by enlarging the mounting holes, and after the modification (right). The mounting holes are enlarged from the original 0.17” to be 0.40” diameter.

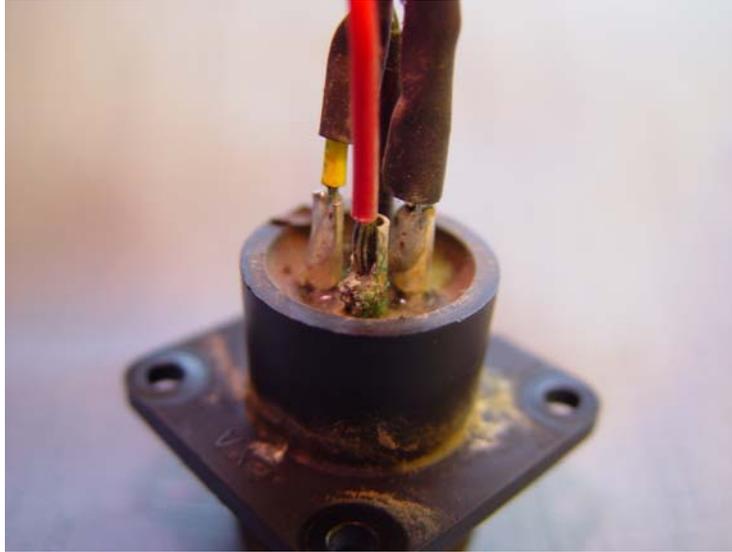
Some of the early USCRN sites experienced a problem with the electrical connector to the aspirated shield. Corrosion was occurring in the connector where the leads from the aspirated shield fan were soldered into the pins of the connector. The corrosion was reaching levels significant enough that the fan speed was unreadable and/or the fan would cease operating due to loss of power. In some cases the corrosion advanced to the stage where the pins almost completely disintegrated. Attempts to seal the connectors with tape or a silicone sealer were not successful.

Figure 7: An example of how the originally supplied aspirated shield fan electrical connectors corroded.

ATDD chose to upgrade the connector to a gold-plated pin connector (Conxall, part number CXS3102A14S-2P). Since the new connectors were installed, there has been no corrosion observed at any locations so equipped.

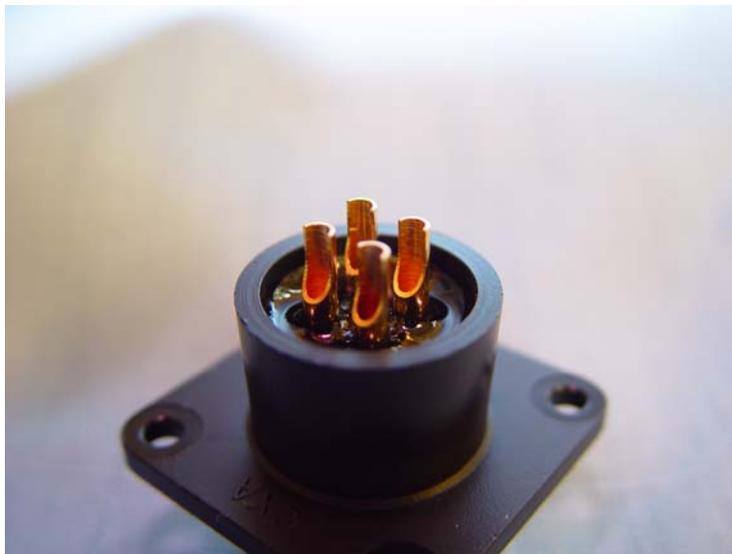
Figure 8: The replacement gold-plated pin connector.
