Response to Physical Impacts on Coral Reefs in Puerto Rico and the USVI

2022 Report

Post Hurricane Fiona Coral Restoration Final Report

March 2023

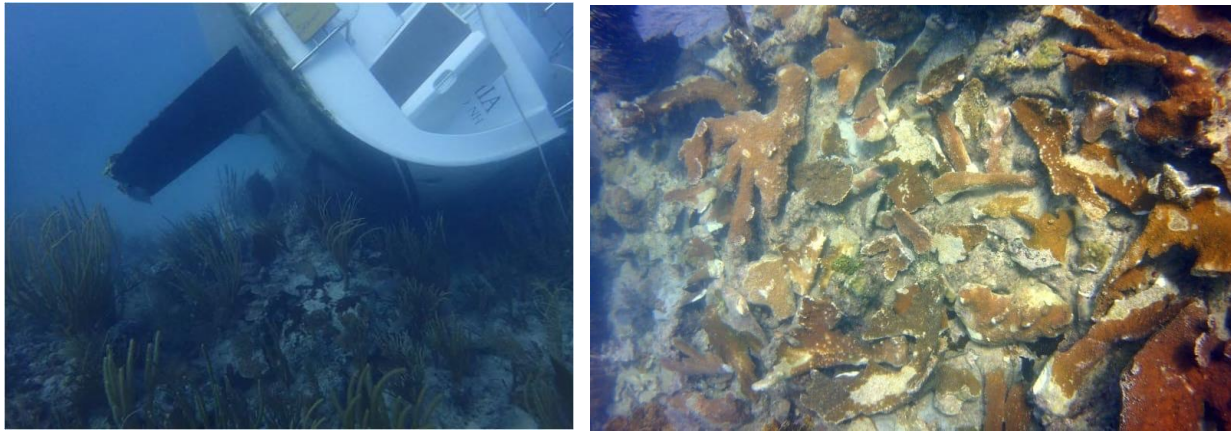
Figure 1: S/V Ef Dia sunk on the reef on left and *Acropora palmata* coral broken during Hurricane Fiona on right (Photo credits: PR DNER on left; Sea Ventures Marine Response Unit on right)

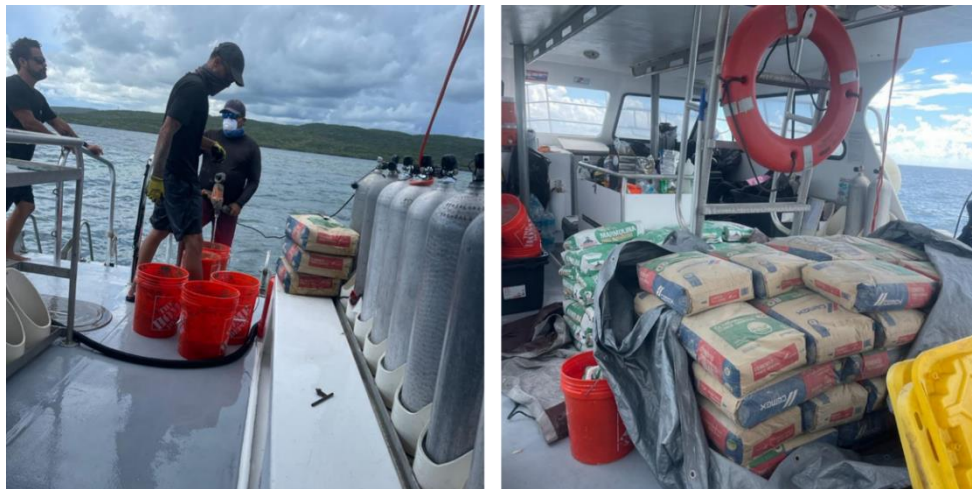
Figure 2. Cement cargo and mixing process aboard to Sea Ventures Marine Response Unit vessel.

To reattach overturned colonies and fragments generated by Fiona, a mixture of cement with marble sand/powder was used. This mixture was prepared in the Sea Ventures and HJR Reefscaping vessel with seawater. For the mixture to have the necessary consistency, a drill was used to help the components (cement, marble and water) mix properly, all this was done inside buckets that facilitated the transportation of the mixture to the reef (*Figure 2*). The buckets were lowered into the water by means of ropes and then they were transported by coral restoration technical divers to the place where the corals were attached. To move large, overturned colonies to adequate substrate for stabilization lift bags were used (*Figure 3*)

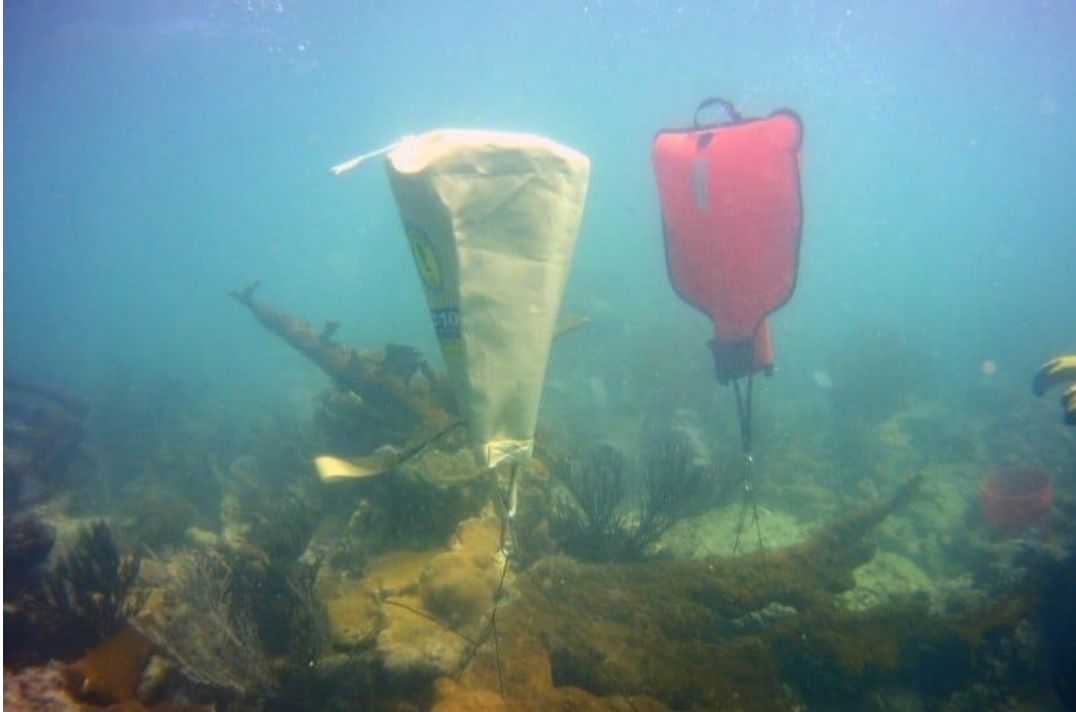
Figure 3. Lift bags used to move large, overturned colonies at Cayo Laurel

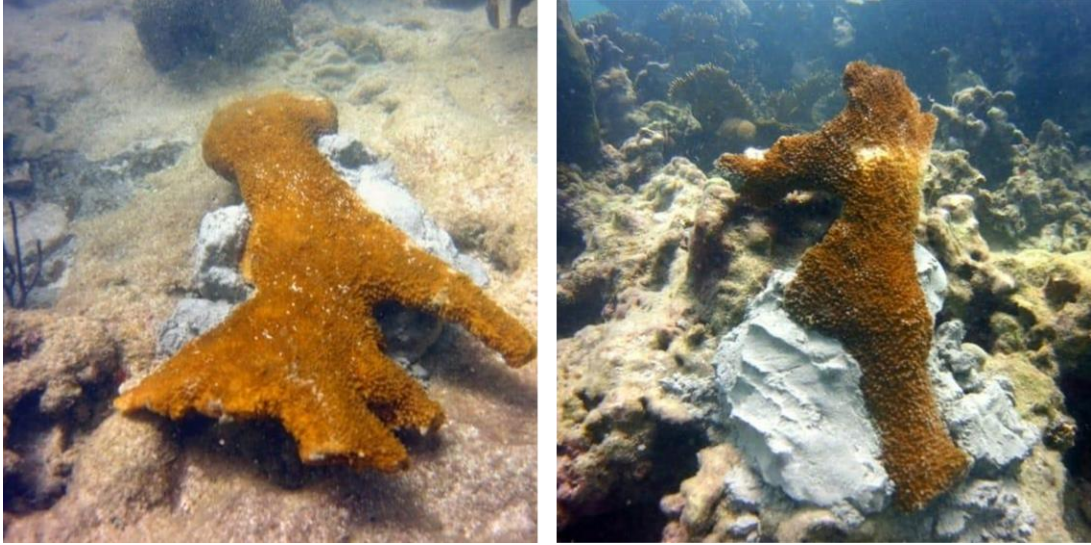
Figure 6. *A. palmata* fragments attached at Cayo Laurel

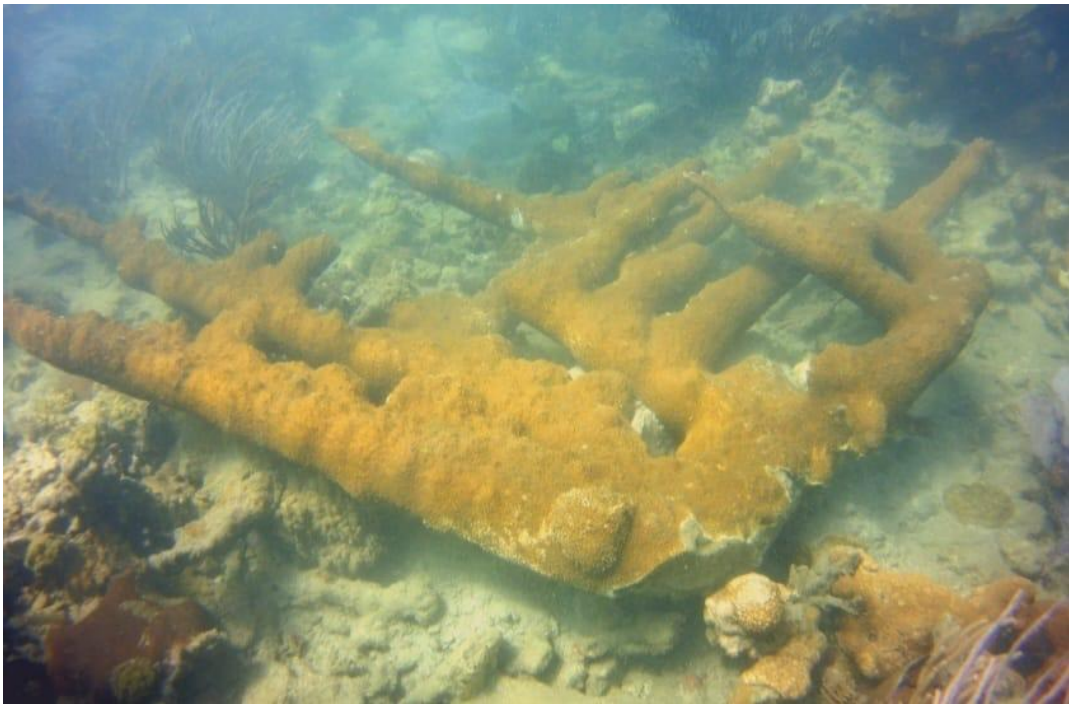
Figure 7. Large *A. palmata* colony (267 cm maximum diameter) attached at Cayo Laurel

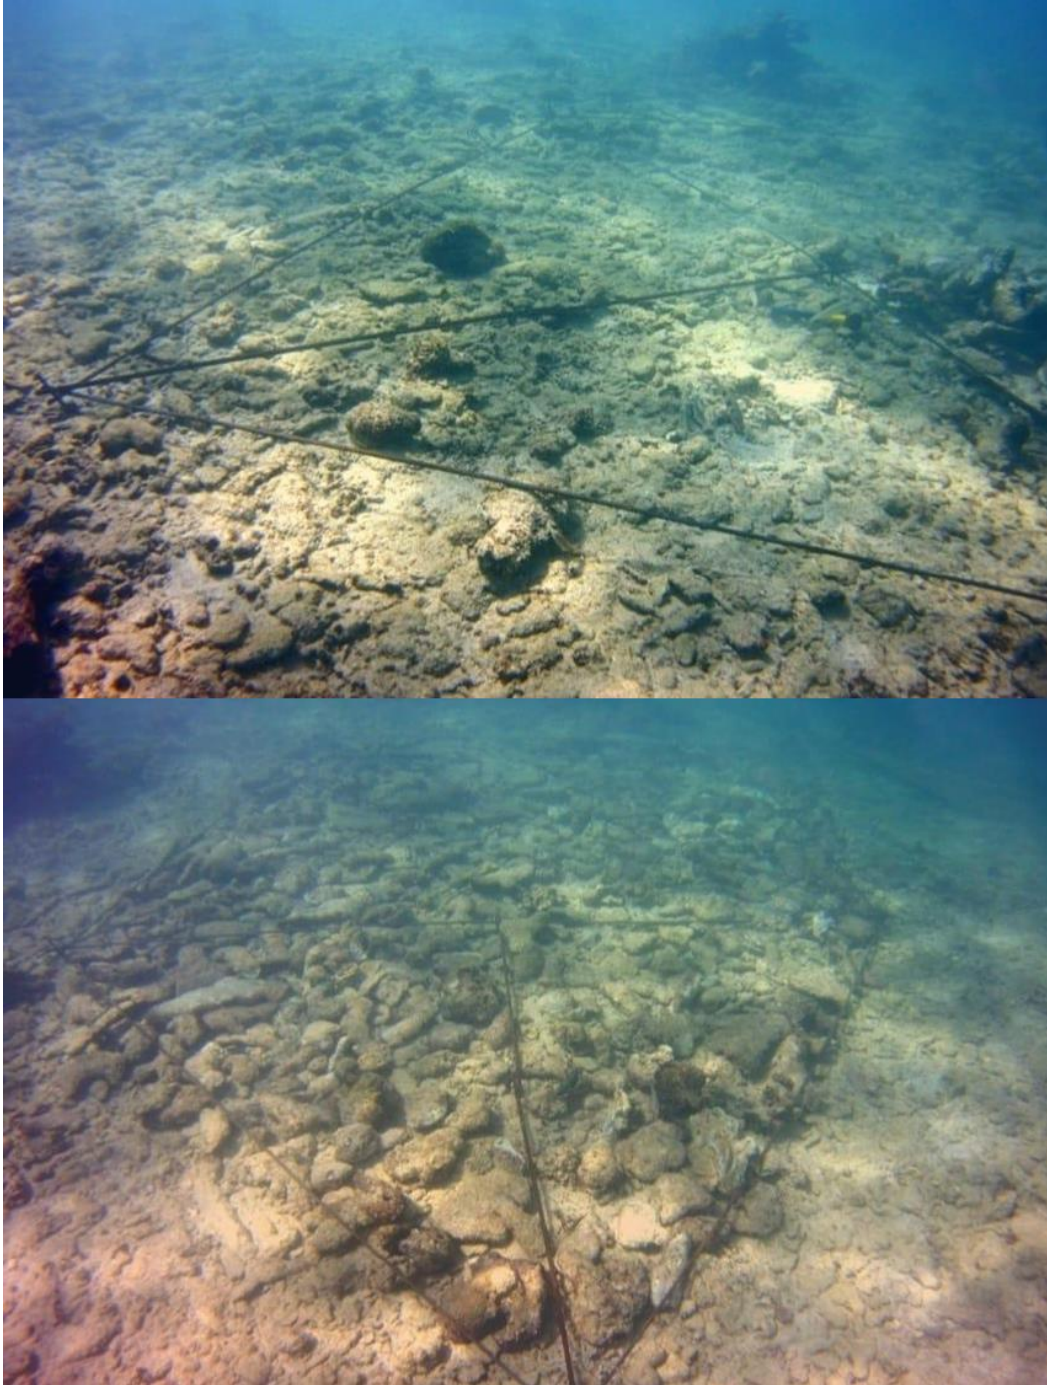
Figure 8. Rubble stabilization setup. A framework of half inch rebar is installed in the benthos and filled with rubble pieces. Subsequently, cement is poured and spread to fix the rebar and maximize surface contact with the rubble. Once hardened, the cement and rebar trap rubble in place. Eventually, corals can be outplanted on the resulting structure.

- We have stabilized the old rubble in some areas creating a solid structure that will eliminate potential rubble projectiles, restore the mechanical damage on the reef with a solid substrate for the new fragments to be attached, and create new habitat.

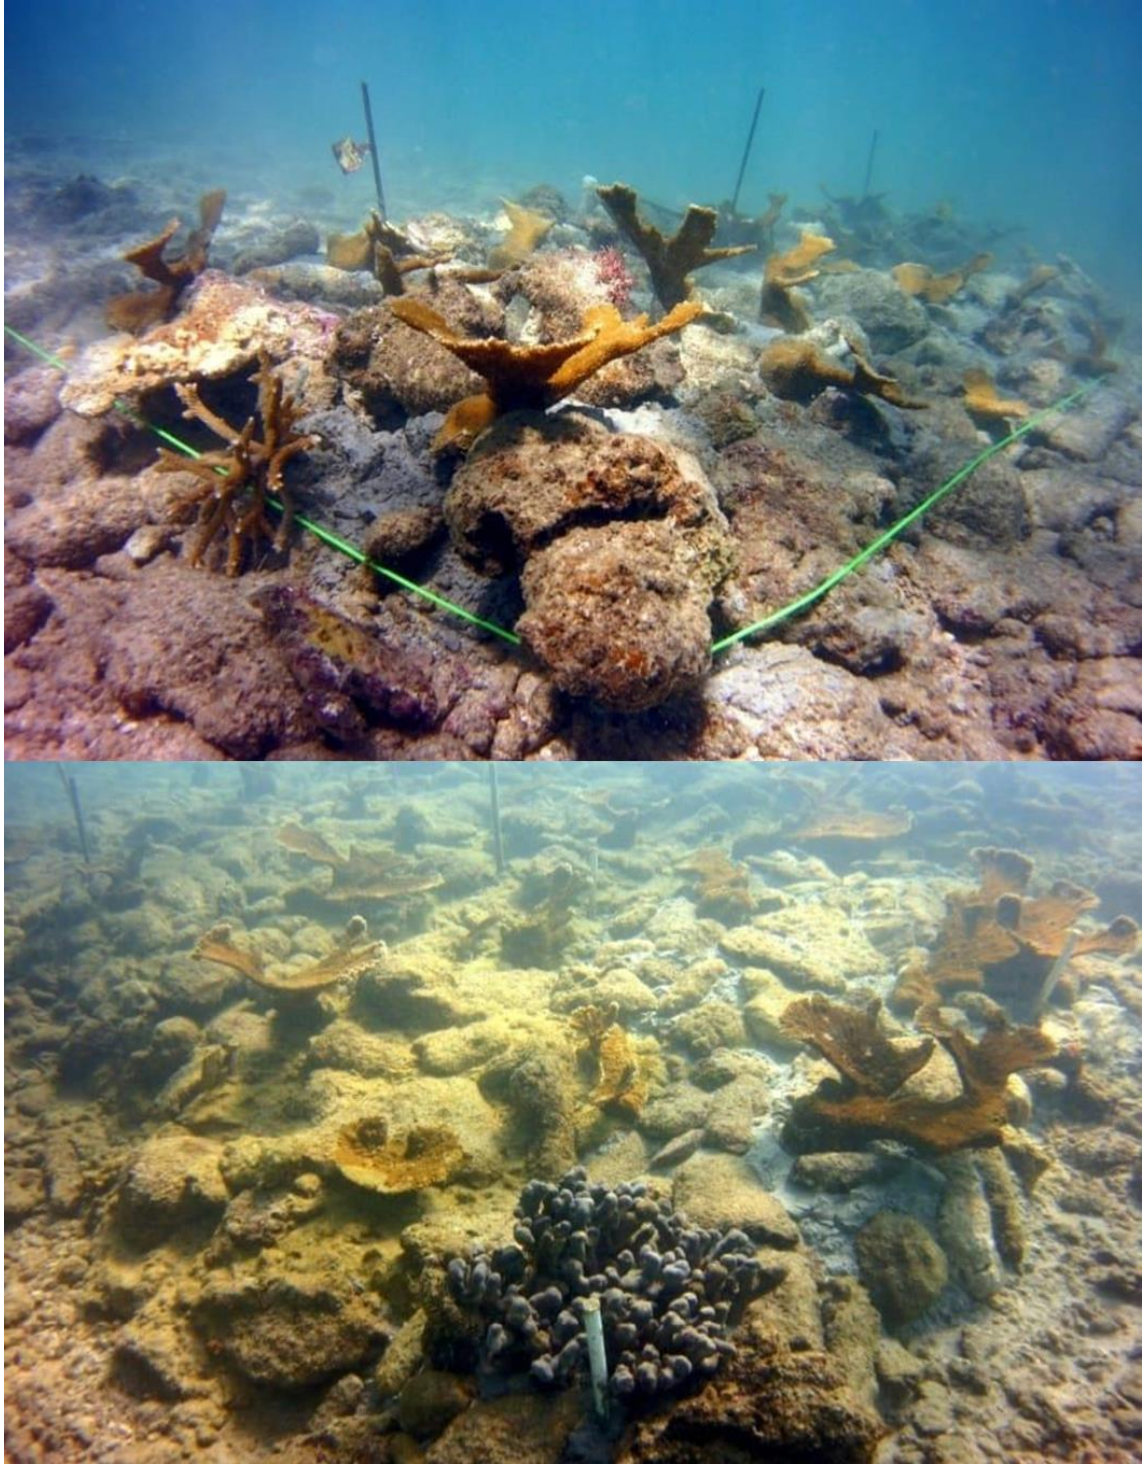
Figure 9. After Rubble stabilization setup with outplanted corals at HF09, Cayo Coral.

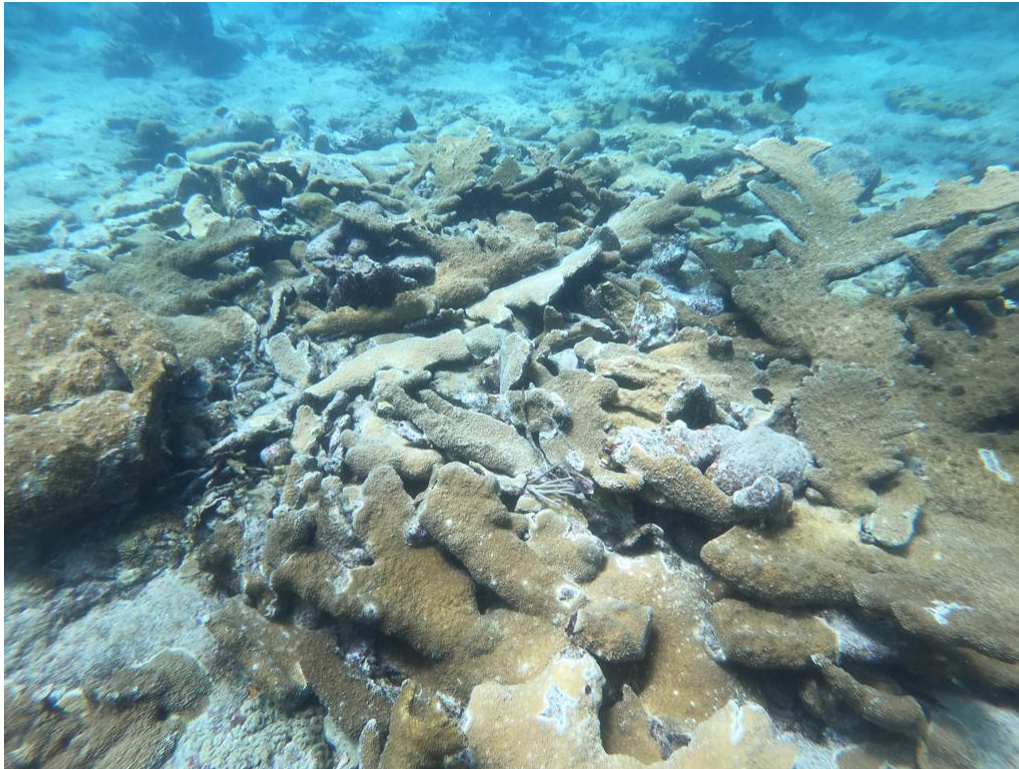
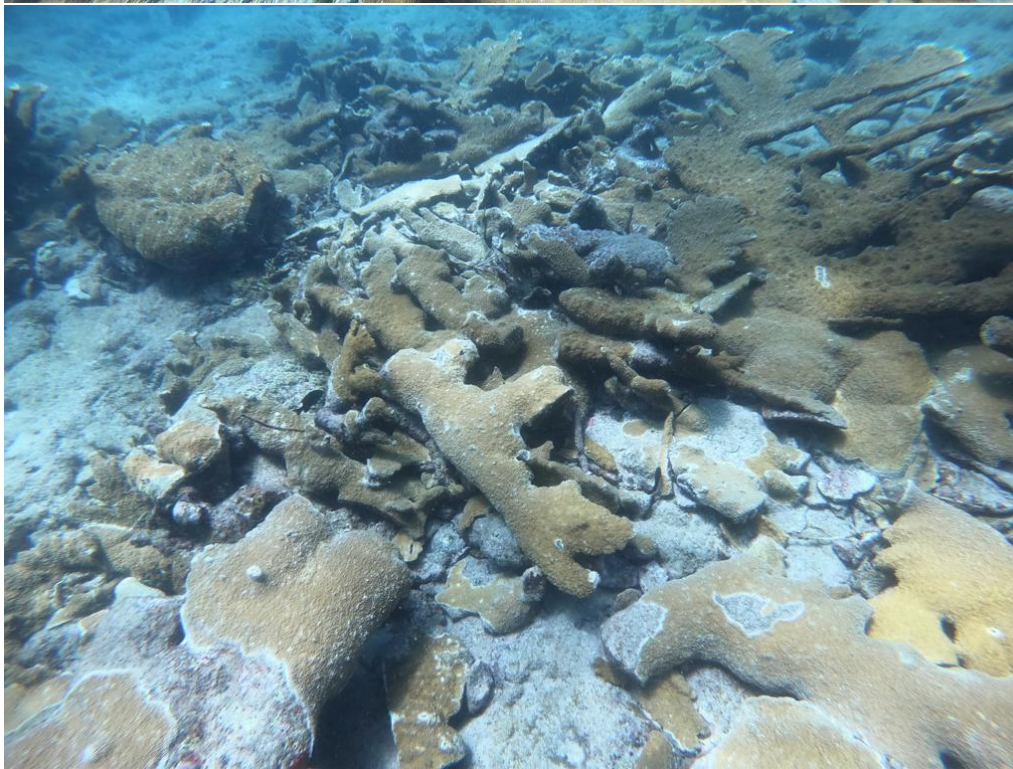
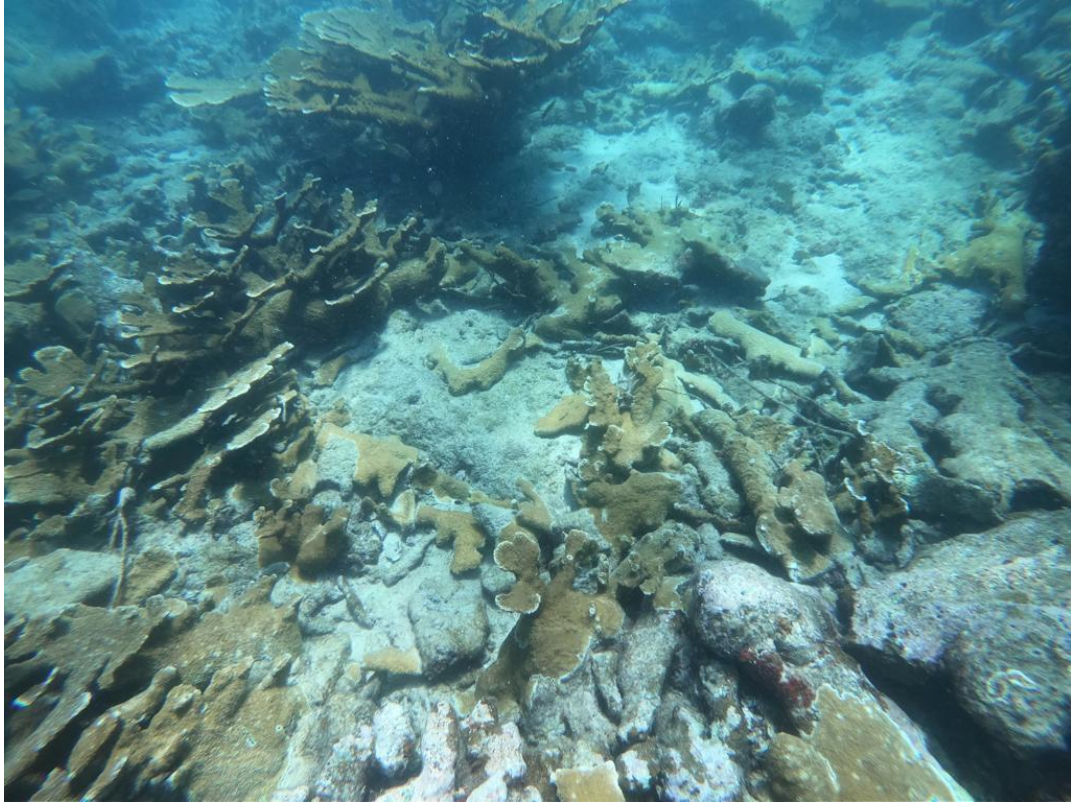
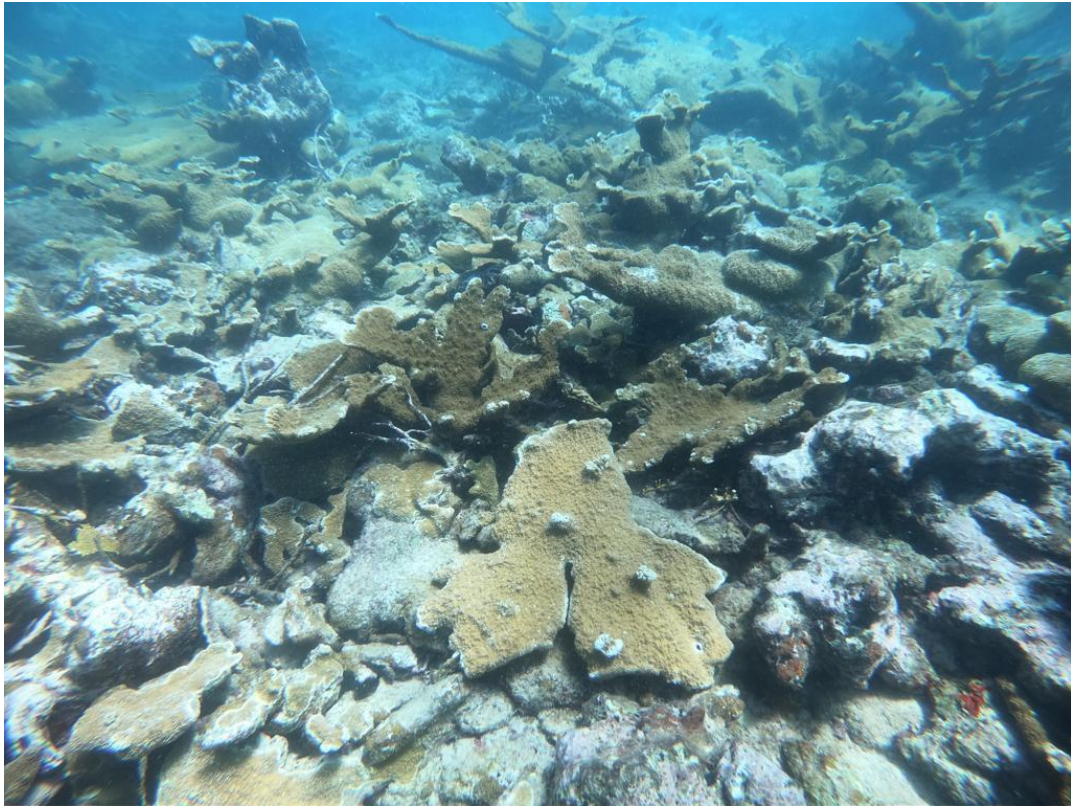
APPENDIX II. At-risk fragments that need further triage²

- However, there are still thousands of *A. palmata* fragments from this event that are still loose (APPENDIX II) and at risk of dying creating another problem like loose rubble, and issue that has creates a constant threat to extant populations during high wave energy events.

² Colonies at-risk documented on March 3 - 2023 in Cayo Aurora, Guanica.

- Respectfully we ask to be considered for additional funding opportunities to continue with coral restoration work and rubble stabilization since there are still a lot fragments detached from Fiona that will not attach well or attach to unstable substrate that do not provide long-term survival. This is key to the output of the implemented triage efforts.
