Río Loco Structure #2 Removal (El Puente)

Task #6 Progress Report

Protectores de Cuencas, Inc.
Box 1563 Yauco
Puerto Rico 00698
September 2018

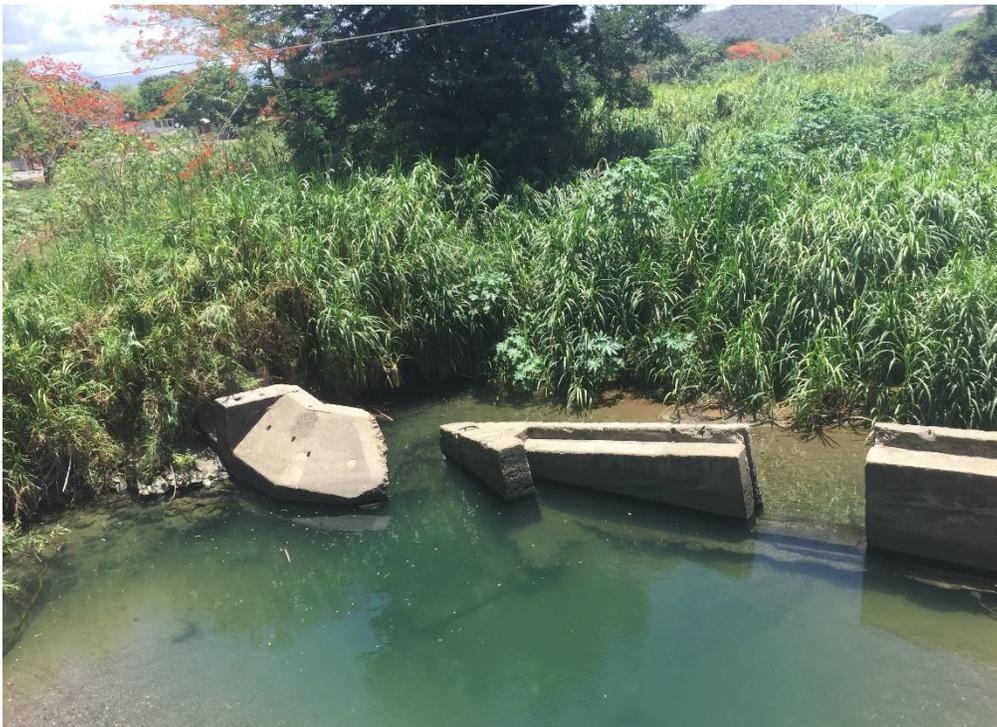
Figure 4. Project site prior to structure removal.

The “El Puente” site is located northwest of Santa Rita Farm, near El Caño community and upstream of El Caño Bridge. The removed structures were composed of the remnant of an old water intake irrigation infrastructure. At the moment of removal, part of the structure had collapsed at the center, backing up the flow of water toward the banks and causing bank erosion and concentrating flow towards the bridge center pillars putting into jeopardy the structural composition of the bridge itself. The proposed action was to remove the structures and locate them near the bridge central pillars to protect them from the energy of the river flow during storm events. This approach also came from site visits with NRCS Engineer and have the support of NRCS, the Conservation District and the farmers of the area (Figure 5).

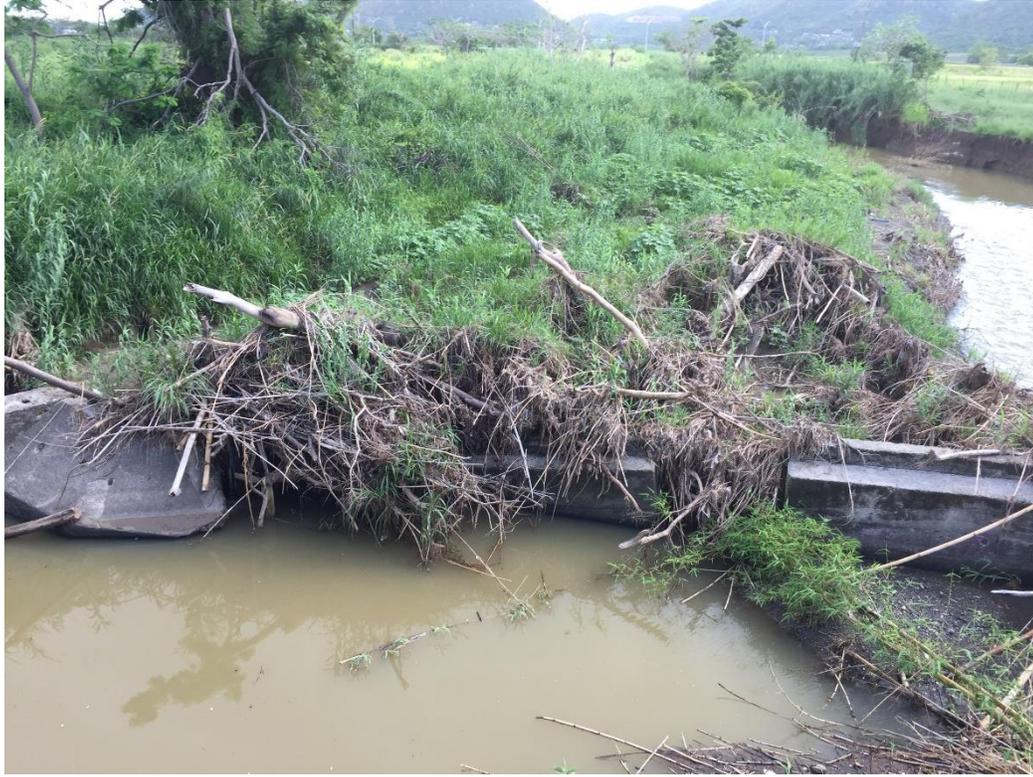
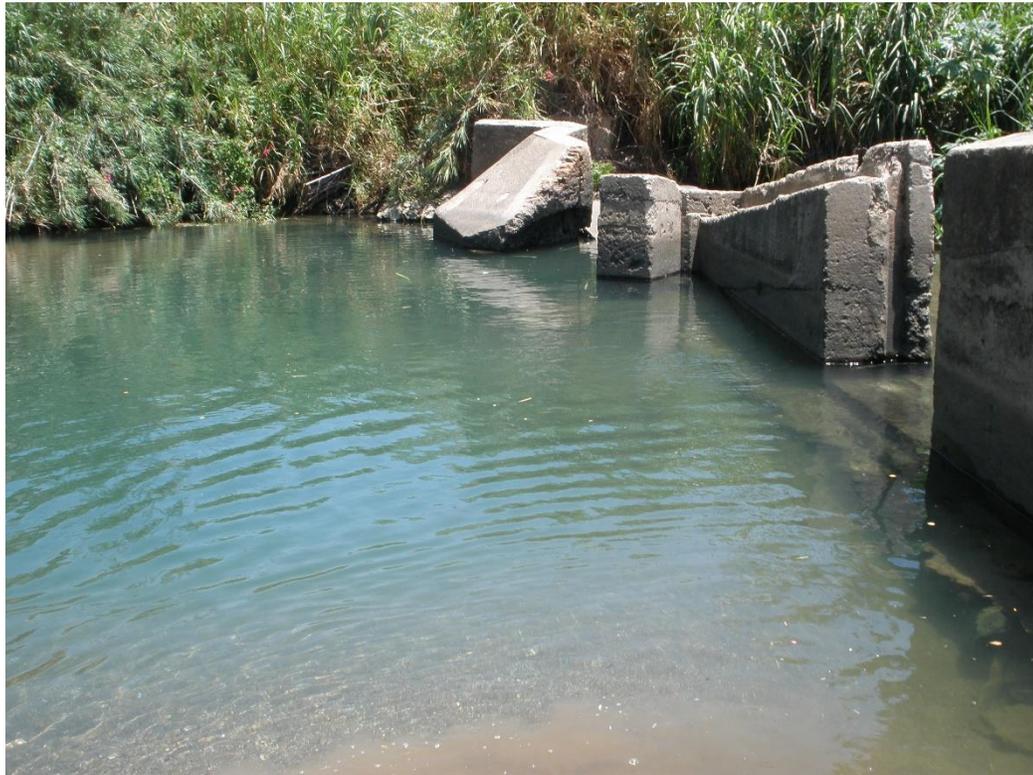
Figure 5. Project site prior to structure removal.

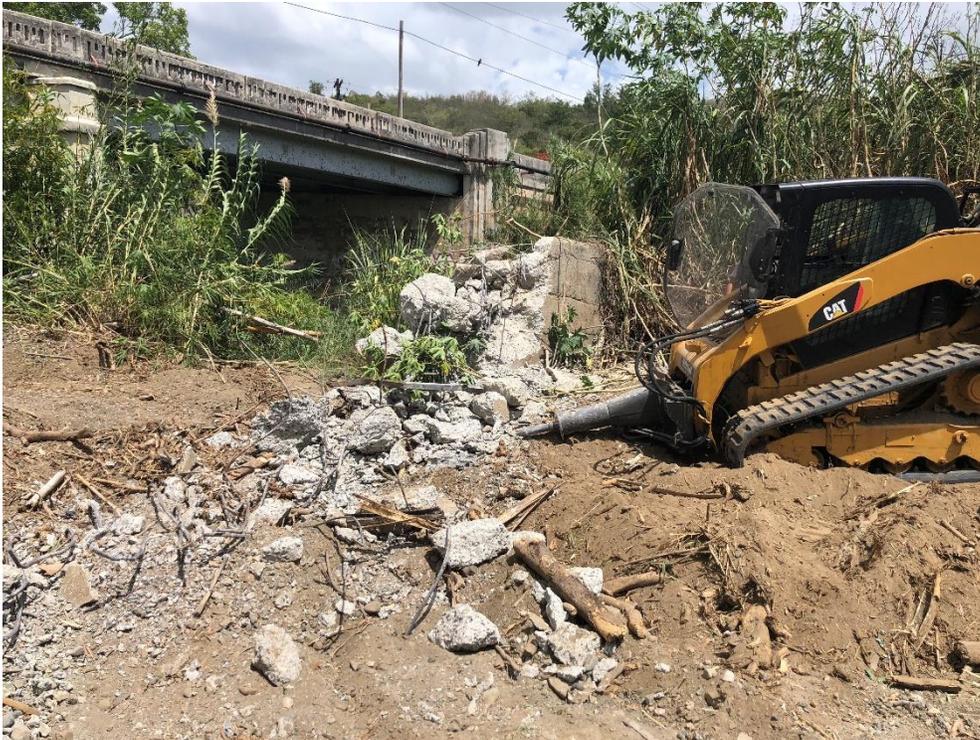
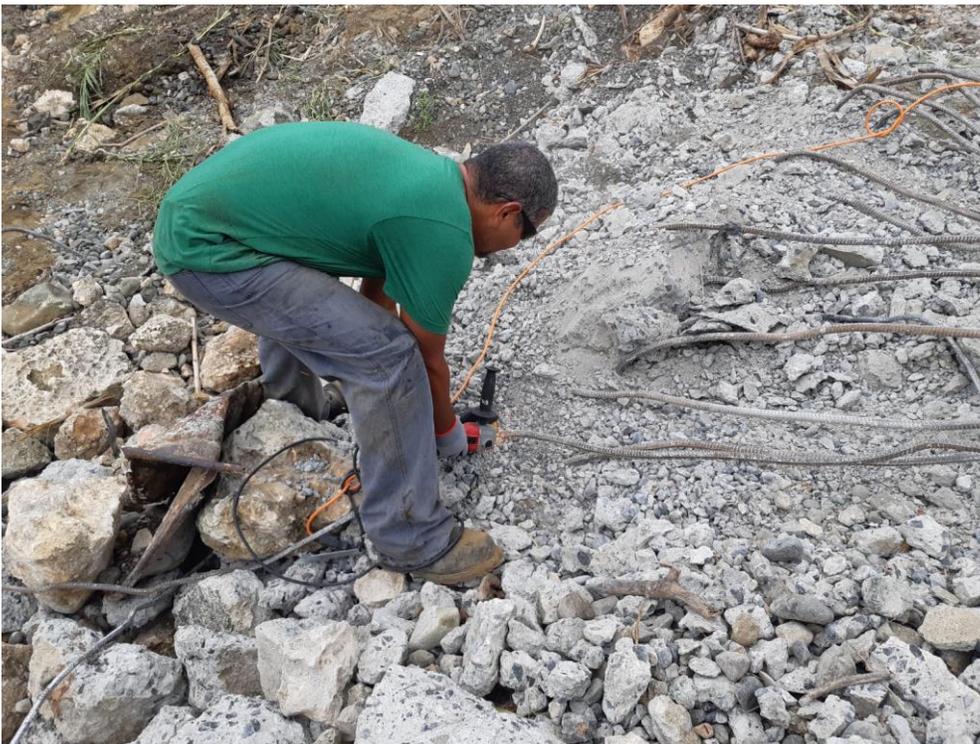
Figure 6. Project site during structure removal.

Removal of structures from the river bed was completed with heavy equipment that included a backhoe, a skid steer with hammer, and crawler dozer. All of the concrete debris was collected into dump trucks and transported for proper disposal (Figures 6-7). The measures taken with this project will help restore the conditions of the Rio Loco river bed, reduce the amount of erosion taking place, and therefore, reduce the amount of sediments being transported downstream and reaching coastal and marine environments associated with the Guanica watershed. Their removal will ultimately improve the water quality and health of the coral reefs systems, not only by reducing sediment loads but also by reducing the impact caused by the presence of debris that had accumulated by the structures.

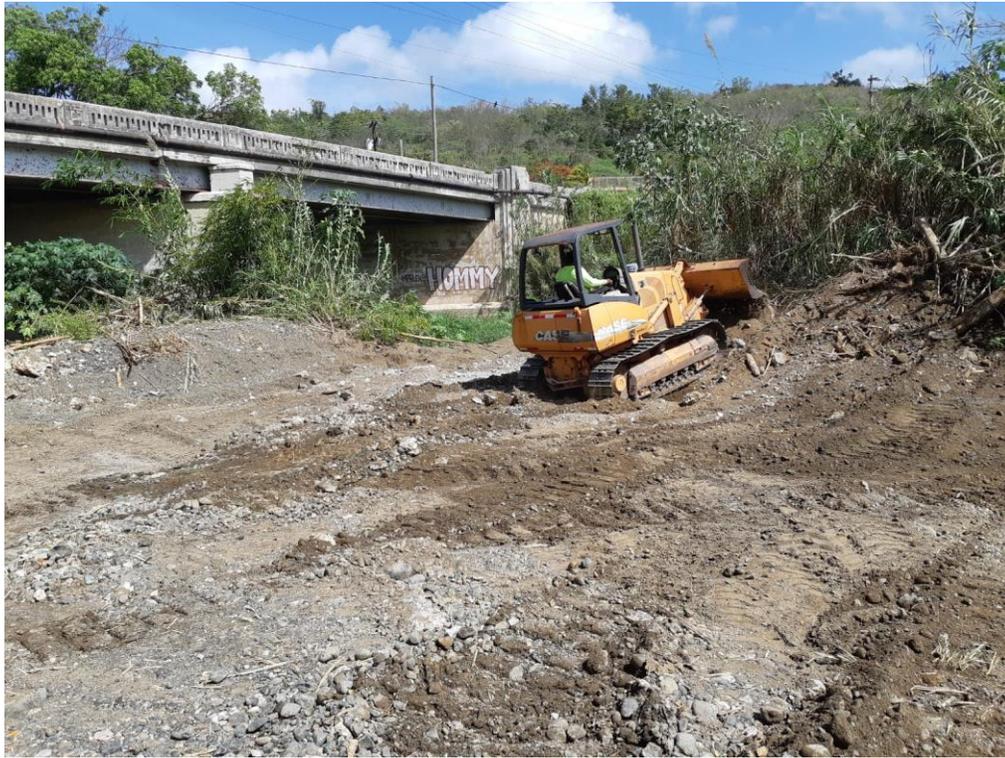
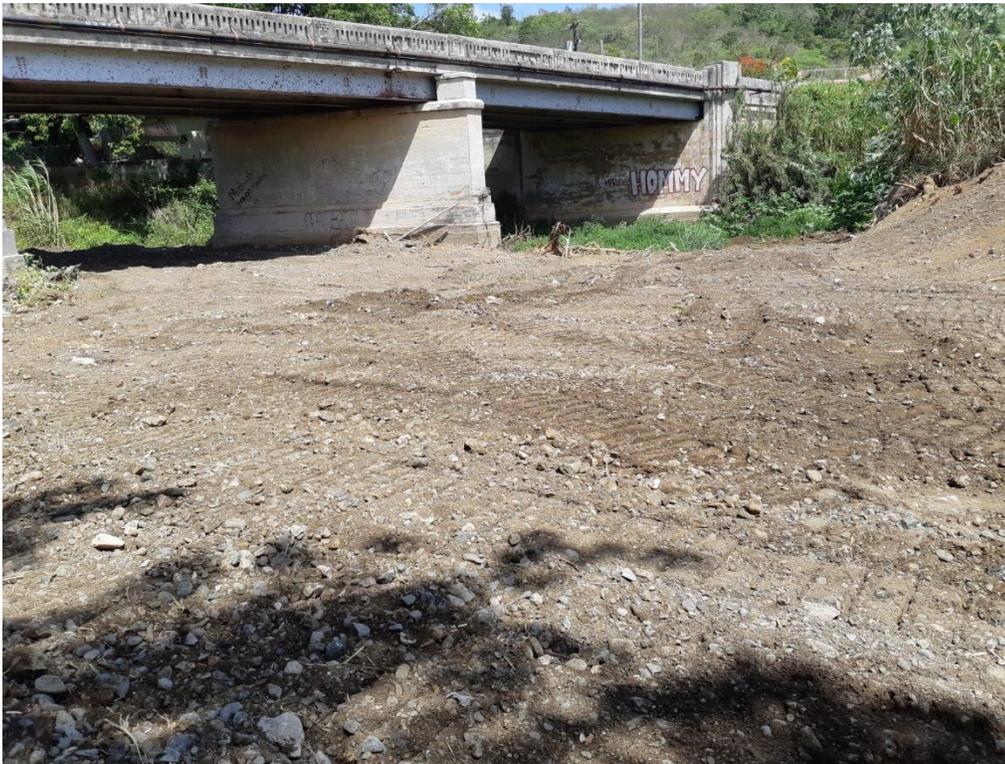
Figure 7. Project site upon completion of structure removal.
