AUA WATERSHED MANAGEMENT PLAN 2023-2028

February 2024

Horsley Witten Group, Inc.

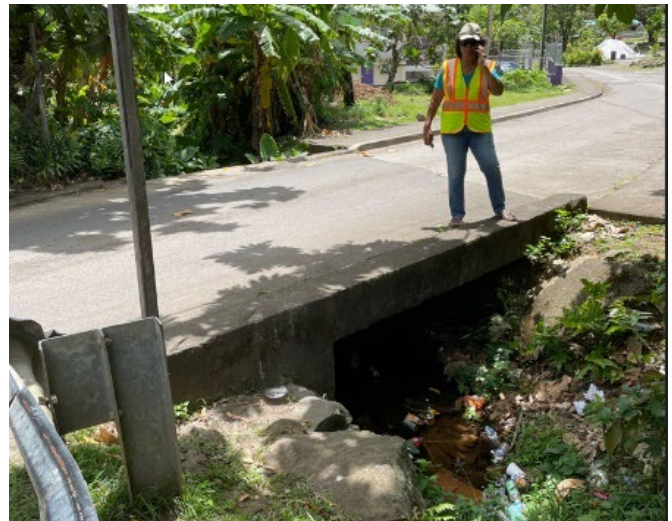
Location of chronic trash buildup in the stream to target during community stream cleanups.

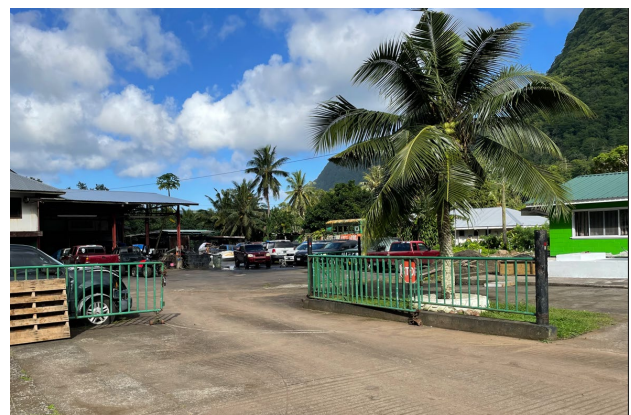
- Site #12. Auto yard backs up to stream, car washing observed, staining on gravel, excessive trash and junk in stream and buffer. Develop pollution prevention plan for proper outdoor material storage and vehicle maintenance and cleanup stream.
- Site #1. Paved interior courtyard (residential/commercial) sees flooding due to high runoff volumes with small, constricted outlet. Exposed outdoor material storage could contribute pollutants via runoff. Replace/improve drainage path and outlet to stream (increase pipe size), pollution prevention (material covering & education).
- Village-wide. Continue to utilize AS-EPA financial support for removal and proper disposal of unneeded vehicles and appliances (every two years).

Help auto repair yard identify and implement low-cost pollution prevention options.

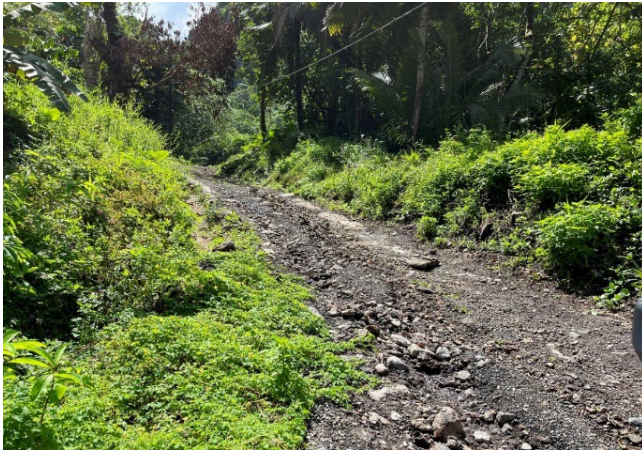
Rutting of unpaved access road/driveway (Site #7) is Erosion gully along unpaved driveway. This could be fixed with regrading of surface to an insloped pitch and installation of a ditch.

- Site #7. This steep, unpaved access road that leads to uppermost housing on Rt 006 was reportedly damaged during the sewer extension work. ASPA will need to fix the drainage on this road. There is gully down surface and clogging inlet on main road due inability of runoff to get into the ditch on the insloped ditch.

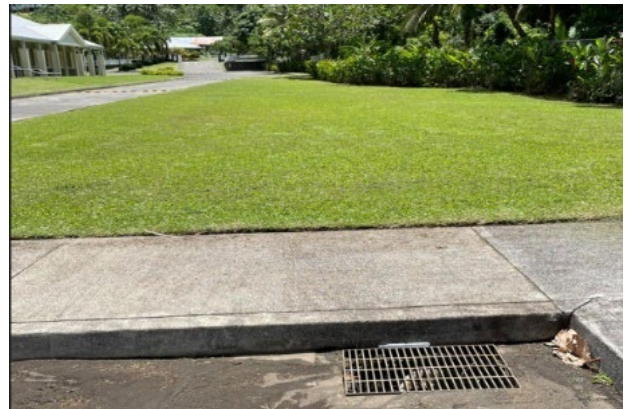
- Site #9 The Mormon Church discharges runoff from 1.5 acres of impervious cover directly to Lalolamauta Stream with no treatment. Use grassed areas to create bioretention or rain garden filters and tap into existing drainage system for overflow. Plant some trees for canopy cover. Clean trench drains.
- Site #2. The Aua Consolidated School (K-8) was recently renovated and paved. The site has over 1.5 acres of impervious cover that discharges untreated to open channels. The site generates a lot of heat given a lack of shade. Vehicle access to the interior of school is not safe for kids. The gym still floods at NW corner. Retrofit opportunities exist for tree filters/trenches, permeable pavers, and small rain gardens. Allow parking in rear and front lots only.

Convert existing lawn area to vegetated filters that can clean parking lot runoff before discharging into existing storm drain at the Mormon Church Site #9.

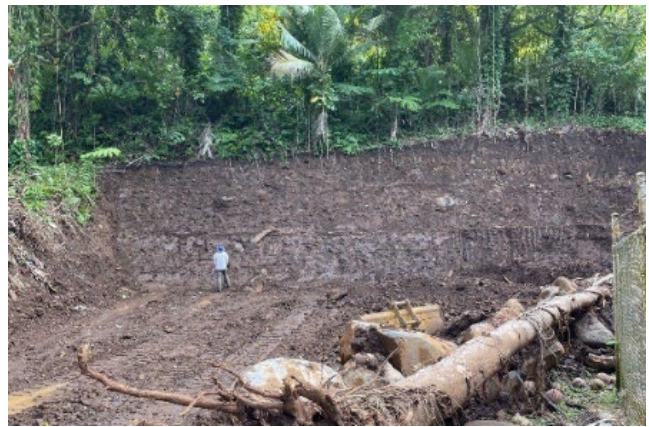
Cut slope close to edge of Rt. 006 behind water tank and other erodible soils at site should be stabilized (Site #6).

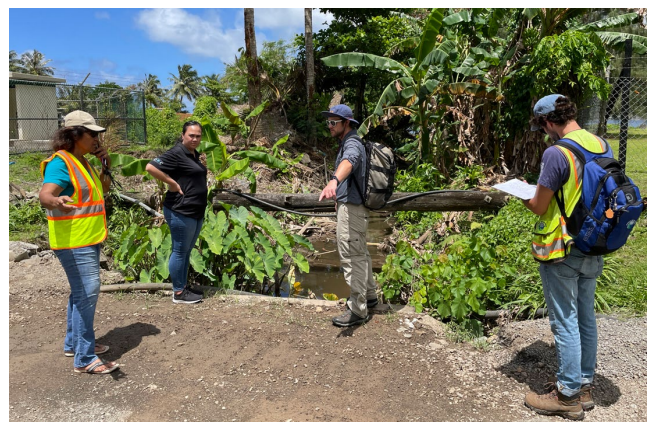
1.6 Erosion and Sediment Control for Public Construction Projects. Few ESC measures were observed as part of the active sewer extension project (some dust control and a few inlet protection devices were seen, but they were mostly ineffective). Perimeter controls around the staging area, along the roads, and near streams impacted by pipe and pump installations were absent. Inadequate inlet protection, dewatering filters, and temporary stream diversions resulted in clogged catch basins, culverts, and significant sediment deposition in streams and the nearshore environment. Reportedly, Phase I of construction was better, but ESC should be implemented for the full duration of land disturbance. Proper ESC measures are described in the [2019 American Samoa Erosion and Sediment Control Handbook](#). Other active and pending projects that will need to implement proper ESC measures in Aua include:

Inadequate erosion and sediment control during sewer extension work has led to extensive sedimentation in streams and turbid plumes in harbor (Site #15).

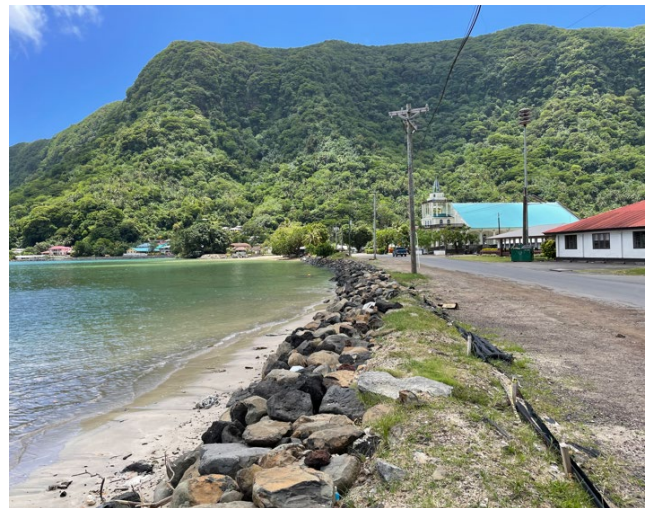
The narrow, unvegetated shorelines highlight the susceptibility of existing utility lines, Rt. 001, and flood-prone buildings are to damage from storm surge and SLR.

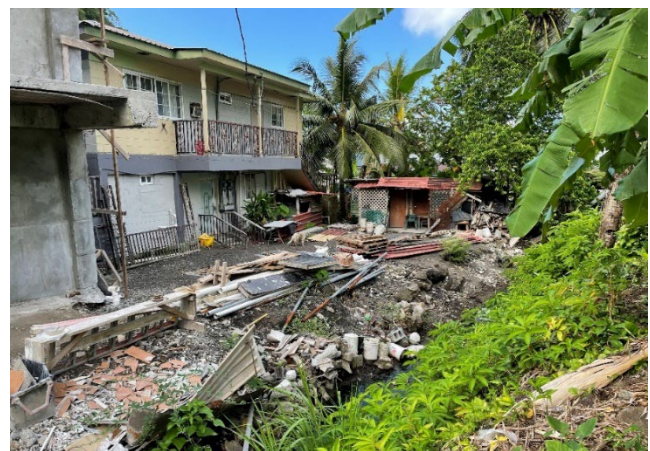
New home construction/renovation activity occurring adjacent to stream and within the flood hazard zone.

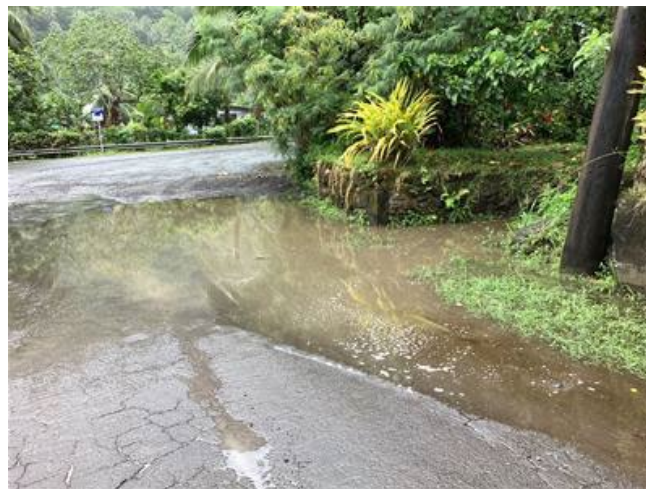
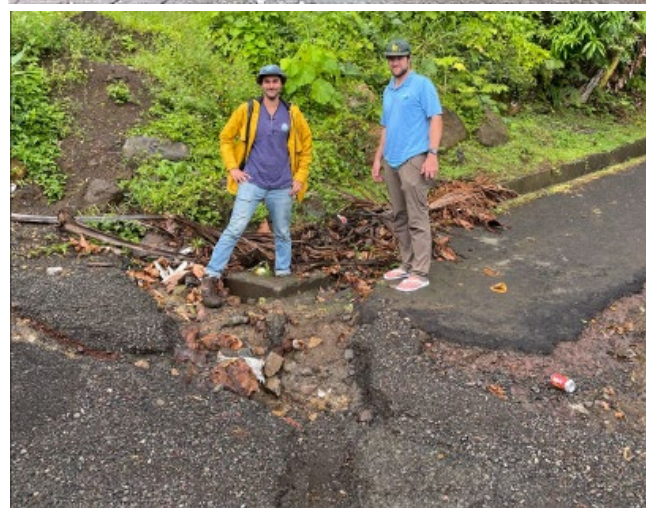
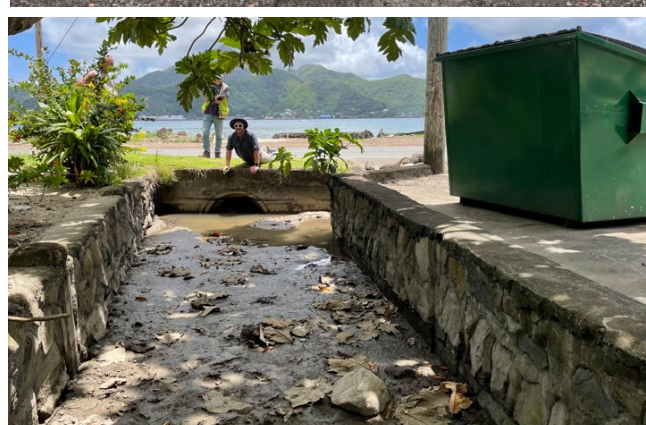
Two clogged drain inlets on Route 006 are causing long-term ponding on the road (I-64, top), erosion, and sediment contributions to road inlets downhill (I-51, middle). A blocked culvert pipe at I-16 causes backup in the stream and contributes to flooding at PT-Mart and Laundry (bottom).

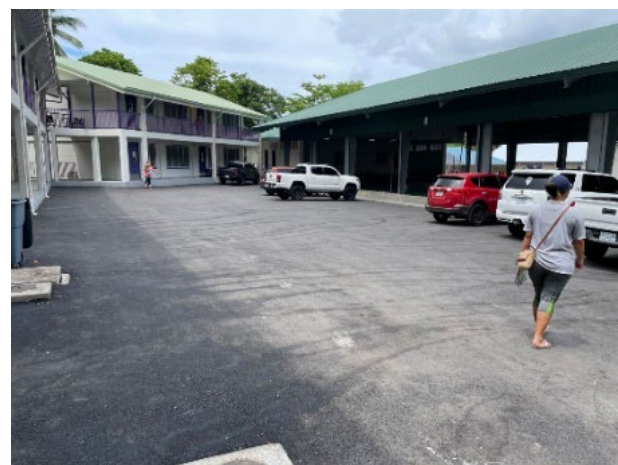
Rear parking and paved courtyard. Consider permeable pavement and tree filters to clean and infiltrate stormwater at the school, while cooling temperatures and providing pedestrian safety.

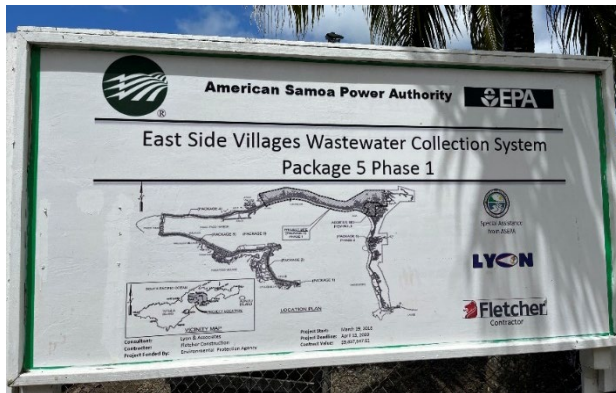
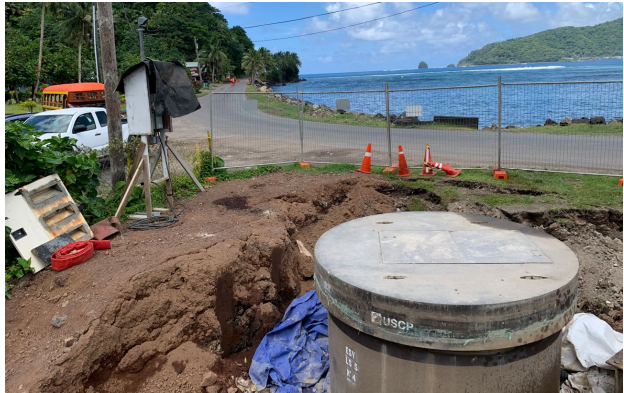
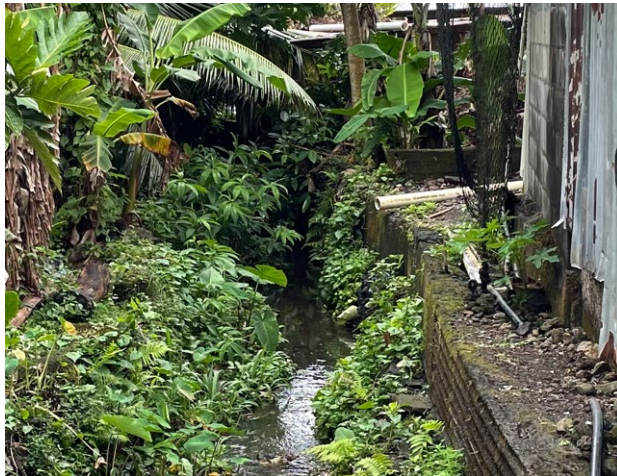
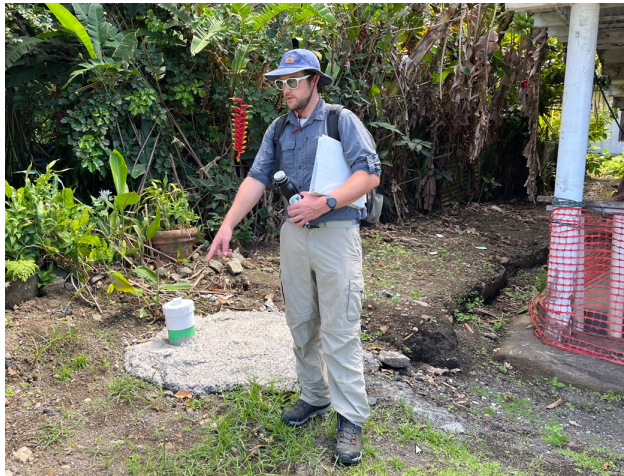
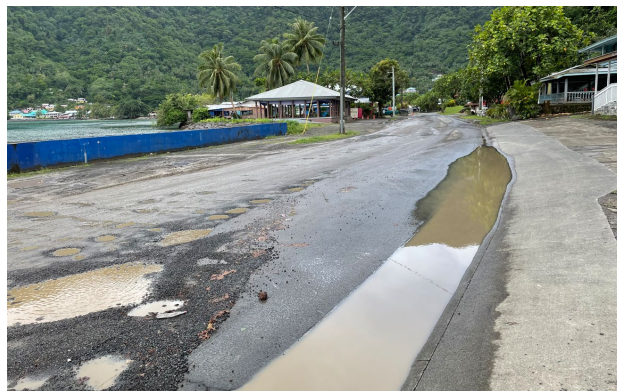
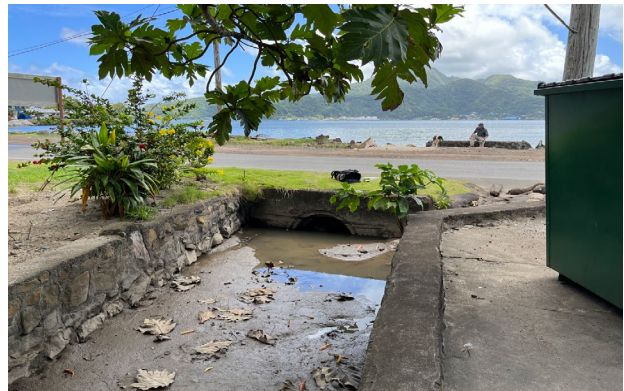
(TOP LEFT) ASPA East Side Villages Wastewater Collection System project map. (TOP RIGHT) Lift station installation in stream. (MIDDLE LEFT) Direct pipe to stream. (MIDDLE RIGHT) New lateral hookup to sewer at a residence. (BOTTOM LEFT) Sediment laden runoff on main road. (BOTTOM RIGHT) Sedimentation from construction in channel discharging to ocean.

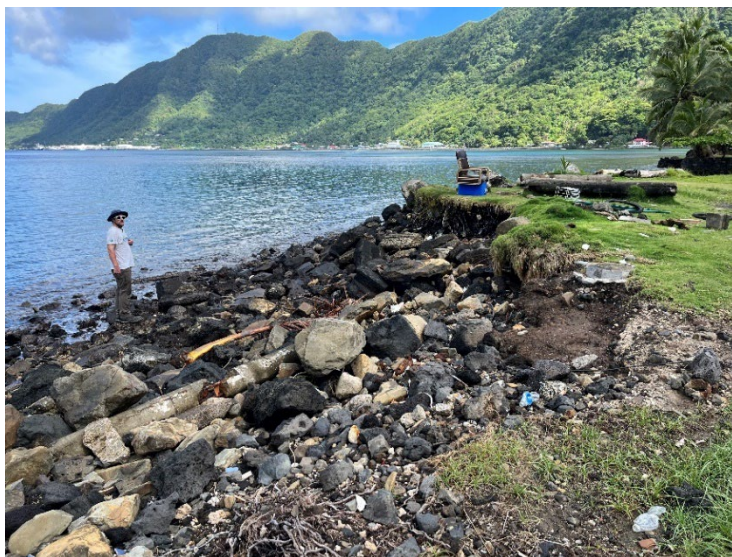
Shoreline erosion in the vicinity of the Aua Coral Transect marker
