St. Croix East End Watersheds Management Plan

U.S. Virgin Islands

FINAL November 2011

Horsley Witten Group, Inc
90 Route 6A, Sandwich, MA, 02563
www.horsleywitten.com

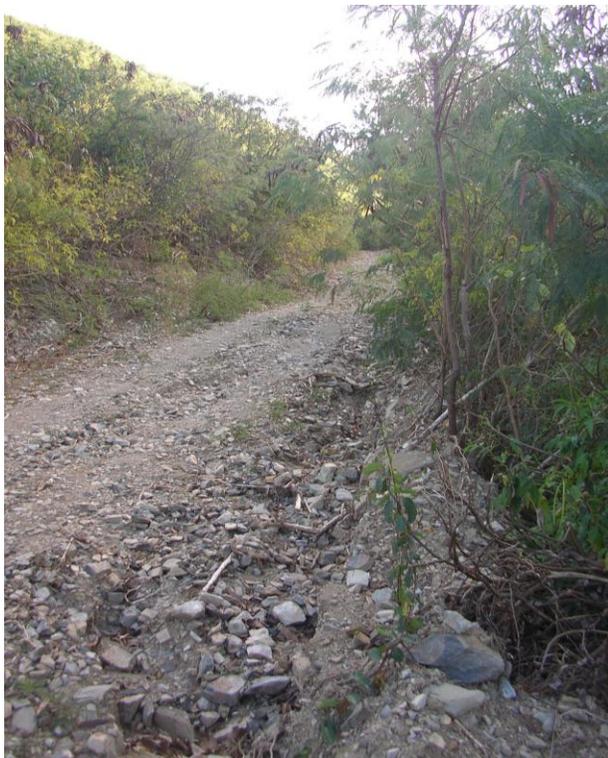
Space alongside road to install stepped/check dam system.

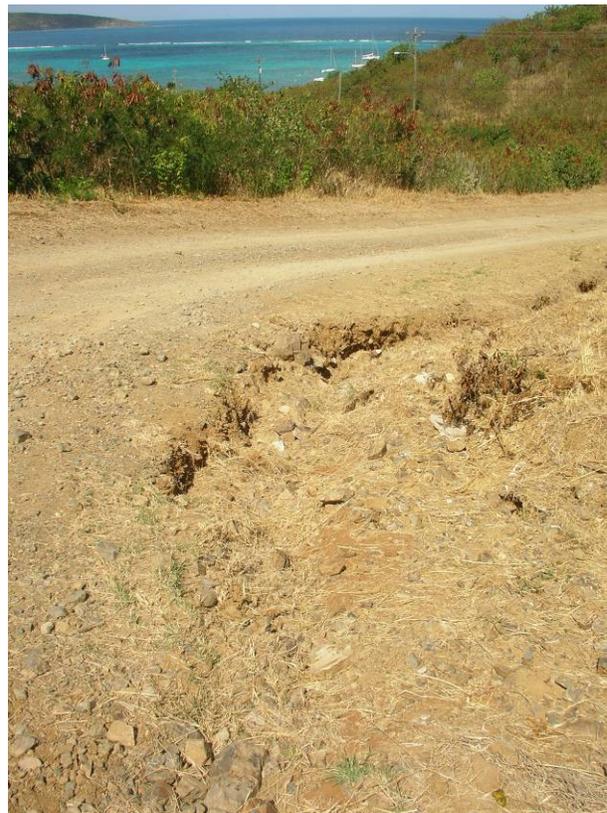
Erosion along ditch at bend in road.

1. Pave lower section of road; or
2. Install a minimum of 4 waterbars;
3. Stabilized bleed-off at top of bend;
4. Install check dams as necessary in roadside ditch to prevent erosive flows;

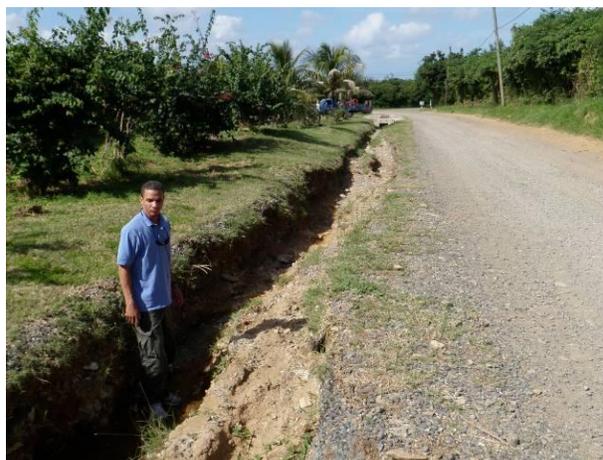
Eroding ditch along lower portion of Seven Flags Rd.

- On the downstream end, install a stilling basin to reduce erosive velocities. Some clearing and grading will be required for this work since the area is currently wooded. Maintenance access should be provided.

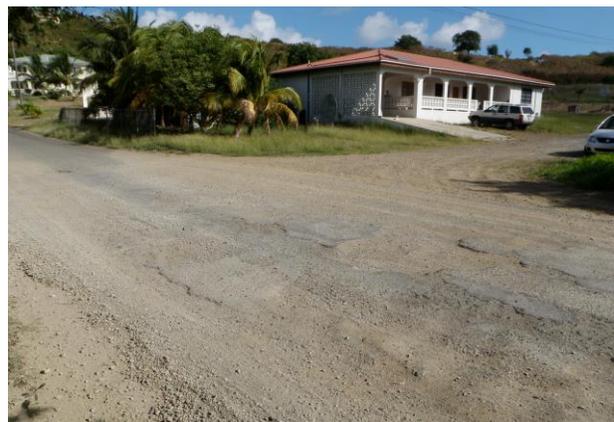
Surface deterioration of South Shore Rd.
