**VESSUP BAY/EAST END  
AREA OF PARTICULAR CONCERN  
(APC)**

***A COMPREHENSIVE ANALYTIC STUDY***

V.I. DEPARTMENT OF PLANNING AND NATURAL RESOURCES  
*Coastal Zone Management Program*

September 21, 1993

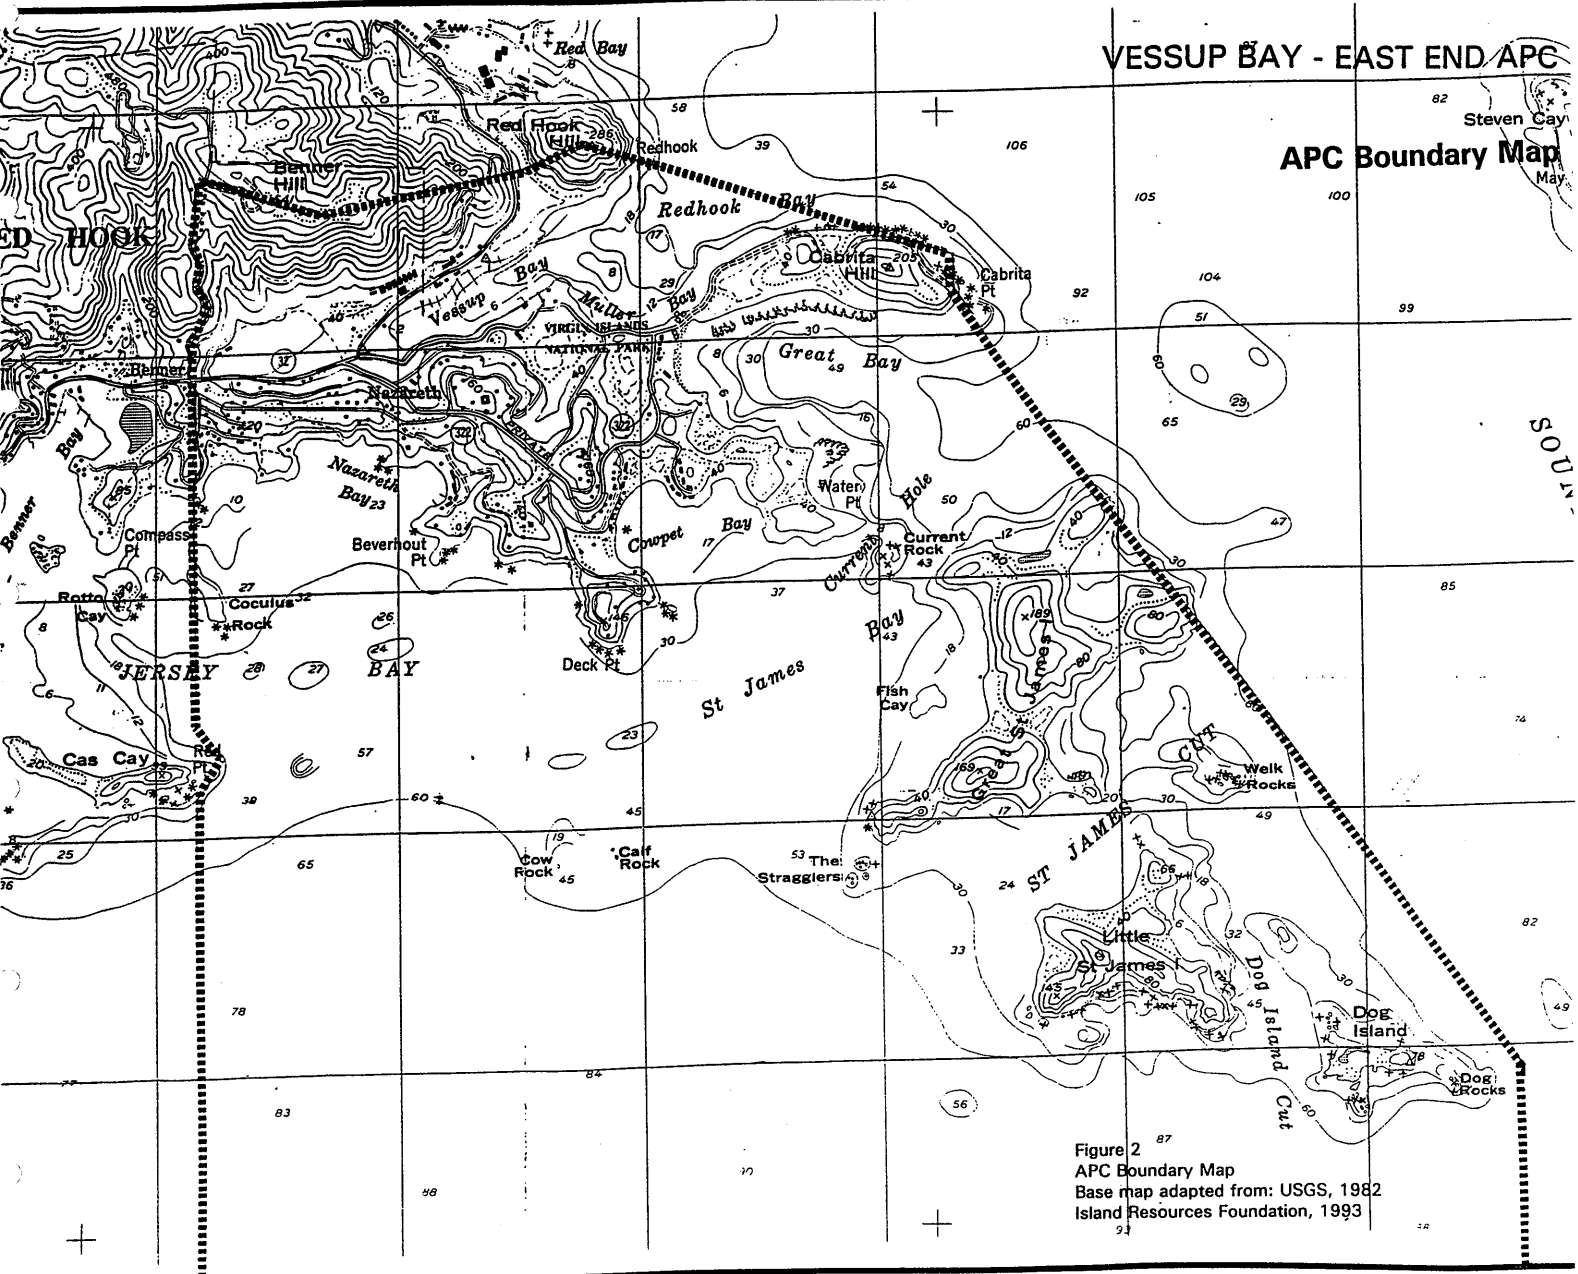
Figure 2  
APC Boundary Map  
Base map adapted from: USGS, 1982  
Island Resources Foundation, 1993

APC Boundary Map

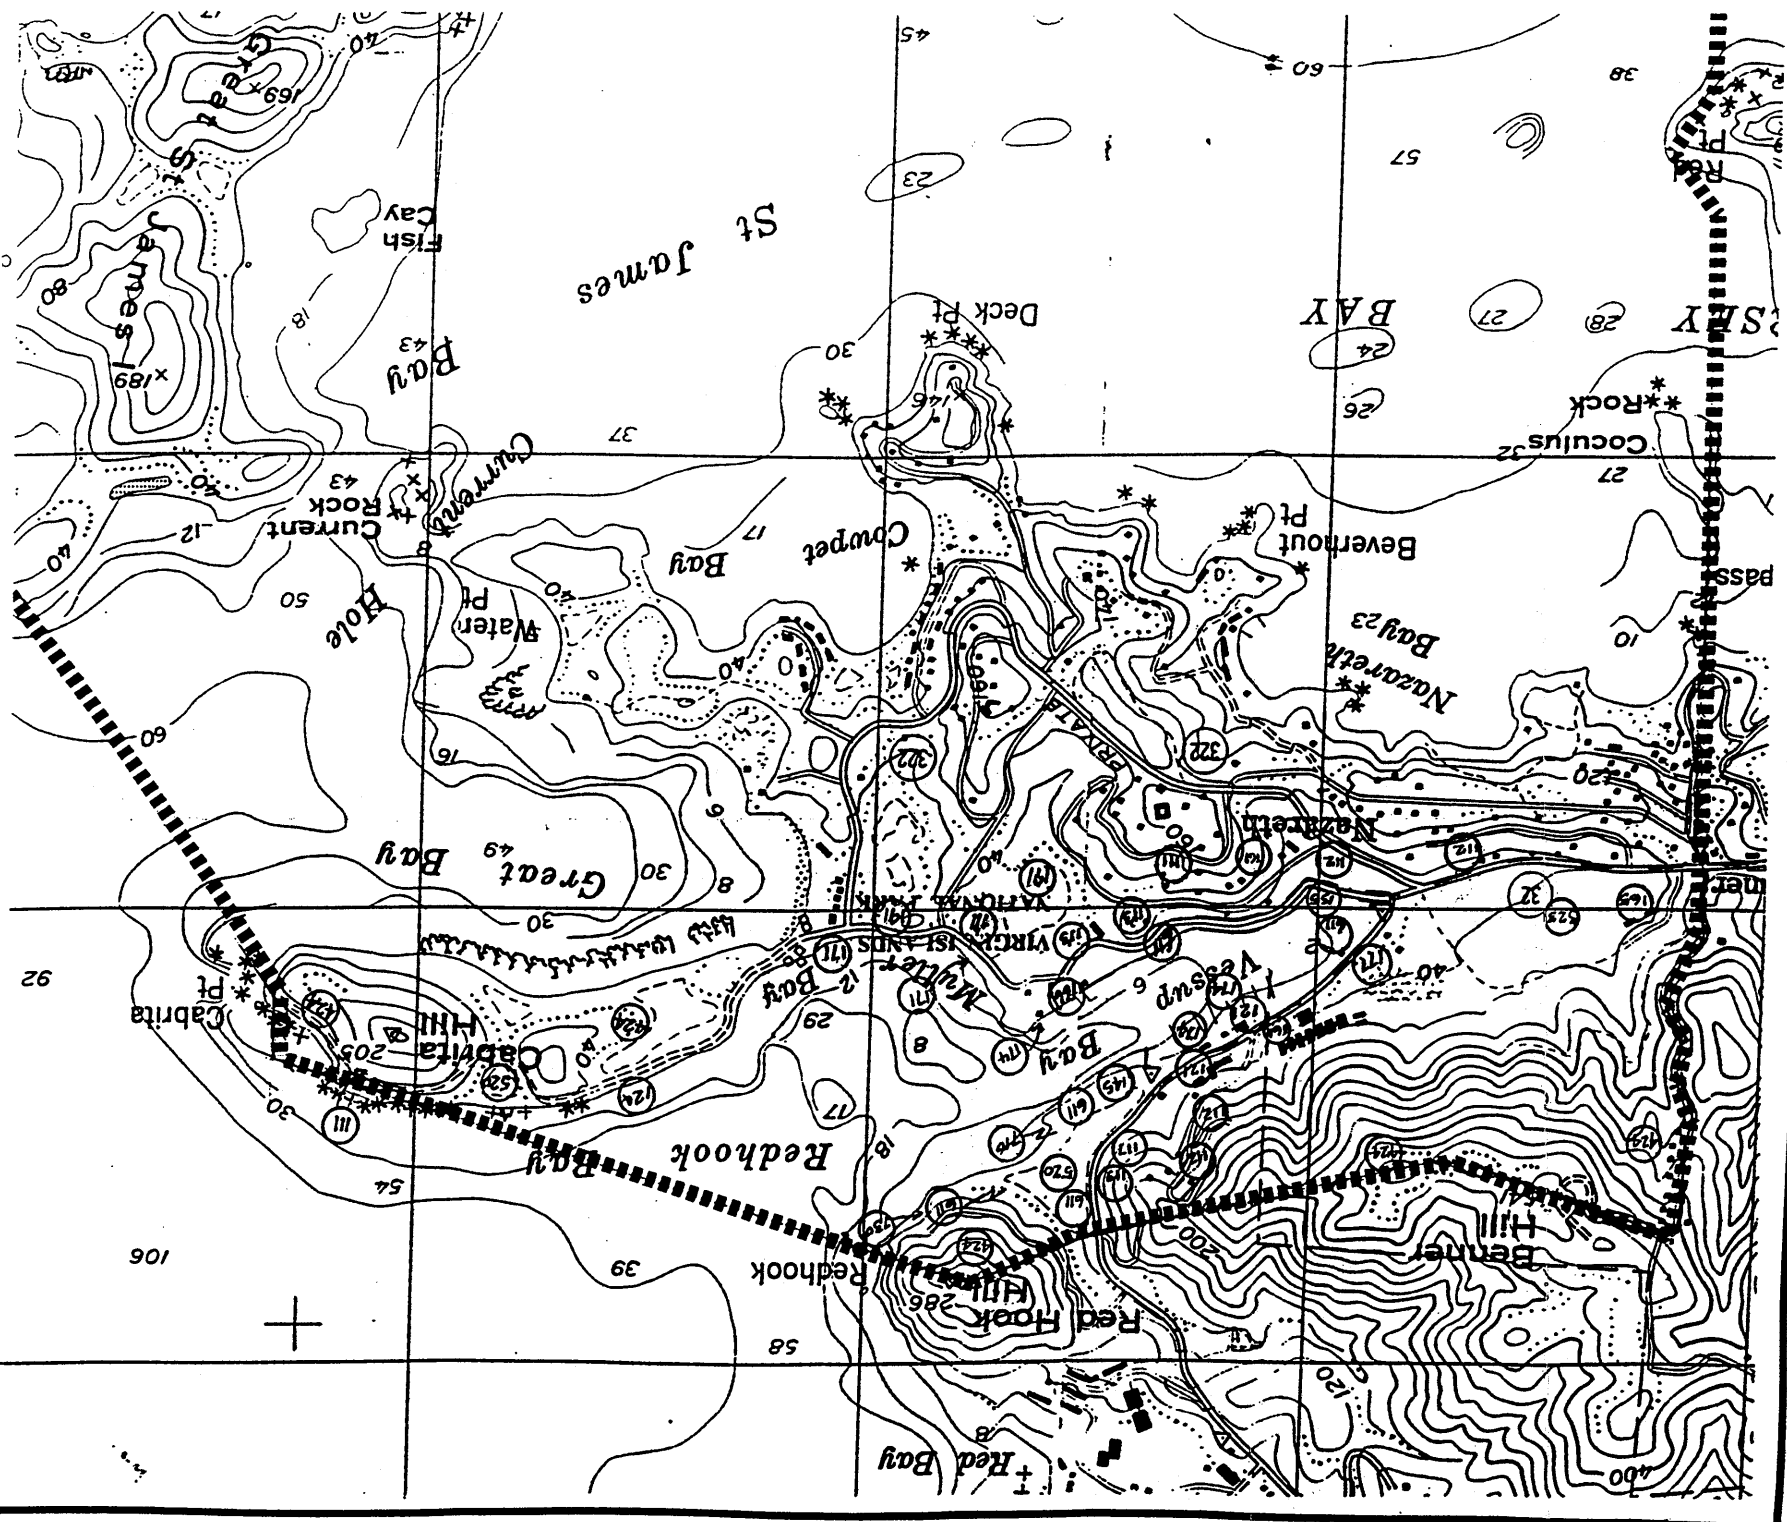
Figure 7  
Existing Zoning  
Adapted from: Real Estate  
Data Inc., 1987  
Island Resources Foundation, 1993

# Vessup Bay - East End APC Existing Zoning

U.S. Virgin Island  
Zoning Codes

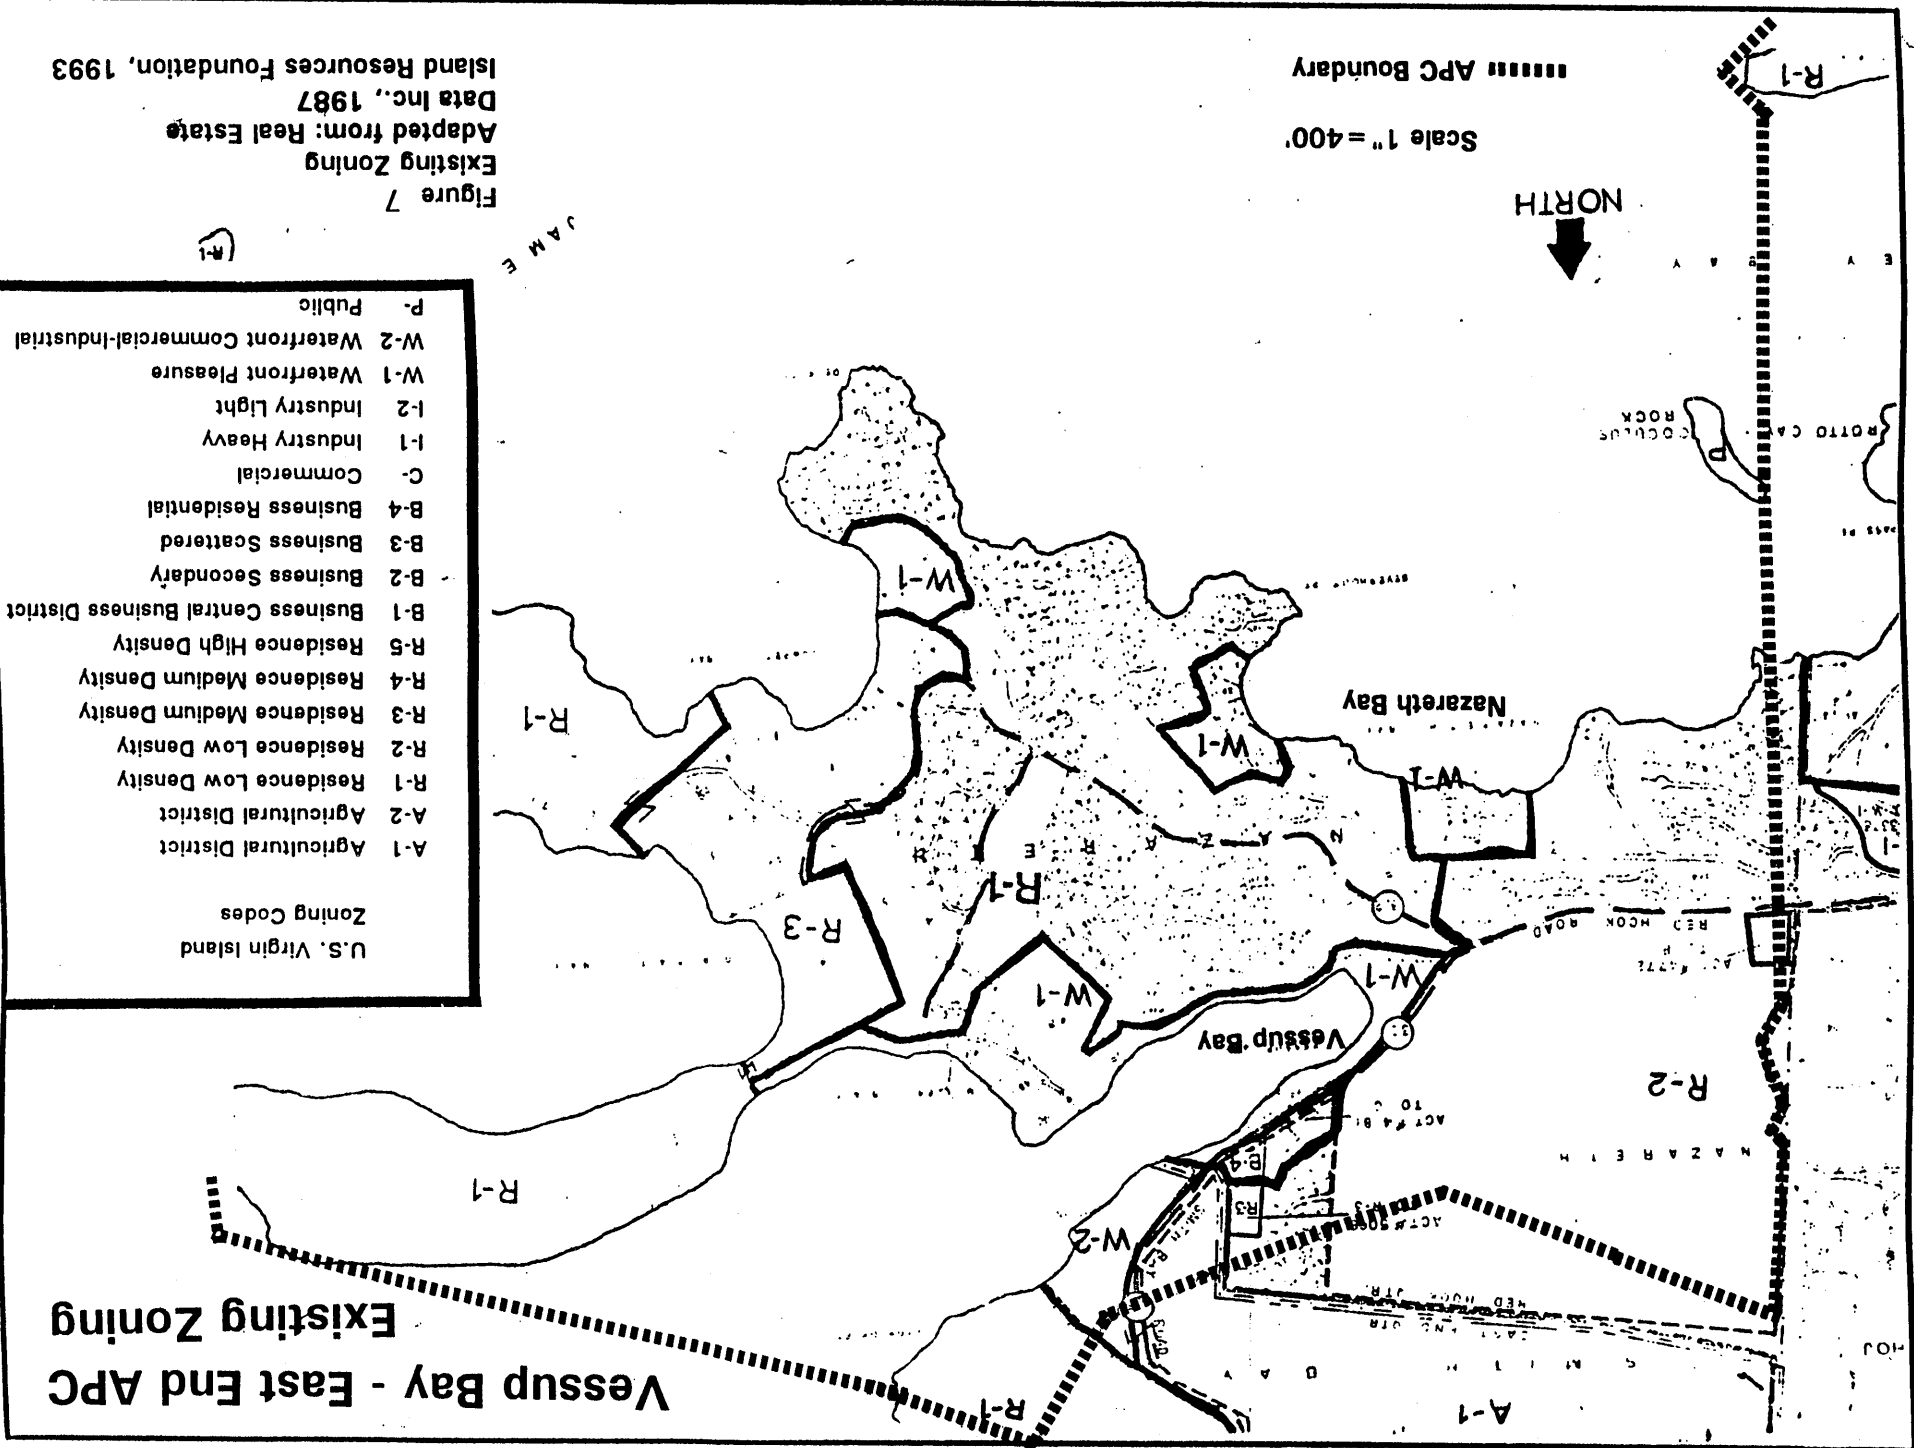
A-1	Agricultural District
A-2	Agricultural District
R-1	Residence Low Density
R-2	Residence Low Density
R-3	Residence Medium Density
R-4	Residence Medium Density
R-5	Residence High Density
B-1	Business Central Business District
B-2	Business Secondary
B-3	Business Scattered
B-4	Business Residential
C	Commercial
I-1	Industry Heavy
I-2	Industry Light
W-1	Waterfront Pleasure
W-2	Waterfront Commercial-Industrial
P	Public
