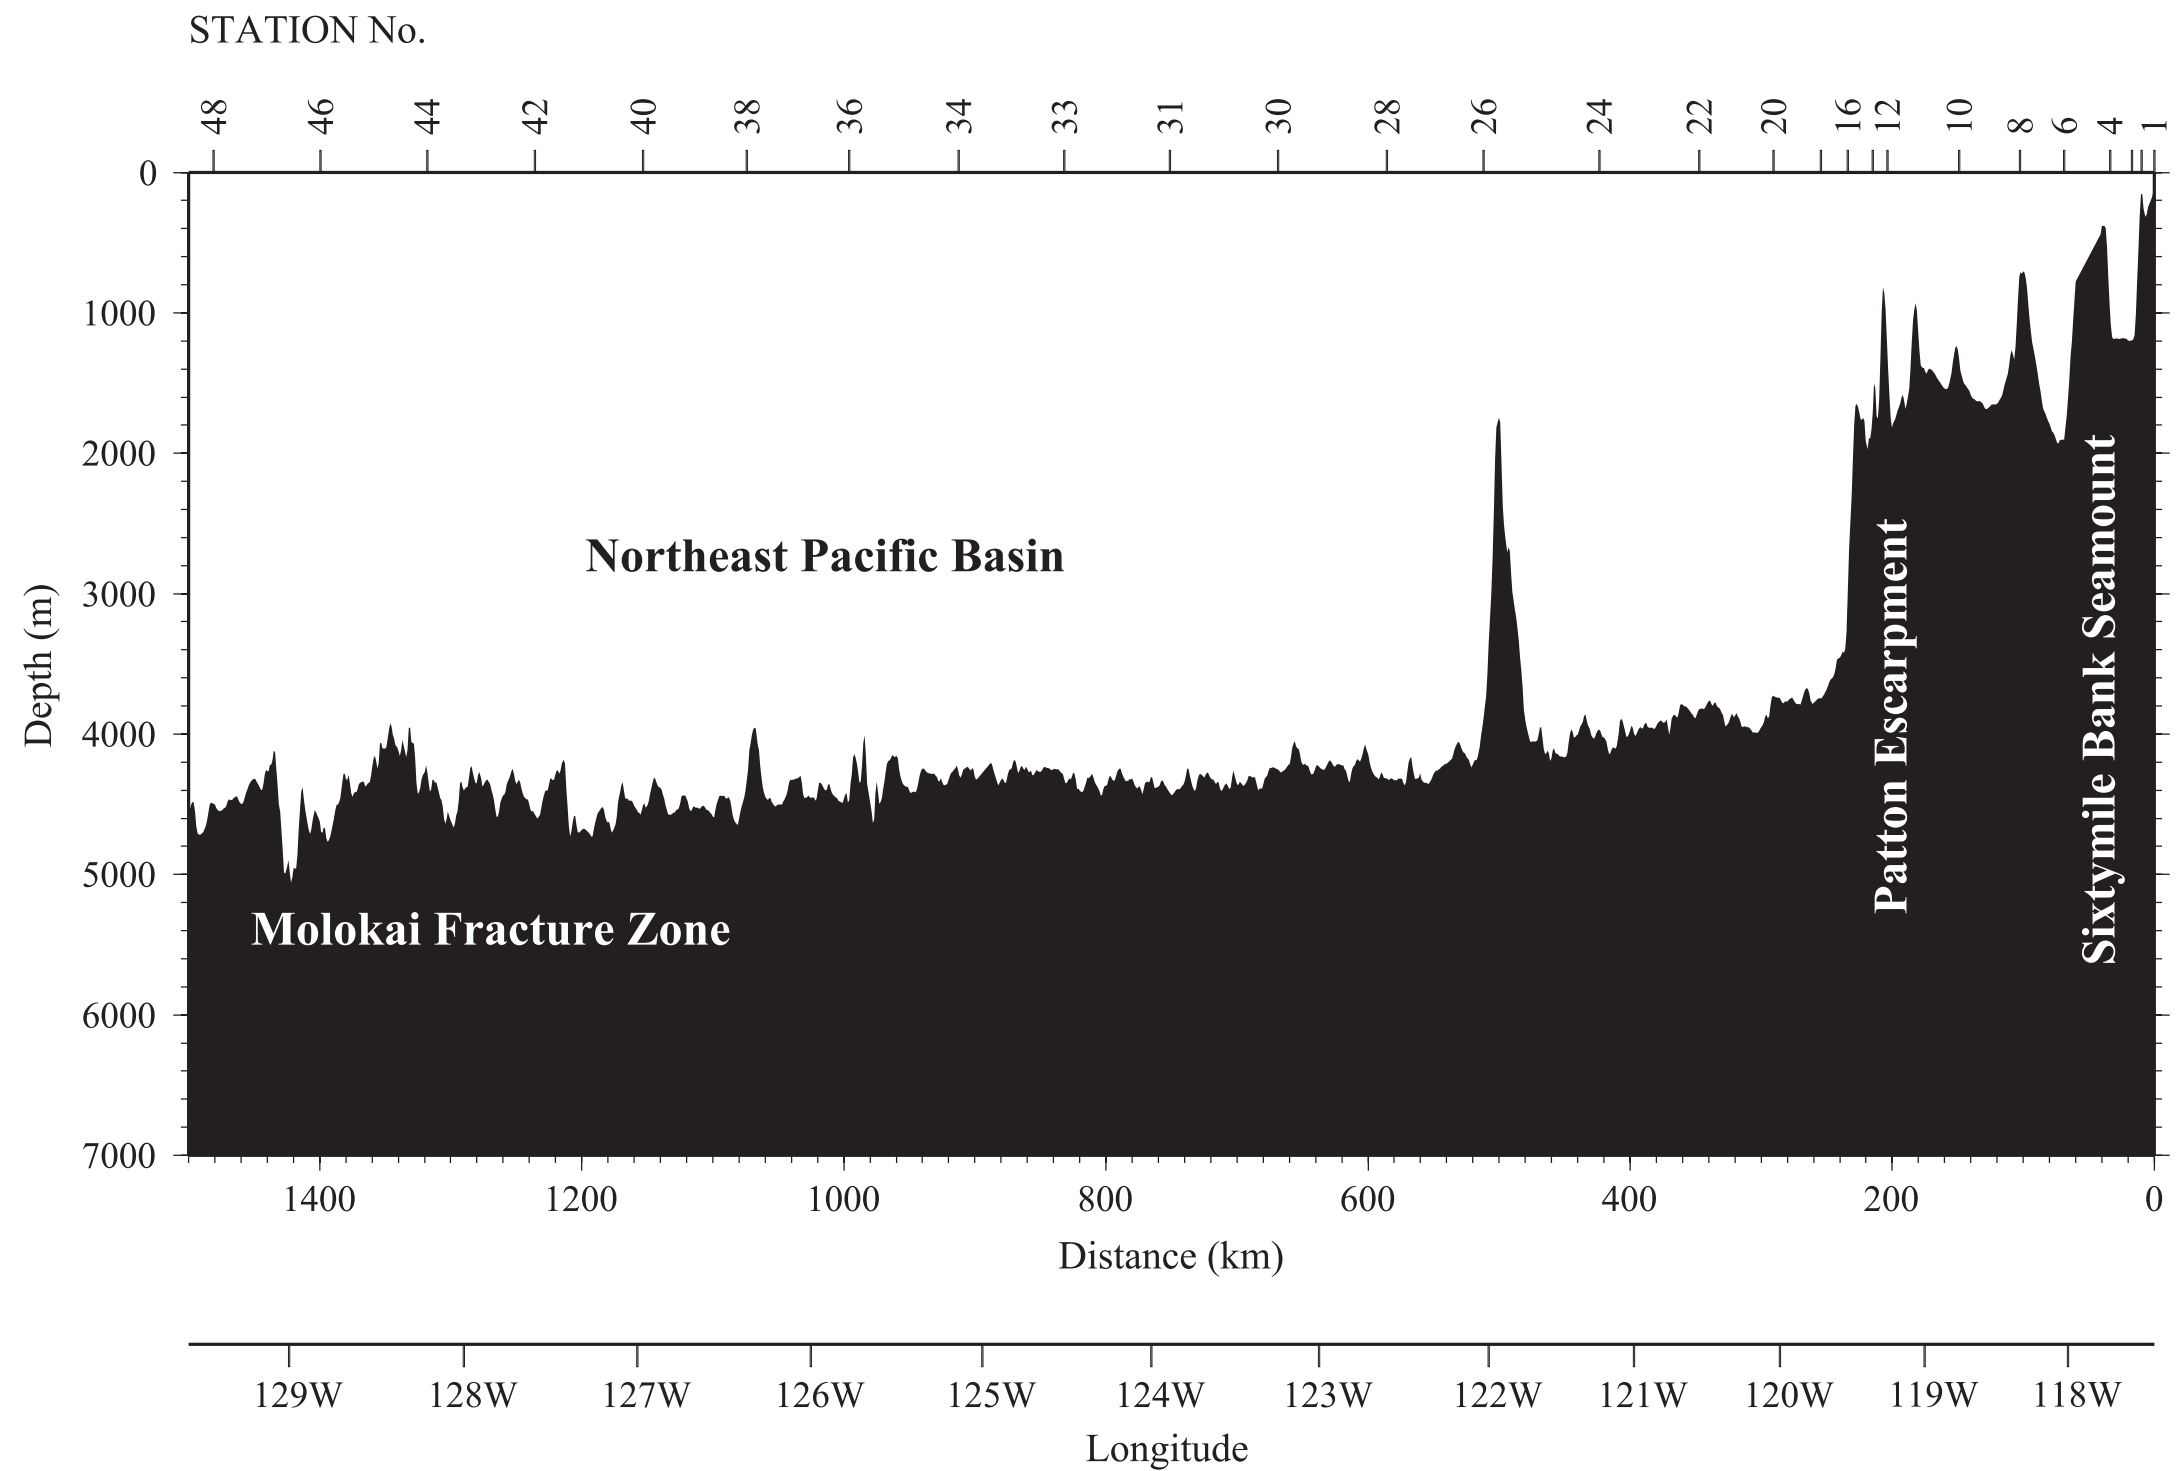
Figure 2

Bathymetry measured by Multi Narrow Beam Echo Sounding System
