**Reduction and control of sediment-laden runoff near critical coral reef ecosystems through the implementation of BMP'S in Culebra, Puerto Rico**  
**FINAL REPORT**

**Protectores de Cuencas, Inc.**

# RUNOFF AND EROSION CONTROL MEASURES FULLADOZA SITE CULEBRA, PUERTO RICO

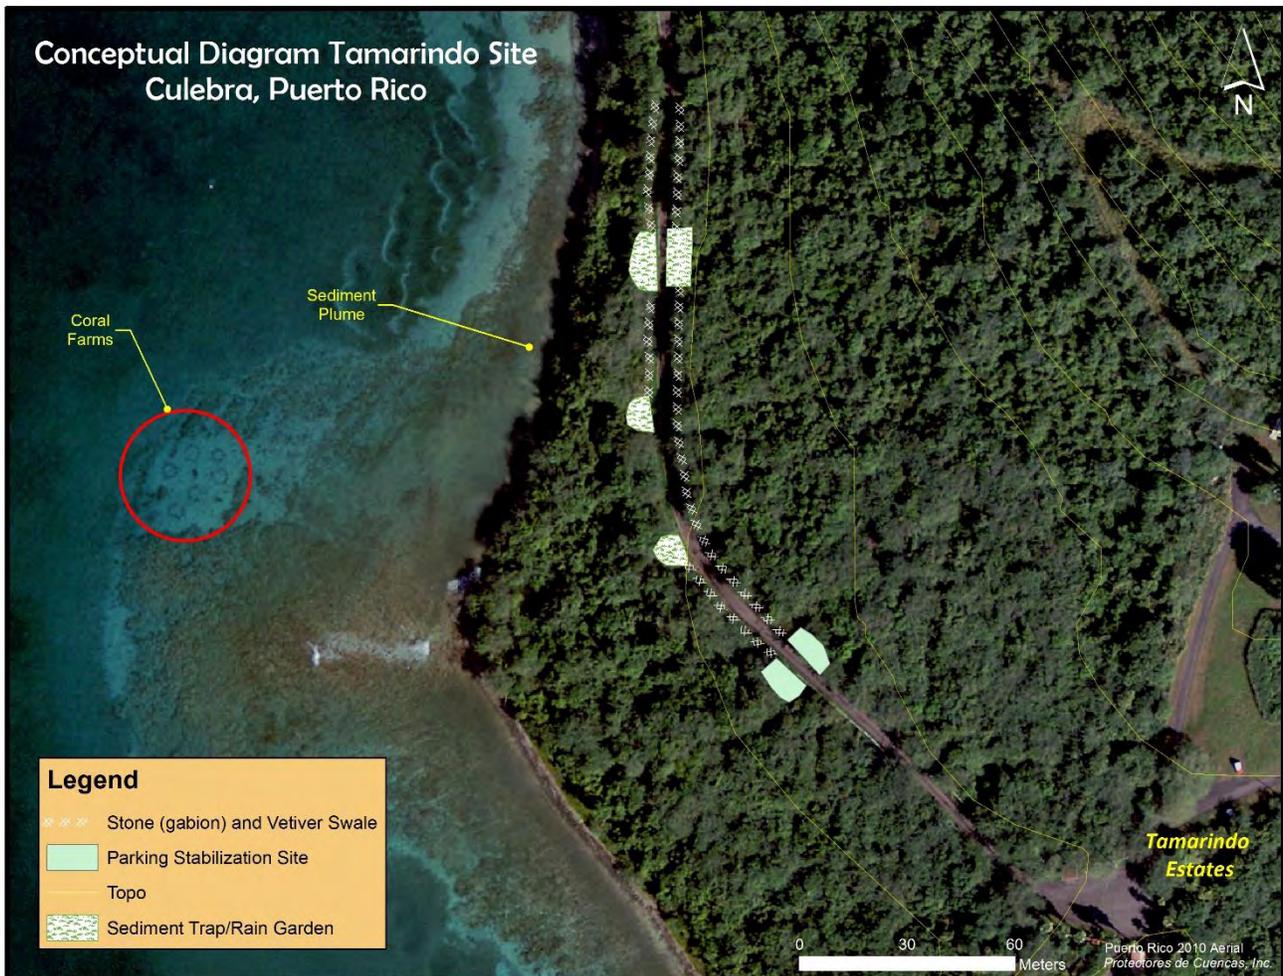
Figure 2. Conceptual diagram of work completed at Tamarindo Beach.

A micro-watershed approach was used as a management unit for this coastal area (Figure 2). The problems identified in Tamarindo were mainly associated with runoff generated from the exposed dirt turnaround (Figure 3) and the extensive areas of unpaved road in areas that drain directly to the Marine Reserve (Figure 4). Existing infrastructure was in a critical state of disrepair with rutting and small undesirable watercourses conveying runoff and sediment down to Tamarindo Beach. This was causing bank erosion that was yielding considerable amounts of sediments directly to coral reef communities (Figures 5).

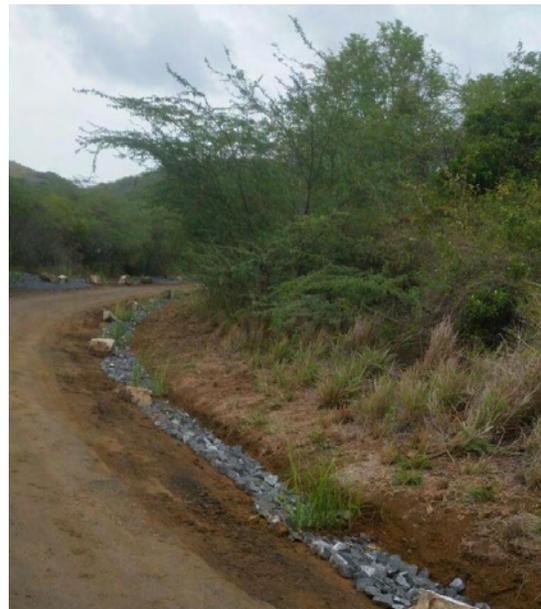
Figure 6. Stabilized culvert drainage.

several lines of Vetiver grass with gabion stones (Figure 6). Further, water was conveyed to intercepts at 3 locations. On both sides of the road, we broke up flow paths and reduced concentrated flow over the road, thus converging flows to areas of treatment. Upon finalizing the rehabilitation, we covered most of the exposed soil with a mixture of different sizes of gravel to allow compaction (Figures 7).

The previously paved road at the end of Tamarindo Beach has suffered a lot of changes mostly from rain, heavy traffic and lack of maintenance. This resulted with greater and newer areas of exposed soil, pot holes, and damaged drainages that were eroding the sides of the road yielding sediments to the marine environment. In order to reduce runoff and dissipate its energy, we rehabilitated culvert drainages with riprap and Vetiver swales built parallel to both sides of the road. The implementation of these practices will promote sheet flow towards a series of sediment trap system built with stones after passing through

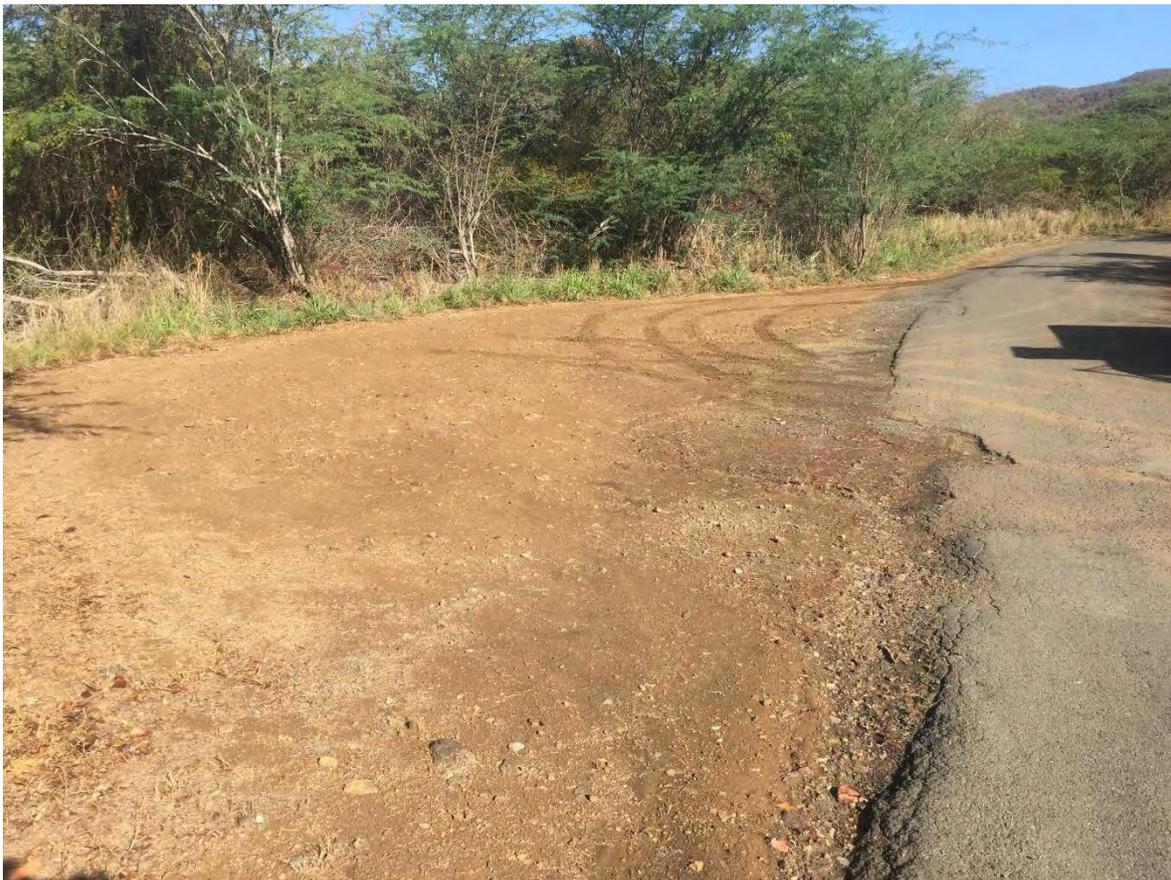
Figure 8. Turnaround site before stabilization.

There is a huge parking demand on Tamarindo Beach and cars use most of the side of the access road to park, making it very difficult for the big passenger vans to be able to turn around. As a consequence, these large vehicles have created a dirt turnaround area over time (Figure 8). This area of exposed soils receives storm water from the uphill paved access road to Tamarindo Estates apartment complex picking up sediments on its way to the nearshore environment a few meters away, just in front of the coral farm site. Conservation practices implemented to stabilize this site were composed of a series of check dams and bio swales with the combination of excavation of 2 to 4 inches of soil and

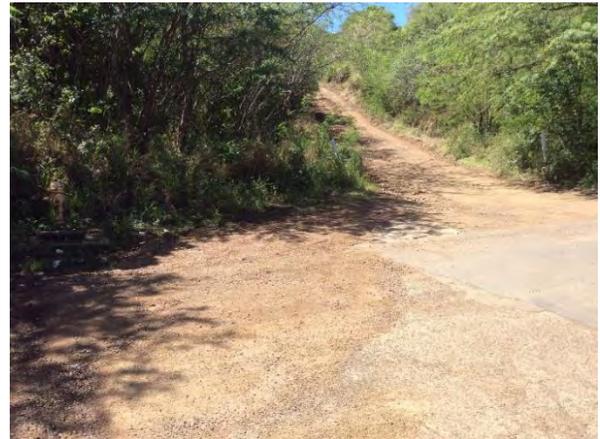
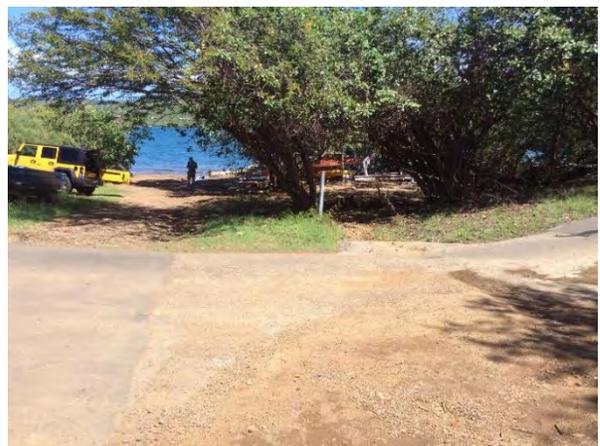
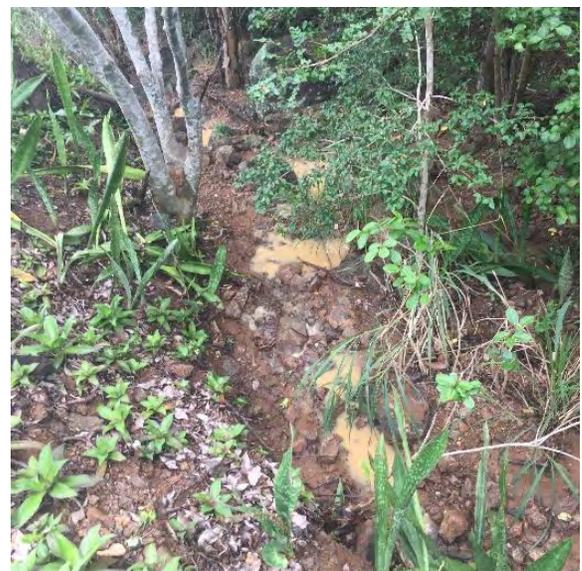
Figure 18. Pictures of existing conditions of the Fulladosa site before stabilization.

This site is a very steep Municipal dirt road (Figure 18). After several site visits with NOAA representatives this site has been selected as a priority for restoration do to the huge sediment load it produces to the Ensenada Honda Bay. This sediment plume has been evidenced by the monitoring component that NOAA has been conducting for the past year. This project has included the participation of Municipality staff as well as most of the home owners from the site. The main problem of this dirt road system is that it was constructed in the flow patterns of a natural dry channel. Most of the runoff that drained naturally through the dry channel has been intercepted by the road and runoff was flowing on the top of the road discharging directly to the Bay without passing through the natural dry channel. The main objective on this project was to redirect runoff to its natural course into the dry channel after passing through a series of

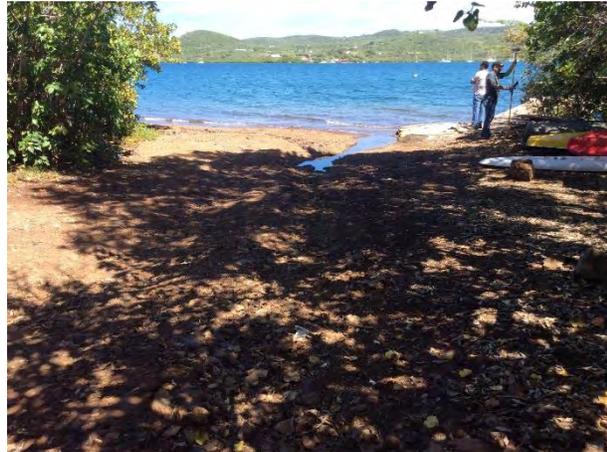
Figure 20. Topographic survey at Fulladosa.

A topographic survey (Figure 20) was conducted from the top of the subwatershed down to the coastal area including the dirt road and where erosion and sediment control practices were to be implemented. With this information, a detailed conceptual design was completed (see Appendix). This task

performed on a 3 acre of land in 0.15 meter

contour intervals to account for minor fluctuations in elevations that may not be detected with 1 meter contour intervals. The conceptual design drawings and preparation task included the design of plans, profile and sections of the restoration site to be used in the construction phase.

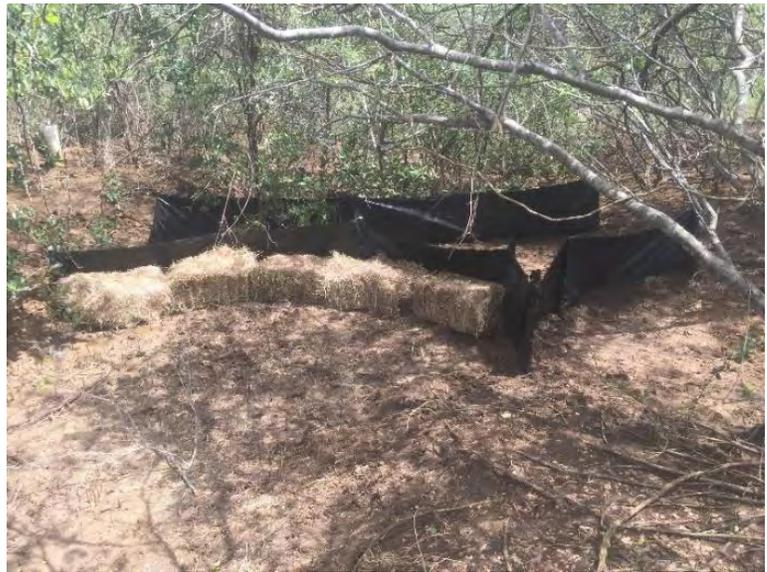
Figure 21. Example of temporary sediment control practices.

installing silt fences and planting Vetiver grass to redirect runoff to forested areas (Figure 21).

Before starting any restoration work in the area, we installed a series of temporary sediment and erosion control practices at the current road and parking lot and also in the areas that new work was going to take place. Sediment control practices included

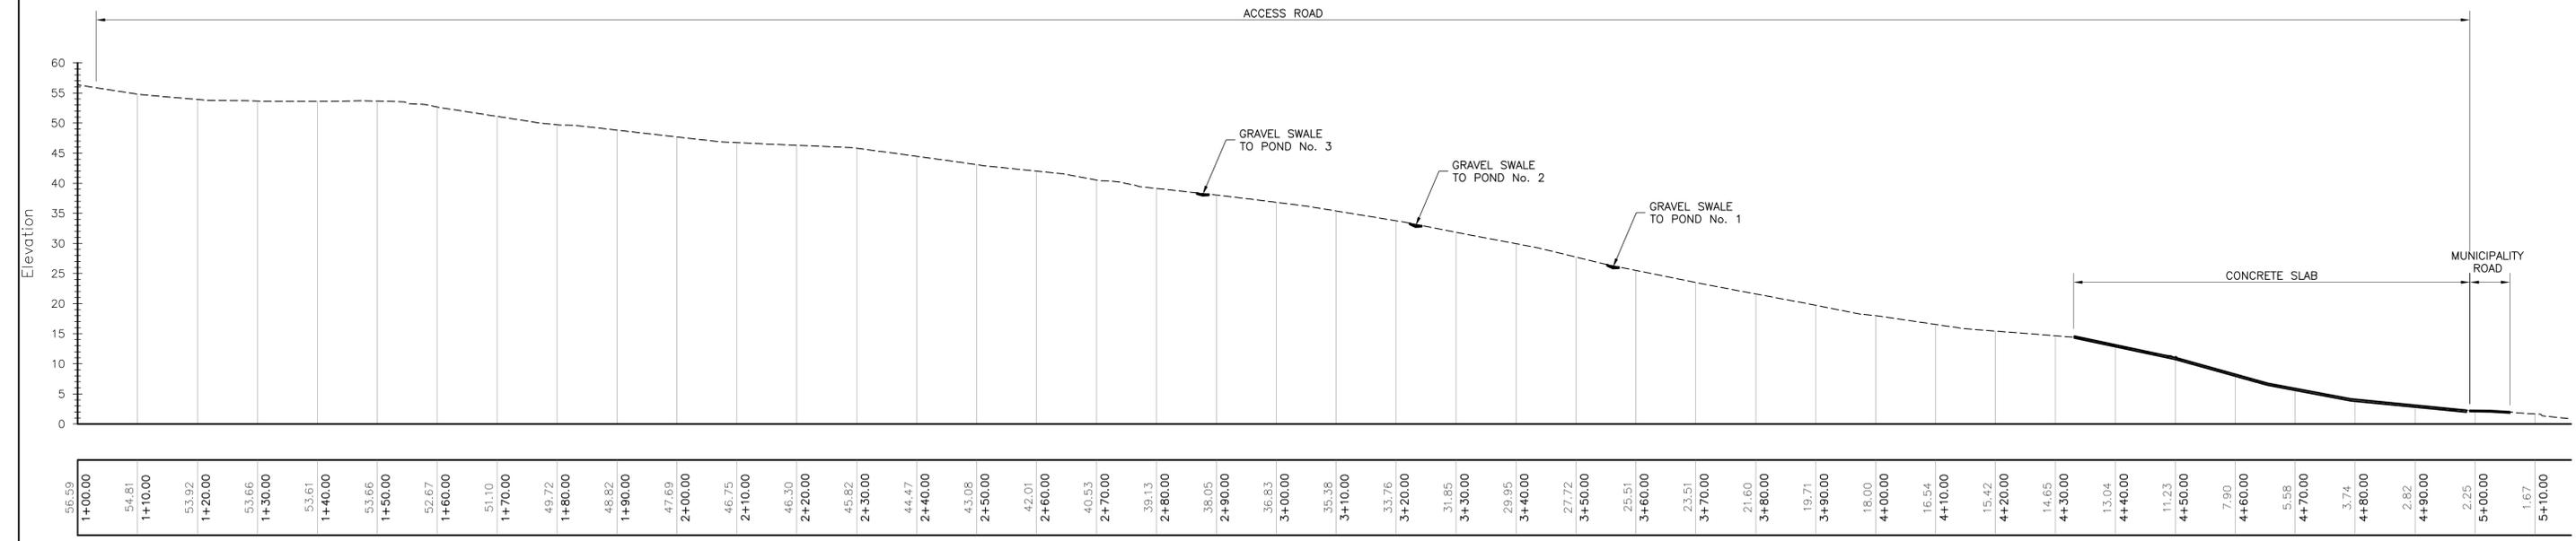
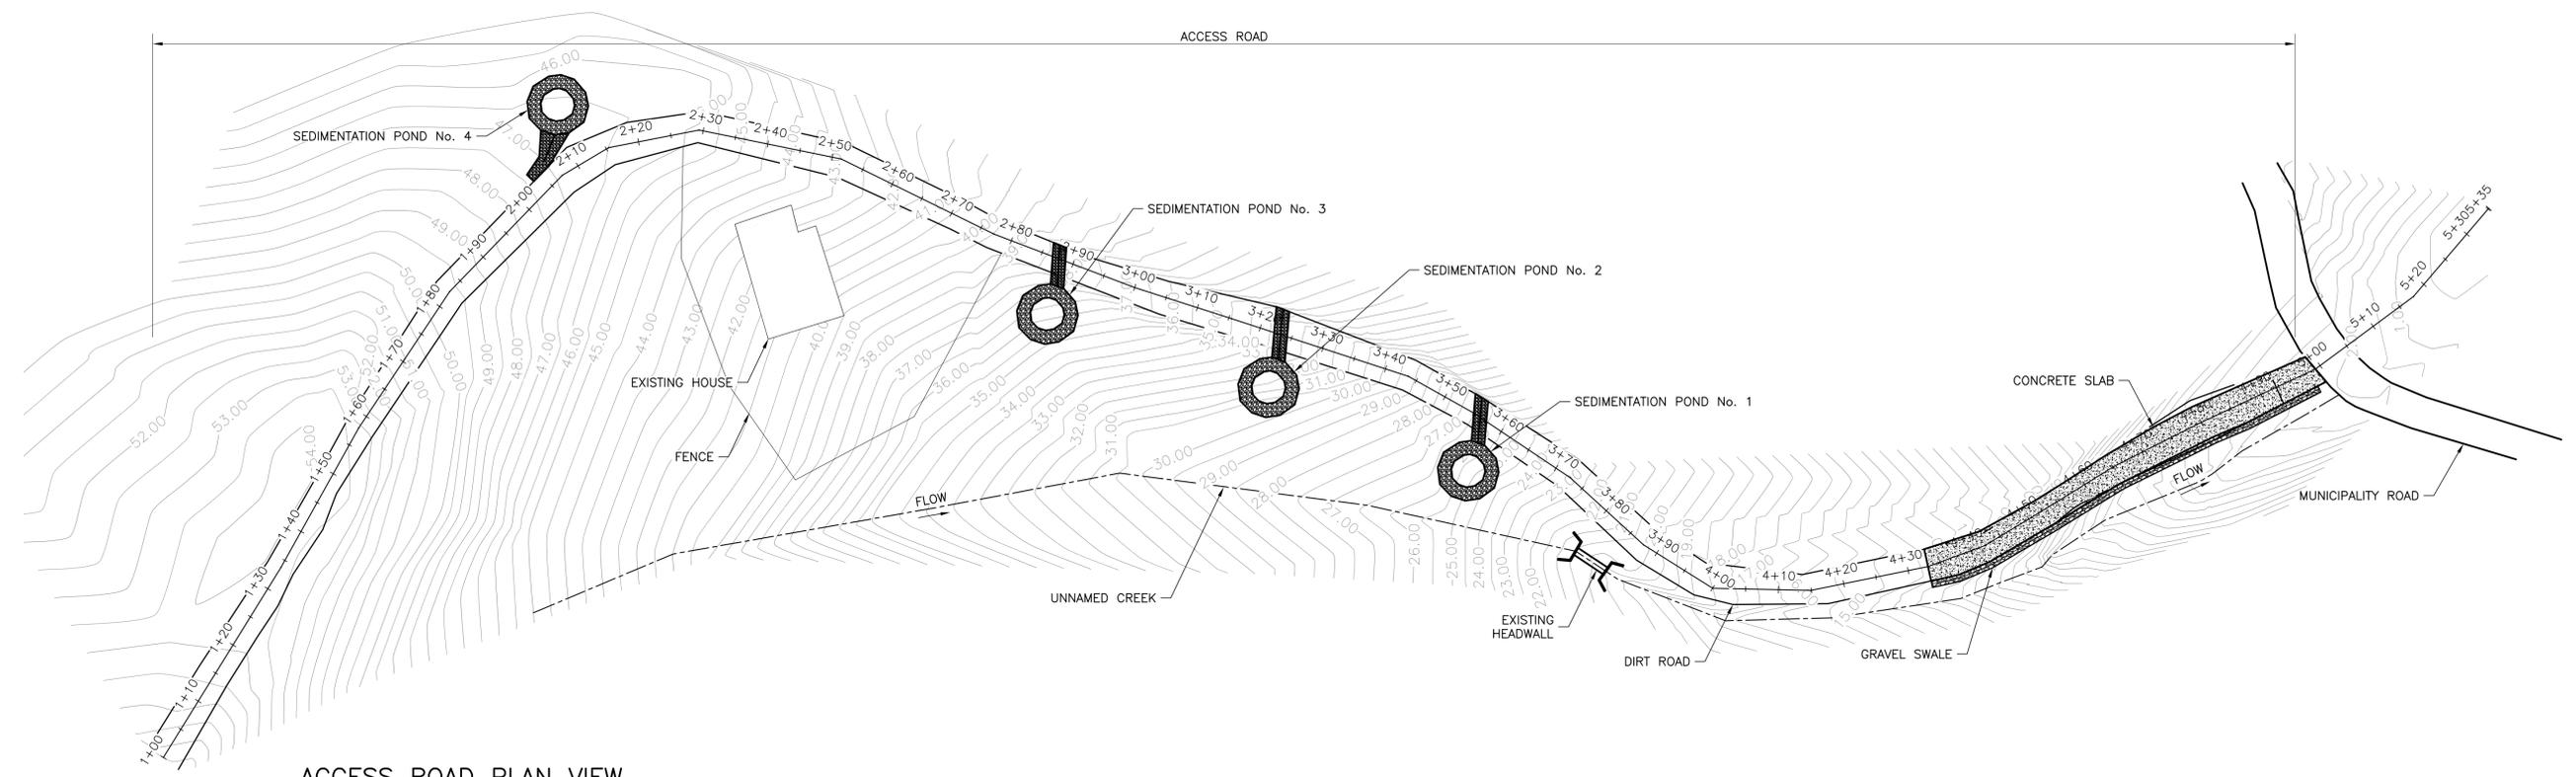
**ACCESS ROAD PROFILE VIEW**  
SCALE: 1=500

**ACCESS ROAD PLAN VIEW**  
SCALE: 1=500

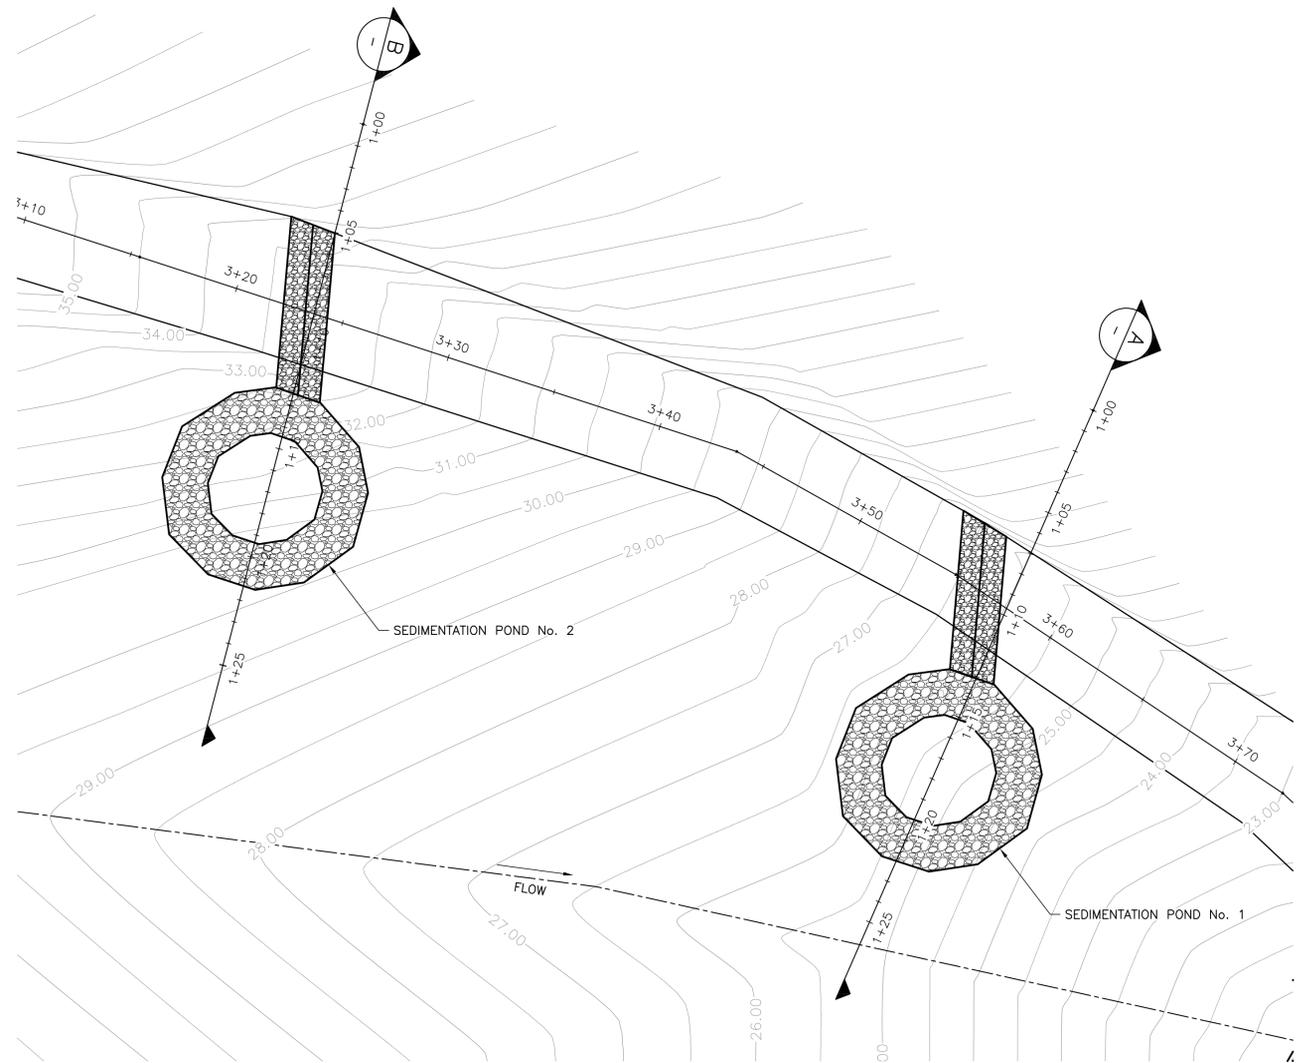
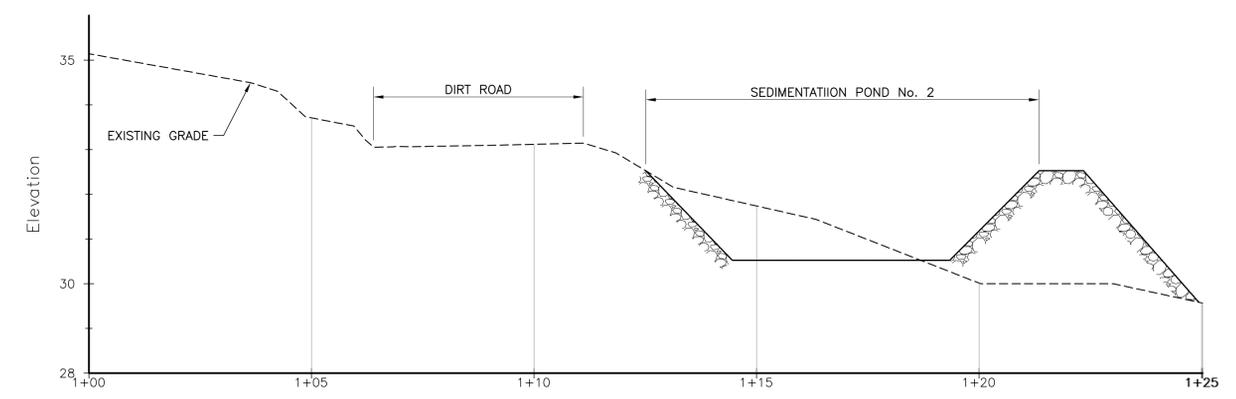
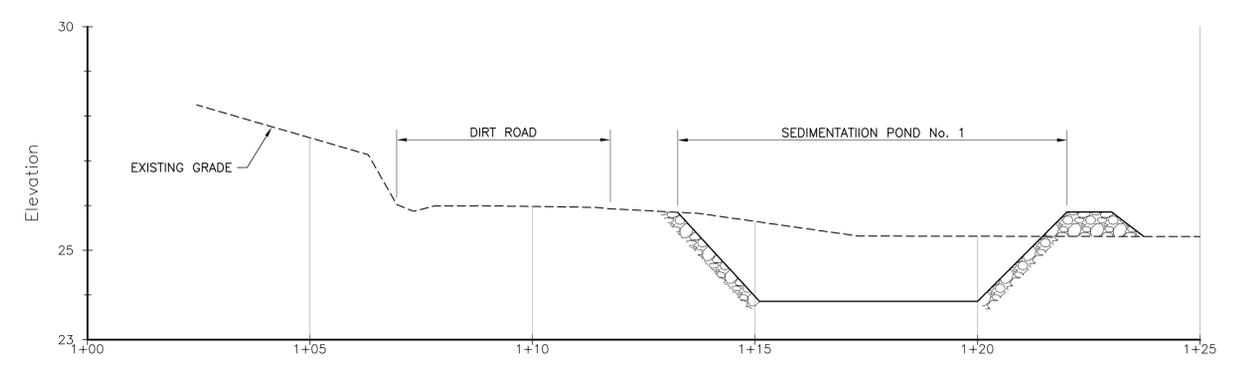
SEDIMENTATION POND NO. 1 AND NO. 2 PLAN VIEW  
SCALE: 1=200

SEDIMENTATION POND No. 2 SECTION VIEW  
SCALE: 1=75

SEDIMENTATION POND No. 1 SECTION VIEW  
SCALE: 1=75

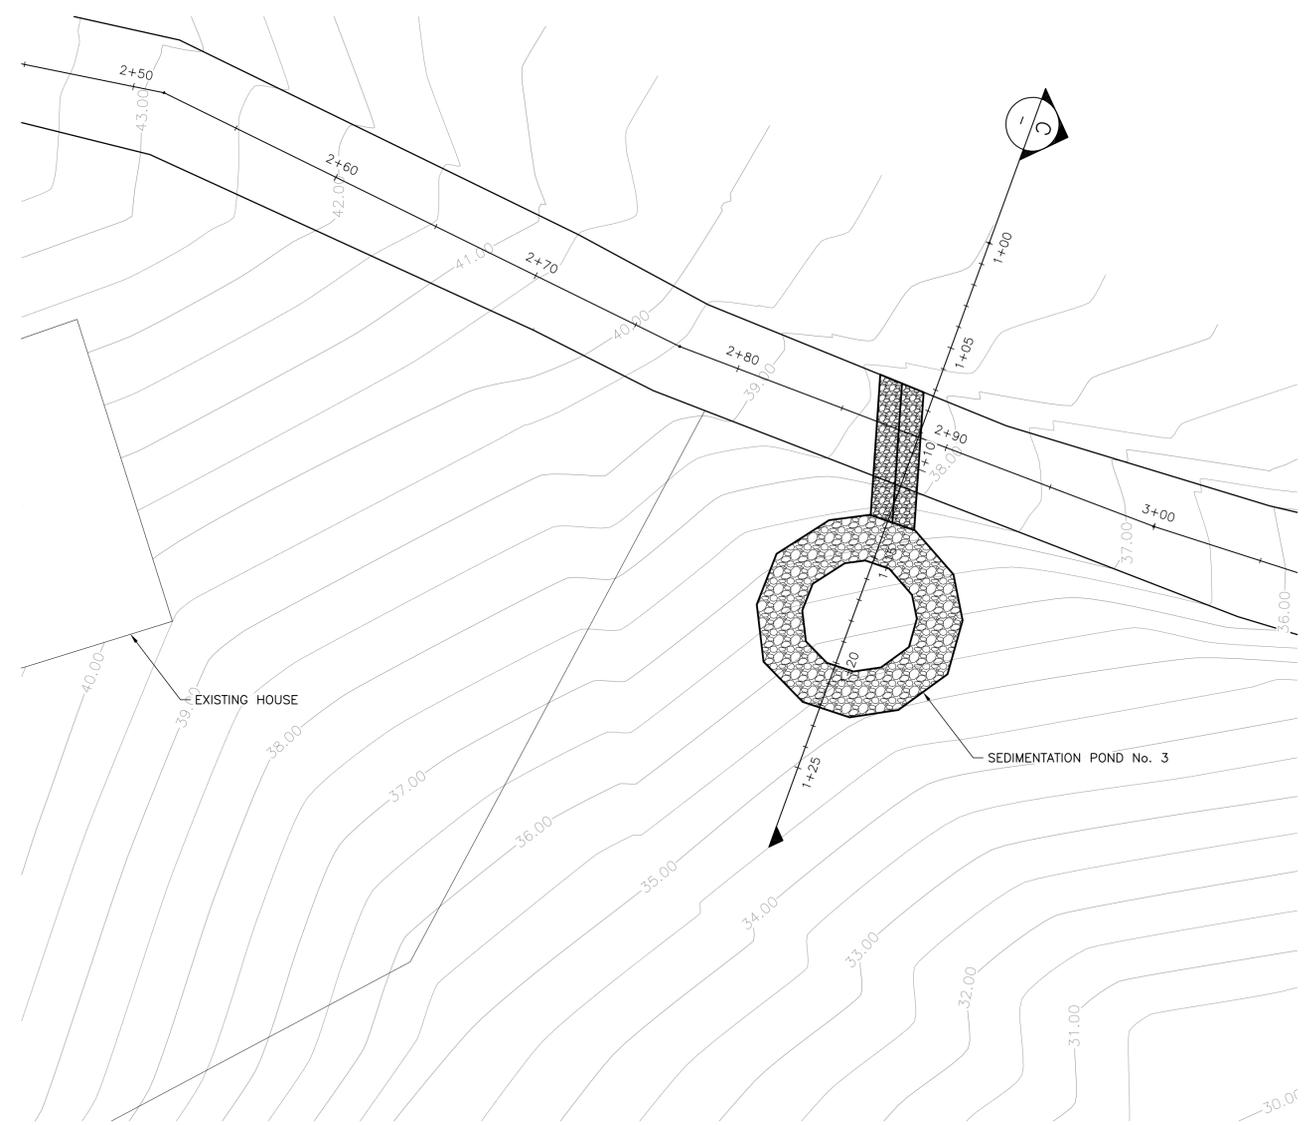
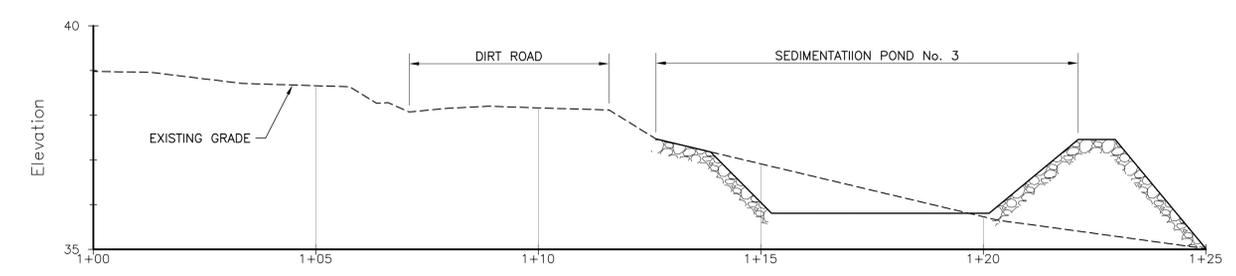
SEDIMENTATION POND NO. 3 PLAN VIEW  
SCALE: 1=150

SEDIMENTATION POND No. 3 SECTION VIEW  
SCALE: 1=75

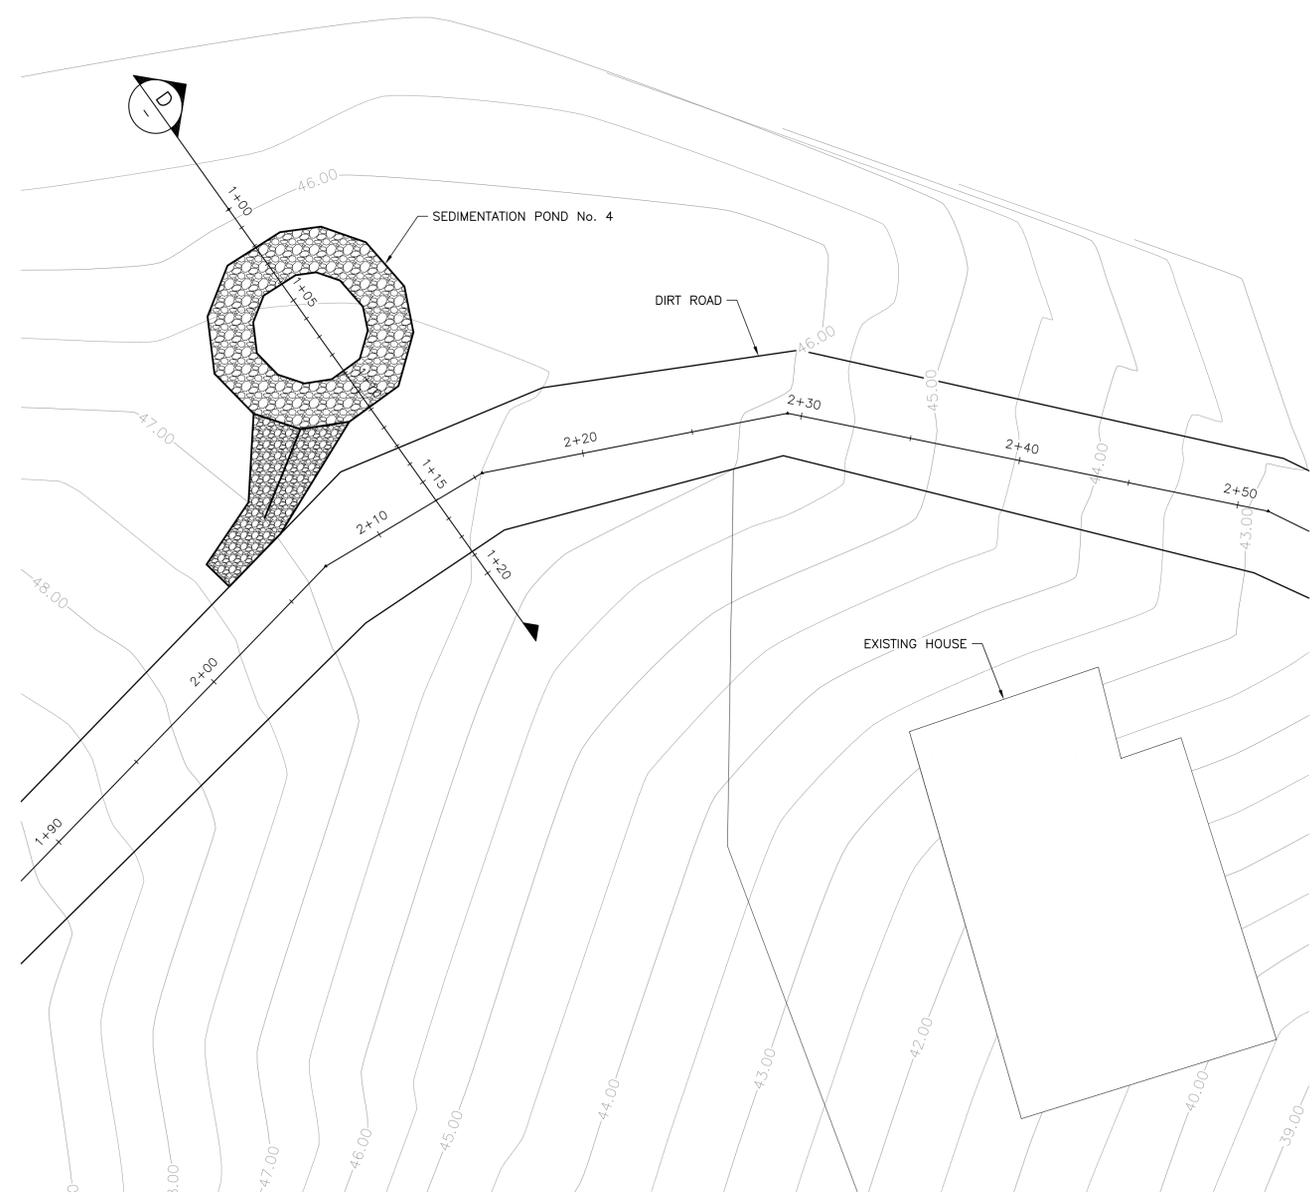
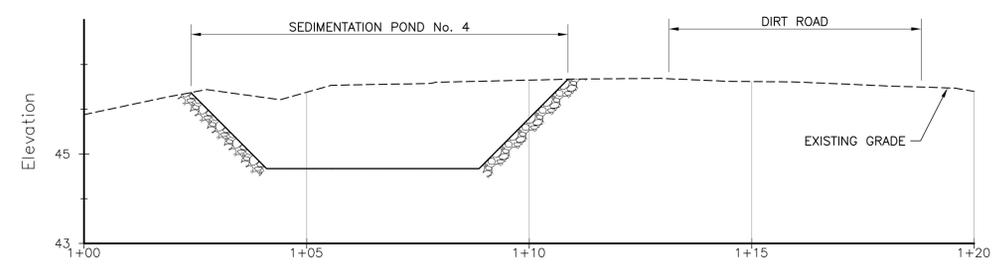
SEDIMENTATION POND NO. 4 PLAN VIEW  
SCALE: 1=150

SEDIMENTATION POND No. 4 SECTION VIEW  
SCALE: 1=75
