Stabilizing three miles of unpaved roads on Culebra Island

Final Report for PO 275

Protectores de Cuencas, Inc.

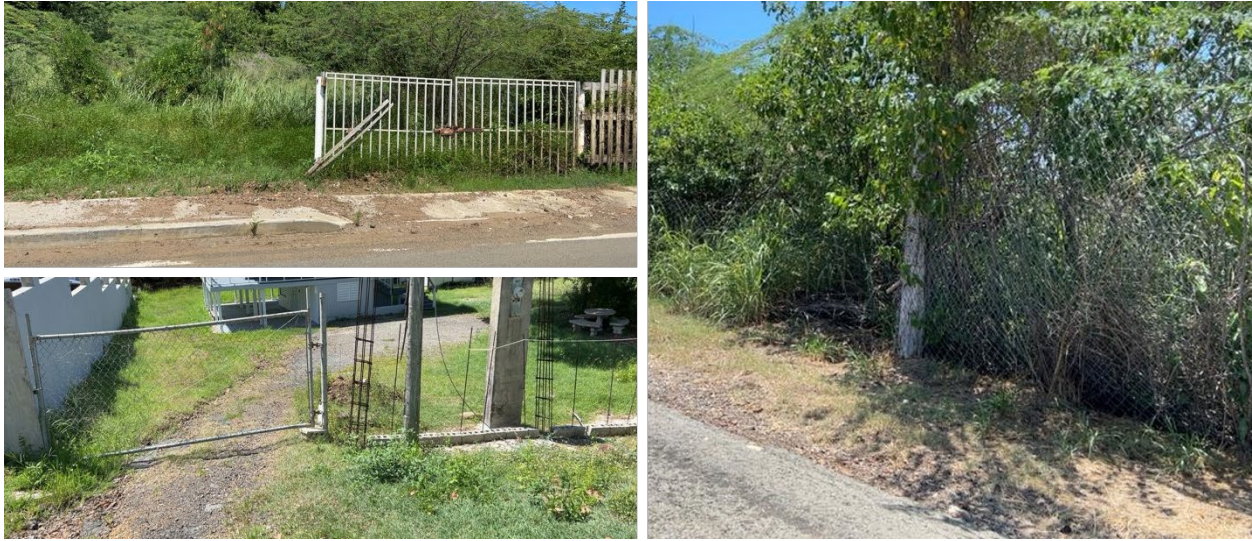
Figure 3 Example of abandoned and paved roads categorized as stabilized by other.

A significant portion, constituting 27%, underwent stabilization through the natural growth of vegetation (Figure 3). Following closely were roads stabilized with gravel (18%) and those paved (14%) (Figure 4). Additionally, 10% of the roads fell under the category of abandonment, indicating that they were no longer accessible for car travel.

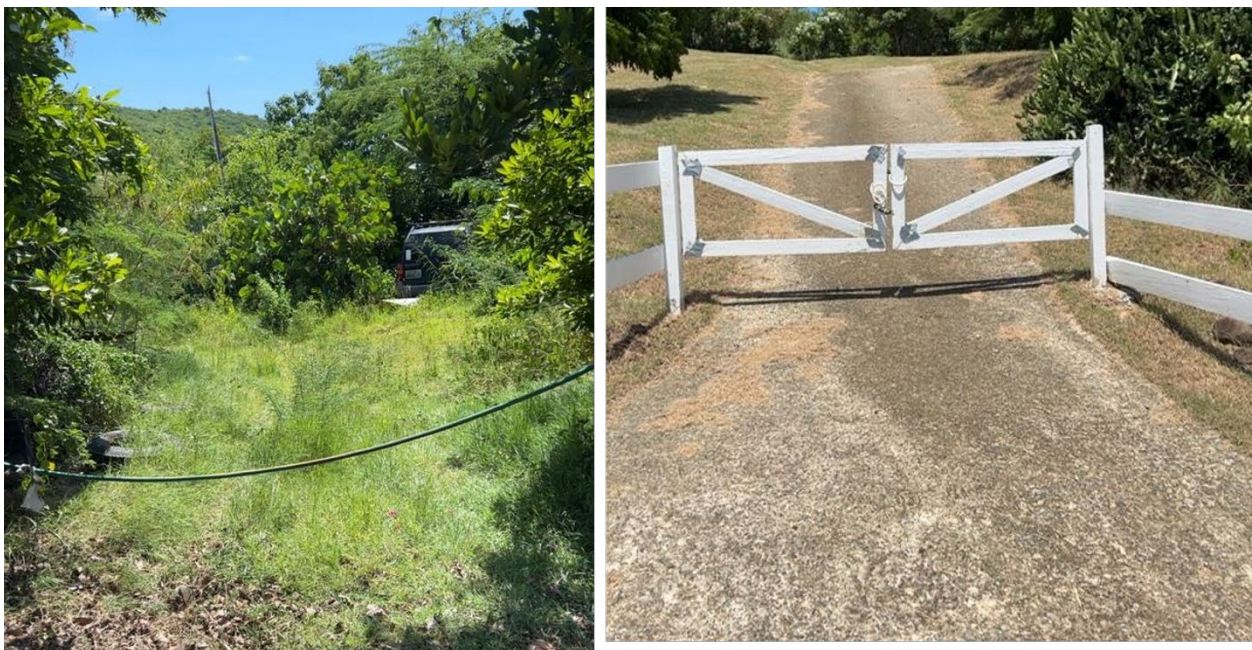
Figure 4 Examples of vegetated and paved roads categorized as paved by others.

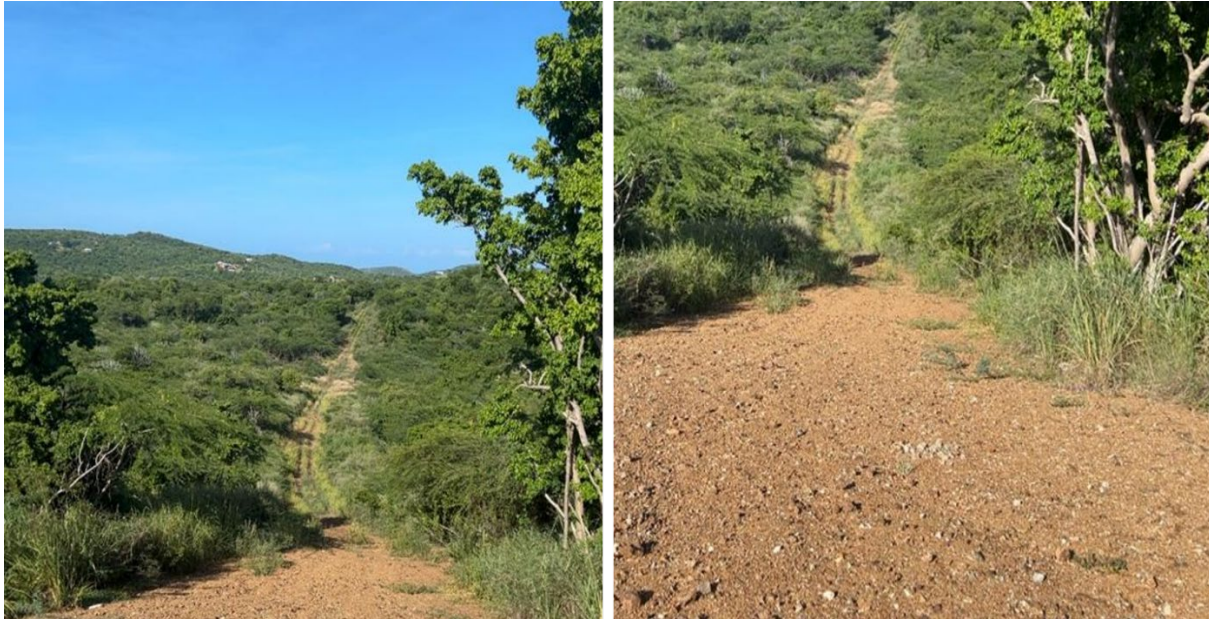
Figure 6 New selected road in the Carenero watershed.

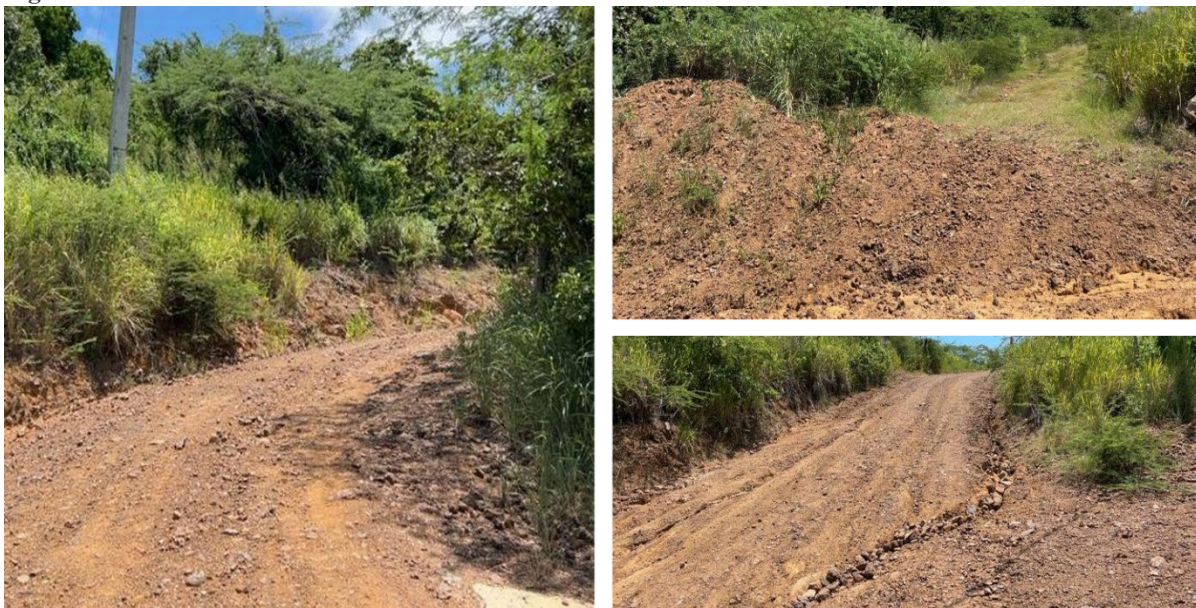
Figure 7 New selected road in the Cabra watershed.

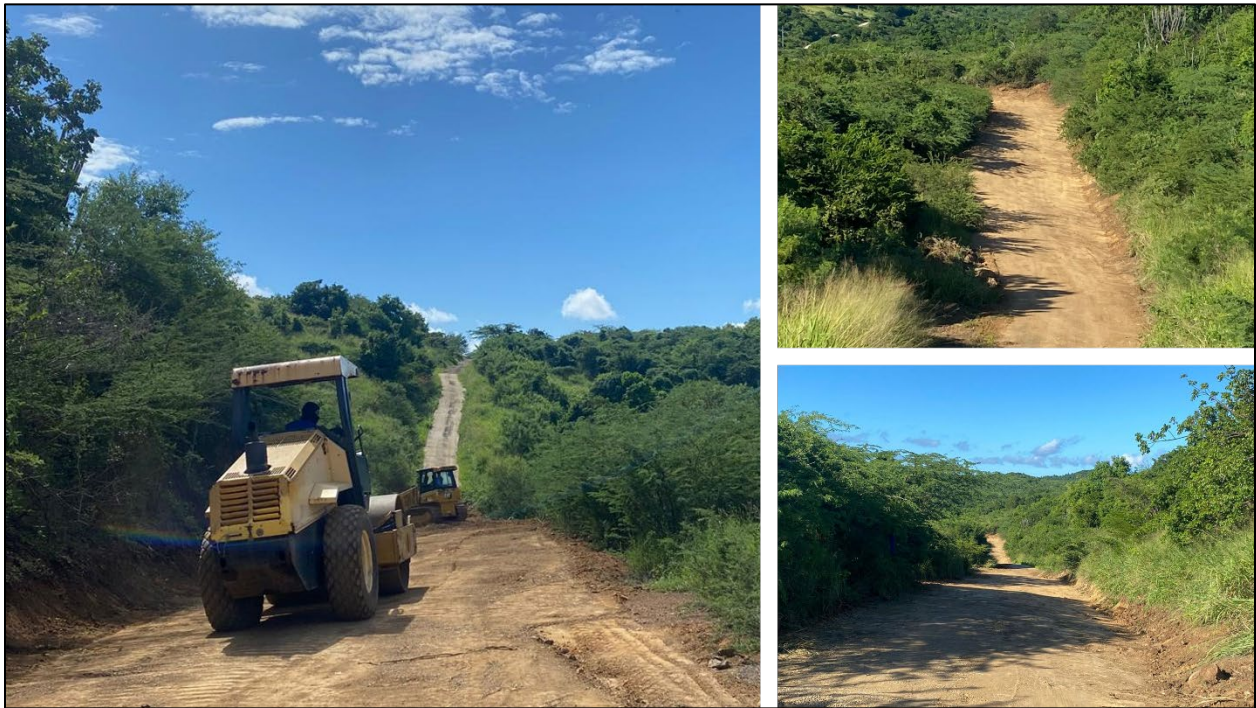
Figure 8 Grading and compaction of road prior to implementation of BMPs.

A pivotal step preceding the implementation of Best Management Practices (BMPs) involved regrading and compacting the road (Figure 8 and 9). The regrading procedure was executed with precision using a Crawler dozer, while soil compaction was achieved using a 15-ton compacting roller. This critical undertaking aimed to establish the desired hydrological patterns conducive to effective sediment control. The runoff was channeled into continuous swales, featuring 4-12” stones, and supplemented with Vetiver grass check dams strategically spaced at intervals ranging from 25 to 50 feet, contingent on the specific slope conditions.

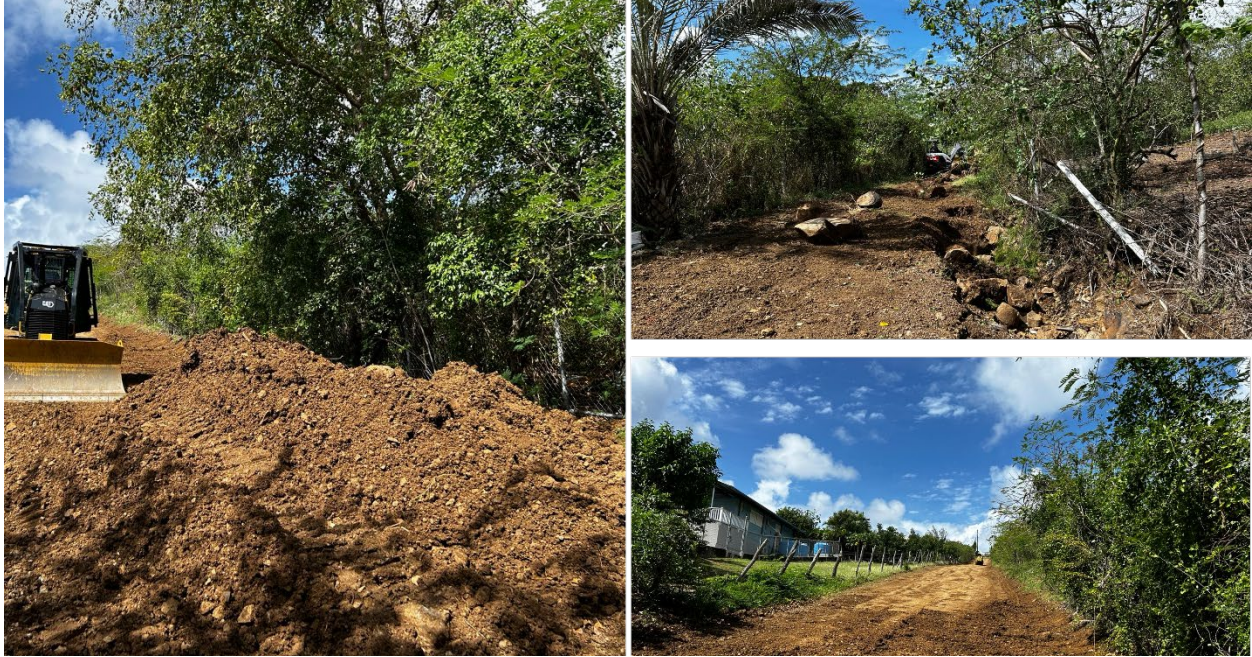
Figure 9 Grading, compacting and ditch construction at Coronel watershed, road segment CO-21B.

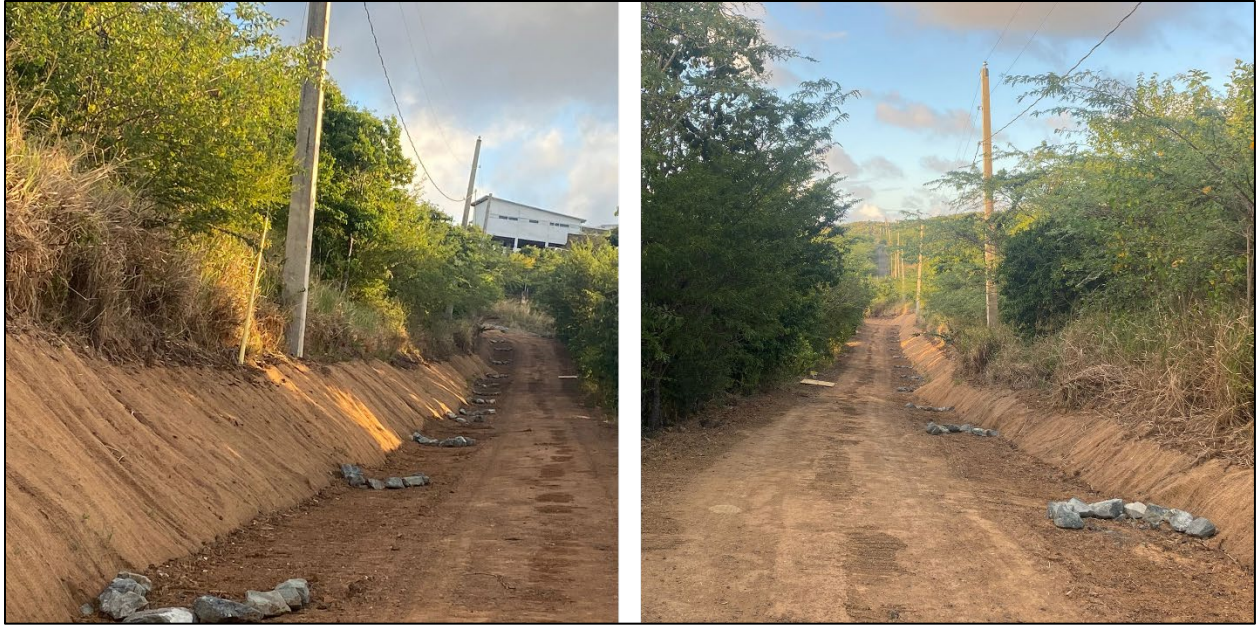
Figure 10 Stabilized road segment (CA-11) in Cabra Watershed. The road was insloped to a ditch and check dams were located in the ditch. The cutslope was protected with an erosion control mat. Left picture: Looking upslope. Right picture looking downslope.

Roads were graded to ensure a slope conducive to directing runoff towards the constructed ditch and into the installed Best Management Practices (BMPs). Ditches play a vital role in channeling runoff away from the road travel lane and guiding it towards check dams, where its velocity and erosive energy are reduced, facilitating sediment deposition. These check dams are crafted using stones and reinforced with vetiver to enhance structural stability. In road segment CA-11 within the Cabra Watershed, this strategic approach was implemented, as depicted in Figures 10 to 12. These figures provide visual documentation of the application of this methodology, illustrating the integration of graded roads, ditches, and check dams in mitigating erosion and managing runoff effectively.

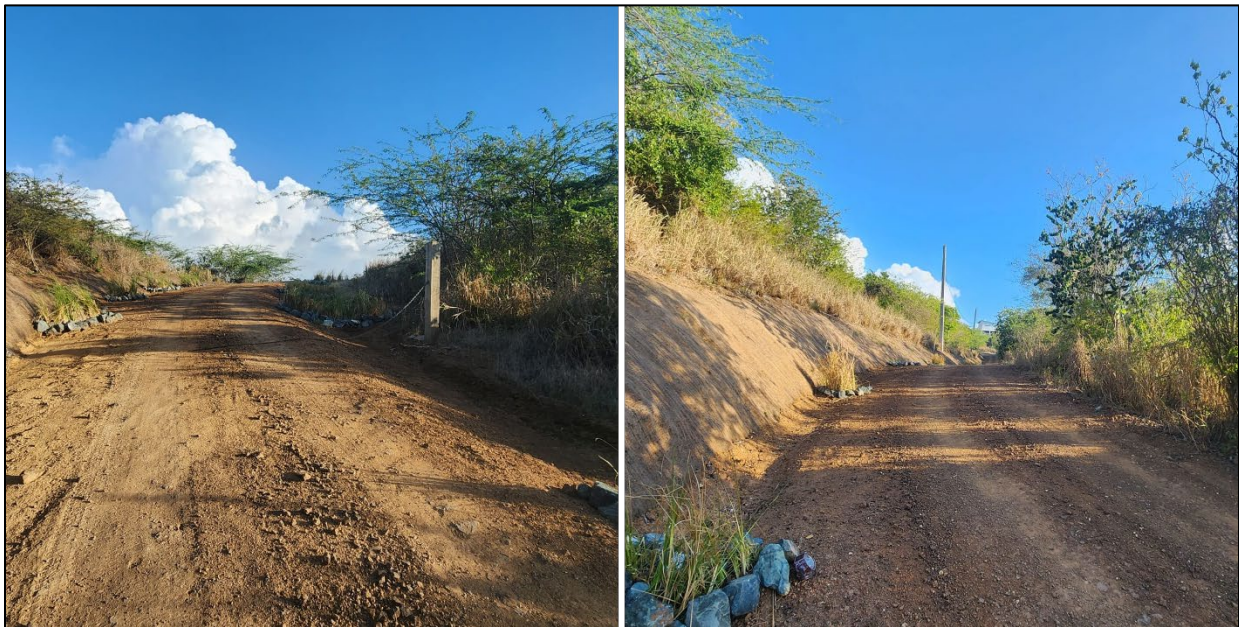
Figure 11 Check dams finalized and with planted vetiver at road segment CA-11 in Cabra watershed. Note the cutslope stabilized with an erosion control mat.

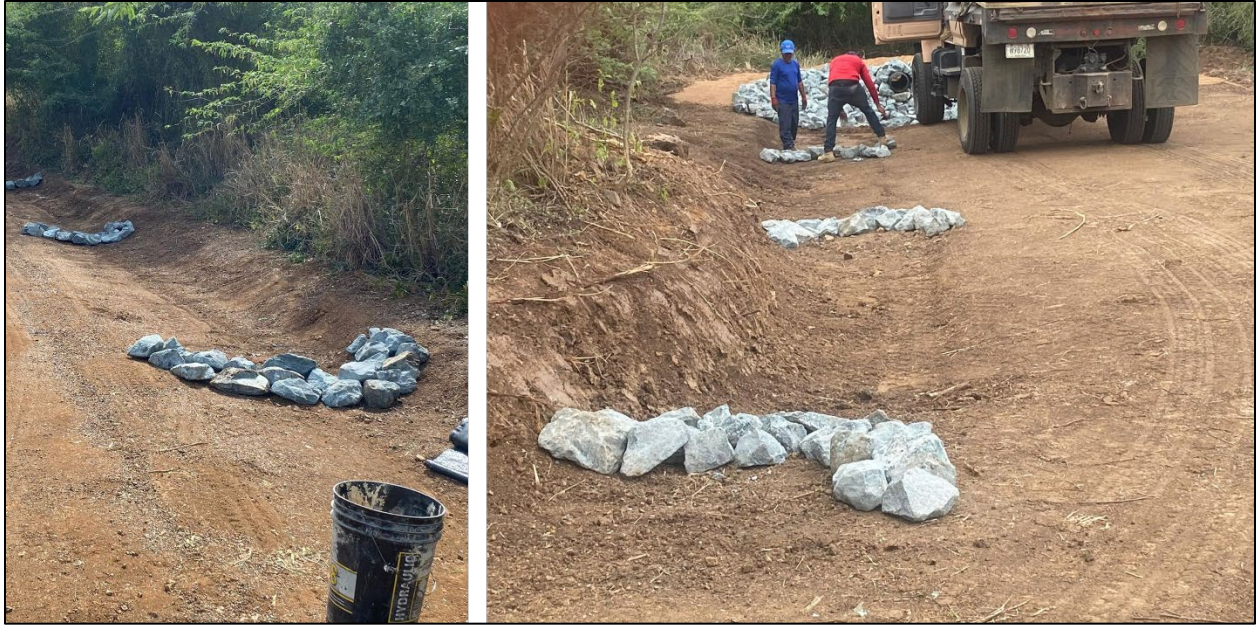
Figure 12 Check Dams and sediment detention pond being constructed in road segment Carenero-2.

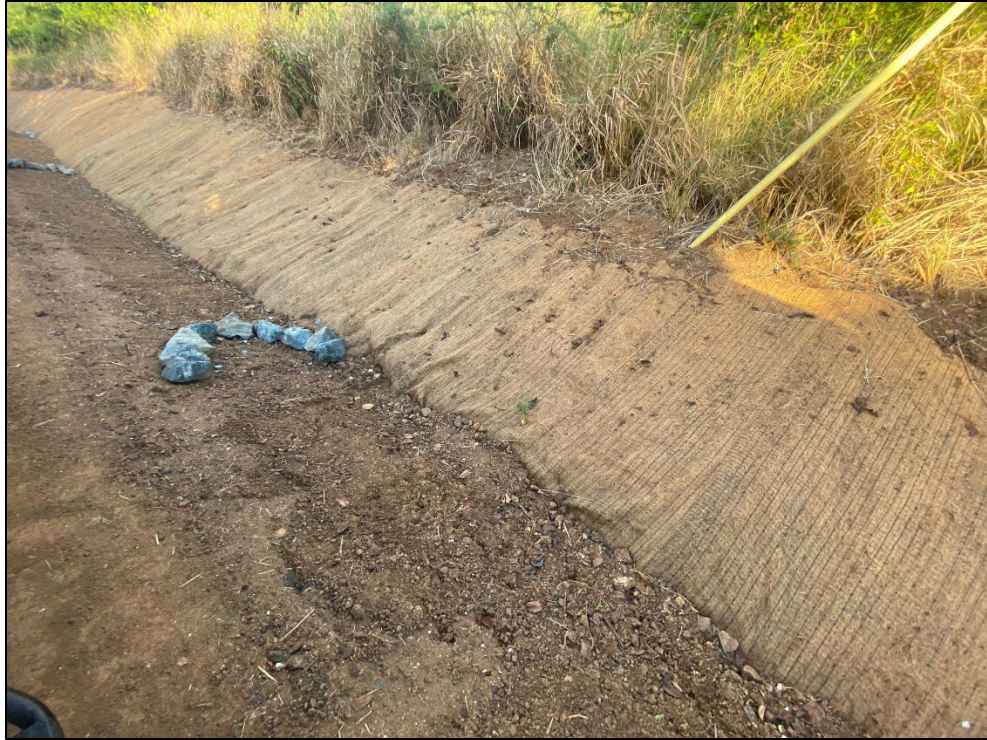
Figure 13 Stabilized cutslope with erosion control mat.

Another important feature of dirt roads are cutslopes. However, these cutslopes, characterized by their steep gradients and inherent instability, pose a notable challenge by generating substantial amounts of sediment. In segments where ditches and check dams are strategically installed, a unique concern arises—erosion from cutslopes has the potential to compromise the functionality of these BMPs by causing clogging and redirecting runoff off the ditch and into the road bed. To proactively address this issue, erosion control mats, proven to be an effective measure in curtailing cutslope erosion, were judiciously deployed in select instances (Figure 13).

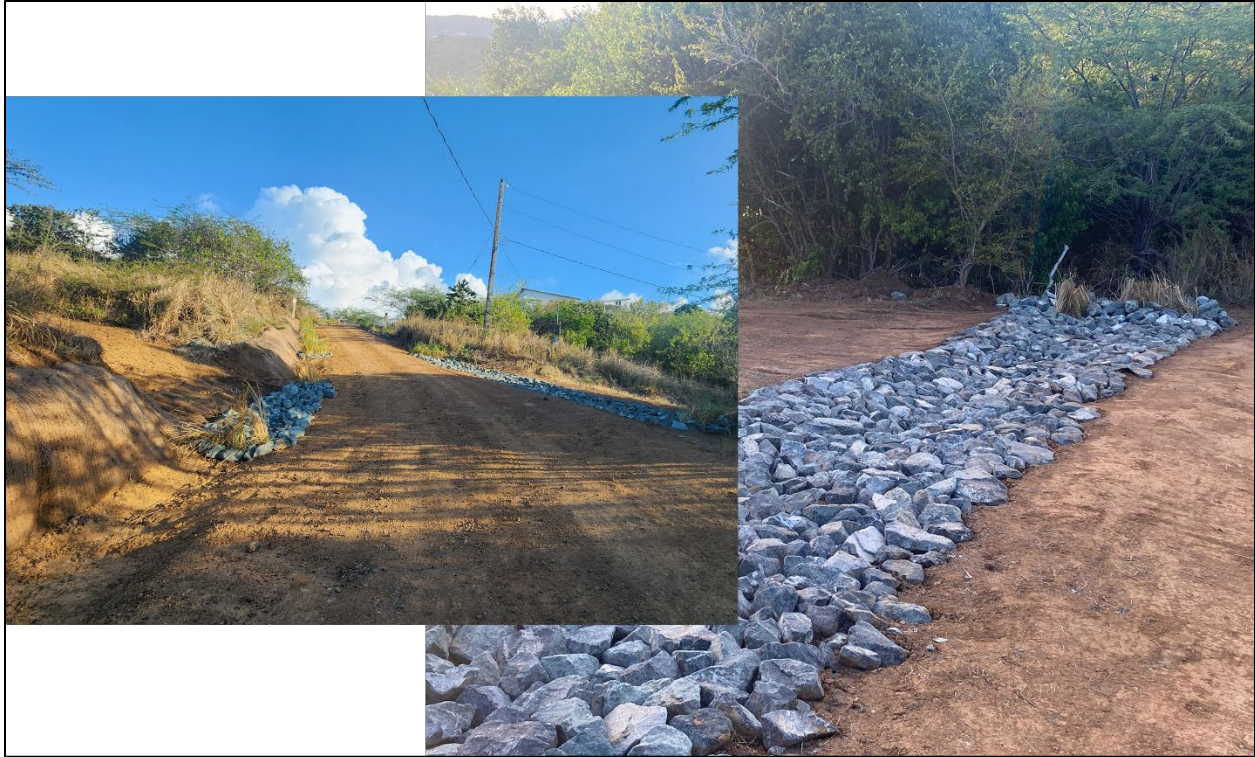
Figure 14 Swale redirecting runoff to forested area at Cabra Watershed (Segment CA-11).

Another crucial Best Management Practice (BMP) implemented in this project was the construction of swales. Swales are depressions strategically created to intercept concentrated runoff, mitigating its erosive force. Through careful excavation and the placement of stones, these swales facilitate infiltration and reduce runoff velocity. The primary objective of these swales is to redirect significant volumes of runoff towards stable outlets, such as forested areas or sediment traps, where sediment deposition can occur.

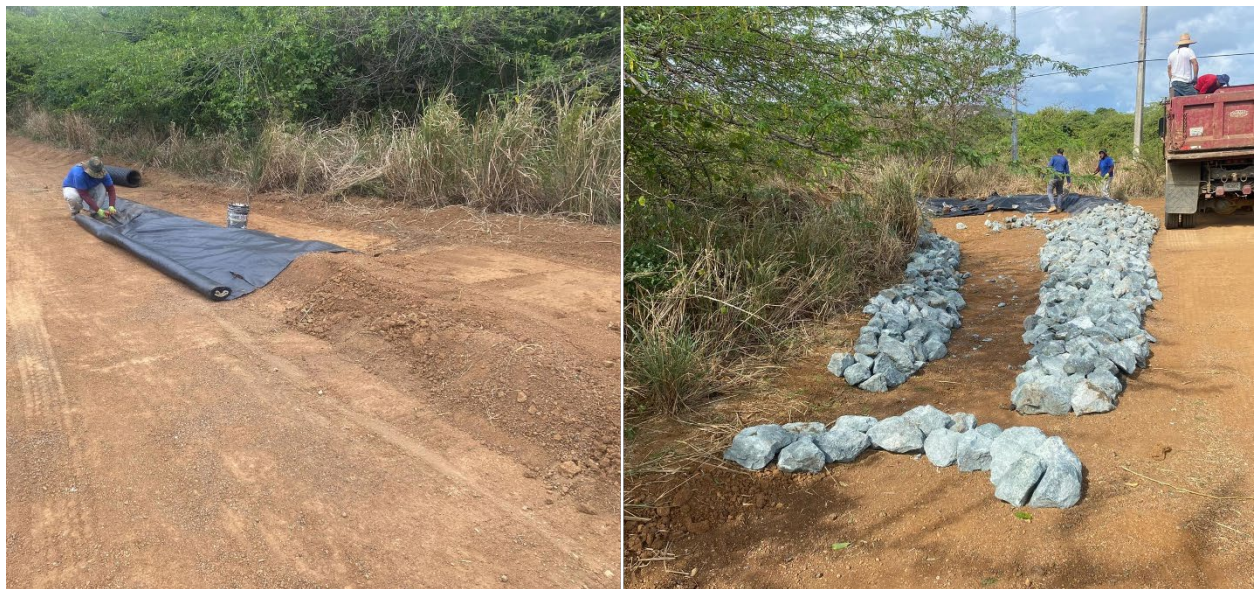
Figure 15 Installation of geotextile and berm to construct inlet to sediment trap at Carenero watershed in road segment Carenero-2.

Sediment traps stand as indispensable components in the effort to safeguard sensitive areas from sedimentation. These engineered structures are designed depressions situated at lower elevations, serving as temporary reservoirs to detain runoff. Within these traps, sediment settles out of the water column, aided by the controlled ponding effect. Reinforced with rock embankments and outfitted with stable outlets or spillways, sediment traps ensure that runoff is released gradually and in a controlled manner. Figures 14 to 21 offer tangible illustrations of the swales and sediment traps constructed as part of this project.

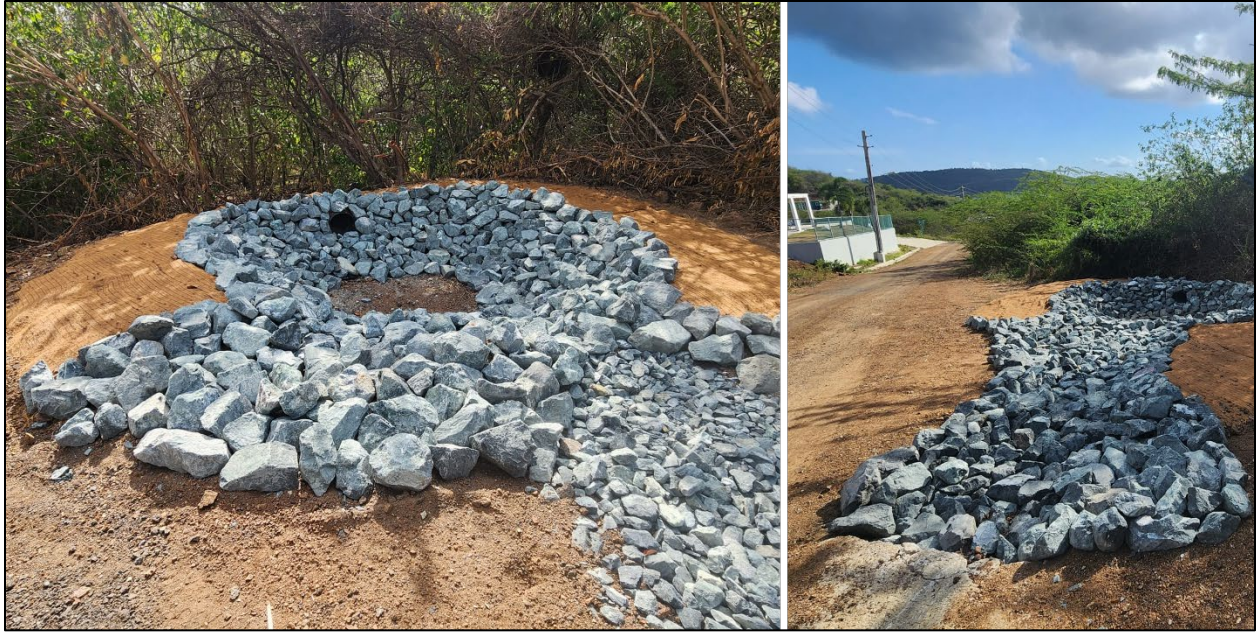
Figure 16 Sediment Traps and swales constructed in Coronel watershed in Segment CO-21B.

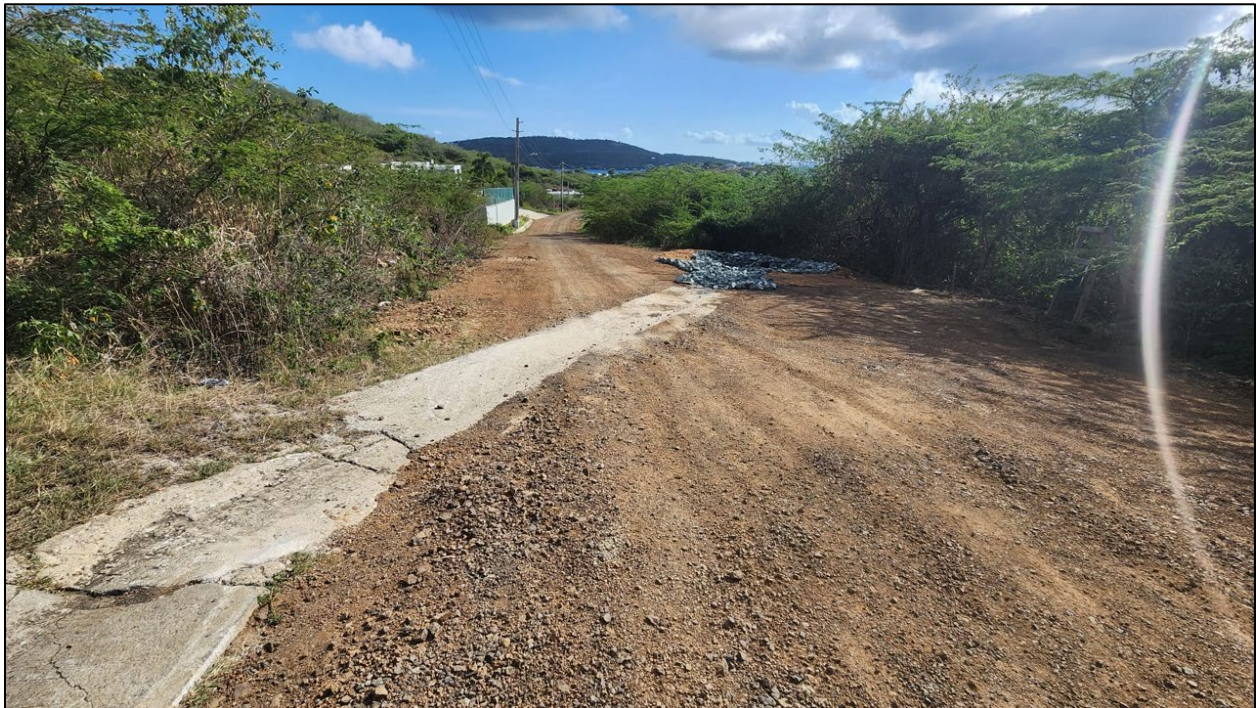
Figure 17 Sediment Traps and swales constructed in Coronel watershed in Segment CO-21B.

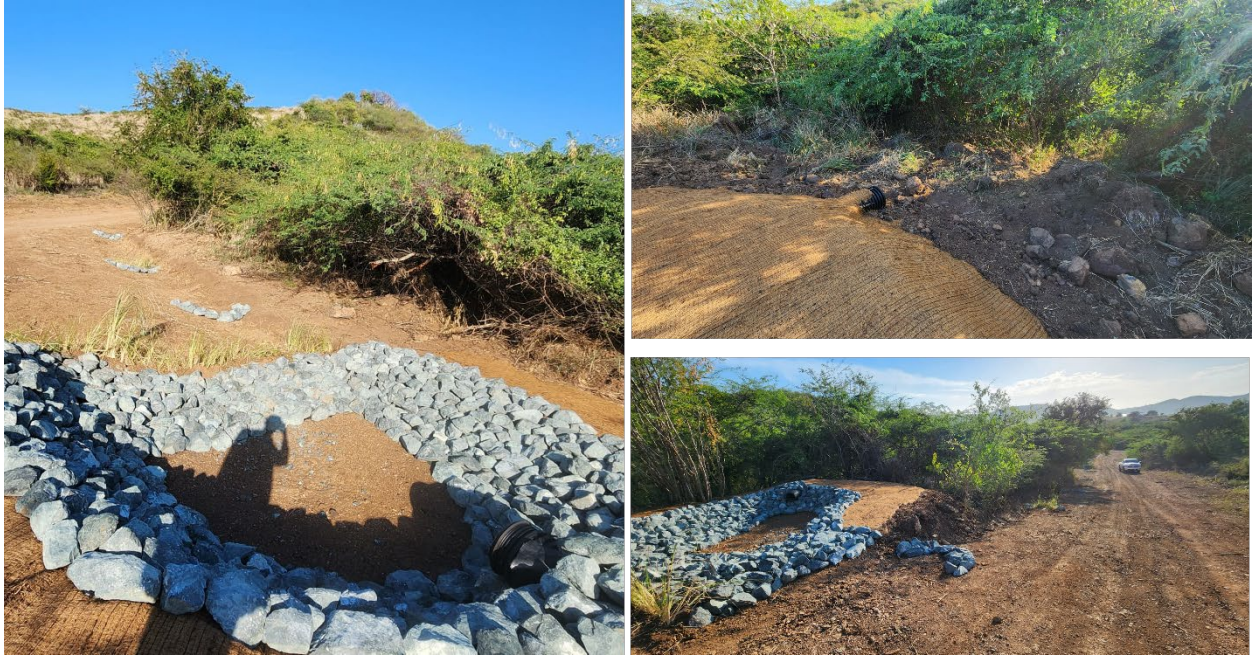
Figure 18 Sediment Trap installed at Carenero watershed in road segment Carenero-2.

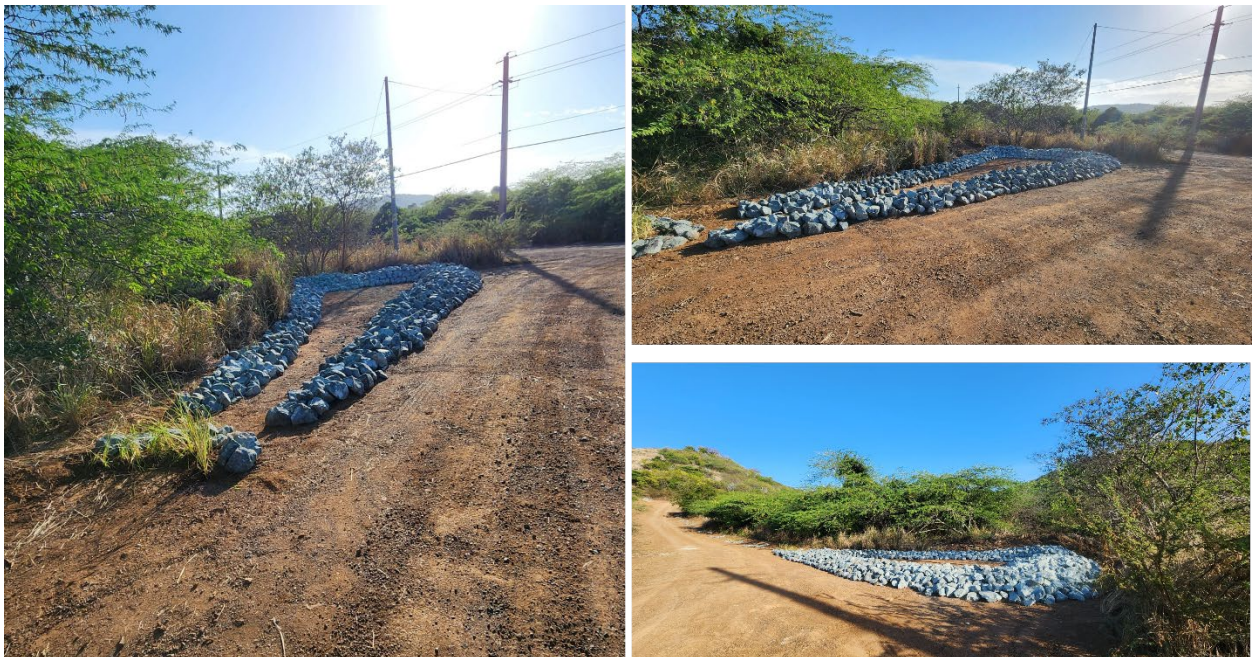
Figure 19 Sediment Trap designed to receive runoff from ditch with check dams at Carenero-2 road segment.

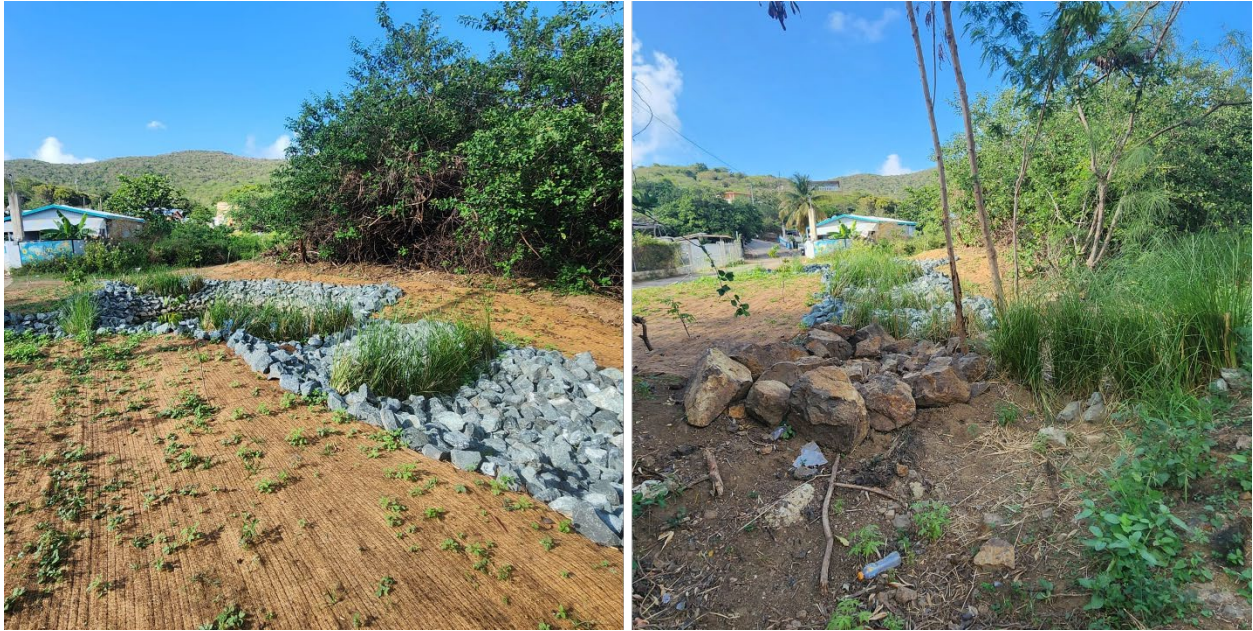
Figure 20 Sediment trap and stabilized outlet and swale constructed at Coronel watershed road segment CO-21B.

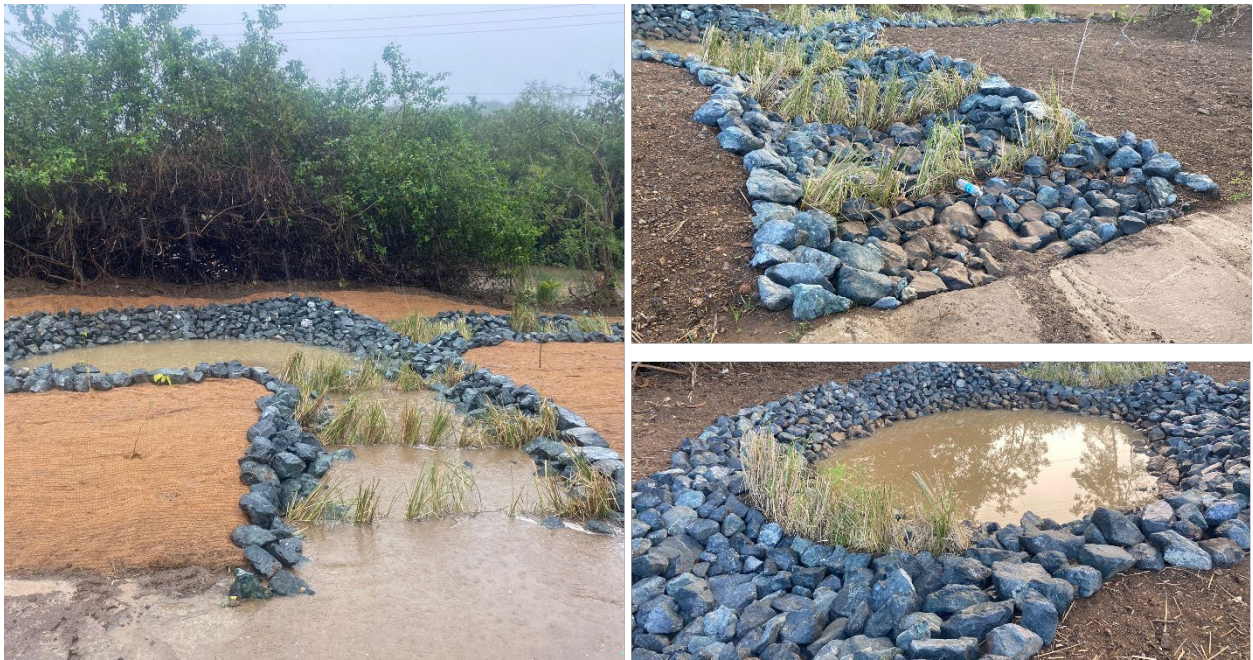
Figure 21 Evidence of sediment traps at Coronel watershed (CO-21B) receiving runoff and sediment.
