Cocos Island, Guam: Passive water sampling to inform restoration efforts

Active installation, passive monitoring

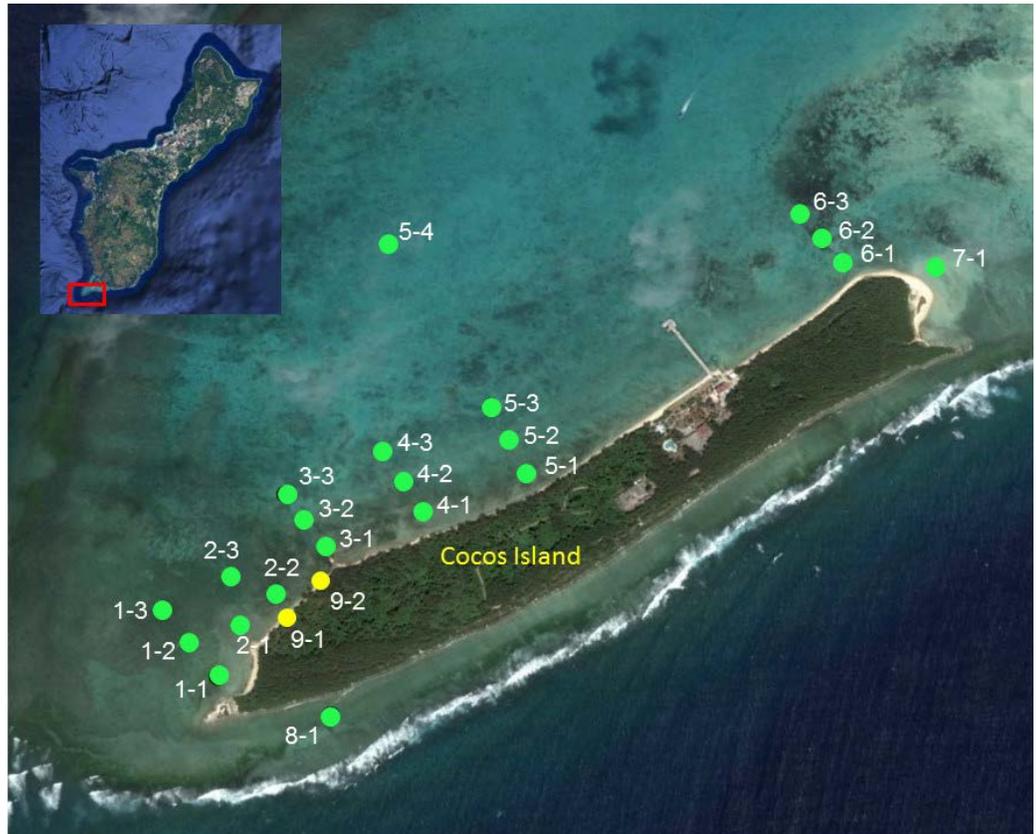
Figure 1. Proposed locations for the deployment of polyethylene devices (PEDs) in waters adjacent to Cocos Island, Guam.

The devices will monitor the waters adjacent to Cocos Island for a period of 30 days. The team from the National Oceanic and Atmospheric Administration (NOAA), Guam Environment Protection Agency (Guam EPA) and the US Environmental Protection Agency (USEPA) will install the PEDs the week of September 18th 2017 and in October, Guam EPA will return to collect them. During that time, the devices will sit underwater but otherwise be unmarked. The proposed deployment (Figure 1) consists of six sets of PEDs, each approximately 50 meters from shore, along the western shore of the island, where elevated concentrations of PCBs and DDT have been found in fish. Two more PEDs will be placed along a transect out from each site, at approximately 150 and 250 meters from shore. Two additional PEDs (9-1, 9-2) will be buried on the beach, just below the high water mark, to assess movement of contaminants below the surface, perhaps as they are transported by water from the island.

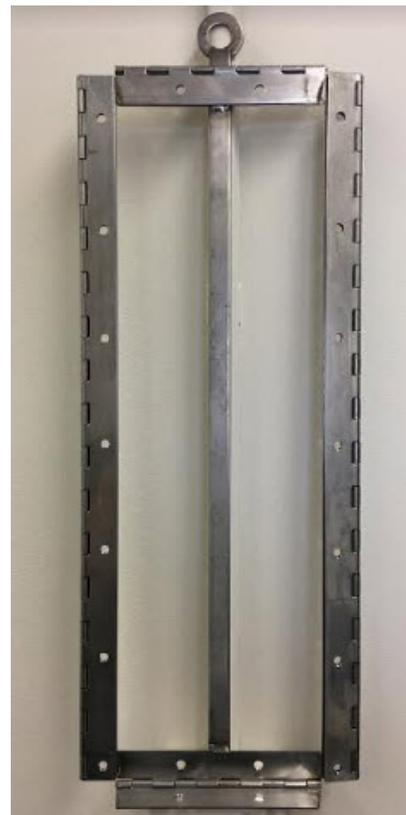
Figure 2. Example of polyethylene device (PED)

The PEDs are small metal frames holding stretched polyethylene, a common plastic. Looking like a reinforced license plate frame, the devices will be placed in the sand or water around Cocos Island, where chemical contaminants like PCBs and DDT, if present, will accumulate on the plastic. After the PEDs are collected and analyzed, local resource managers will have better information on whether these chemicals are being transported in the water. This information will help inform future assessment and restoration efforts in the area of Cocos Island.

If you find a PED (Figure 2), please leave it alone. Though simply made, it is a sensitive piece of scientific monitoring equipment and should be treated as such. As it is a small and unobtrusive device consisting of metal and plastic, it is not expected that fish will congregate near them.
