**CORAL REEF ALLIANCE
NOAA CRCP FINAL REPORT**

- 1) *Project Title:* **Delineate, Designate, and Demonstrate Stream Riparian Buffers in Wahikuli, West Maui**
- 2) *NOAA Grant Award Number:* **NA18NOS4820112**
- 3) *Project Manager:* **Jennifer Vander Veur, Program Manager**
- 4) *Period Covered by this Report:* **08/01/2018-01/31/2020**
- 5) *Program Officer:* **Liz Fairey**

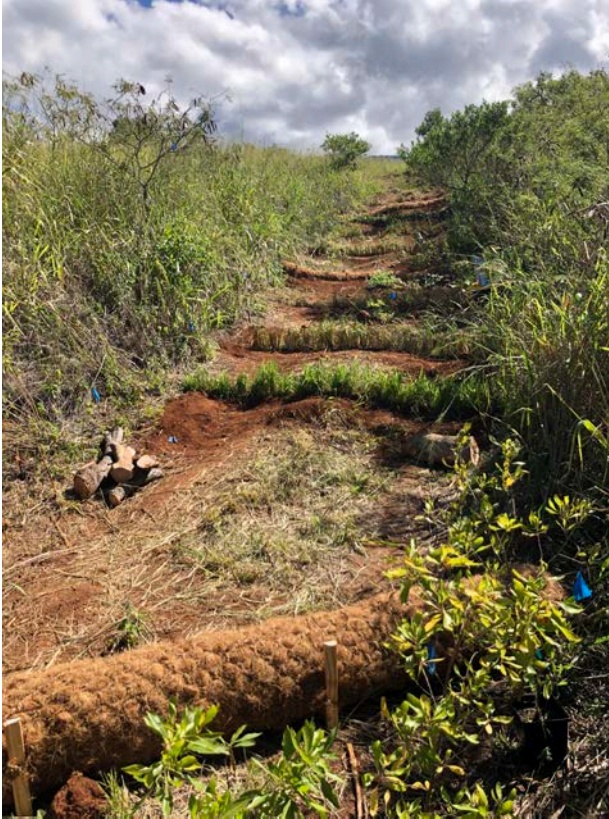
Figure 2 BMP treatment train

- Trained and coordinated 48 community volunteers who donated 192 hours over 6 days to install BMPs. Fifteen of these volunteers helped to build a nursery, construct a storage shed, and install plants.
- Stabilized sediment on the dirt road and push piles of sediment material left within the stormwater flow path by installing 57 BMPs which included:
 - 7 check dams
 - 23 rows of vetiver
 - 9 rows of native grasses (kawelu, pili grass, and uki uki)
 - 10 coconut coirs (used instead of GrowSoxx)
 - 8 water redirection BMP using 8 rows of native plants (65 plants total) planted diagonally

between rows of native grass sediment traps which stabilized accumulated sediment across .25 acres of exposed dirt road.

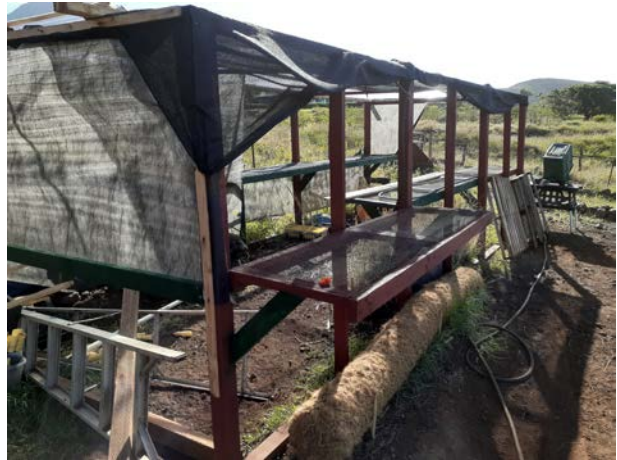
Figure 3 Storage shed and plant nursery at Maui Animal Farm

- Formed a partnership with Maui Animal Farm to establish a native plant nursery in West Maui where we will grow plants for Phase 2 restoration.
- Constructed a shed and native plant growing area.
