Implementation of the Guánica Bay Watershed Management Plan

Integrated Watershed Management Actions

Final Report 2012-2017

Protectores de Cuencas, Inc.

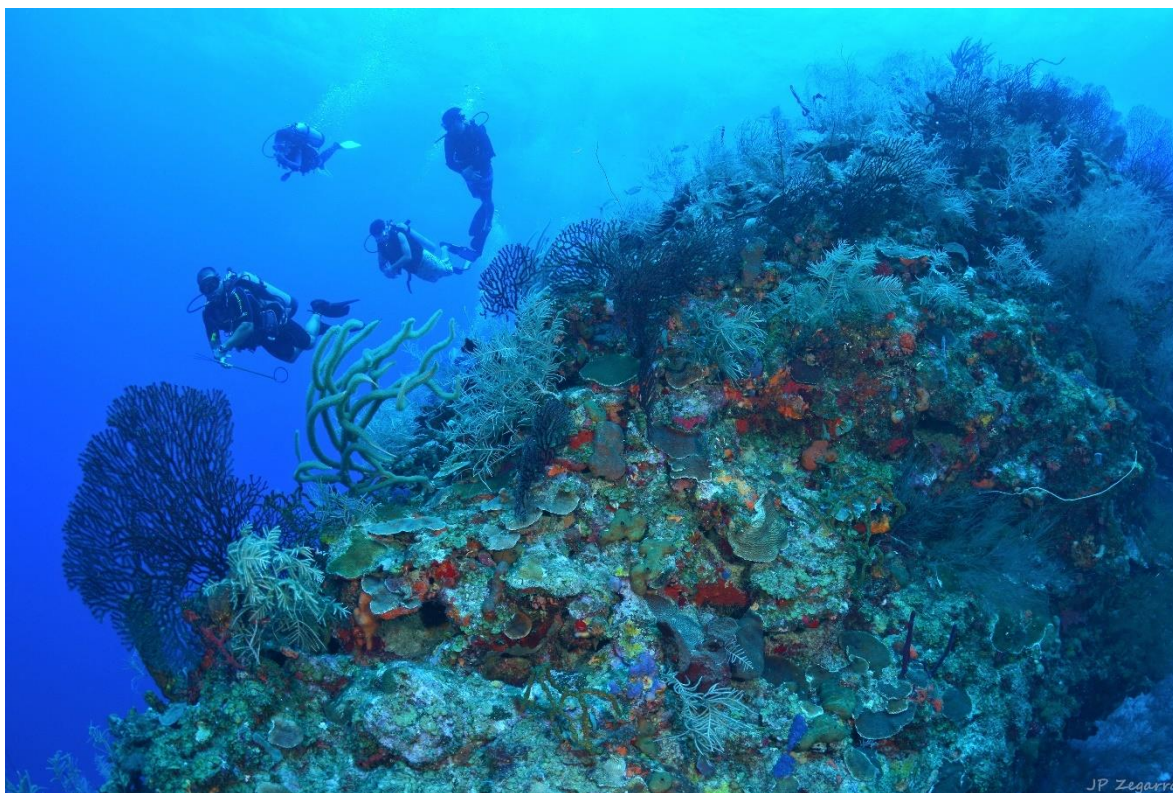
Figure 1. Actual coral reef area in Guánica.

Historically, the Guánica Bay area was associated with some of the most extensive and healthy reef complexes in Puerto Rico (Figure 1). Unfortunately, coral reefs worldwide have experienced an unprecedented decline over the past 30-40 years, some estimates suggest that in the Caribbean we have lost more than 50% of live coral and over 90% of sensitive and federally listed *Acropora palmata* (elkhorn) and *Acropora cervicornus* (staghorn) species. Meanwhile studies by scientists in Puerto Rico have shown that nutrients and sediment contaminants have increased by 5-10 times pre-colonial levels and several times in the last 40-50 years (Ortiz-Zayas et. al., 2006). 'Coral reefs of Puerto Rico are among the most highly threatened Caribbean reef systems' (Ramos-Scharrón, 2010; Burke and Maidens, 2004). The U.S. Coral Reef Task Force determined that reducing the

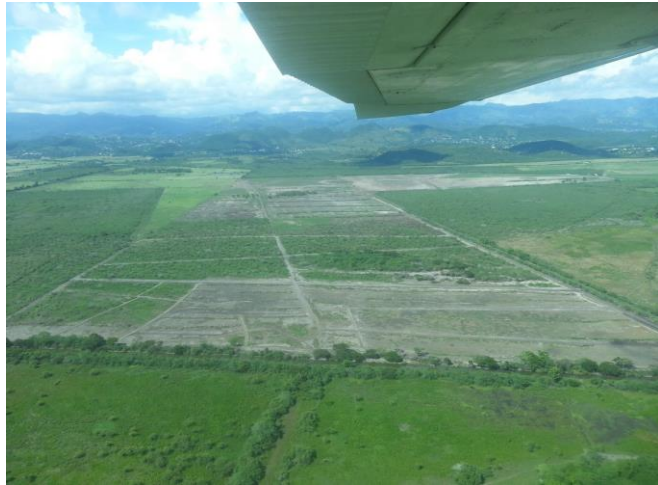
Figure 10. Aerial photo of some of the wetland areas impacted by the Puerto Rico Land Authority.

An important drawback in the restoration efforts raised because of the intentions of the past Head of the Department of Agriculture to regain farming activities inside the historic footprint of the Guanica Lagoon (Figure 10). During this process, the Puerto Rico Land Authority started clearing wetland areas for farming without any environmental compliance process and public engagement. Because of these

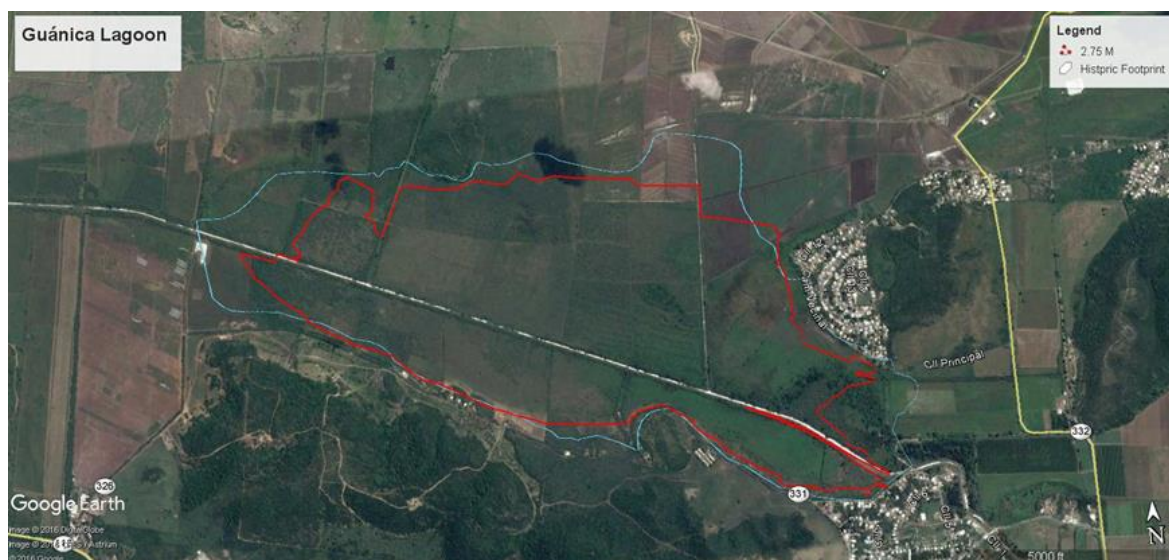
Figure 11. Recent (August 2016) Google Earth image of the Lagoon area showing the historic (blue) and proposed restoration areas (red)

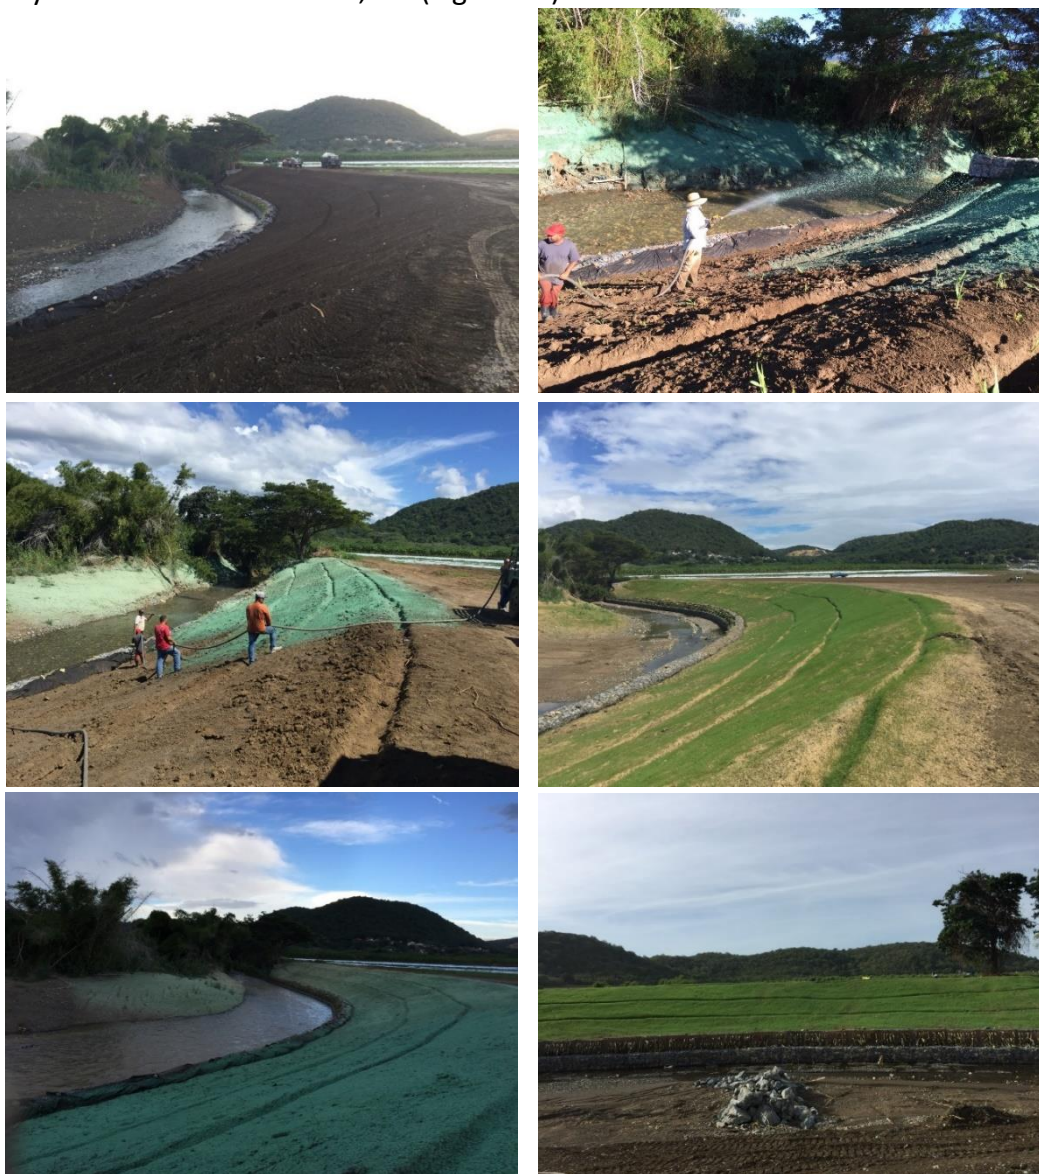
Figure 13. Areas of the Río Loco riverbank restoration project hydroseeded by PDC.

For the past four years, a series of coordination efforts lead by the Natural Resources Conservation Service (NRCS) have led to the implementation of three major restoration projects on the Río Loco river to restore river banks with bioengineering strategies that included the implementation of a collaborative effort to apply hydroseeding on the restored areas by Protectores de Cuencas, Inc (Figure 13).

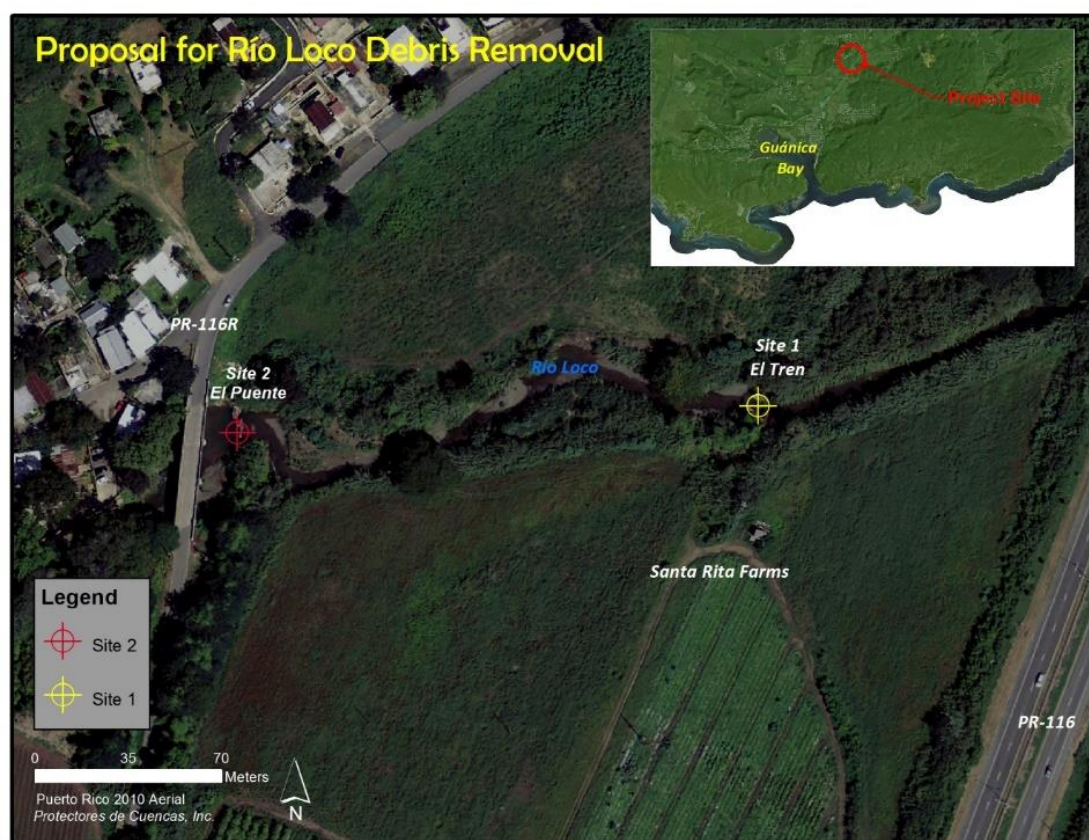
During this process, most of the old abandoned irrigation infrastructure inside the river that was identified in the Watershed Management Plan as priority to be removed were taken out of the river. From the total identified structures, there are two sites remaining that we have secure funding from the DNER to remove (Figure 14).

Figure 14. Map of the remaining sites with structures to be removed.

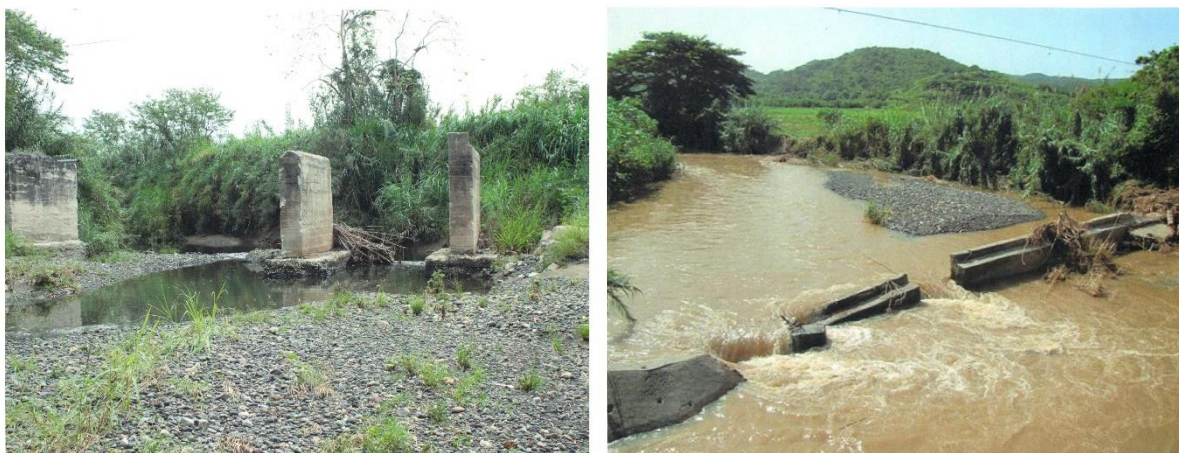
The structures are mostly associated with the past use of surface irrigation that has been replaced by drip irrigation in the Guánica Valley, as a result these structures are in a state of disrepair and inhibit natural flows in the channel and create conditions for excessive erosion.

Figure 15. Pictures of the structures that are going to be removed from the Río Loco, El Tren Site (left and El Puente Site (Right)

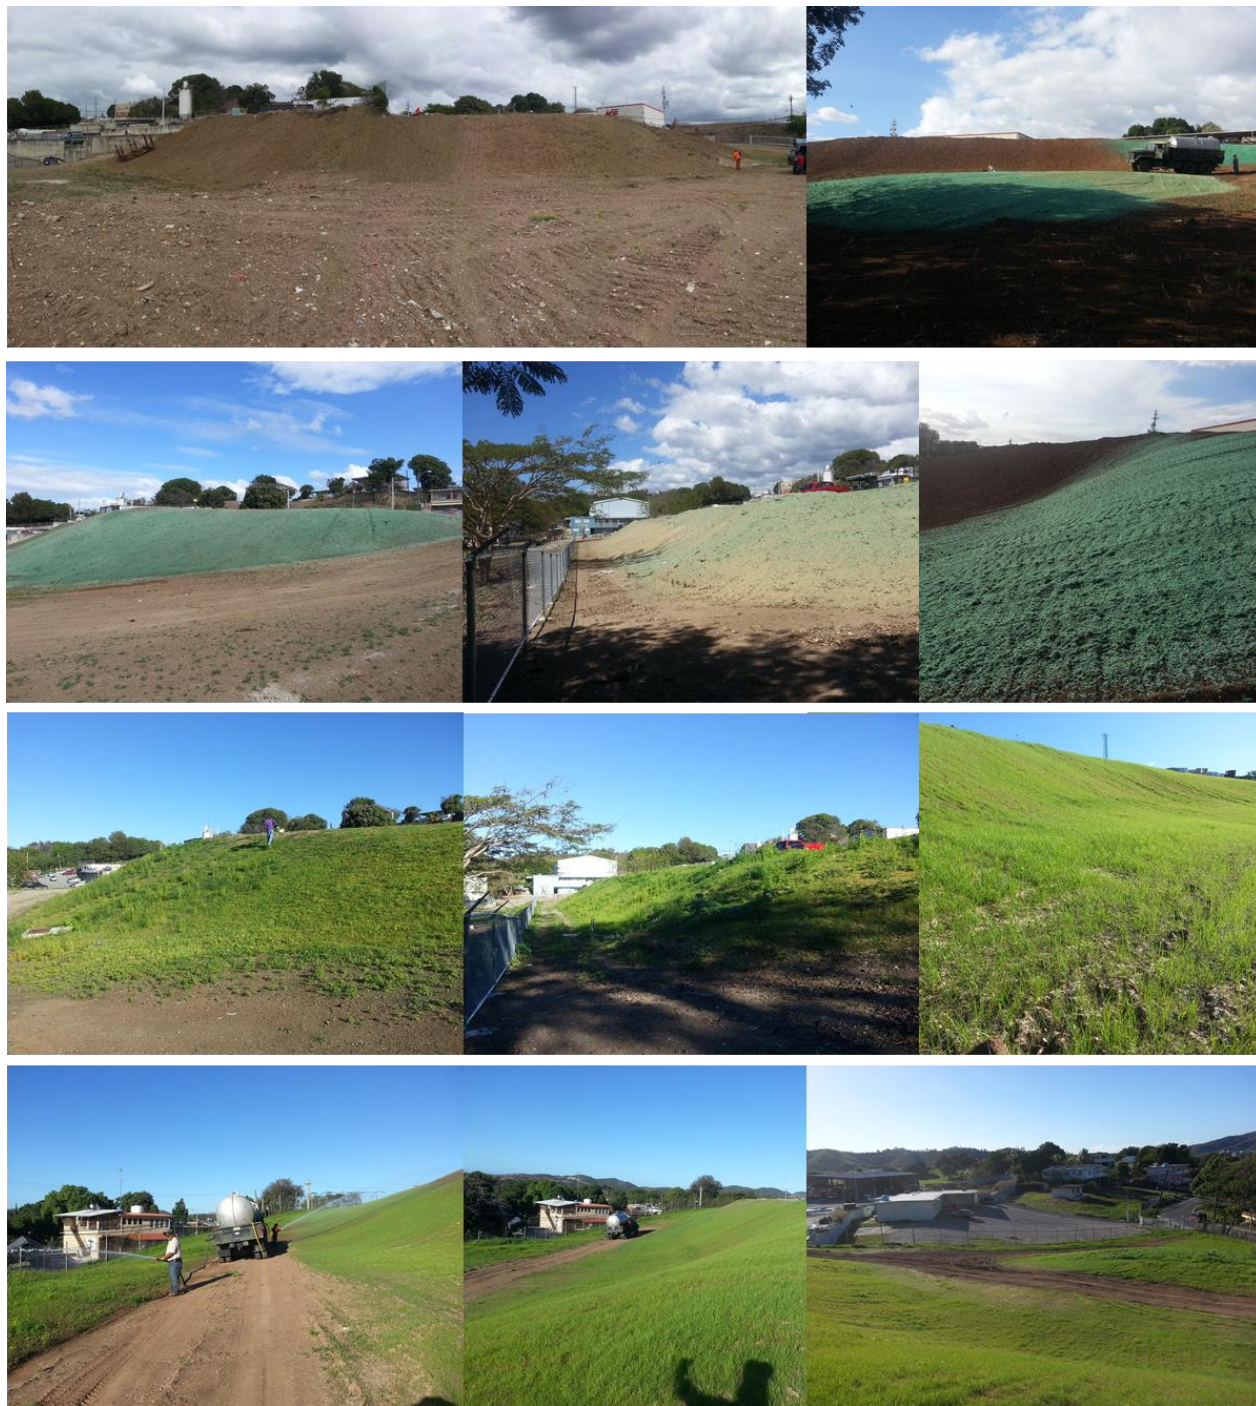
product fixation to the soil. The following pictures are from some example sites that shows the Hydroseeding process (Figure 18).

Figure 18. Hydroseeding process on one of the multiple Hydroseeding sites of the GB/RL Watershed.

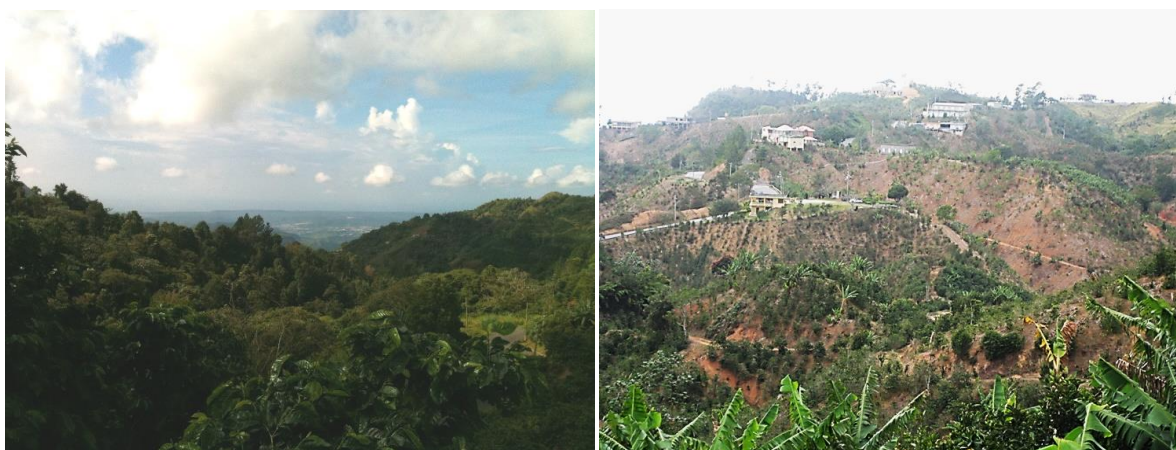
Figure 19. Actual image of a shade coffee farm (left) and a sun grown coffee farm (right).

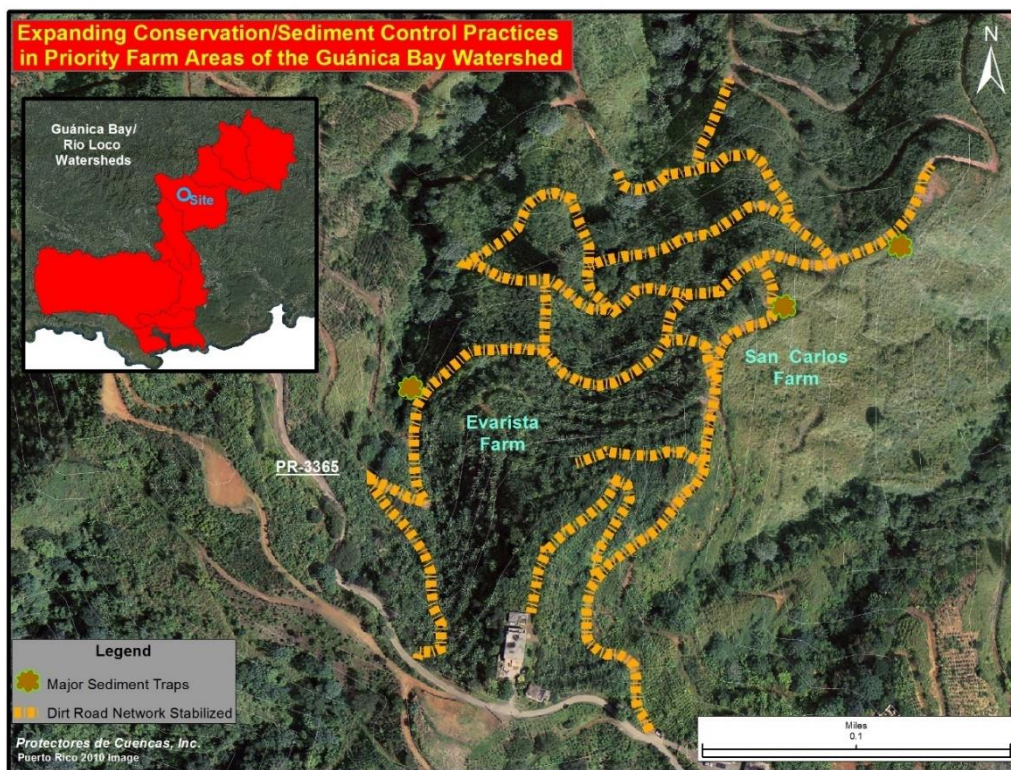
Figure 21. Schematic diagram of the work completed on the three farms selected for the pilot project.

The project assisted farmers in reducing the need for re-grading dirt roads. We also provided them with guidelines for long-term maintenance. The project worked closely with all stakeholders and farm owners to train them in proper installation of temporary and permanent sediment and erosion control practices. We also provided training in construction of stormwater control swales, check dams, creation of infiltration systems with vetiver grass and native trees as well as proper maintenance techniques for Best Management Practices (BMP). By installing these conservation practices, we assisted farmers in reducing the need for re-grading dirt roads that farmers had to do two to three times a year, producing massive sediment runoff. PDC has a partnership with the Natural Resources Conservation Service (NRCS) on these efforts to address this major threat to coastal ecosystems and to work together on creating a set of standard practices to address runoff from dirt roads in the near future.

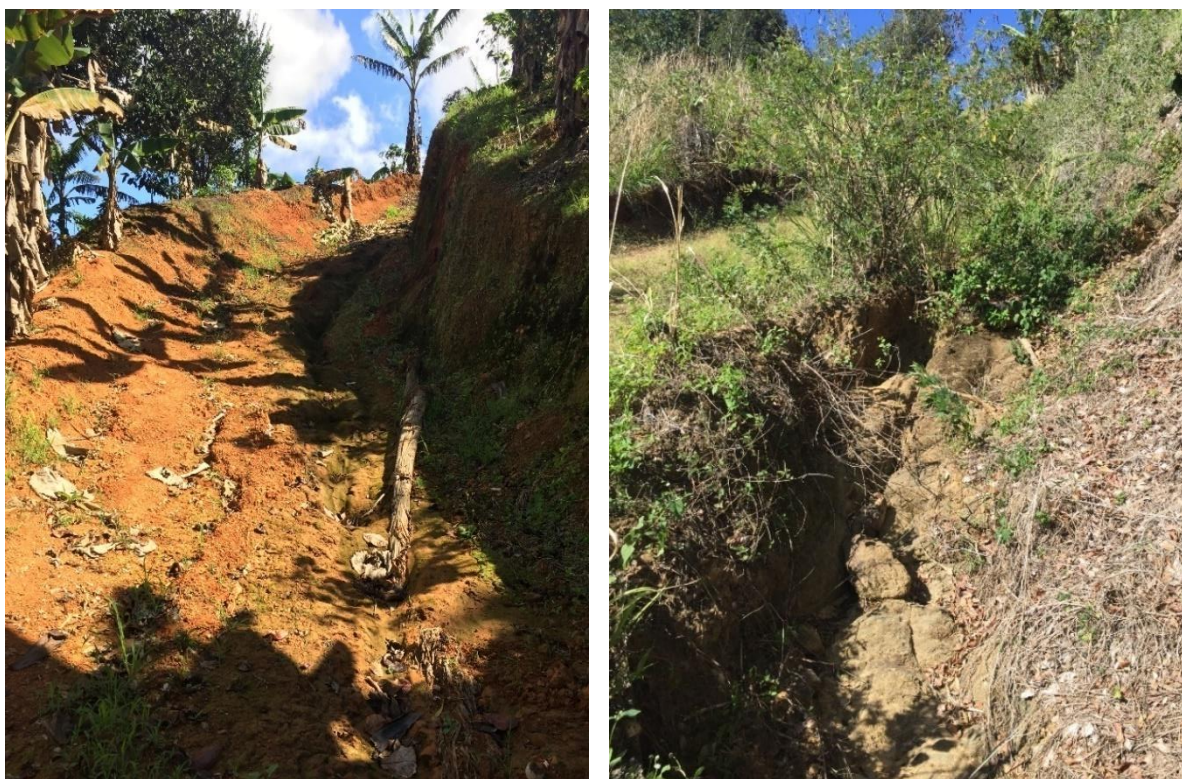
The primary goal of this project was to stabilize bare soils in the upper watershed farms to reduce sediment loads to the Guánica Bay (Figure 23). This will protect and build resilience of coral reef ecosystems in this priority area. Prior to stabilization, in most parts of the dirt road network, runoff was running through the center of the road causing erosion forces to transport sediments into our watershed water resources. After completing the installation of temporary sediment and erosion control measures, PDC stabilized approximately 1.7 miles of dirt roads in three coffee farms. Installed BMPs included sediment traps, check dams, swales, regrading, rip-raps, Vetiver grass and paving with granulate fill material and compacting (Figure 24). A brief description of each BMP is provided here to help understand their function and purpose.

Figure 23. Previous existing conditions of segment of the coffee farms dirt roads.

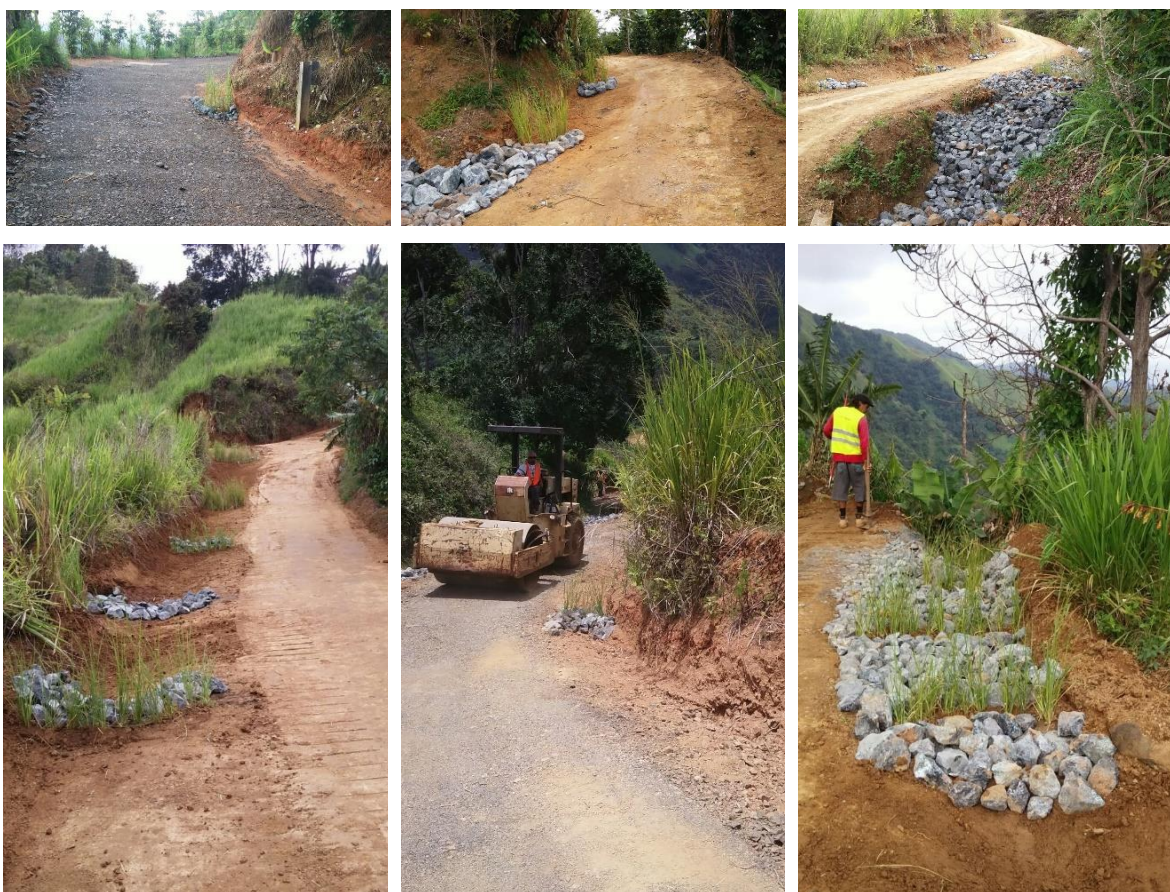
Sediment traps serve to detain sediments in stormwater runoff to protect receiving streams, lakes, drainage systems, and the surrounding area. An outlet or spillway is often constructed using large stones or aggregate to slow the release of runoff. Check dams are a commonly used practice constructed across a swale or channel. They are used to slow the velocity of concentrated water flows, a practice that helps reduce erosion. Check dams are typically constructed out of gravel, rock, sandbags, logs or treated lumber, or straw bales. Similarly, swales are designed to manage water runoff, filter pollutants, and increase rainwater infiltration and refers to a vegetated, open-channel management practices designed specifically to treat and attenuate stormwater runoff for a specified water quality volume. As stormwater runoff flows along these channels, it is treated through vegetation

Figure 24. Some examples of the BMP's implemented on the pilot project.

slowing the water to allow sedimentation, filtering through a subsoil matrix, and/or infiltration into the underlying soils.

Based on our experience implementing BMP's, we can recommend that one practice on its own is not enough to observe an improvement. Instead, it is important to implement a series or combination of BMP practices that are best suited for the location, while taking into consideration other factors such as slope gradients, soil type and composition. The different slope gradients found at each farm will help us compare the effectiveness of the different BMPs implemented on the long term. This information will allow us and farmers to better understand which BMPs are best suited to their particular farms. As PDC continues to implement sediment and erosion control practices, this project will help to develop and standardize cost-effective techniques to reduce sediment loads from the upper Guánica Bay watershed.

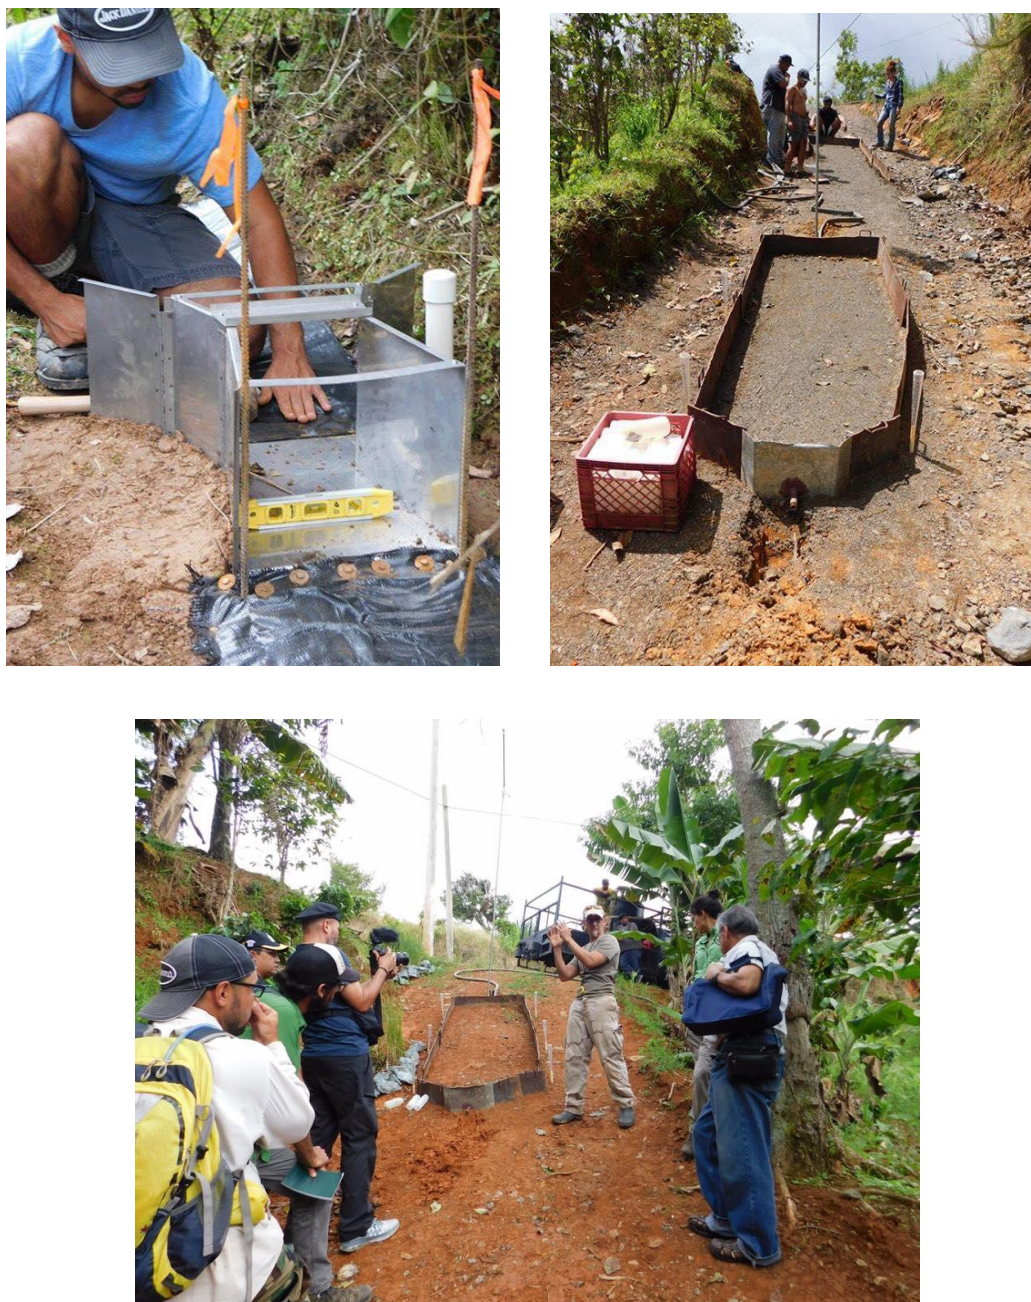
A study published in *Land Degradation and Development* by Ramos-Scharrón and Thomaz in 2016 describes the methodology used during the BMP training sessions (Figure 31) that took place in San Carlos Farm. Rainfall simulations experiments conducted to quantify runoff and soil erosion from different land surface types, including unpaved roads within farms. Water samples were collected to measure sediment concentration levels and compare them to samples taken in other areas of the farm where bare soils are not exposed. Results of the published 2016 study indicated that bare soil dirt roads within farms begin to mobilize and transport sediment with less than 0.1 cm of rainfall within 1 to 2 minutes into the simulations, with an average of 69g of sediment eroded during 30 minutes of simulation. Authors concluded that unpaved roads account for over 90% of the eroded sediment reaching the watershed (Figure 27).

The research project associated with this effort serves to compare the erosion rates of the different surface covers found at coffee farms. This has helped us identify the surface cover that generates the most erosion and therefore focus our efforts on one specific type of surface. Preliminary data from the rain simulation experiments and sediment traps indicate that bare dirt roads are the primary generator of erosion. To control the erosion and ultimately the water quality, management efforts should focus on the dirt roads. Therefore, it is important to work with all stakeholders to continue with the design, implementation and maintenance of sediment control practices that are focused on farm dirt roads.

Figure 27. Images of methods of rain simulation implemented by Dr. Carlos Ramos.

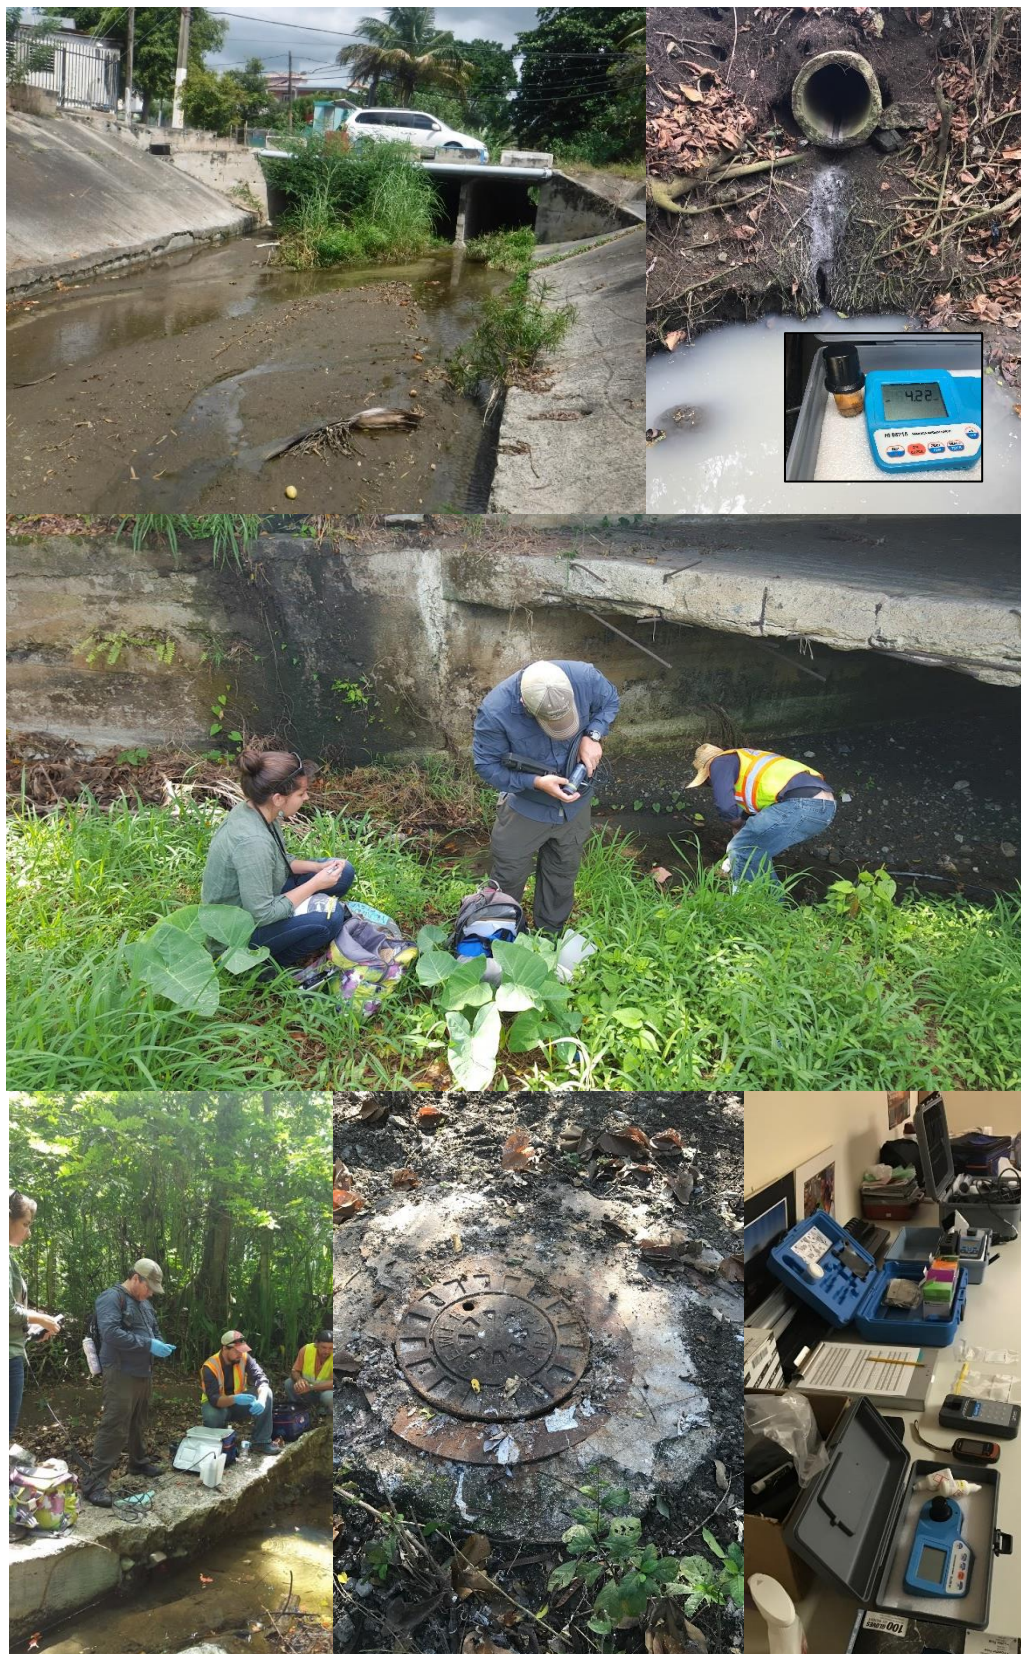
Figure 34. Part of the site assessments and lab analysis.

Water Quality Sampling was conducted in 35 sampling points including outfalls and streams coming in and pollution was further tracked between and upstream of these points using parameters which include total nitrogen, total phosphorus, optical brighteners, ammonia, turbidity, Chlorophyll A, and enterococcus bacteria. The methods utilized are the EPA funded and approved guidelines listed under the document 'Illicit Discharge Detection and Elimination: A Guidance Manual for Program Development and Technical Assessments'. A series of conceptual restoration strategies are being drafted as well as cost estimates for recommended remediation actions (Figure 34). Data collected in this project is being incorporated in the revised Guánica Bay Management Plan. Training on water quality sampling and illicit discharge detection was incorporated to high school and university students and science teachers.

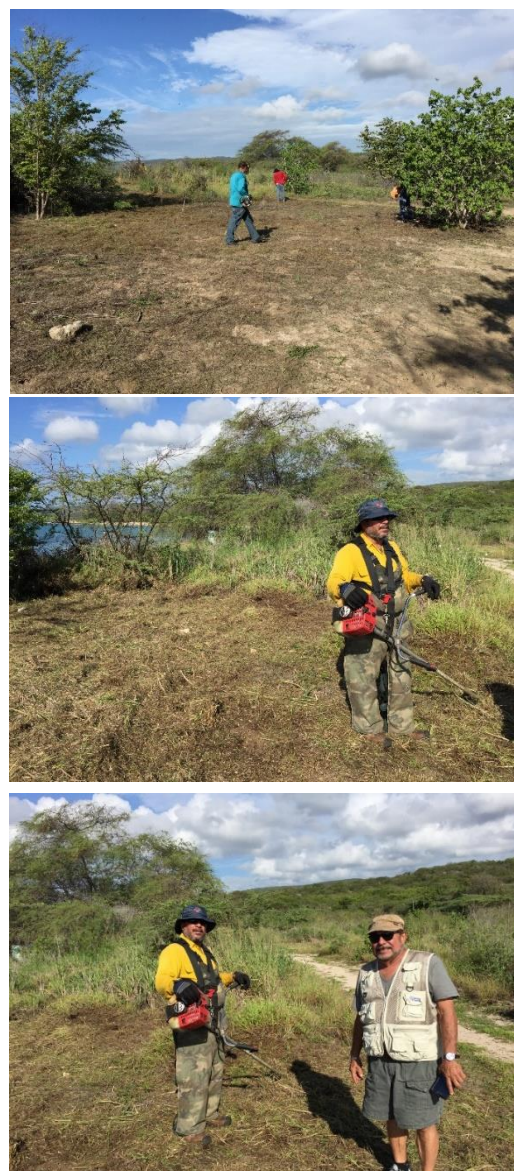
Figure 35. DNER personnel collaborating with PDC on the site preparation process and our technical advisor Miguel Canals Mora

This task included the design of a reforestation plan for the coastal forest sites that included the conservation of desirable existing trees, shrubs and vines. The plan specified the type of vegetation and at what density was going to be planted; it also proposed management features such as fire break trails. The plan included the preservation of the desired species identified in the surveying process with the technical support of the DNER Forest Management Officer. Boring and drilling activities, fertilization and irrigation of planted trees were thoroughly discussed with the working group. A total estimated area of 7,200 m² of coastal forest (using Arc GIS tools) was restored. The process began by conditioning the area for reforestation activities with the help of DNER personnel (Figures 35).

Invasive grasses as well as other undesirable non-native shrub species were selectively removed from the sites. Bigger non-native trees such as the mesquite tree were left on site pruned for up to 25% so that the new planted trees had enough sunlight to grow. A total of approximately 1,750 native trees were planted with the help of DNER staff, local NGO's and students from schools of the Yauco, Guayanilla and Guánica in the area (Figures 36). Some of the planted species included Sea Grapes (*Cocoloba uvifera*), Almácigo (*Bursera simaruba*), Uverillo (*Coccoloba microstachya*), Roble Nativo (*Tabebuia heterophylla*), Emajagüilla (*Thespesia populnea*), among others as recommended by DNER specialists.

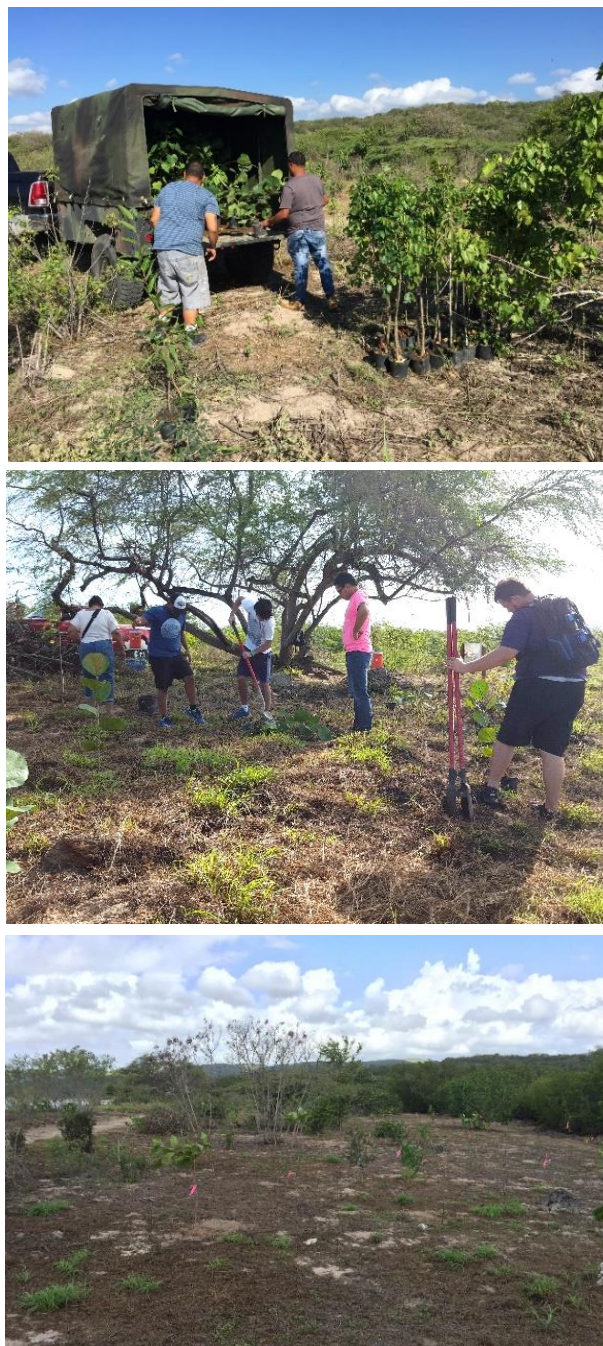
Figure 36. Coastal Forest reforestation process.

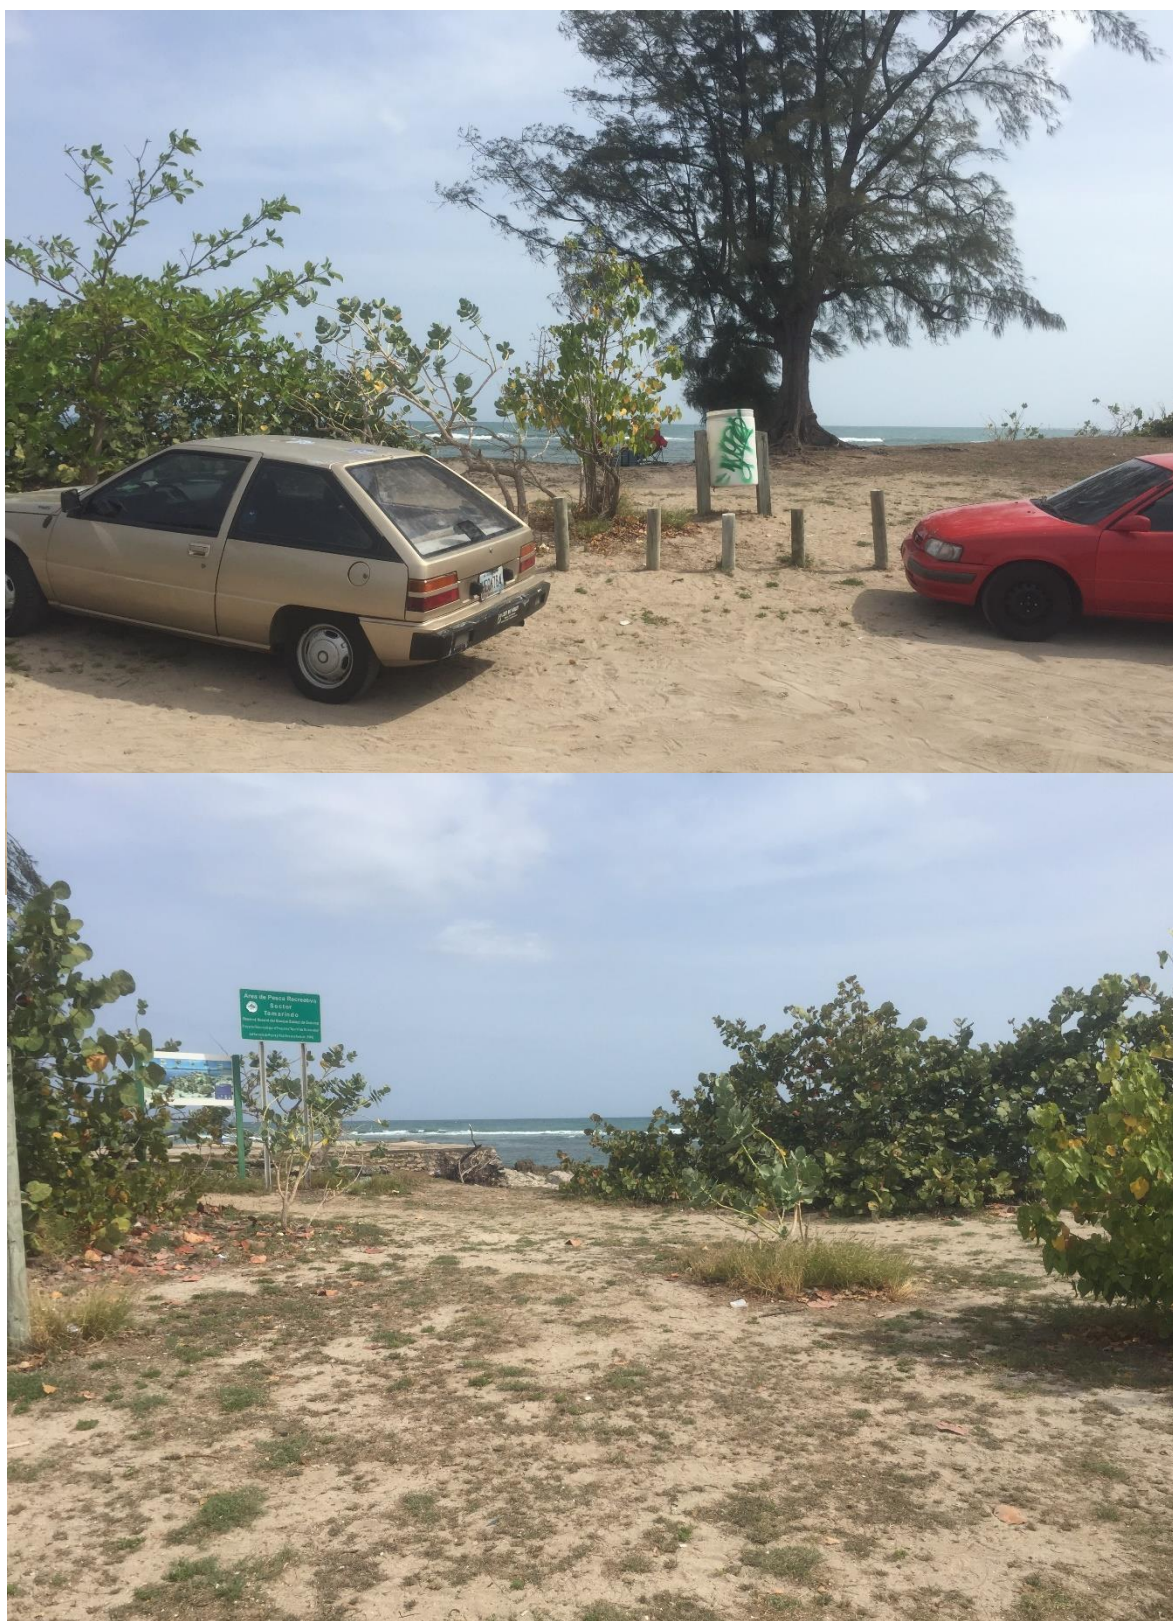
Figure 37. Sand dunes prior to restoration.

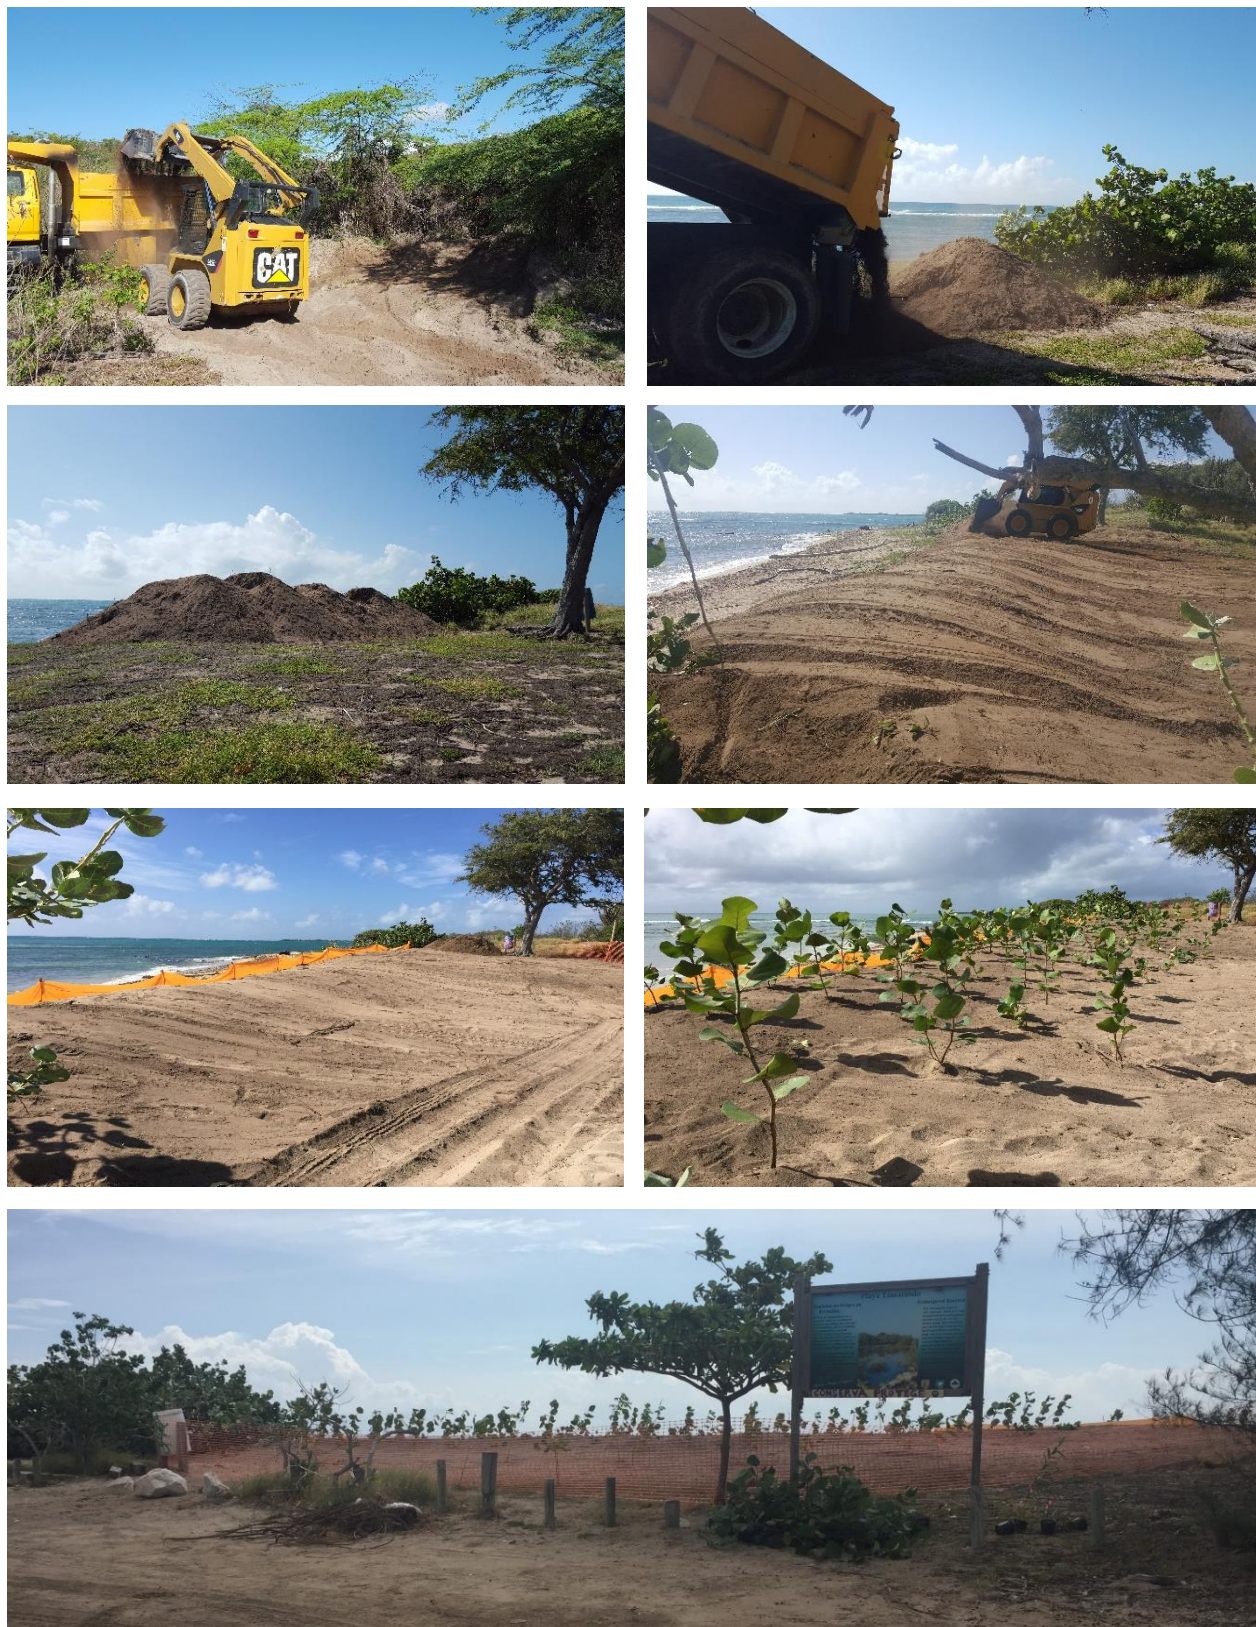
Figures 38. Part of the sand dune restoration process.

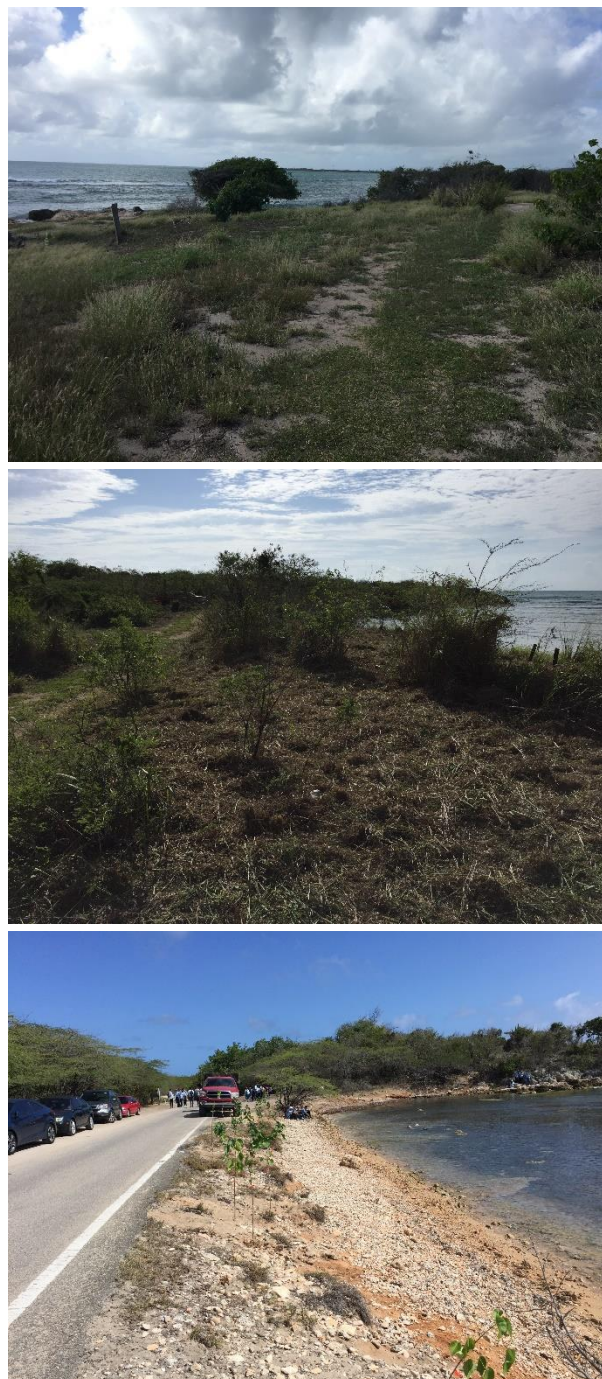
Figures 39. Coastal areas prior to stabilization.
