Implementation of the Guánica Bay Watershed Management Plan

Integrated Watershed Management Actions

Final Report 2012-2017

Protectores de Cuencas, Inc.

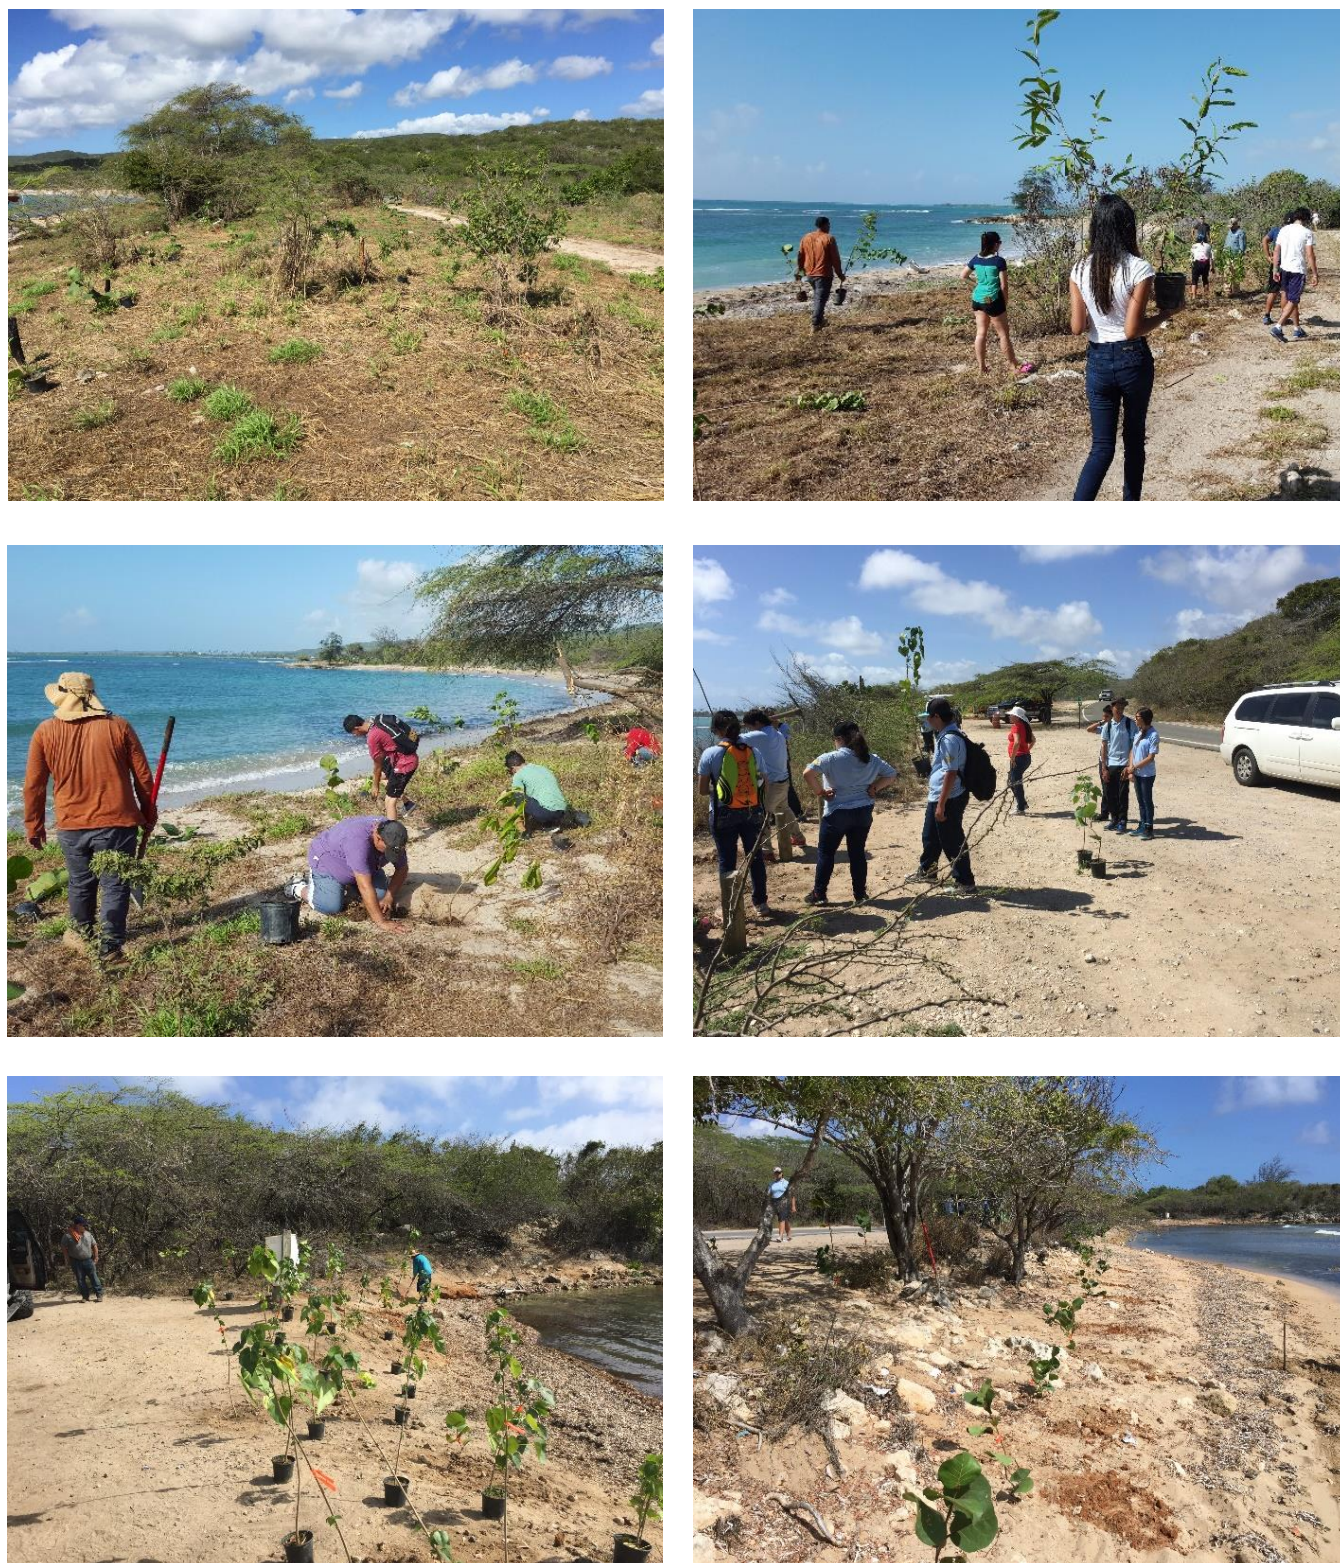
Figure 40. Coastal berm restoration process.

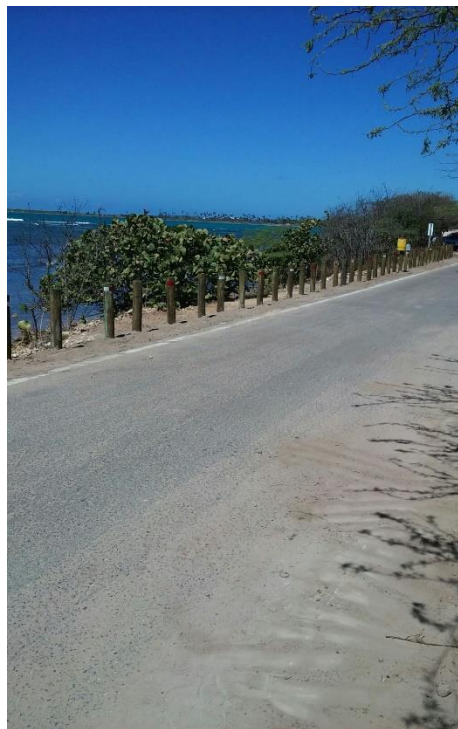
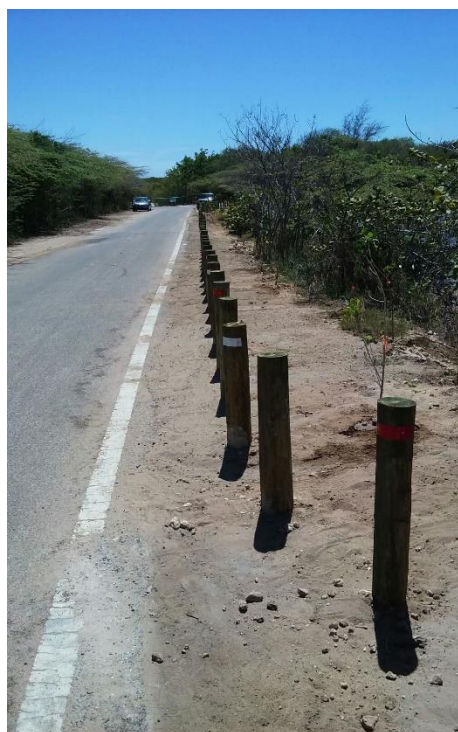
Figures 41. Delimitation of critical areas.

The essential coastal habitat in Tamarindo has been seriously impacted by uncontrolled public usage. Based on the field evaluations and with technical recommendations from the Sapo Concho Management Committee we restored the coastal forest, sand dunes and beach berm areas with native vegetation barriers and delineated public access to the beach. This delineation was conducted by installing treated wooden posts buried about 18 inches deep and fixed with concrete at the base leaving about 30 inches of pole exposed to set limits to the area (Figure 41). Wooden posts were placed at a distance of three feet from each other to prevent the passage of small vehicles. Wood fences were built to protect the area re-nourished of sand dunes to prevent pedestrian access through restored sites (Figure 42). Three elevated boardwalks were constructed for public access to the beach without impacting restored vegetation buffers, sand dunes and tadpoles. One boardwalk is 350 feet long and the other two are 30 feet long. These set of boardwalks were built approximately 2.5 feet above the ground to protect terrestrial species and provide ecological

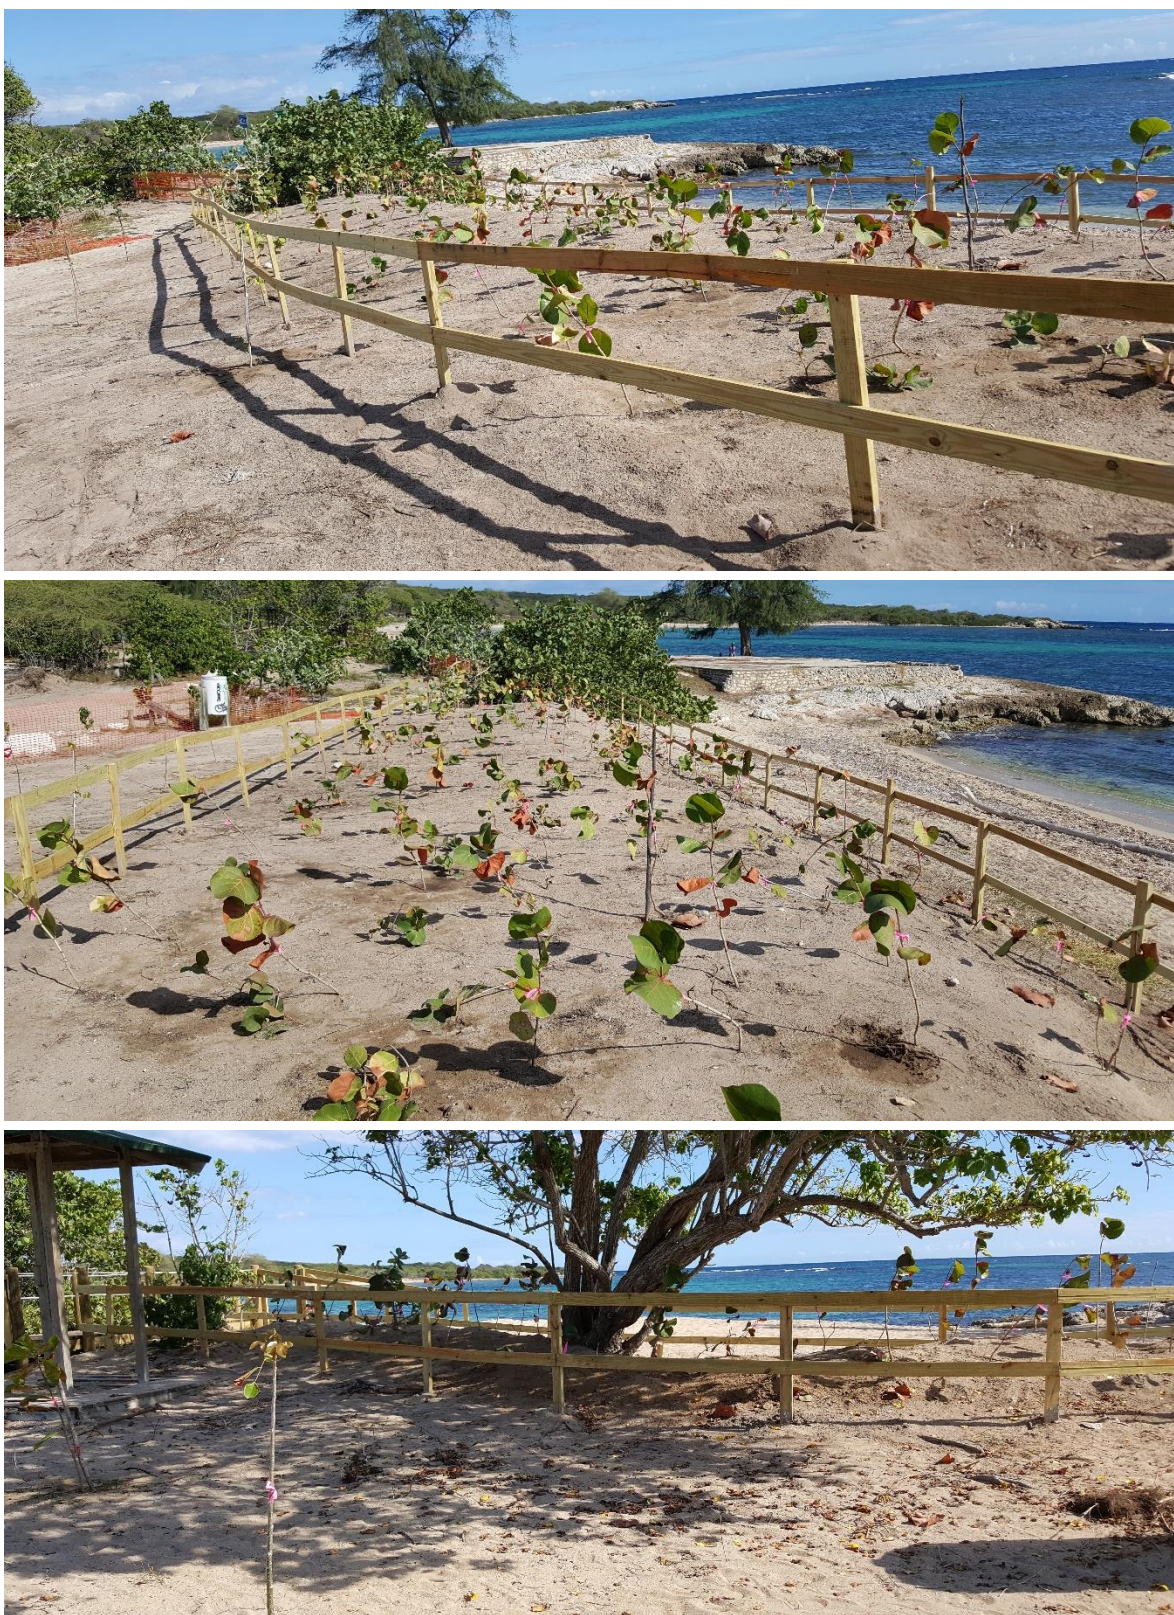
Figures 42. Delimitation of restored areas.

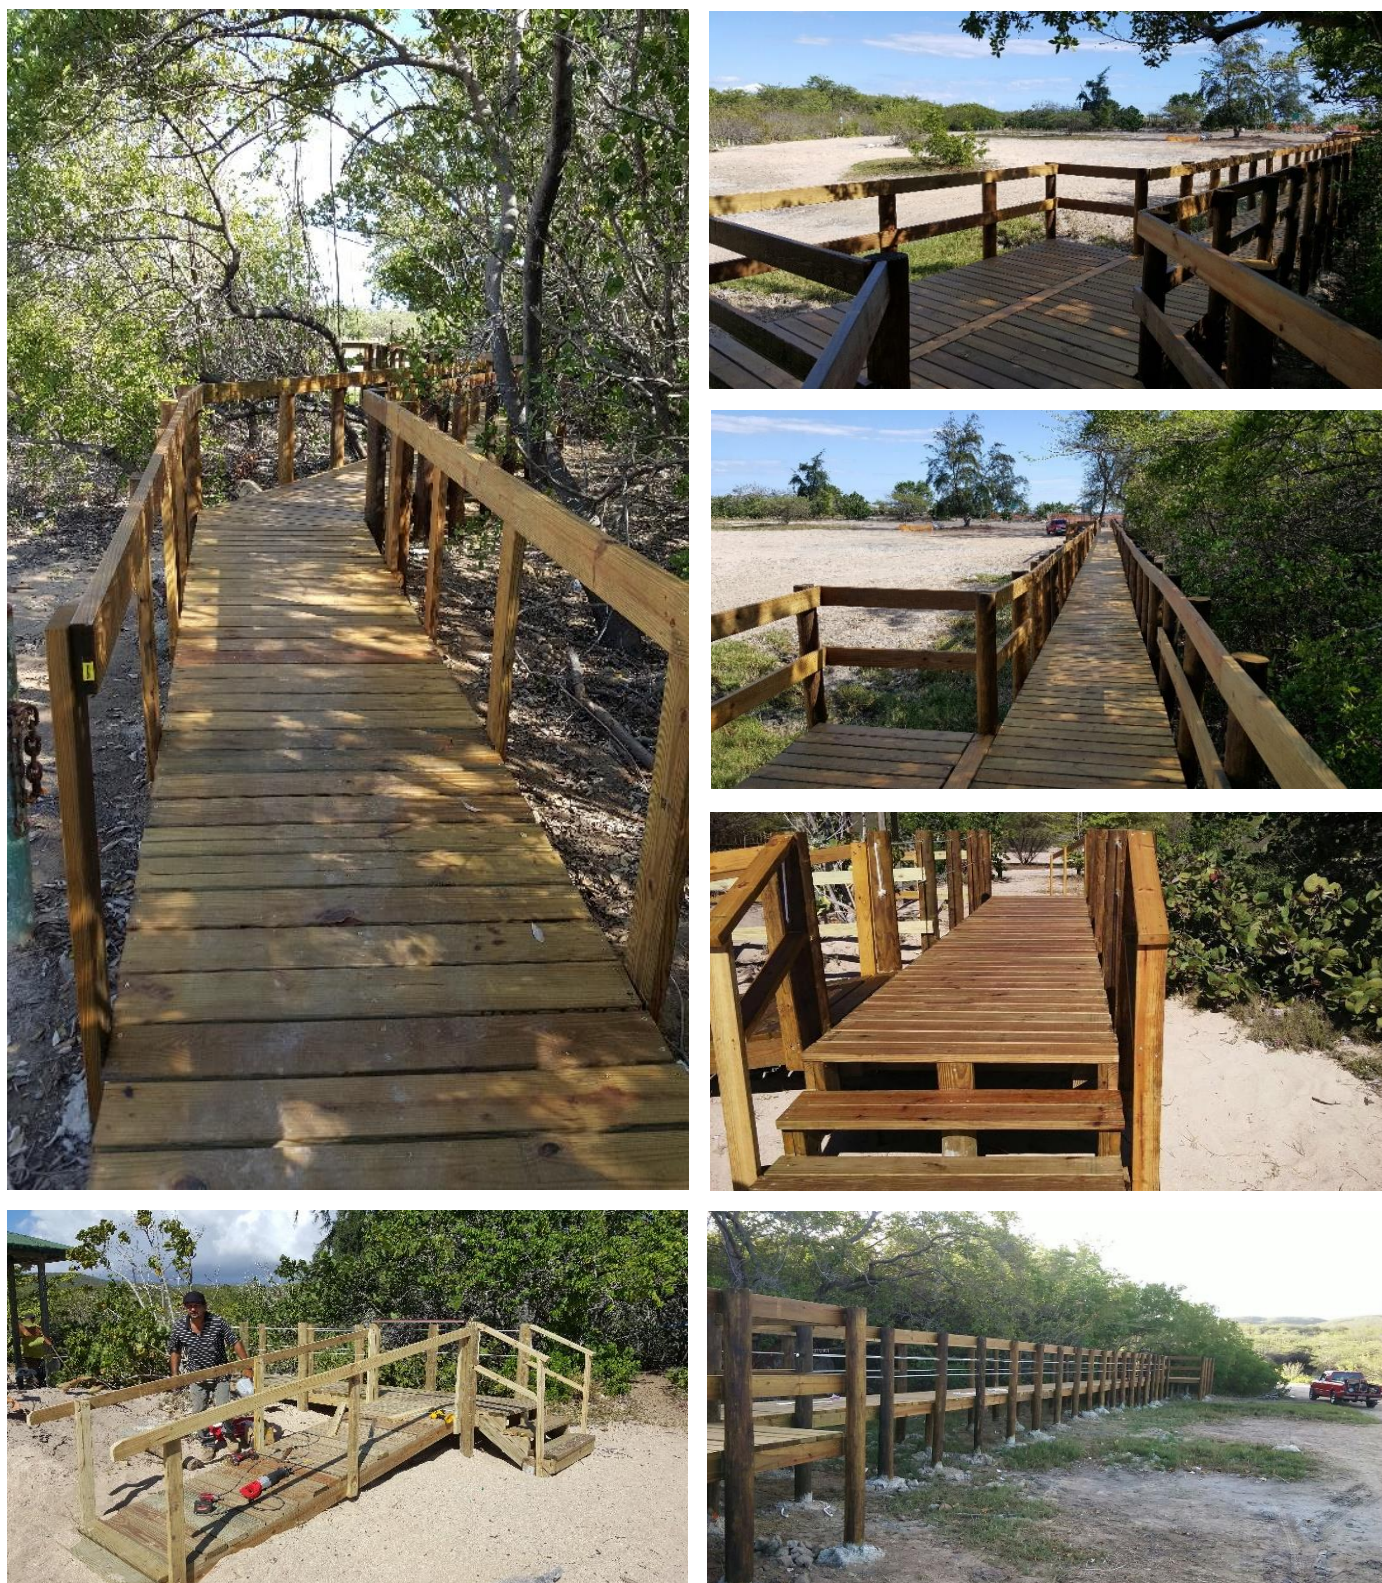
Figure 43. Elevated boardwalks constructed.

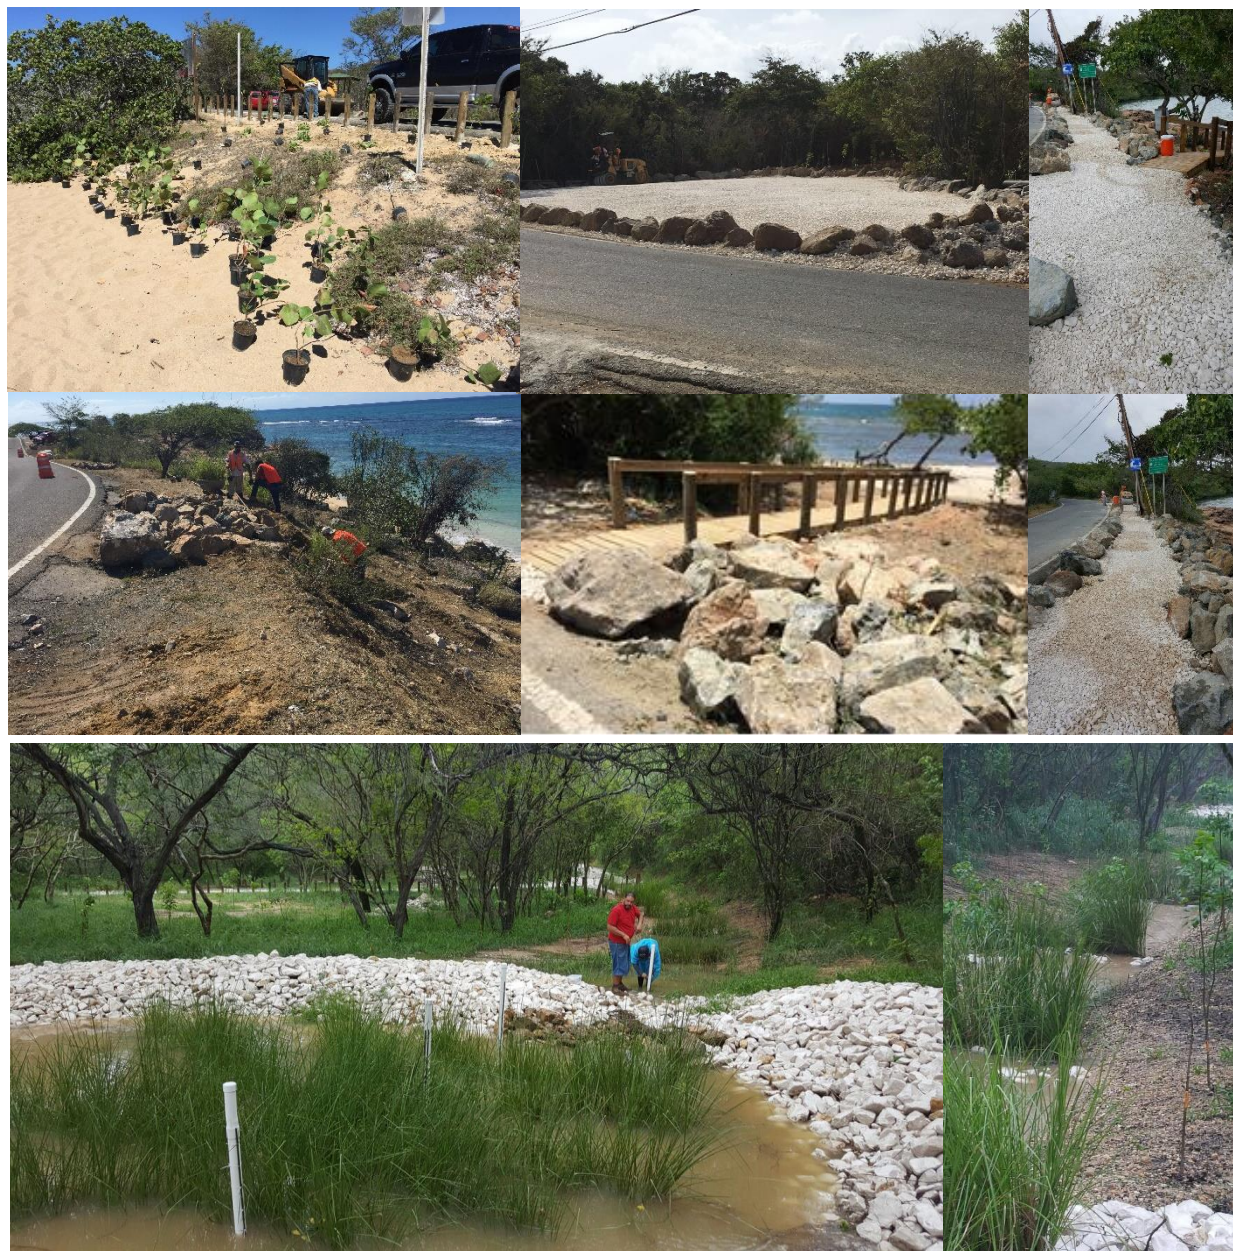
Figure 44. Some examples of the BMP's implemented.

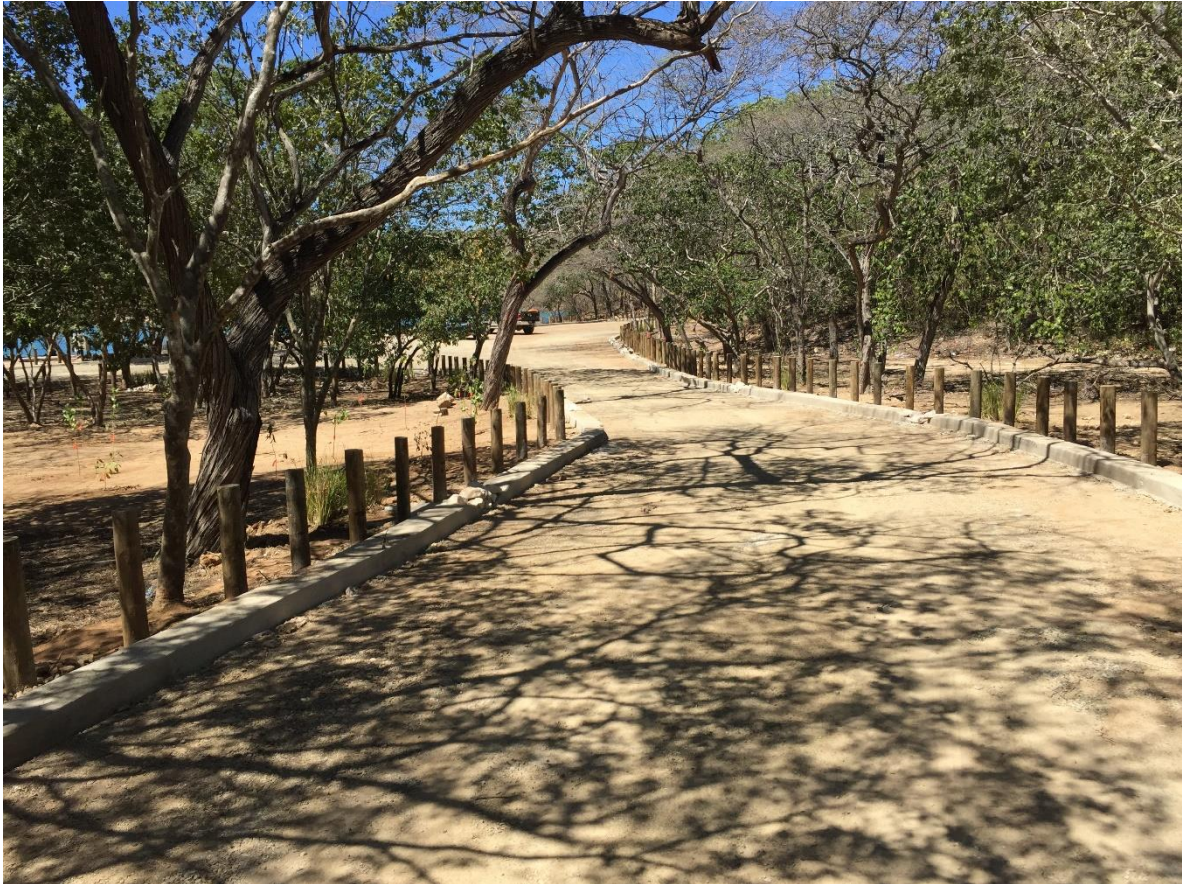
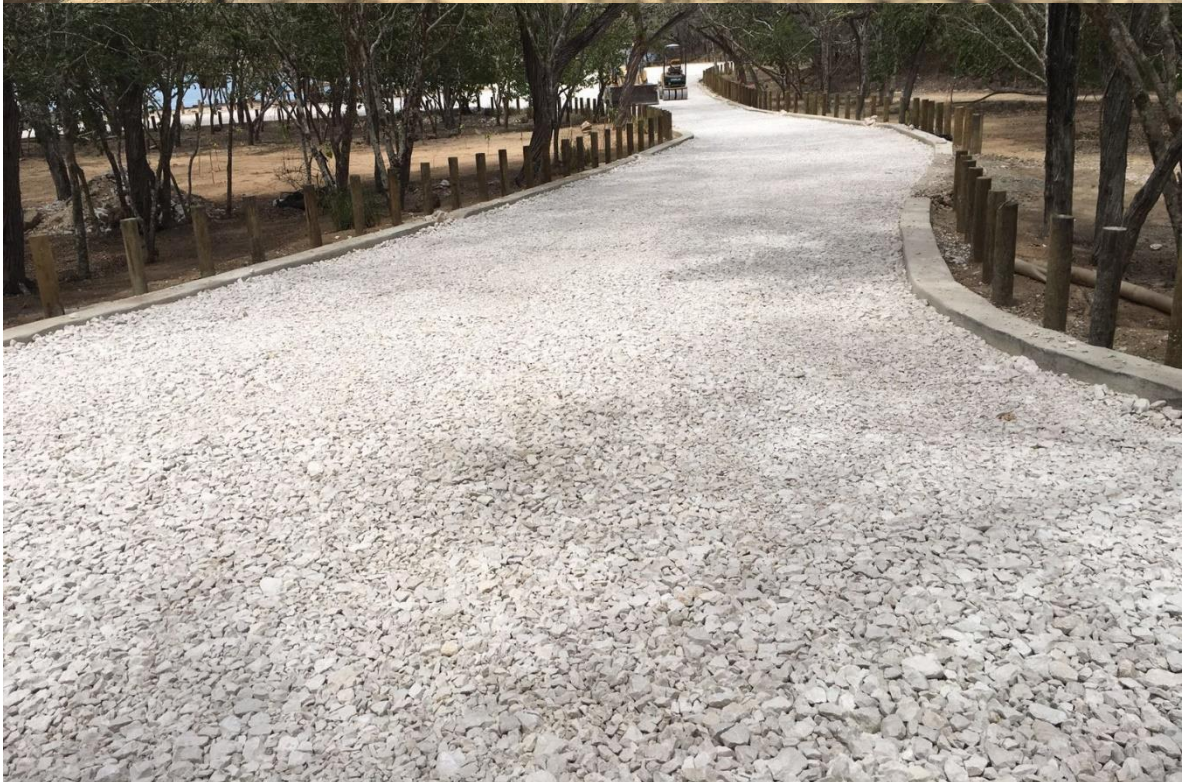
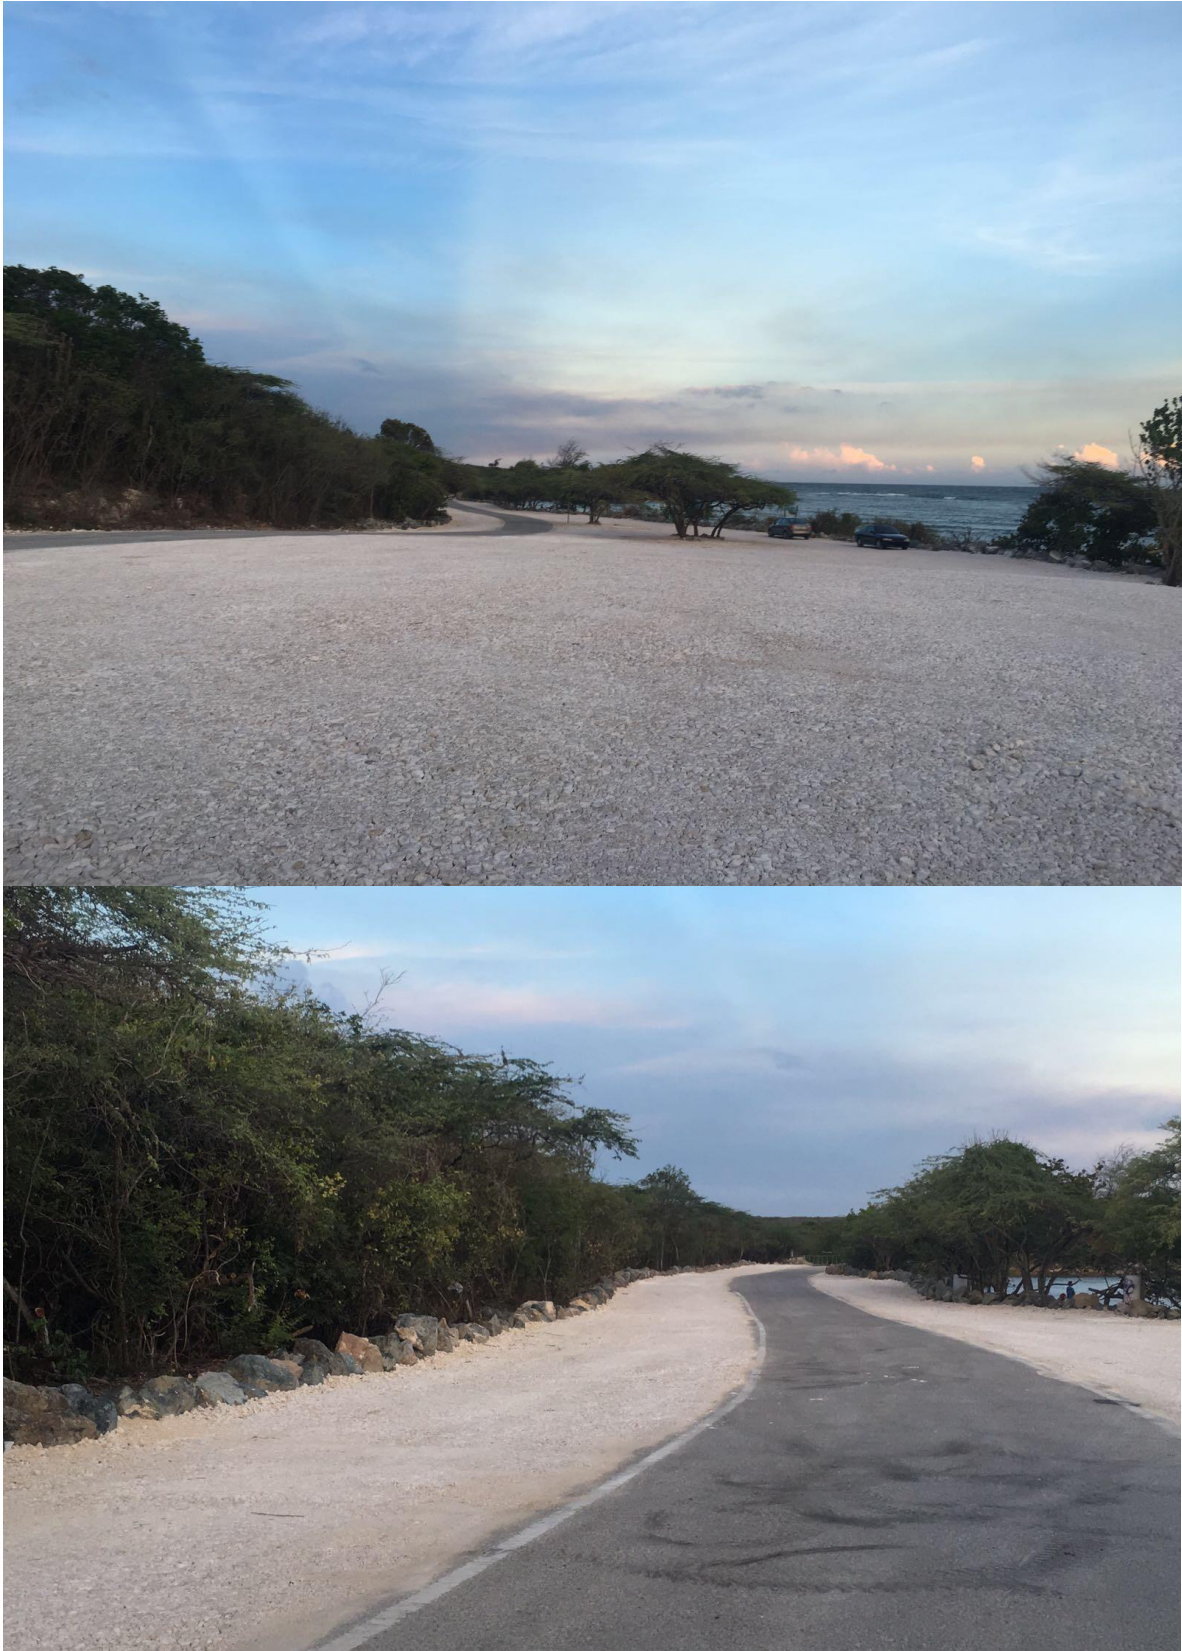
Figure 45. Some examples of dirt road and parking lot stabilization.

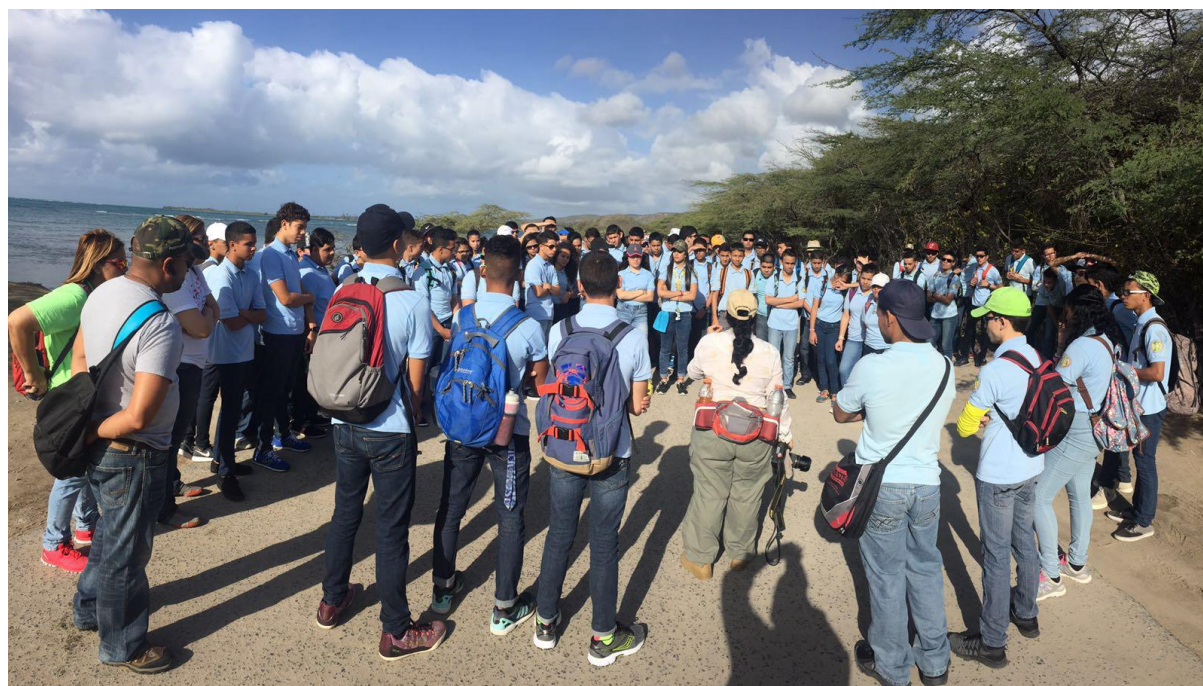
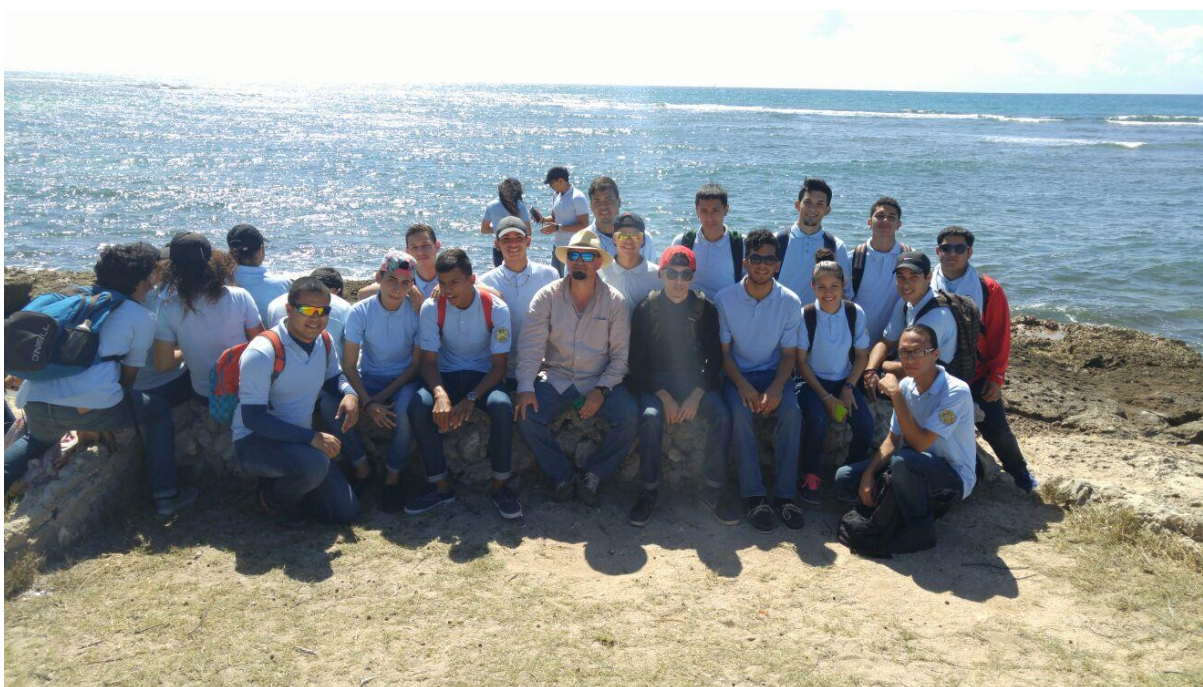
Figure 50. Volunteer groups during maintenance and irrigation activities.

Monthly visits were conducted to ensure that the practices installed were working properly, particularly after rain events. Problems encountered were fixed during this period. We have also removed any unnecessary temporary measures installed after the site was fully stabilized and restoration activities were completed. During this period plants planted were irrigated and grasses and vines were removed to help in the plant survival. After each planting section was finished a periodically irrigation process begun. A water truck equipped with special irrigation components was used for the irrigation and maintenance component of the project. Any tree with unhealthy growth during the irrigation and maintenance period was replaced. These implementation efforts mark a paradigm shift in the historic usage of the area. In order to ensure the longevity of the practices, proper use by visitors and make it a successful we will maintain a coordinated management and maintenance of the areas with the DNER and local volunteers as part of our Co-management Agreement of the area (Figures 50).

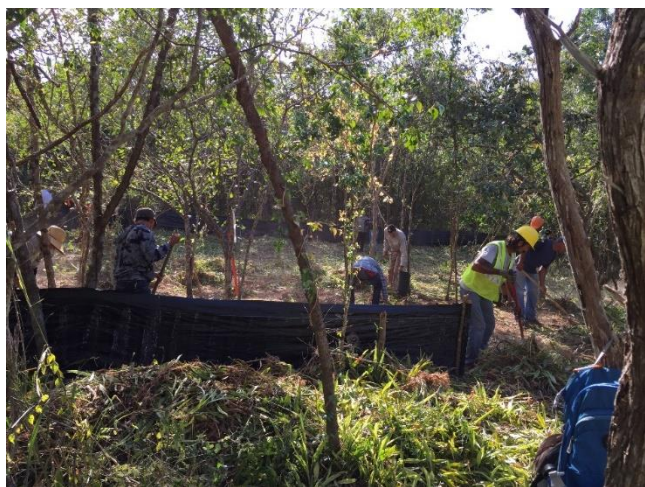
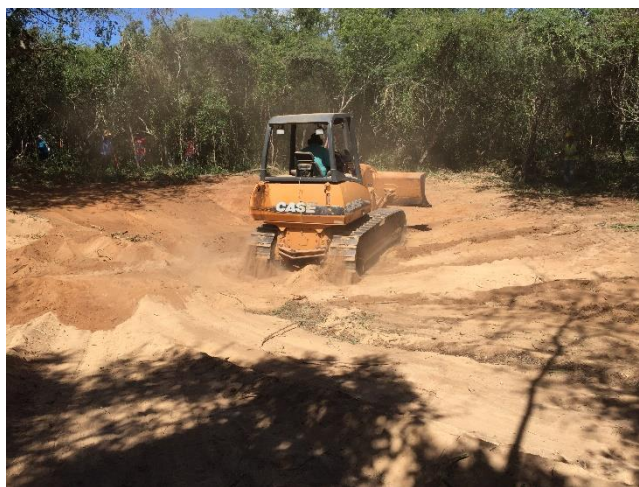
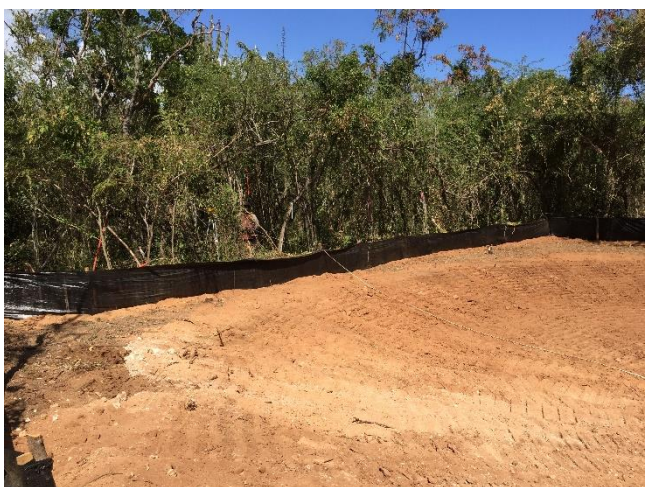
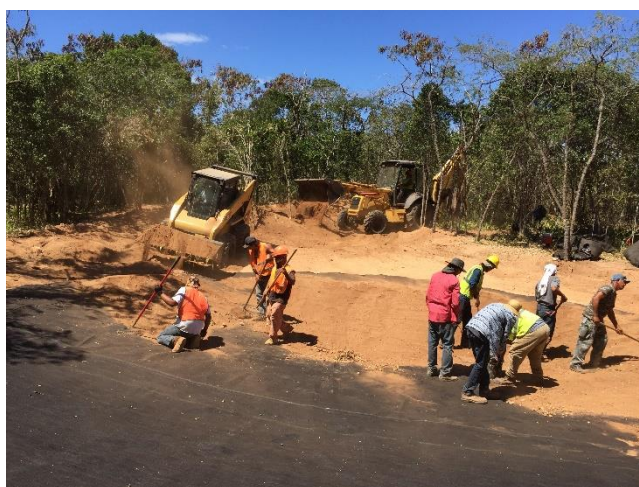
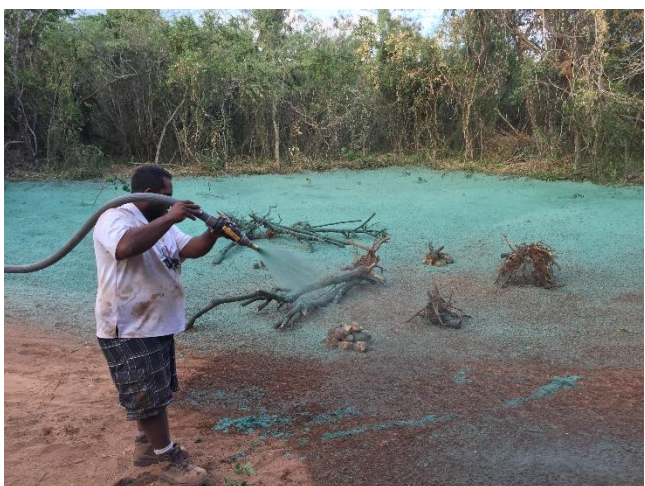
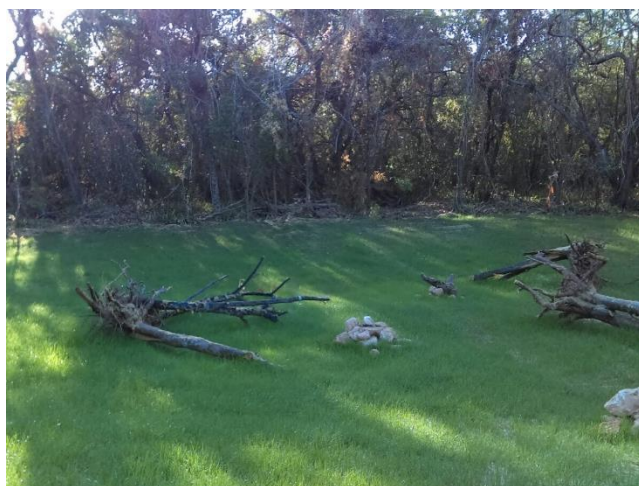
Figure 52. Images of work completed during wetland creation activities.

This project was made possible thanks to the efforts and funding of US Fish and Wildlife Service, Department of Natural and Environmental Resources, Association of Zoos and Aquariums and the Municipality of Yauco (Figure 52).

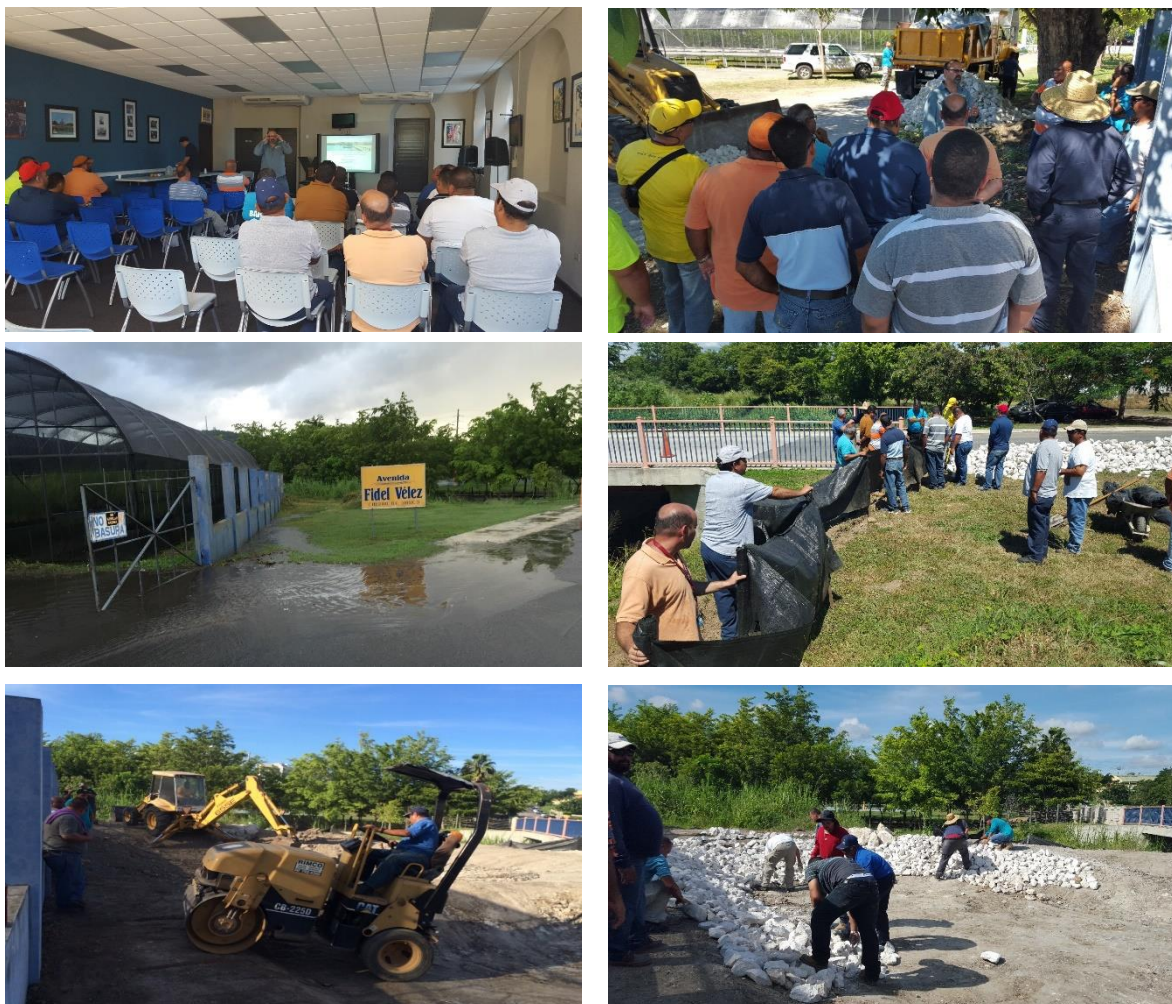
Figure 53. Workshop activities on PDC premises in Yauco.

This project provided for the personnel of the municipal public works departments of the municipalities of Cabo Rojo, Lajas, Guánica and Yauco as well as their respective contractors to be trained in BMP's implementation. For this task, a series of theoretical and practical workshops were held on appropriate practices in the handling of heavy equipment, earth moving and the installation of barriers, both temporary and permanent, for sediment and erosion control (Figure 53).

The workshops were directed to public officials who operate heavy equipment, municipal contractors and employees from other branches such as brigades of ornamental, emergency management, sports and recreation and recycling officers. The main purpose of these workshops was to provide the necessary tools to public officials who carry out the maintenance, preparation and cleaning of areas that involve dirt movement and vegetation removal. These workshops were also open to other people involved in land-disturbing activities and who are agency consultants. The main objectives were to; raise awareness of the impacts of sediments on water bodies and marine ecosystems and the need to implement sediment erosion controls; Develop techniques that involve the use of physical conditions present in the work area to reduce the impact of erosion; Familiarize the participants with the use of economically viable techniques for sediment and erosion control that can be carried out using existing terrain conditions; Familiarize the participants with the correct process of installation of the most appropriate erosion and sedimentation control practices.

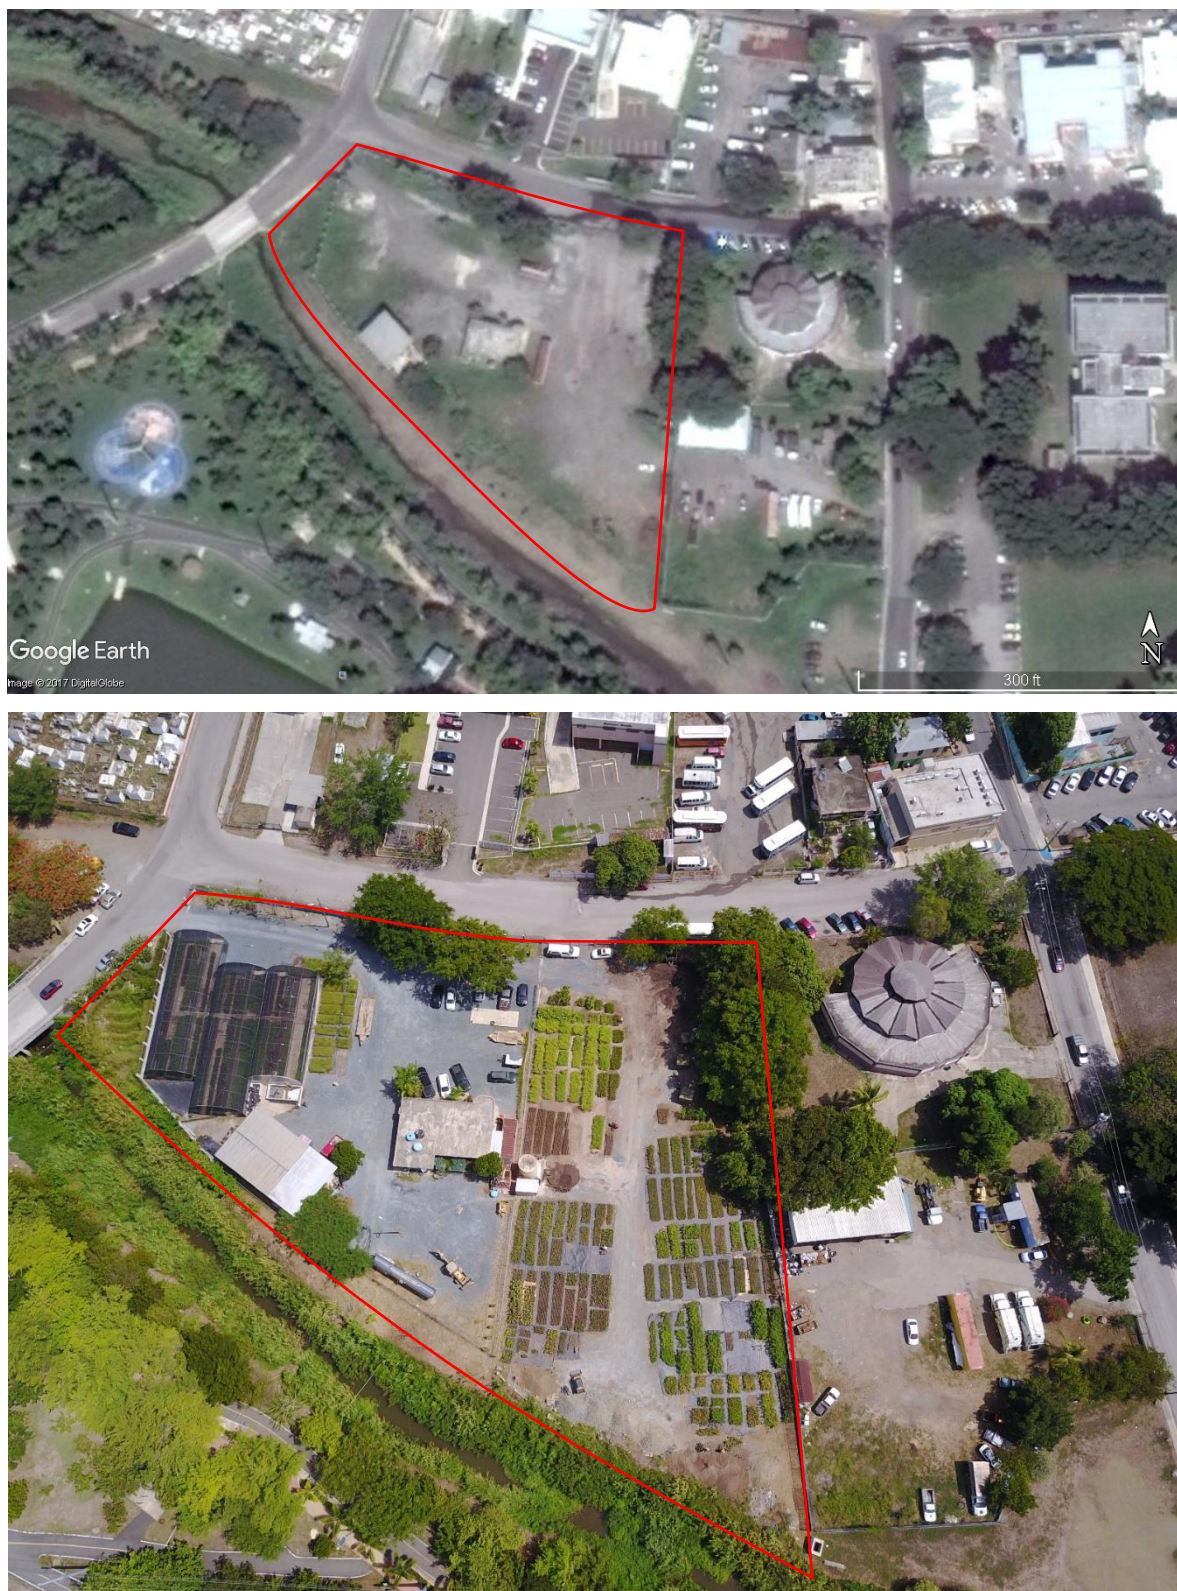
Figure 54. Google Earth 2014 image (top) of the area donated by the Yauco Municipality before the nursery was constructed and a recently Drone image (bottom) showing constructed nurseries and maturing area.

With a grant from NFWF and the collaboration of the Yauco Municipality, PDC built three nursery/greenhouses of 100' x 36' to produce native plant materials for the ongoing restoration projects (Figure 54). So far PDC has produced more than 100,000 native plants for restoration projects across the archipelago of Puerto Rico (Figure 55). Then main purpose of this project was to be able to accelerate and sustain short and long-term watershed conservation and restoration efforts in Puerto Rico. through the production of a nursery/green house. This project increased capacity building for the sustainability of future conservation efforts. PDC is now able to grow their own plants for restoration purposes and will no longer have to limit restoration efforts upon availability of plant material in the nurseries of the Department of Natural and Environmental Resources (DNER) or other partners. These species of trees are typically very difficult to obtain commercially.

The production of these trees and plants have decreased the costs of all restoration efforts led by PDC. Two years ago, the Municipality of Yauco donated approximately 1 acre for PDC to establish the nursery/greenhouse including water and electric services. Recently, another 2 acres of adjacent grounds were donated by the Municipality of Yauco to expand the available space to grow and store the plants, including a maturation station necessary to acclimate plants to the intense weather conditions found at some of the restoration project sites. Agreements with neighboring schools have helped us gather volunteers that helped with the collection of seeds as this activity is linked to the Environmental Education Program activities. Students also help maintain plant production and plantings.

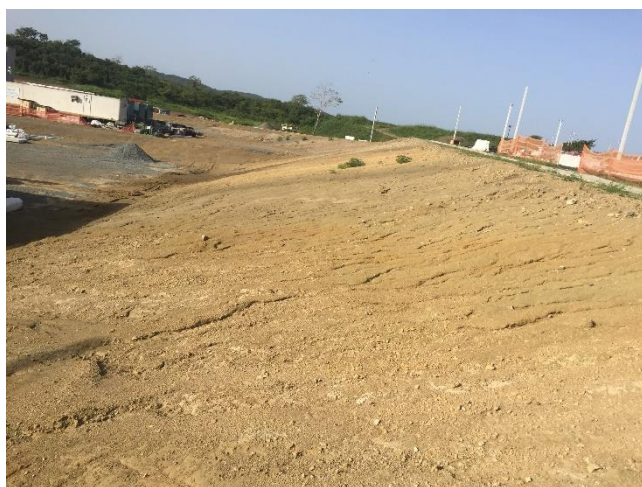
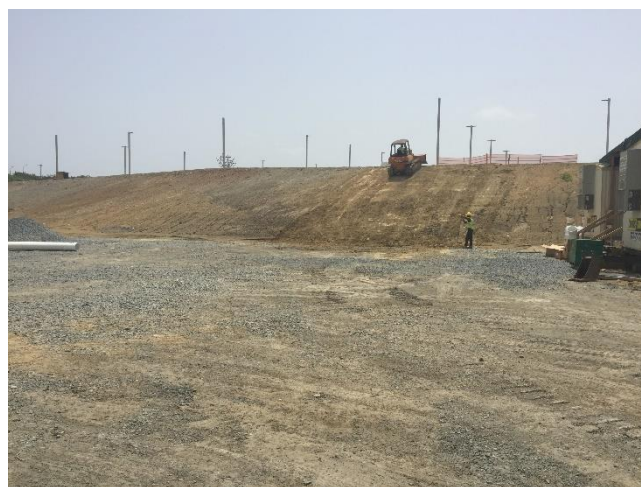
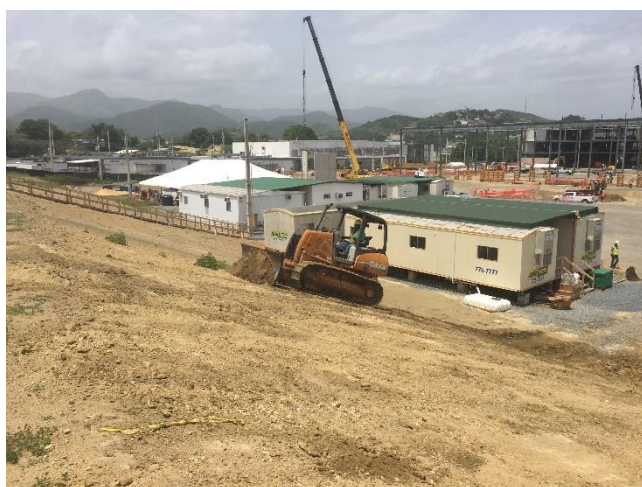
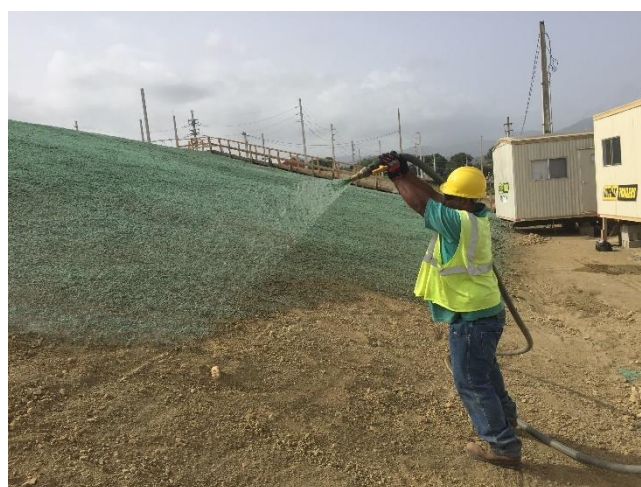
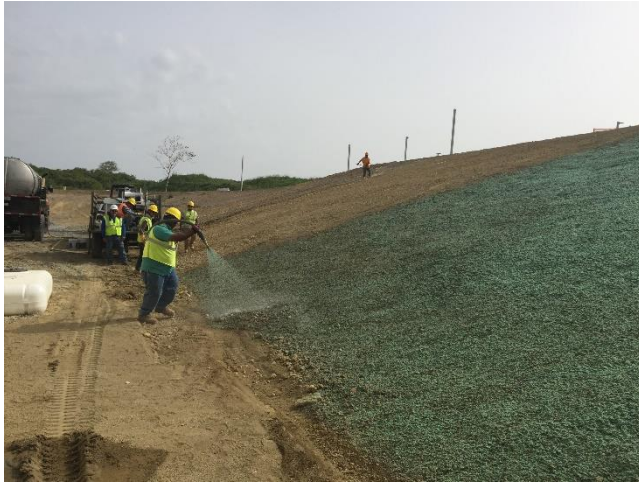
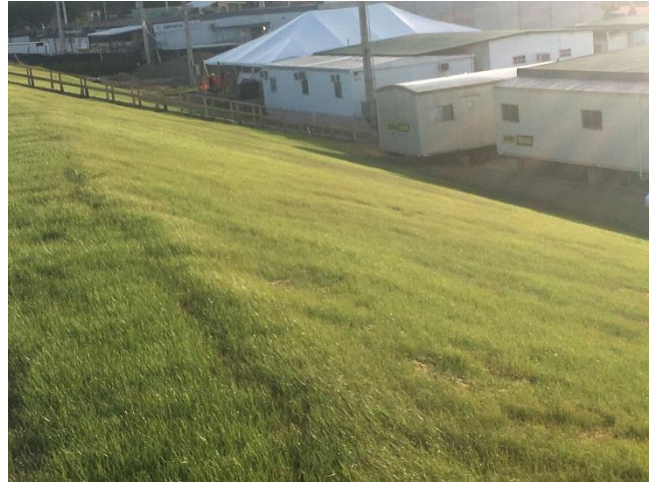
Figure 56. Images during Hydroseeding implementation of Sartorius Plant Expansion Project in Yauco Puerto Rico.

Protectores de Cuencas, Inc. (PDC) was contracted by the biotechnology company Sartorius Stedim to implement sediment and erosion control practices through Hydroseeding during construction in their new Plant Expansion (Figure 56). After construction is completed it is expected that PDC will provide services for Landscaping and long-term maintenance activities and operations.
