Guam's Manell-Geus Watershed

Current Projects, Successes, and Future Goals

Anna Simeon
Coral Reef Watershed Coordinator
Bureau of Statistics and Plans

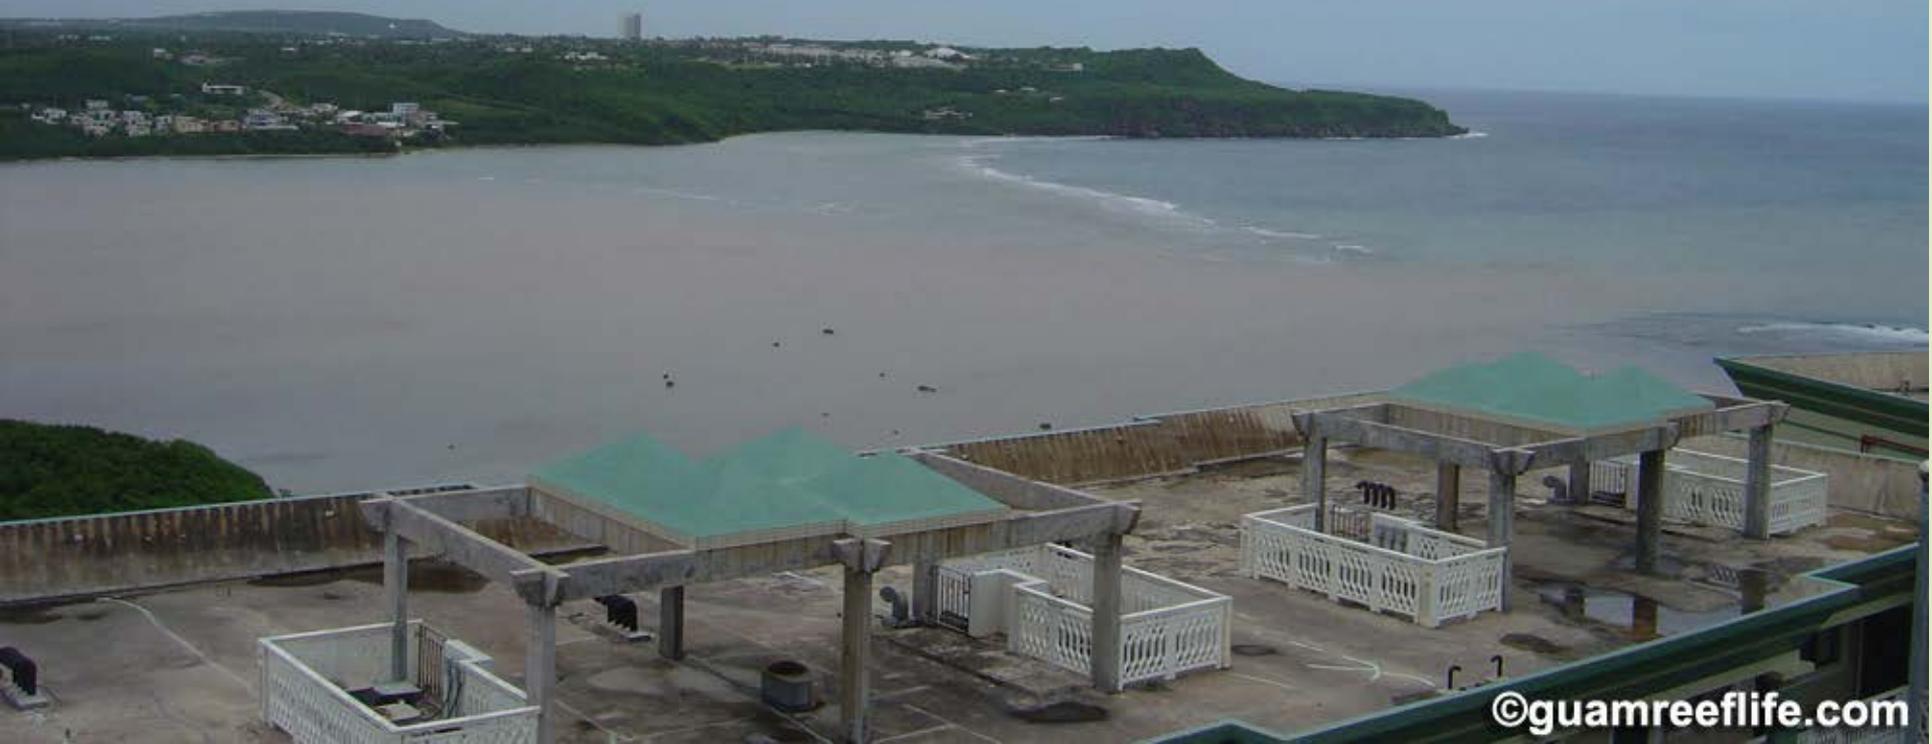
► Loose soil ends up on the reef

- Sediment smothers adult corals and inhibits recruitment and survival of juveniles
- Sedimentation may discourage herbivory

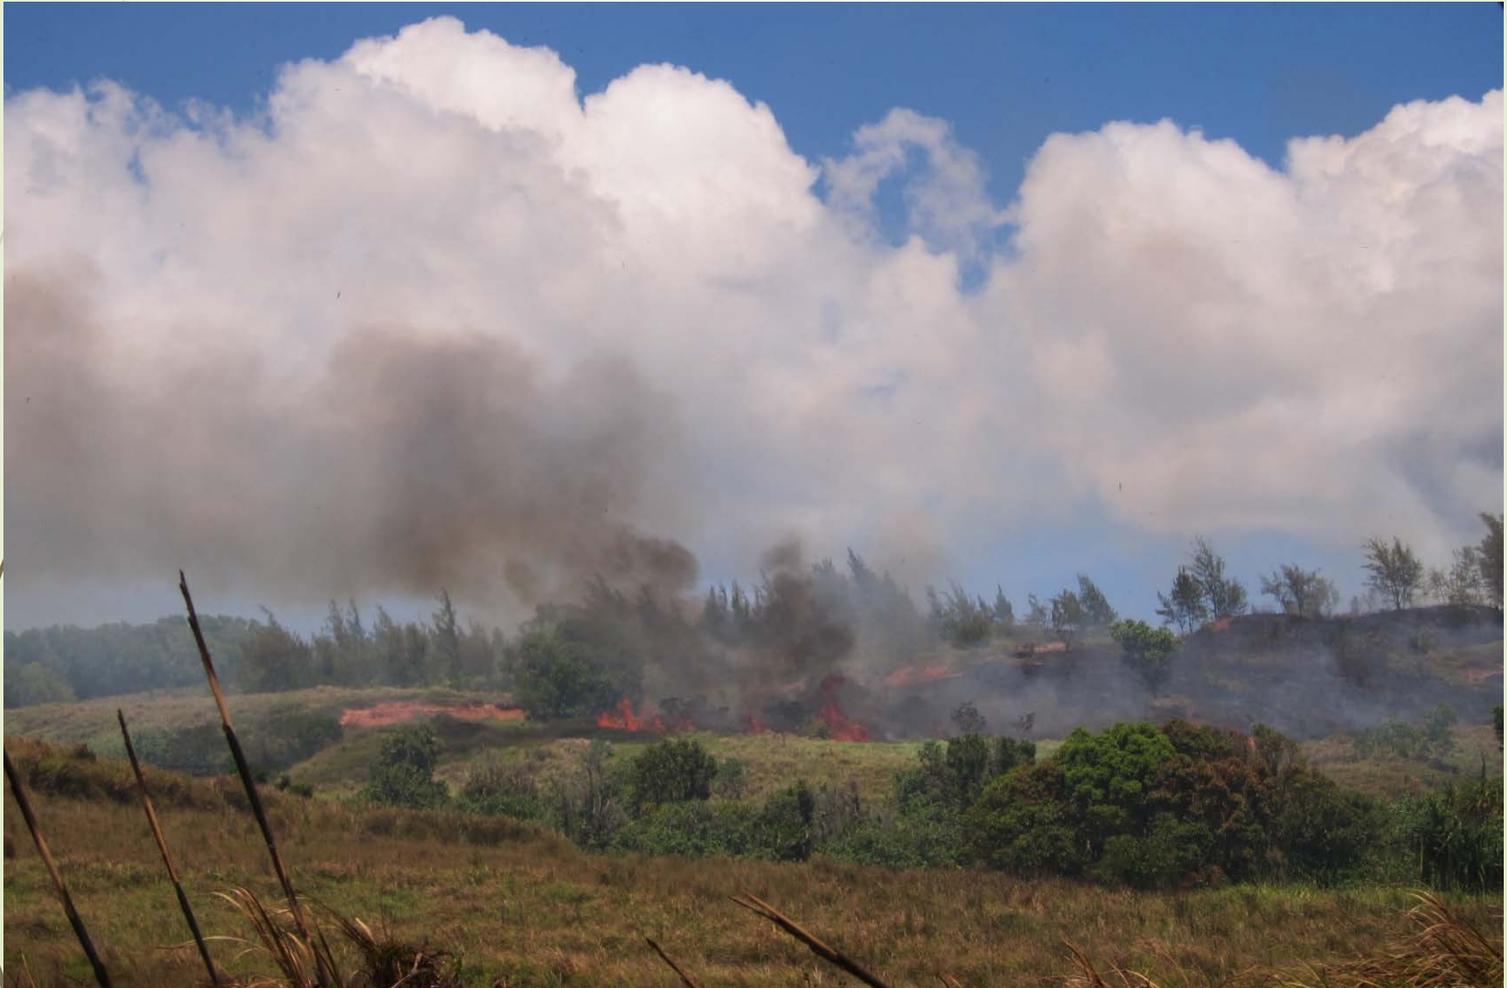
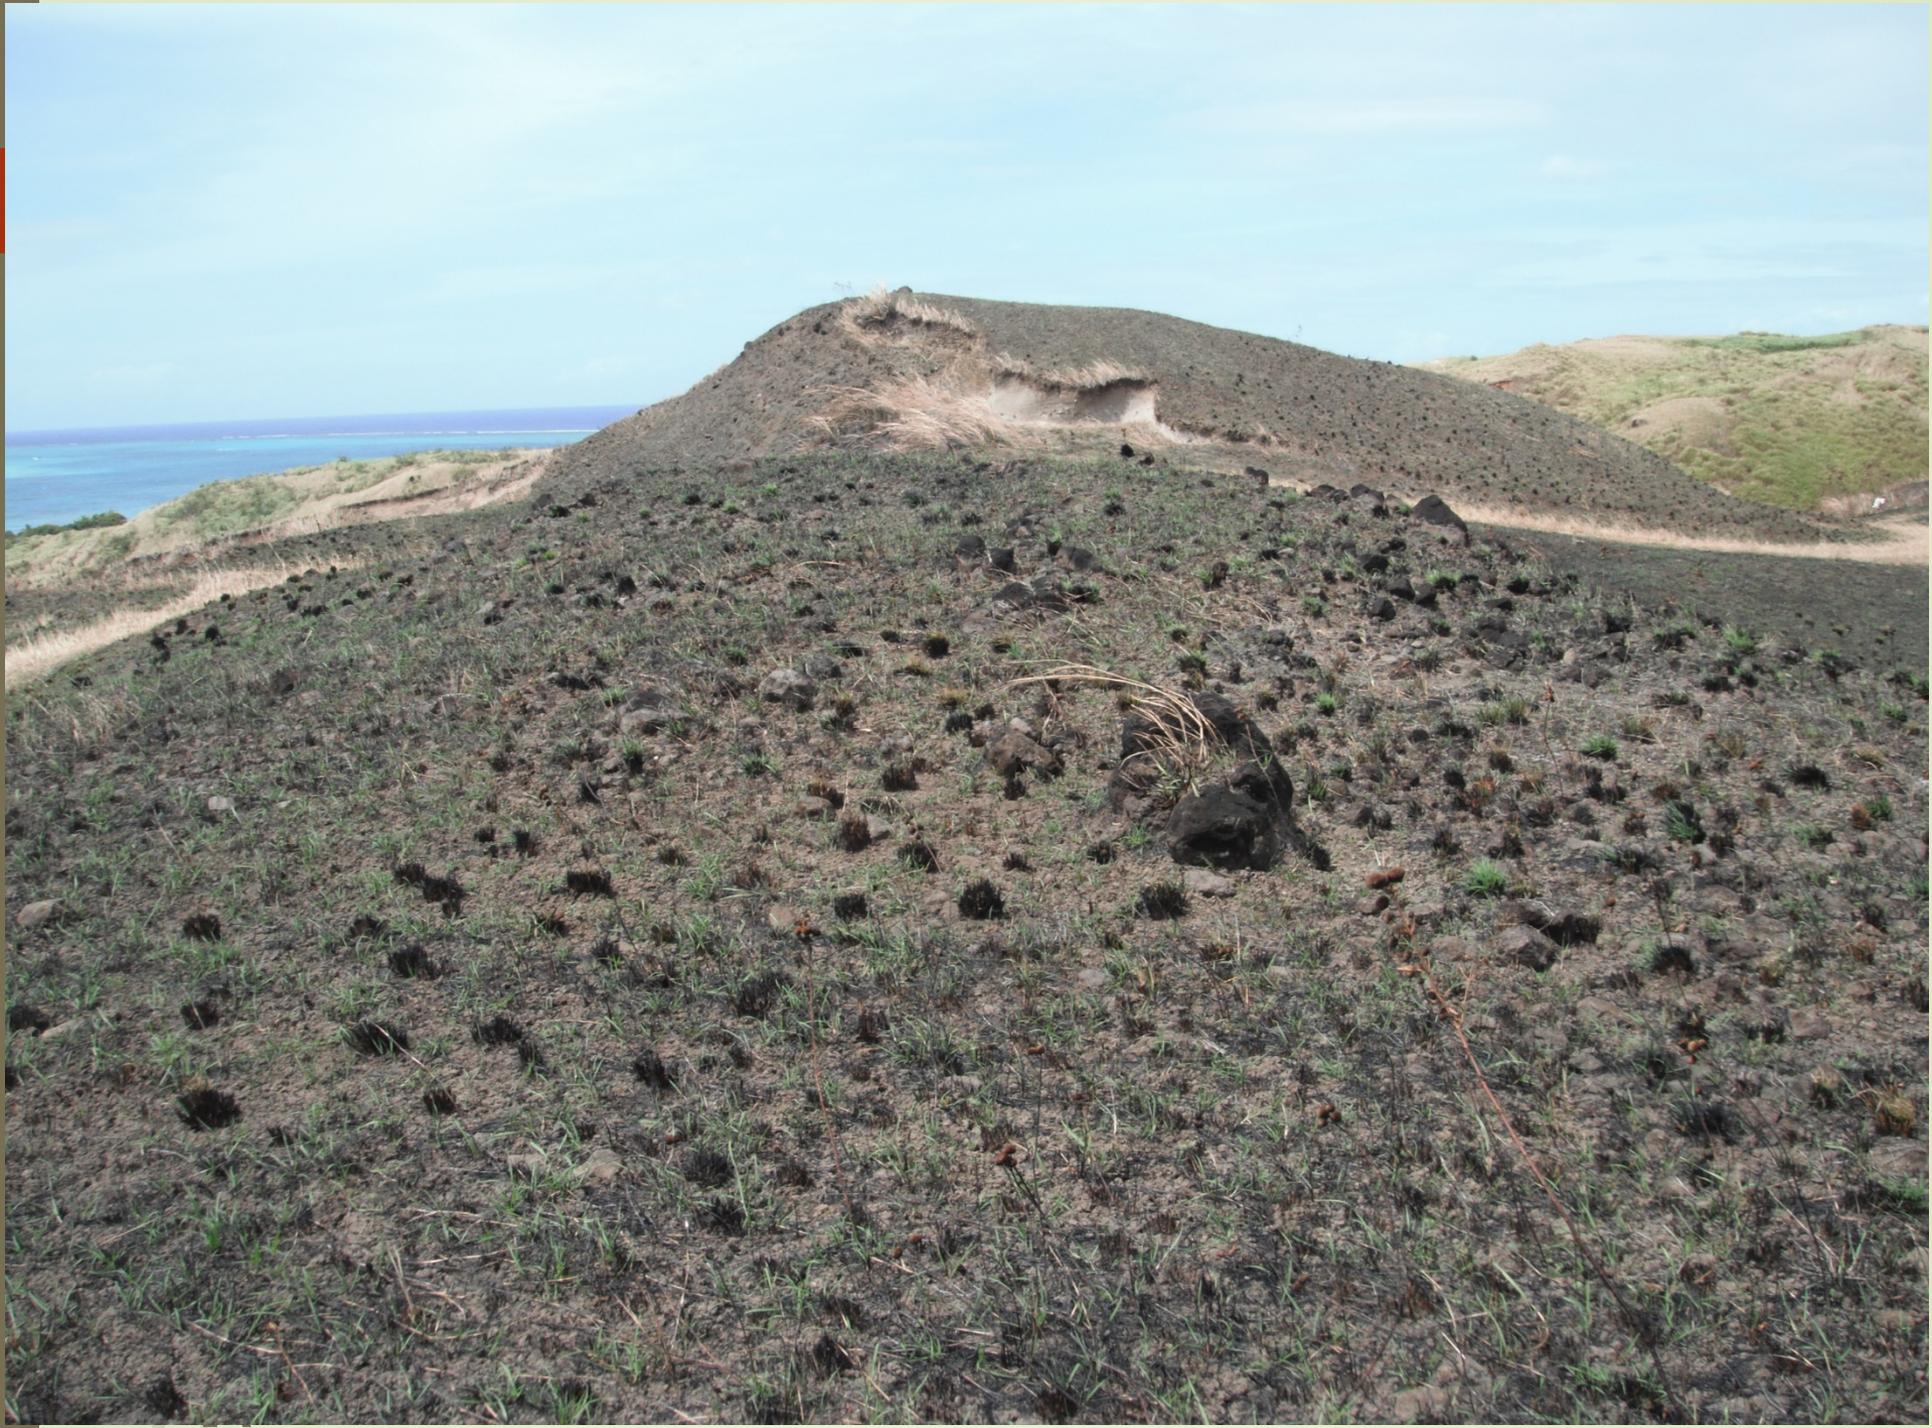
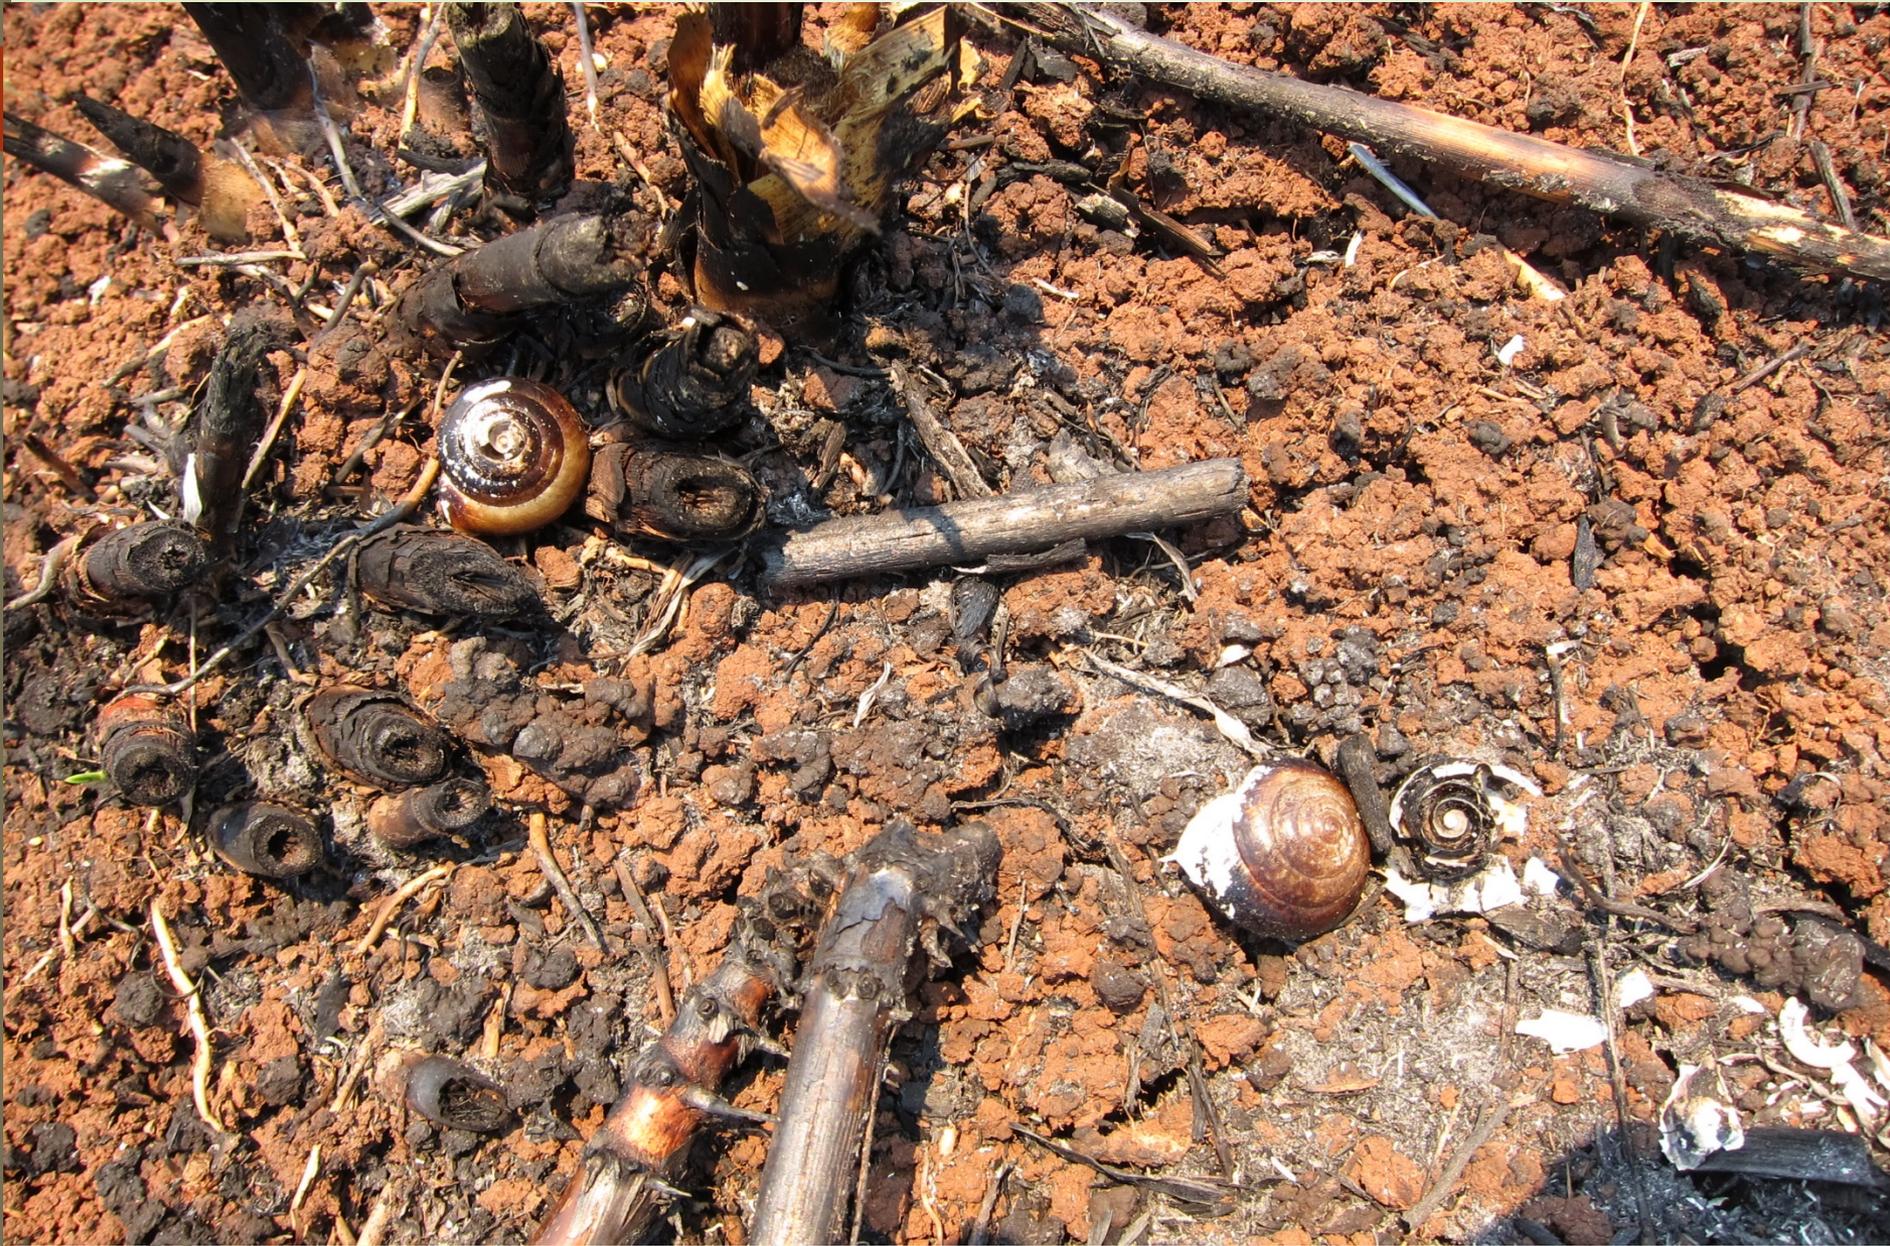
Sediment Source #1: Burning and Bare Ground

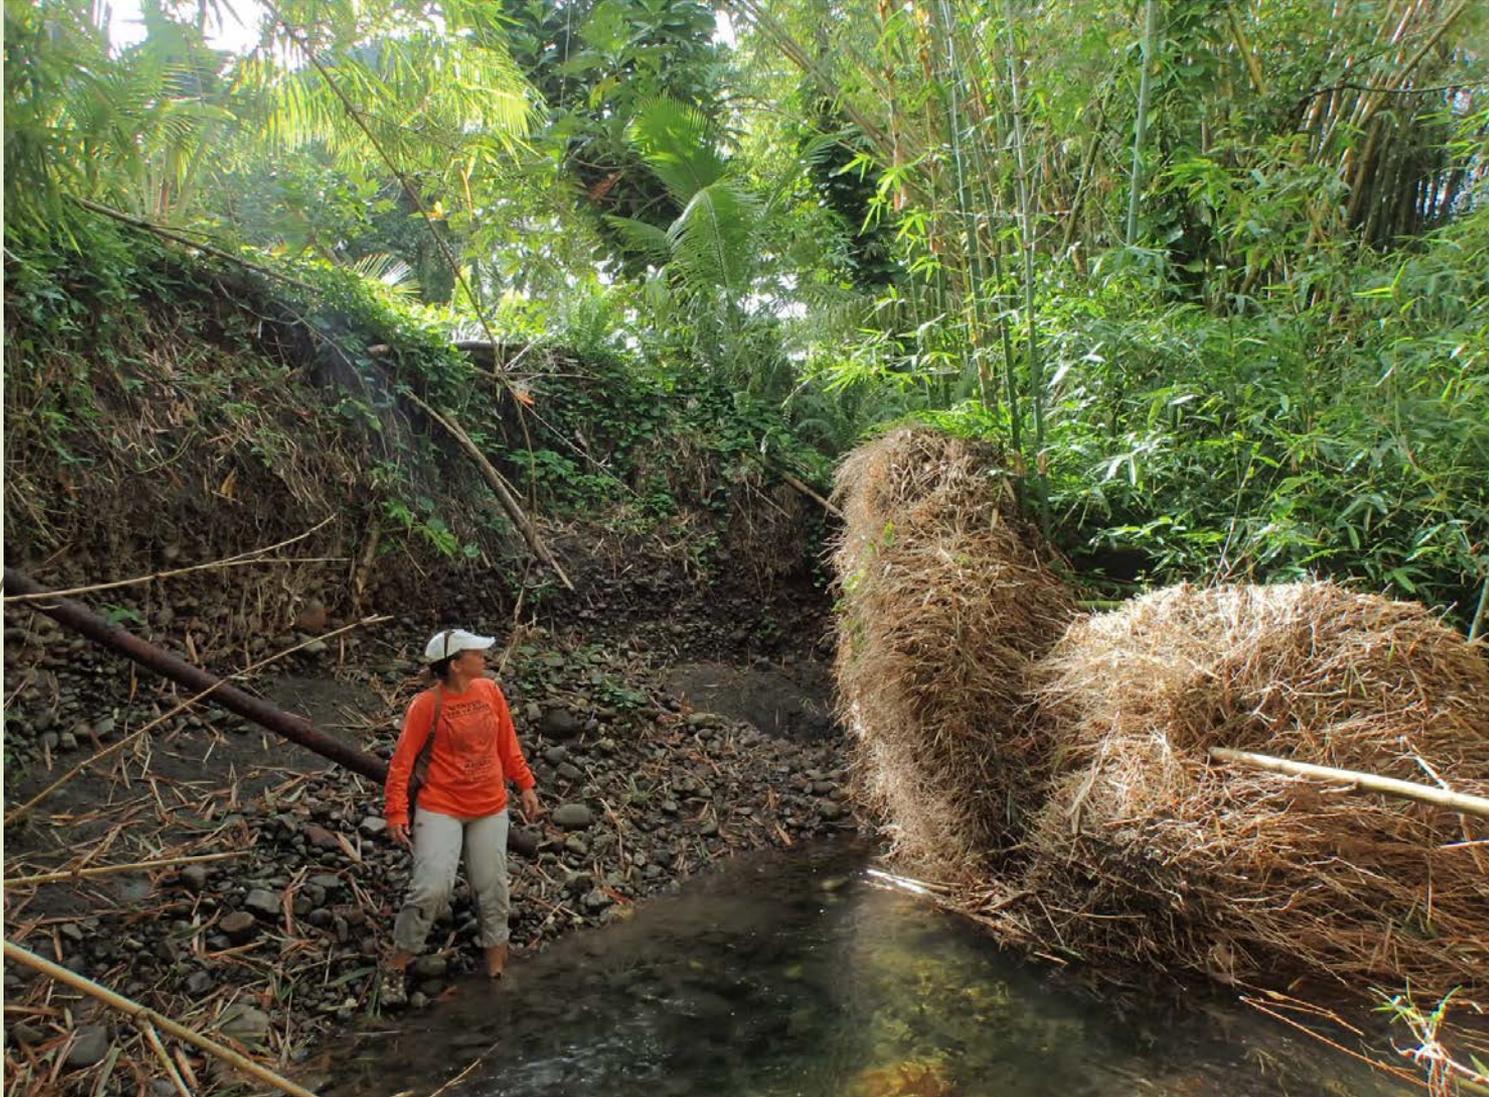
Sediment Source #2: Streambank Erosion

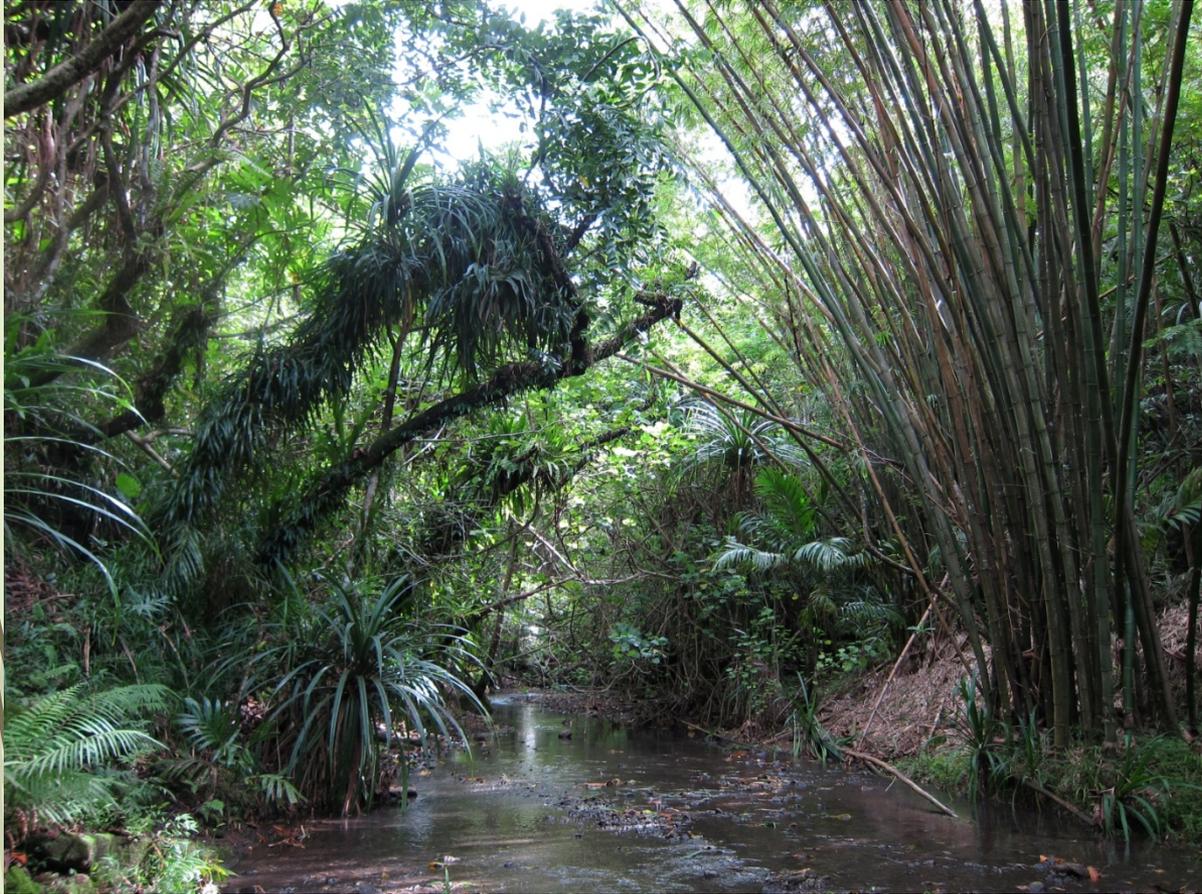
Bamboo harms our forests and reefs

- ▶ Canopy and excessive leaf litter block sunlight
- ▶ Native and soil-stabilizing plants are shaded out
- ▶ No root systems to hold ground in place
- ▶ Fallen stands force river to erode bank

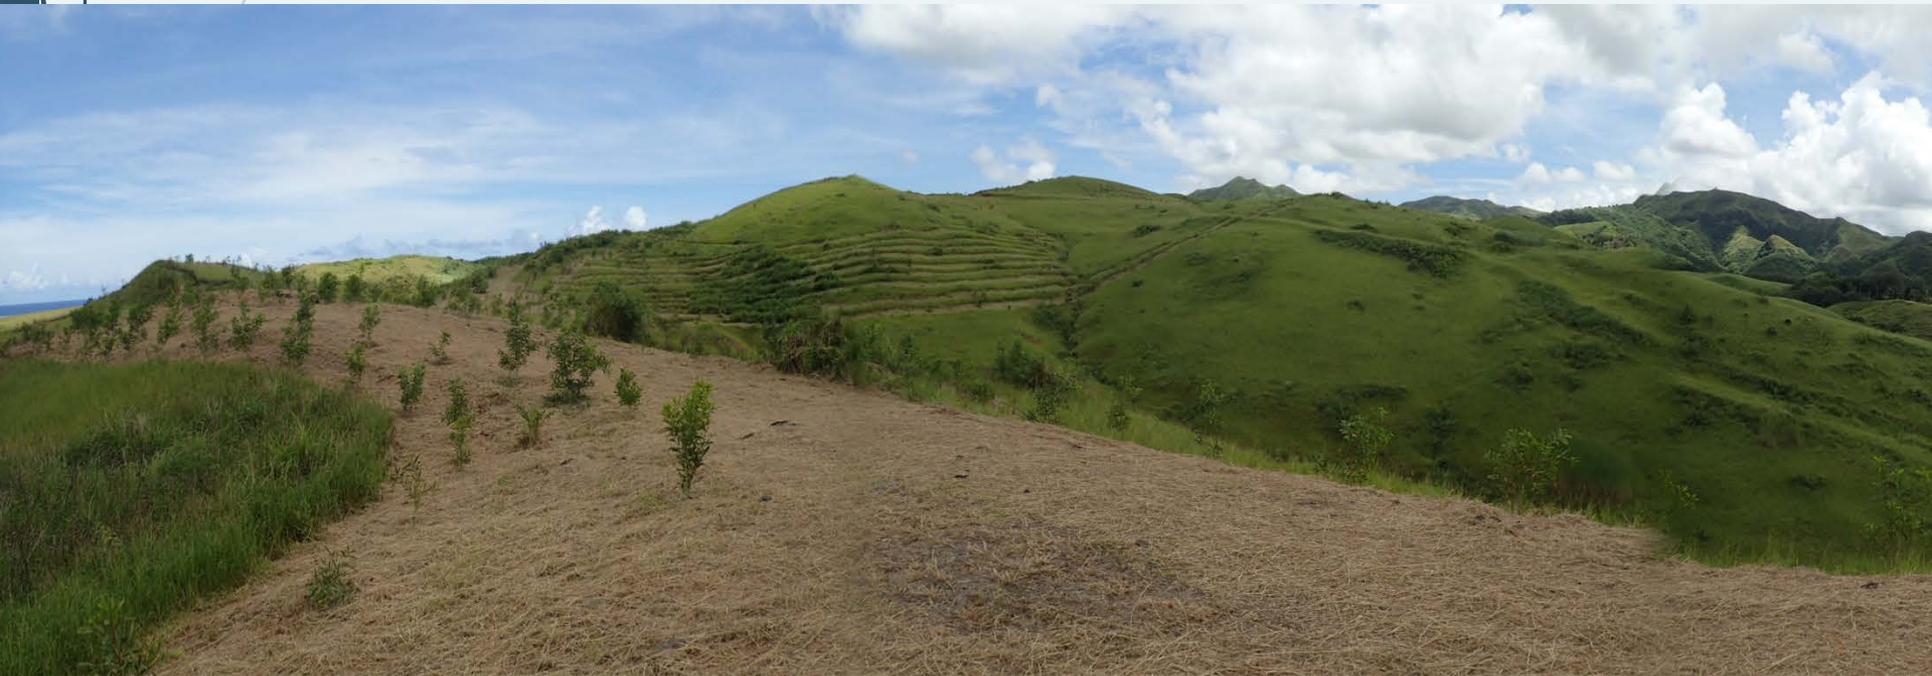
Sediment Solution #1: Plant Trees

- ▶ August 2015: Department of Forestry initially planted over 2000 *Acacia* trees

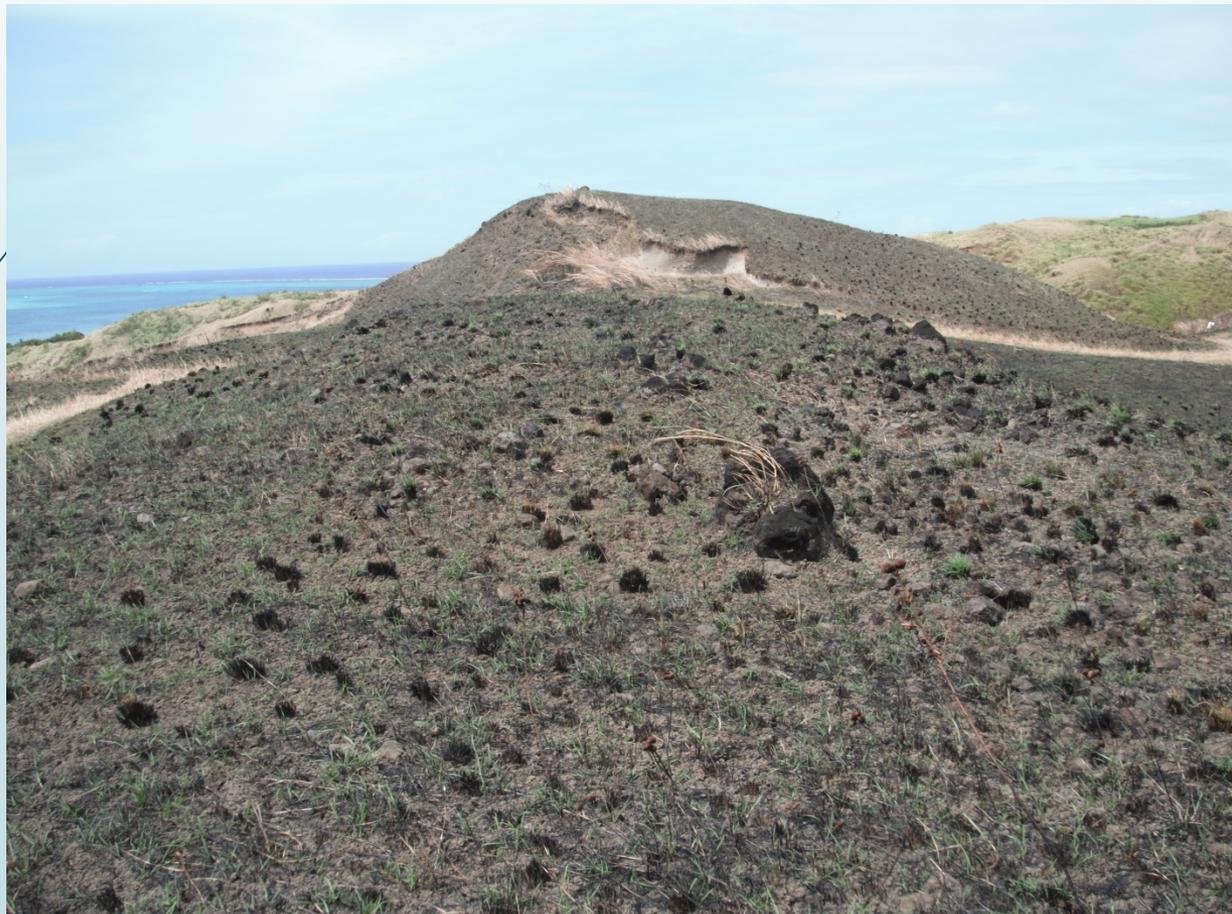
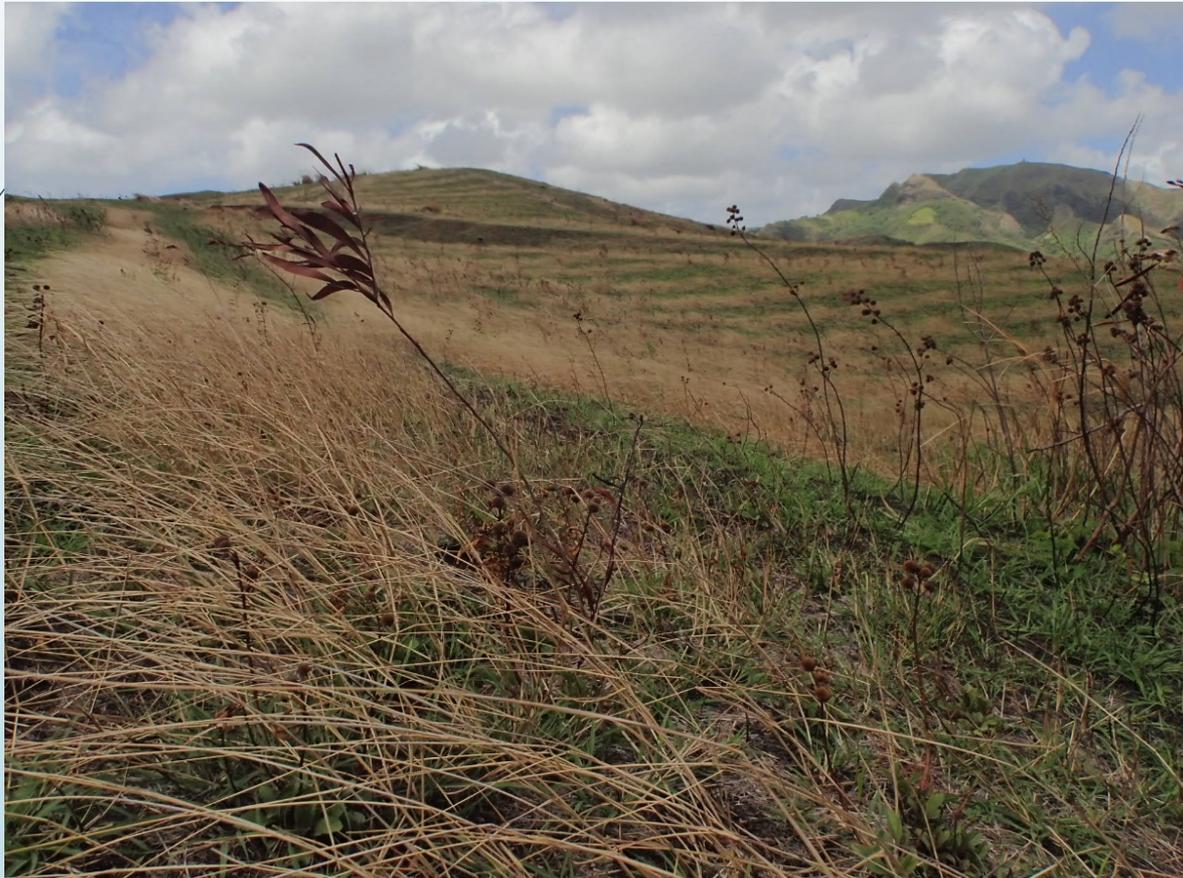
- ▶ February 2016, fire burned 90 acres over 5.5 hours

- ▶ February 2016, fire burned 90 acres over 5.5 hours
- ▶ Around 40-50% of seedlings ultimately died

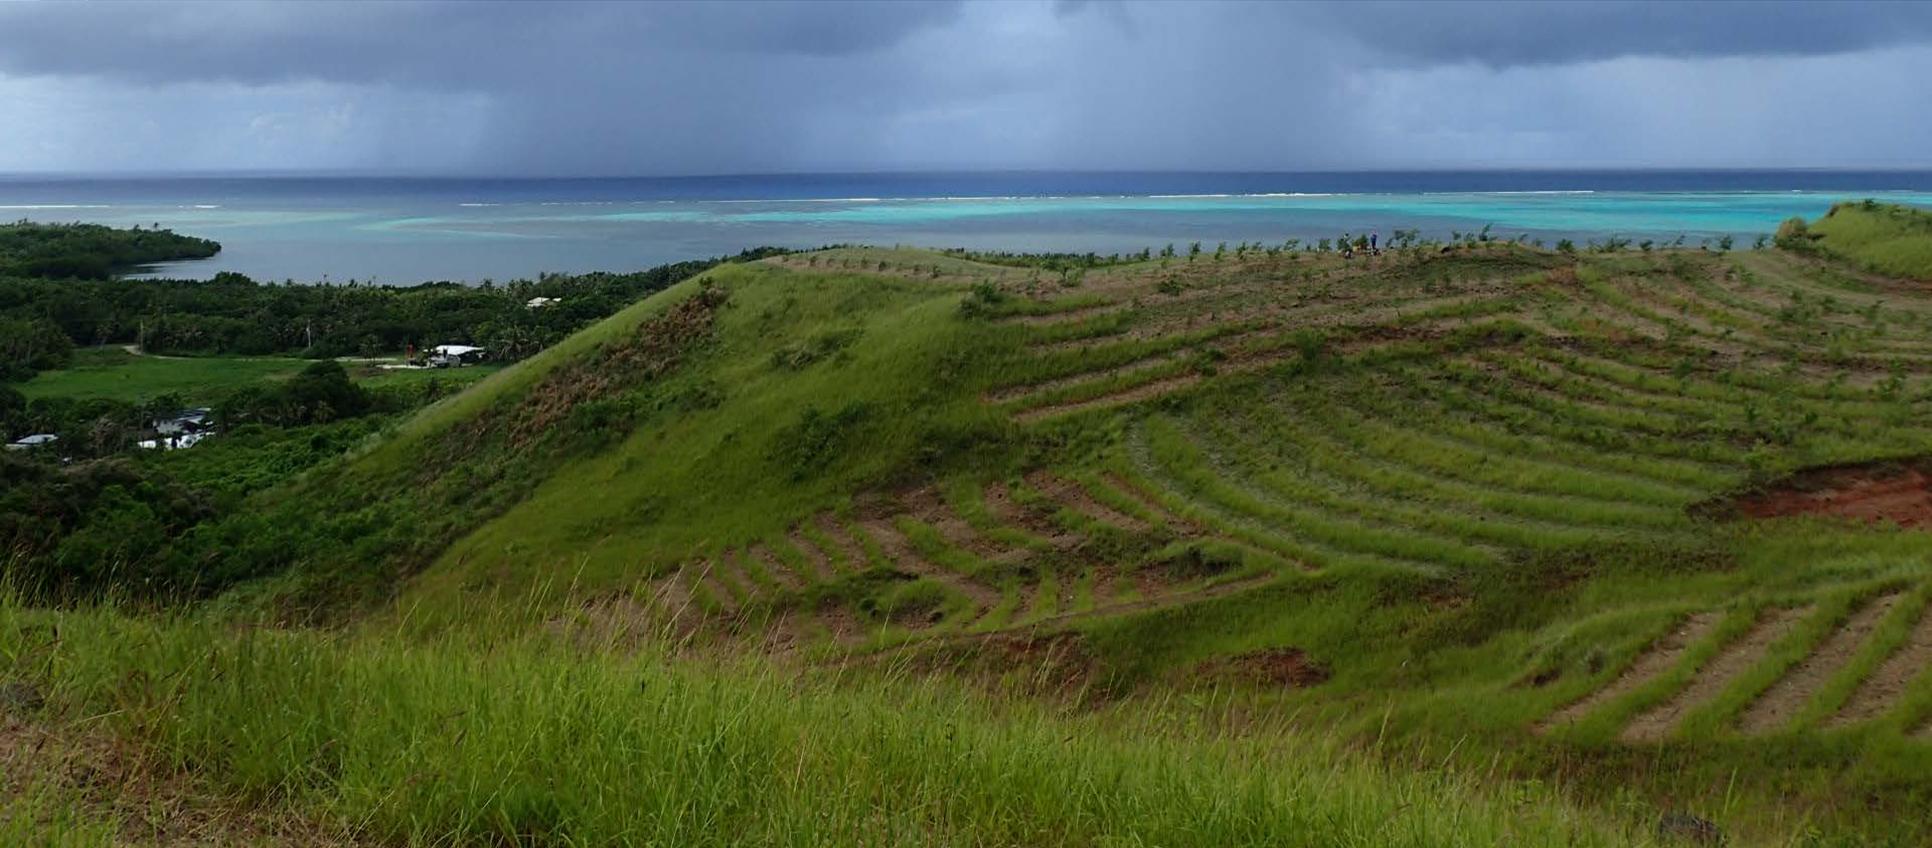
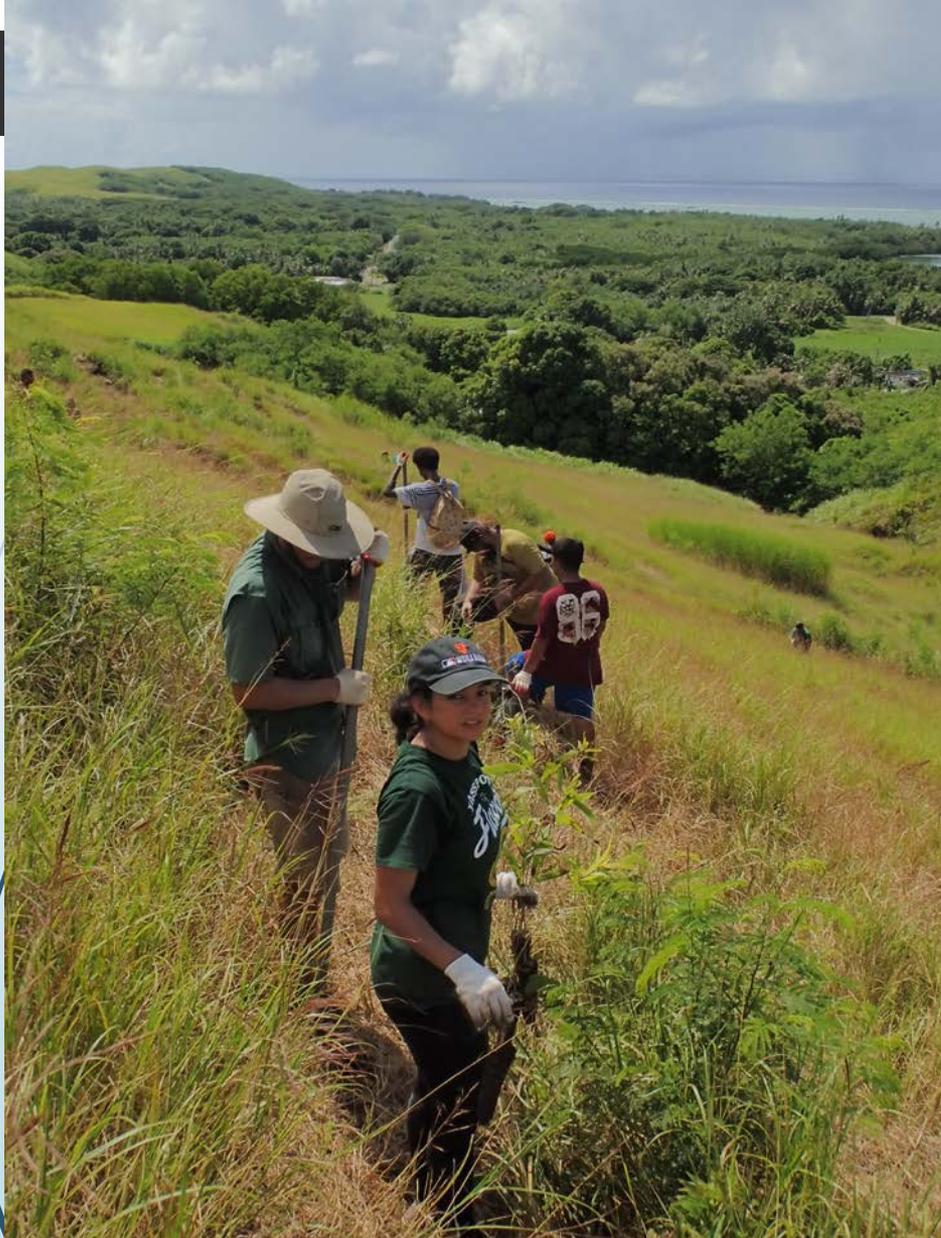
- ▶ August and September 2016 – another 2000 trees planted, footprint expanded

- ▶ Re-planting effort required 780 hours of staff time and 500 volunteer hours
- ▶ To date, entire project has required over 2000 hours of staff time
- ▶ Fire break maintenance absolutely necessary to protect investment!

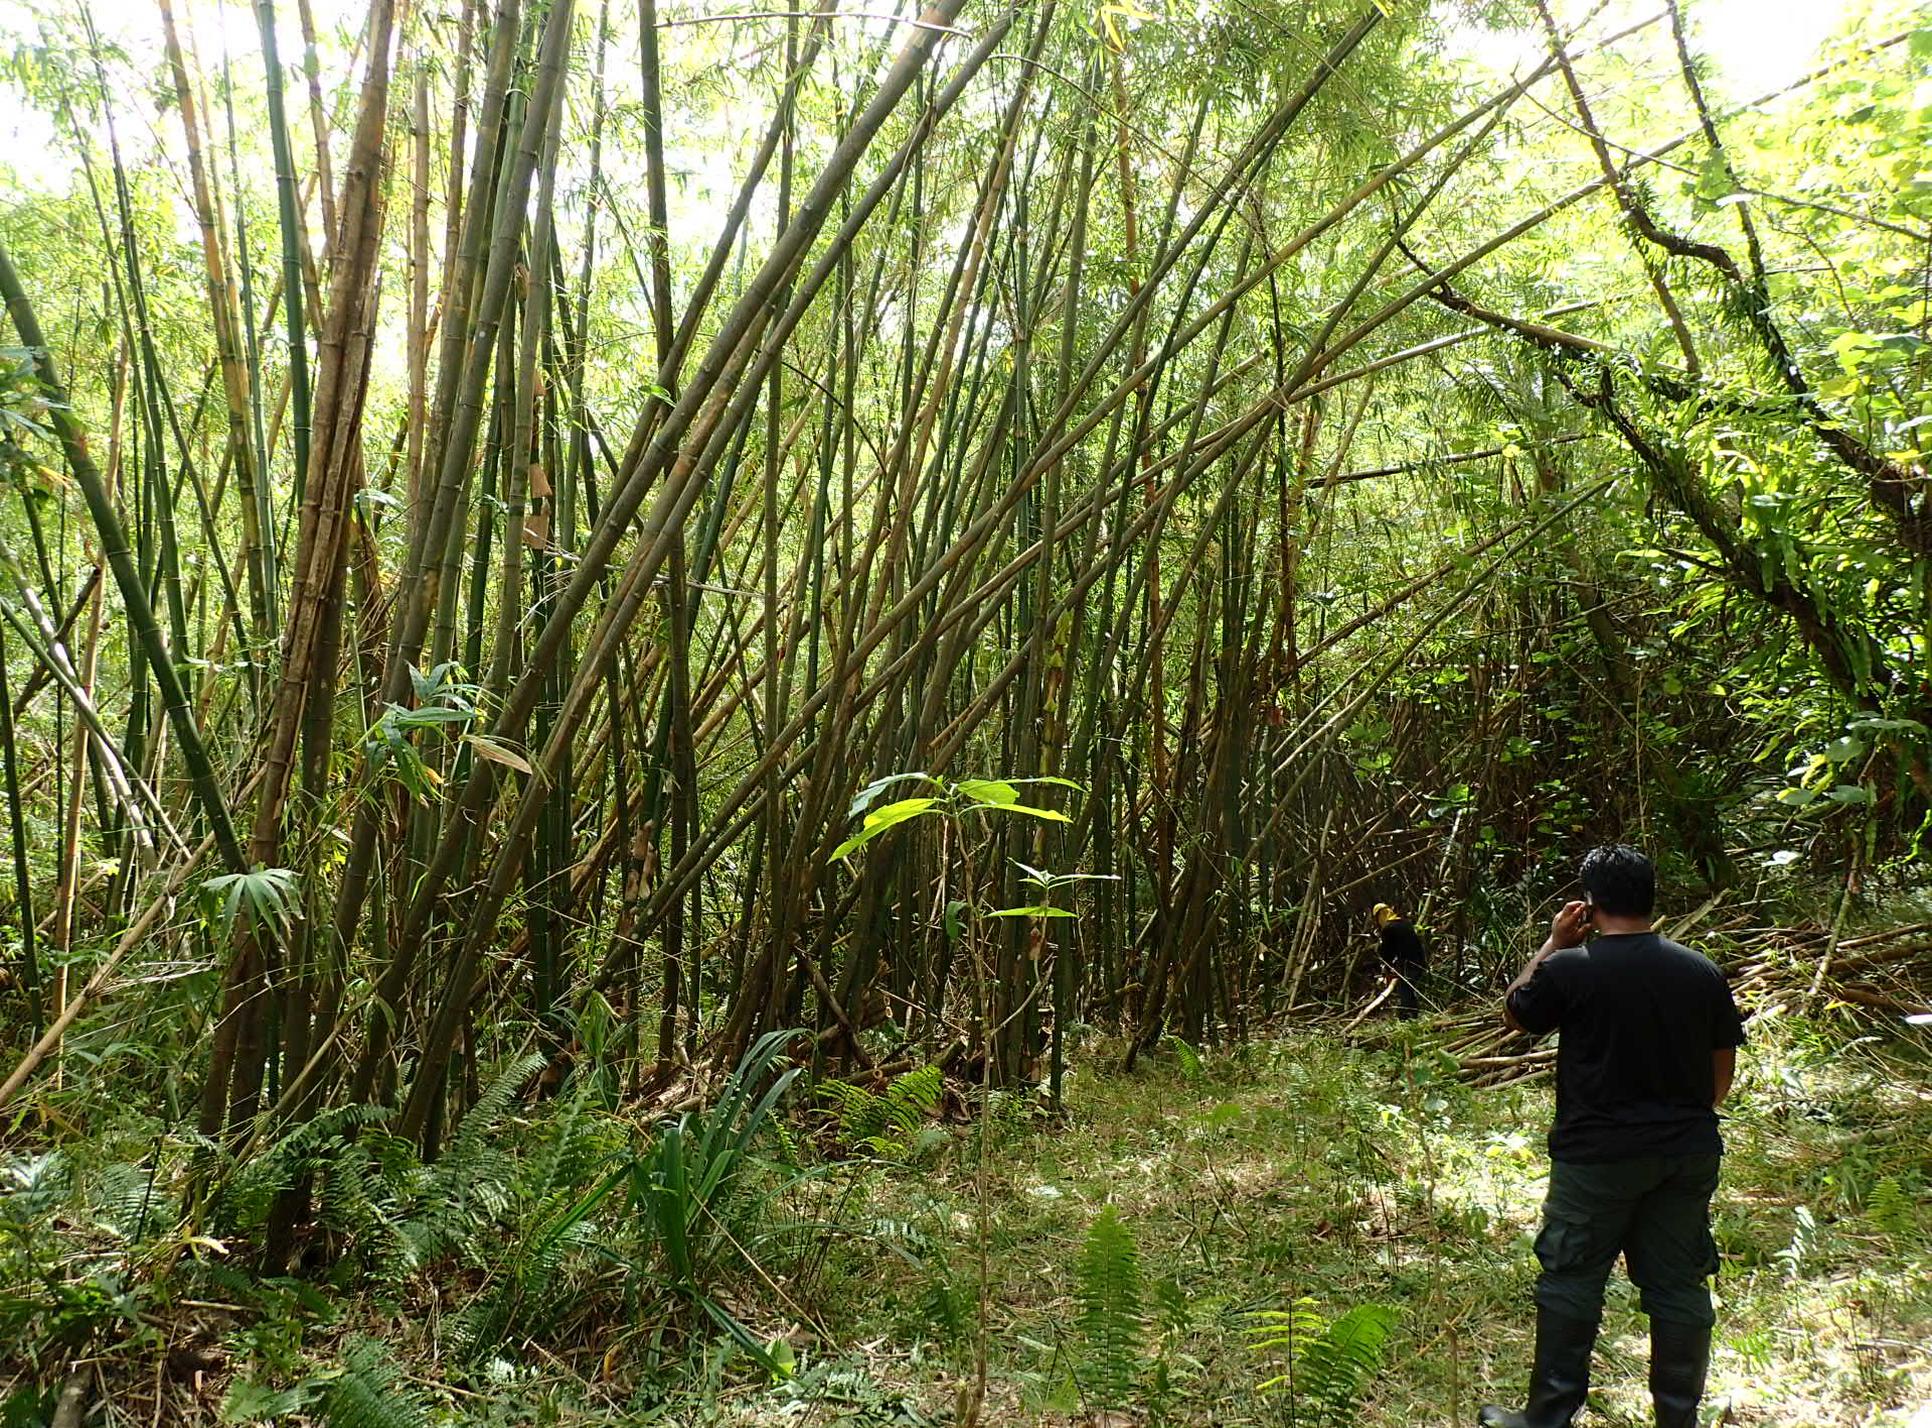
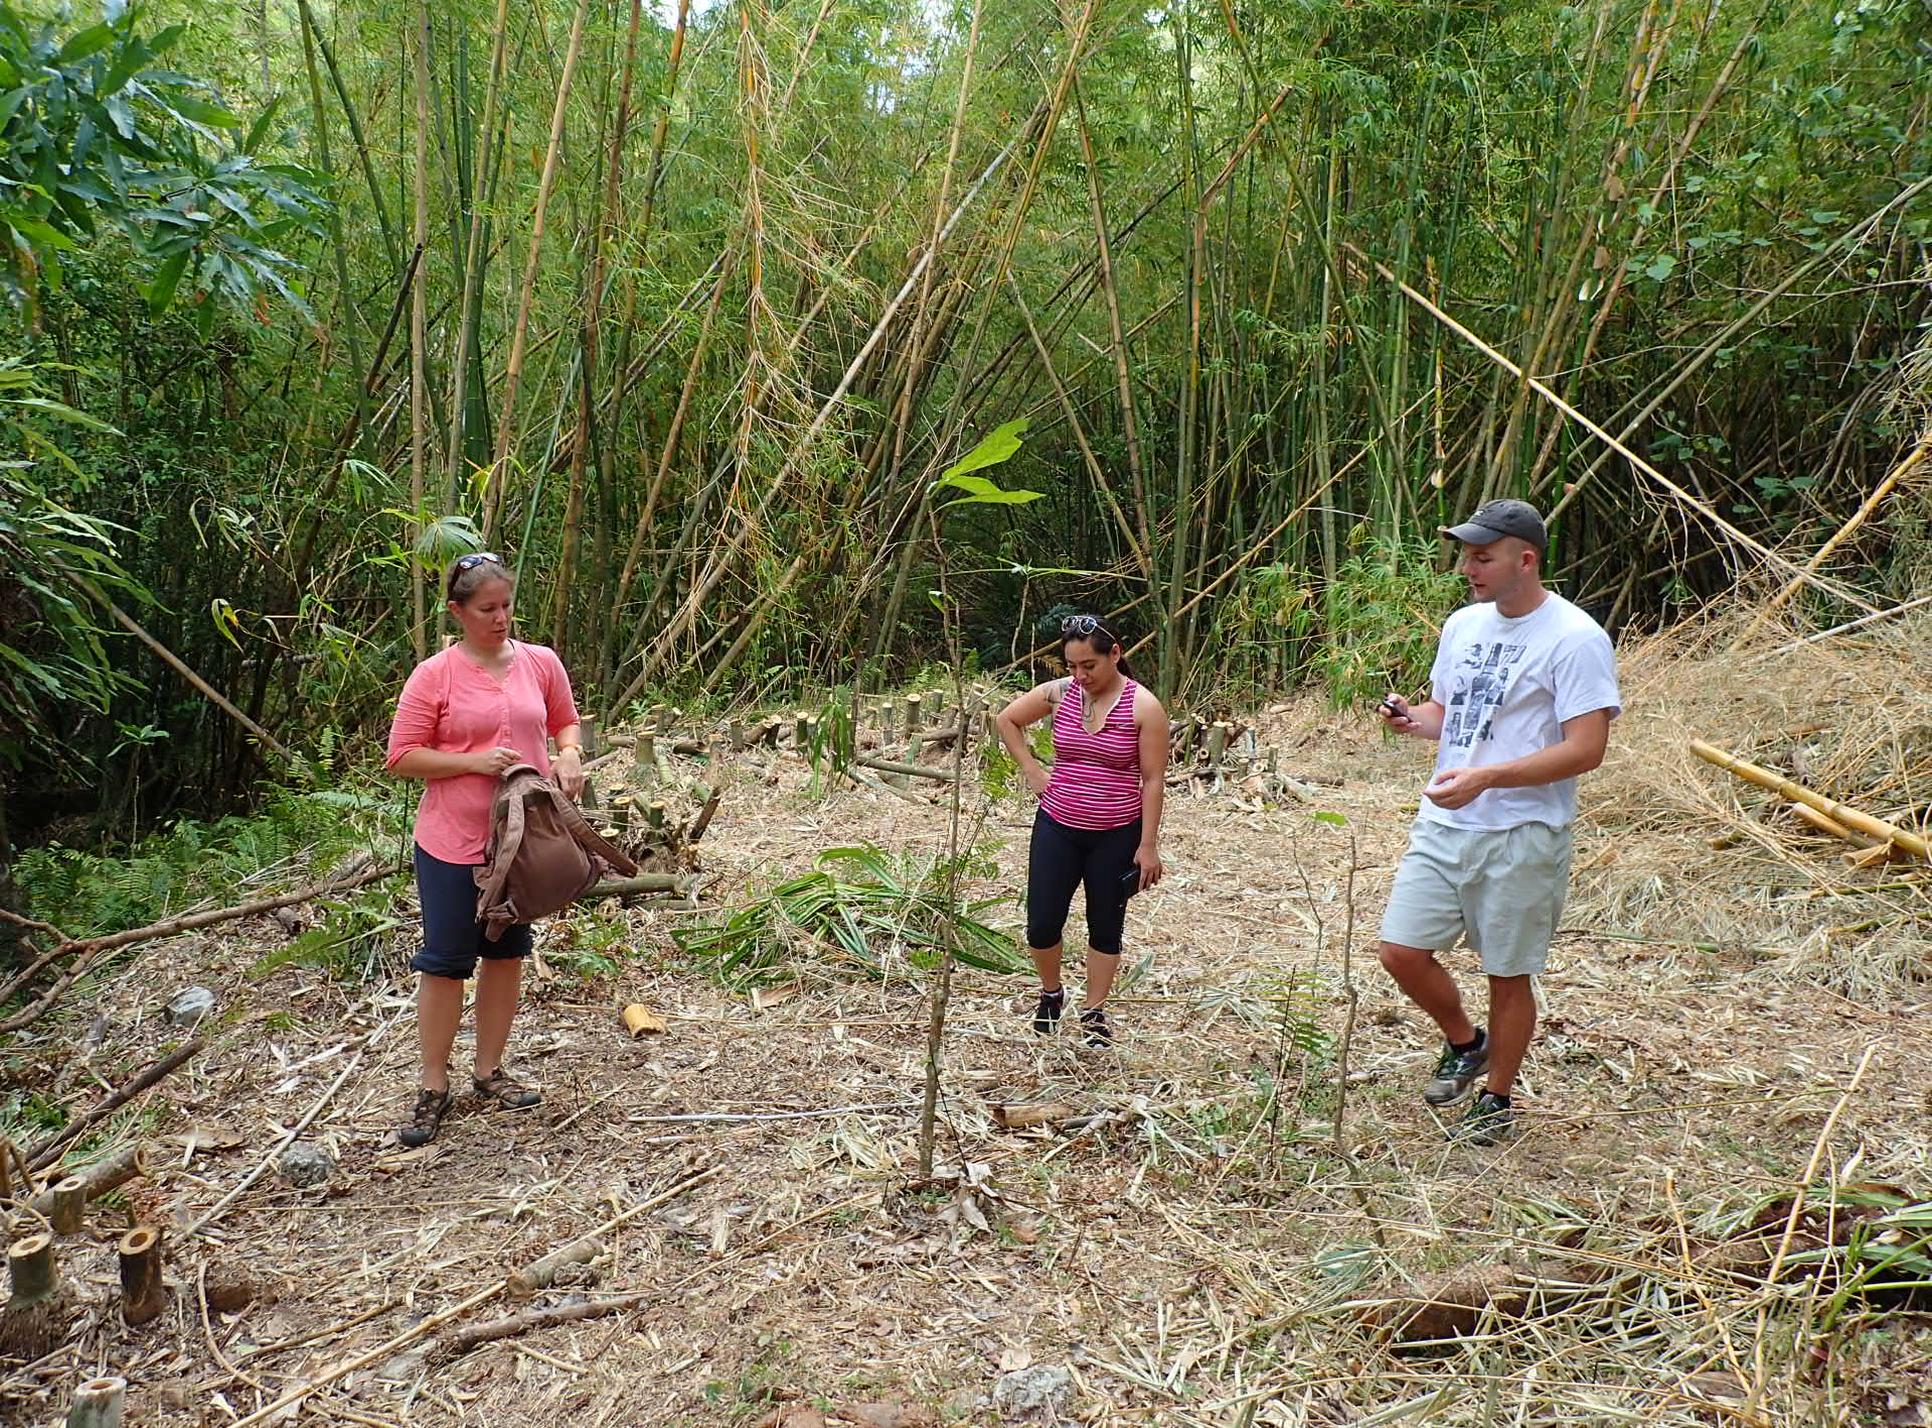
- ▶ Identify method, cost, and labor required to effectively and safely remove stands
- ▶ Determine timeline for bamboo shoot regrowth and stand death with and without herbicide use
- ▶ Reach out to partners – how to get people to use bamboo?

- ▶ Small (16") chainsaws work great
- ▶ 3-4 people and two chainsaws can clear out ~120 Stalks in ~10 hours
- ▶ ~2 oz. herbicide (glyphosate) into each stalk and on top of fresh cut (about ¼ cup)

- ▶ Small growth seen as early as 3-4 weeks after cutting
- ▶ After 5 months of repeated herbicide application on new shoots, stands are completely dead
- ▶ Diluted herbicide less effective
