Guam's Manell-Geus Watershed

Current Projects, Successes, and Future Goals

Anna Simeon
Coral Reef Watershed Coordinator
Bureau of Statistics and Plans

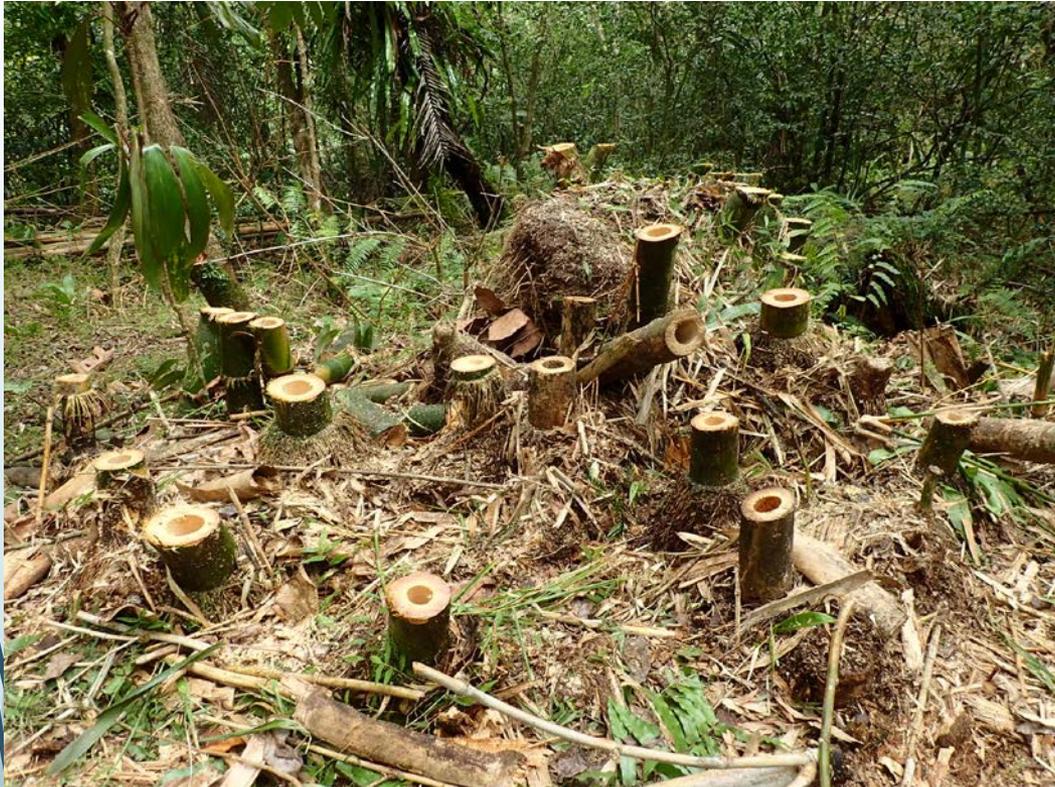
- ▶ Small (16") chainsaws work great
- ▶ 3-4 people and two chainsaws can clear out ~120 Stalks in ~10 hours
- ▶ ~2 oz. herbicide (glyphosate) into each stalk and on top of fresh cut (about ¼ cup)

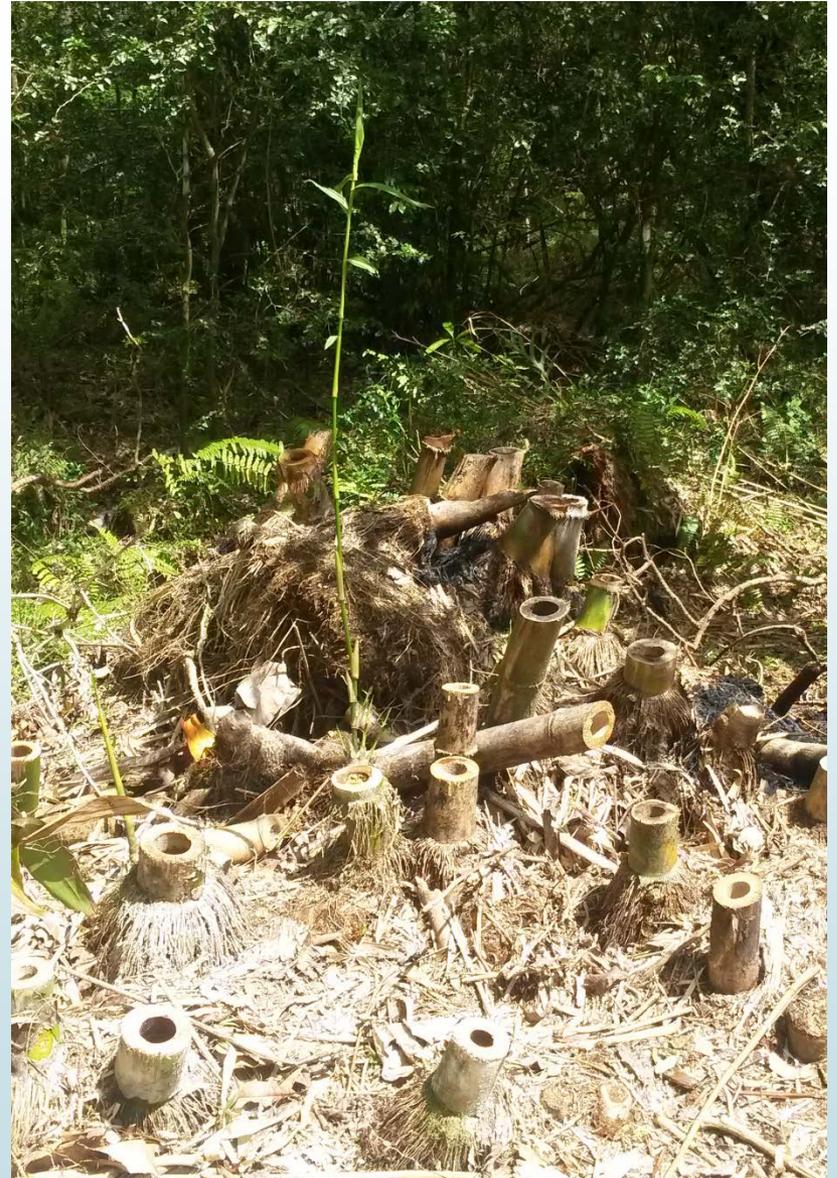
- ▶ Small growth seen as early as 3-4 weeks after cutting
- ▶ After 5 months of repeated herbicide application on new shoots, stands are completely dead
- ▶ Diluted herbicide less effective
