*Removal of Structures Creating Riverbank Erosion in Rio Loco in
Guanica, PR*

Project Implementation and Feasibility Report

**Feasibility and Cost Analysis for the Removal of Structures
Creating Riverbank Erosion in Rio Loco in Guanica, PR**

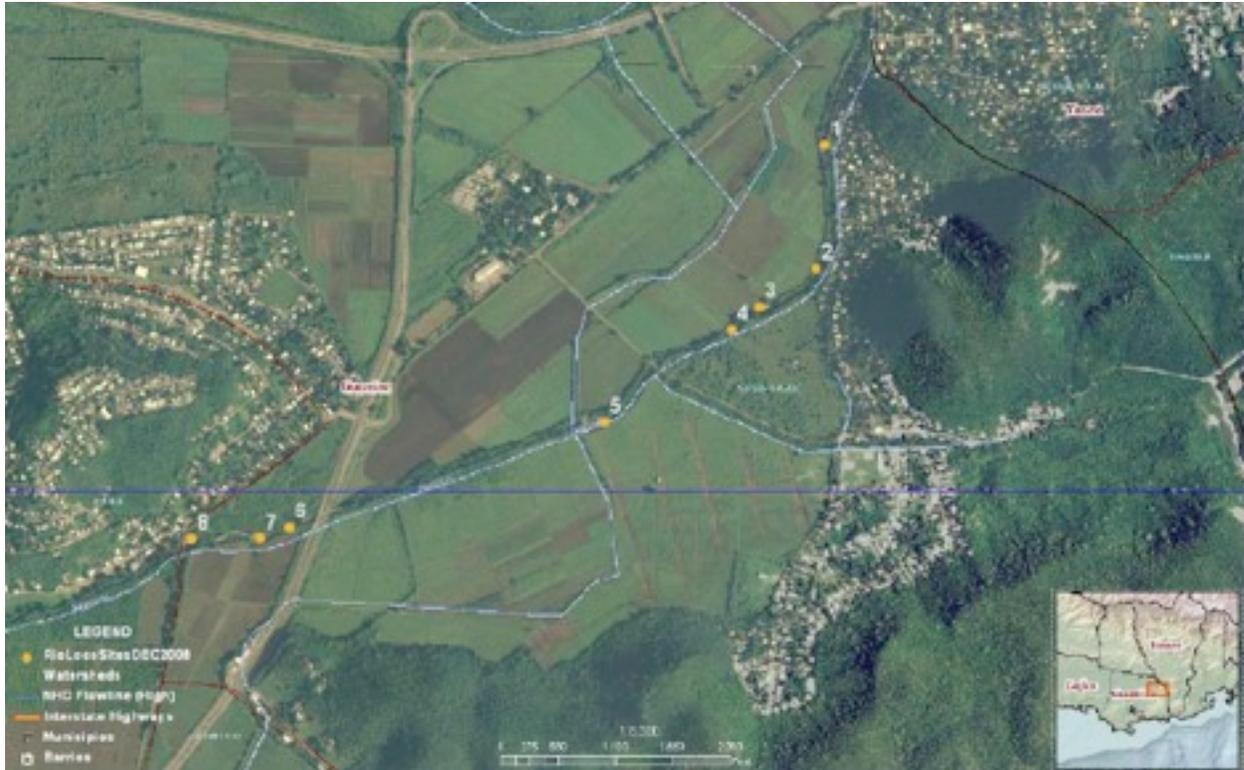
Figure 1. Shows the primary locations of severe erosion in the Rio Loco as is summarized in our field technical memo (Sites 5 and 6 are the two locations where instream structures are still contributing to river channel erosion)

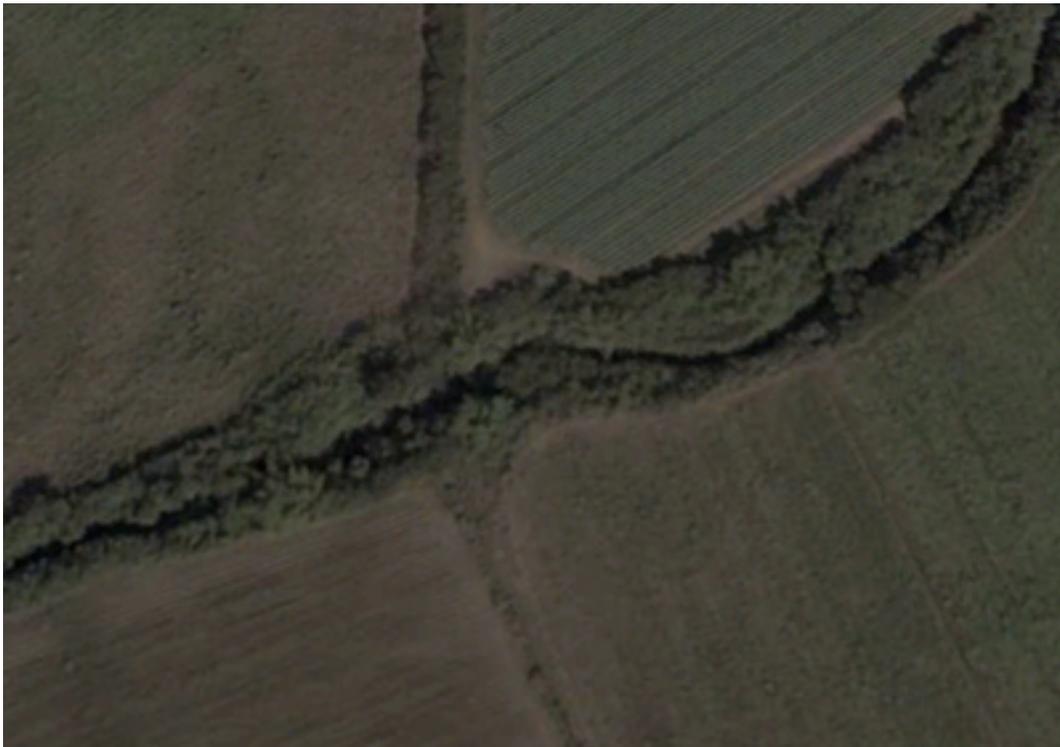
Figure 2. Condition of the channel in 2001 (Source: Google Earth) (relatively stable configuration prior to the collapse of the pipeline/structures)

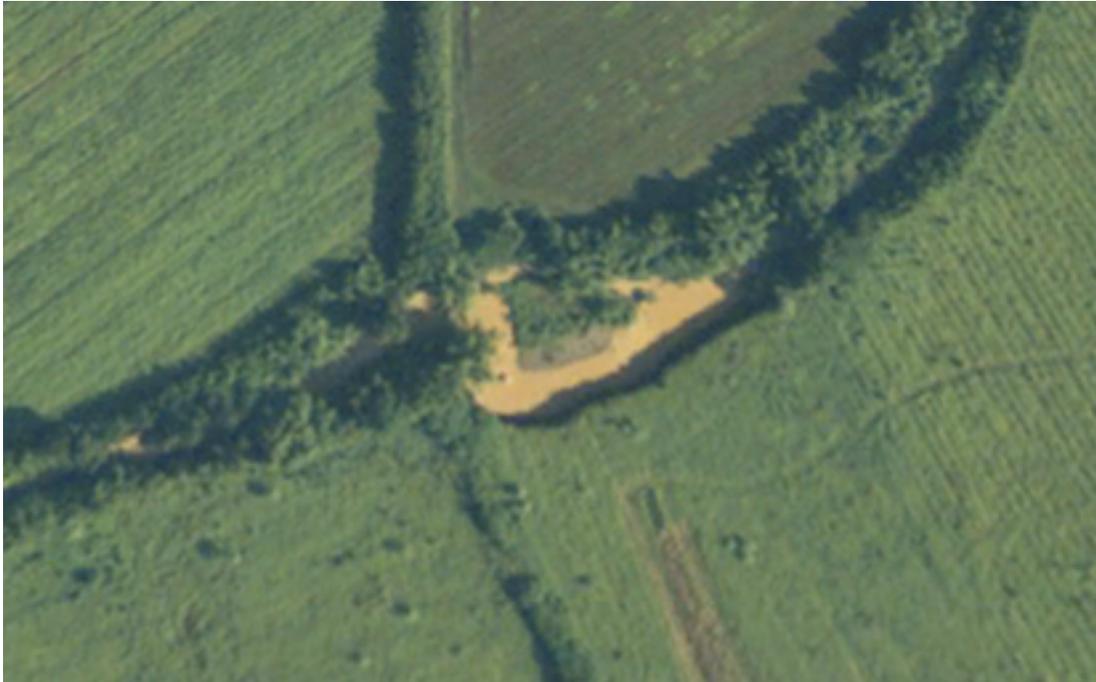
Figure 3. Between 2001 and 2004 an event must have occurred where debris accumulated and partially blocked the channel creating this new condition and resulting in tons of sediment lost to Guanica Bay (Google earth)

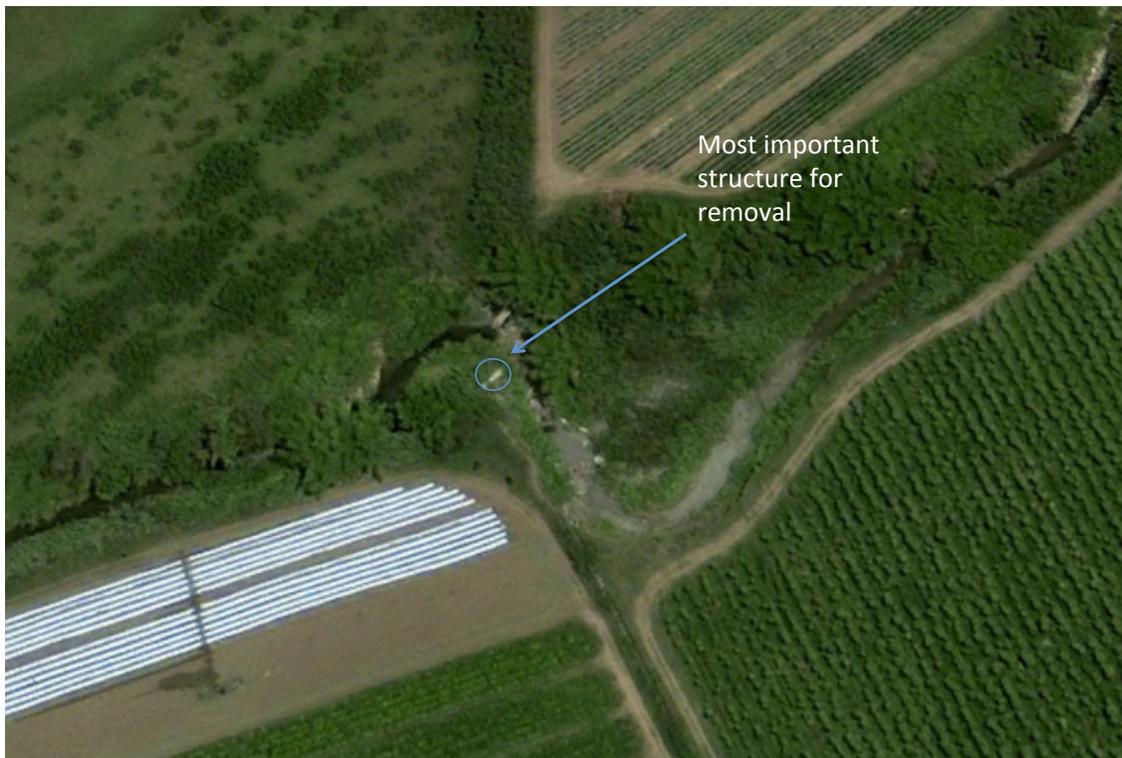
Site 5 is the largest site with the most amount of old infrastructure that is deposited in the channel. Due to the existing channel configuration and remaining structures it is where debris from upstream often gets deposited. It is located on the Santa Rita Farm and is composed of a series of three large concrete structures holding a irrigation pipeline (no longer in use) that was constructed across the channel. In addition, this area which is now a sharp curve in the river due to the major debris blockage on the pillars which are located in the middle of the channel. The channel now has a 90 degree turn and has eroded significantly into an adjacent farmers crop field over the last 10-12 years. (note pictorial sequence below)

Figure 4. One of the key structures for removal and one that acts to impede downstream flow and create debris dams during large events (Figure 5 shows more detail)

- 3) In the absence of adequate funding: at a minimum before the Rio Loco river restoration project construction -- the most problematic structures should be removed / broken up in place. These include the critical structure at Site 5 Santa Rita Farm (shown in Figures 4 & 5) and at Site 6 the railroad bridge the standing structure in the middle of the channel and the one laying down in the channel should be removed, the 3rd existing structure should be removed as well if cost allows.

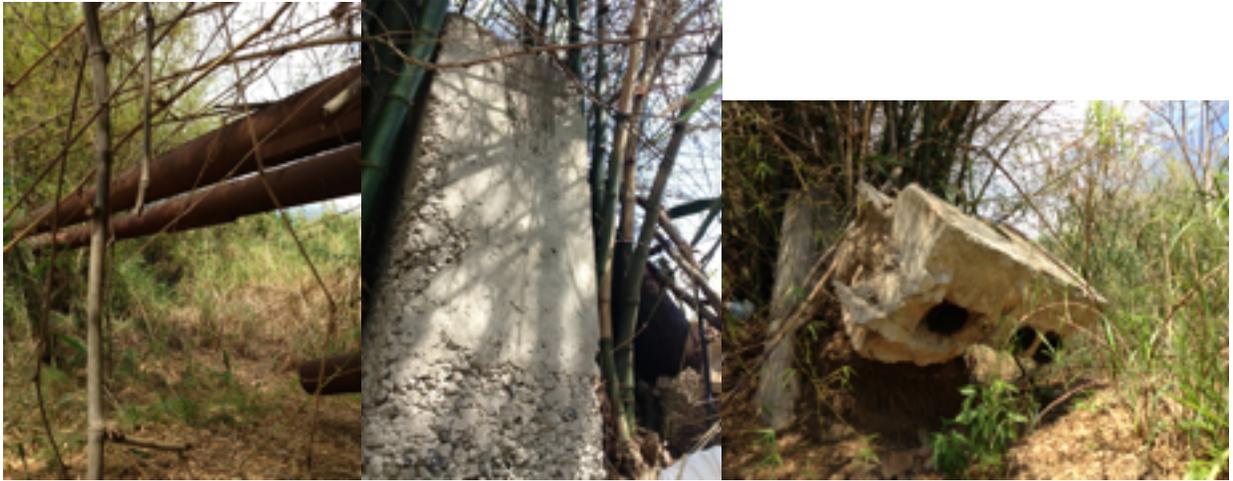
Figure 5. Shows the patchwork of structures that makes up the key structure for removal and the structures most responsible for debris dams and erosion

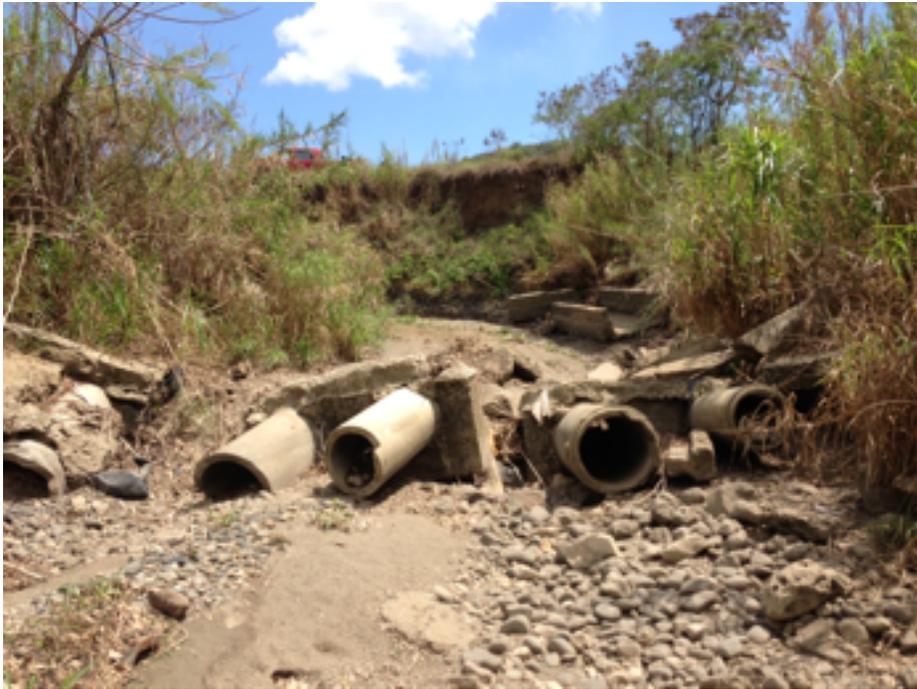
Due to there being 20-30 concrete structures in the channel at this location (Figure 6) (some likely deposited here from upstream) a considerable work effort would be required to effectively remove the majority of structures from the channel. Again most of these structures would be broken up in place and the metal and steel and other trash would be removed and disposed of or recycled.

Figure 6. Photo that captures just a partial look at the many in-stream structures

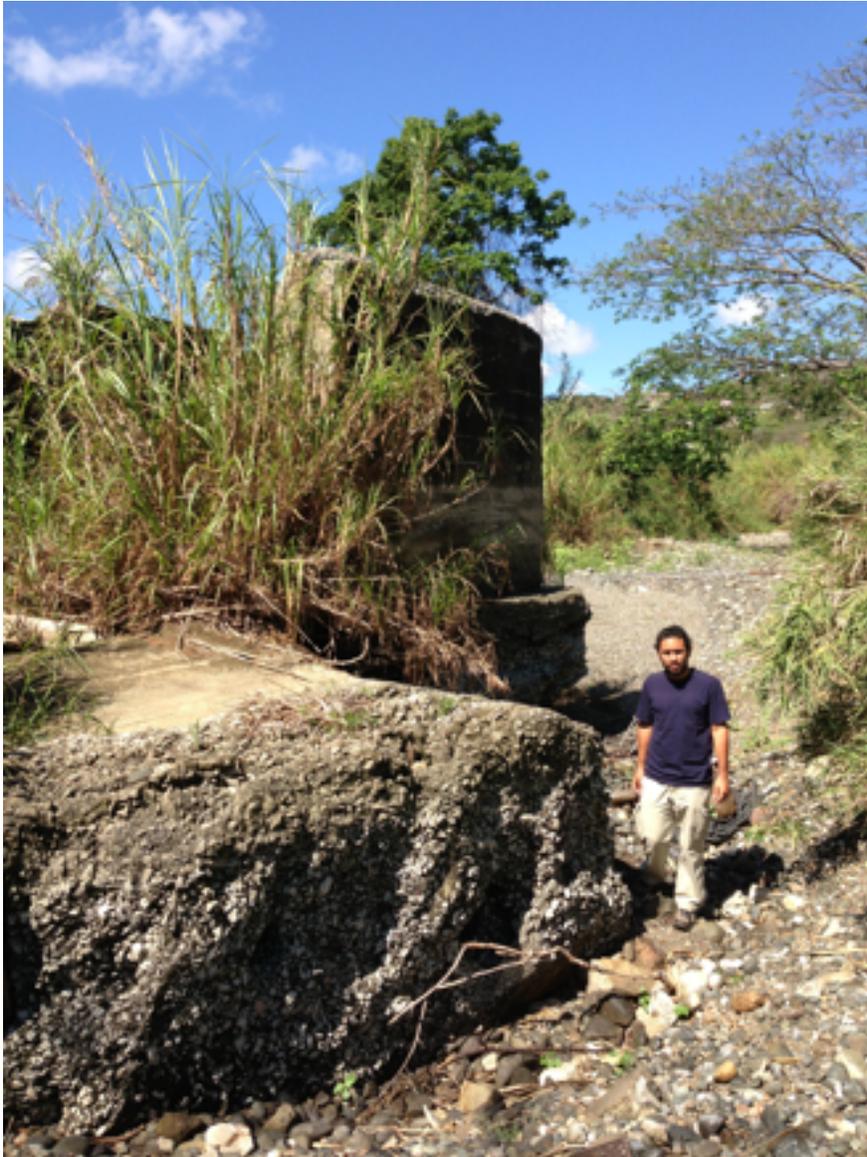
The railroad bridge structure is composed of 3 large concrete pillars that previously carried a railroad track in the days of the sugar cane harvest. The pillars are 14 ft high by 12 ft wide - the bases of the structures over 4ft high by 12 ft wide. The structures themselves are relatively massive and require significant effort to break up. One of the pillars has fallen over into the channel (Figure 7) as it previously was part of the river bank. A second pillar the middle one is rapidly being undermined by erosion and is likely to fall during the next rainy season.

Figure 7. Railroad bridge located downstream of Rt. 116

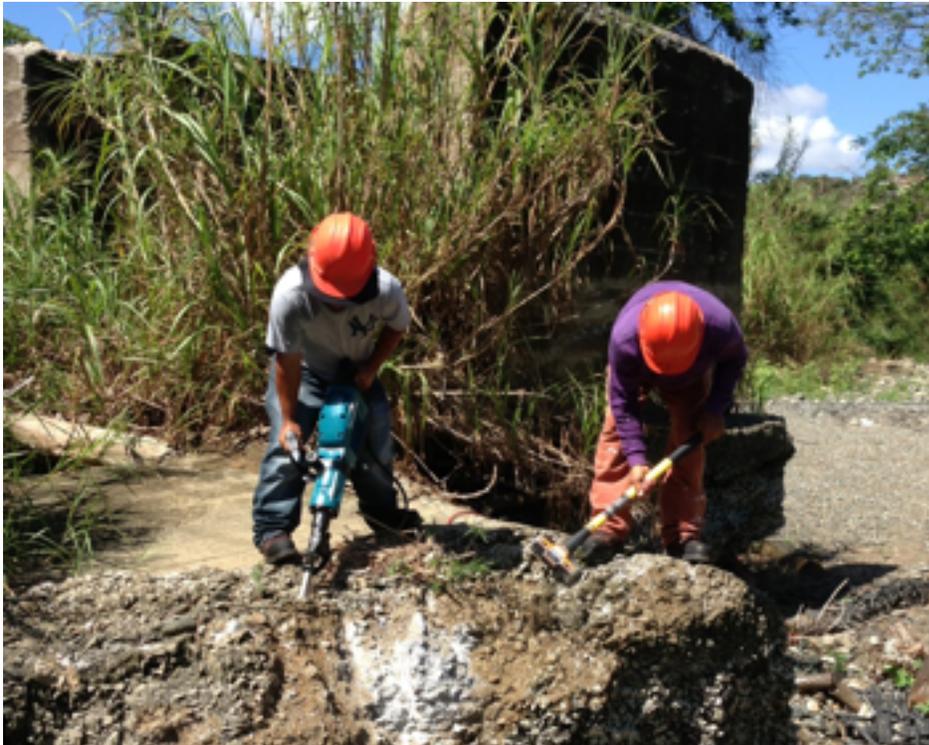
Concrete was tested at the sites in order to determine if traditional jack hammers could be used to break up the concrete. A generator and jackhammer equipment were rented in order to test the various concrete structures for potential demolition. This also helped us to be able to determine the amount of time, labor and machinery estimates that would be required to complete the work.

Two types of concrete were consistently identified: poured concrete where wire or rebar was used to maintain the integrity of the concrete and aggregate concrete that in some cases may have been poured in place and used local stone or aggregate as a higher percentage of the mix. This is summarized in Table 1.

Figure 8. Testing concrete structures
