**PROGRESS
REPORT**

**ASSESSMENT OF
TURBIDITY IN THE
GEUS RIVER
WATERSHED IN
SOUTHERN GUAM**

**WATER AND ENVIRONMENTAL RESEARCH INSTITUTE
OF THE WESTERN PACIFIC
UNIVERSITY OF GUAM**

DECEMBER 2014

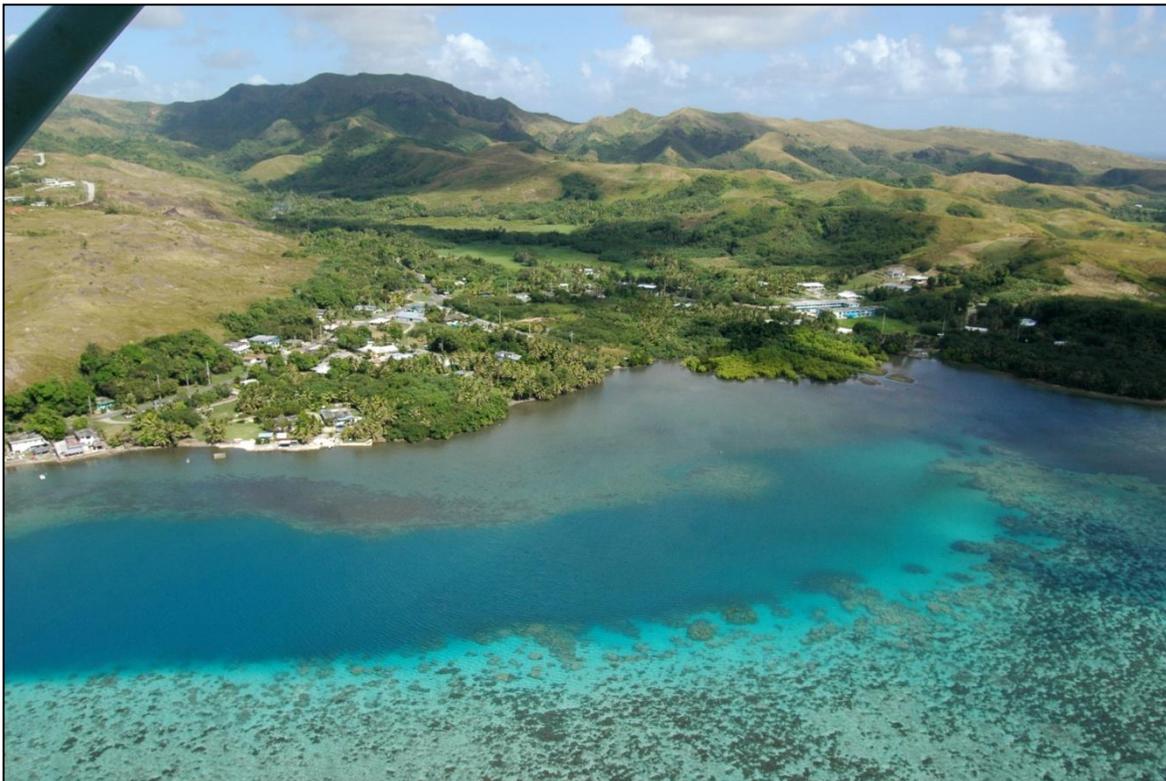
Figure 2. Geus Watershed, Merizo (Khosrowpanah et al, 2007b)

At the Southern tip of Guam, the Geus Watershed is bound at the coast by Cocos Lagoon. With 1.73 sq. miles (4.48 km²) it is the second smallest of the 14 major watersheds in southern Guam. The Geus River is about 2.7 miles long with several upland tributaries. The river discharges to the interior of Cocos Lagoon and the Mamaon Channel (Figure 2). Access into the Geus Valley along the river is provided via Espinosa Street, which extends about one mile into the watershed and is sparsely developed for residential purposes. Of the surrounding ridges, only the western ridge contains significant developments including residential housing and the Pigua subdivision, Merizo Elementary School and Ball Park, and the Merizo Community Center and Mayor’s Office.

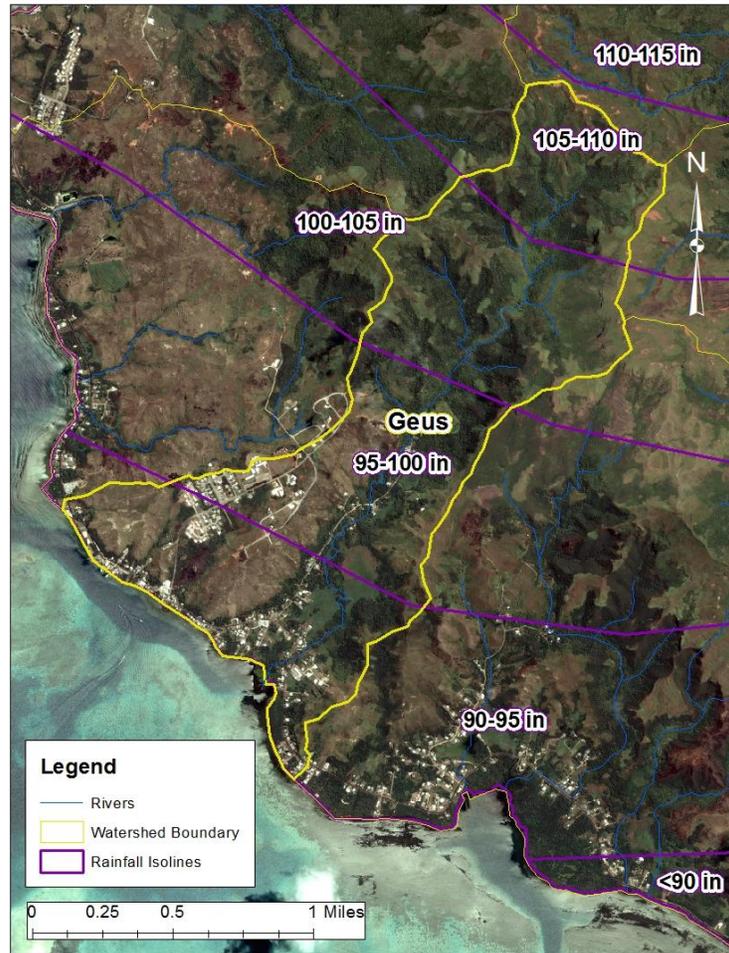
Figure 3. Average Annual Rainfall Distribution (Lander and Guard, 2003)

Locally, rainfall distribution is influenced by topographical variances and the general orientation of the island except during the more extreme rain events (Lander and Guard, 2003). In general, rainfall patterns are oriented in a north-northeast to south-southwest manner. However, rainfall during typhoon conditions is distributed based on the structure and path of the storm. Average annual rainfall over the Geus Watershed ranges from 90-95 inches along the coast to 105-110 inches atop the inland mountains (Figure 3).

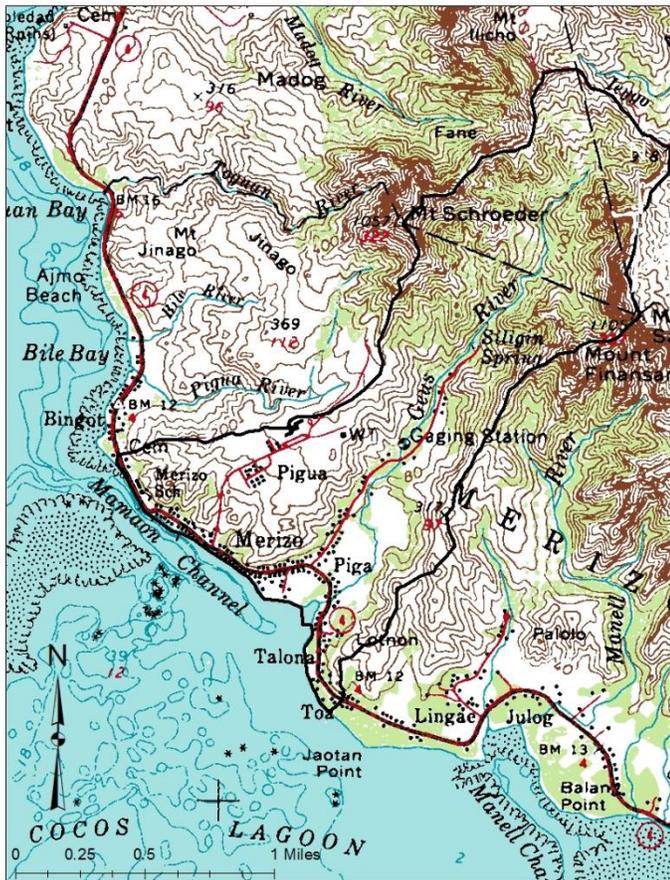
Figure 4. USGS Topographic Map

The Geus Watershed extends over two miles inland with increasingly steep topography and a maximum elevation of 833 feet at the north east corner of the watershed (Figure 4) (Khosrowpanah et al, 2007b). The geology consists of rock formations from the Facpi and Umatac episodes of Guam’s volcanic history (Siegrist et al, 2008). These formations are relatively impermeable in comparison with the limestone material that constitutes much of Northern Guam. As a result, they do not support a viable groundwater aquifer; instead surface water features (springs and rivers) are more prominent.

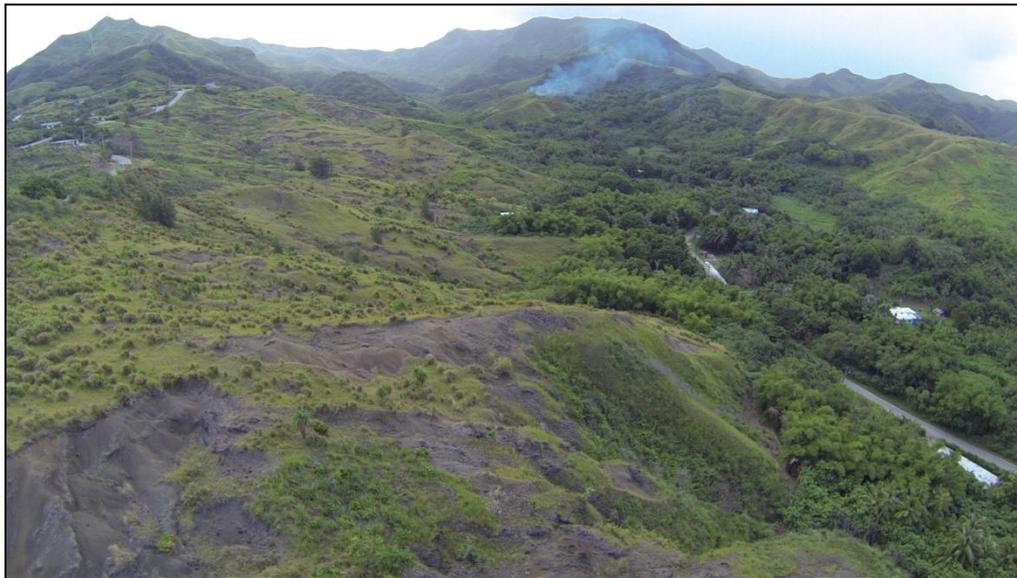
Figure 8. Geus Watershed, Merizo (June 17, 2014)

The upper reaches of the Geus River and its upland tributaries are largely forested, grading to grasslands and some badlands on the surrounding high slopes (Figure 8). There is very little off-roading in this watershed, with some four-wheel traffic (mainly hunters) along the ridges on the north and east sides of the watershed boundary. The uplands are the site of many early Chamorro artifacts. There are likely a very large number of ungulates (wild pigs and deer) inhabiting the area. Wildfires are common in the dry season, and occur primarily in the grassy areas located on the steep slopes and highest terrain of the surrounding mountains.

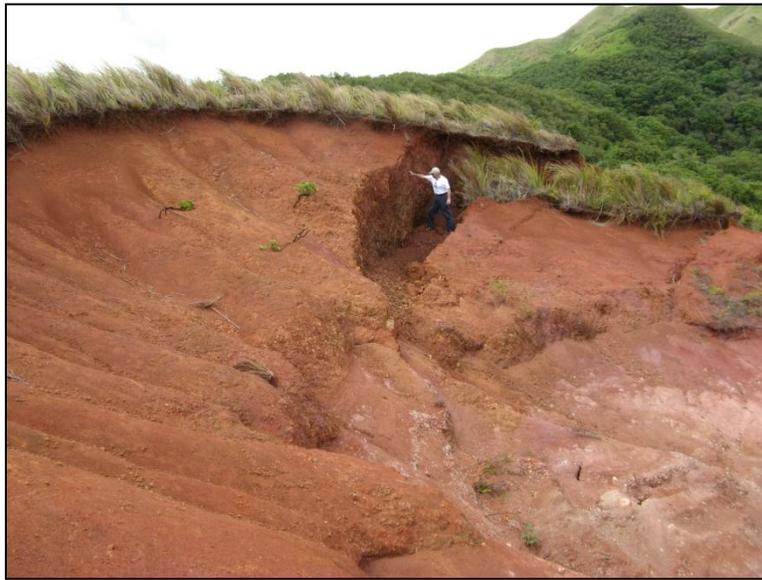
Figure 9. Badlands Atop the Pigua Ridge, Merizo (March 15, 2014)

Field visitations were conducted on a weekly basis from December 2013 through December 2014, and are still on-going. During each visit, conditions that may contribute to erosion and sedimentation that were observed were documented. These conditions include vegetation types, badland locations, slope and topography, and fires or other human activities (Figure 9 and 10). In addition, aerial surveys were conducted to observe land coverage from above and identify areas with more potential susceptibility to erosion.

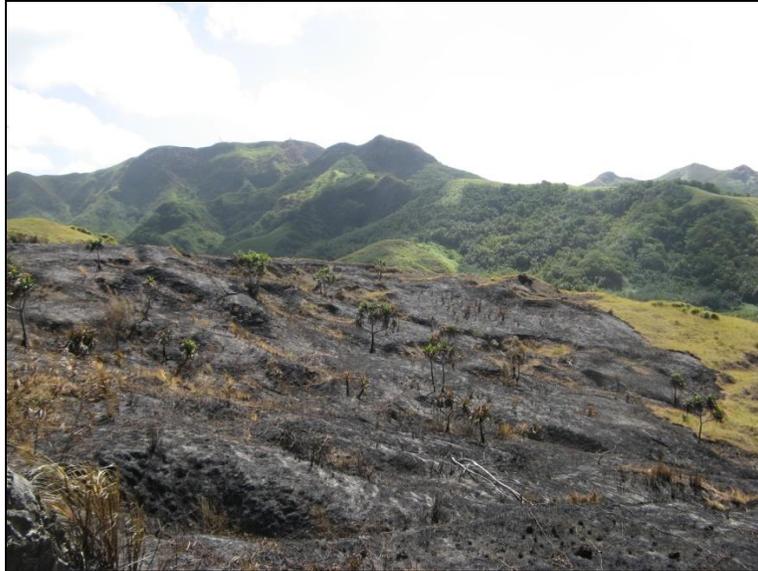
Figure 10. Burned Savanna along the Geus Slopes (April 2, 2014)

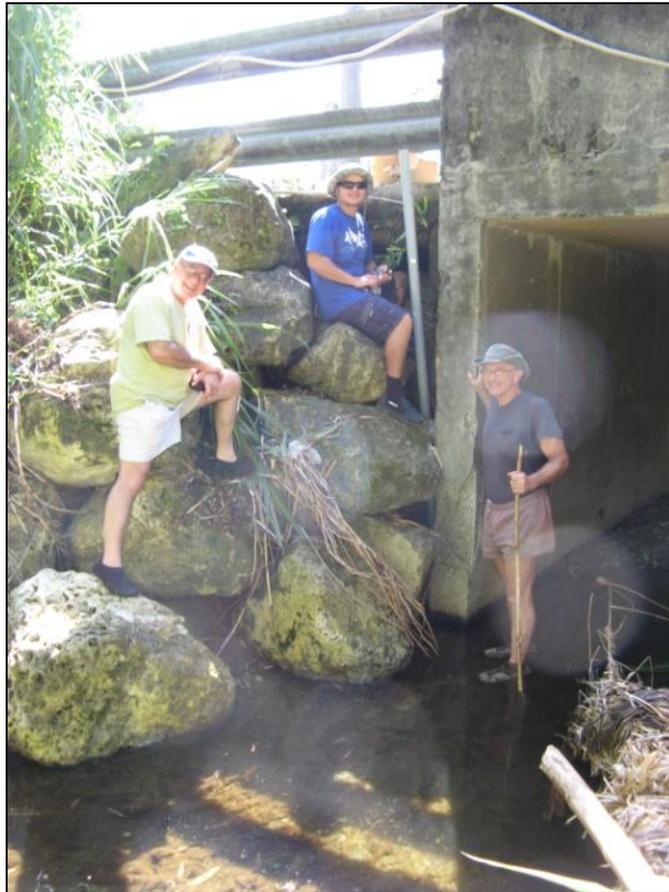
Figure 12. Installation of Data Loggers (January 15, 2014)

Stream level is simply the height of the Geus River water column at the data collection site. Stream level was measured using two HoboWare® U20 water level data loggers with a range of 0 to 30 ft and an accuracy of 0.015 ft (Figure 12 and 13). The level loggers were collocated with one level logger resting at the bottom of the water column and the other logger outside of the water column to account for atmospheric pressure variations. Pressure readings were collected at 5-minute intervals, and the pressure difference between the river level logger and the atmosphere level logger provided the pressure (in psi) attributed to the water column. Water column height was calculated during data processing.

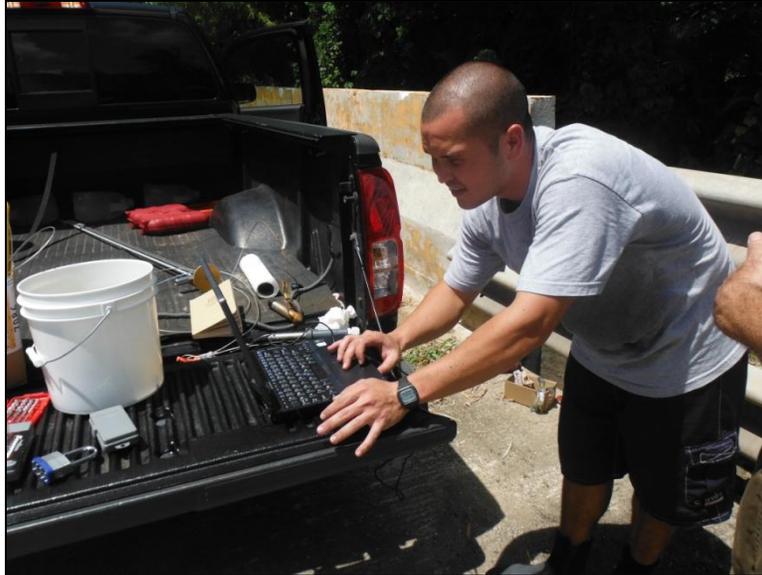
Figure 13. Field Download of Level Logger Data (March 5, 2014)

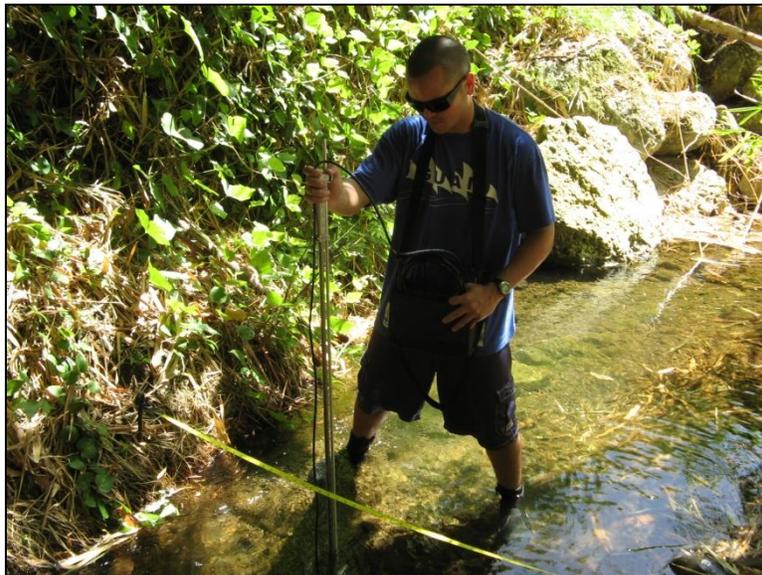
Figure 14. Stream Flow Measurement in Geus River (January 15, 2014)

Stream flow was measured close to the primary data collection station during weekly site visits (Figure 14). A Flow-mate™ Model 2000 Portable Flowmeter was used to collect readings (in cfs) along a transect set perpendicular to flow direction. A correlation between total flow and stream level over time produces a discharge rating curve.

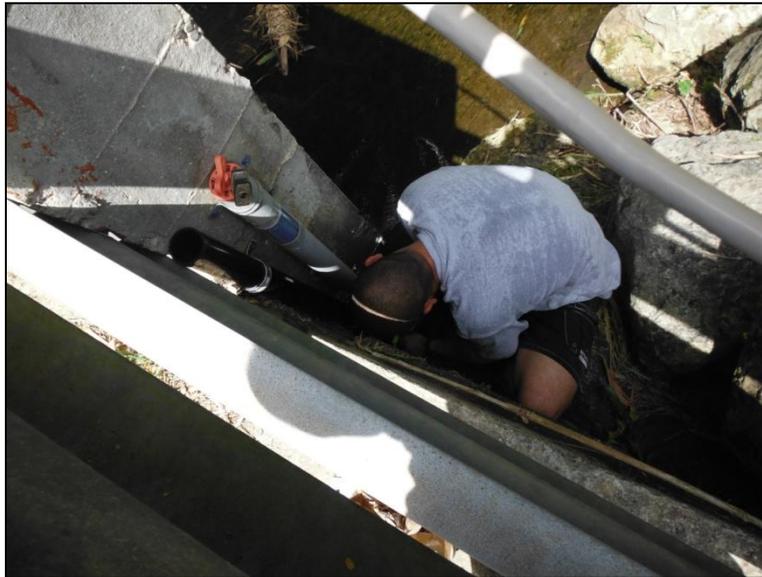
Figure 15. Turbidimeter Housing Installation (March 5, 2014)

Turbidity was measured two ways. An Analite NEP495P Turbidity Logging Probe was used to collect turbidity readings at 15-minute intervals in the water column (Figure 15). In addition, during weekly site visits water samples were collected and analyzed using an Omega TRH444 Portable Turbidity Meter. Both turbidimeters measure suspended particles in a solution based on the amount of light scatter produced with infrared light. Accuracy of the portable turbidity meter was verified prior to each use. The turbidity logger was calibrated prior to deployment and accuracy was assessed weekly by comparison with the portable turbidity meter. Maintenance was conducted weekly during long-term deployment and recalibration was conducted periodically as necessary.

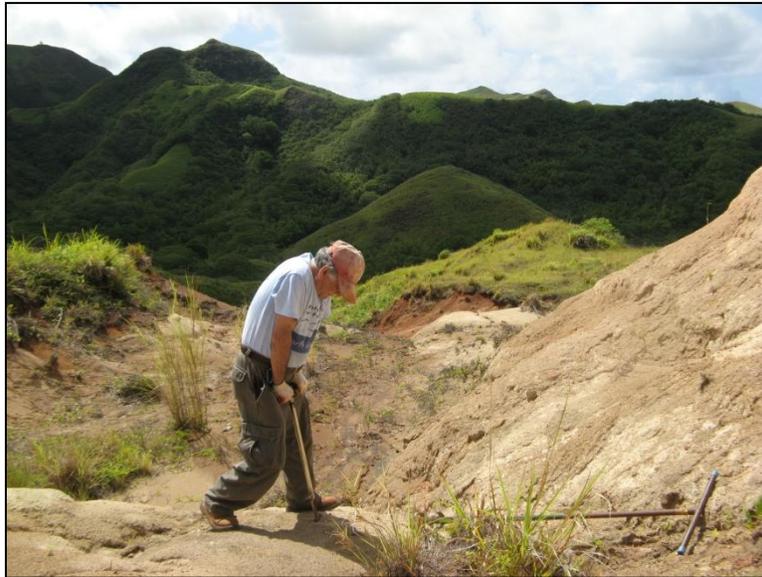
Soil from seven locations was sampled and tested in the lab to identify the various soil types represented in the Geus Watershed. Samples were collected as composites from the sample locations selected based on exposed soil observations or supported vegetation types (Figure 16 and 17). Four samples were collected along the upland ridge including areas consisting of the more prominent badlands and grasslands. Three samples were

Figure 16. Soil Sample Collection (June 3, 2014)

Upon collection all samples were processed and analyzed at the University of Guam Soil Research and Testing Laboratory. Samples were dried, ground, then sifted through a standard two millimeter sieve. Sample aliquots were individually analyzed for pH, soil texture, organic matter content, and nutrients.
