# ***CABO ROJO***

## ***COMMUNITY WATERSHED ACTION PLAN FOR WATER QUALITY AND CORAL REEFS***

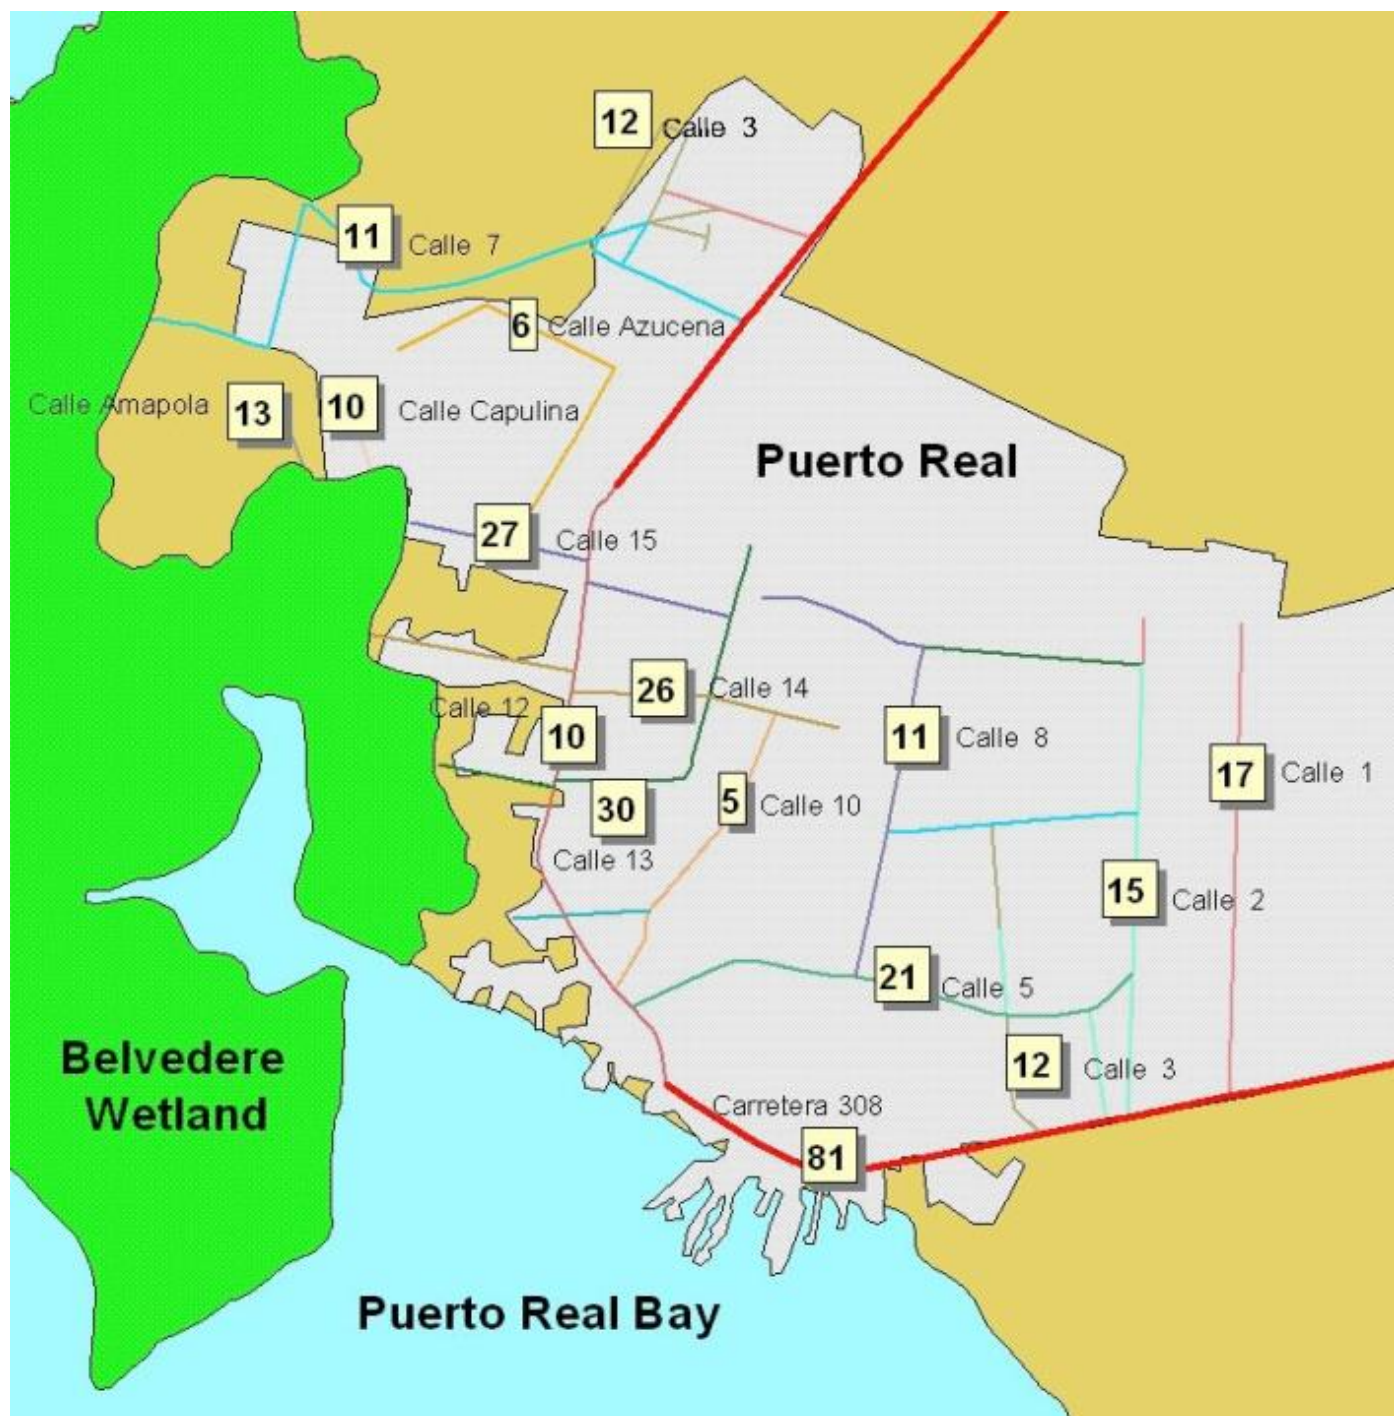
Figure 8. Puerto Real number of septic systems per street shown in the yellow box (from Norat and Mattei, 2006) – two priority areas in our analysis were the 81 along the coast on Road Pr-308 and El

### Fangito Street with no buffer and those along Calle 1 where we observed high rates of failure via water quality sewage indicators

(Figure 8) that were likely experiencing failure and contributing sewage and contaminants to the Belvedere wetlands and Puerto Real Bay. In addition, for this watershed plan, baseline data was collected for nearshore coral reefs by Sociedad Ambiente Marino (SAM), UPR CATEC, and CESAM in a gradient from areas close to land and sources of pollution to areas further off the coast. Widespread degradation was identified at nearshore reefs and as well as sites just outside Boquerón Bay.

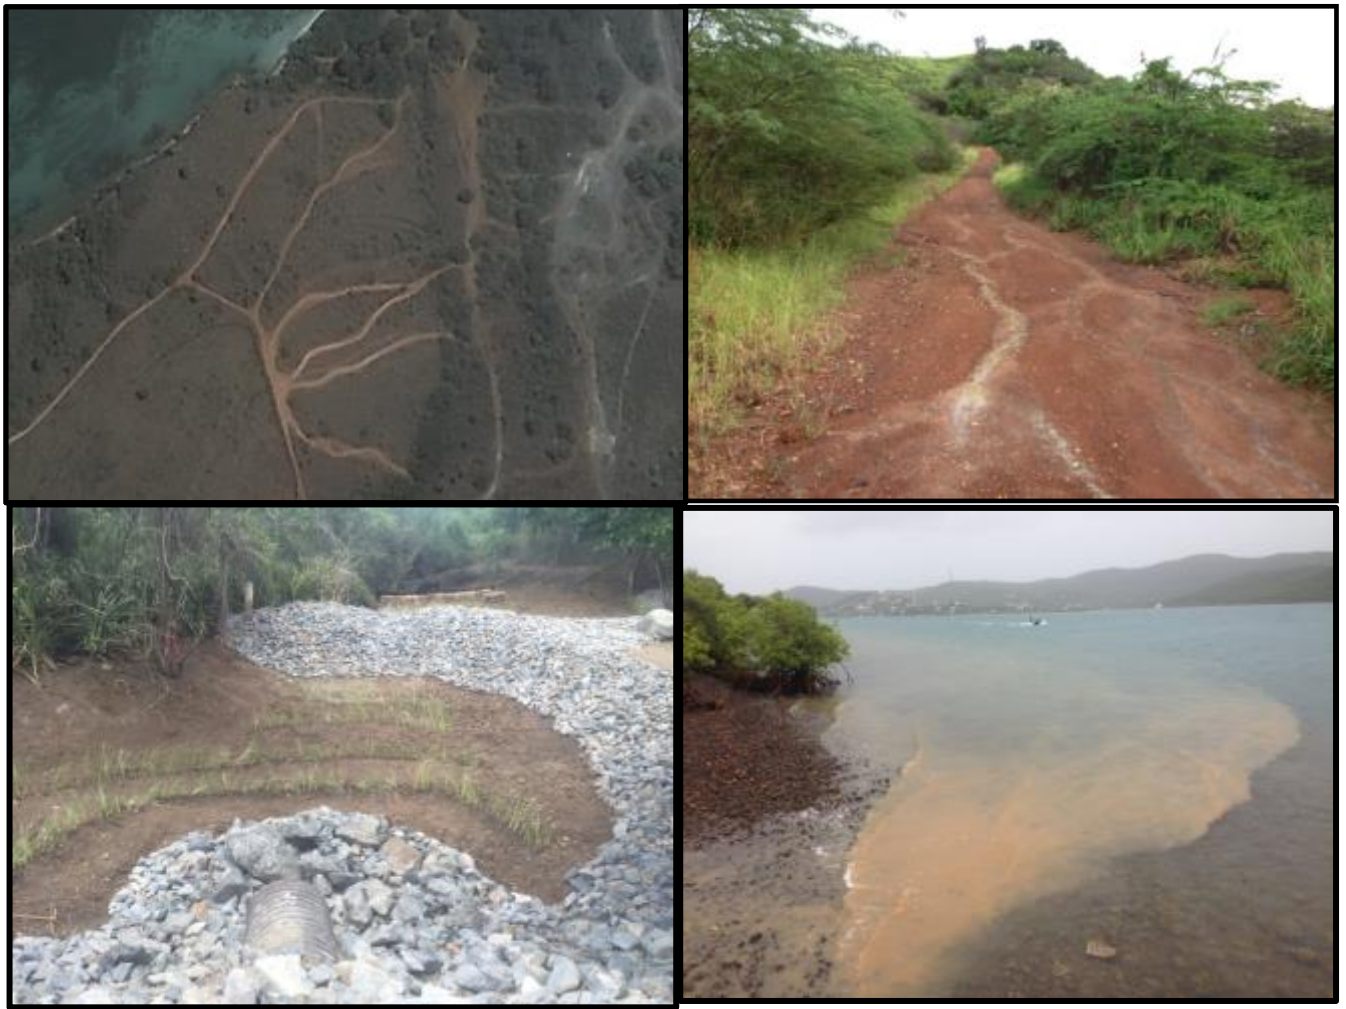
**Figure 13. Clockwise from top left: Dirt roads in Los Pozos near Combate, a significant source of sediment to coastal waters, (right) example of surface rills conveyance over the road surface creating erosion and resulting in fine sediment losses, bottom right sediment reaching coastal waters; bottom left: recently constructed sediment trap in Cabo Rojo to capture sediment before it enters Boquerón Bay**

Stabilization of bare soils (Figure 13) involves the rapid re-stabilization of vegetation and generally a transition to more native and stable forms of vegetation. One effective way to re-establish vegetation in an area is to utilize hydroseeding followed by watering to rapidly transition to a more stable vegetated system where runoff is reduced. Dirt roads are stabilized using methods to remove water from the road and reduce erosion. These include concrete or dirt cross-swales, check dams and sediment traps. The recommendations for dirt road and bare soil stabilization are found in Table 6. Maps are found toward the end of the section in Figure 16. Each of the bare soil restoration projects is important in its own right due to the high loads associated with bare soils.

It should be noted that all exposed soil and dirt roads transport sediment at a rate of 5x to 100x the natural transport rate from a forest or a field, so maximizing the amount of roads and bare soil areas treated is a critical element of the watershed plan, as is reducing the impact of future road development.

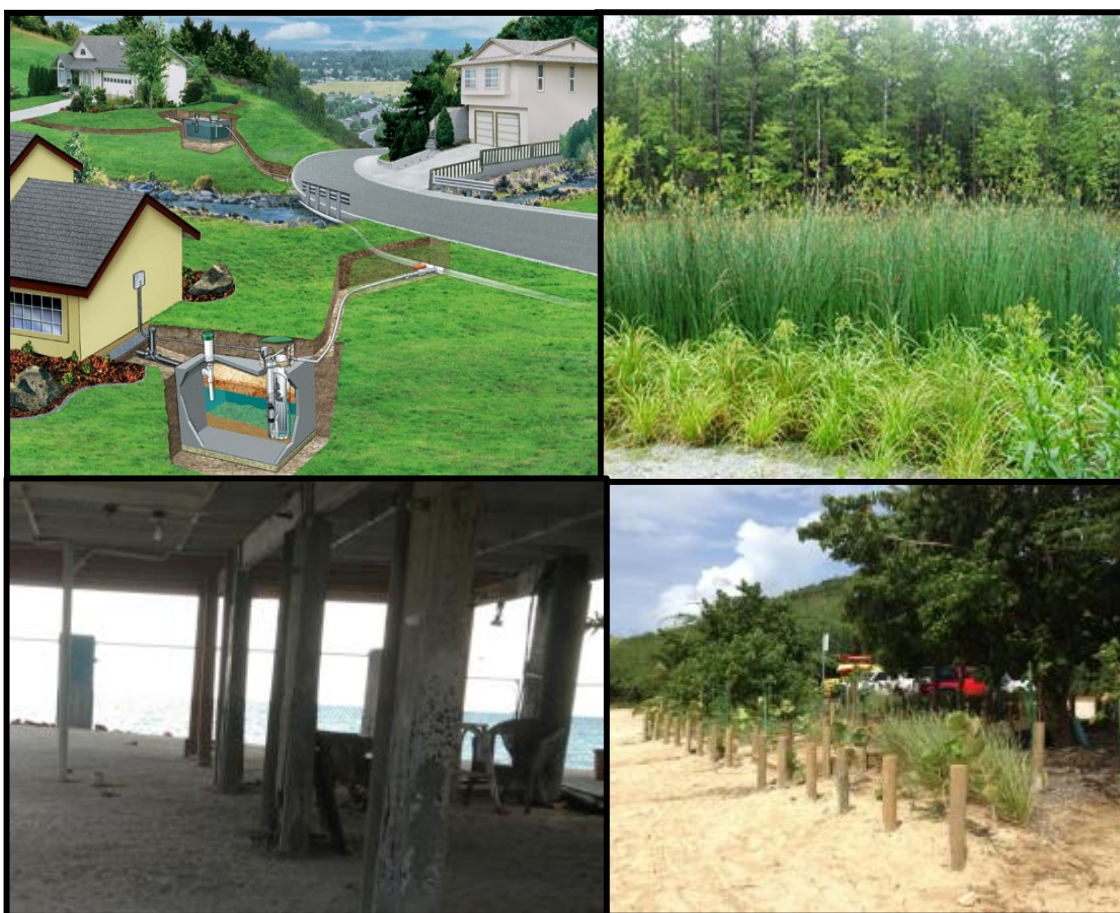
**Figure 14. Top (Pump and treat system where effluent is pumped from homes to a constructed wetland or landscaped area (right); Bottom: (left) sewage effluent enters a septic system in the beach berm in Combate, (Bottom left) a passive low cost approach to addressing this issue is to restore a vegetated beach berm to include the use of vetiver and native species such as sea grape (uva playa) as has been done in Tamarindo Beach in Culebra**

into the groundwater and maximizing nutrient removal via vegetation and uptake or by promoting denitrification. Examples of a pump and treat system are found in Figure 14 - the effluent can be pumped to a constructed wetland such as is shown in the top right of Figure 14. These efforts should be focused in areas where space is limited between the septic system and the coast and where septic failures are occurring and connecting to the PRASA sewer system is not an option. Examples would be to use these practices at small hotels and restaurants in places like Joyuda and Combate. Other more passive systems are also possible particularly where space is limited such as structures located on the beach itself – in this example from Combate septic systems are located in the beach berm. Restoring the beach buffer with native plants and vetiver (which can grow its roots to 3-4 meters deep) to attempt to intercept contaminated groundwater before it enters the nearshore waters with a dual benefit of also helping protect the shoreline from erosion by allowing the beach berm to aggregate sediment.

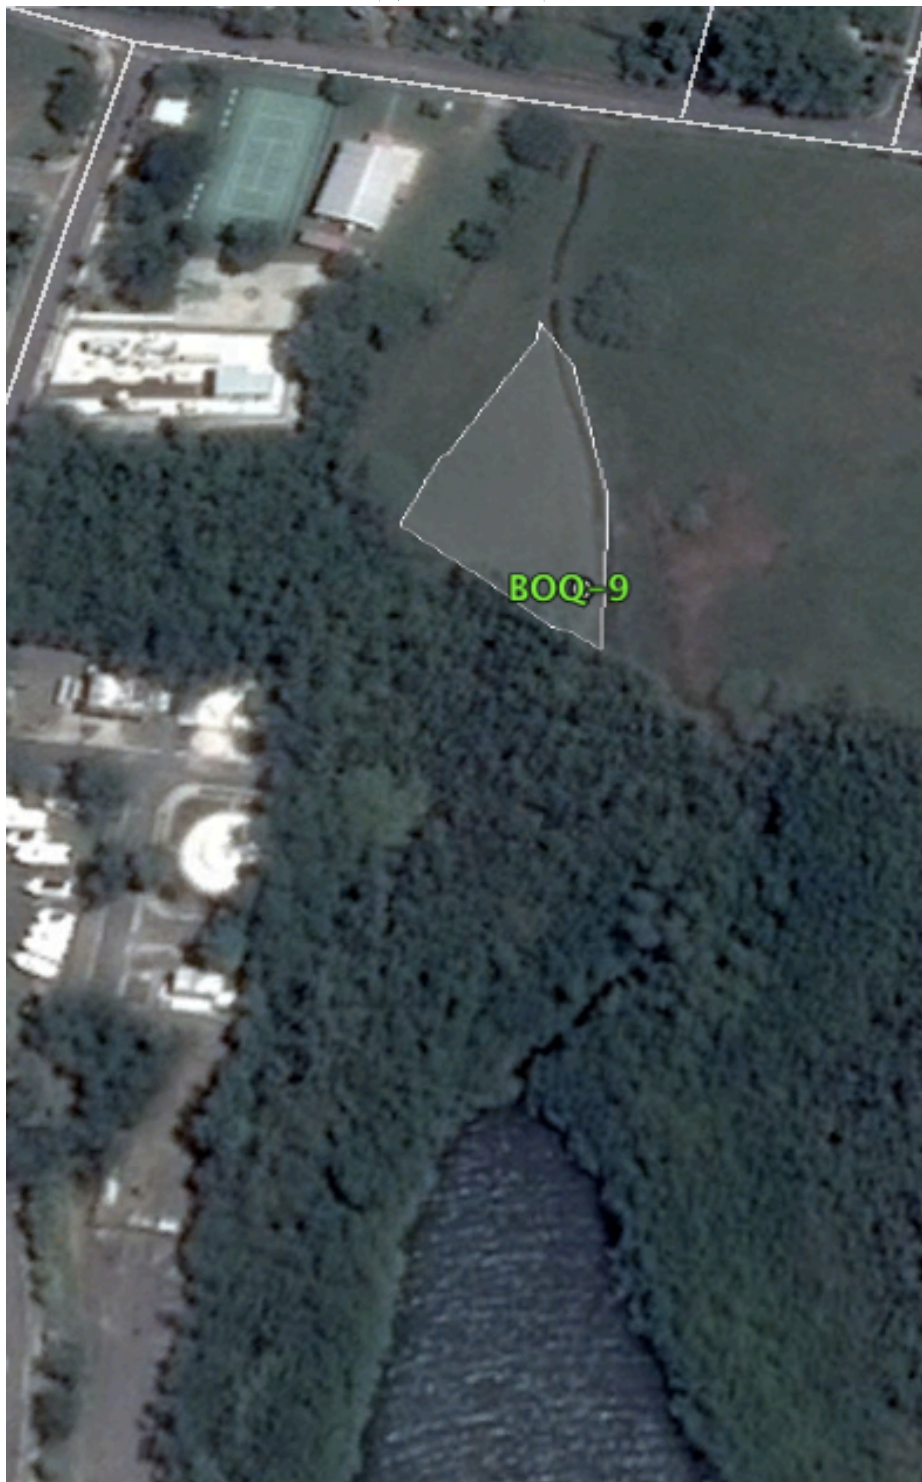
Location for a treatment wetland to address uncontrolled stormwater and elevated nutrients and bacteria

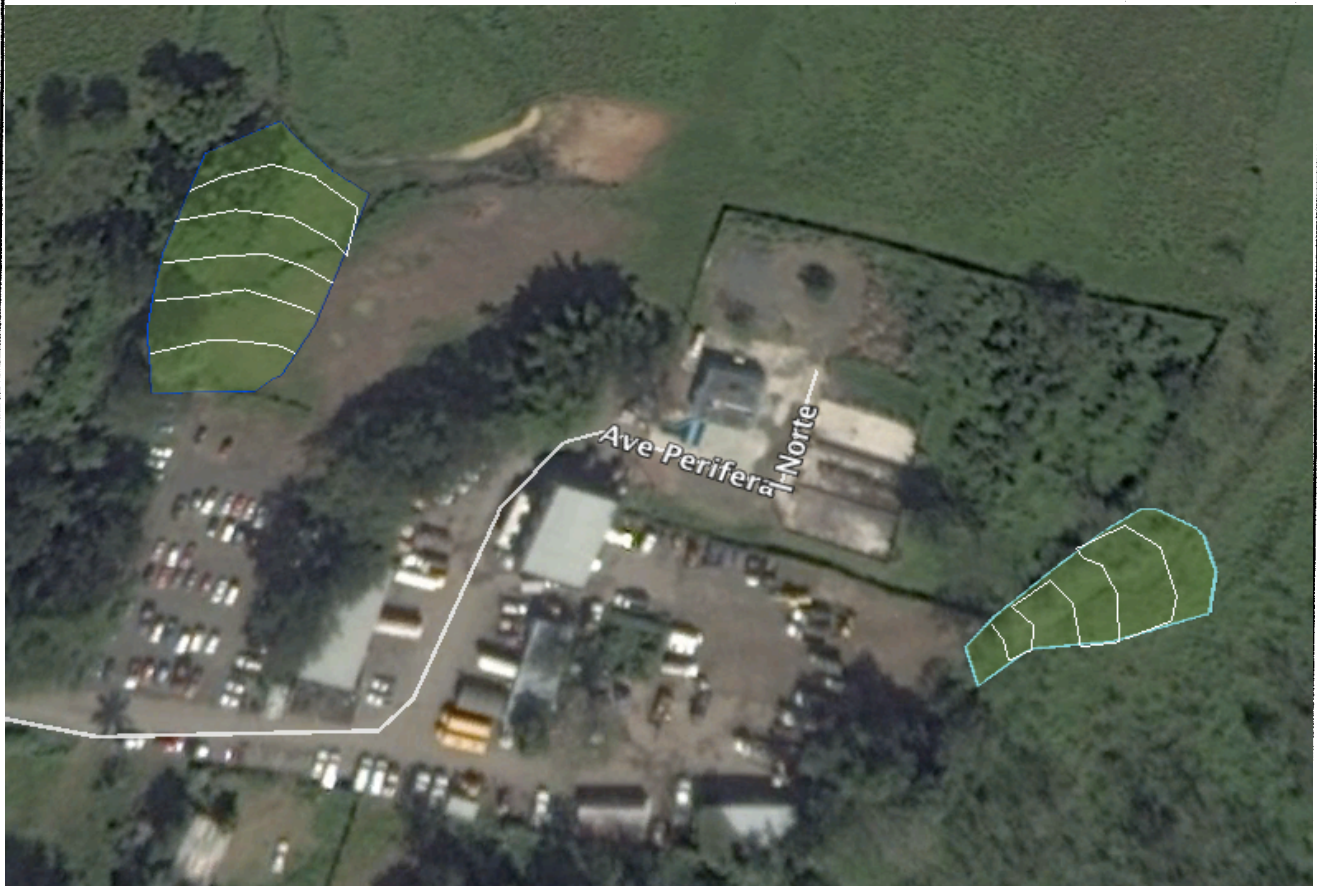
Two potential locations for stormwater wetlands at the existing public works facility in Cabo Rojo

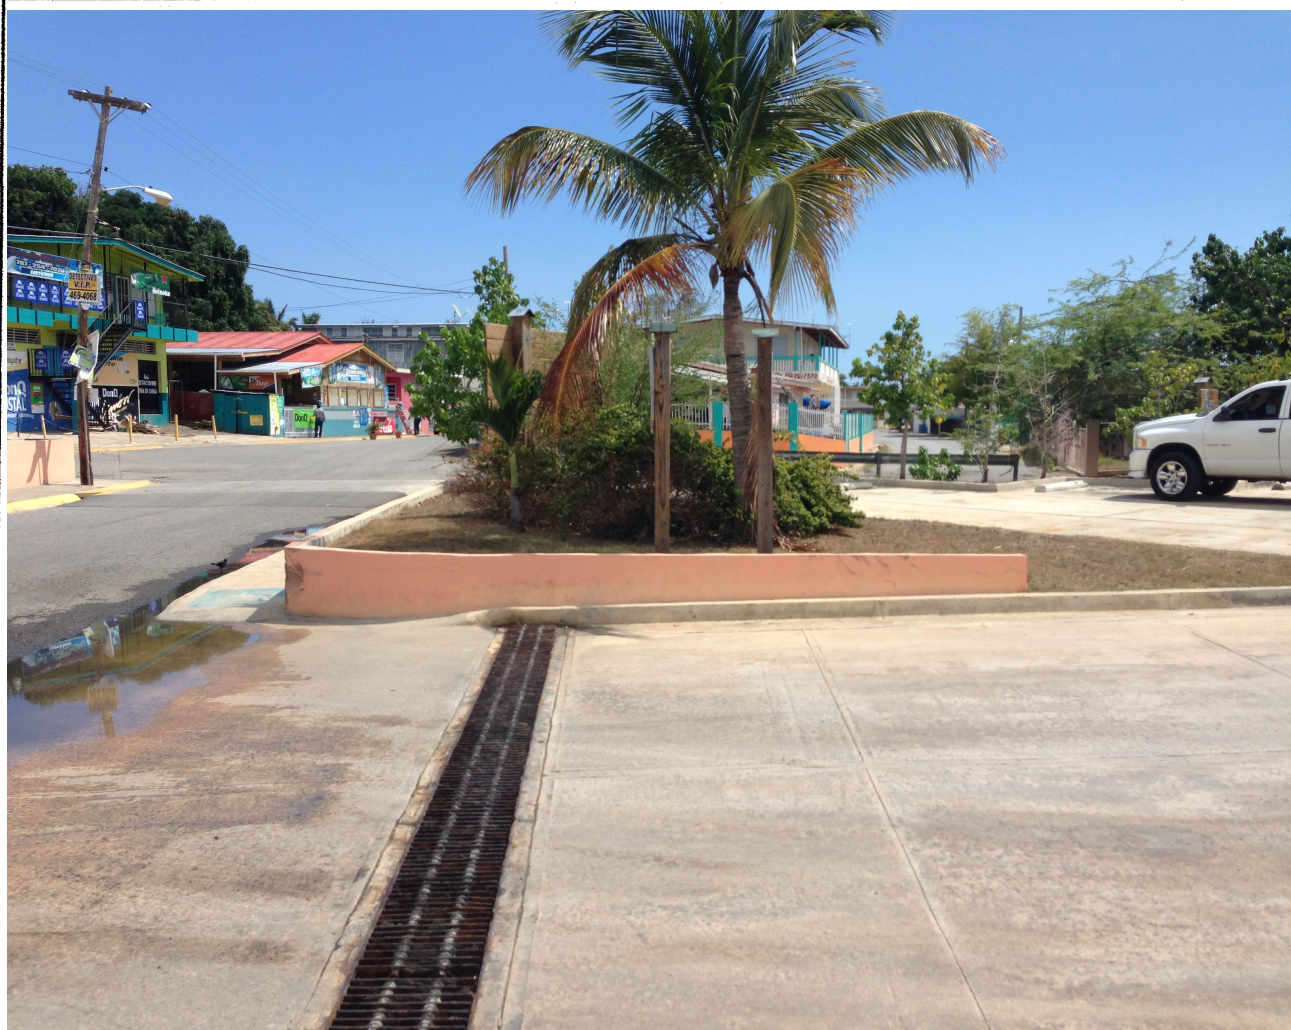
Convert clogged stormwater practice to surface sand filter within the existing vegetated island -- see overview of both practices on next sheet
