NOAA ARRA USVI Watershed Stabilization Project

Coral Bay Watershed Management Project – Carolina Valley Drainage Improvements

March 31, 2012

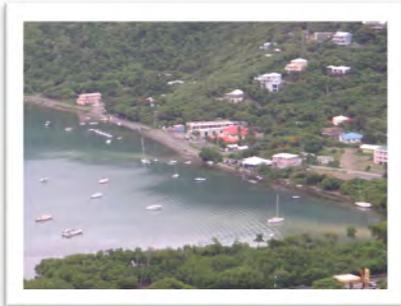
This plume is generated by runoff from the roadside concrete swale in King's Hill Road. Runoff primarily originates in the areas along the Gerda Marsh Road before it intersects King's Hill Road and has its direction changed by a kneewall and then proceeds down the road discharging across Rt. 107 into the Mangroves adjacent to the dumpster area. This runoff is very contaminated with sediment from the dirt portions of Gerda Marsh Road. The level of sediment in the water is too high for the mangroves to effectively filter, and it produces the plume in the bay. The conditions contributing to the problem in this area are the fact that Gerda Marsh Road acts as a conduit for water intercepted from the normal ghut system and redirects it down the road to King's Hill Road. Prior to being directed down the road, much of the runoff ran overland, sheeting down the hill and into a major Ghut that runs across King's Hill Road just northwest of the kneewall. The photos below are from a previous storm, but the conditions shown are compatible to any storms that produce runoff in this watershed.

Plume evident in lower right even during
Small runoff events

- Return water to ghut system at Gerda Marsh/King's Hill Intersection –
In order to restore the flow into a more natural area, and encourage the natural cleansing and recharge that the gut system provides, it is recommended to remove a portion of the Kneewall to allow water to flow overland to the ghut. Some existing channelization is evident behind the kneewall from previous water flows prior to installation of the kneewall. A small amount of excavation is necessary behind the kneewall to allow the water to flow from the road into this conveyance channel and ultimately into the ghut. Any new channel cut should be provided with a simple rock liner and immediately seeded to prevent further erosion. It is noted that initial conversations with the landowner in this area indicated a desire to cooperate and allow us rights to construct and maintain any structures. Formal easement documents are being worked towards at the time this memo is being written.

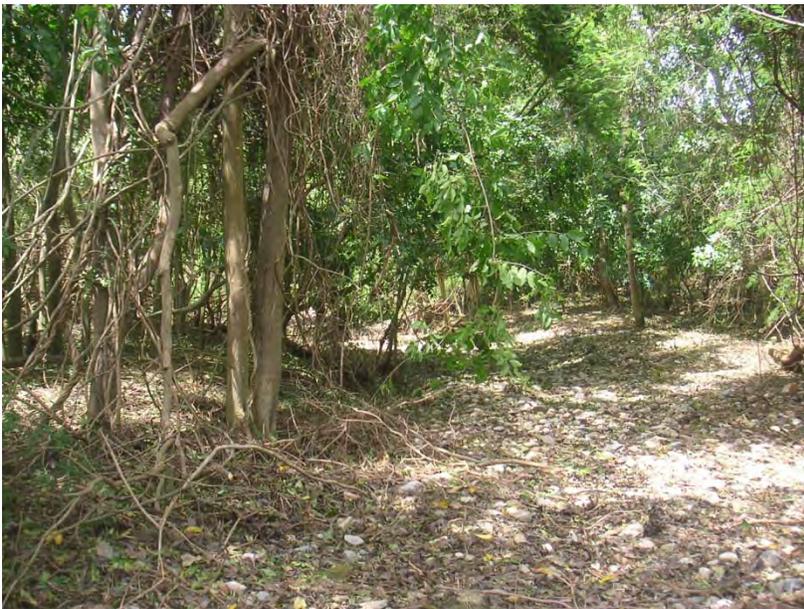
Gut area to have sediment removed and create basin

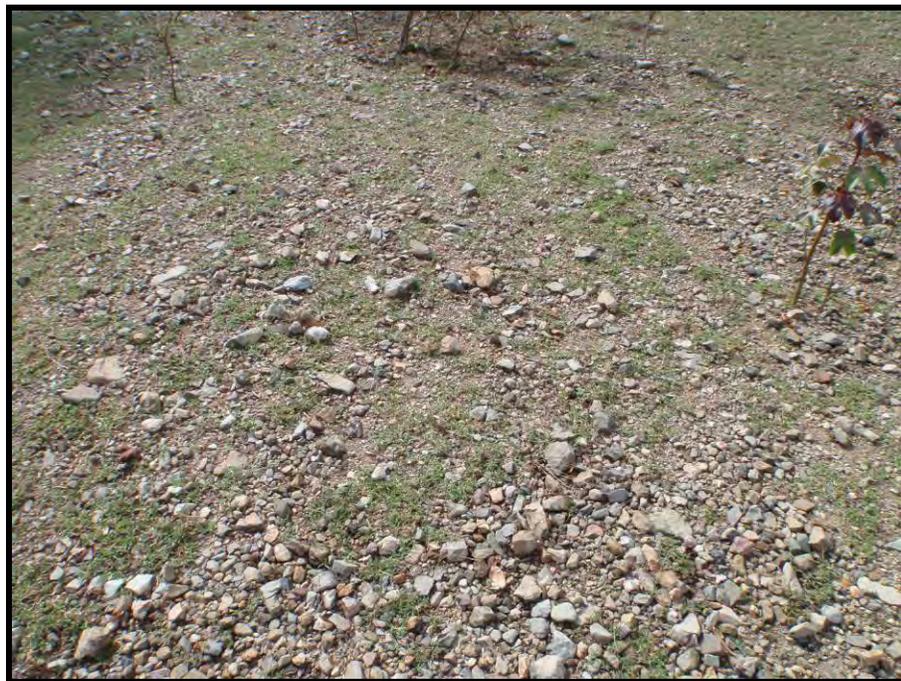
Figure 3: Photograph of characteristic ground surface in Parcel 6-4

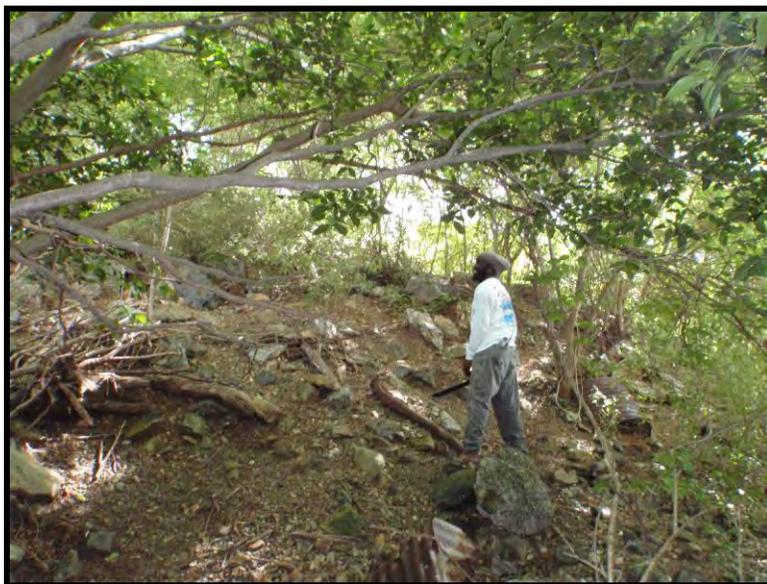
Figure 5: Photograph of large spoil pile in Parcel 6-4

Both parcels contain small, medium and large spoil piles, particularly Parcel 6-4, which has been used to dump soil and hard fill such as concrete slabs, guard rails, and numerous other items, including the remains of a rubble masonry building. We currently estimate that approximately one half of Parcel 6-4 contains spoil piles such as those shown in Figures 4 through 9. These spoil piles are also indicated on the recently completed topographic map as contour anomalies, however we note that not all of the spoil piles are shown on the map presented in Section 3.0, particularly the smaller ones that dot both of the subject properties. No information regarding the conditions of the ground surfaces on which the spoil piles rest is available, but we assume that these materials (spoil) were deposited on both disturbed and natural ground surfaces.

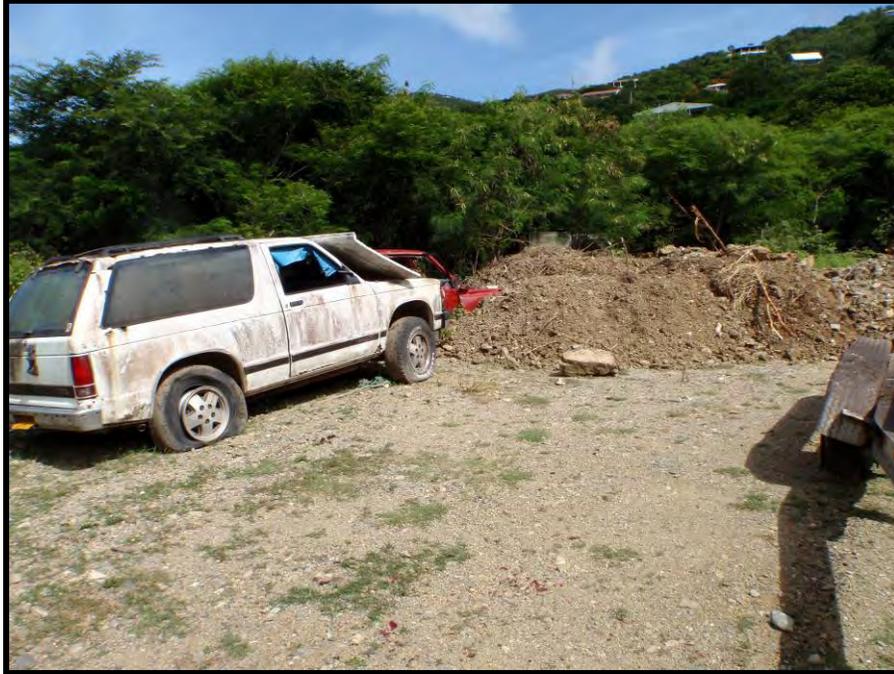
Figure 6: Photograph of active dump site in the northern part of Parcel 6-4

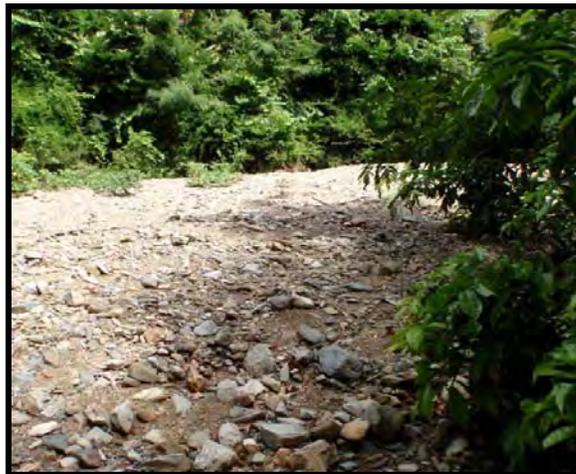
Figure 11: Sand and gravel bar associated with the meandering stream

The subject properties are drained by a meandering stream that appears to undergo accelerated rates of deposition as evidenced by the formation of a sand and gravel bar shown on Figure 11. Additionally, one area in or near the southeast part of the proposed basin was found to contain a well sorted sand bar.
