NOAA ARRA USVI Watershed Stabilization Project

Coral Bay Watershed Management Project – John's Folly Drainage Improvements

March 31, 2012

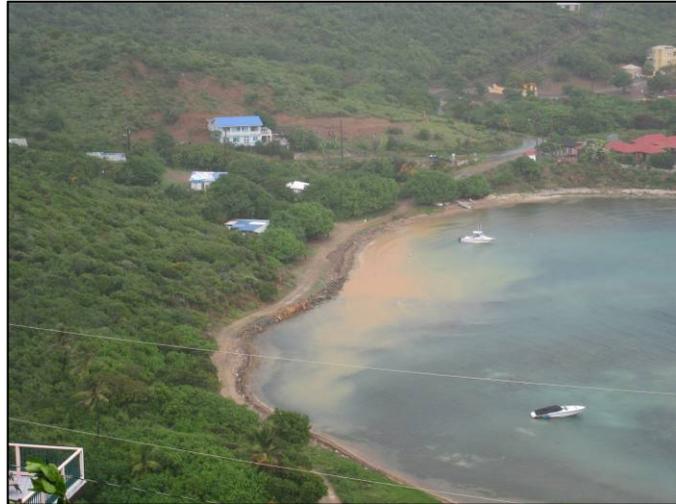
Photo 1: Plume into John’s Folly Bay prior to drainage improvements.

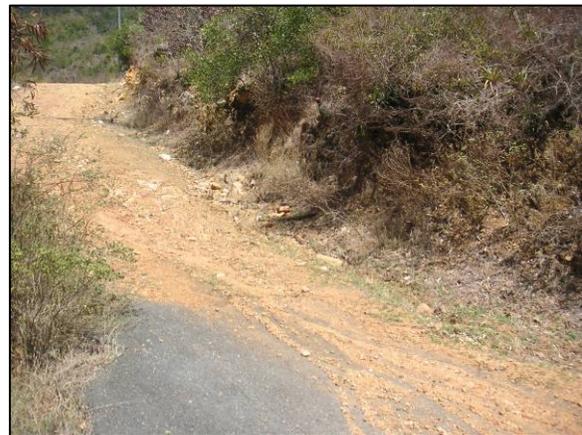
On Parcel 14C John’s Folly, an area subdivided into approximately twelve lots and split by Route 107, the road modifications described above led to an extremely erodable ghat channel running directly by several homes. Although Public Works (PW) made some efforts to armor the ghat channel near two houses in the area, no overall evaluation had been performed on how the the complete problem (not just the potential home damage) might be addressed. In addition, prior to the NOAA ARRA Project, a 30-year-old subdivision road had been re-cut up the hill alongside the ghat to allow for construction of a home without any stormwater management BMPs incorporated into the road design (Photo 3). In the NOAA ARRA Coral Bay Workplan, work in this area was expected to be limited to rock filters and checkdams in the ghats to reduce velocities and help protect

Photo 3: Parcel 14C subdivision road runoff in Drainage Basin #1.

from additional bank erosion, as well as repair and installation of naturalized rock linings in eroded ghut areas within 300 yards of the ocean.

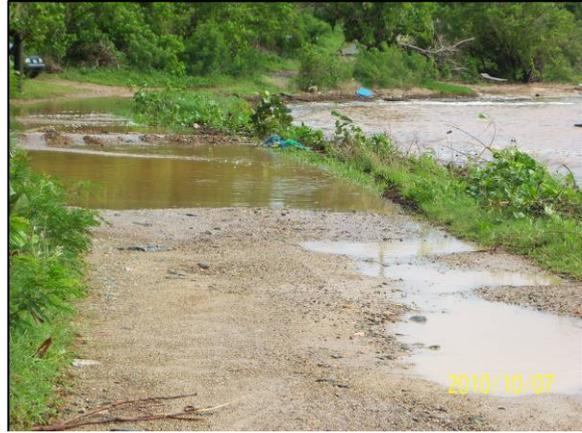
The ghuts emptying Parcel 14C flow over the access road along the John’s Folly Bay shoreline. This shoreline road is a narrow dirt road directly behind the cobble beach and vegetation berm that extends all the way along the bayfront. This road provides access to a number of shoreline properties, including several homes and a small seasonal beachside tourist stop. All stormwater flows entering John’s Folly Bay cross the shoreline road, generally in wide natural swale areas or by running along this road (Photo 4). While traffic is limited on this road, after storms water sits in the low water crossing spots and the roadbed is further eroded by vehicle traffic, thus perpetuating puddle/pothole and related erosion problems (Photo 5). The shoreline road continues into Drainage Basin #2 and the above problem also exists there.

Photo 4: “Long” Ghut swale runoff over the shoreline road.

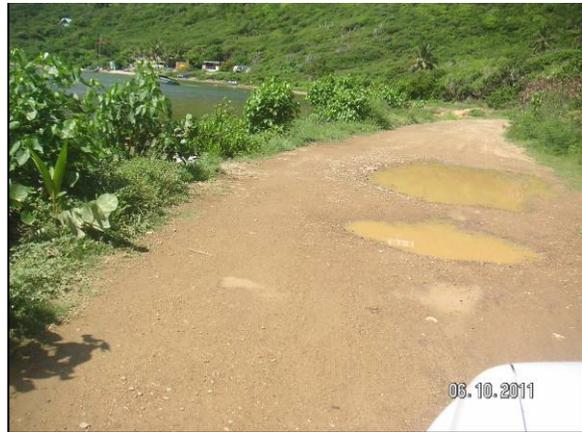
Photo 5: Runoff creating puddles/potholes along the shoreline road.

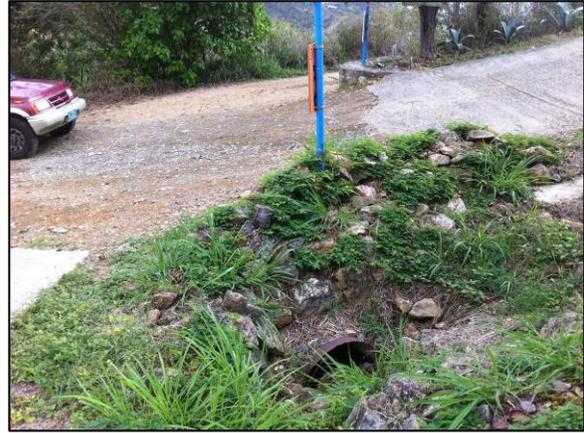
This gully area drains a residential area that grew substantially in the early 2000s. Flow increased so much that a delta of fist-sized rocks and dirt has been forming out in John’s Folly Bay since 2004 (Google Earth time lapse photos show these occurrences). In the 1960s and 1970s, land in Estate Concordia was subdivided into lots as small as 10,000 square feet on steep hillsides with highly erodible soils, although almost no development took place here until the 2000s. During the course of project work, CBCC encouraged the owners of these new homes to form the Sugarbird Hill Homeowners Association (HOA), and this area subsequently became known as the Sugarbird Hill subdivision. The altered drainage flows in this location (Photo 6) and proposed solutions are discussed in detail in Section 4.2 BMP Selection Process.

Photo 6: Sugarbird Hill subdivision culvert sending flows downhill the wrong way to Parcel 14J-2.

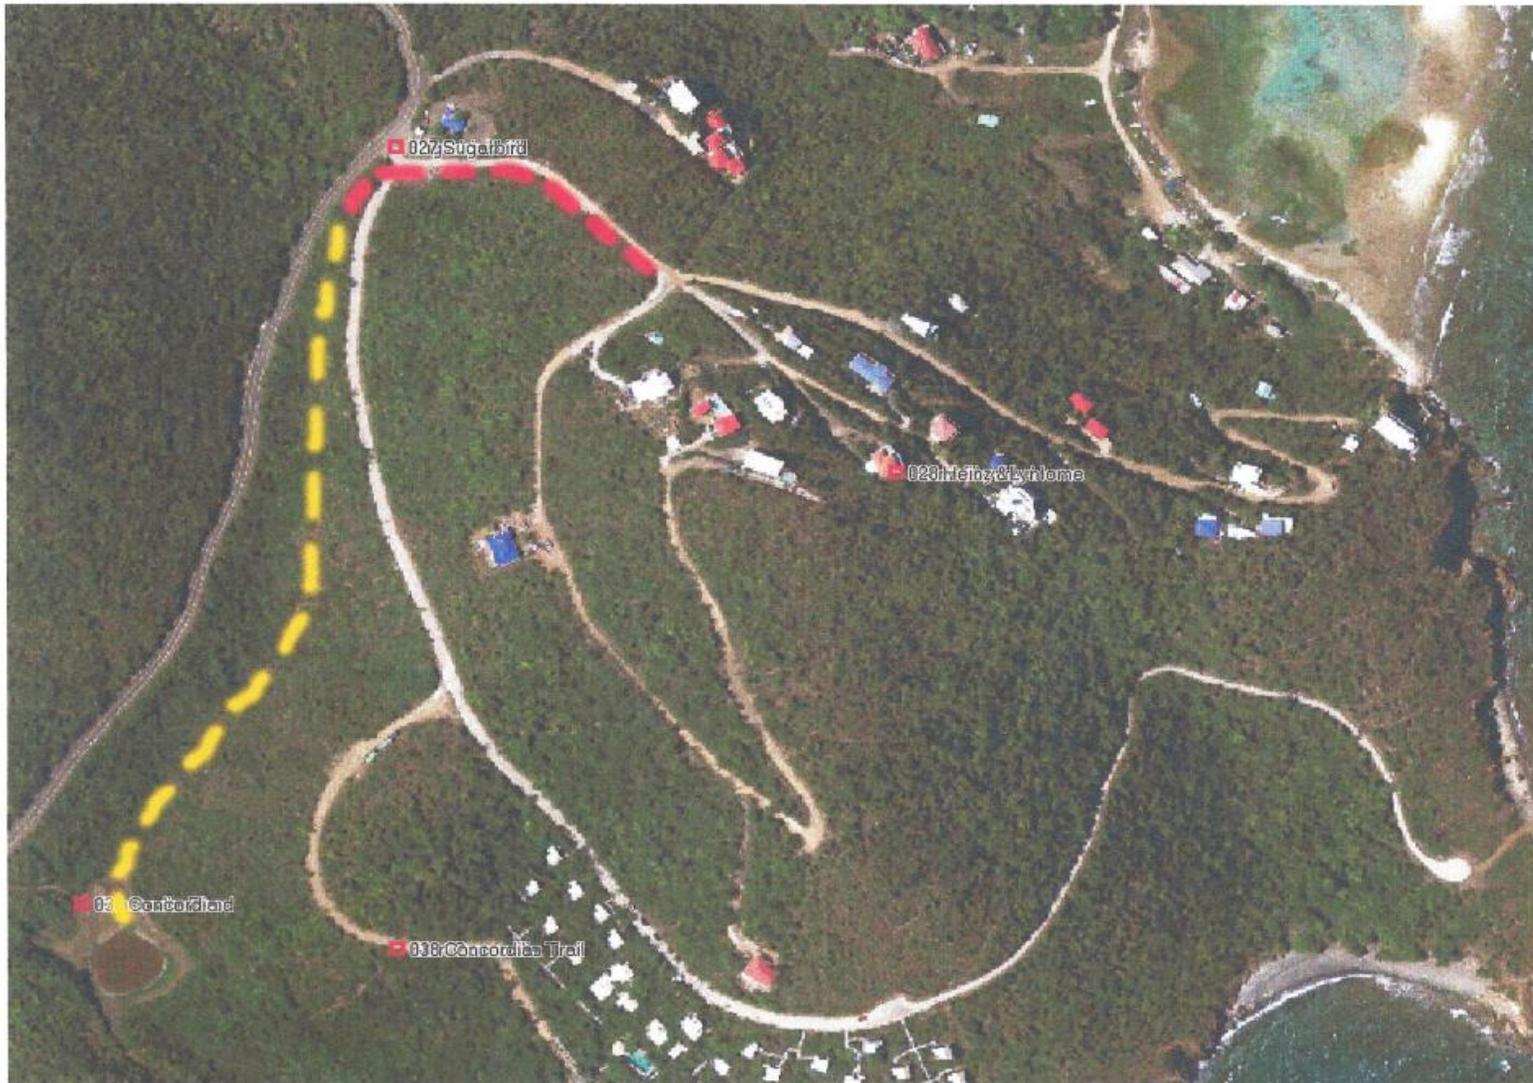
Figure 4: Drainage Basin #2 - Sugarbird Hill Drainage Path (Red – constructed; Yellow – natural)

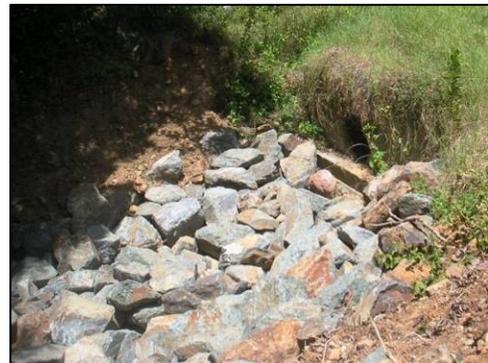
Photo 7: Drainage Basin #1 plunge pool repair riprap.

Plunge pools form as the result of scour where water comes off a waterfall or manmade object such as a spillway. At John’s Folly, flows from a culvert outlet have eroded the ghut forming a plunge pool that requires repair and stabilization. The contractor excavated the plunge pool to produce a relatively smooth sided area. He then installed Propex® TRM on the excavation sub-grades. Finally he placed large rock riprap (<1’ diameter) on the Propex® TRM and

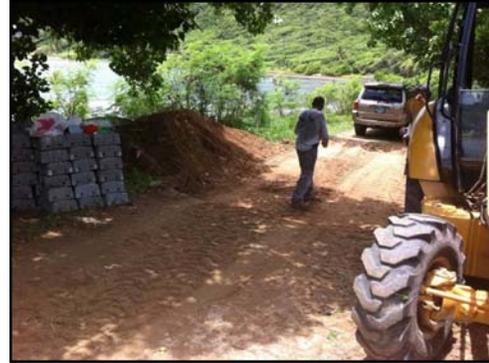
Photo 8: Drainage Basin #1 shoreline swale under construction.

Stormwater managers typically use swales to convey runoff in a desired direction. For instance, “cross-road” swales are used to channel runoff from one side of the road to the other into appropriate drainages. For Drainage Basin #1, CBCC armored two existing swales across the shoreline road and into John’s Folly Bay to stop deterioration of the road and reduce erosion, which was contributing sediment to the bay. The Stormwater Engineer chose to use Armorflex® articulated blocks in the swales partly as a demonstration project to see if they could be an alternative to concrete paving. Swale construction (Photo 8) included excavation and construction of Armorflex® lined swales with an erosion control mat underlay. Each swale was designed to be 12 feet wide, 1-foot deep, and 17 feet long.

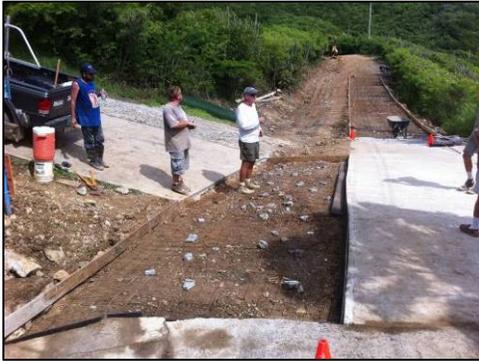
Photo 9: Sugarbird Hill roadwork showing paving installation.

As noted above, engineers design roadside drainage to funnel water to appropriate drainage areas. At Sugarbird Hill, the contractor constructed a 484-foot long grass-lined drainage channel alongside Sugarbird Road to funnel water downhill towards Route 107 (Photos 12-14). Drainage channel construction included: (1) excavation so the finished channel drains at a grade of at least one inch in four feet without low spots that would hold water; (2) placing Propex® TRM

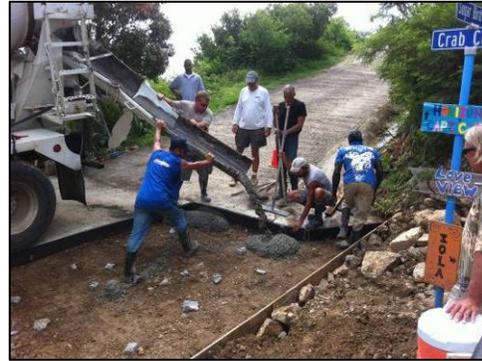
Photo 10: Sugarbird Hill roadwork showing paving installation.

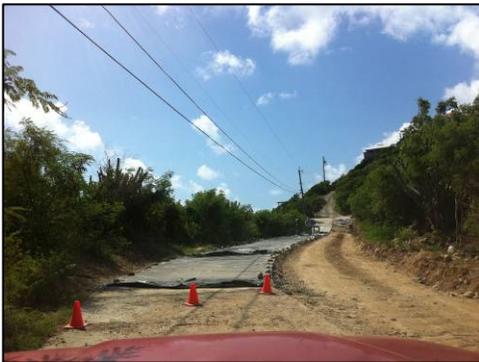
Photo 11: Sugarbird Hill roadwork showing paving installation.

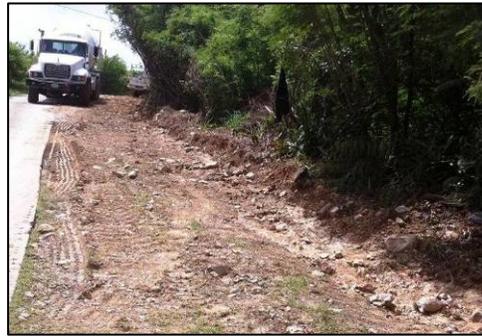
Photo 12: Sugarbird Hill roadside drainage channel under construction.

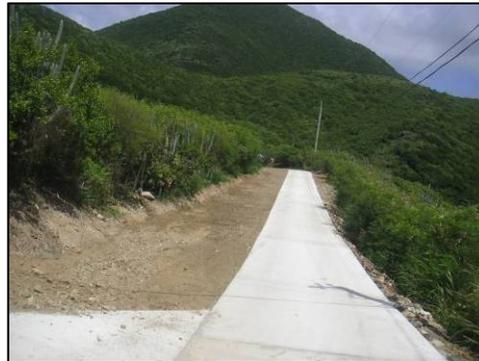
Photo 13: Sugarbird Hill roadwork showing wide width of roadside swale and completed paving.

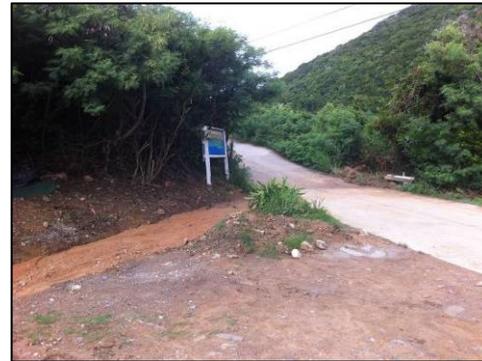
Photo 14: Sugarbird Hill new roadside swale leading to existing cross-road swale.

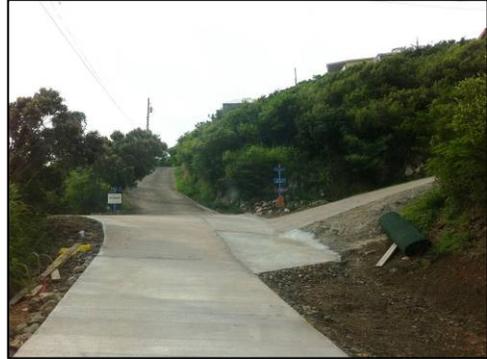
Photo 15: Sugarbird Hill new swale paving to direct water to roadside channel.

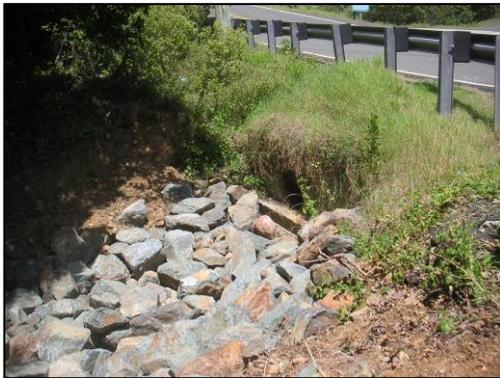
Photo 16: Drainage Basin #1 riprap plunge pool outfall.

The photos below depict completed BMPs including a riprap plunge pool outfall (Photo 16), Armorflex® swale (Photo 17), rock check dam (Photo 18), and roadside swale and paving (Photo 19). Attachment A includes the interpretive poster to highlight these achievements. Additionally, because CBCC’s Stormwater Engineer provided additional expert advice on Sugarbird Hill’s Donkey Trail Road, the HOA was able to fund construction to divert additional road runoff away from John’s Folly Bay.

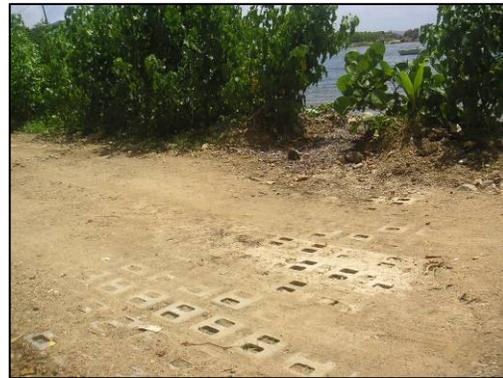
Photo 17: Drainage Basin #1 Armorflex® swale.

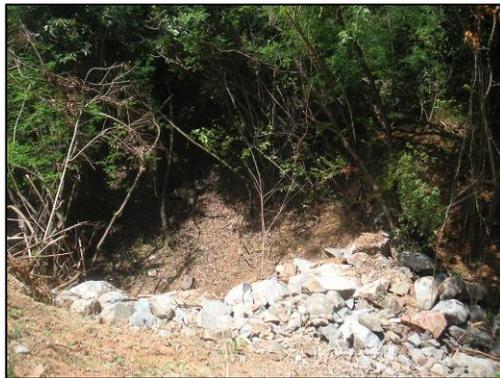
Photo 18: Drainage Basin #1 rock check dam.

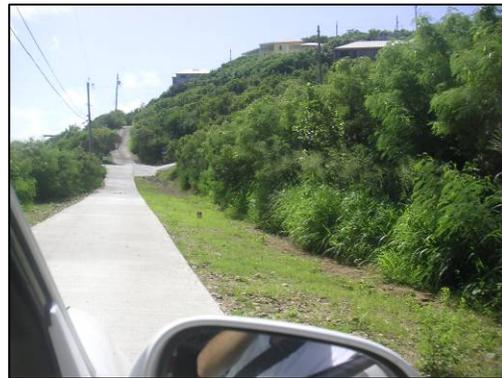
Photo 19: Drainage Basin #2 Sugarbird Hill roadwork.
