EVALUATING THE SEDIMENT RETENTION FUNCTION OF SALT POND SYSTEMS IN THE U.S. VIRGIN ISLANDS

February 16, 2006

Water Resources Research Institute
University of the Virgin Islands
St. Thomas, USVI 00802

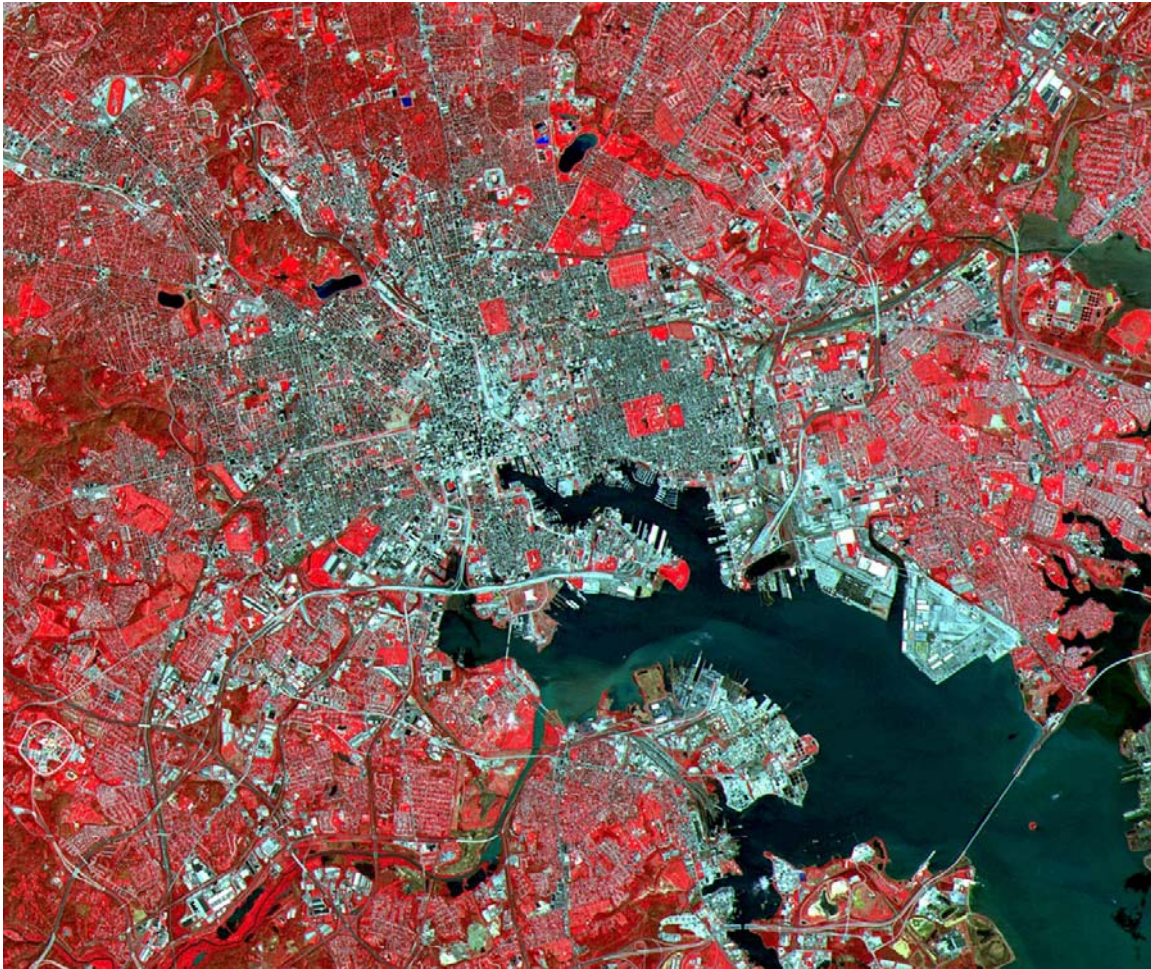
Figure 26. ASTER image of Baltimore, Maryland (Advanced Spaceborne Thermal Emission and Reflection Radiometer), April 4, 2000. Sediment in the water column in Baltimore Harbor is evident as it disperses from the river running from the bottom left corner to the south side of the harbor.

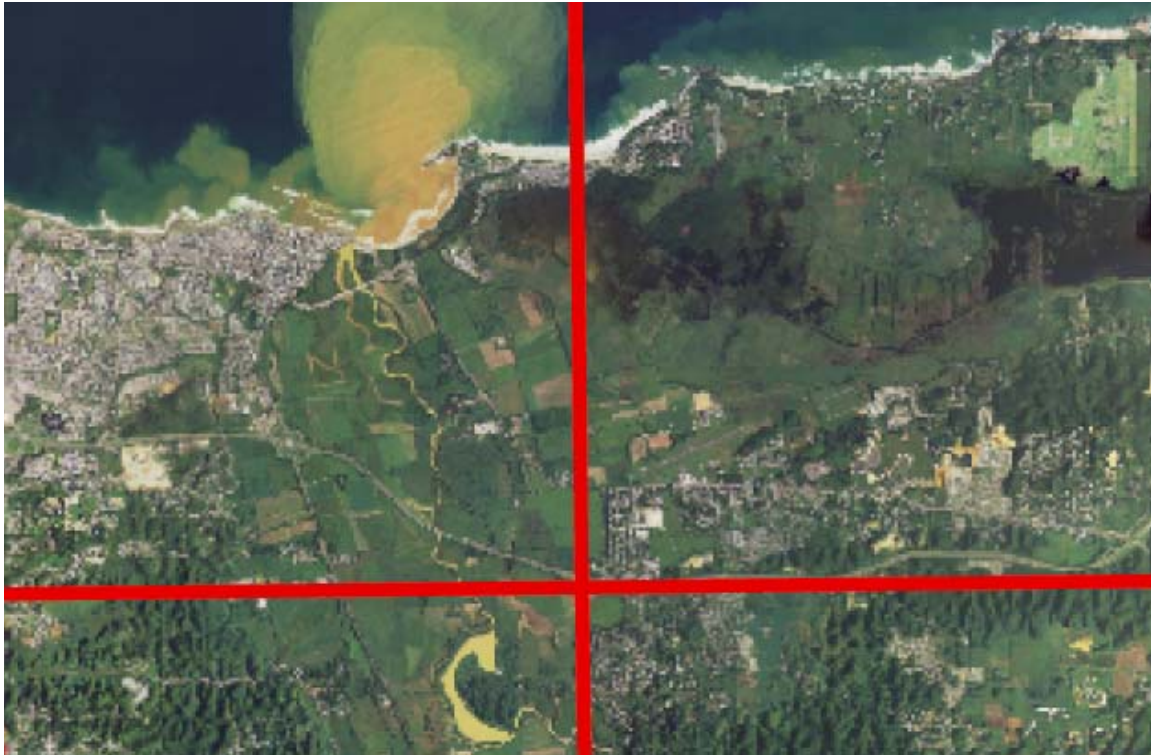
Figure 27. Northwestern coast of Puerto Rico, Arecibo, Rio Grande de Arecibo. September 21, 2004. Sediment is evident in the Rio Grande de Arecibo itself and a sediment plume is evident at the mouth of the river in the nearshore waters.

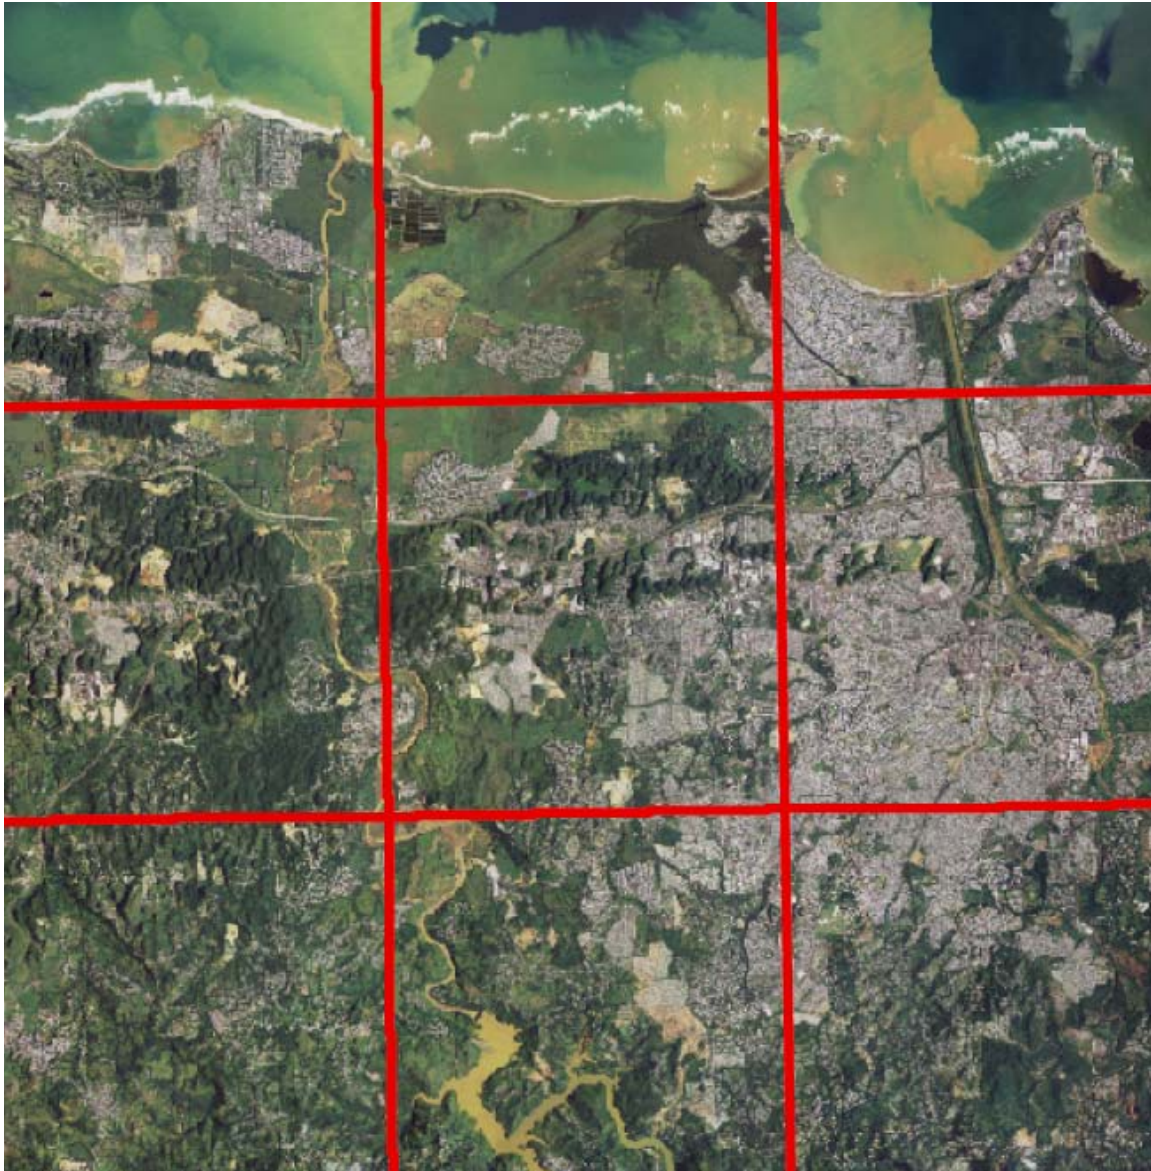
Figure 28. North central coast of Puerto Rico, San Juan area. September 21, 2004. West -- Rio de la Plata, East -- Rio de la Bayamon. Sediment plumes are evident at the mouths of both rivers.

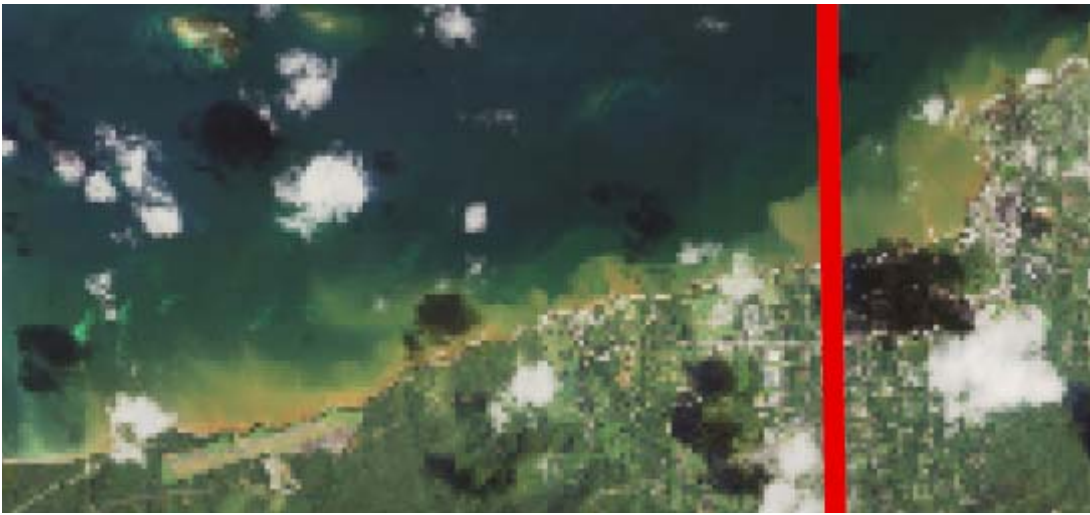
Figure 29. Northshore of Vieques. September 21, 2004. In the lower left is the Aeropuerto de Vieques, in the upper right is the town of Isabel Segunda. Suspended sediment in the water column is evident along much of the depicted coastline.

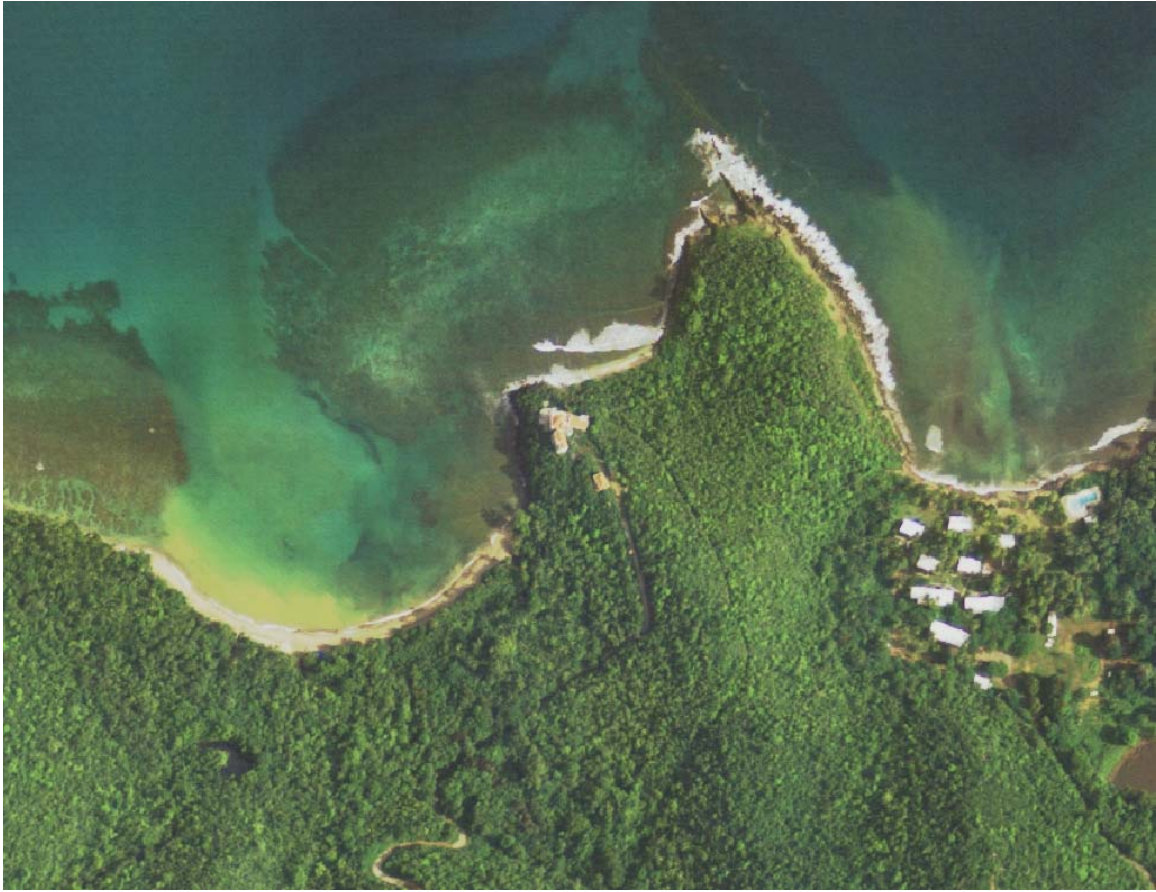
Figure 30. Neltjeberg Bay, north coast of St Thomas, USVI. September 21, 2004. The yellowish band immediately off the beach is a sediment plume.

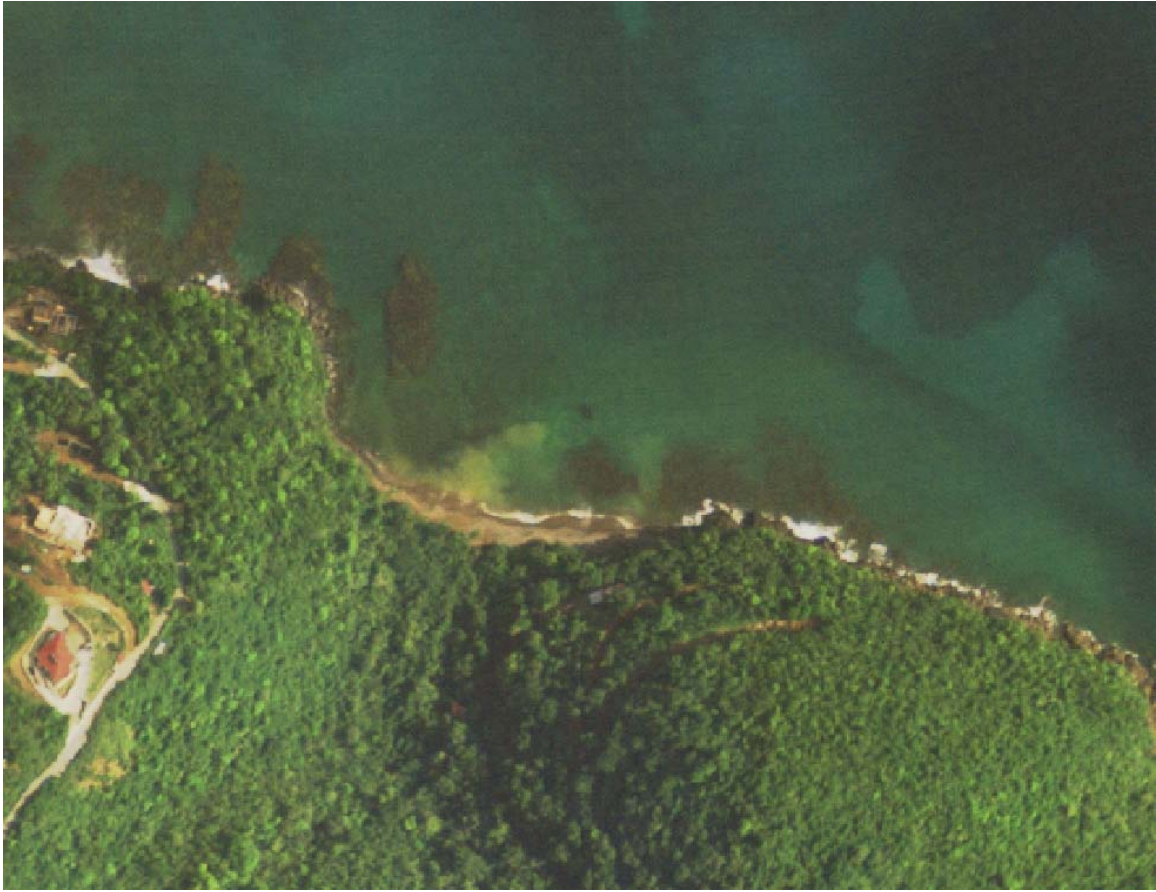
Figure 31. Lerkenlund Bay (in Magens Bay, north coast of St Thomas, USVI. September 21, 2004. The yellowish plume immediately off the beach is a sediment plume.
