Implementation of an Erosion Control Program to Reduce Sediment Loading Rates from Land-Based Sources to the Coral Reefs of Culebra, Puerto Rico

Punta del Viento Estates Development Area

August 2012

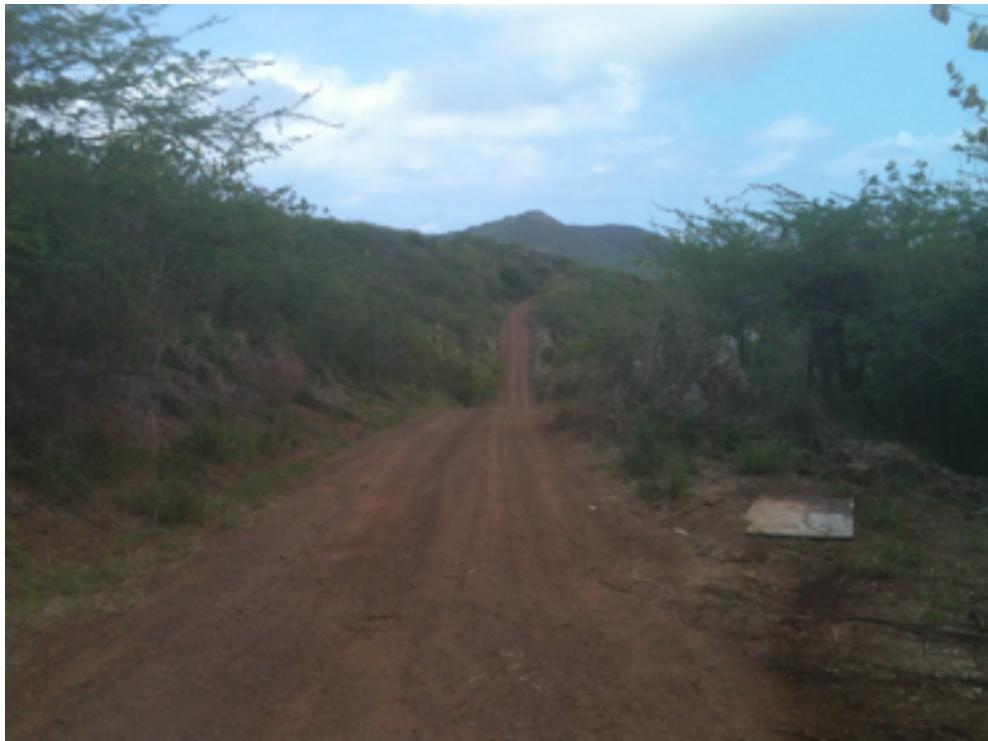
Figure 1. Illustrates one of the road areas for stabilization in Punta del Viento

Approximately one half mile of road was stabilized with a number of practices including approximately 30 rock check dams, 5 inlet and outlet protection, 3 cross swales to convey water in small amount to native vegetation areas where water could be infiltrated and uptaken by plants. The main goal was really to distribute the runoff into as small as units as possible -- so it would have minimal time to pick up additional sediment, and so it could be effectively managed by natural vegetation and soils.

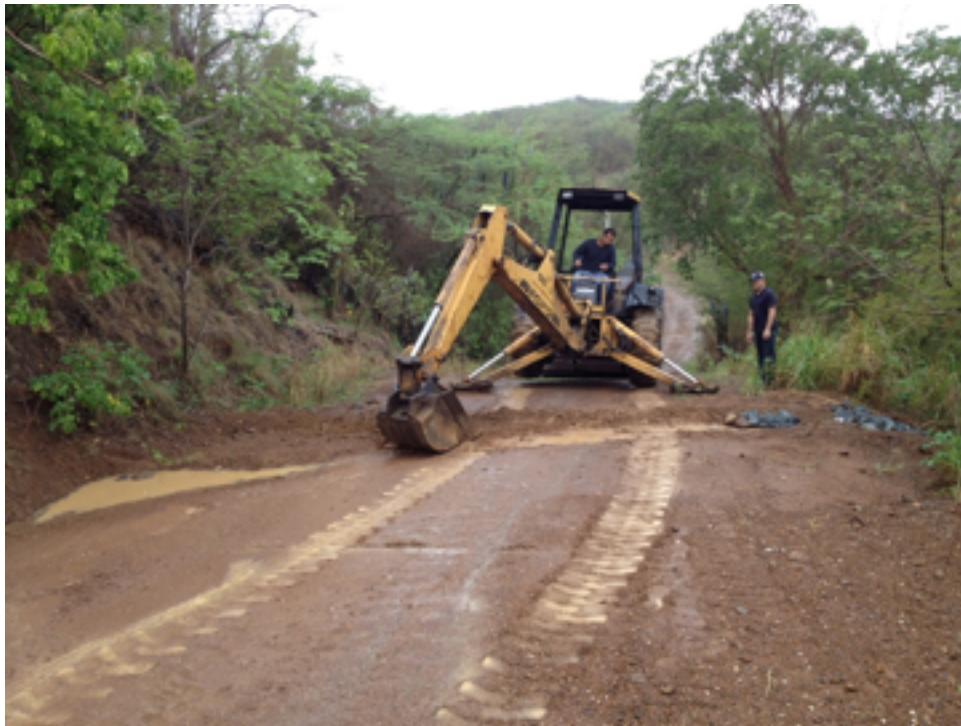
Figure 3. Illustrates the construction of a cross swale and outlet protection

The main practices installed were cross swales (Figure 3), rock check dams (Figure 6) and rock outlet protection (Figure 3). Cross swales were used to distribute the flow into smaller units before return to vegetation; rock check dams were used to slow velocities; and rock outlet protection was used to limit erosion and head cutting at outfalls.

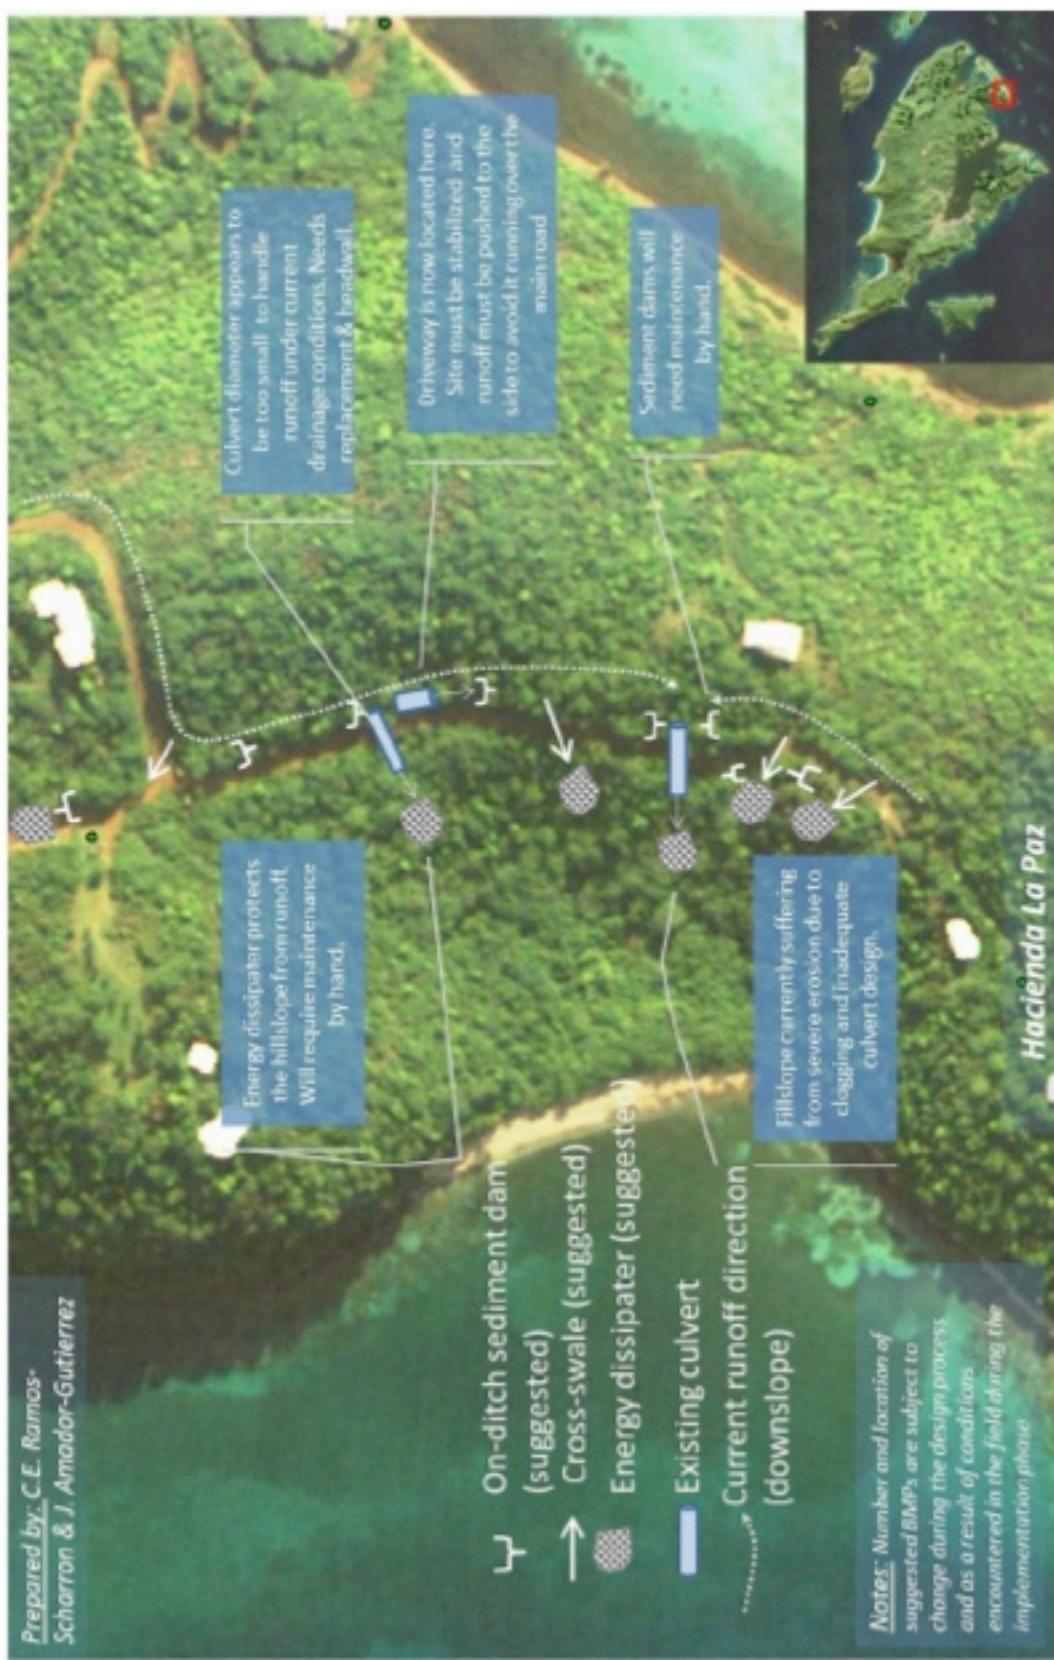
Figure 4. Restoration Site #1 and proposed practices

An overview of the work that was to be done is provided in Figure 4 and Figure 5. The main changes to the original design were adding additional check dams to reduce velocity in the drainage channels and the inability to create a cross swale across the road at Restoration Site #2 because of a shallow existing water line (additional check dams were used to reduce the velocity of water flow to compensate for the limitation). Eduardo and Juan, the on-site engineers with GMA COOP, organized the personnel on the four backhoes who were all working on various aspects of the erosion control practices at the same time and they completed the work quickly. Our limitation to accomplishing even more beyond the scope was the limited amount of rock we had for the check dams and outfall protection.

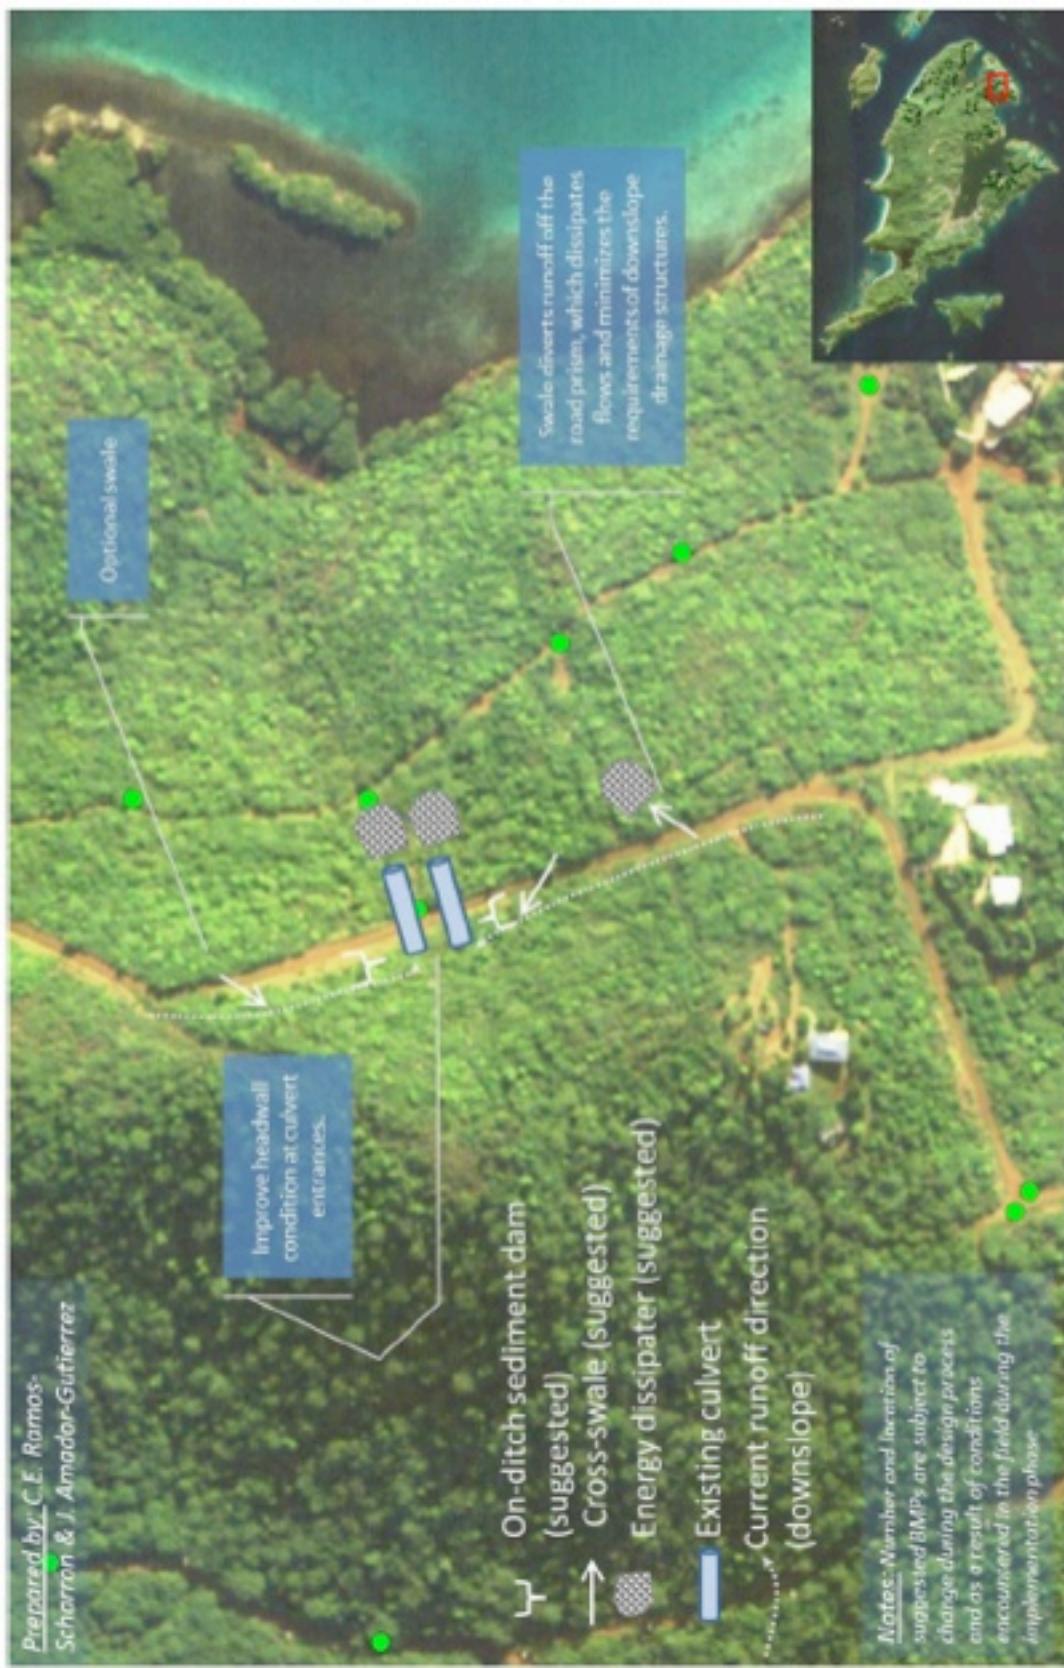
Figure 5. Restoration Site #2 and Proposed Practices

In the future some of the design work can be done as the stabilization is being completed as microtopography and utilities are not mapped by are in many cases only known by the operators themselves -- since they installed them. As a result in the field in our recent work, we had to change the designs due to the location of a water line in the middle of the road -- that limited any excavation on the road surface.

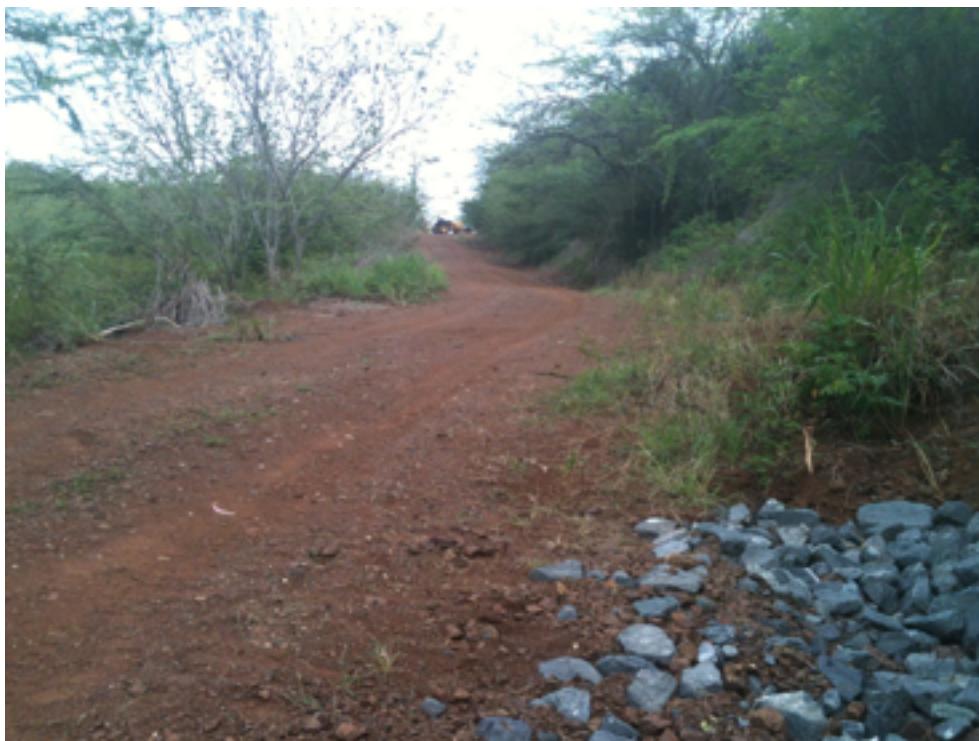
Figure 6. Note a series of check dams up the hill on the right (these slow the velocity of the water and drop out sediments) also the cross swale in Figure 3 was constructed midway up the hill to reduce the drainage area of the flowpath. The rocks in the foreground attenuate flows coming from the opposite direction.

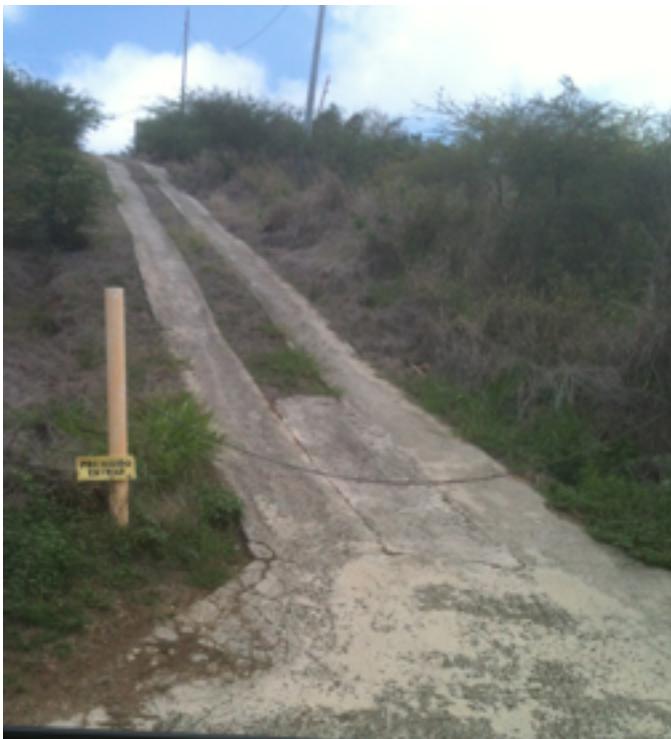
Figure 8. Example of a road on a steep slope that seemed to have minimal impact - two track drive - minimal impervious cover and crowned in the middle. This is a potential BMP for steep high use areas.
