**Design and Implementation of Watershed  
Restoration Projects in the  
Manell and Geus Watersheds  
in Southern Guam**

**NOAA/ National Marine Fisheries Service  
Pacific Islands Regional Office,  
Habitat Conservation Division**

EA Engineering, Science, and Technology, Inc., PBC

December 2014

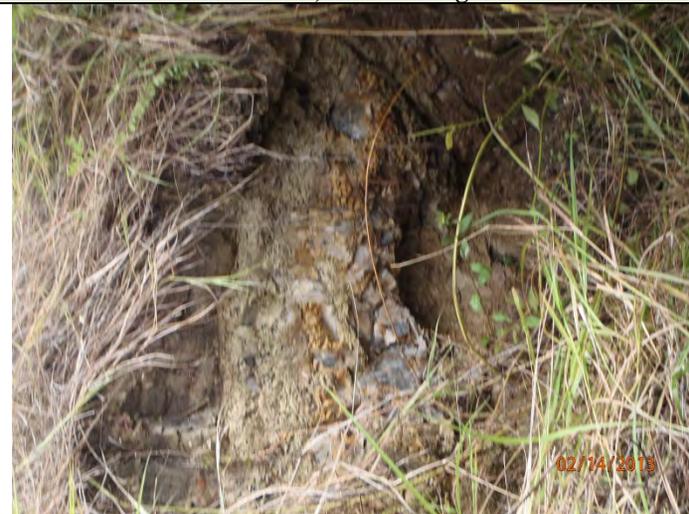
**Manell Site 1, Soil Texture**

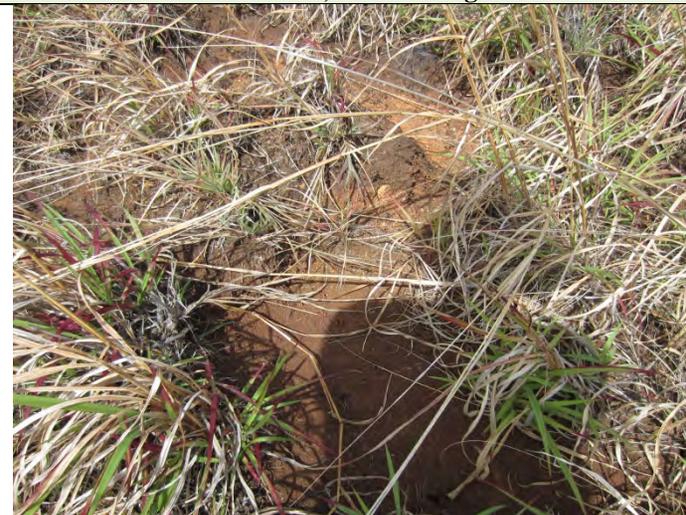
**Manell Site 2, Sparse Vegetation Cover**

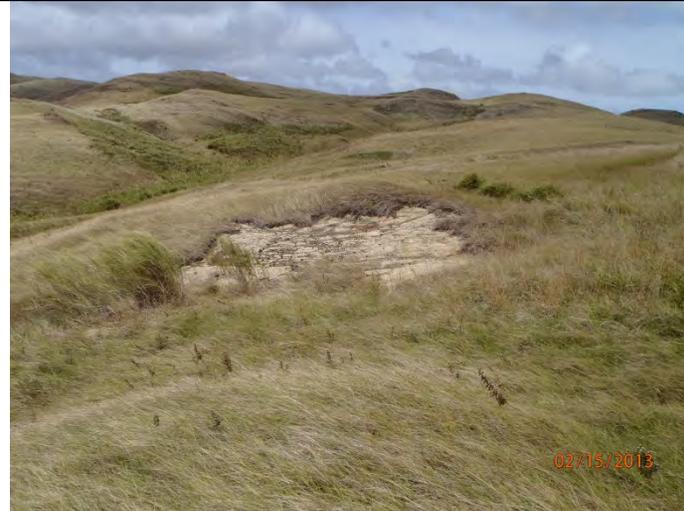
**Manell Site 3, Bare Patch of Soil from Erosion**

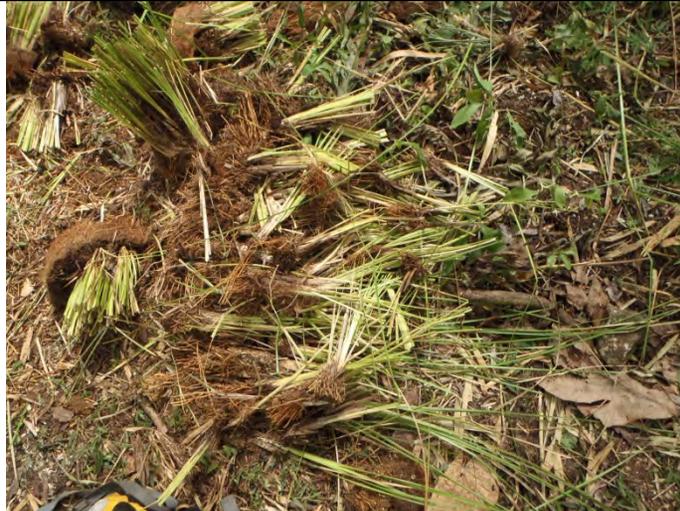
**Geus Site 1, Preparing Vetiver Slips for Planting**

- *Bare Root Planting.* Bare root specimens of vetiver grass at four stems per linear foot were selected to hold deep loose soil such as in colluvial deposits, as well as create vegetative filter strips near channels and head cuts to limit the surface transport of sediment into stream channels. Vetiver is a non-native species from Southeast Asia, however it does not produce seed and spreads through rhizomatous action. It is seen as a local control for erosion with low risk of spreading to pristine habitats as an invasive species. Coupled with tree and shrub plantings, it is likely to be eventually shaded and replaced by native species, once canopy is established.

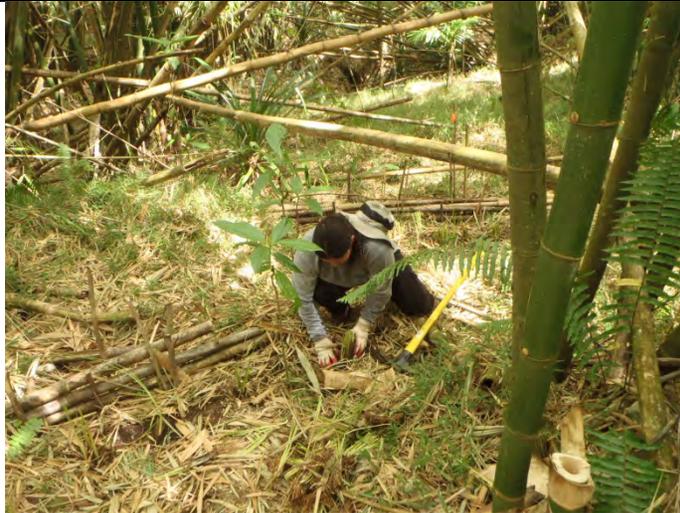
**Geus Site 1, Installed 1<sup>st</sup> Log Check Dam and Filter Strips**

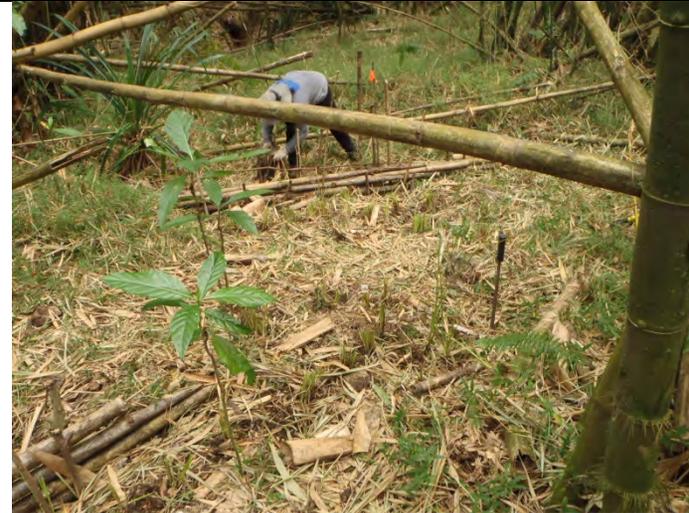
**Geus Site 1, Completed Log Check Dams and Filter Strips**

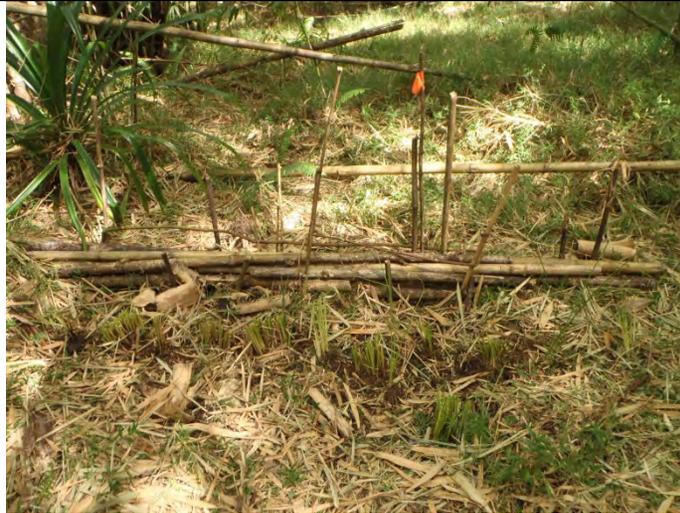
**Geus Site 1, Installed 2<sup>nd</sup> Log Check Dam and Filter Strips**

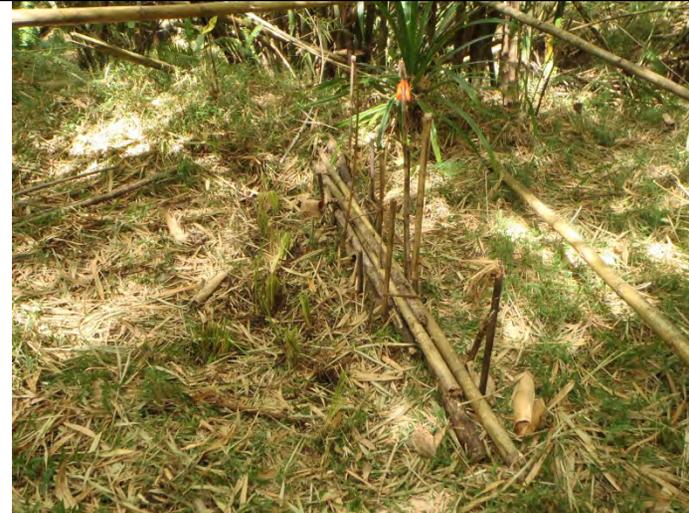
**Geus Site 1, 2<sup>nd</sup> Log Check Dam and Filter Strips**

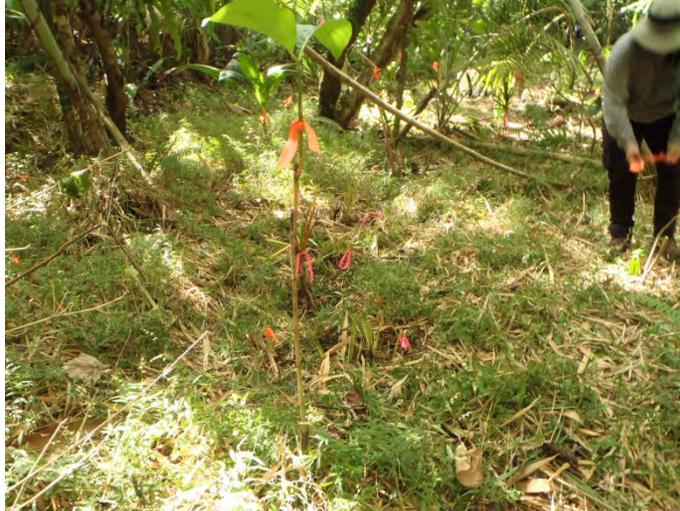
**Geus Site 1, Installation of Filter Strips in a Small Gully**

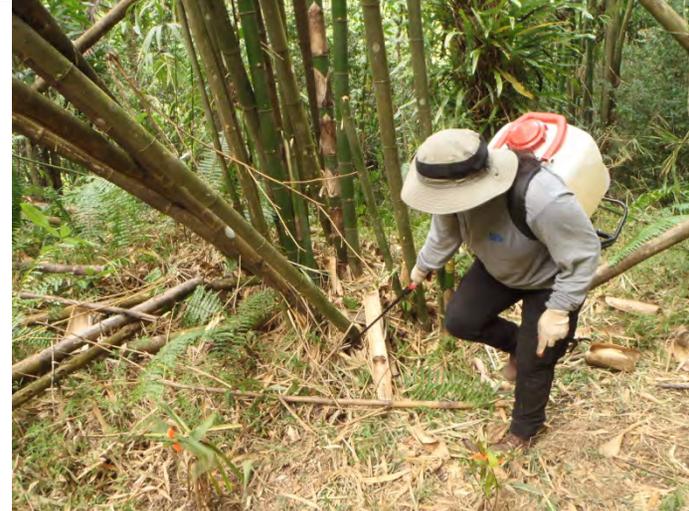
**Geus Site 1, Spraying Bamboo with Herbicide**

Within the plot, three bamboo clumps were sprayed and treated with the herbicide glyphosate using the recommended rates specified on the label. The bamboo was sprayed with one application at the bases of intact and the cut bamboo culms.

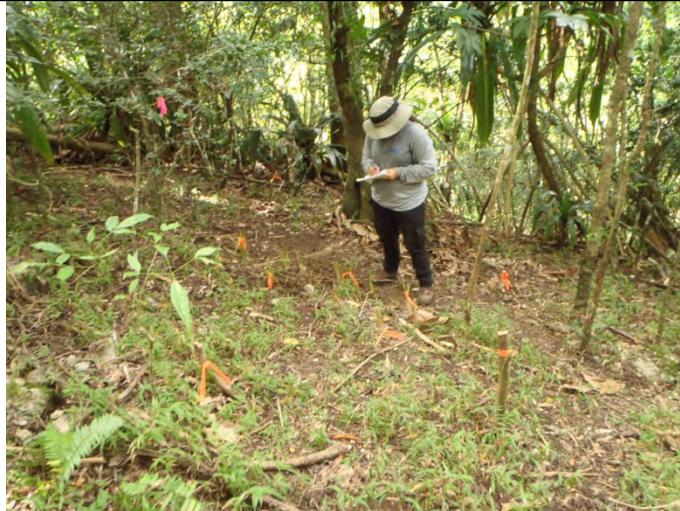
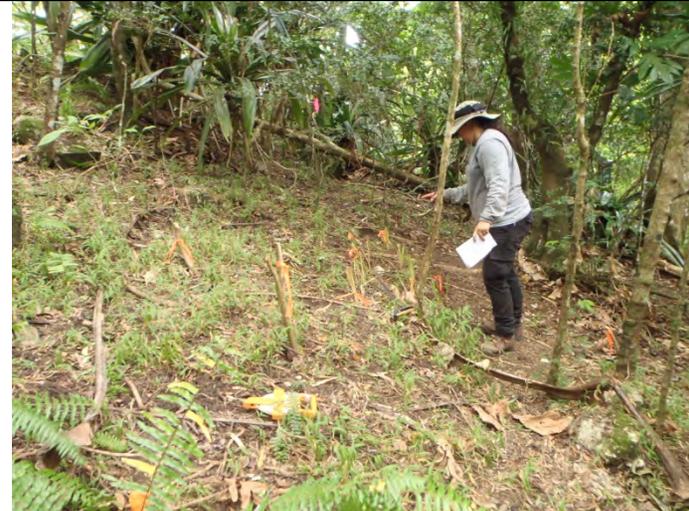
**Geus Site 2, Completed Installation of Filter Strips**

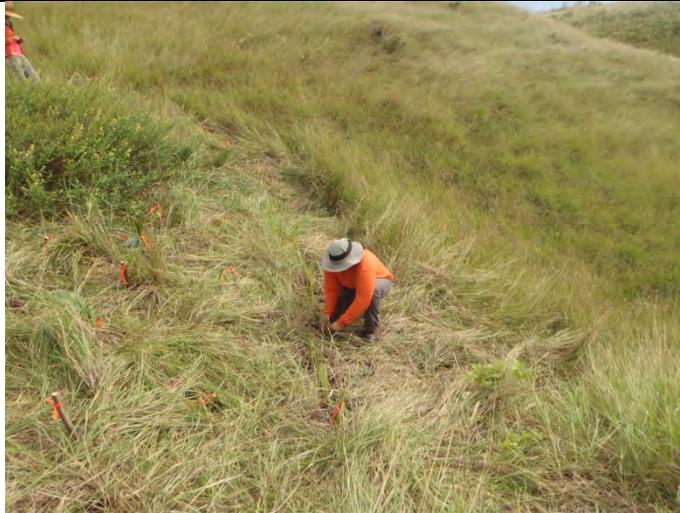
**Manell Site 1, Installation of Filter Strips**

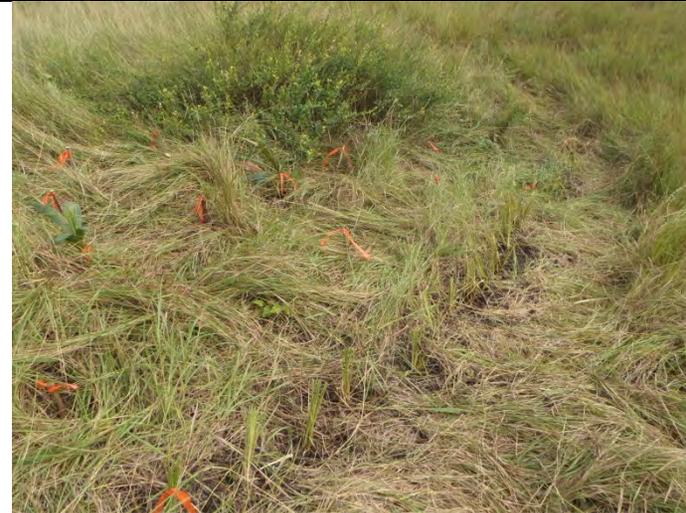
**Manell Site 1, Installation of Filter Strips and Plants**

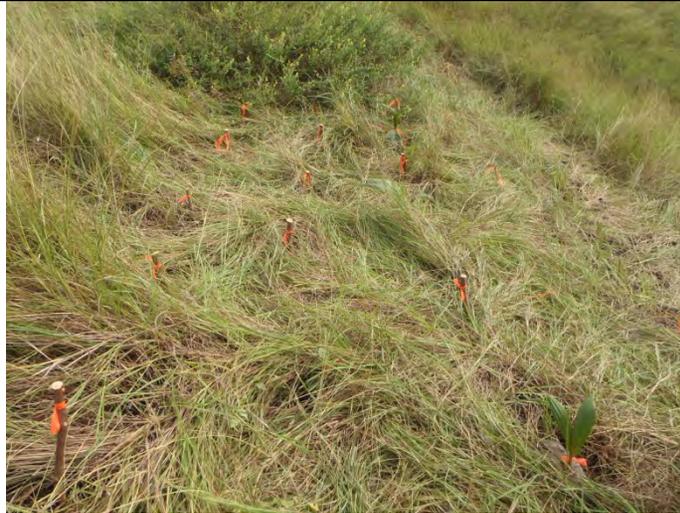
**Manell Site 1, Completed Installation of Pago Live Stakes**

- *Live Stake Planting.* Live stakes of pigo is a cost effective means of introducing vigorous riparian vegetation to the sites. Rapid growing and tolerant of wet or dry conditions, pigo live stakes can aid in the restoration of native vegetation to these sites.

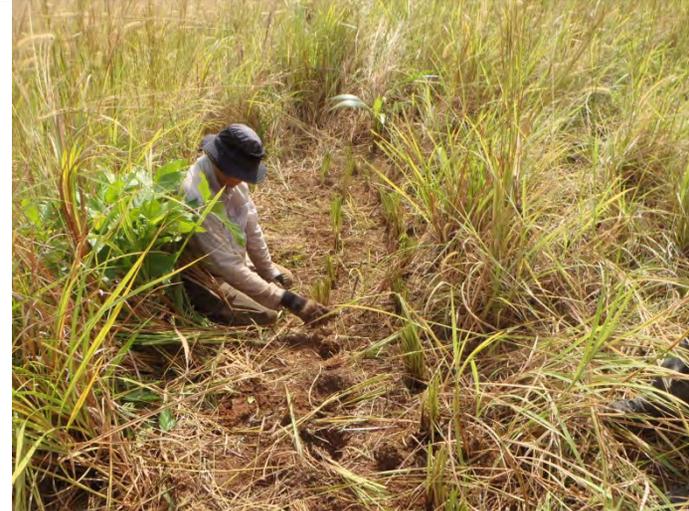
**Manell Site 2, Installation of Filter Strips and Plants**

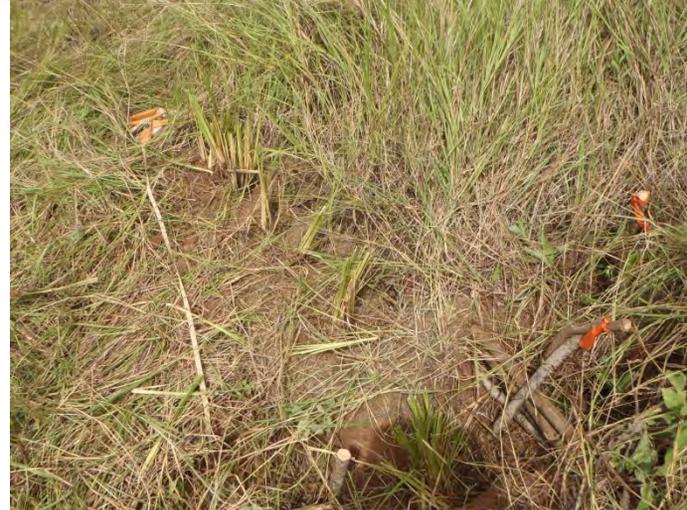
**Manell Site 3, Installation of Filter Strips and Plants**

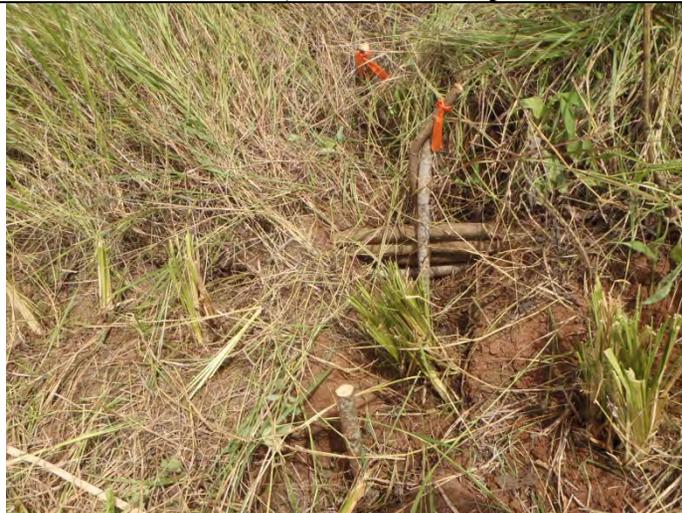
**Manell Site 3, Installation of Filter Strips and Log Check Dam**
