R I D G E T O R E E F S /  
P R O T E C T O R E S D E  
C U E N C A S

*Restoration and Implementation Efforts in Culebra*

**March 2014**

# Environmental Restoration Project Playa Tamarindo Culebra, Puerto Rico Phase I

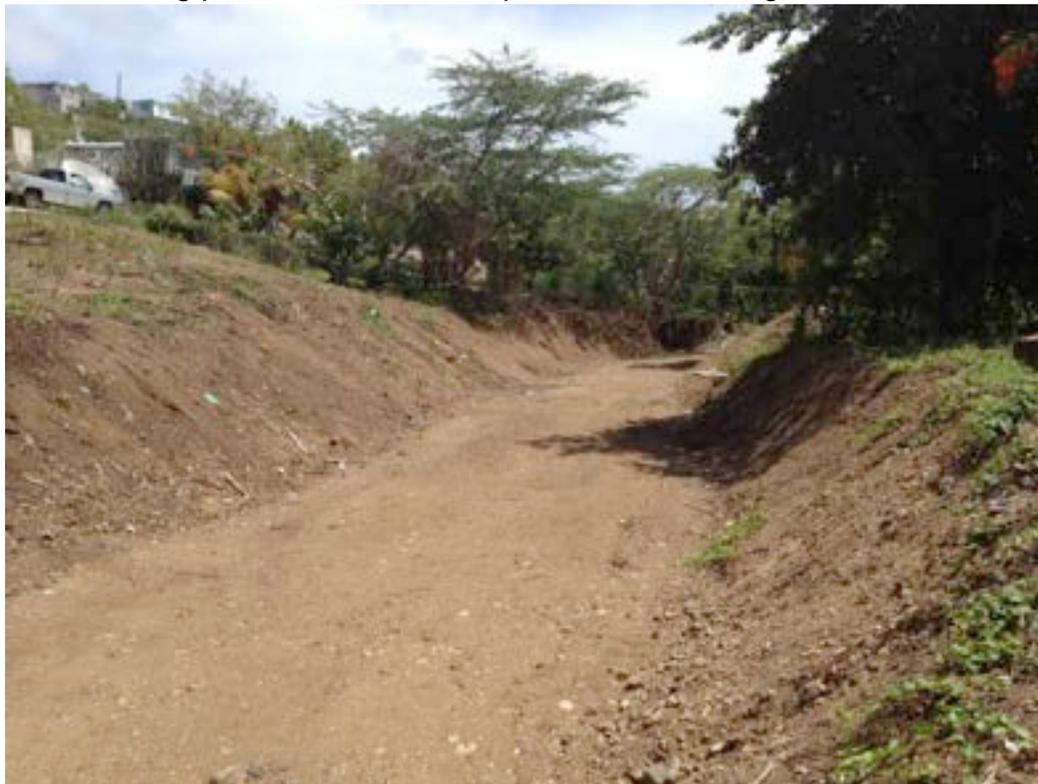
**Figure 1. Precondition -- bare soils and slopes**

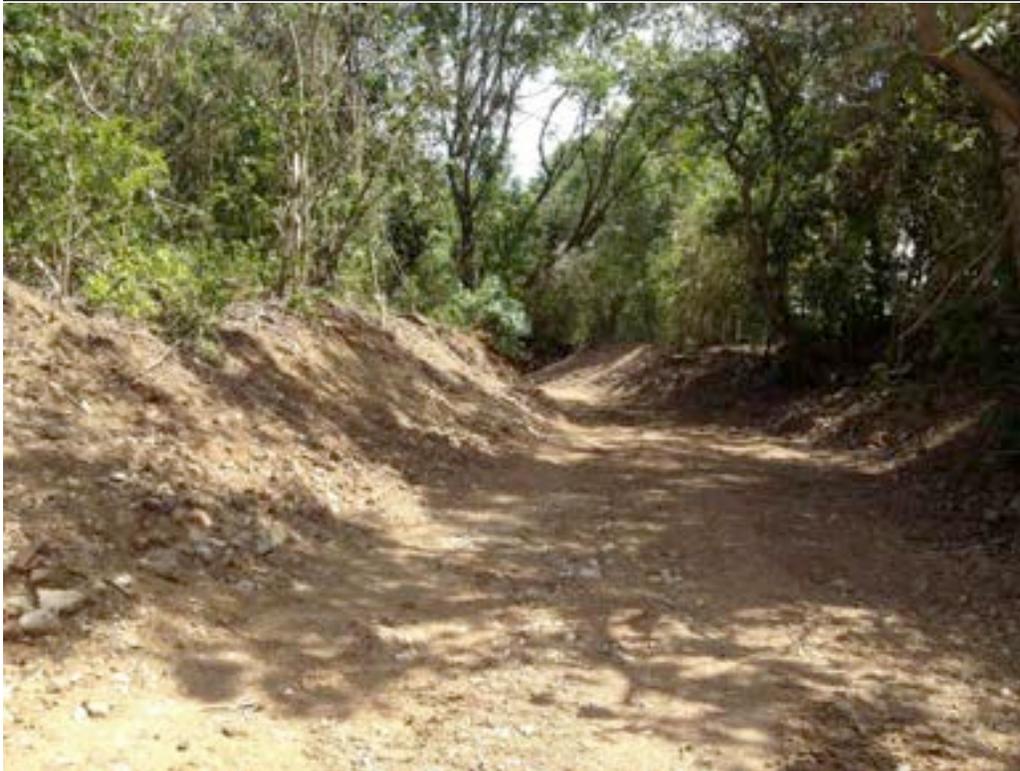
**Figure 2. More bare soils and slopes**

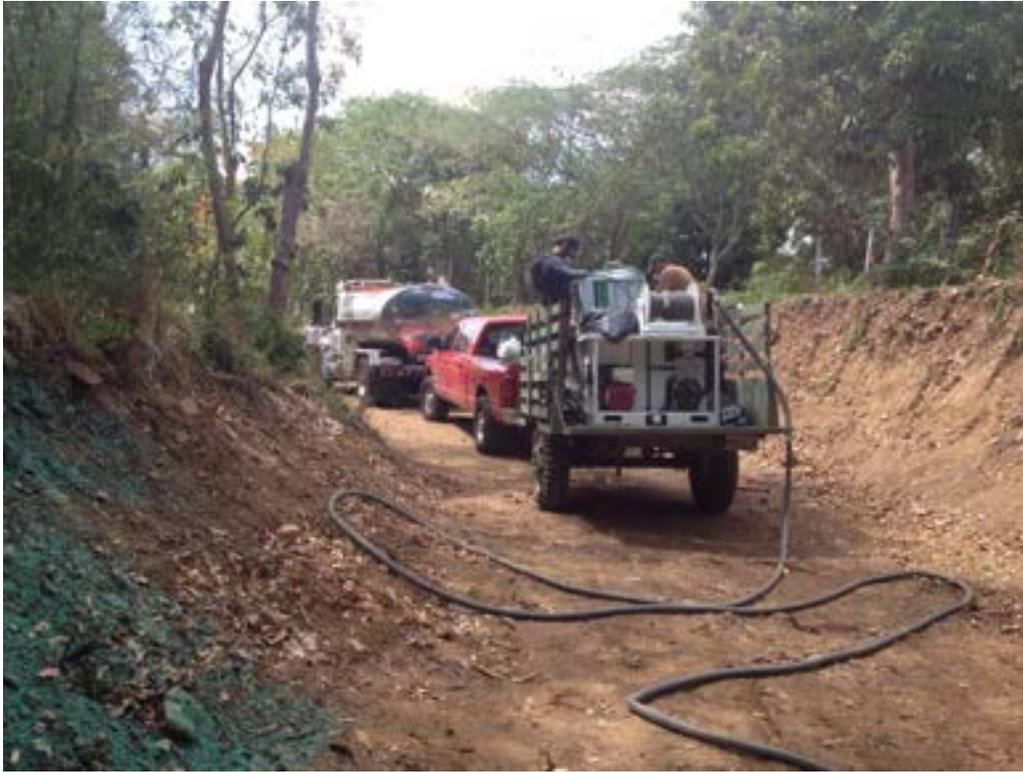
**Figure 3. Hydromulching initiation**

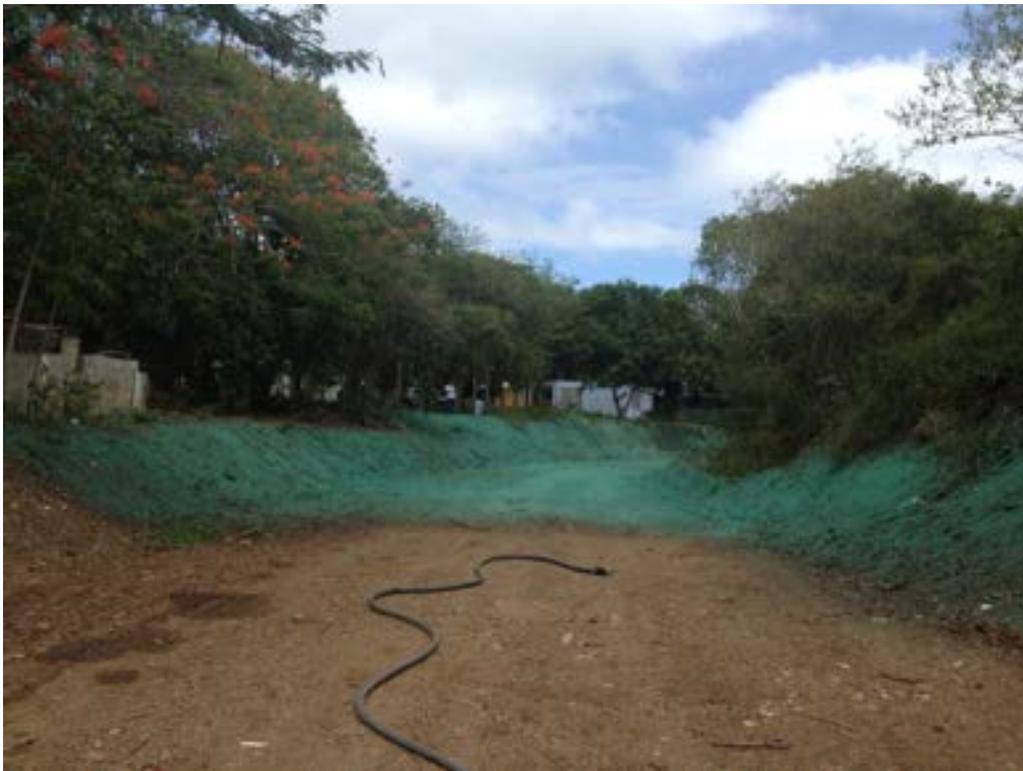
**Figure 4. Hydromulching Initiation**

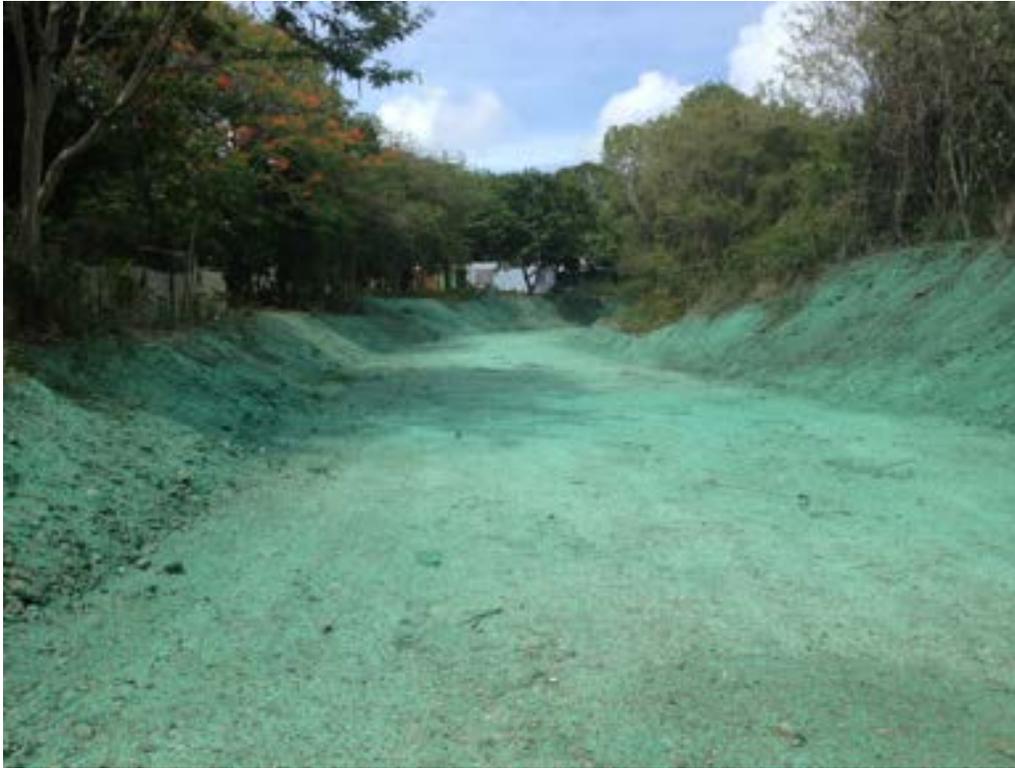
**Figure 5. Hydromulch completion**

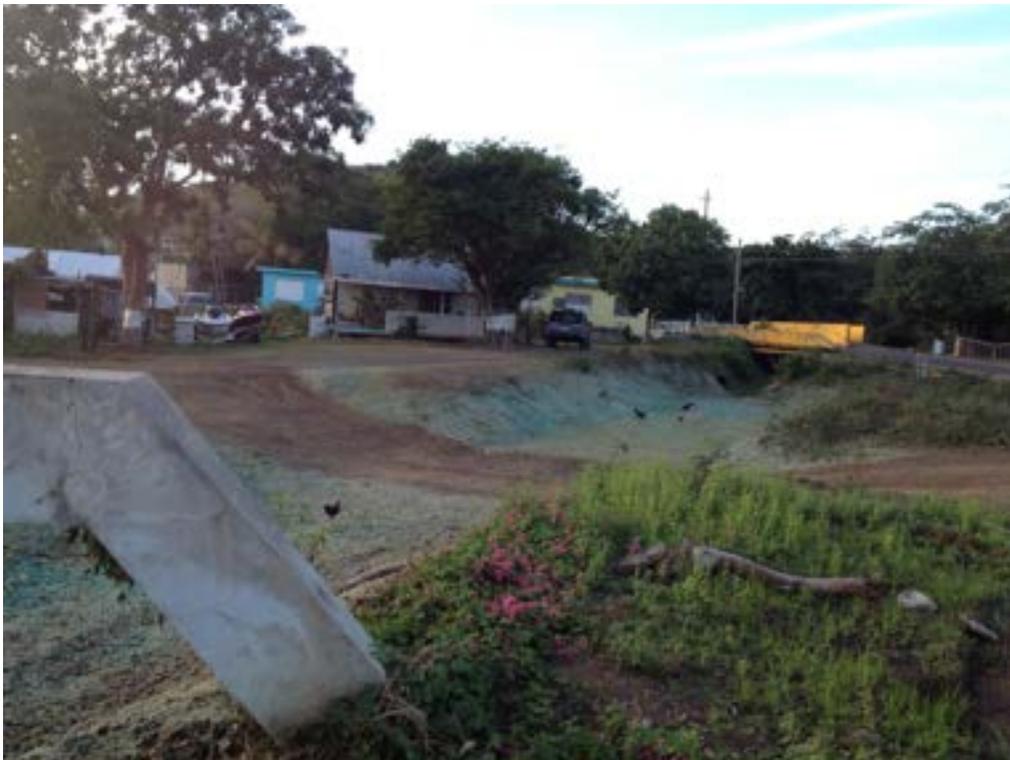
**Figure 6. More stabilization: note hungry chickens eating seed**

- Issues with chickens eating the grass seed used to stabilize the arroyo channel using hydroseeding -- particularly a challenge at the apex of the slope into the channel and the steepest parts of the bank where destabilization of the hydromulch material and seed is most vulnerable (over 100 chickens were rounded up with the community to reduce their impact on the restoration project)

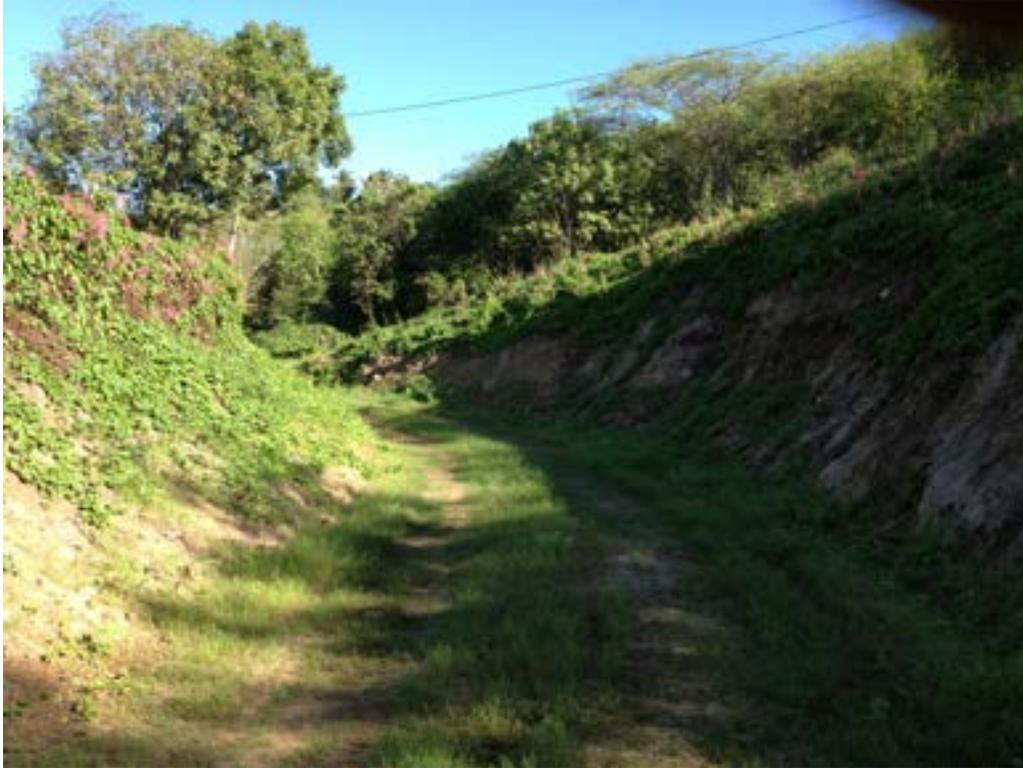
**Figure 7. Post stabilization -- note challenges with side slopes**

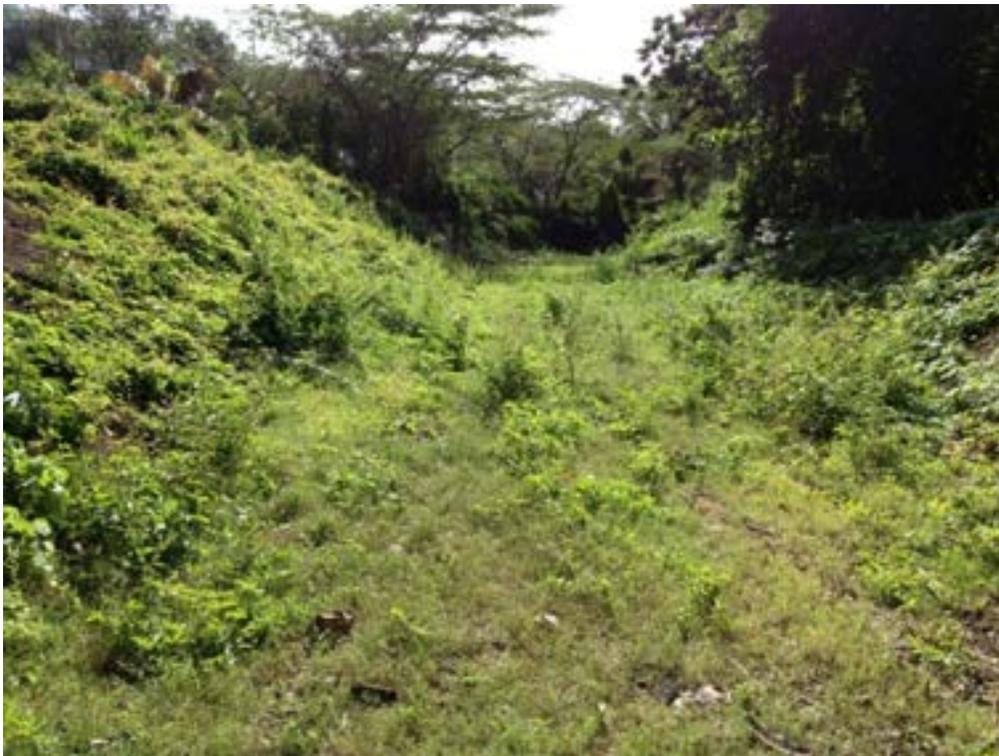
**Figure 8. More post-stabilization**

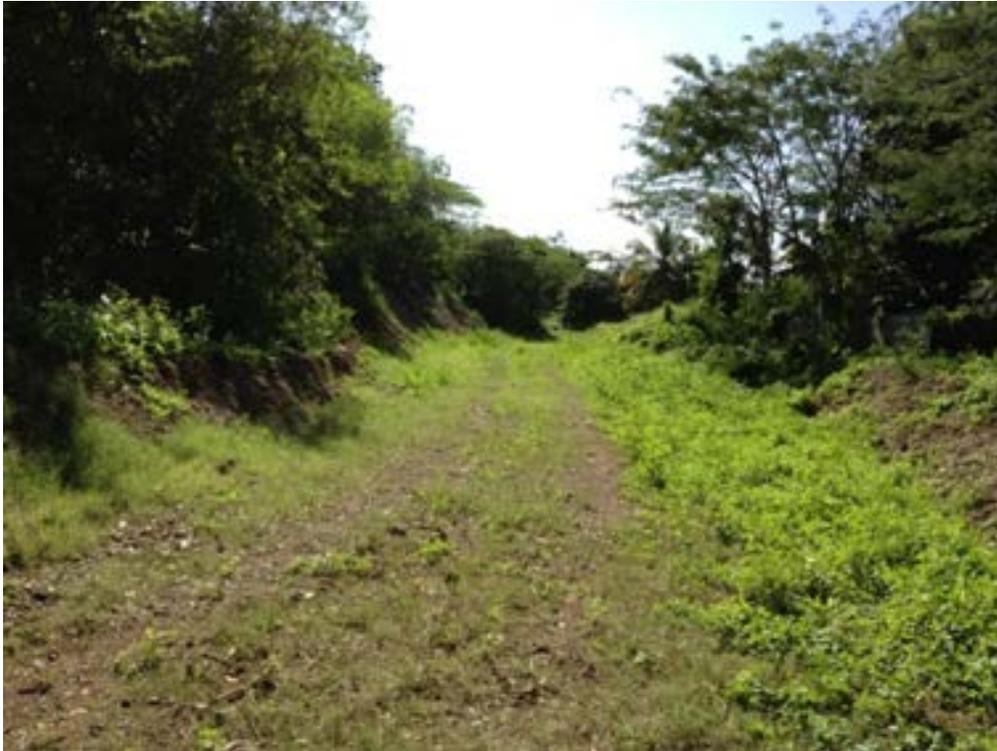
**Figure 9. More stabilization -- note tire tracks from watering truck as there was not other access to the channel in this location**

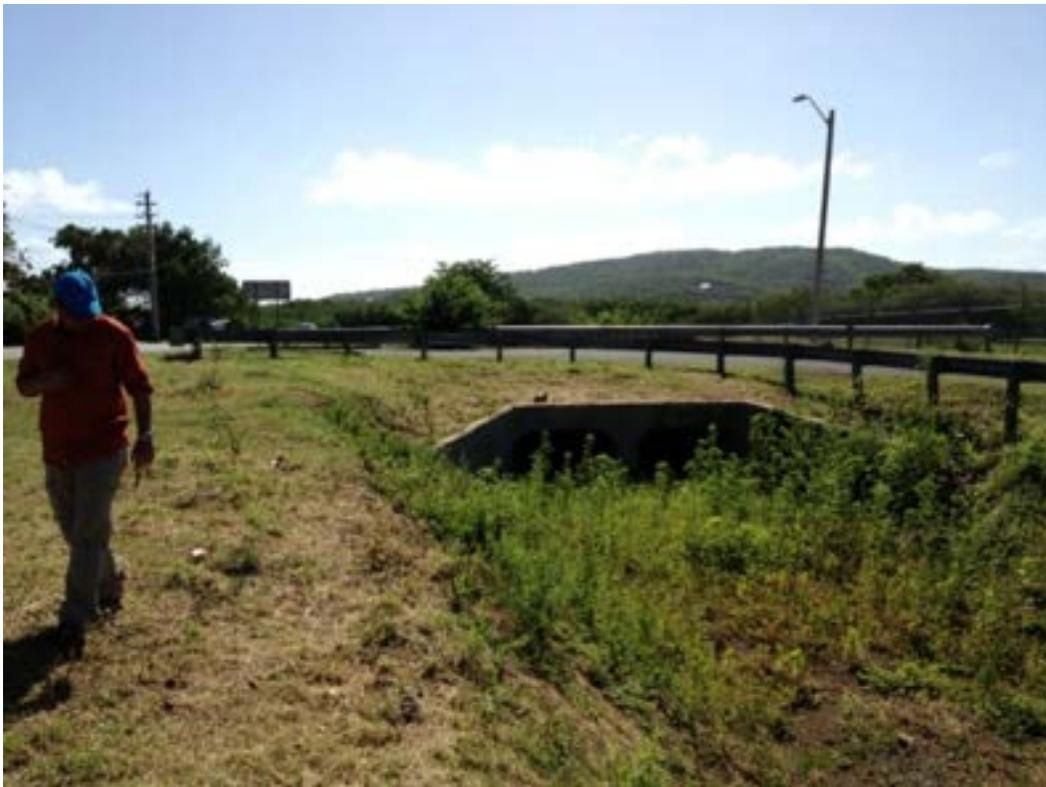
**Figure 10. Further downstream - post stabilization**

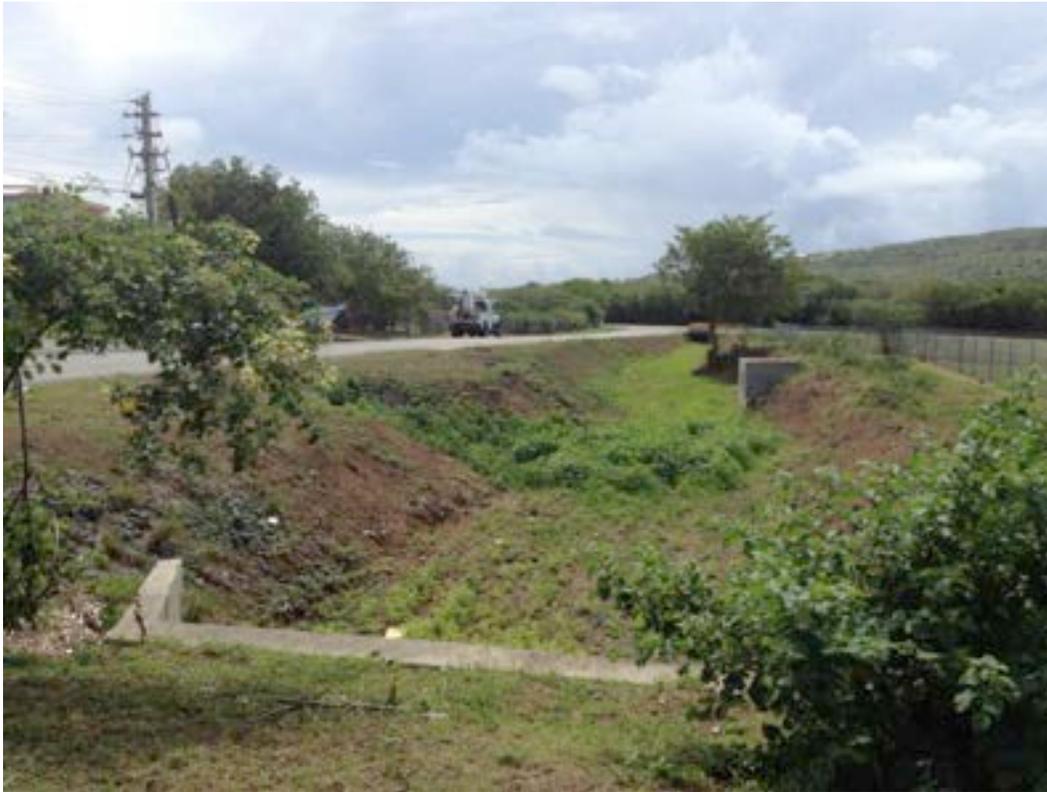
**Figure 11. Lowest section adjacent to airport**

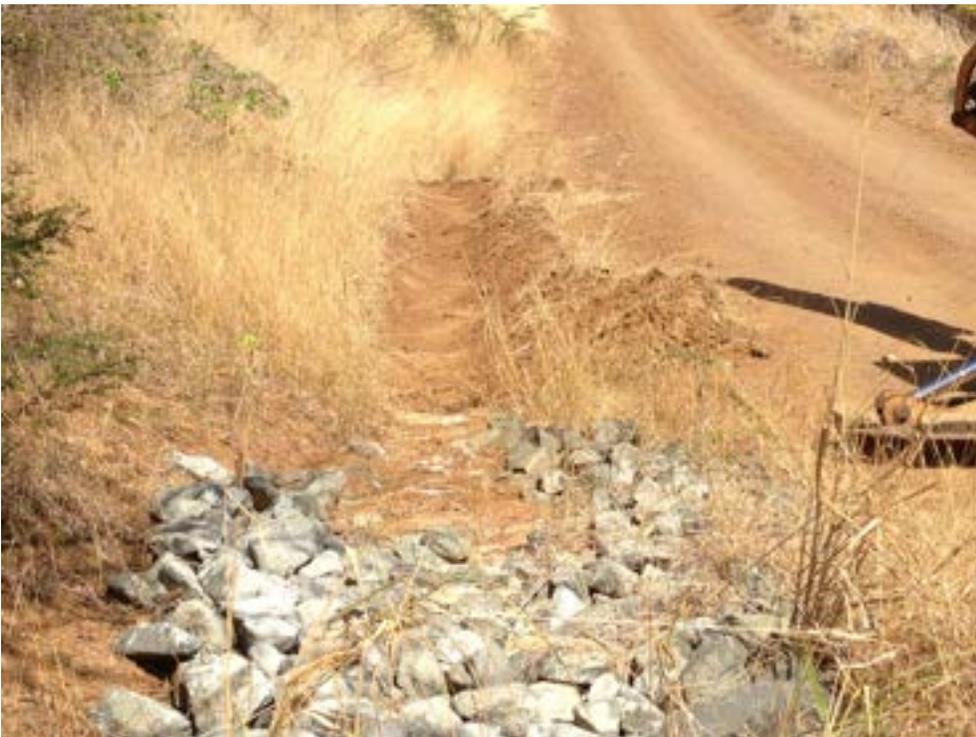
**Figure 14 Illustrates excavation adjacent to a rock check dam**

Maintenance of structures including check dams and cross swales are critical to continue sediment reductions in the Punta del Viento Estates subwatershed areas. There were many check dams that were full of sediment and one even was used by a contractor or homeowner to empty/clean out a cement truck. The maintenance effort was focused on reducing the sediment and concrete in one case from behind the check dams. This effort will allow for the further accumulation/storage of additional sediment behind the check dams and also reduces the runoff velocity. An initial verbal agreement was negotiated with Punta de Viento Estates for the on-going maintenance of the practices in the earlier project led by Greg Morris Engineering and a verbal agreement was secured by the project team with the existing president of the homeowner's association. However, a new homeowner's association president was elected after our maintenance project and coordination has been much more difficult as he is seldom on island. In addition, it had taken at least 5 hours of one-on-one education and field visits with the previous HOA president to get him up to speed on the importance of the project and the techniques used. This underscores the issue of dirt roads which needs to be addressed island-wide in Culebra and maintenance procedures and requirements should be established. Long-term maintenance and dirt road standard requirements were a major recommendation in the watershed plan and efforts to improve these programs at the municipal level will be initiated with FY13 funds.

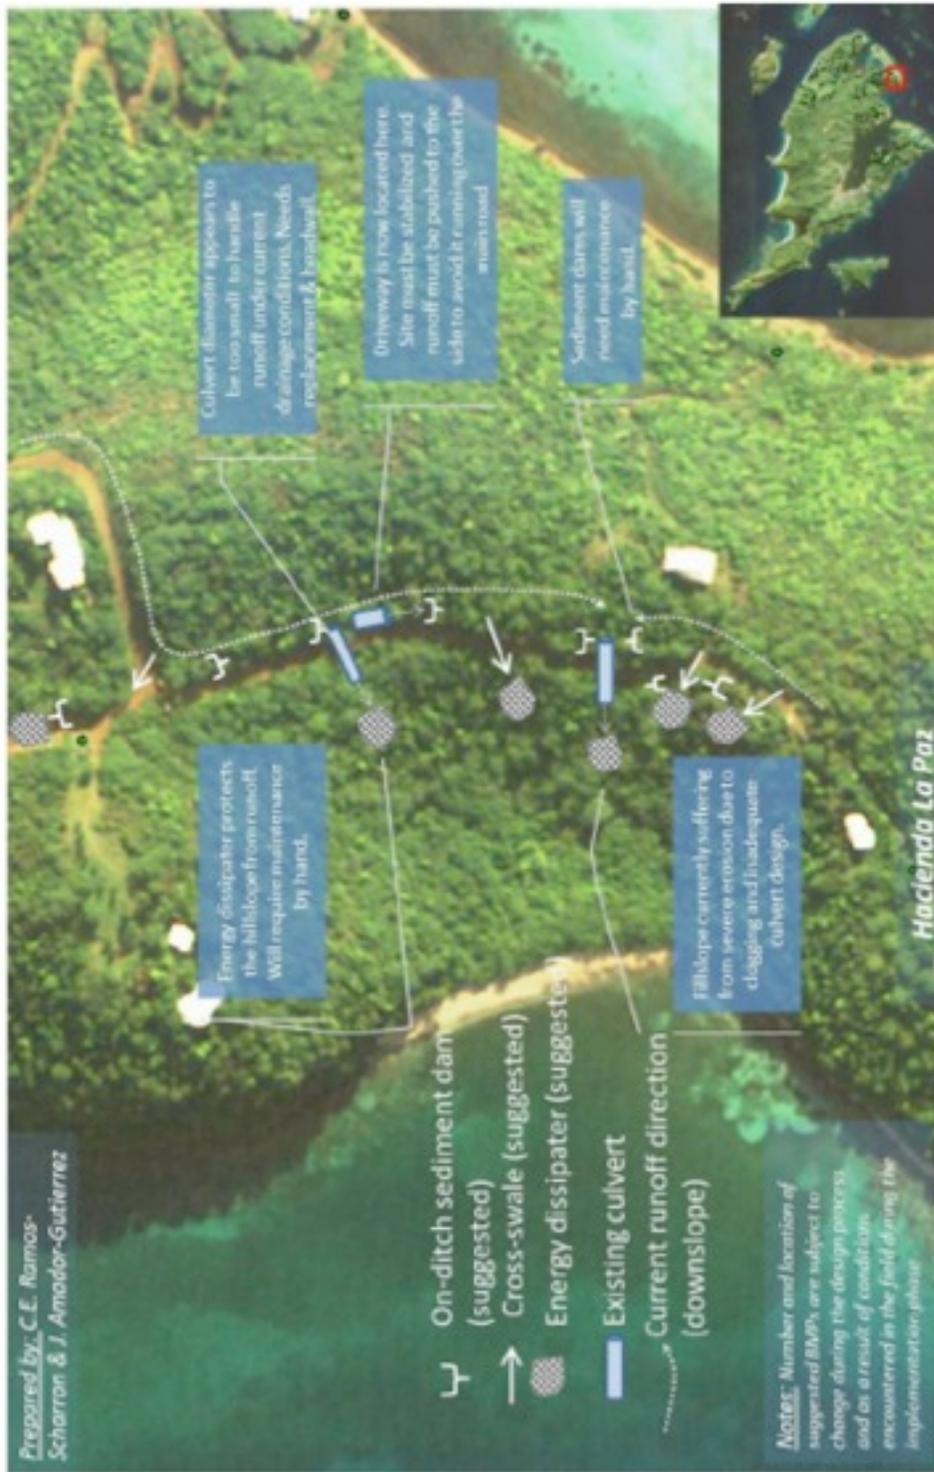
Figure 15. Restoration Site #1 and proposed practices

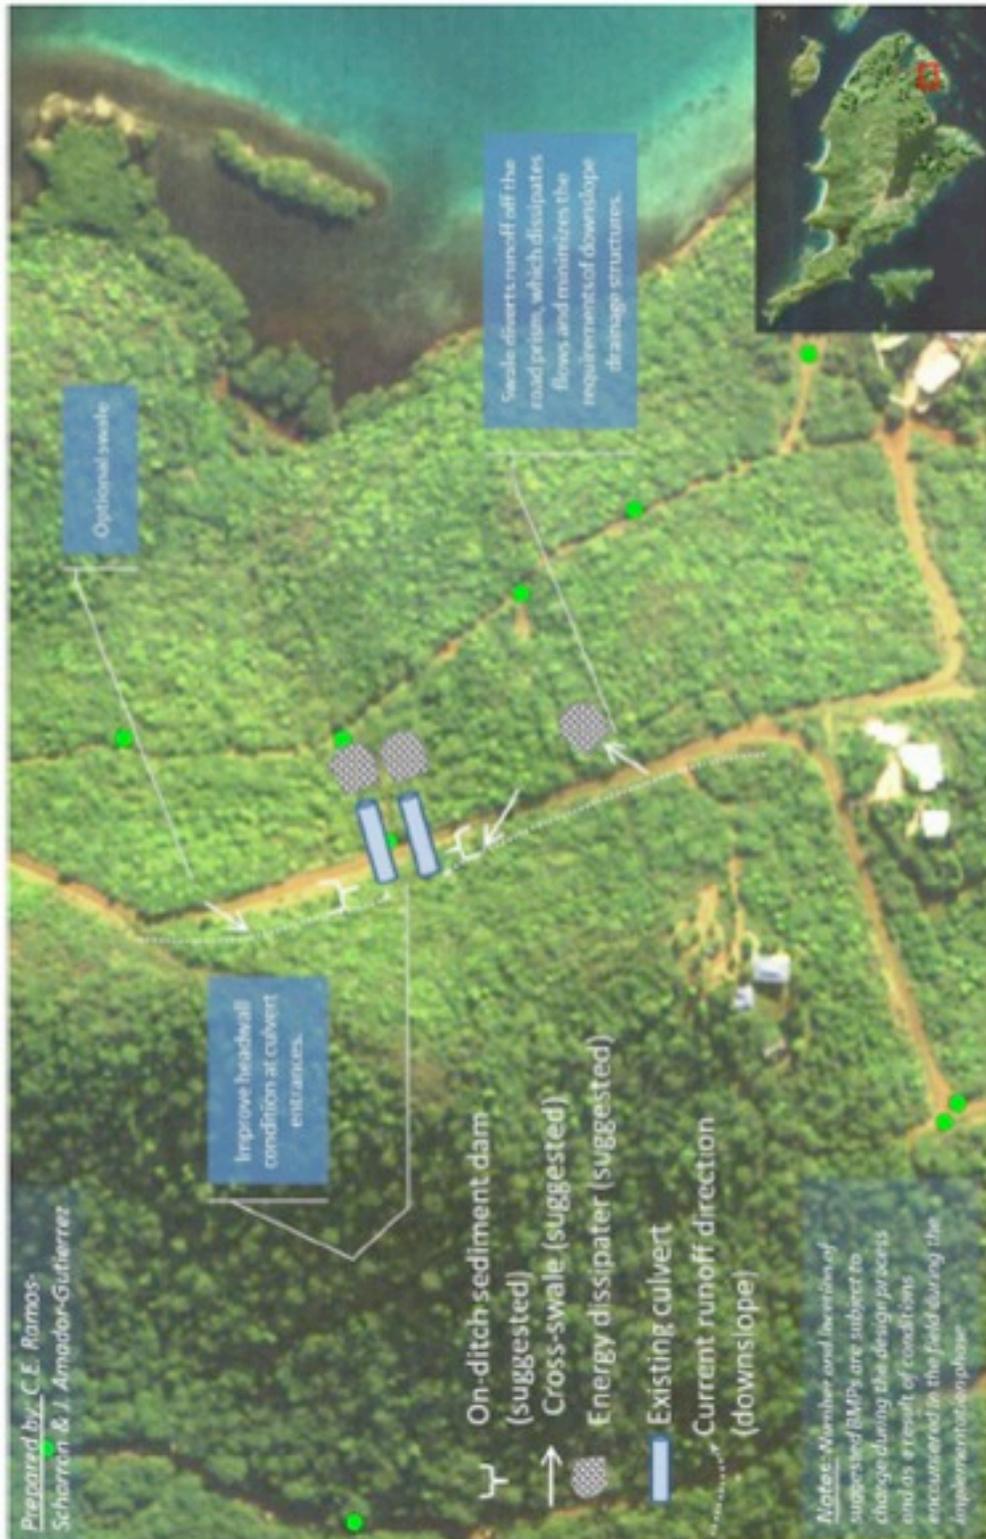
Figure 16. Restoration Site #2 and Proposed Practices

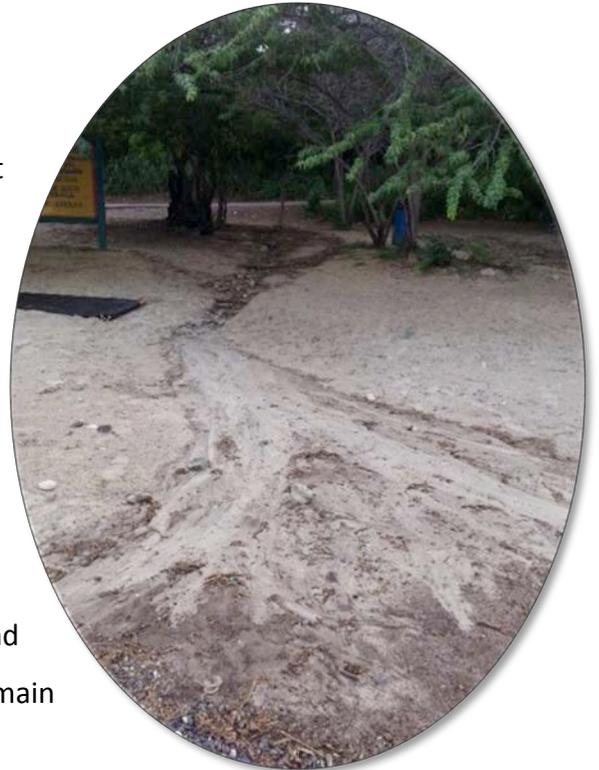
Area affected by runoff associated to the parking, previous to the restoration project.

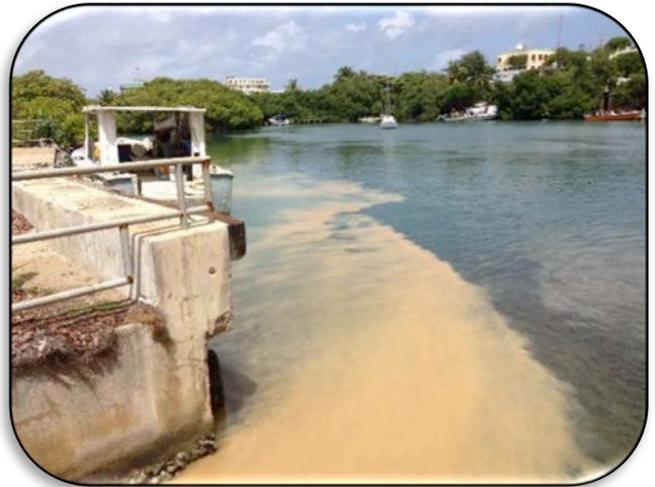
Sediment discharge to the Lobina Canal because of erosion from a dirt road after a water tank overflowed in Culebra.

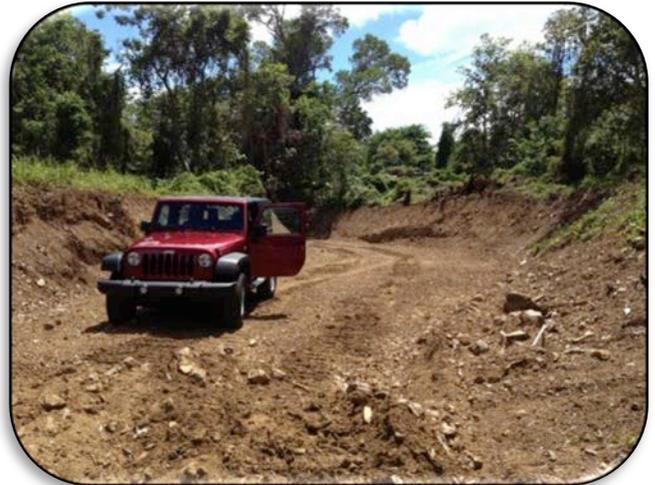
Culebra runoff channel enlarged and devoid of vegetation by the municipal administration of Culebra last before being restored through hydroseeding technique.

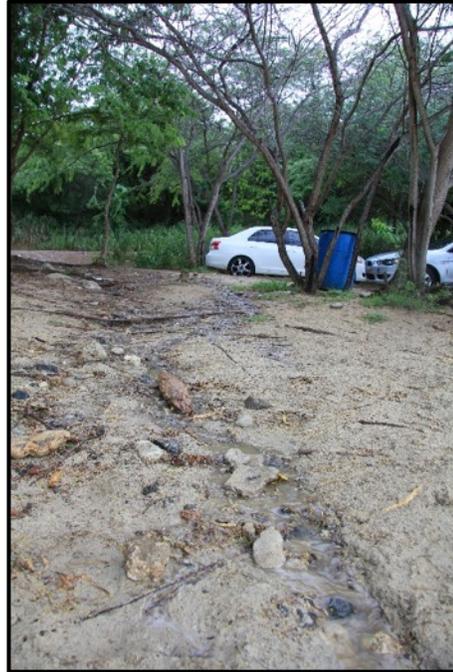
Parking area prior to restoration.

The problems of erosion and sedimentation in Tamarindo beach are mainly associated runoff coming from the dirt parking lot and access road to the beach that is only partially paved and in a critical state of disrepair with lots of exposed soil. The parking lot covers an area of approximately 160 m<sup>2</sup>. Prior to the rehabilitation of the parking area, motor vehicles had direct access to the permanent vegetation areas of the beach and in several places, vehicles could get to the beach area, and sometime traversed the beach in the evenings.

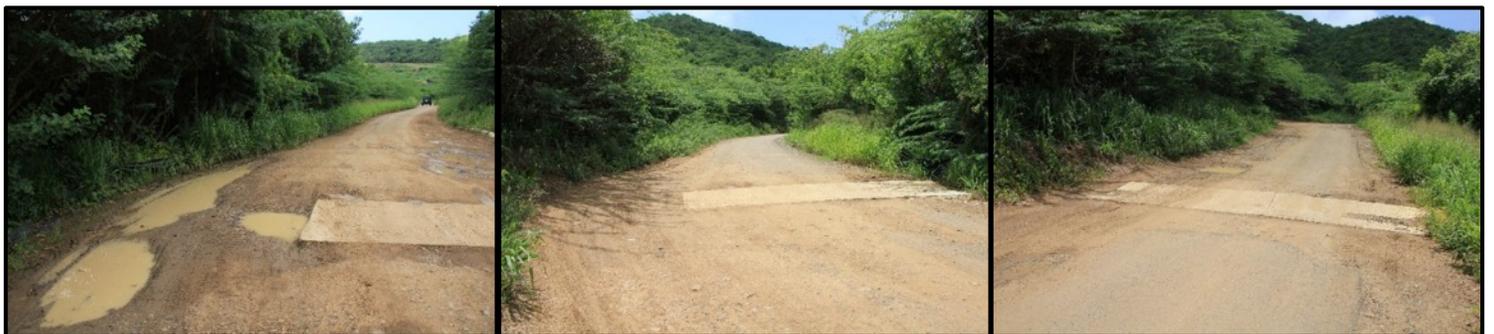
Current conditions to the road leading to Playa Tamarindo.

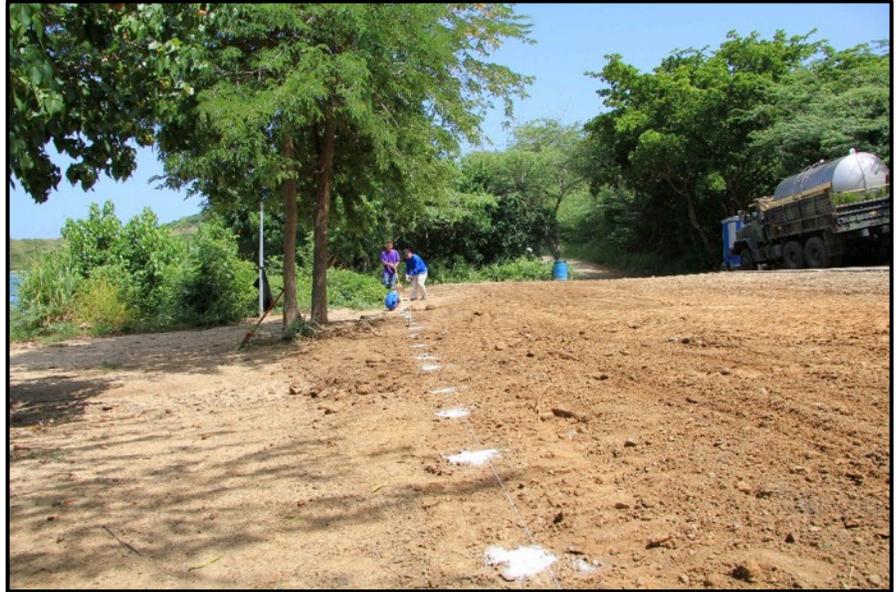
Process of demarcation and delimitation of the new parking area.

The procedure was, first, to delineate the parking area above the permanent vegetation zone of the beach. This delineation was conducted by installing wooden posts buried about 18 inches deep and fixed with concrete at base leaving about 30 inches pole to demarcate the area. Wooden posts were placed at a distance of three feet from each other to prevent the passage of small vehicles such as golf carts that have become a major means of transportation in Culebra. Each pole was connected to each other by using 2x6 boards, which in turn, act as a barrier to keep in place the stone used to stabilize the parking lot.

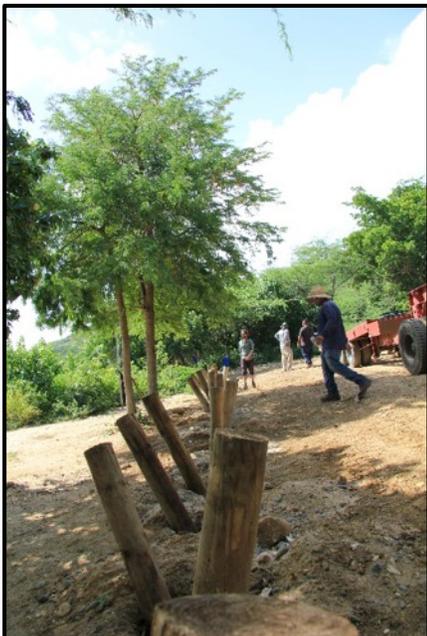
Process of creating the new parking area.

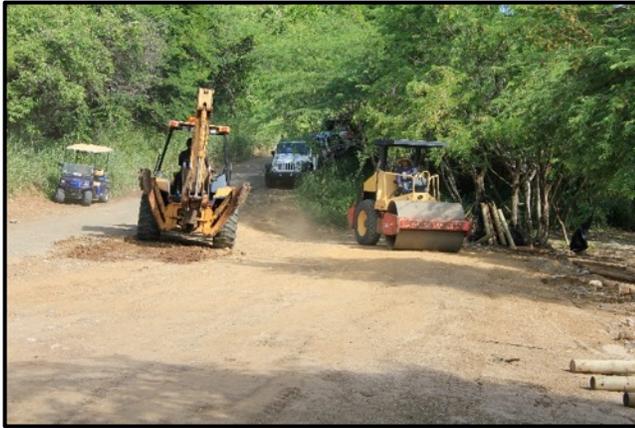
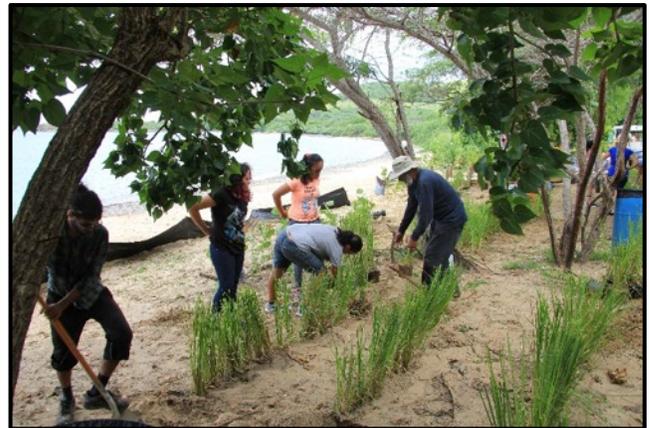
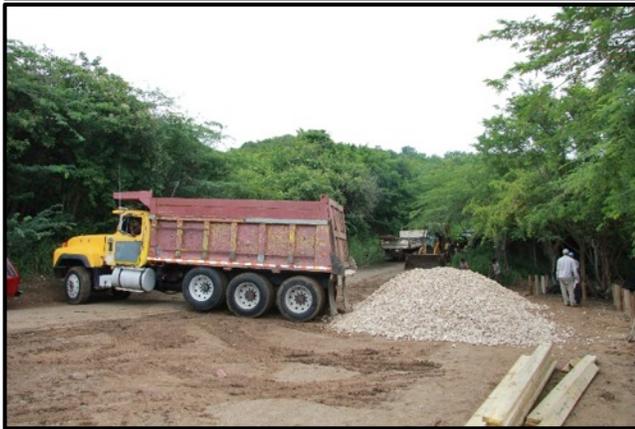
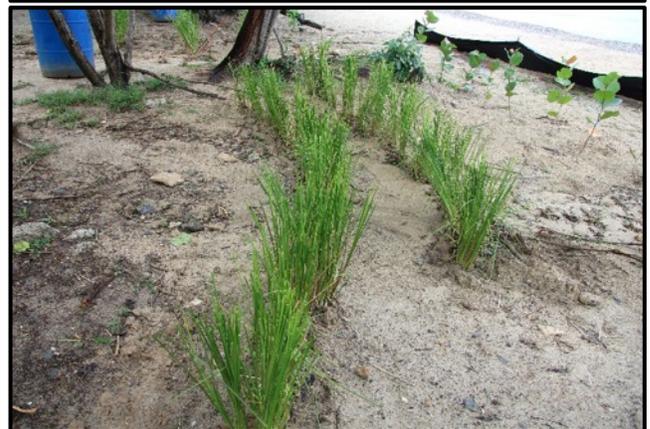
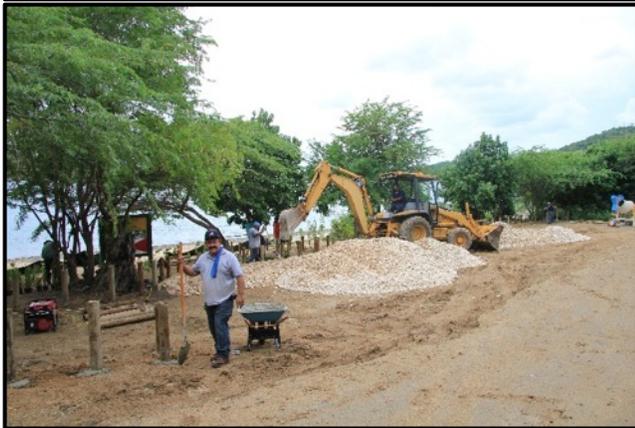
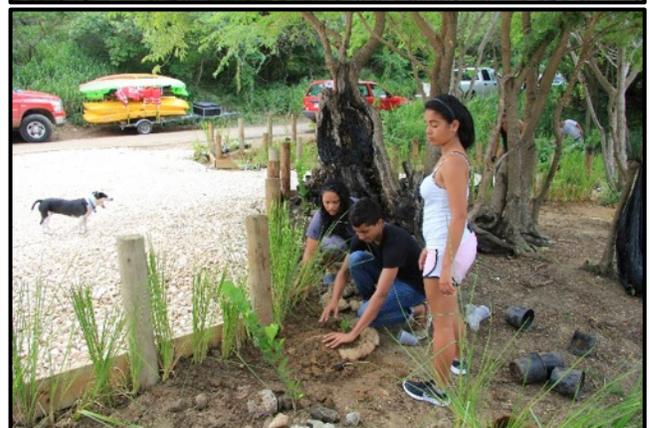
Parking stabilization process.

Second, stone was laid in the parking lot to promote infiltration and reduce surface water flows causing erosion during rainy periods. Approximately 60 m<sup>3</sup> were used of A1 washed stone. The material used has the same specifications of the material that was approved by the DNER to stabilize coastal roads and trails in the Reserve International Guanica Dry Forest. The stone was compacted slightly using manual equipment to both maintain a safe walking surface and some degree of infiltration in the area. Prior to the placement of the stones the ground was leveled. Third, erosion control plants and infiltration galleries were added to enhance deposition of sediment from the runoff from the road and parking lot. 600 vetiver plants (*Vetiveria zizanioides*) were planted to reduce runoff and enhance sediment deposition. The vetiver has a dense and deep root system that intercepts surface runoff and reduces energy of the water and traps sediment. Fourth, the shoulder area of the road where most of the runoff was generated and conveyed now intercepts water through cross swales at five locations to break up flow paths and reduce concentrated flow of runoff over the historically dirt parking lot.

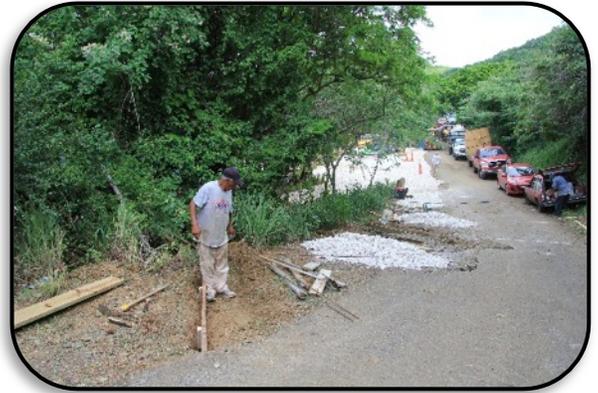
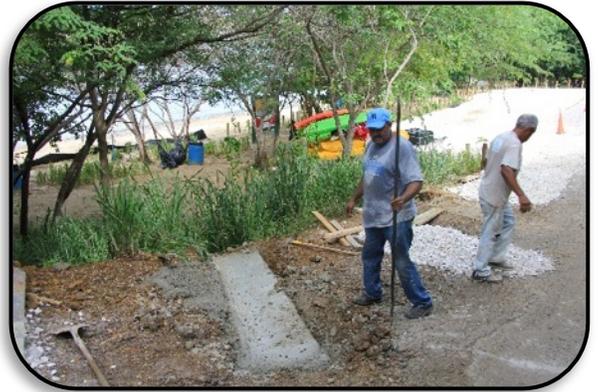
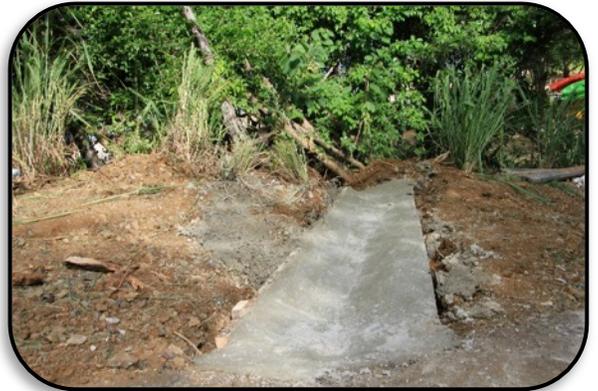
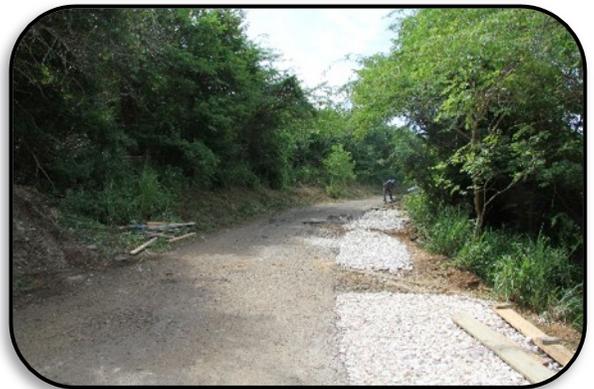
Improvements to the road drainage -- attenuation and flow reduction and redirection.

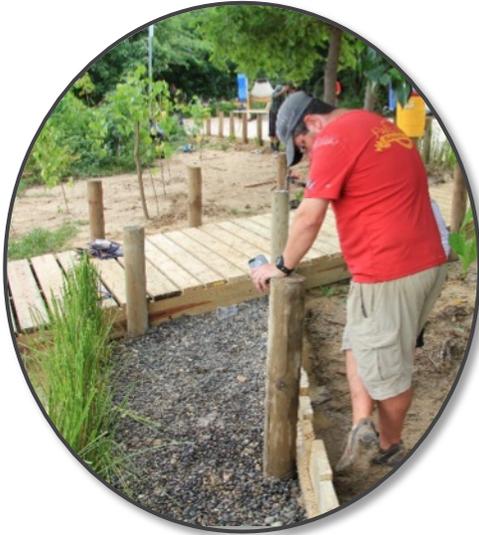
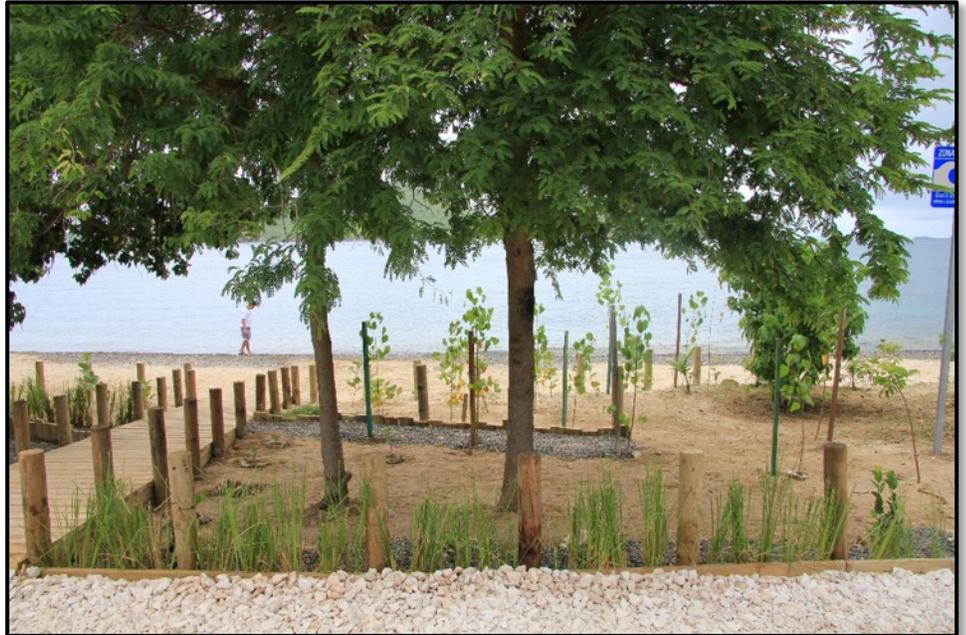
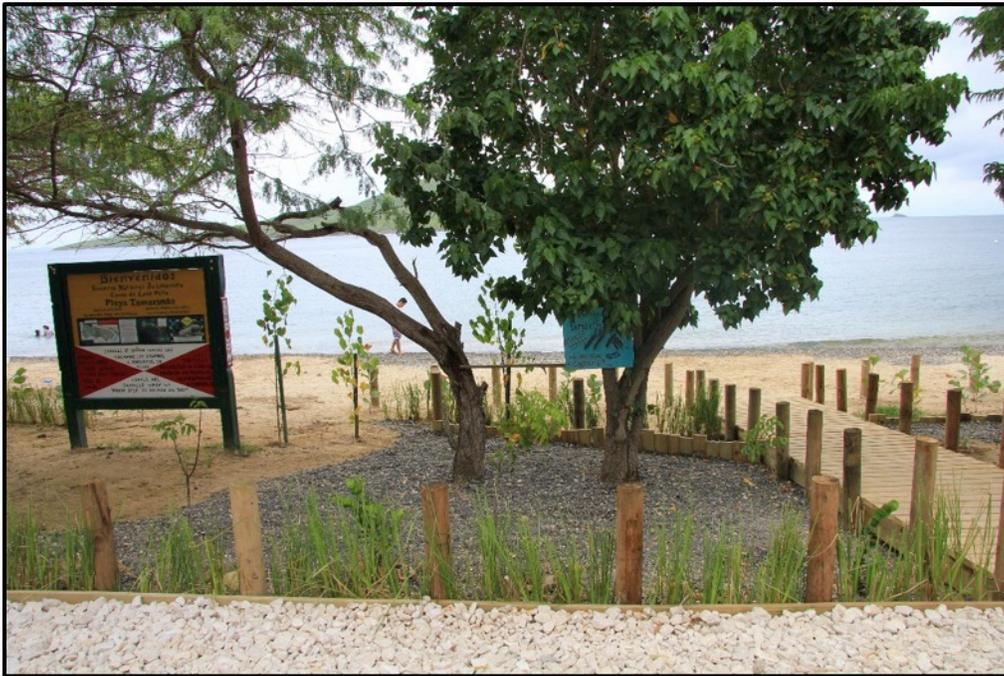
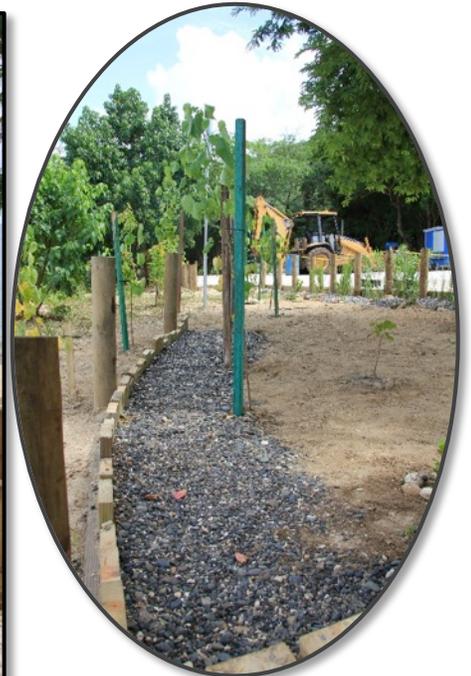
Images of bio-filters/infiltration galleries been built.

Fifth, we created two small bio-filters/infiltration galleries to treat runoff not infiltrated by the parking lot. The bio-filters were built with wood, sand and gravel. Temporary sedimentation measures (silt fence) controls were installed prior to construction and remained in place for the duration of the implementation.

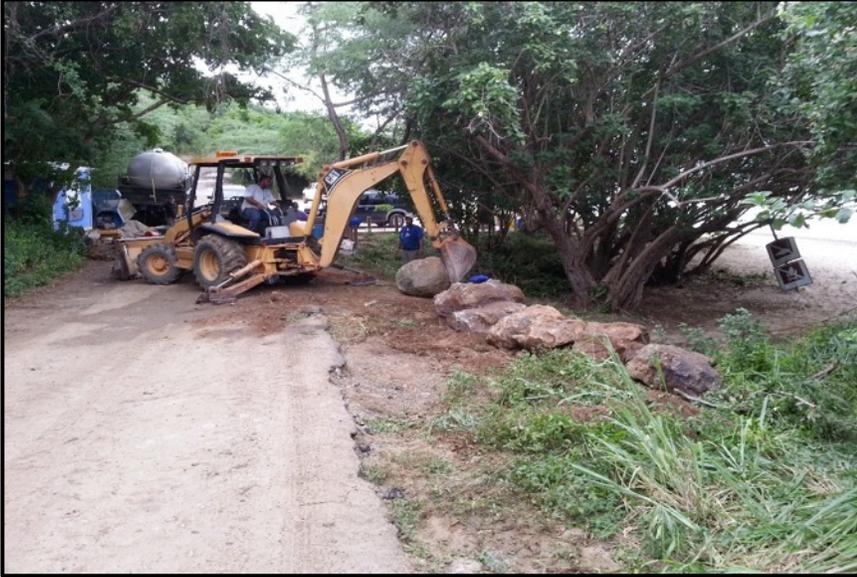
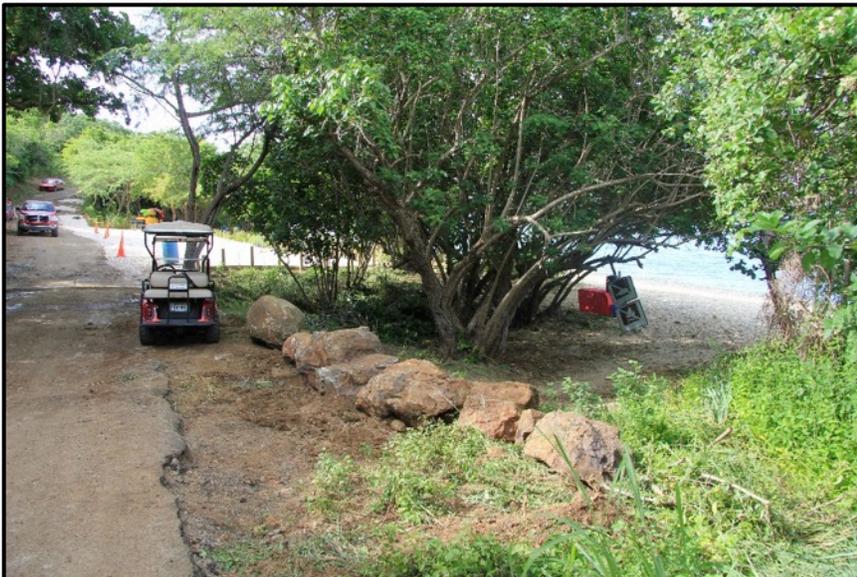
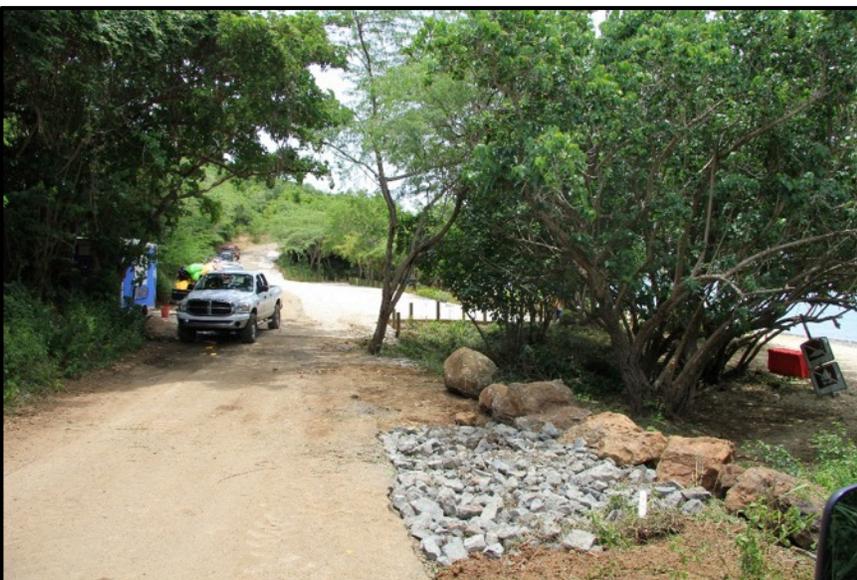
Sedimentation and erosion control practices established by the community.

Another aspect of our work was to stabilize and block an area sometimes used to access the beach with vehicles which also was an eroding conveyance of runoff from the access road to Tamarindo beach. The work in this section consisted of placing large rocks that surround the vehicular access and stabilizing the eroding access with large stone sized gravel to minimize erosion. The area was reforested with seedlings and emajagüillas. This section was designed and implemented by the Culebrenses, Omar Villanueva, Alexander Ayala and Tomás Ayala, who took part in a workshop on techniques for erosion and sedimentation control that we facilitated about a year ago in Culebra. The Ayala's were also volunteers in the effort providing their technical assistance and expertise to benefit their community. It was great to see the community leading the establishment of erosion and sediment control practices.
