R I D G E T O R E E F S /  
P R O T E C T O R E S D E  
C U E N C A S

*Restoration and Implementation Efforts in Culebra*

**March 2014**

# Environmental Restoration Project Playa Tamarindo Culebra, Puerto Rico Phase I

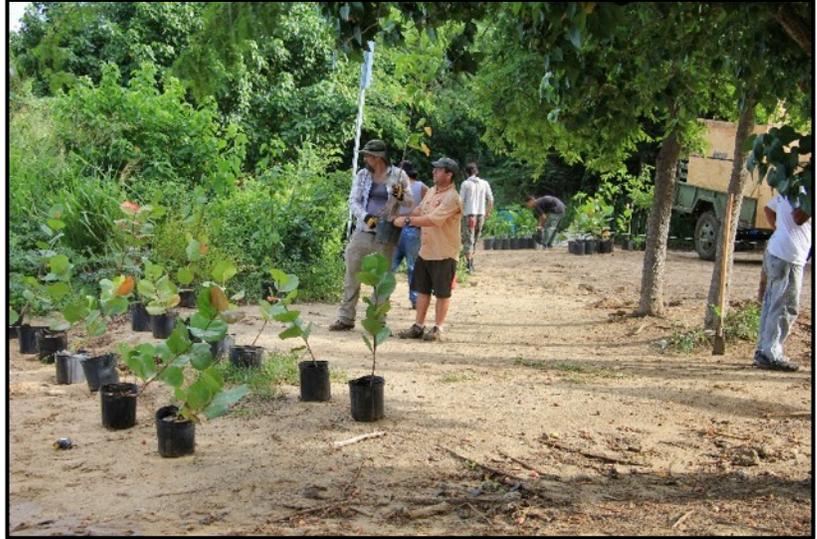
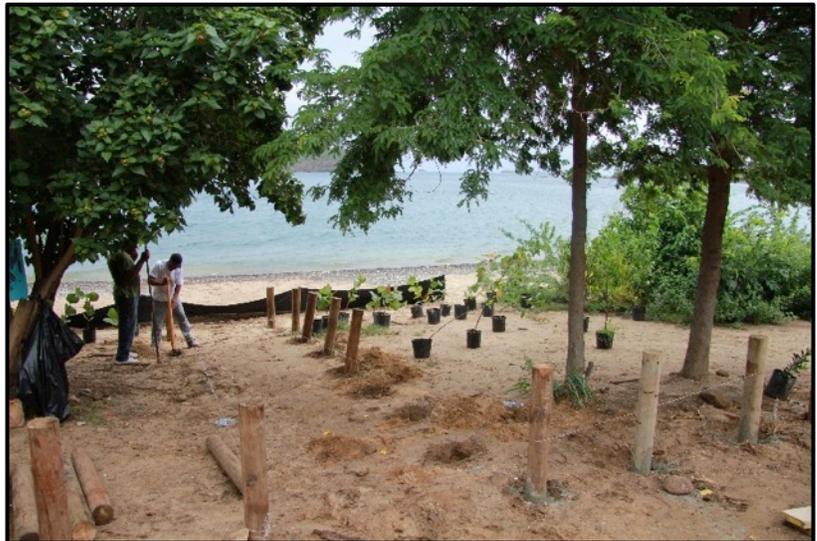
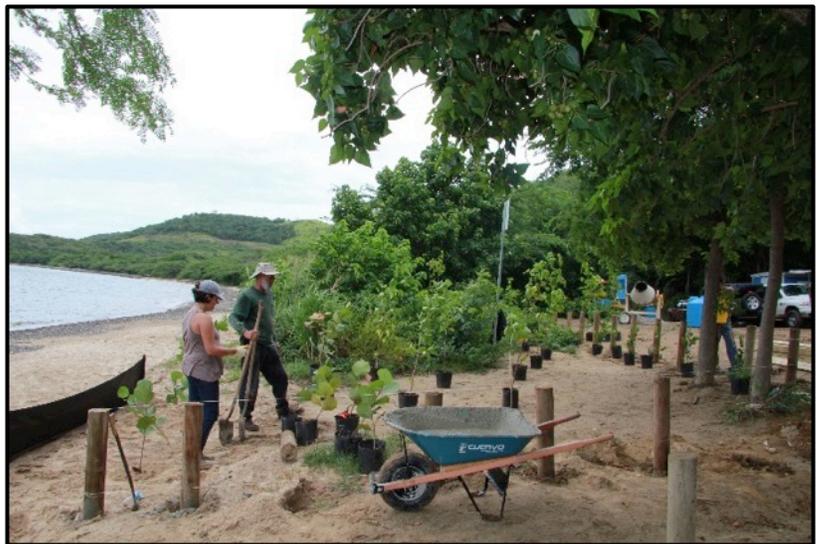
Design process to reforest areas.

The coastal habitat at Tamarindo beach had been seriously impacted by public uncontrolled public access and was in a very dilapidated state where the soil was compacted and eroding into the near shore waters. In order to restore the coastal vegetated berm and buffer, the team re-planted native species of endemic to coastal areas of Puerto Rico. Over 325 trees and shrubs were planted including a hundred sea grapes (*Cocoloba uvifera*), a hundred emajagüilla trees (*Thespesia populnea*), a hundred cooperwood (almácigo) seedlings (*Bursera simaruba*) and thirty icaco bushes (*Chrysobalanus icaco* L.). Furthermore, the project defined the pedestrian access areas to the beach. Reforested areas were delimited and access restricted primarily to three areas of public access. In two of these areas small elevated boardwalks were constructed for the public to access the beach without impacting vegetation and sand dunes. In the area closer to the coast the sea grapes planted at an average distance of one foot apart, and in two parallel lines

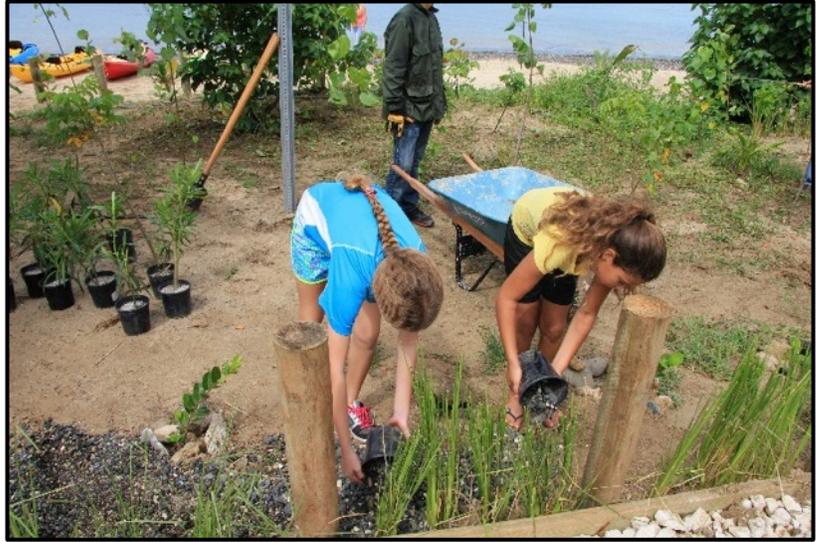
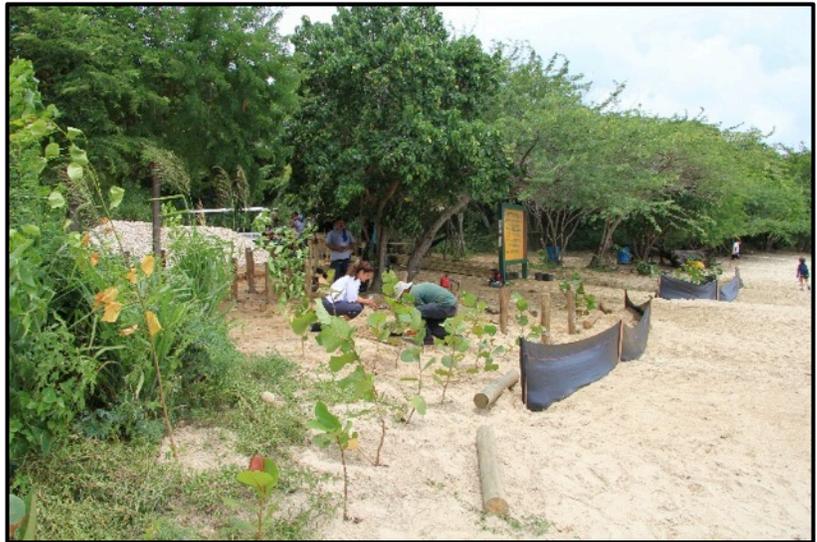
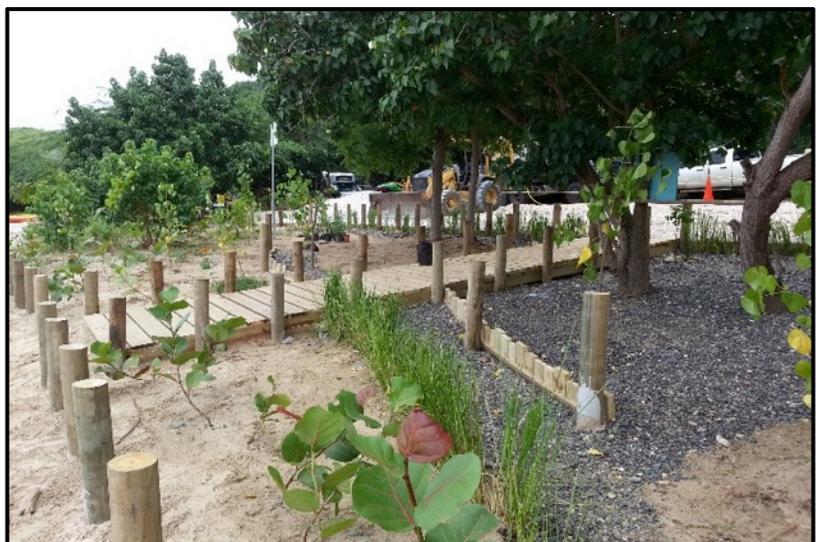
Reforestation process.

In the second phase of the project over 260 trees and 900 vetiver were planted in order to restore 1 acre of native forest to the coastal buffer and to attenuate runoff from flowpaths. Additional large stones, vetiver grass and trees were placed at cross swales to keep vehicles from driving around them and creating more erosion.

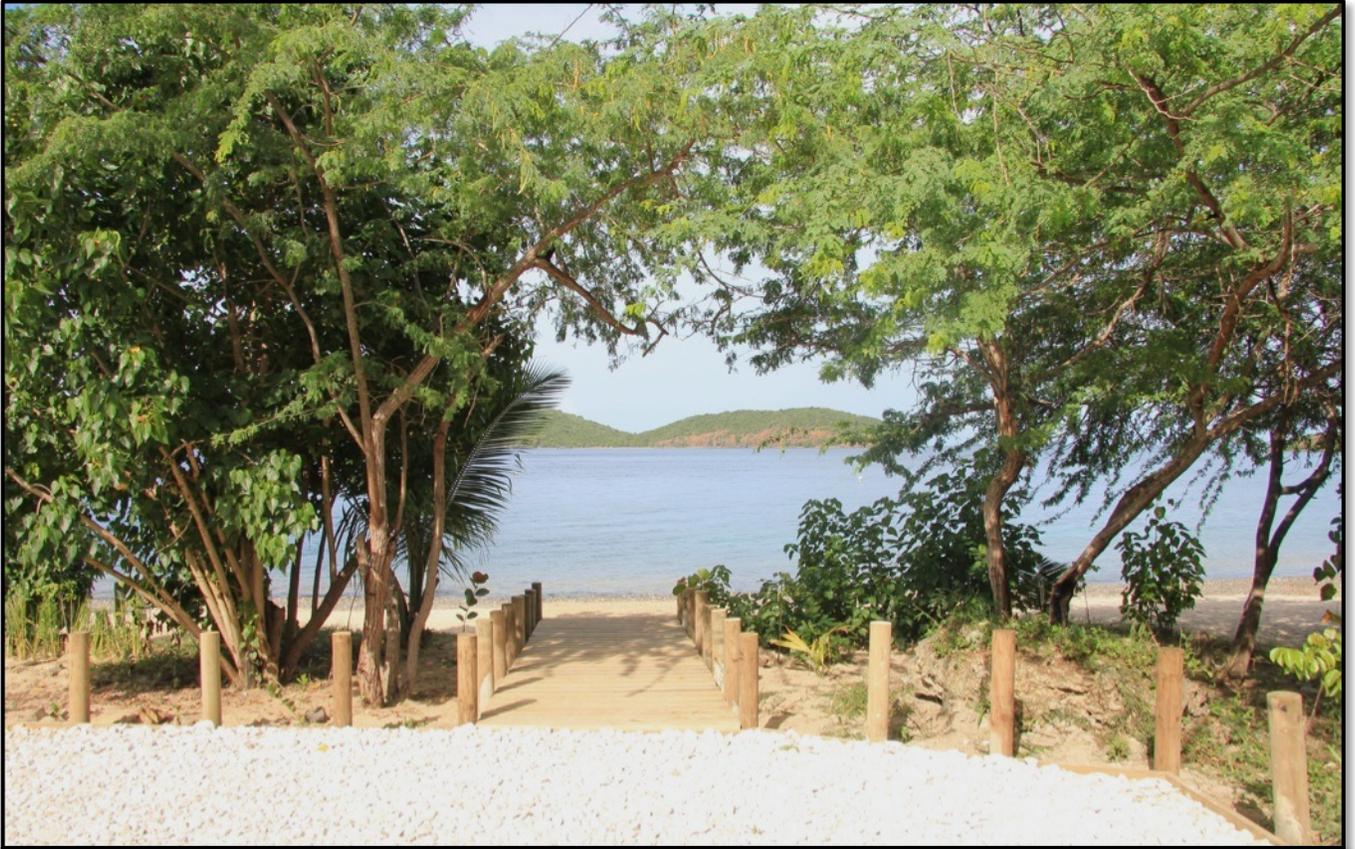
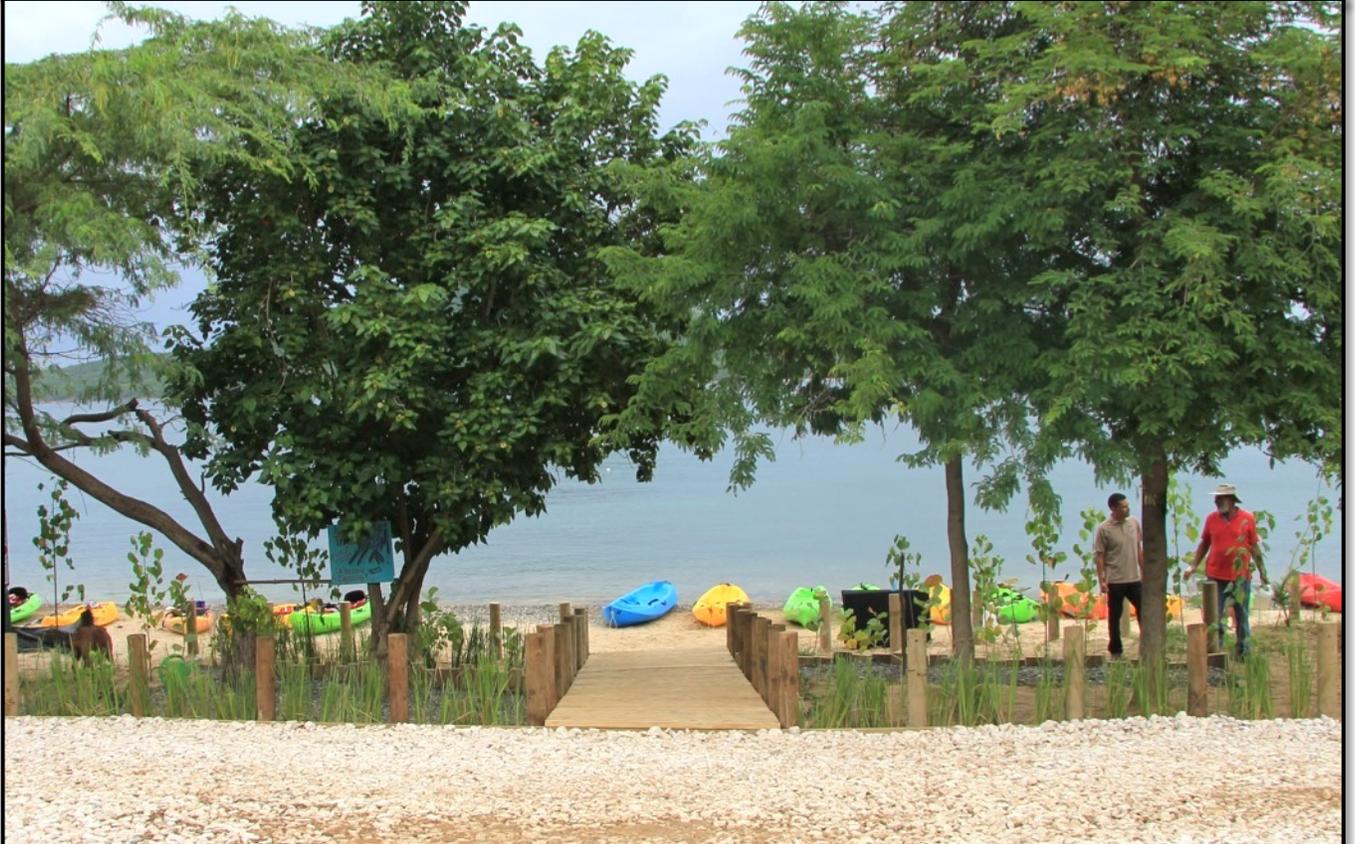
Boardwalks to delimit the beach access and protect the dunes and vegetation.

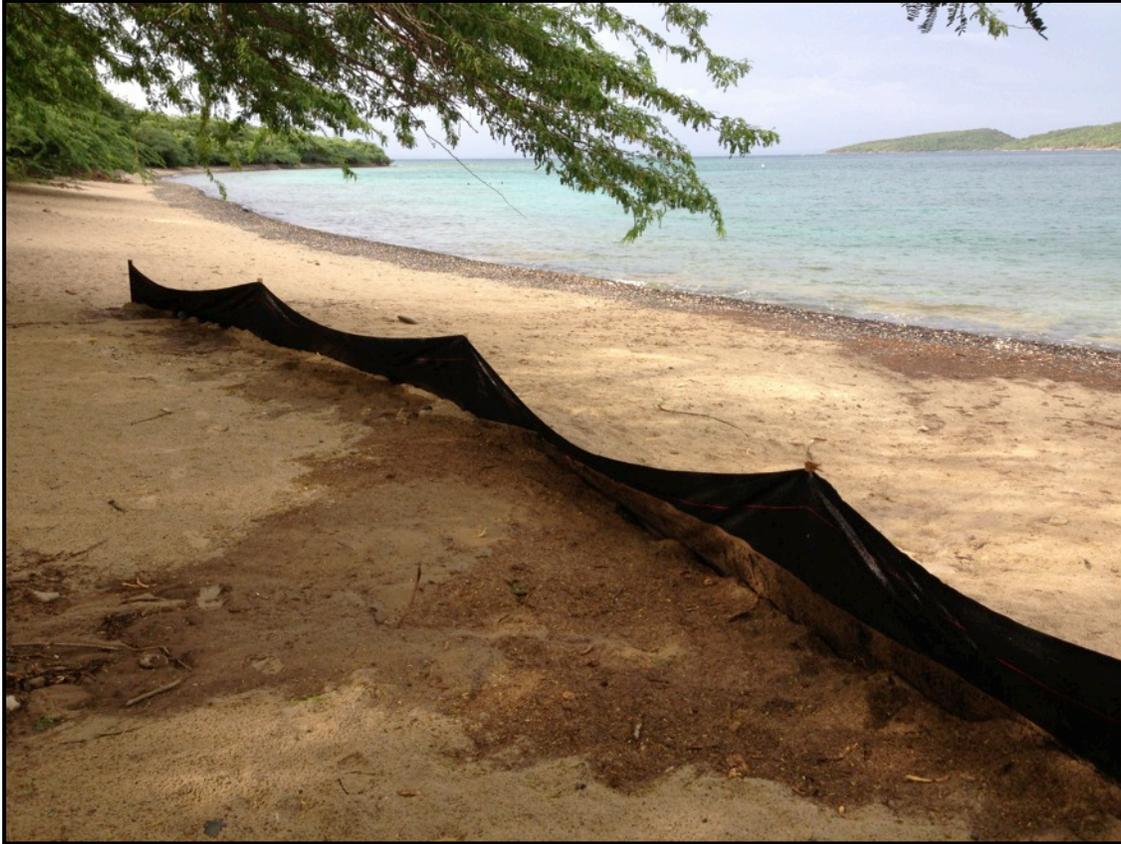
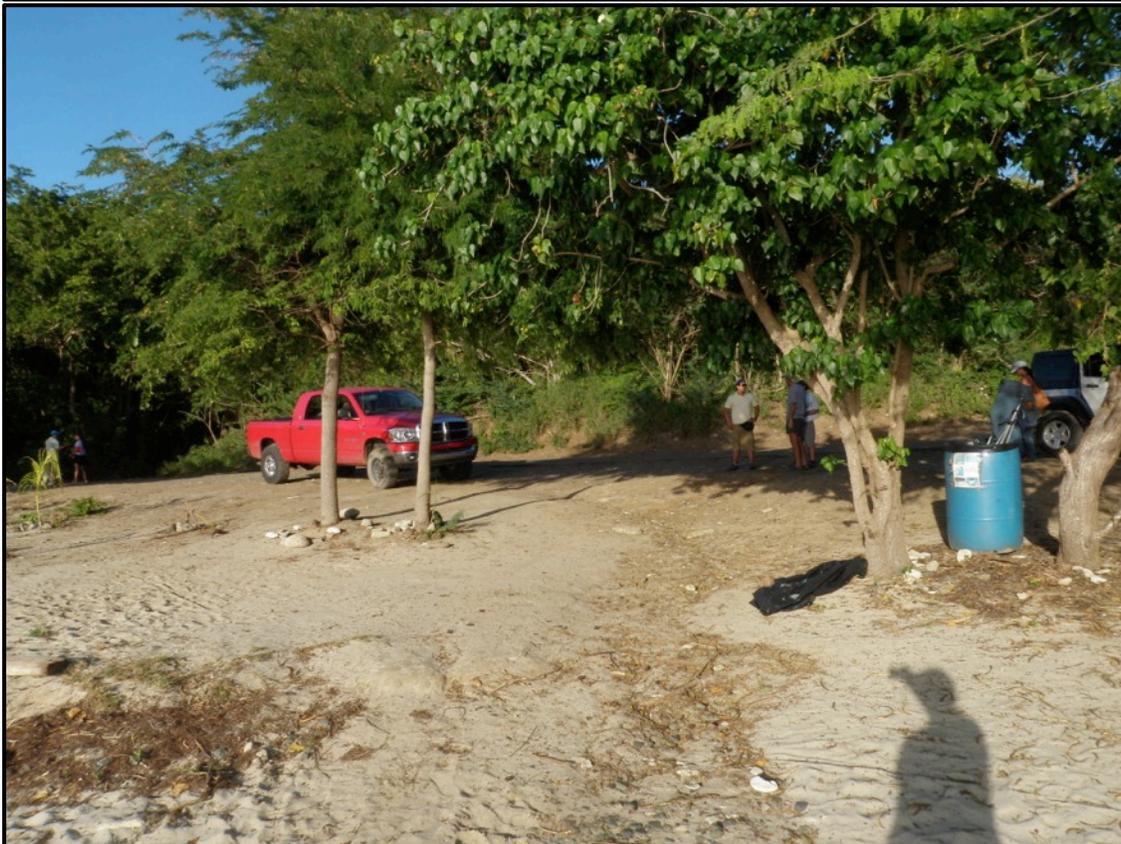
Pre-restoration photos: the silt fence in the upper picture was set up the day before we started and a rainstorm occurred that evening transporting the sediment shown; the lower photo shows one of the flowpaths for sediment prior to our work

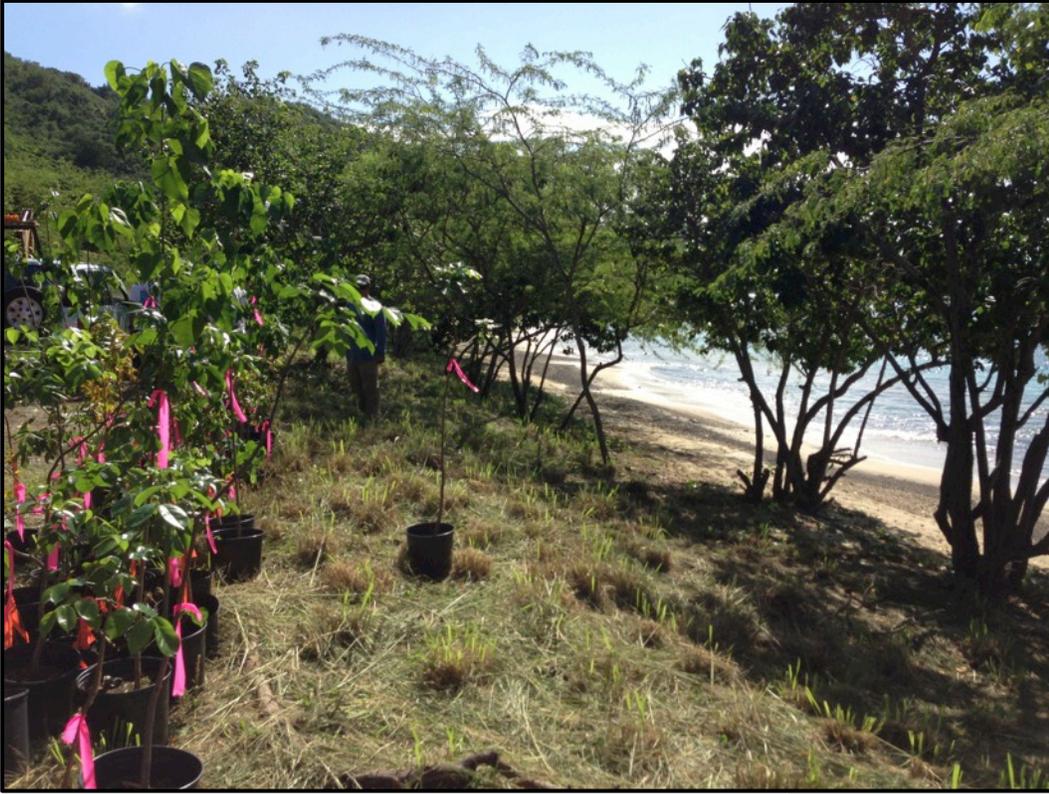
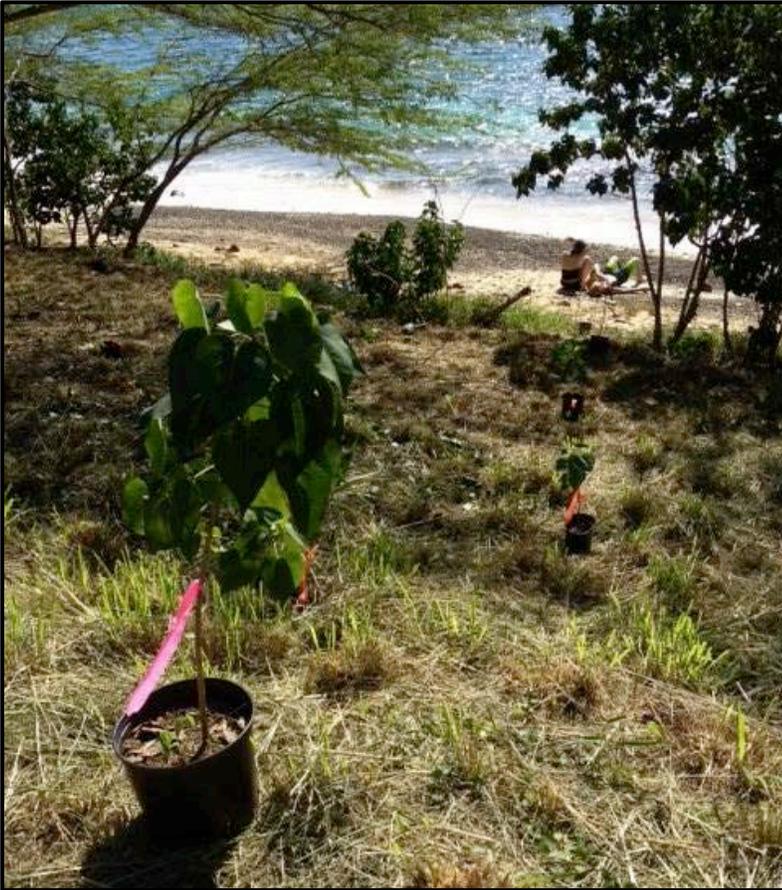
**Invasive species removal and native forest regeneration – over 260 native trees were planted as part of our follow up effort re-establish a native forest buffer in the coastal buffer areas**

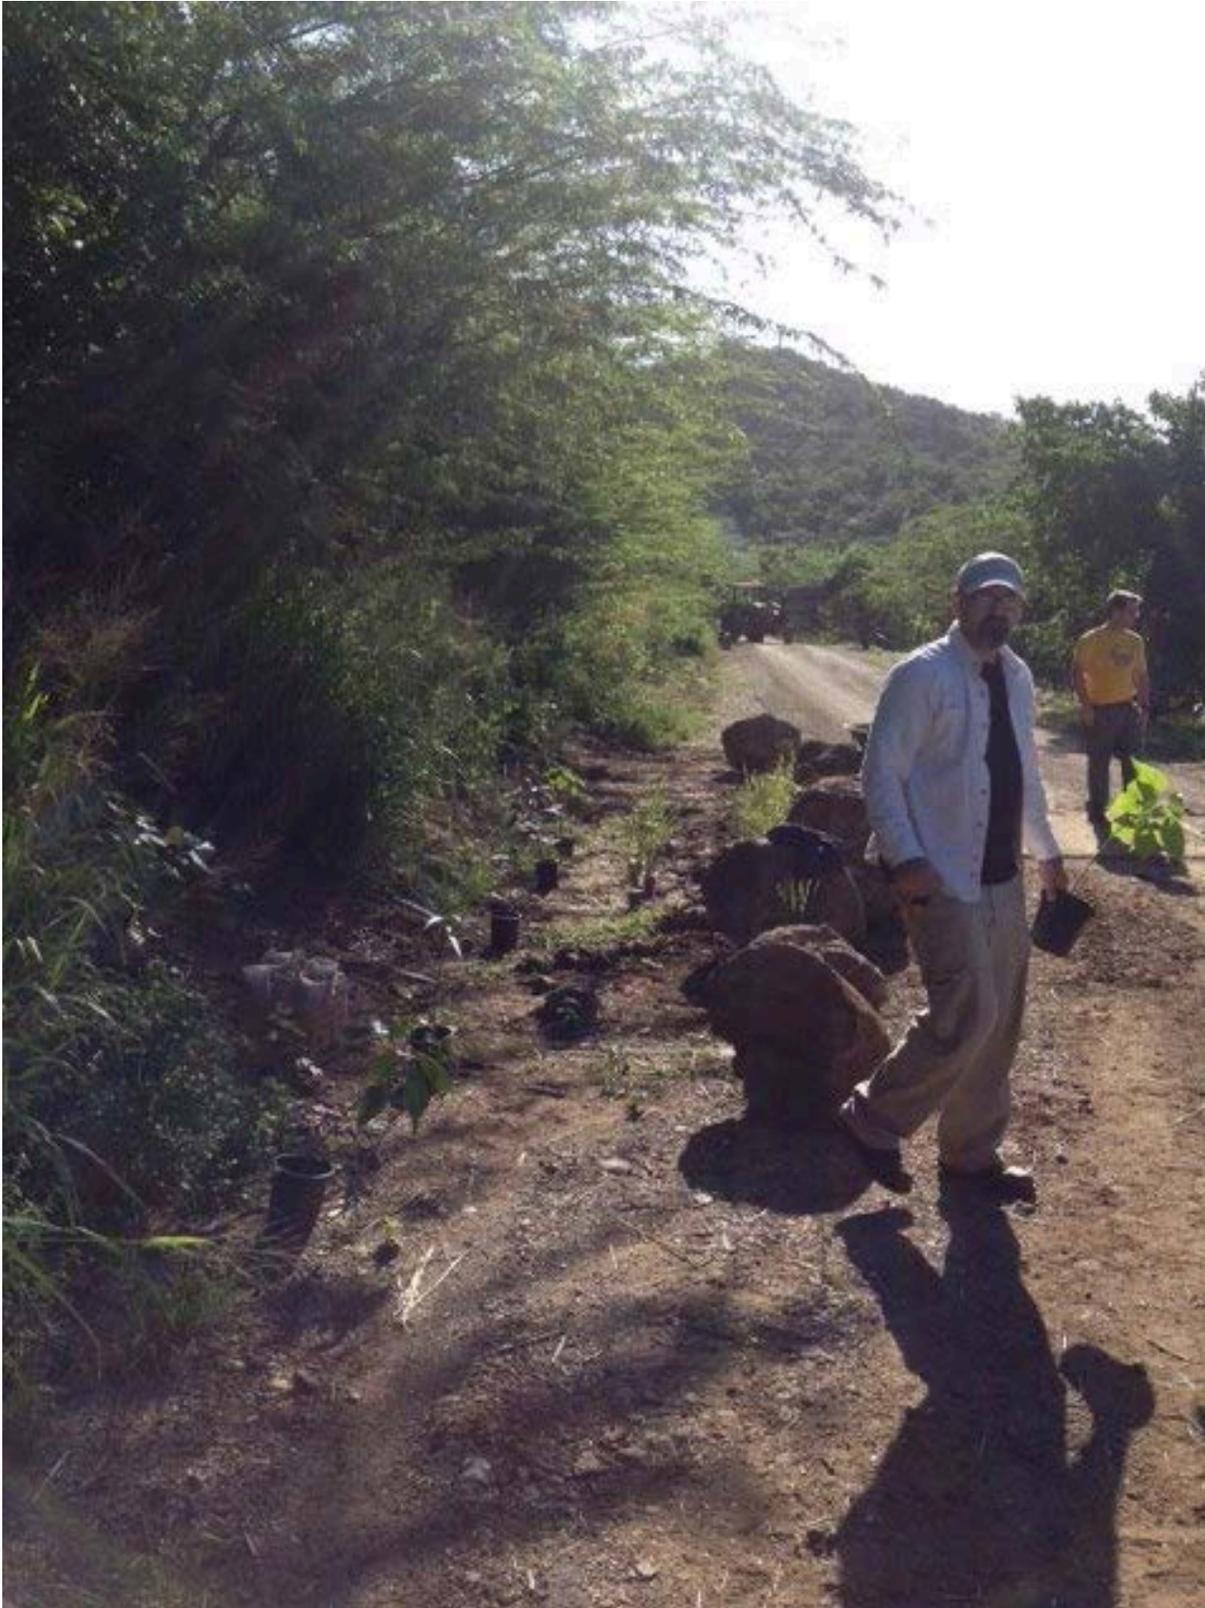
**Invasive species removal and native forest regeneration – over 260 native trees were planted as part of our follow up effort to help re-establish a native forest buffer in the coastal area**
