R I D G E T O R E E F S /
P R O T E C T O R E S D E
C U E N C A S / N O A A R C

Guánica Hydroseeding 2014

Paul Sturm, Ridge to Reefs
Protectores de Cuencas, Inc

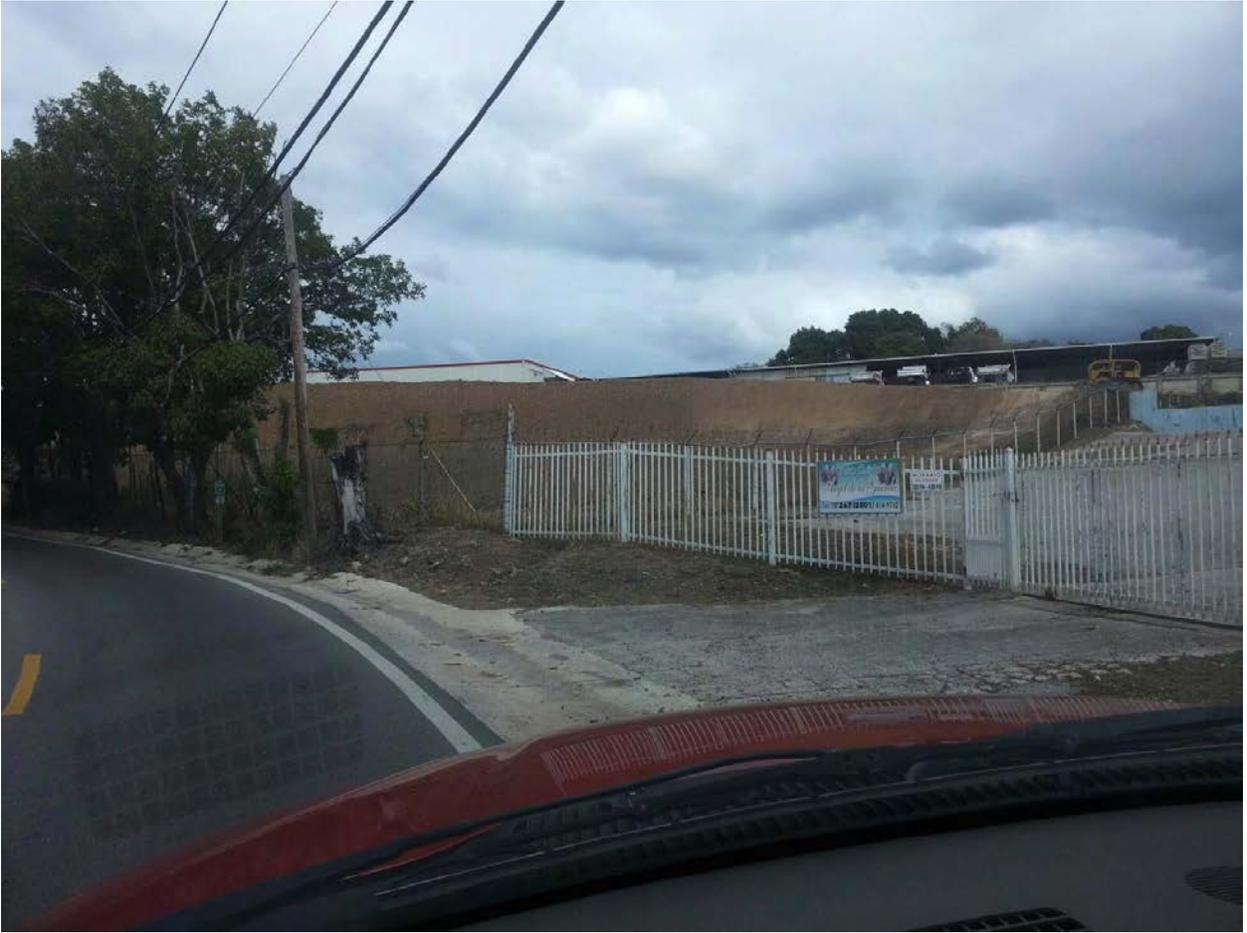
Figure 5. Bare soil from the hardware site

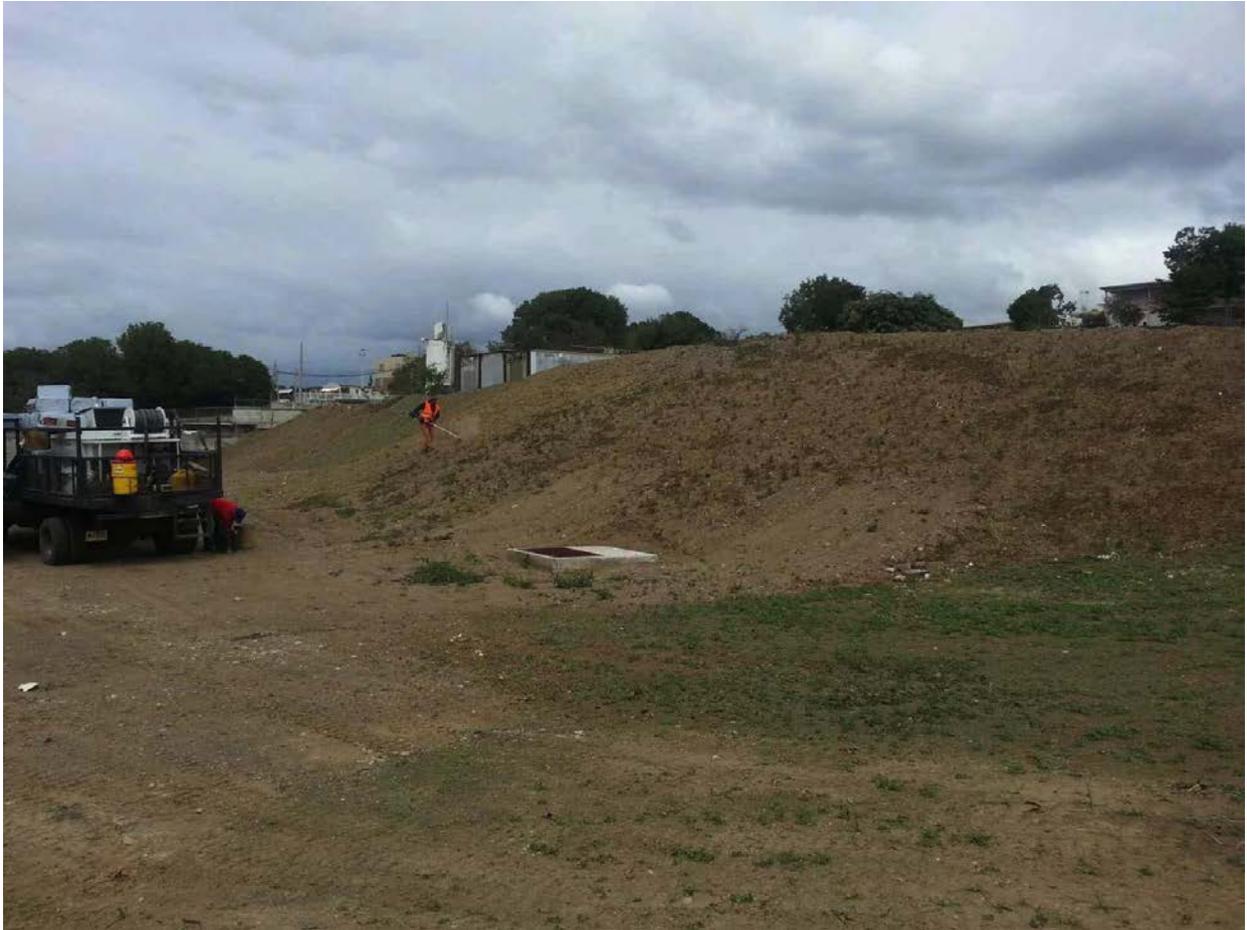
Figure 6. Preparing the site for hydroseeding

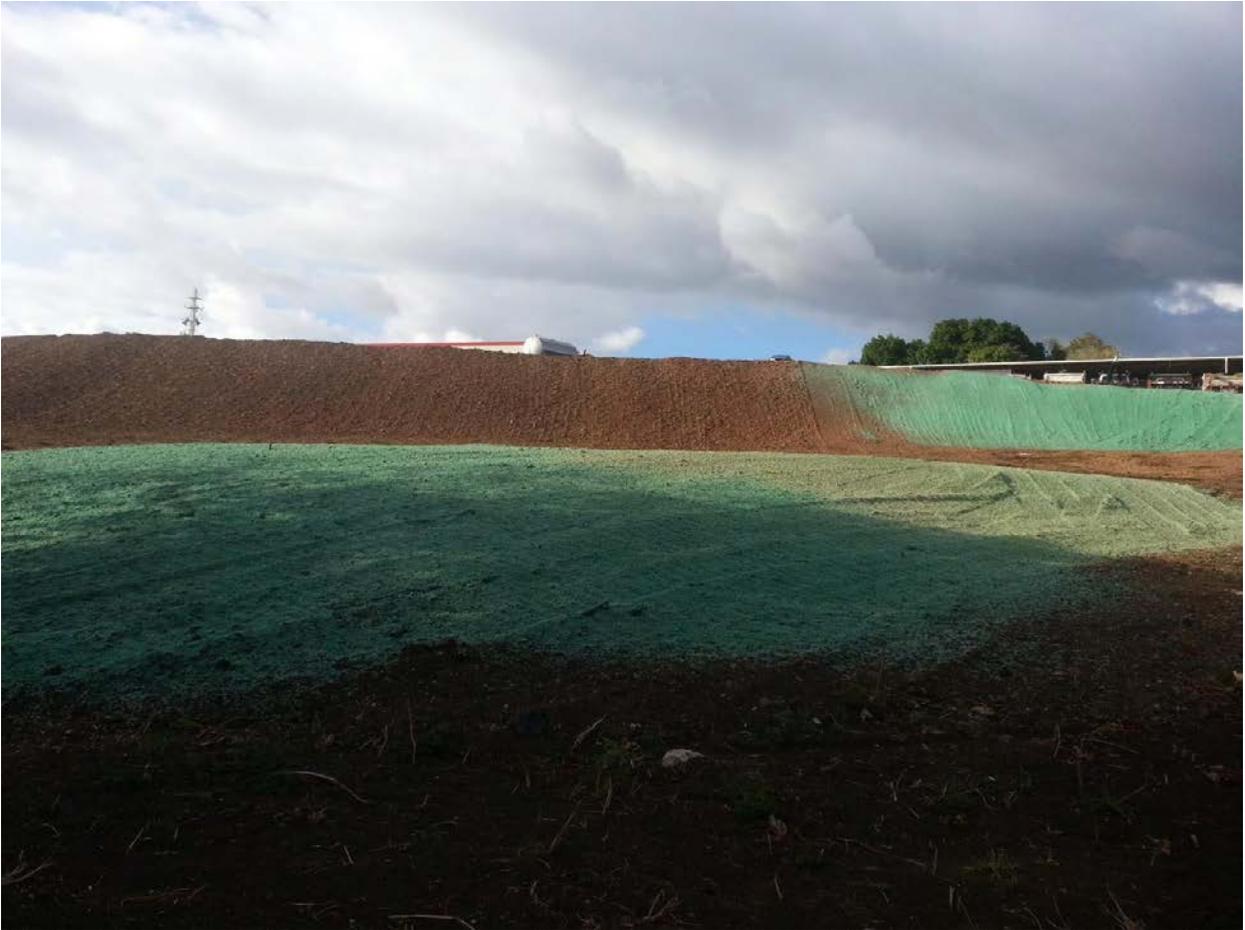
Figure 7. Hydroseeding in process at the hardware store site

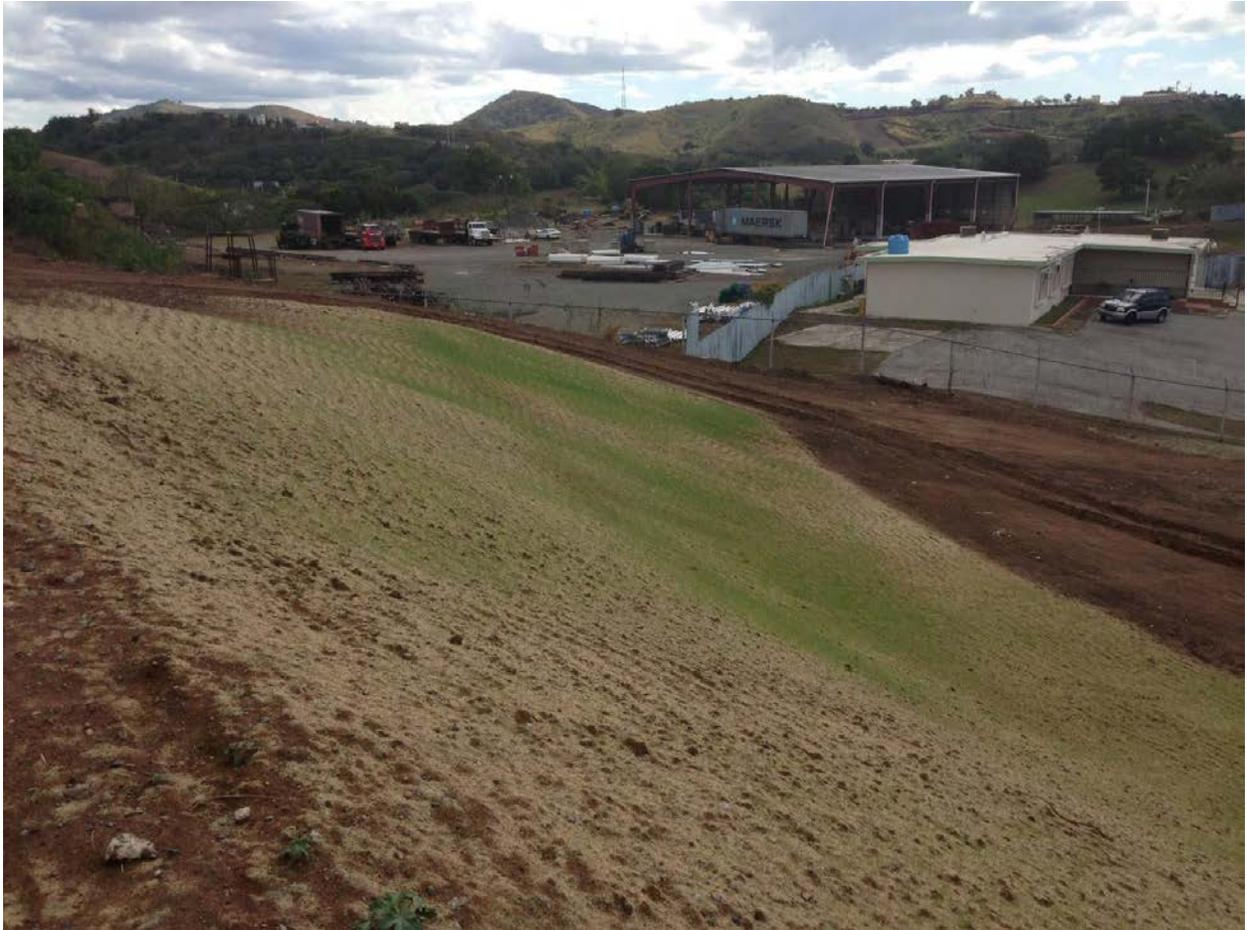
Figure 8. Stabilization and initiation of germination of hardware site

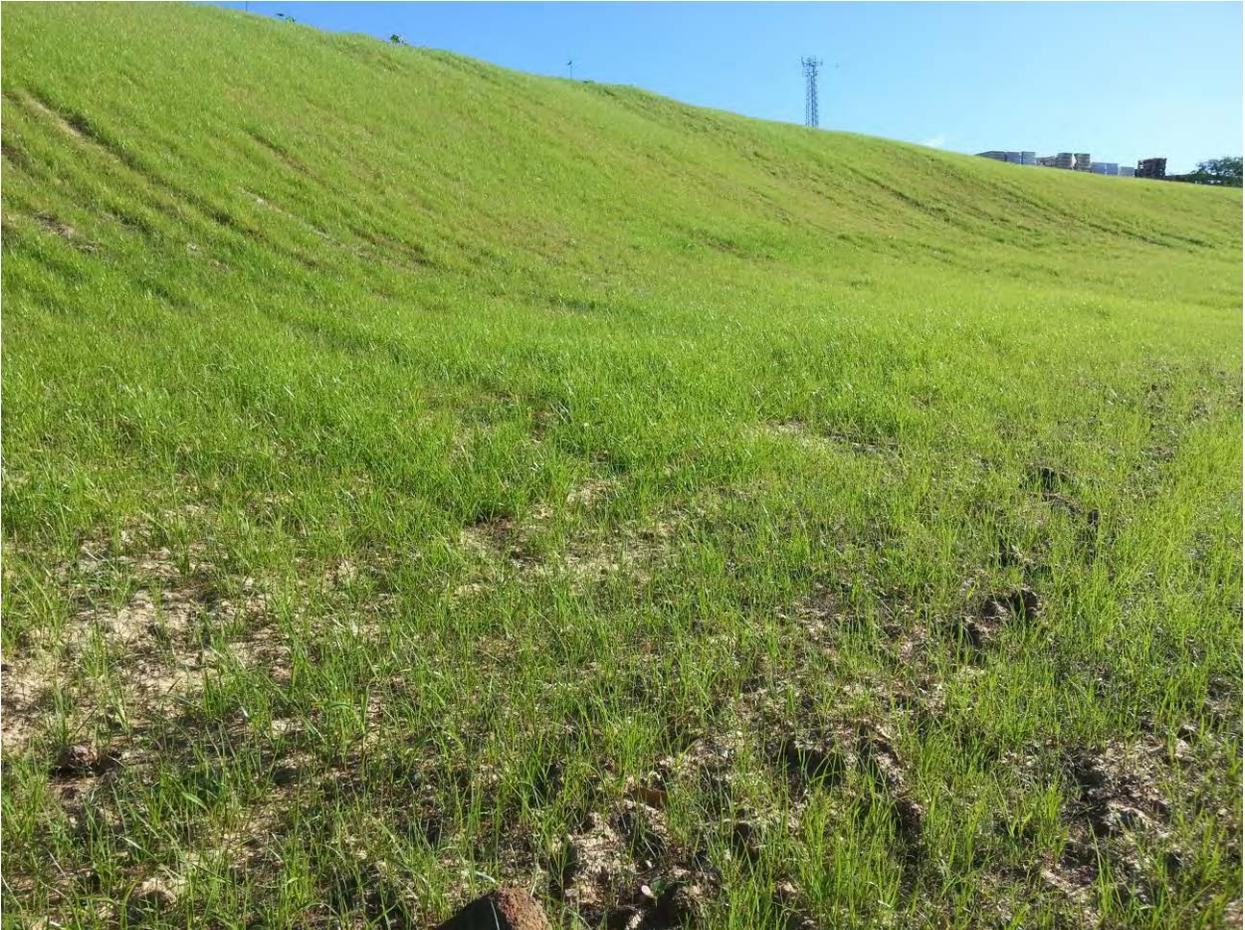
Figure 9. Re-establishment of grass at the site

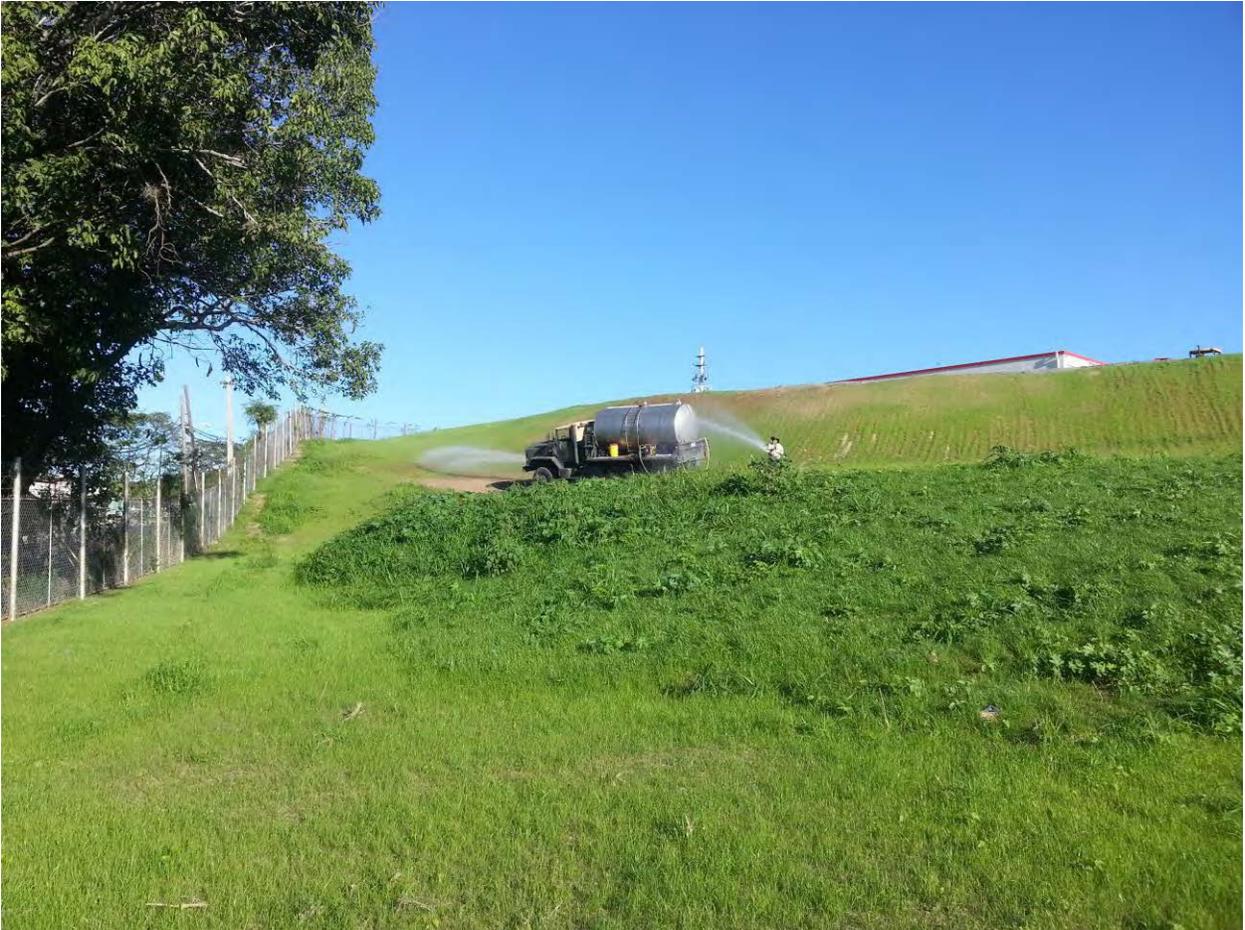
Figure 10. Vegetative stabilization and watering at the hardware store site

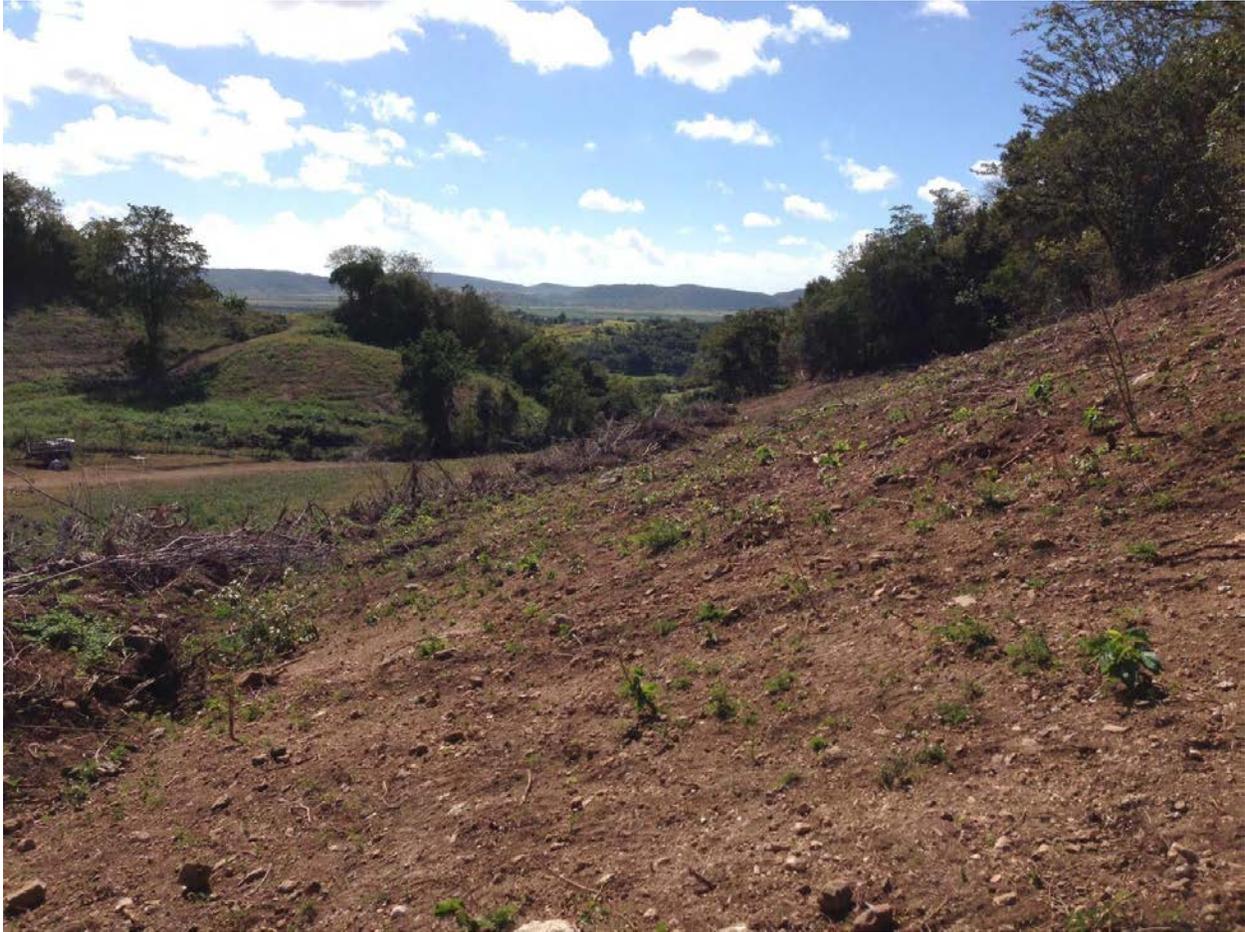
Figure 11. Bare soil cleared on Finca La Paz -- note piling of woody debris to break the slope and reduce concentrated runoff from the hillslope

- stabilization occurs best immediately after disturbance the longer the time between clearing and stabilization -- results in a less favorable substrate as often good soil for germination and growing can be washed away prior to hydroseeding efforts -- even considering that issue we were able to achieve >90% vegetative cover for Finca La Paz

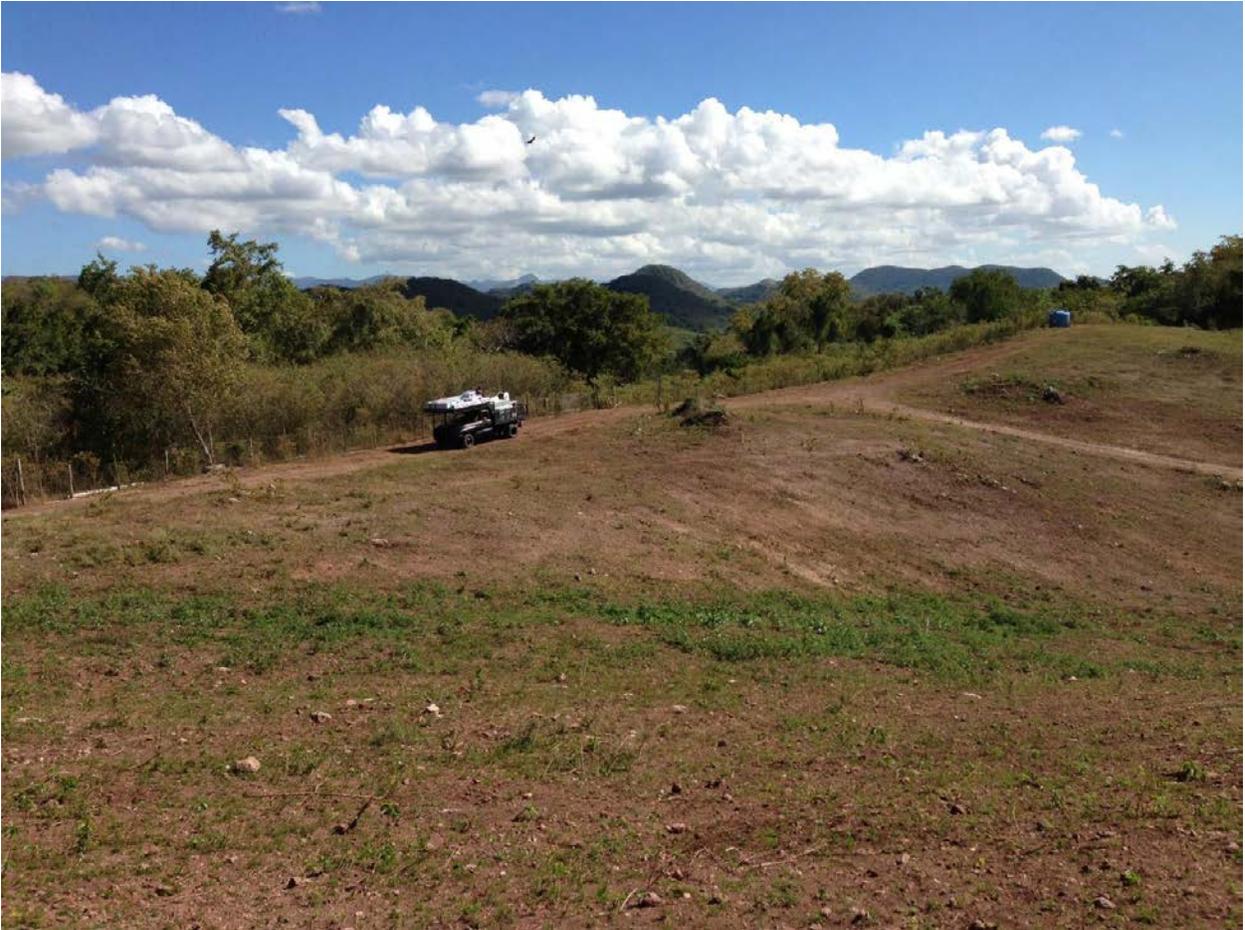
Figure 12. Part of the La Paz site prior to stabilization

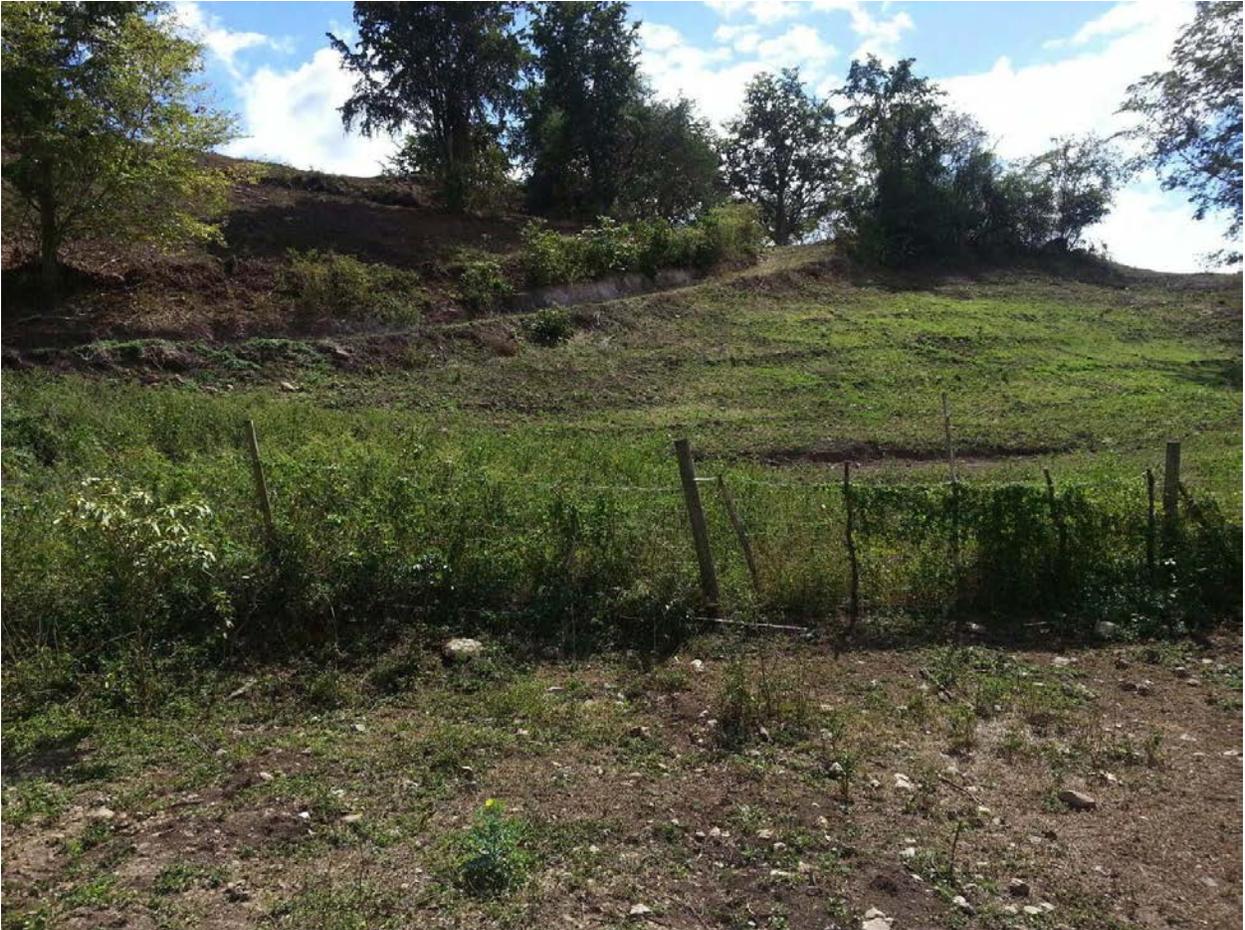
Figure 13. Germination of the La Paz site

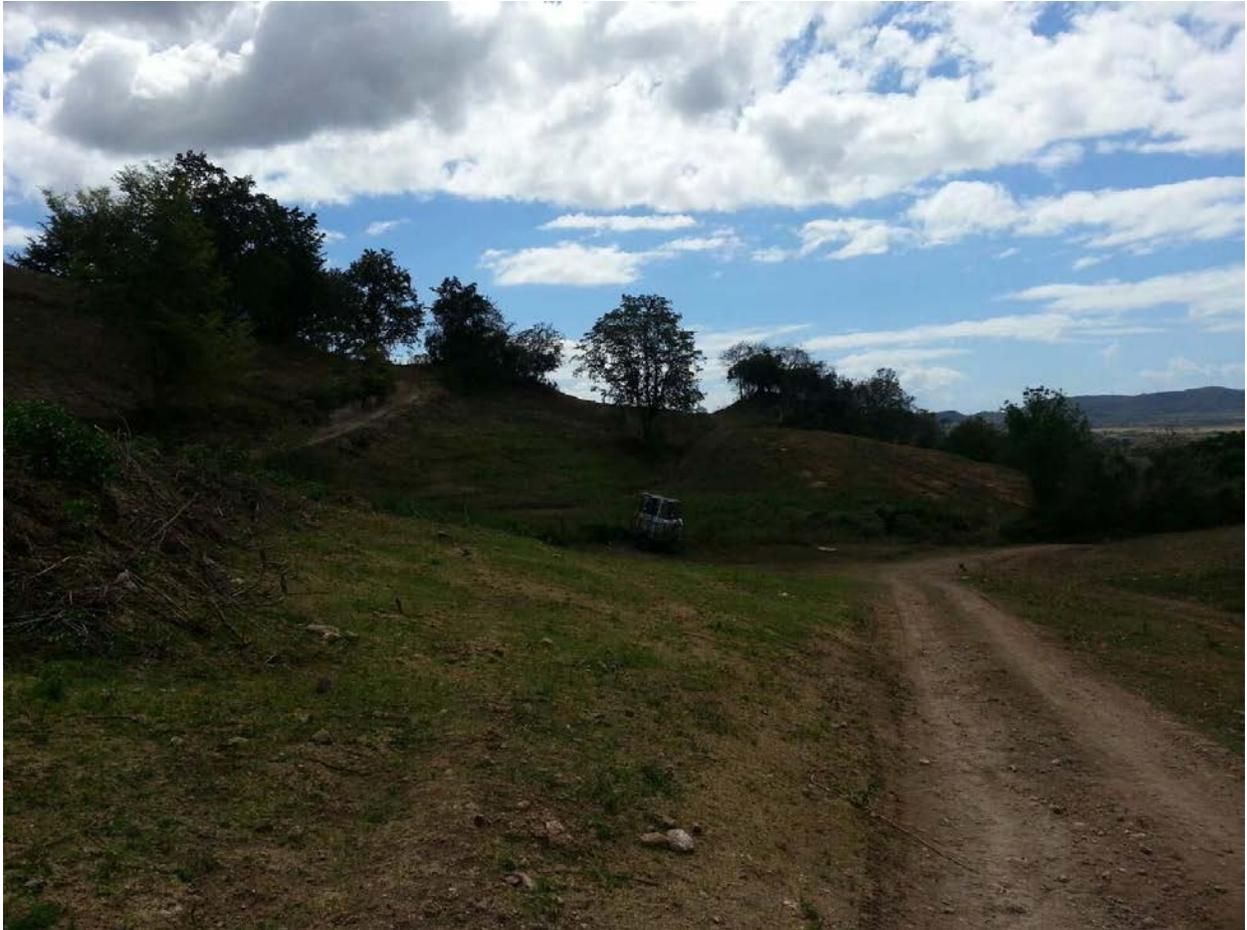
Figure 14. Germination and greening of the La Paz site

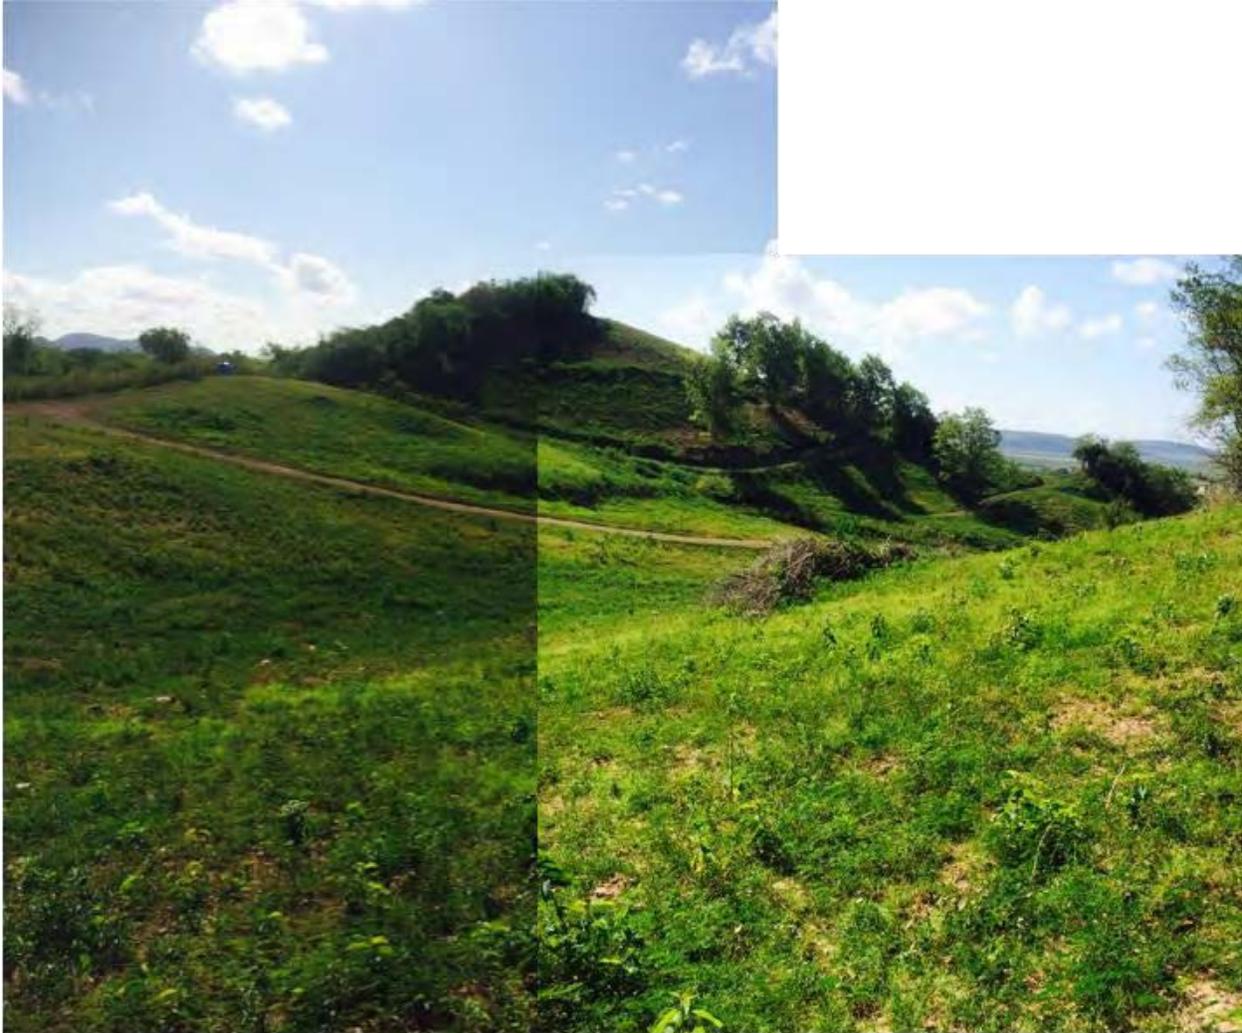
Figure 15. Stabilization at the Finca La Paz site

Percent vegetative cover was restored to the sites at the respective rates 90% and >95%, the Finca La Paz farm site stabilization was diminished slightly due to the age of the site as it has been over 60 days since the site was cleared by the farmer –this resulted in lost soil, more sporadic growth at first and compacted soil making stabilization more challenging including lengthening the amount of time we needed to water than a freshly cleared site (Note: re-clearing the farm site would have increased cost and the risk of even more soil loss if a storm were to happen). Match in FY2013 included: water for hydroseeding and for watering to ensure germination and successful stabilization; labor from volunteers and agencies including Puerto Rico Department of Natural Resources

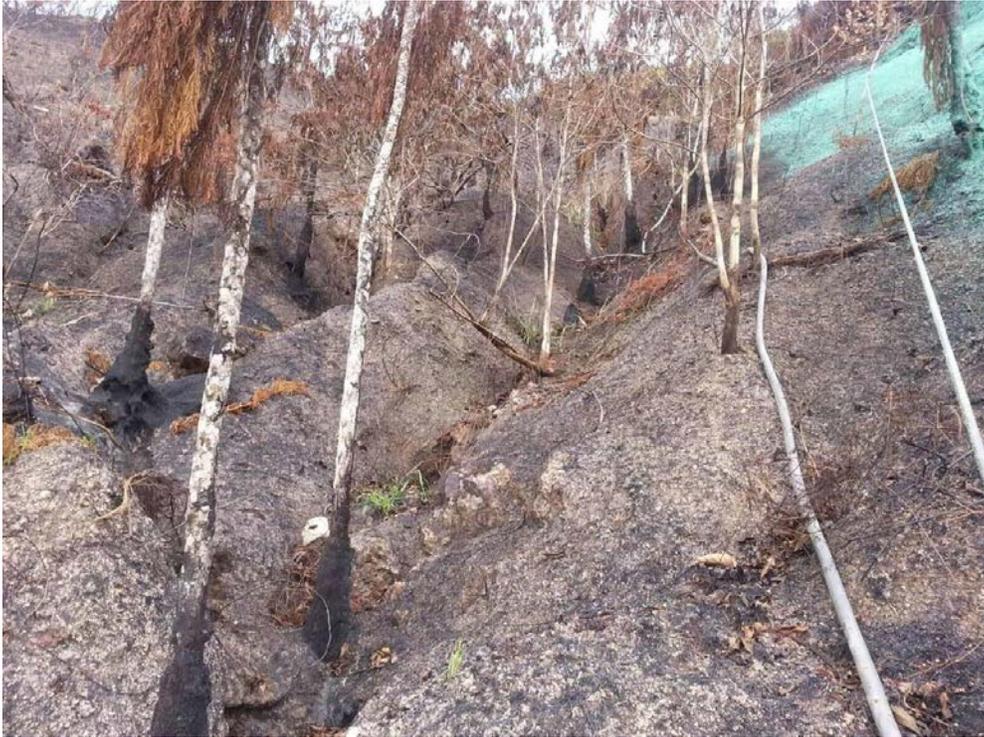
Figure 16. Conditions after the burn (note stabilization efforts on left)

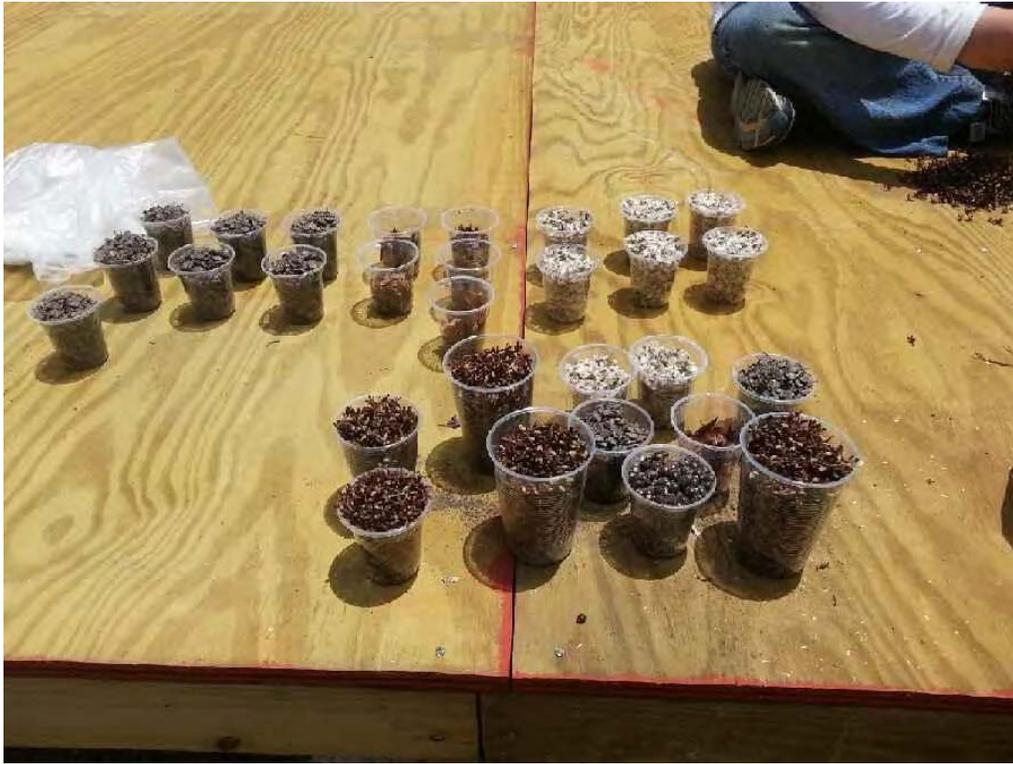
Figure 18. Native seeds used in the hydromulching mix

- **it is possible to incorporate native tree and shrub species into hydroseeding mixtures with seeds collected by local biologists and members of the community**

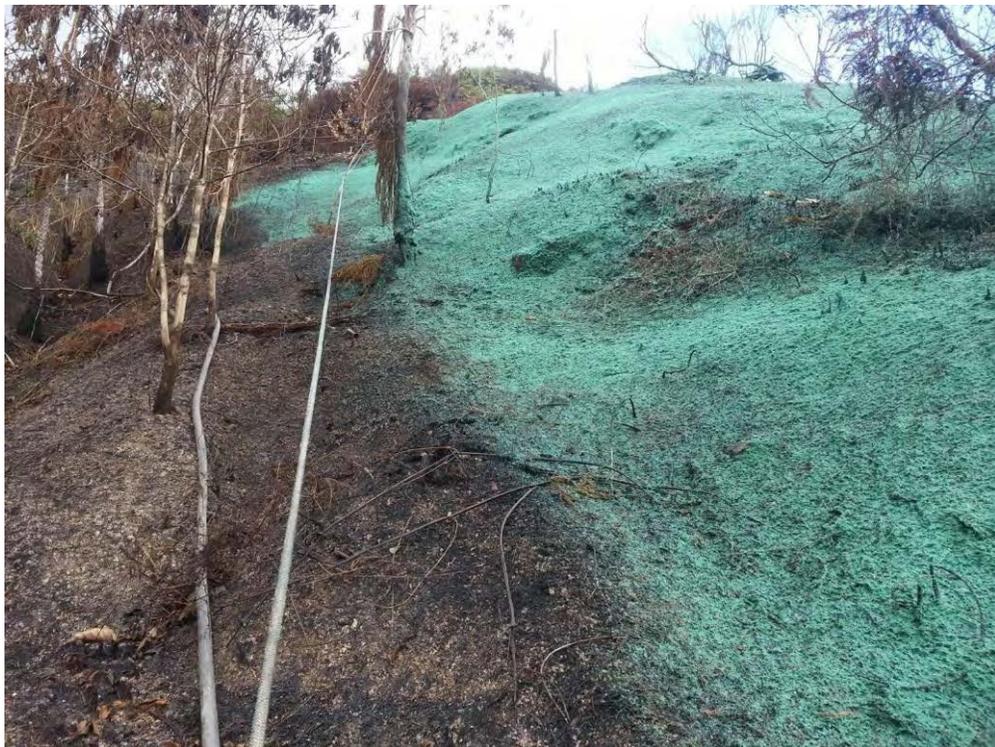
Figure 19. Post stabilization of one of the sites in Bosque del Pueblo

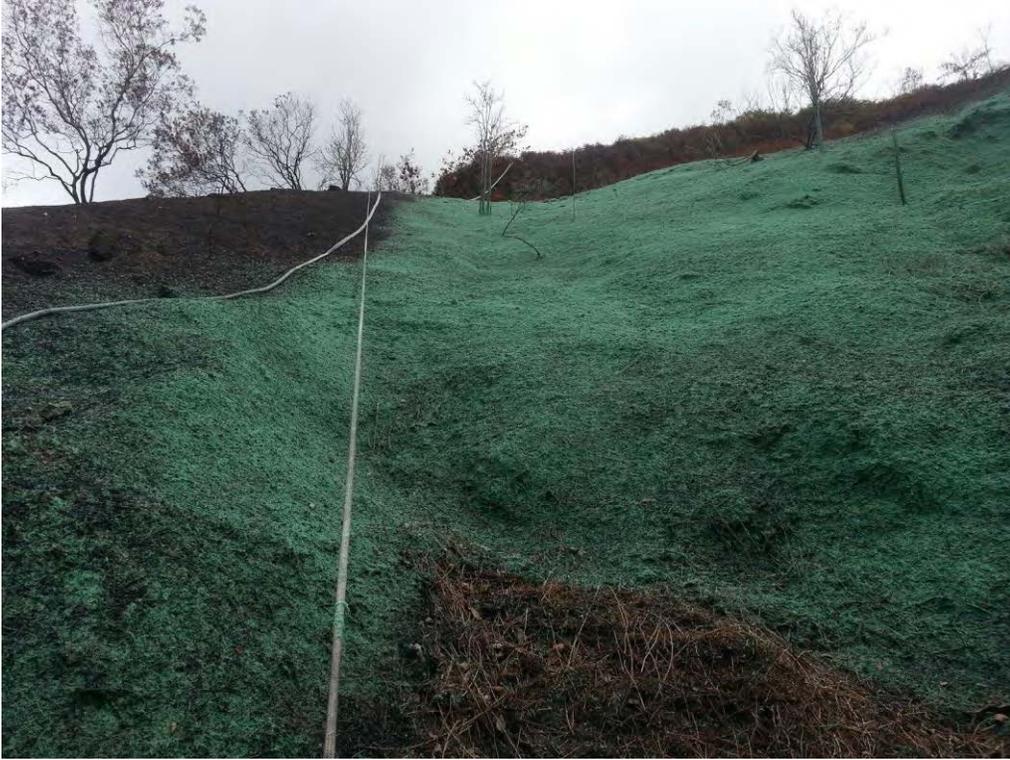
Figure 20. Test plot in Bosque del Pueblo

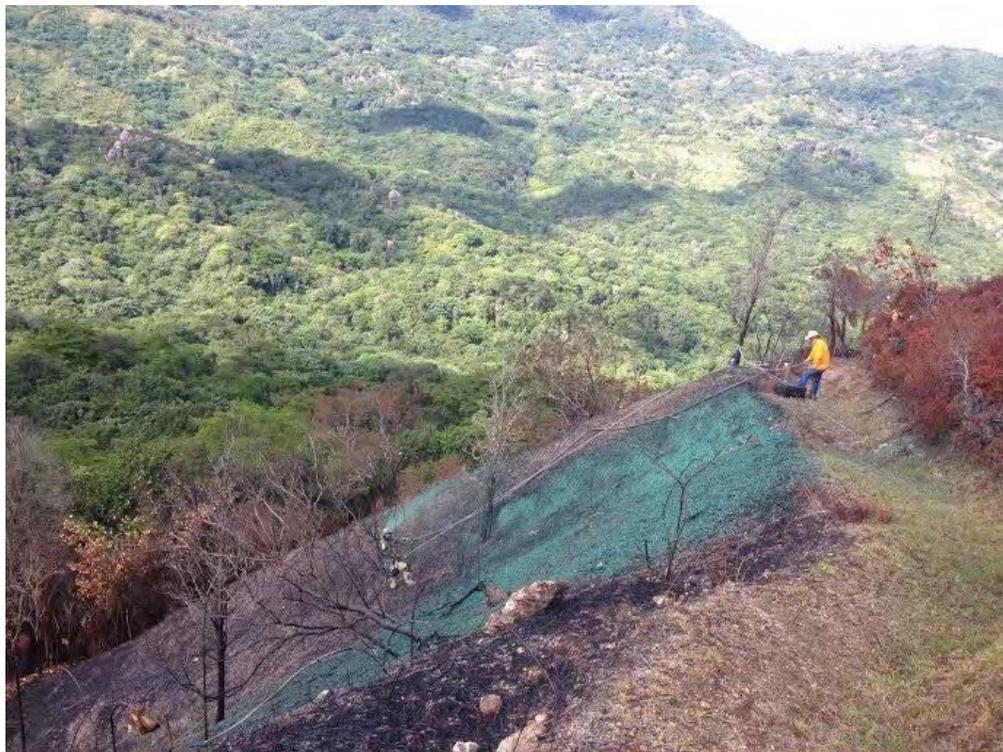
Figure 21. Laying out the test plot and applying hydroseeding

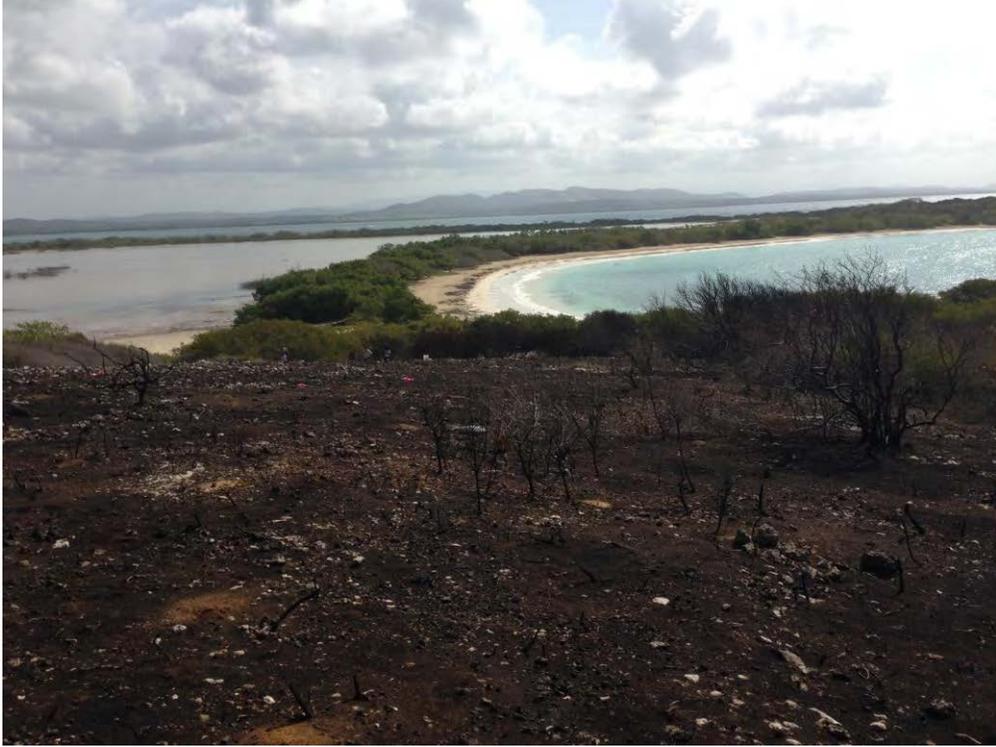
Figure 23. Burn site prior to restoration efforts

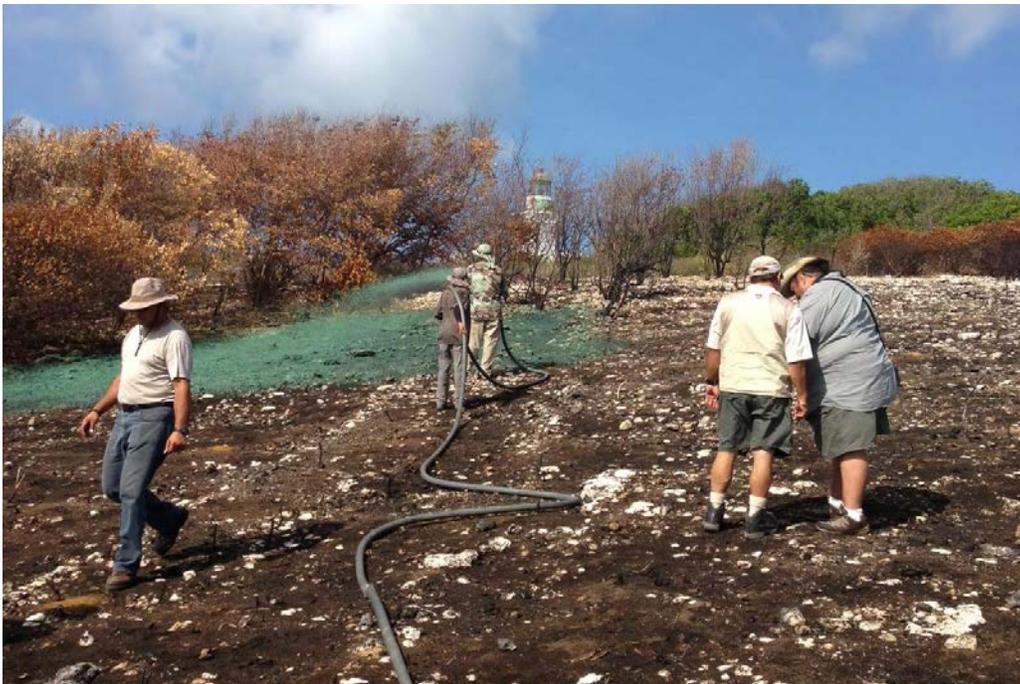
Figure 24. Hydroseeding and restoration effort

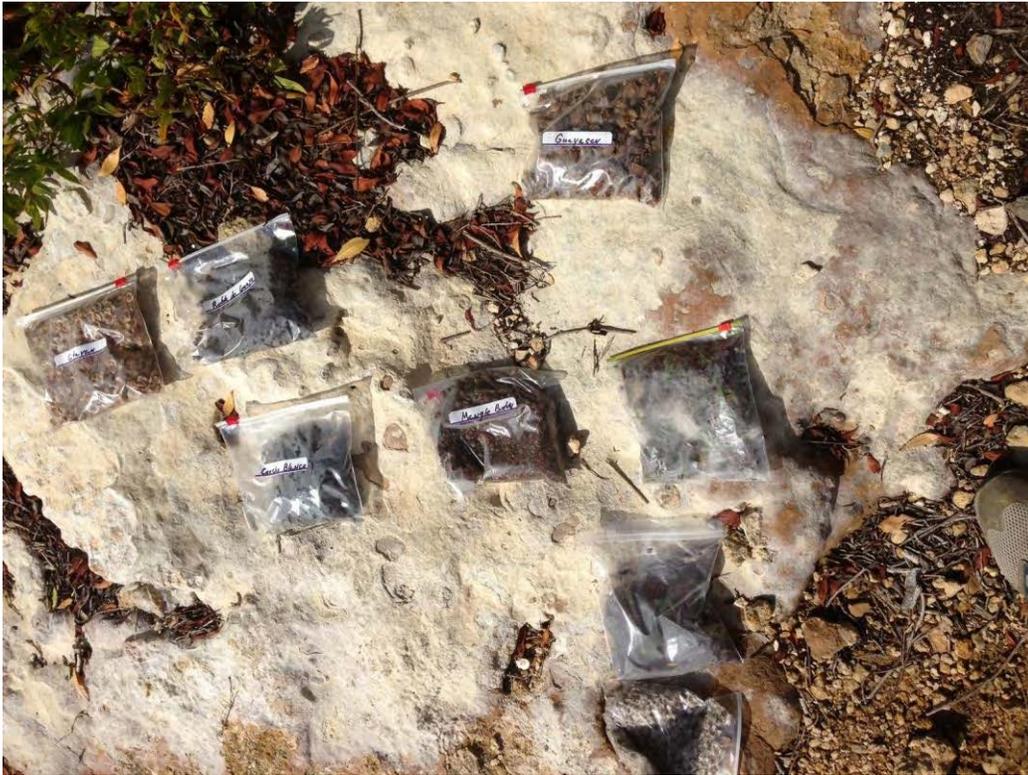
Figure 25. Native seeds used in hydromulching mixture
