FIELD ASSESSMENT NOTES

Subwatershed: Bavon

Site Name: BCB School (BO-1)

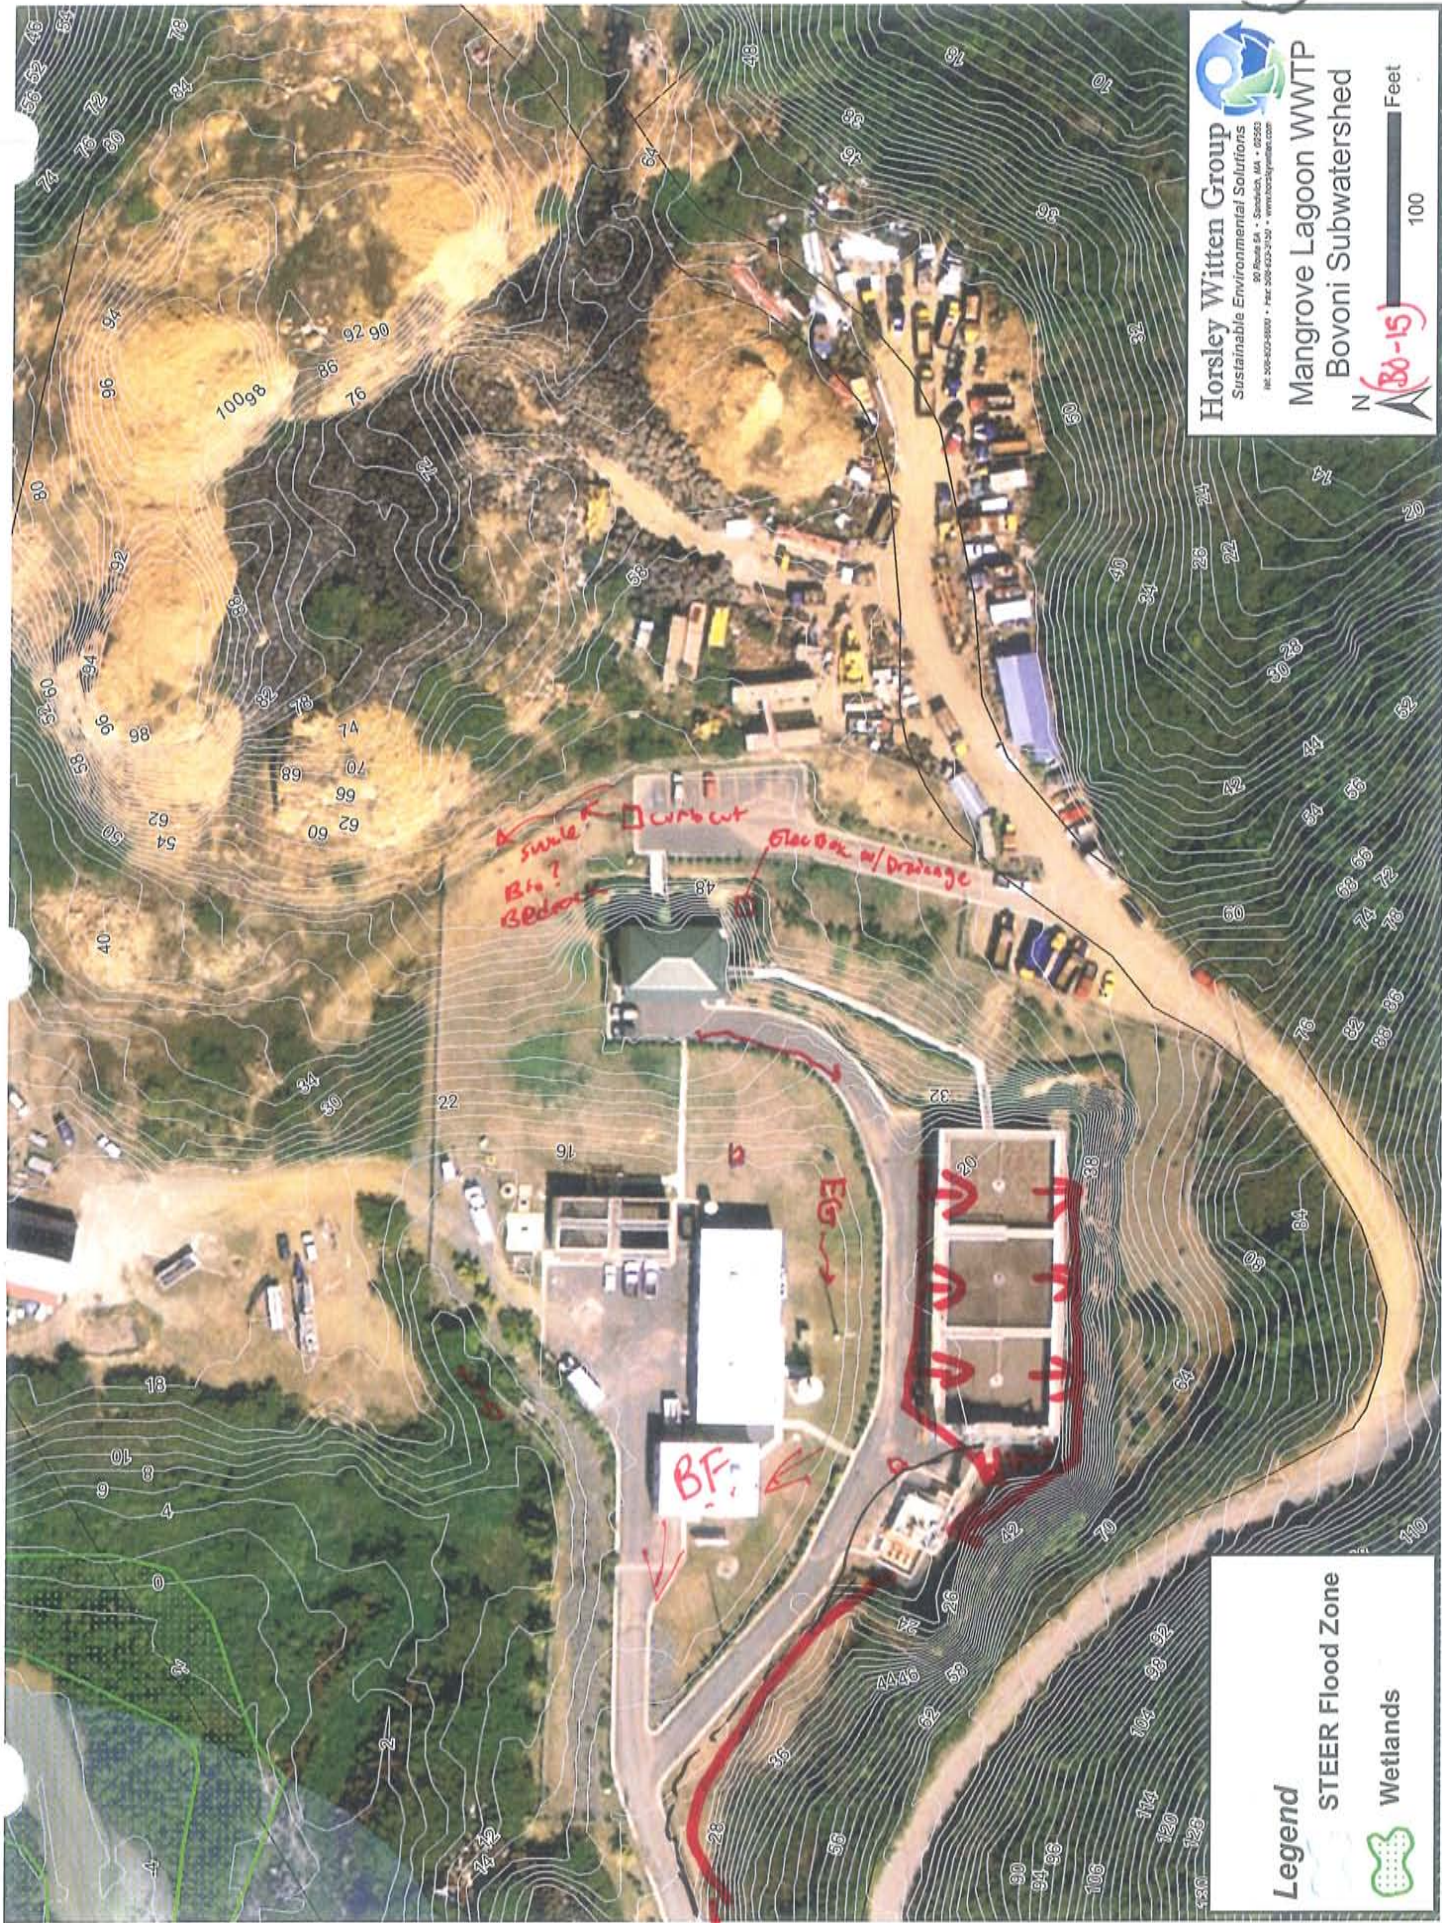
Mangrove Lagoon WWTP
Bovoni Subwatershed
N 80-15
Feet
100

- going to replace Versup

food station connect to ML then to Versup.
