FIELD ASSESSMENT NOTES

Subwatershed: Nadir

Site Name: Elm Rd/gut NG-1

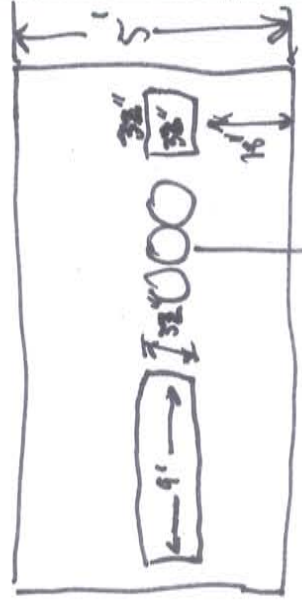
Tropical Marine
DS End

- gut takes a right angle turn to go under road ulvvert. There is an existing set of plans for a proposed stream restoration project here.

- Reports that septic pump out vehicle discharge at this ulvert/location

- Surface of boat yard drains directly to bay without treatment.

- Consider pollution prevention opportunities here such as
① paving for areas where fluids are drained.

- ② trench drain to O/W separator
- ② or sand filter
